Window Survey

The window frames and sash of 32-34 Mt Auburn Street are a mix of old and new components. The frames are original 1920's openings, with parts of the casings and brick moldings replaced during the 1991 renovation. The sashes are not original, with two campaigns of reproduction and retrofitting, the first in 1991, and the second sometime in the past 10 years.

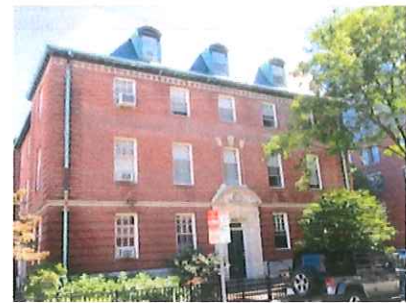
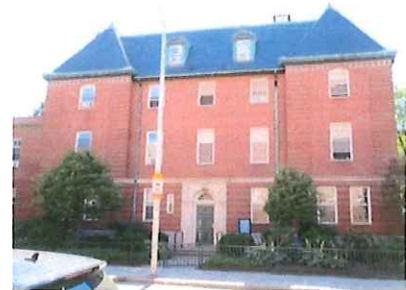
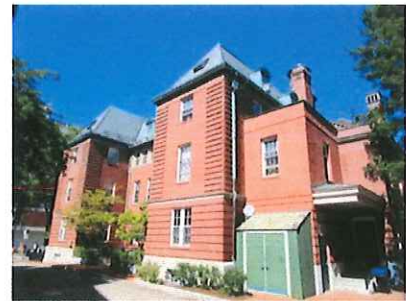
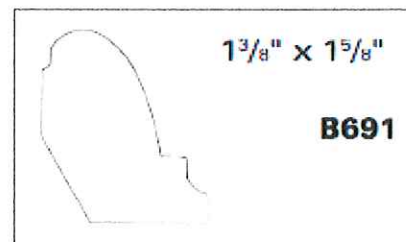
Brosco B691 brick moldings replaced in 1991

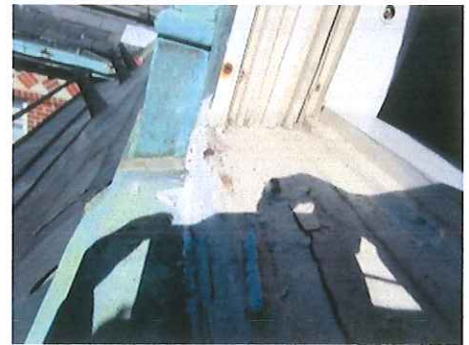
Group A- Copper clad exterior trim and sill requiring repair

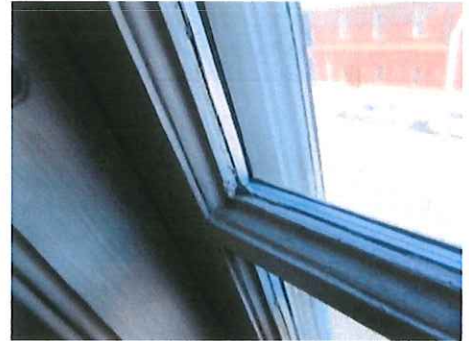
- Sash were retrofitted with insulated glass in 1991.
 - Glazing rails were cut deeper and wider to accept 1/2" insulated glass
 - The insulated glass putty glazing is failing

Group A- Retrofitted insulated glass

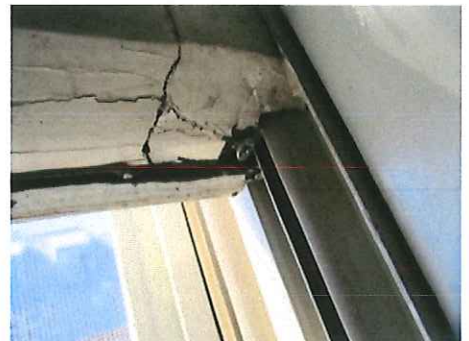
Group A- Plastic spring balance jamb liner

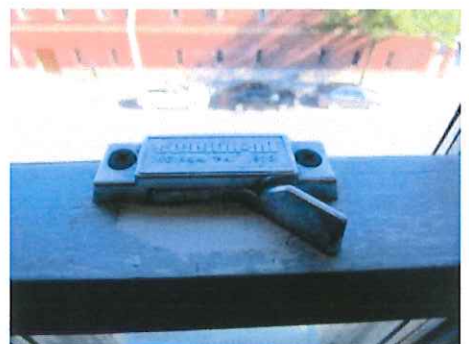
Group A- New Lock

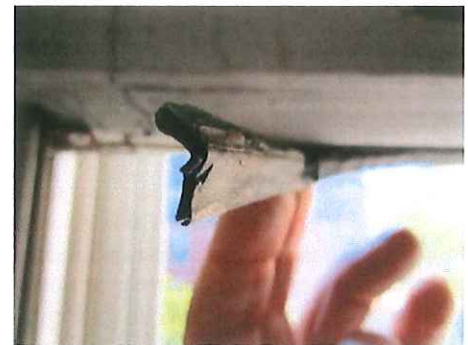
Group A & B- Bottom sash weather stripping

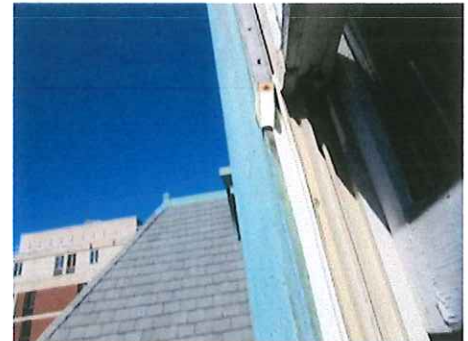
Group A & B- ½ screen hardware

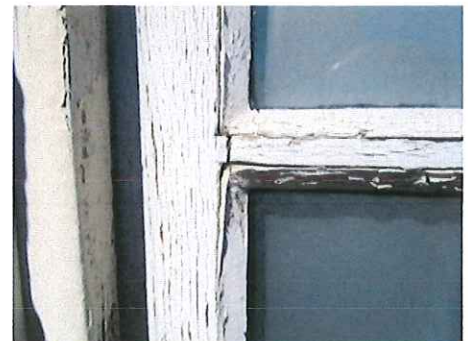
Group A & B- Sash cut for IGU. Paint, glaze, & wood in poor condition

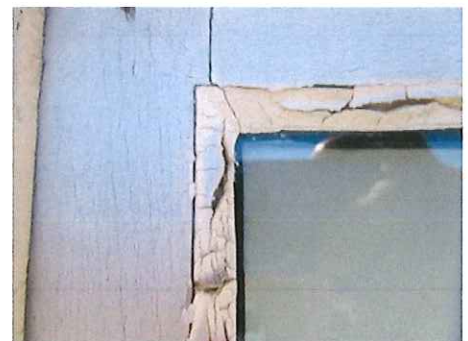
Group A & B- Sash cut for IGU

The sashes are not original and they have been modified in a way that makes repair ineffective. The 1991 modifications included cutting the glazing rabbets deeper and wider, as well as the stiles cut to accept the initial plastic jamb spring balance and later tube spring balance, have compromised the integrity of the wood sash. And since the balance and weather stripping systems have been ineffective from the start, retrofitting yet another system will not guarantee an effective operating and weather stripping system.

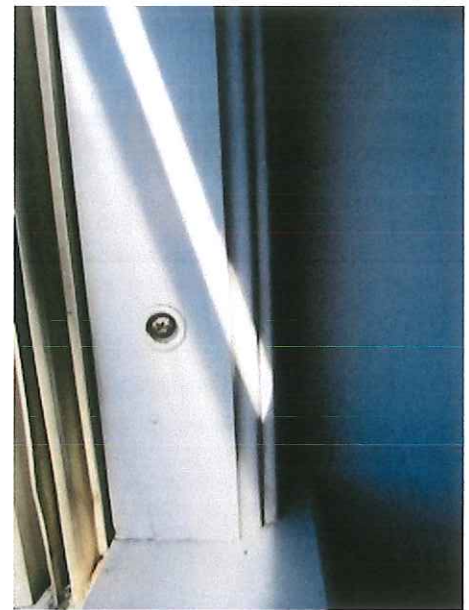
Group A & B- Original stop

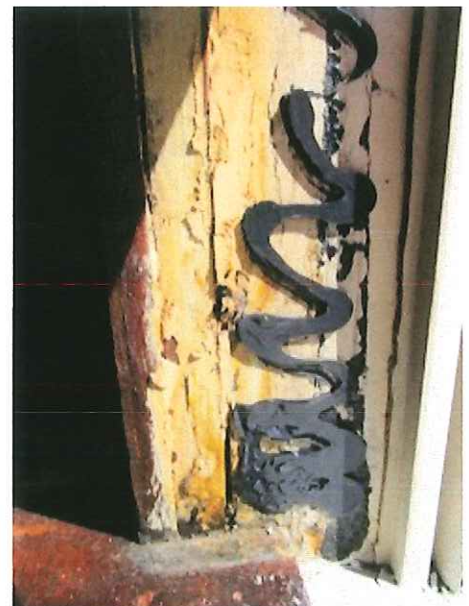
Group A & B- Lower sash with aluminum clad jamb and original paint behind

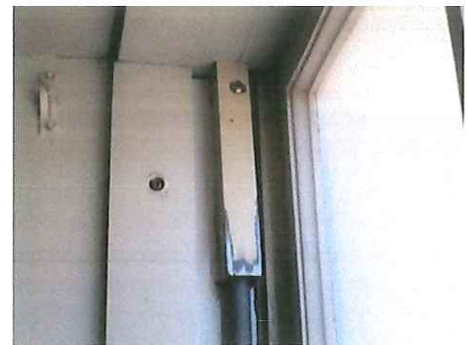
Group B- Lower sash tube spring balance

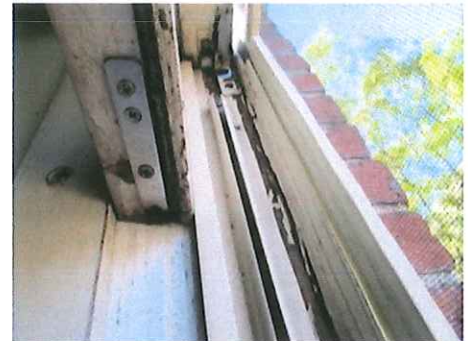
Group B- Upper sash plastic spring balance jamb, and lower sash tube spring balance with aluminum jamb

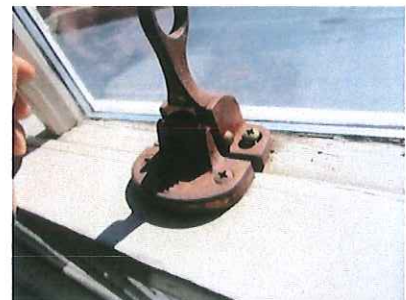
Hardware- Does not seem to be original, since they are designed for use on sash with a pole.

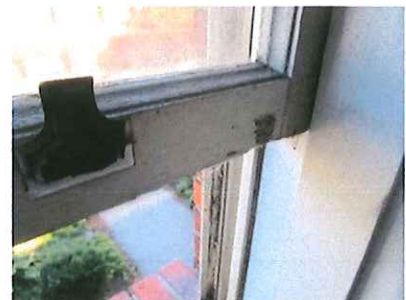
Hardware- Only a few lifts. May be original

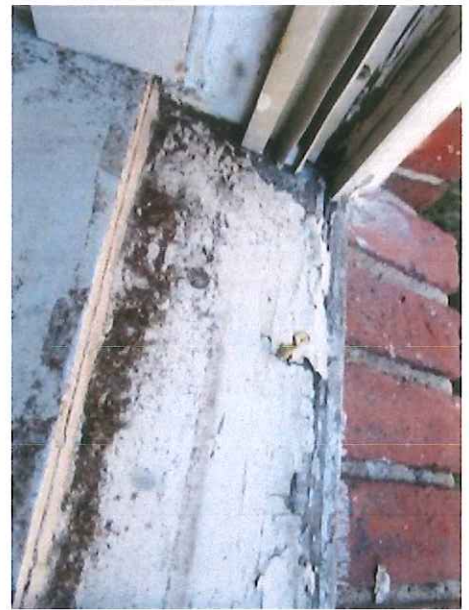
Group A, B, & C- Sill require scraping, consolidation, and refinishing

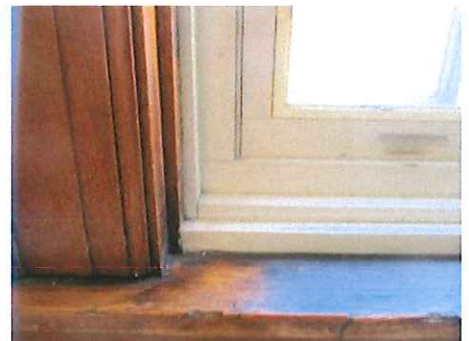
Group C- New window insert's jamb and balance extends past the original jamb by about 1”

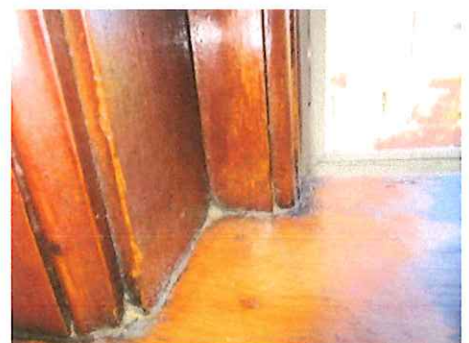
Group A & B- Original jambs and stops
