TAC STATION CONDITION SURVEY REPORT:

On July 20th at 5:30 Members of the Transit Advisory Committee Subcommittee on the MBTA made a site visit to Lechmere Station to assess the conditions of the station.

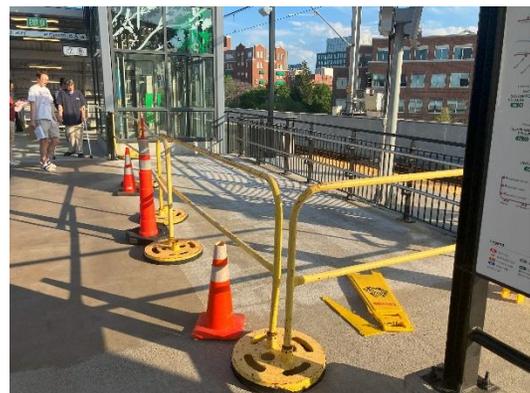
Figure 1 Section of Station Closed Off by Barricades

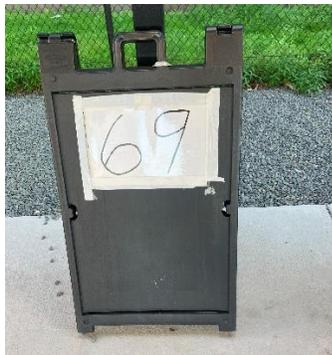
The ability to make connections at Lechmere was where the station suffered. The busway contained only signage for one bus line, the 69 bus, and this sign was on a temporary sandwich board. There were no signs for any of the other bus lines, including for EZride. The subcommittee could only locate one area map in the entire station. The station had an impressively large number of bike racks due to the two pedal-and-parks, but neither were open or usable. The subcommittee hopes the MBTA will open the pedal and park soon.

Figure 2 The Only Signage at the Busway
