## STRUCTURAL REPORT

Re: Project 2018-54

2 Chetwynd Road, Cambridge, MA

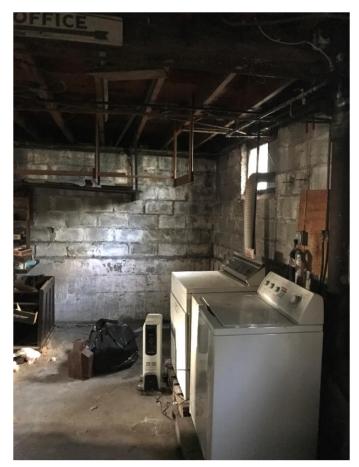
Photo 3 Basement

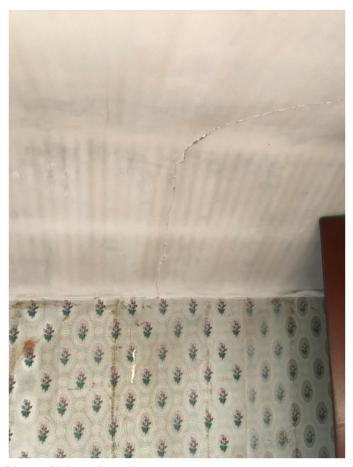
Photo 5 Moisture intrusion
