Out of Town News - Historic Restoration
08.01.16

CONCEPTUAL DESIGN STATUS AS OF: 08.01.2016

GPR INVESTIGATION OUT OF TOWN NEWS STAND CAMBRIDGE, MASSACHUSETTS

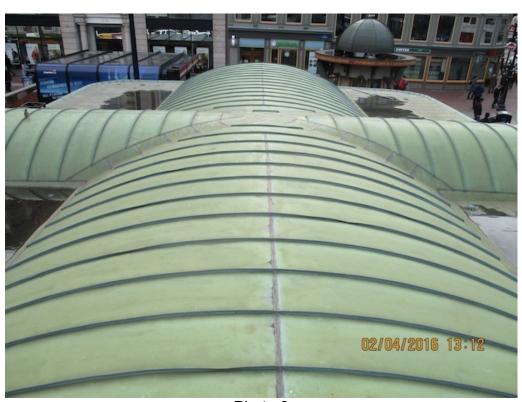
Photo 6

Facing South and showing three obstructed drains. Water infiltration is occurring when failed solder joints within the flat seam copper system are flooded.

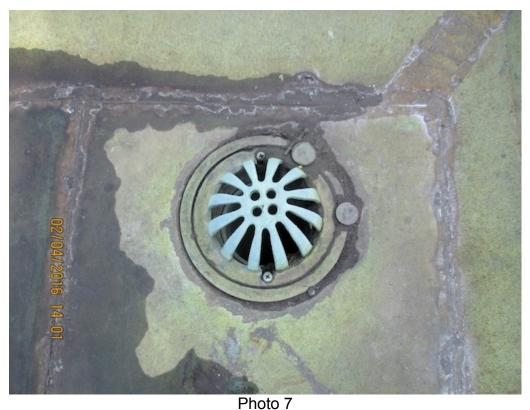
Detail of 3" bronze roof drain. Drains on the East and West elevations are leaking at the exterior wall, below the soffits.

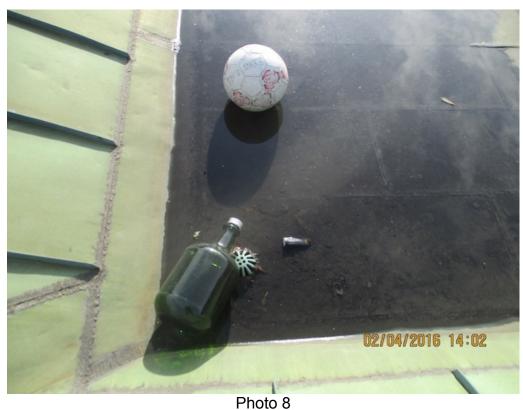
Southwest roof drain. All copper drain lines should be "scoped" to determine their interior condition.

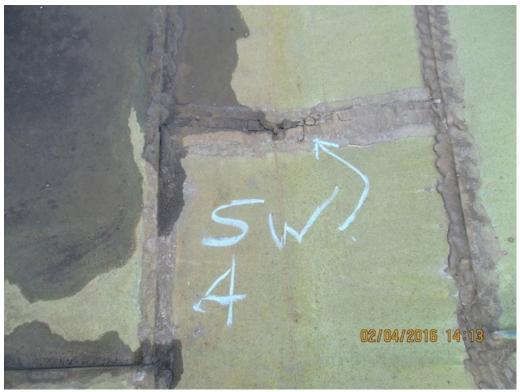
Photo 9
Failed solder seam at the low-slope/ steep-slope transition.

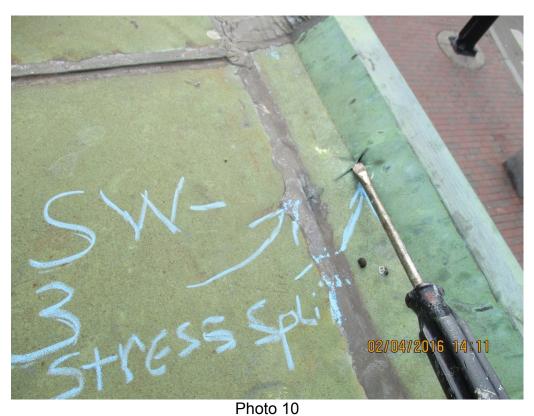
West elevation eave: Copper stress failure due to restricted thermal dynamic movement.

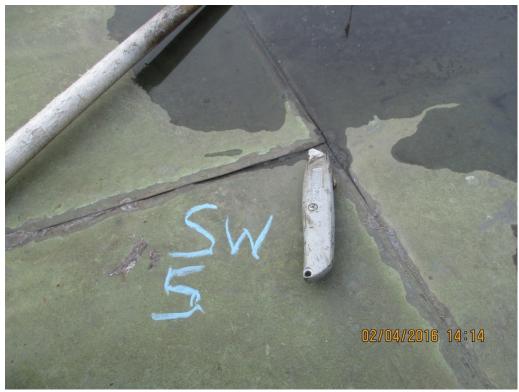
Photo 11
West elevation: Solder seam failure in the flat seam copper roof.

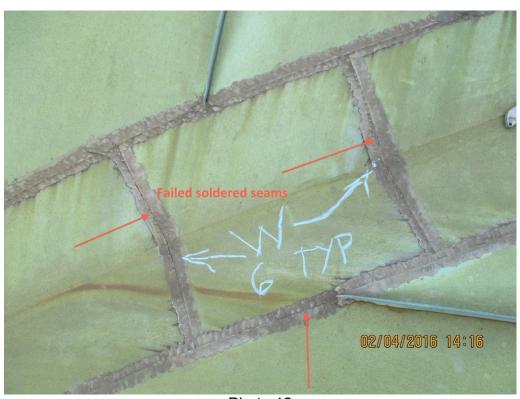
Photo 12
Southwest valley: Multiple solder seam failures (TYP).

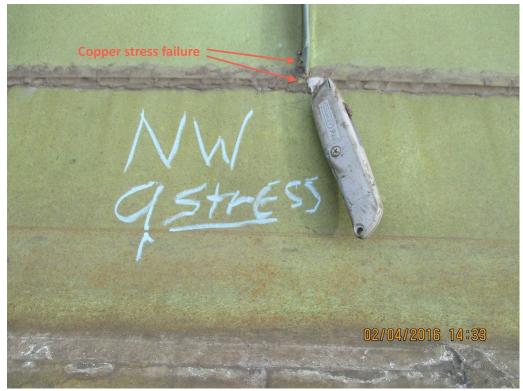
Photo 13
North elevation: Copper stress failure at the flat seam/ standing seam transition.

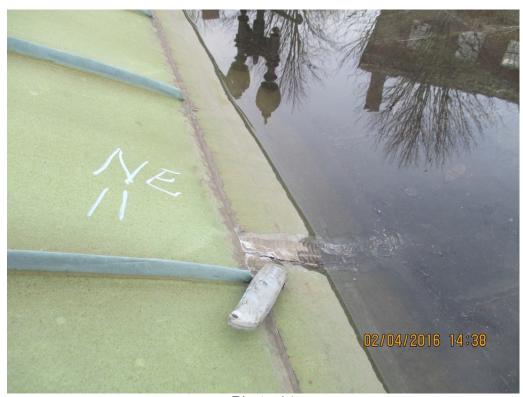
Photo 14
East elevation: Failed solder seam at a water infiltration site.

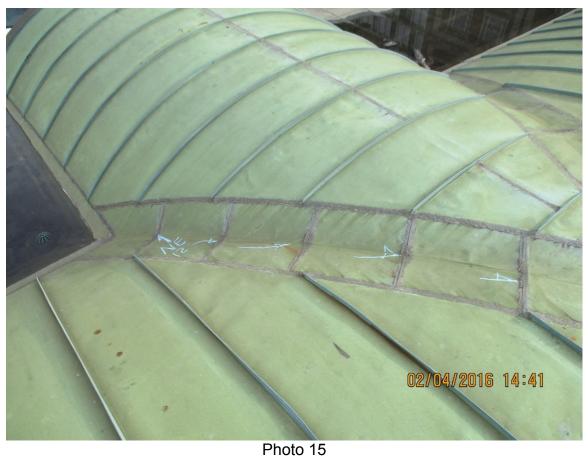
Northeast valley: Multiple failed solder seams. Note: "oil-canning" due to lack of thermal movement provisions.

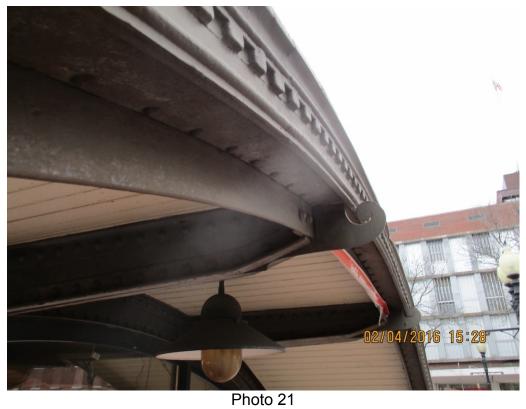
North elevation: Detail of decorative lead coated copper cornice and steel framing.

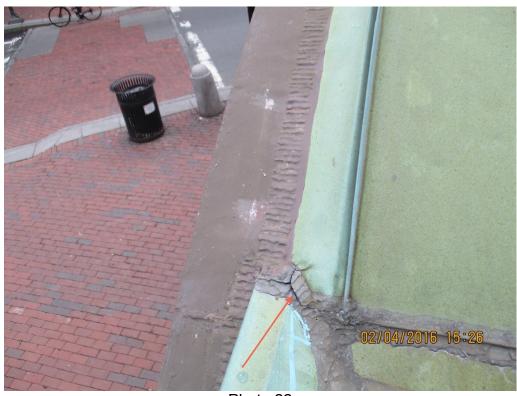
Photo 22

North elevation: Detail of transition between the standing seam copper roof and decorative cornice. Note failed solder joint.

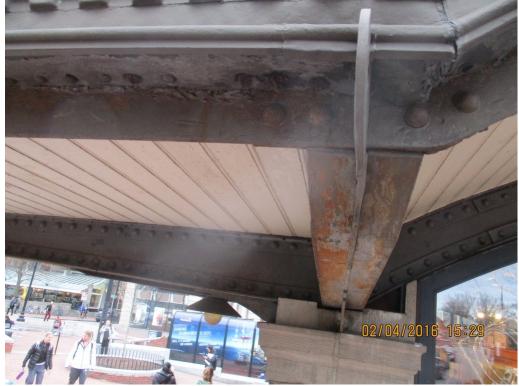
Photo 23

North elevation: Detail of decorative cornice attachment to steel framing. Note accelerated oxidization of the lead coated copper cornice and steel rivets due to a lack of dissimilar metals separation.

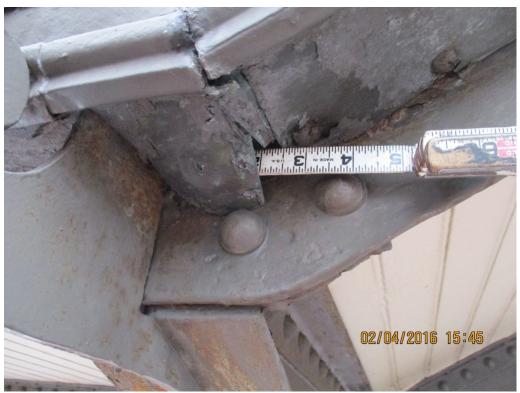
Photo 24

North elevation: Note decorative cornice deterioration due to water infiltration and a dissimilar metals reaction.

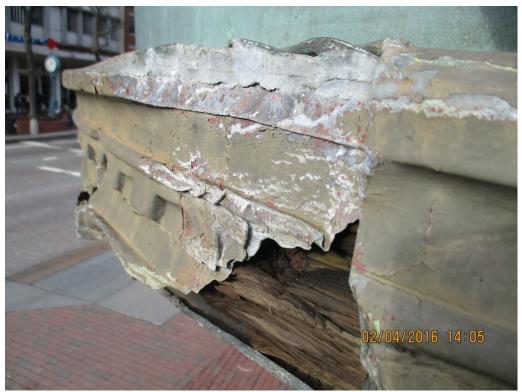
Photo 25
Southwest decorative cornice damage and wood blocking.

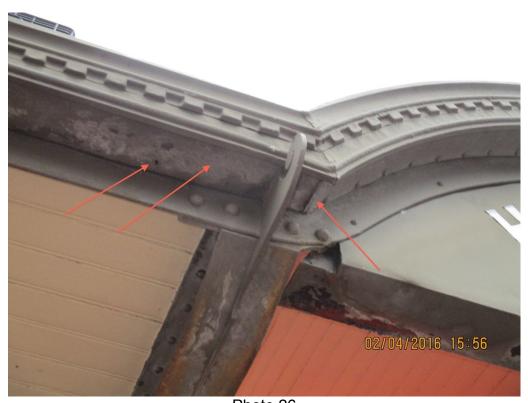
Photo 26
West elevation: Decorative cornice detail. Note accelerated oxidization of the lead coating.

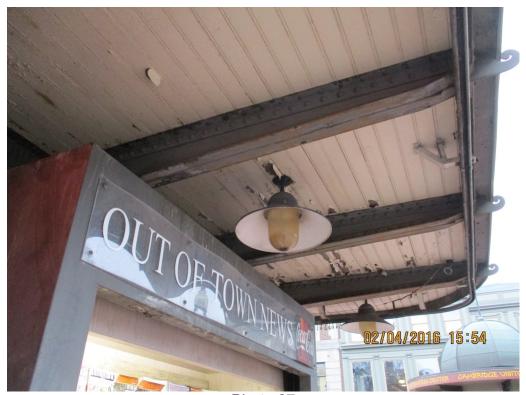
Photo 27
Northwest soffit deterioration.

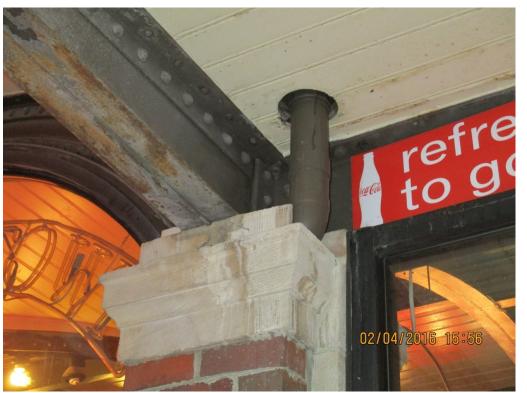
Photo 28

Northwest copper roof drain leader. This detail is source of water infiltration within the masonry chase and was leaking on the day of inspection.

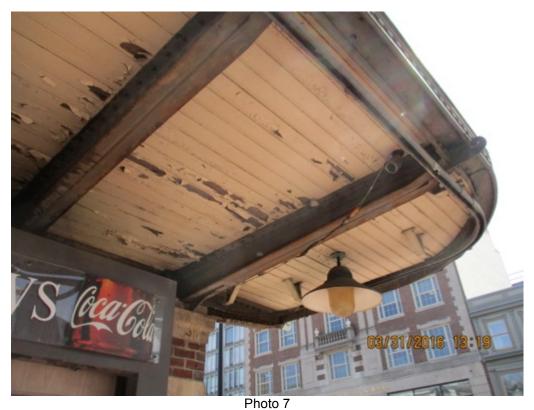
Significant oxidization due to a dissimilar metals reaction and water infiltration.

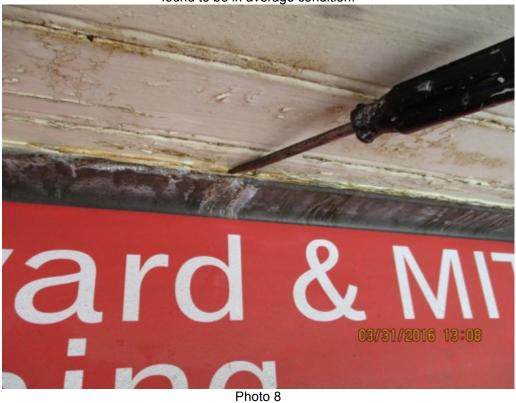
Soffit at the Northeast elevation. Although evidence of water infiltration exists, the cedar soffit was found to be in average condition.

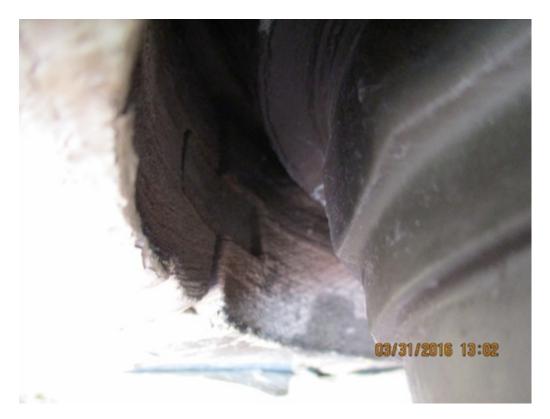
East elevation soffit showing oxidization of the steel frame due to water infiltration.

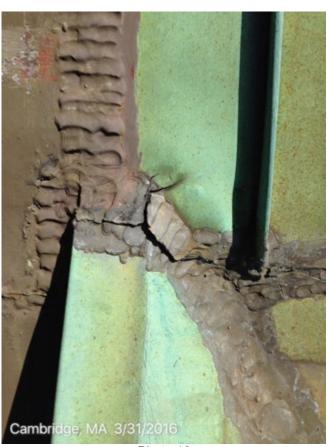
Photo 10

North elevation showing stress fractures at the copper cornice/ roof juncture, due to a lack of thermodynamic provisions.
