50 YORK STREET – PHOTOGRAPHS OF EXISTING CONDITION

Impact of December 3, 2016 Fire on 50 York

**RE: 50 YORK STREET
CAMBRIDGE, MASSACHUSETTS**

SUBJECT: FIRE DAMAGE INVESTIGATION

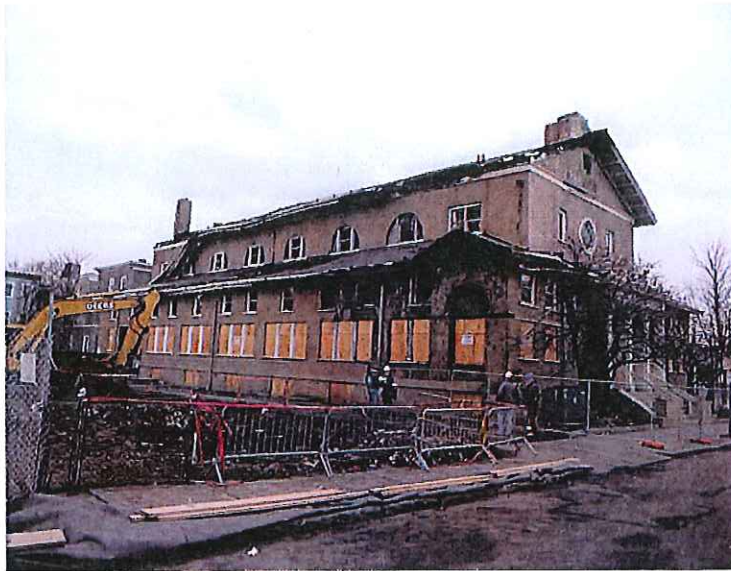
Photo 1

- By observing the building from outside, we noticed fire damage to the First Floor and Second Floor units at the southeast corner of the building, to the existing Second Floor roof over the southern units, and the south side of the main roof of the building. Please see Photo 1.

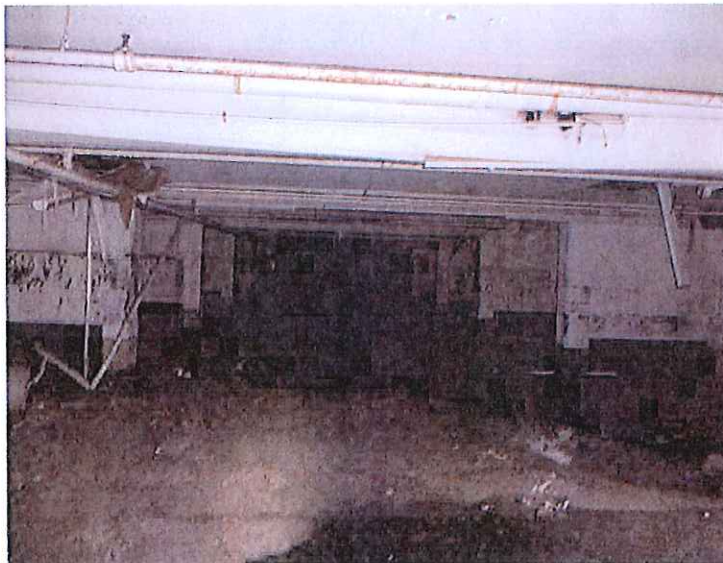
Photo 2

- We entered the basement and we didn't notice any fire damage in the basement or in the ceiling under the overhead first floor framing plan. There was water damage to the architectural elements. The ceiling was covering the First Floor Framing and we could not observe the First Floor decking or wood joists to evaluate water or any other type of damage. Please see Photo 2.

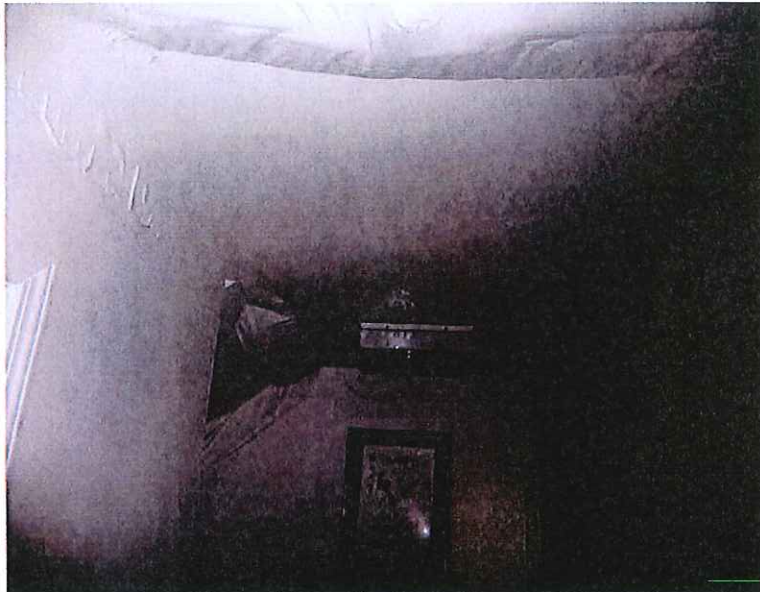
Photo 5

- We then visited the First Floor. Two units at the southeast corner were blocked off due to the partial collapse of the floor above and we observed them from the corridor. We entered the other units. The first floor appeared to be okay with some water damage and debris from the above. We went to the second floor of each unit and we noticed that the existing roof over the southern units was extensively burnt and damaged. Please see Photos 3 and 4. In addition, it appeared that the interior beam supporting the existing shed roof and the clerestory wall above was also compromised due to the fire. The units on the north side of the corridor didn't have fire damage but had extensive water damage due to the roof damage. Please see Photo 5.

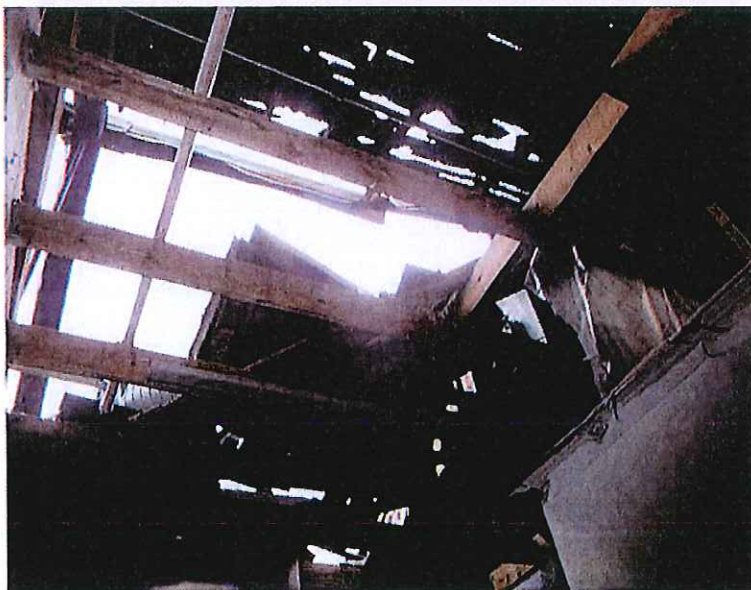
Photo 6

- We went up to the second floor so we could access the third floor units through the second floor corridor. We noticed that in every third floor unit on the south side, the existing roof over the unit was mostly burnt and the unit was exposed to the elements. Please see Photos 6 and 7. We also noticed that the existing 10x10 wood columns supporting the roof trusses were partially damaged in some units. Please see Photo 8. The top and bottom chords of the wood trusses in these units were charred and it was not possible to determine the remaining depth of the charred members. The units on the north side had partial fire damage close to the ridge of the truss and a lot of water damage due to the roof openings. Please see Photos 9 and 10.
