TAC STATION CONDITION SURVEY REPORT: (DRAFT 5/8/2023)

On April 20th at 5:30 Members of the Transit Advisory Committee Subcommittee on the MBTA made a site visit to Central Square Station to assess the conditions of the station.

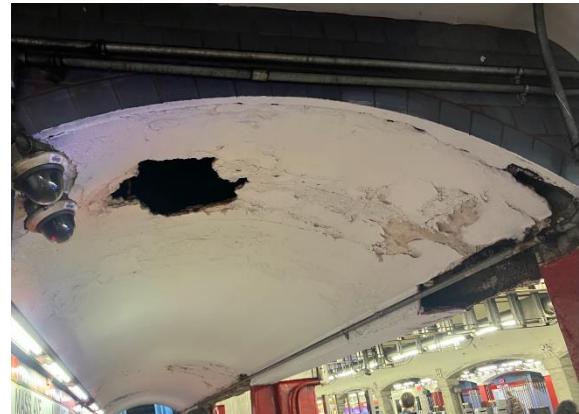
1: Hole in ceiling of station exit.

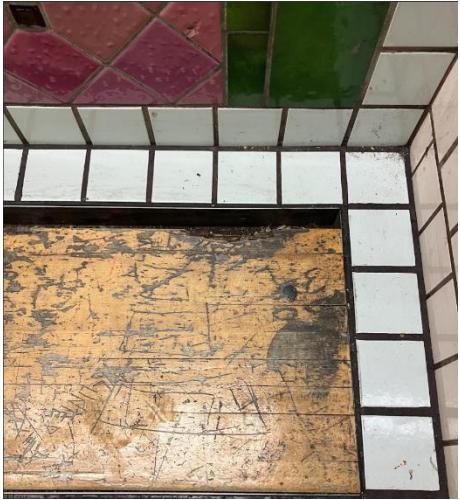
The Subcommittee found the static geometry of the station to be in poor condition. Walls, floors, ceilings, and station art were all covered in a thick layer of grime. Floor tiles were visibly water damaged in certain places, especially around station entrances and at the join between the original platform and the 6-car platform extension. The ceilings were found to be functional but in need of repair. Paint is peeling on almost every surface, and there are a number of holes in the ceiling throughout the station. Station lighting is acceptable in most places, most lightbulbs in the station are working, however several entrances, especially the entrances on the outbound side of the station are very dark, due to lightbulbs being out, lack of lights in general, and the grime. The subcommittee recommends that all entrances at Central Square station should be lighted like the east entrance on the inbound side. The seating at the station is usable and not sticky, however the wood was heavily scored and the bench in front of the watermelon tile work was missing a plank of wood. The

2: Bench missing plank of wood

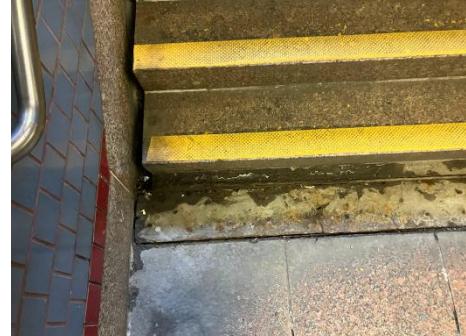
3: Visibly water damaged tiles at station entrance

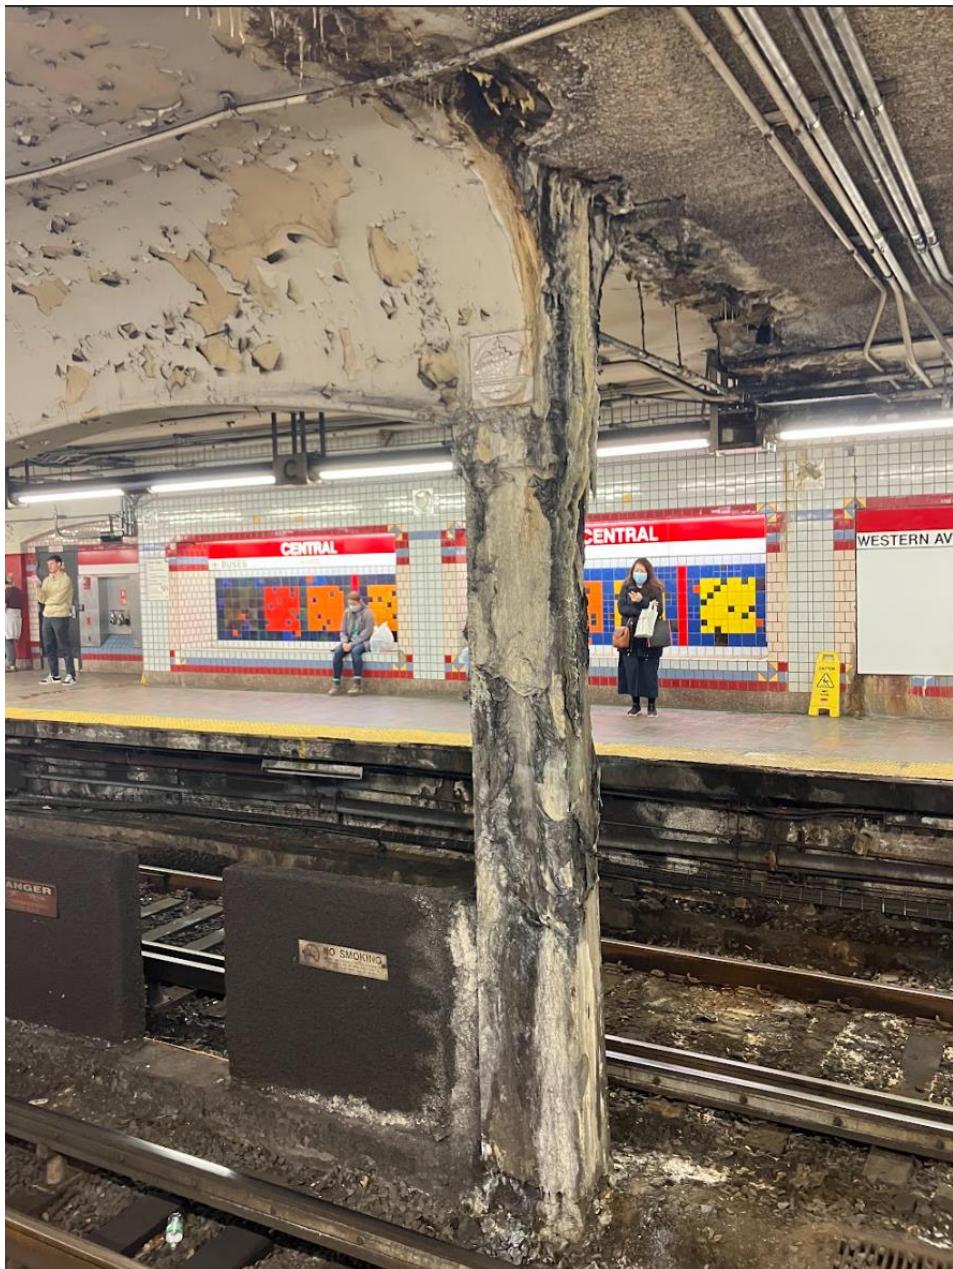
4: Water damage, area of station in need of repair.
