**Re: Design Change Amendment to PB #17 PUD special permit**

**Premises: Thomas Graves Landing Condominiums 4-6 Canal Park**

Project 190734 – Plaza Condition Assessment, Thomas Graves Landing Condominiums,  
4 and 6 Canal Park, Cambridge, MA

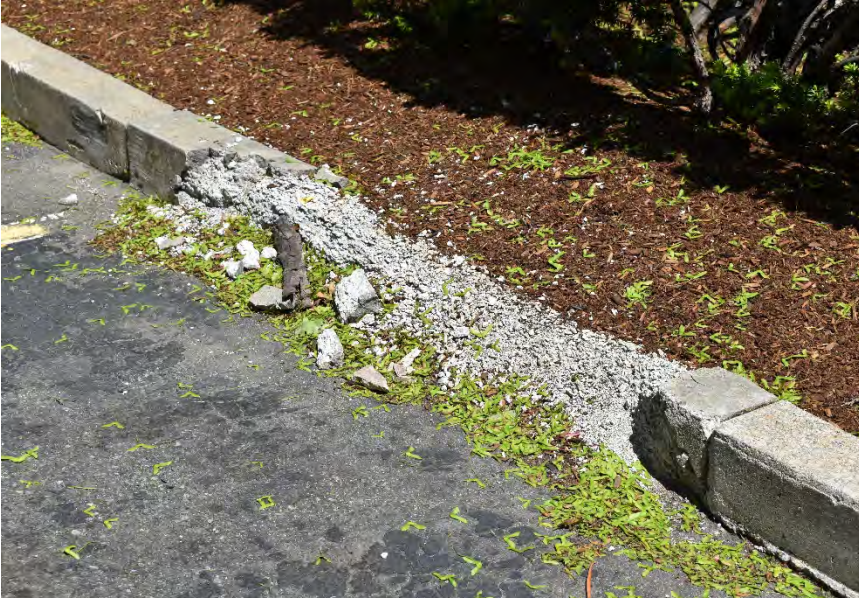
**Photo 1**

- Approximately 150 linear feet of concrete curb around the perimeter of the asphalt pavement is severely deteriorated (Photo 1).
- There are widespread raveled edges along the concrete sidewalk joints (Photo 2) and isolated areas of spalling (Photo 3) and scaling (Photo 4).

Deteriorated concrete curb.

Until the plaza rehabilitation project begins, the concrete sidewalks, curbs, and expansion joint cover plate should be repaired immediately to remove potential trip hazards.

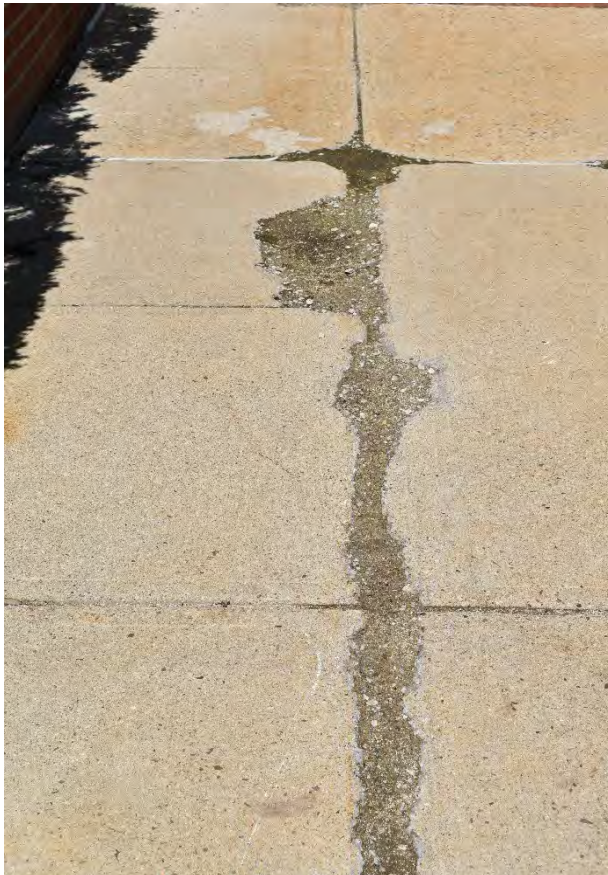
**Photo 2**

Raveled edges at concrete sidewalk joints.

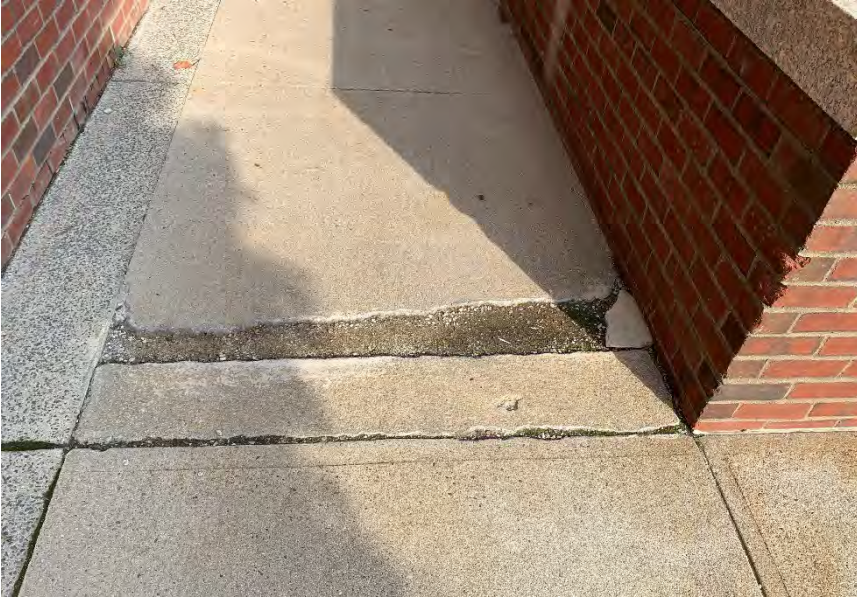
**Photo 3**

Spalled sidewalk concrete.

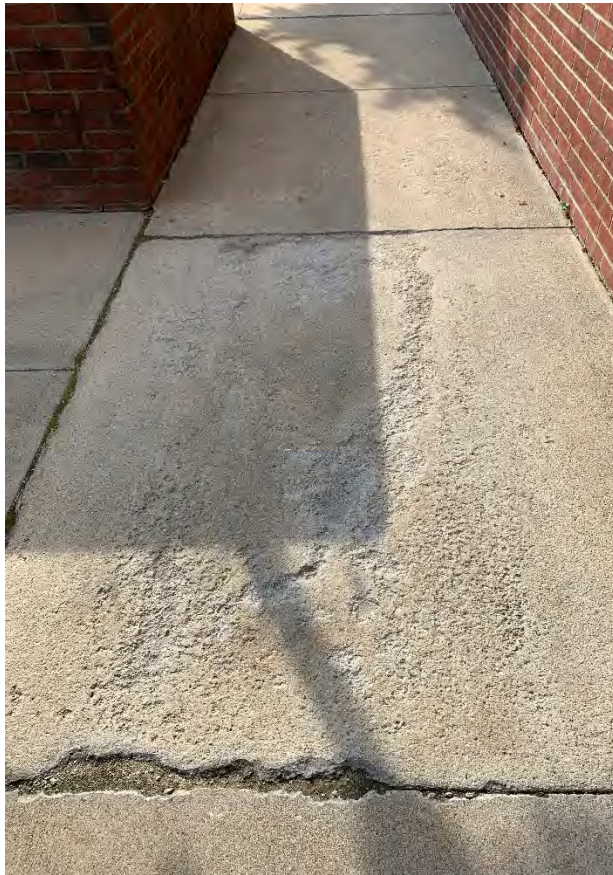
**Photo 4**

Scaled sidewalk concrete.

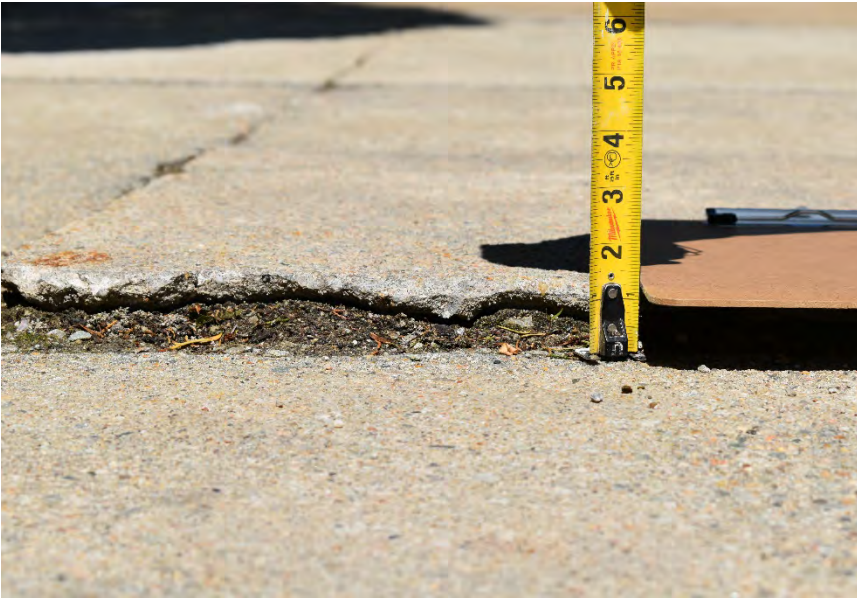
**Photo 5**

- There are several changes in elevation greater than 1/4 in. between differentially settled sidewalk panels (Photo 5) and at sidewalk spalls that create trip hazards.

Differential displacement between adjacent sidewalk panels.

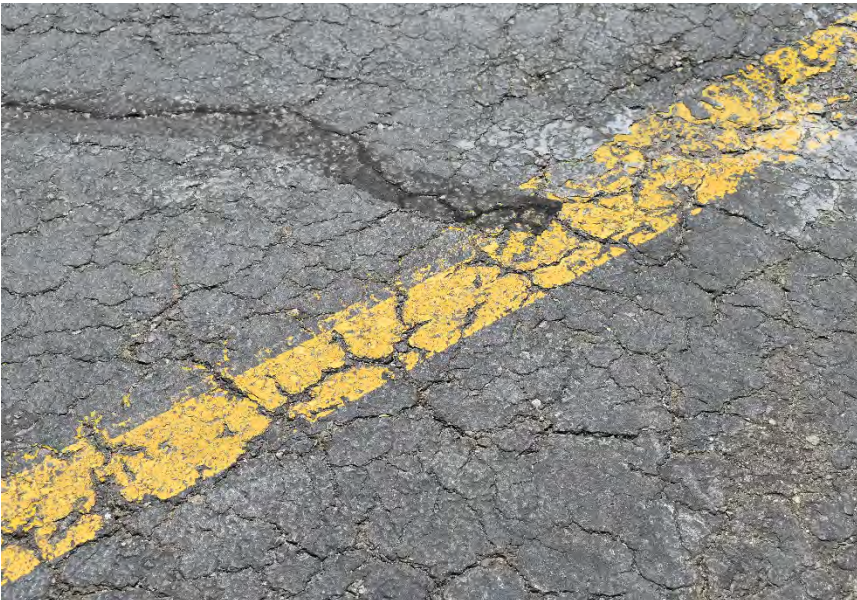
**Photo 6**

- There is widespread cracking in the asphalt pavement on the west portion of the plaza (Photo 6). An asphalt sealer is installed at some of the crack locations (Photo 7).

Cracking in asphalt pavement.

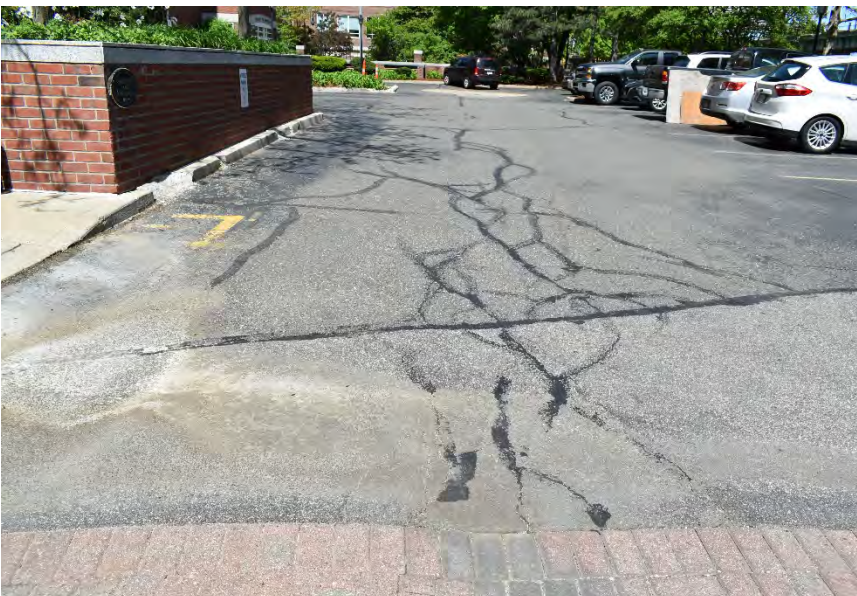
**Photo 7**

Sealer installed at cracks in asphalt pavement.

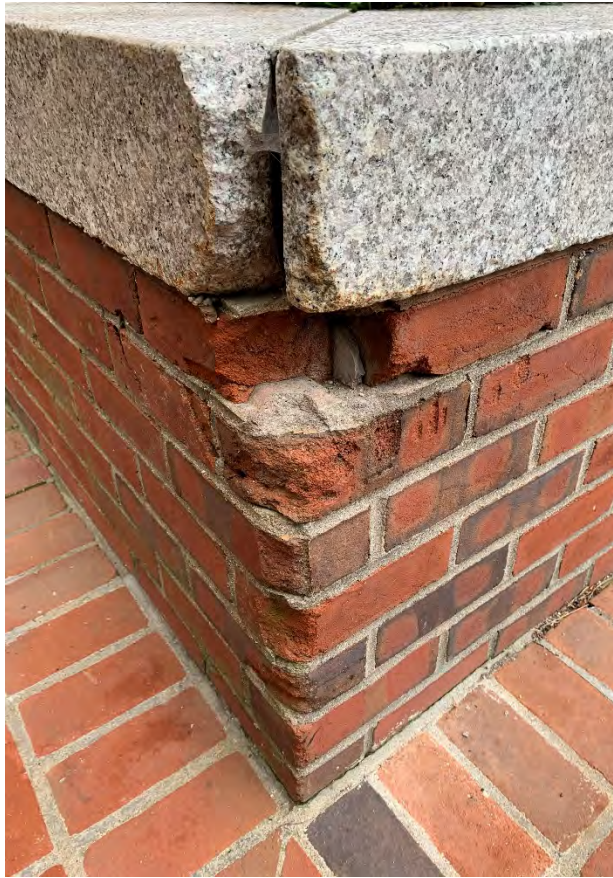
**Photo 8**

- There are isolated spalled brick (Photo 8) and deteriorated mortar joints (Photo 9) at the brick veneer on the planter walls and ramp wall.
- There is severe staining and efflorescence at weeps in the brick masonry wall at the southwest entrance to the building (Photo 10)

Spalled brick at planter.

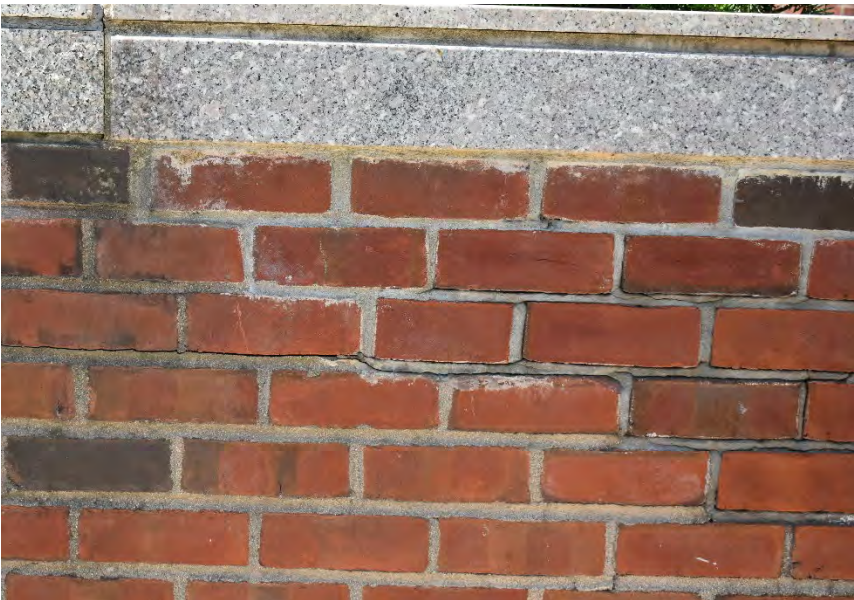
**Photo 9**

Deteriorated and cracked  
brick mortar joints.

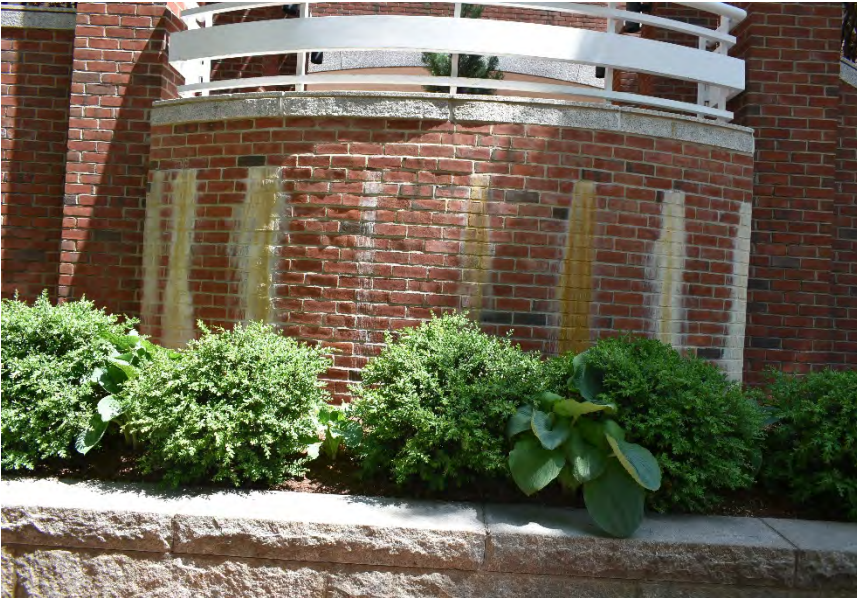
**Photo 10**

Staining and efflorescence at weeps at southwest entrance.

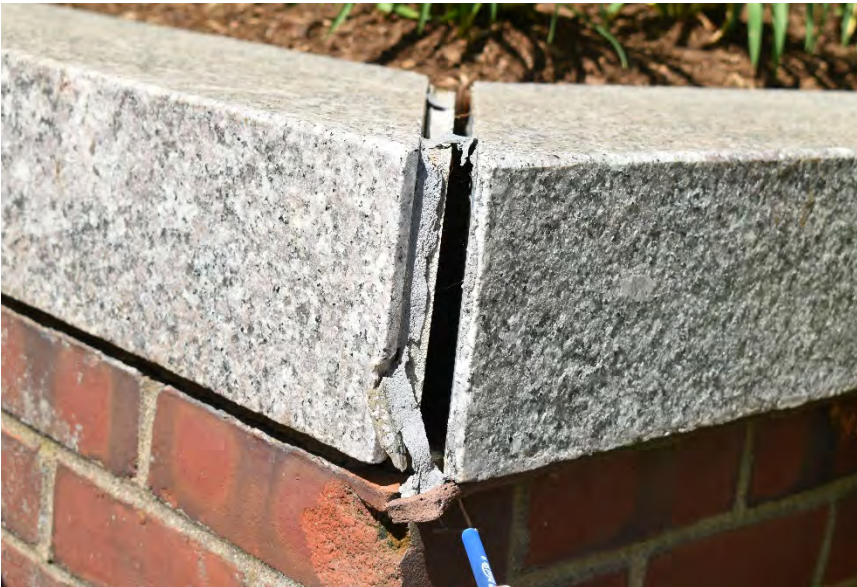
**Photo 11**

- The sealant and mortar head joints at the planter coping stones are failed at several locations (Photo 11).
- The metal expansion joint cover plate anchors in the asphalt pavement are sheared off (Photo 12).

Failed sealant at coping stone head joints.

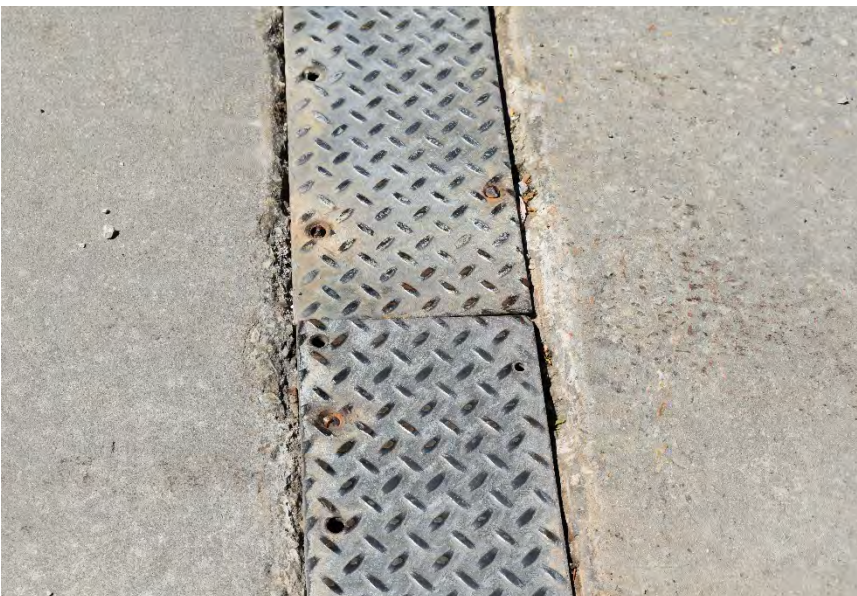
**Photo 12**

Sheared anchors at expansion joint cover plate.

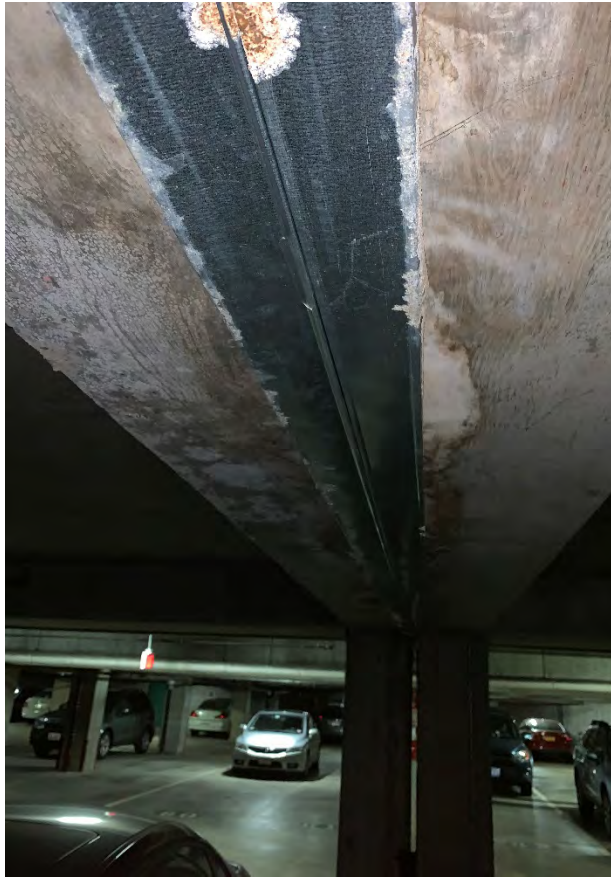
**Photo 13**

- There is evidence of leakage at the north and south ends of the expansion joint and a drip pan installed at the south end of the joint (Photo 13).

Drip pan installed below expansion joint.

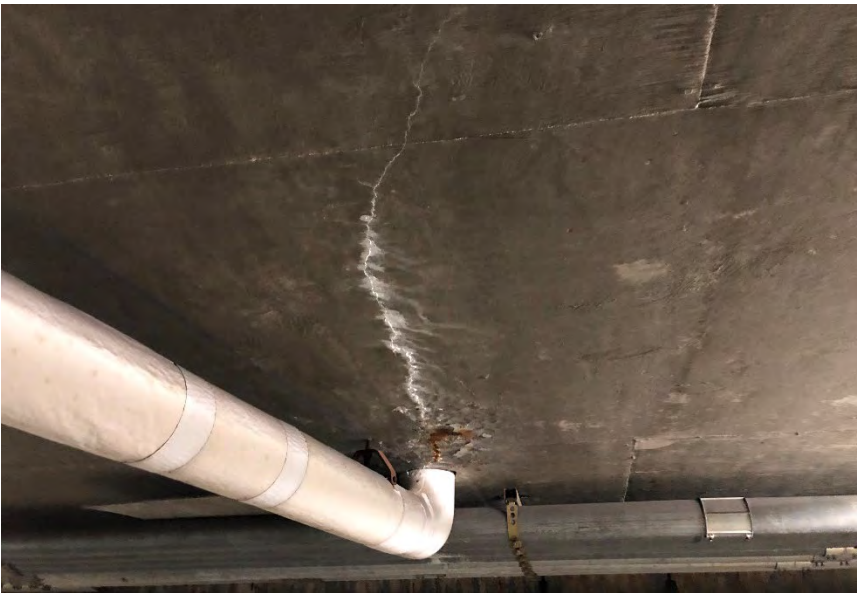
**Photo 14**

- There are isolated cracks throughout the underside of the plaza slab with efflorescence and evidence of leakage (Photo 14). Drip pans are installed at several areas below cracks in the slab (Photo 15).
- There is evidence of leakage at utility penetrations through the slab.
- There are minor, isolated areas of spalled concrete at the underside of the plaza slab (Photo 16). We observed four locations totaling approximately 15 sq ft.

The underside of the structure is in fair condition. We observed very isolated, minor corrosion damage and isolated cracks with evidence of leakage. Cracks in the concrete slab allow moisture to more easily penetrate the slab and leak into the garage. The cracks are not a structural concern at this time, but they will continue to allow salt-laden water to leak into the garage until the waterproofing is repaired.

Crack at underside of plaza slab with efflorescence.

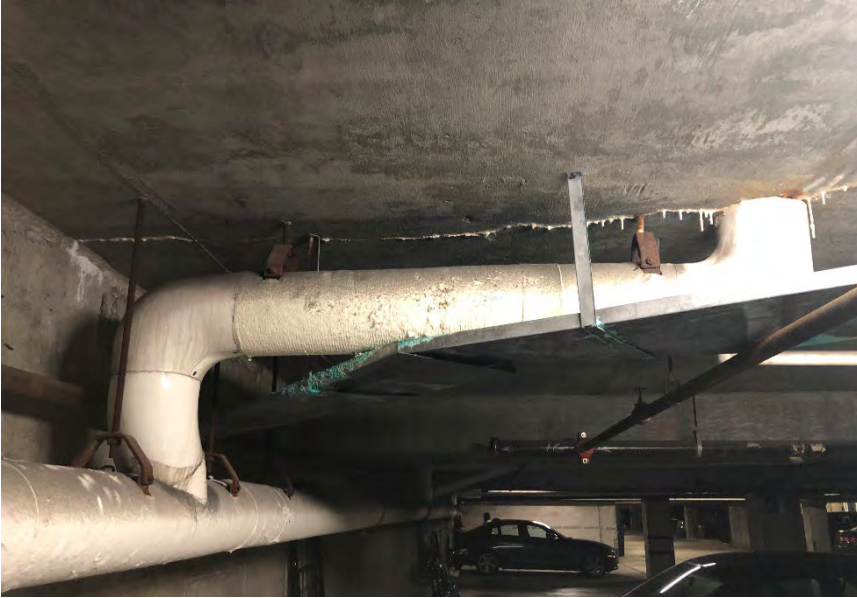
**Photo 15**

Drip pan installed below crack with evidence of leakage and efflorescence.

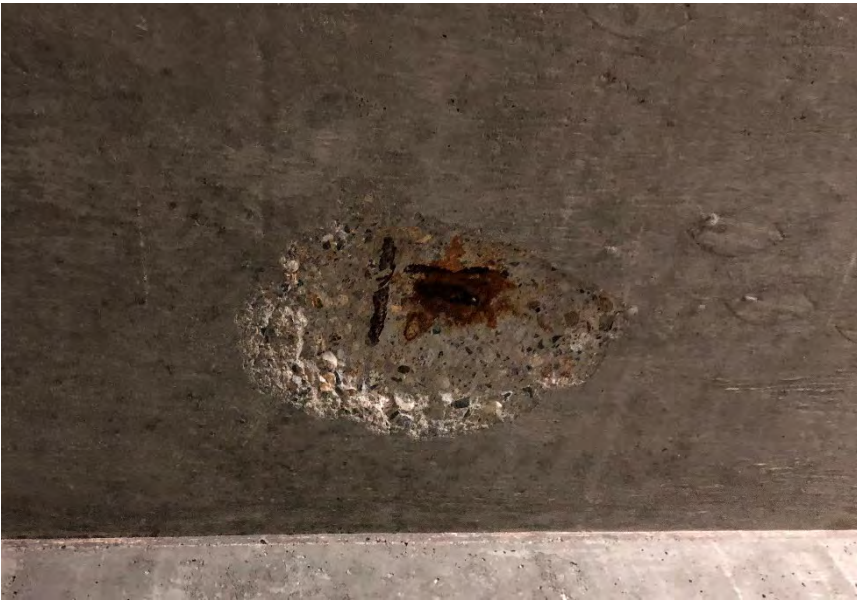
**Photo 16**

Spalled concrete at underside of plaza slab.

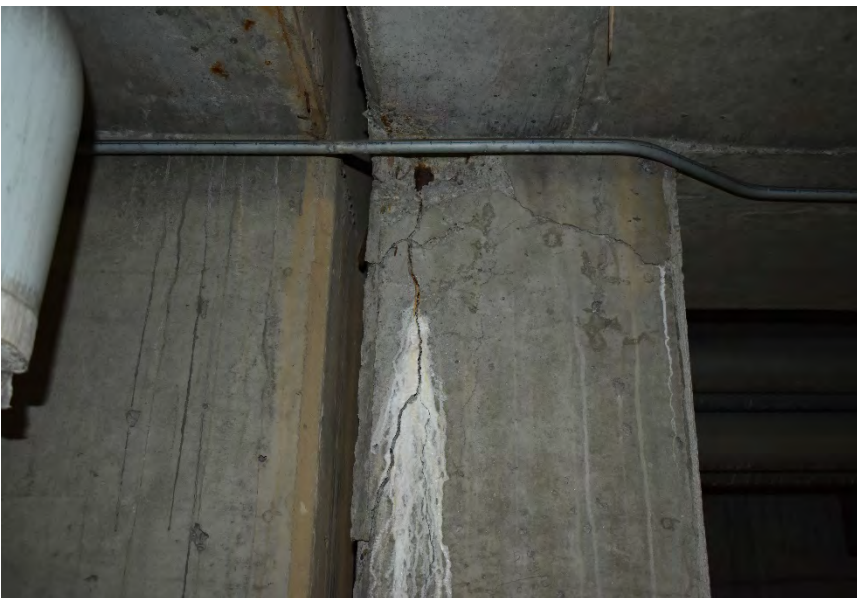
**Photo 17**

- There are isolated areas of spalled and cracked concrete with evidence of leakage at two of the columns located along the expansion joint totaling approximately 10 sq ft (Photo 17).
- There are isolated areas of cracked concrete with evidence of leakage at the garage walls (Photo 18).
- There is delaminated and spalled concrete totaling approximately 32 sq ft along the wall at the entrance to the garage (Photo 19).

Cracked concrete column with evidence of leakage.

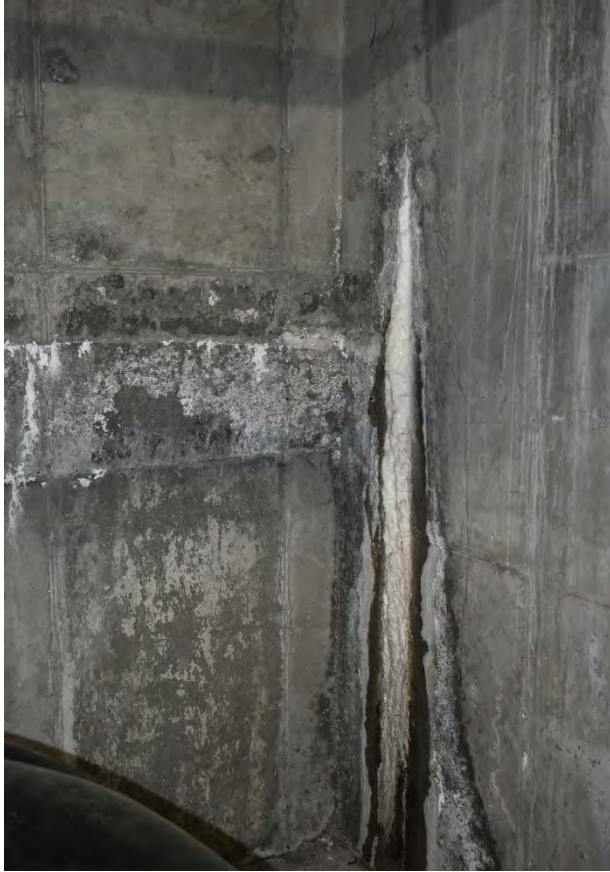
**Photo 18**

Cracks at concrete wall with evidence of leakage.

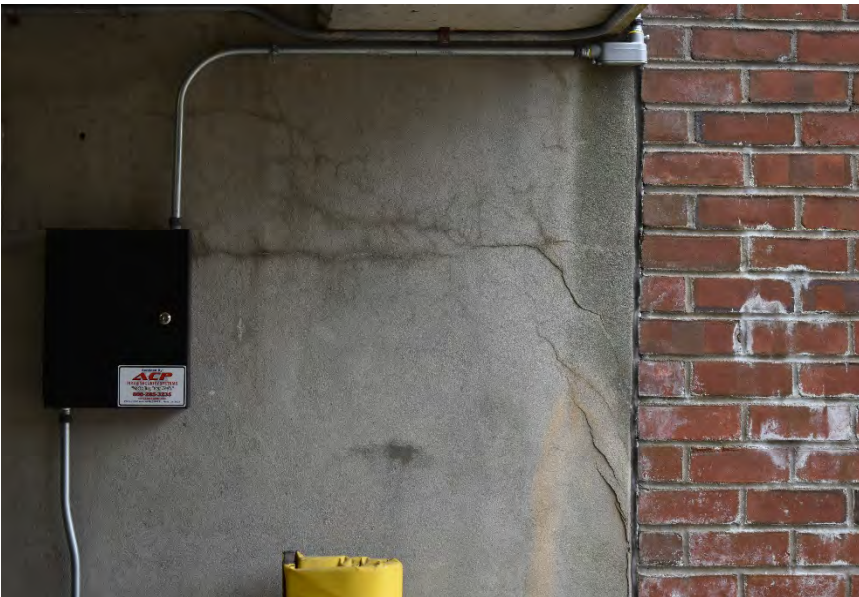
**Photo 19**

Delaminated concrete at wall at entrance to garage.

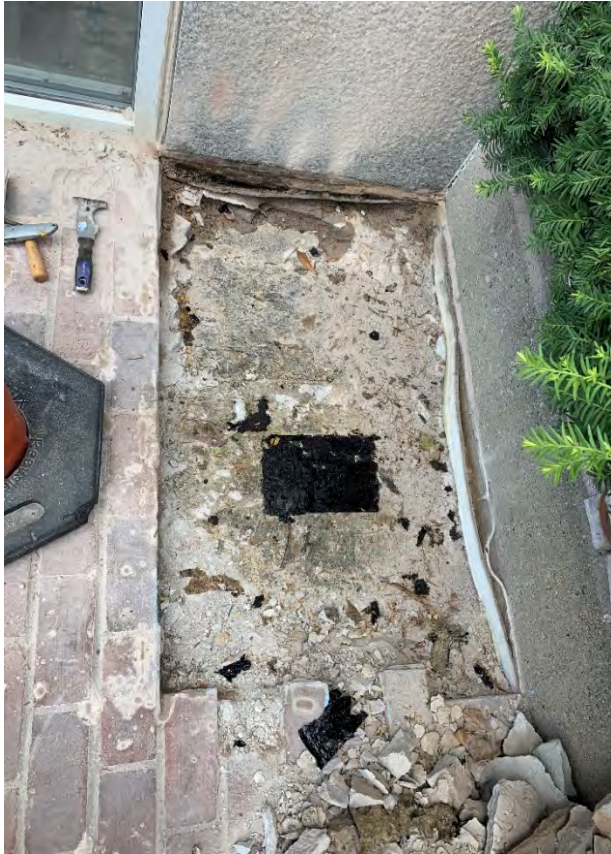
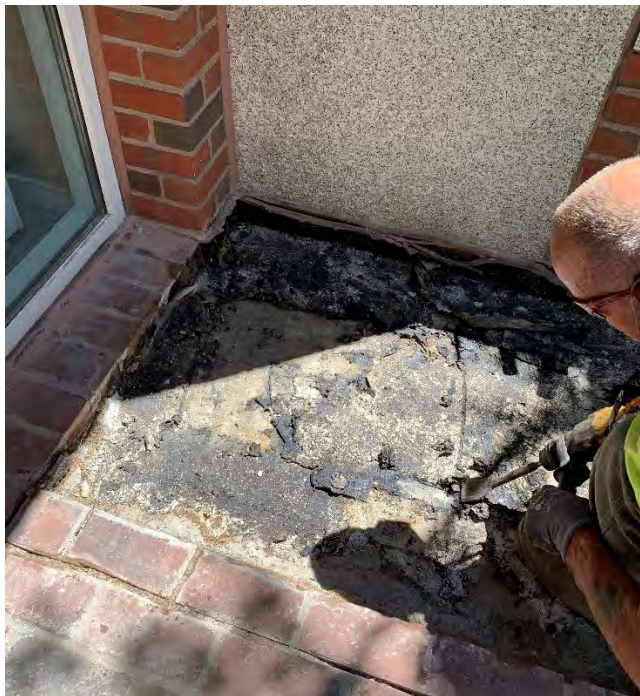
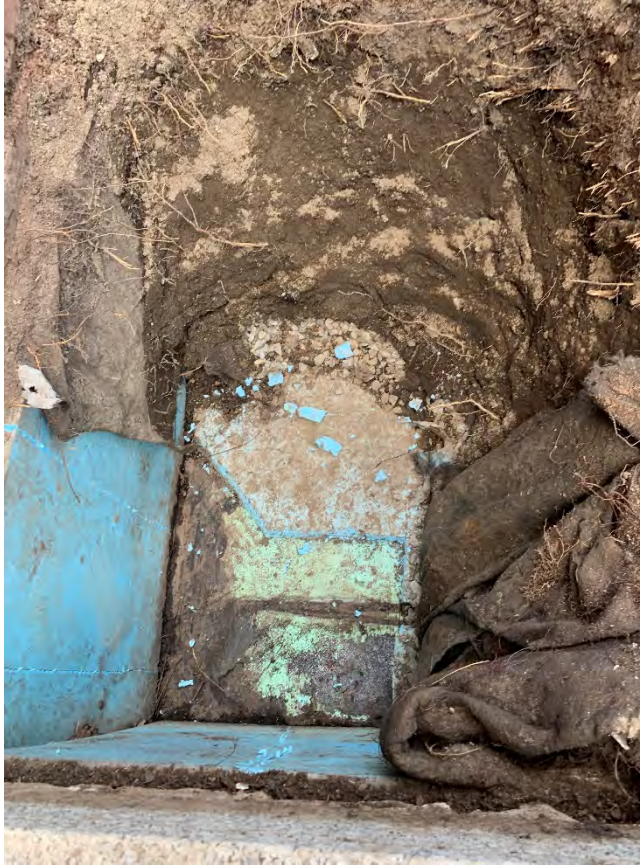
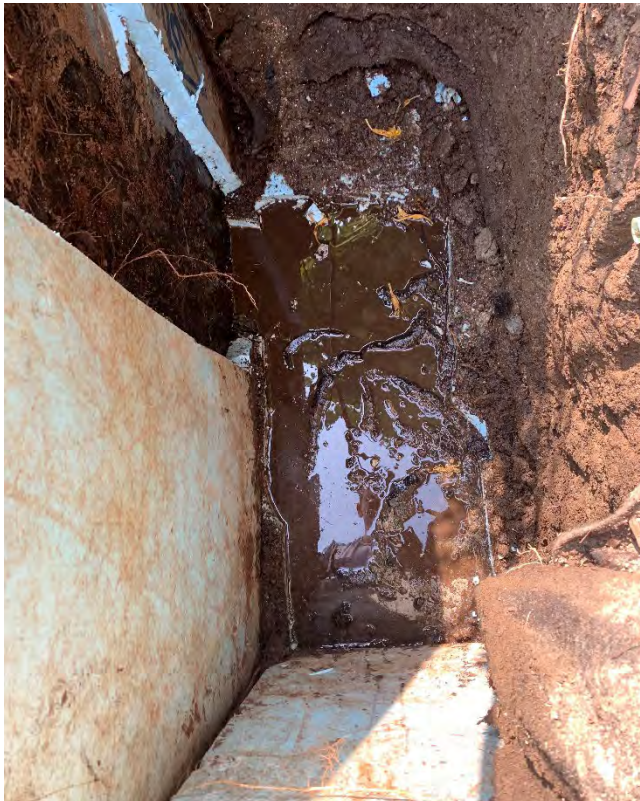
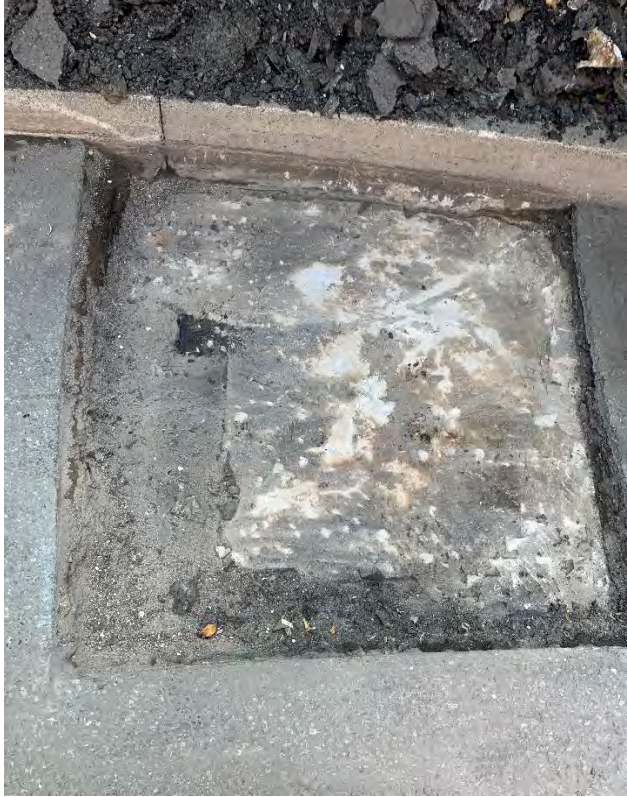
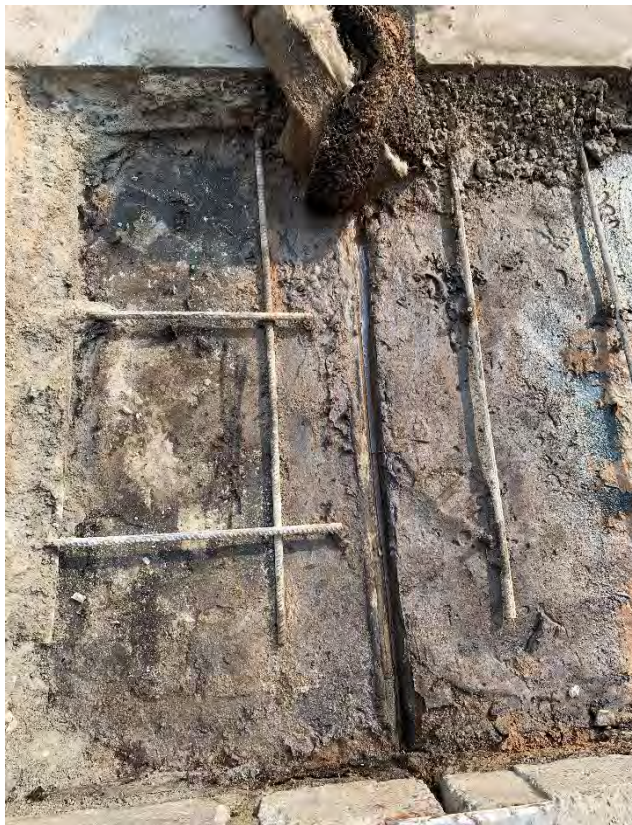
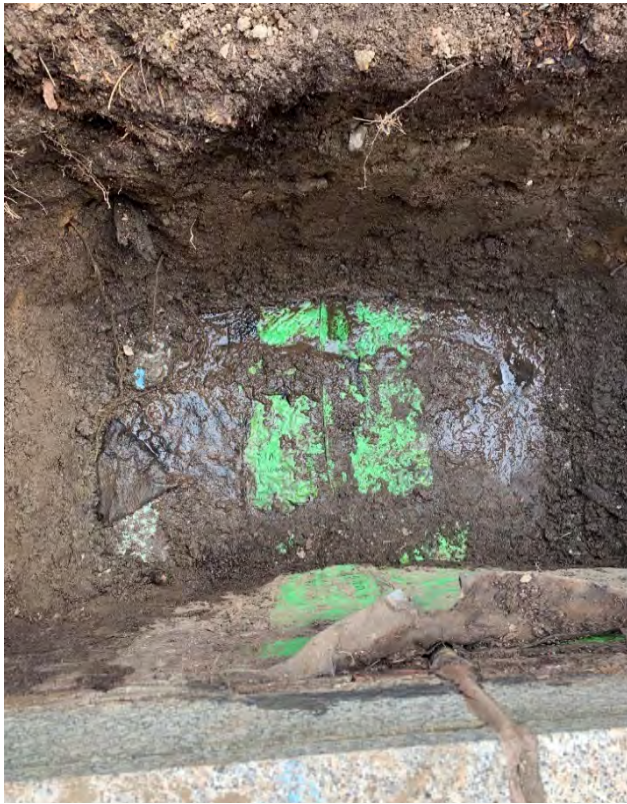
- The waterproofing is generally very thin (as little as 1/32 in.), poorly adhered, and in some locations debonded.
- We observed moisture below the waterproofing membrane at several locations.
- We observed standing water in several of the exploratory openings (Photo 23) and in the draped waterproofing at the expansion joint in the drive lane. When we removed the standing water, the openings immediately started to fill with water again.
- All concrete is sound at each exploratory opening.

The waterproofing membrane exposed within exploratory openings is typically debonded and very thin. Moisture is present below the waterproofing at several locations, indicating that the waterproofing is at the end of its useful life and is not performing as originally designed. We observed evidence of leakage, efflorescence, and drip pans throughout the underside of the plaza deck and at the south portion of the expansion joint. We understand that this leakage has been ongoing for many years. The leakage is typically located at cracks in the concrete slab, the expansion joint, and pipe penetrations. These areas are the most susceptible to leakage and are the first indicators that the membrane has failed. Leakage will become more widespread and corrosion damage will become more severe until the waterproofing is replaced.

When the waterproofing is replaced, we anticipate the following general scope of work:

- Removal and disposal of all overburden, including asphalt paving, brick paver, sidewalks, landscaping, guards, planter walls, curbs, lighting, irrigation systems, existing waterproofing, expansion joints, and other various site elements.
- Repair of concrete at the following locations:
  - Topside of plaza-level structural deck
  - Underside of plaza-level structural deck
