**CITY OF CAMBRIDGE**  
**BOARD OF SURVEY**

Re: Board of Survey Report Pursuant to G.L. c.  
143, § 8 Re: Address: 221 Mount Auburn  
Street, Cambridge, MA.

## RIVERVIEW CONDOMINIUMS – SUPPLEMENT TO 27 JUNE 2025 SGH LETTER

Re: Board of Survey Report  
221 Mount Auburn Street, Cambridge, MA

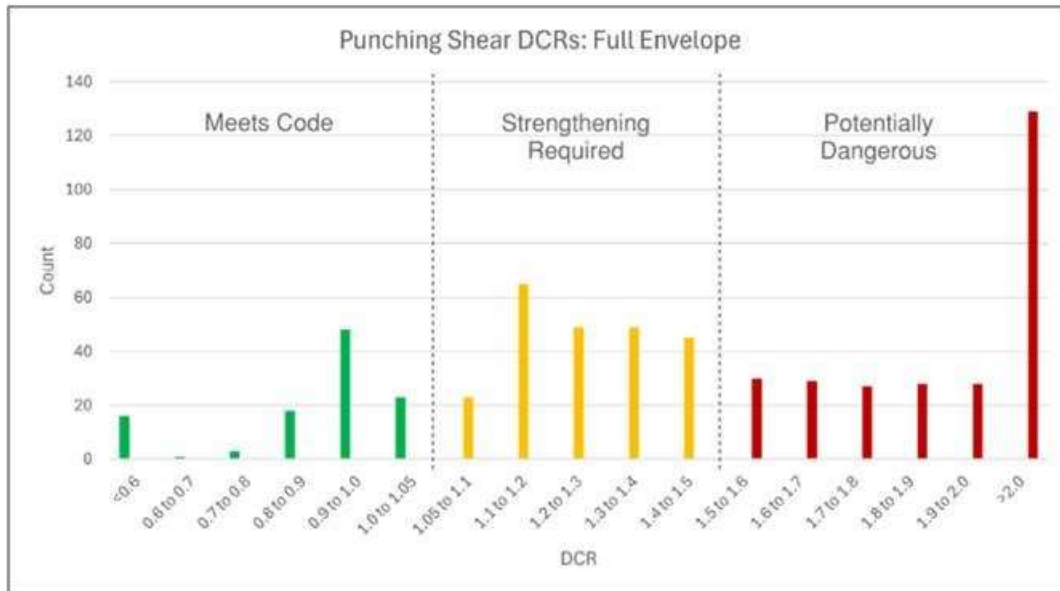
**FIG. 1** – Count of slab-column connections by DCR range for full code-required gravity loading (envelope), showing categorizations (meets code, strengthening required, potentially dangerous) in accordance with IEBC and ACI 562.

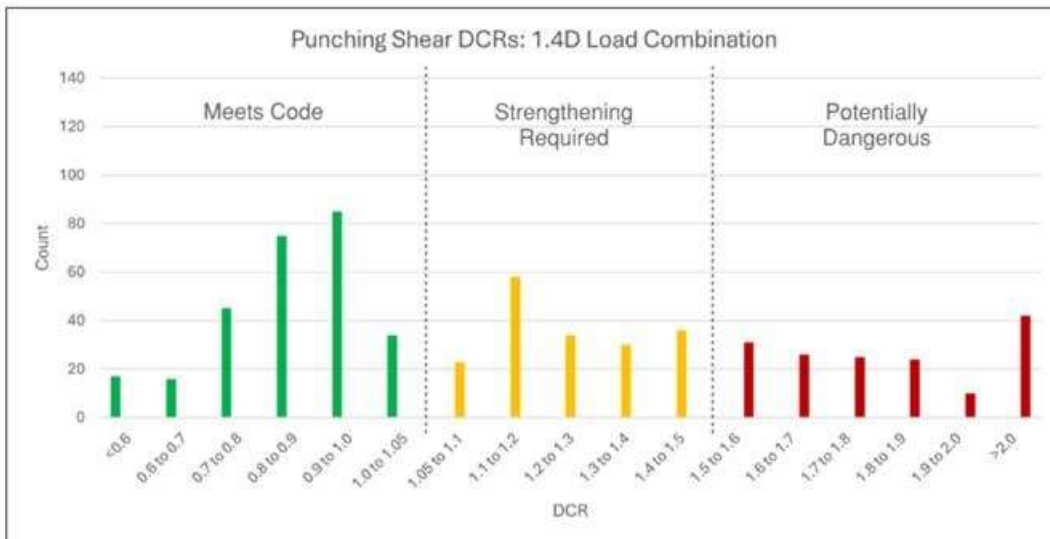
**FIG. 2** – Count of slab-column connections by DCR range under dead-load only (structure self-weight), showing categorizations (meets code, strengthening required, potentially dangerous) for the unloaded structure.
