Riverview Condominiums

Punching Shear Review

Thornton Tomasetti

February 14, 2025

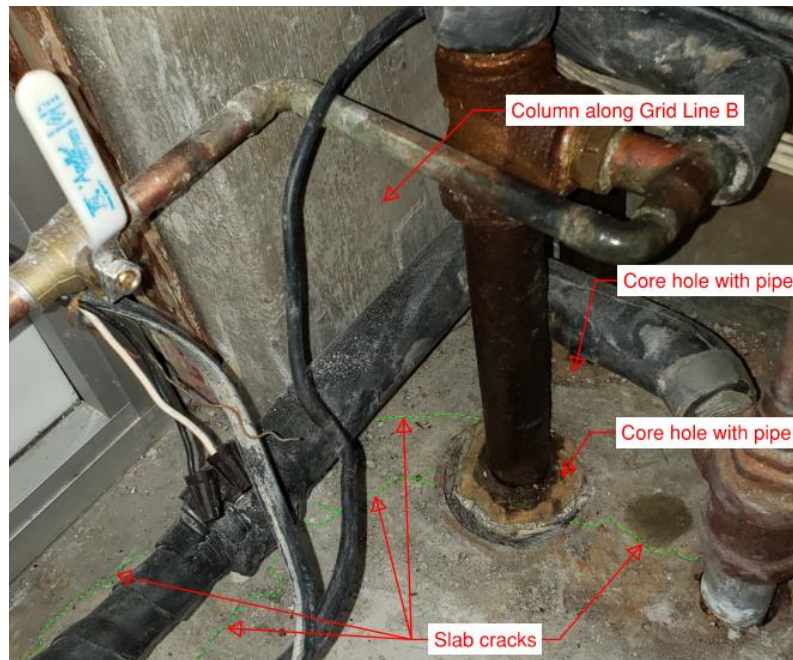
TT performed a second site visit on June 26, 2024 with SGH to view exposed floor slab areas on multiple levels as part of their limited exploratory program. We observed slab cracks in the vicinity of several columns along Grid Lines B and E (Figure 3). Various core holes are located around the columns along Grid

Figure 3: Visually identifiable slab cracks around a column along Grid Line B. At least two core holes are potentially positioned along the critical slab section for punching shear.

Visual evidence of slab cracks emanating around several slab-to-column connections, combined with the presence of core holes reducing the critical slab sections at numerous slab-to-column connections, underlines the importance of strengthening the connections. Also, visual evidence of rebar corrosion at the floor slabs along Grid Line E amplifies the urgency of implementing immediate repairs. As such, TT concurred with SGH's October 31, 2024 recommendation to the City of Cambridge Inspectional Services Department to either:

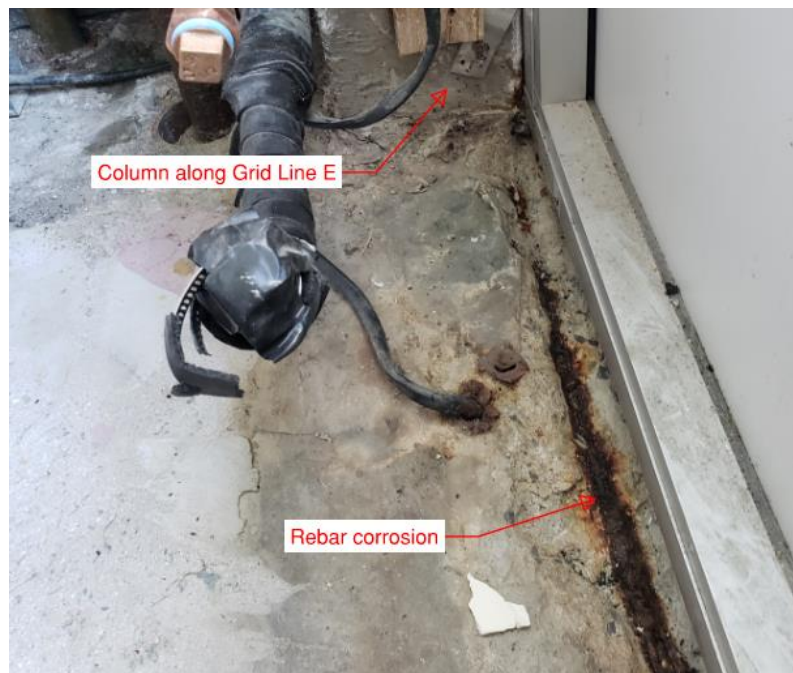
Lines B and E. TT did not observe exposed slab-to-column connections along Grid Lines C and D. We observed evidence of concrete spalls and rebar corrosion at the floor slabs along Grid Line E (Figure 4).

Figure 4: Concrete spalls and rebar corrosion near slab edge along Grid Line E.

- Floor slab top rebar is set lower than specified in the existing structural drawings, contributing to reduced punching shear capacity and flexural capacity.
- Floor slab as-built concrete design compression strength is substantially lower than specified in the existing structural drawings, contributing to reduced punching shear capacity.
- Presence of core holes in the slab around the columns, reducing the punching shear critical slab sections.
- Evidence of rebar corrosion, specifically near the slab edge along Grid Line E.

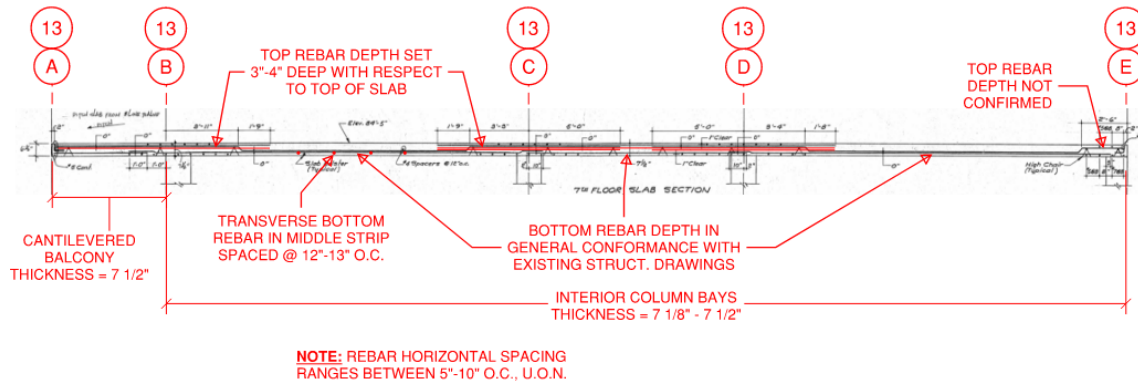
Our scans indicate that the interior slab thickness ranges between 7 1/8" – 7 ½". We field measured the edge of balcony slab to be 7 ½" thick instead of 6 ½" thick, suggesting that the as-built condition of the balcony slab does not have a pitched surface per the existing drawings.

Figure 2. Typical section of 7th Floor slab indicating as-built conditions.

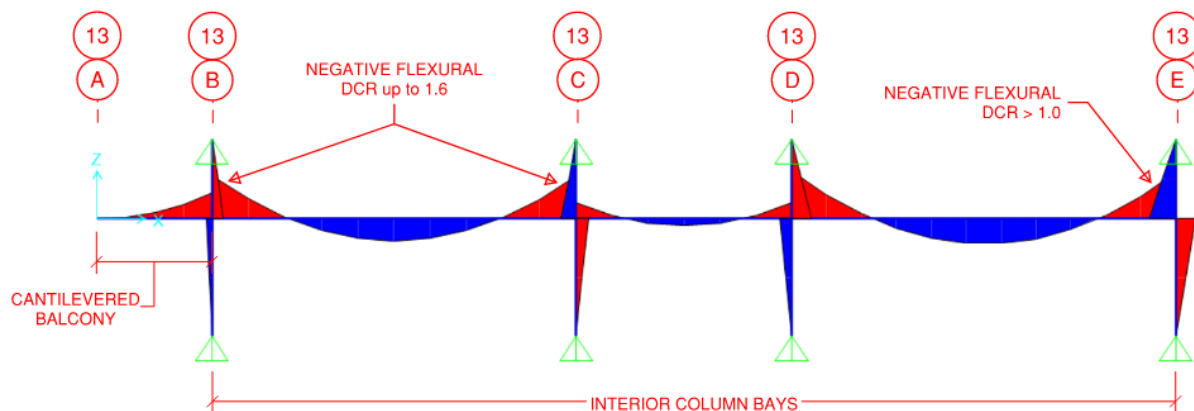
The elastic strip methods determined that the slab has inadequate negative flexural strength at three locations along the representative column strip when considering the as-built slab conditions (Figure 3). Of note, the cantilevered balcony slab has sufficient negative flexural strength where the slab joins the south column line along Grid Line B.

Figure 3. Moment diagram of column strip along Grid Line 13 at 7th Floor showing locations with inadequate negative flexural strength.

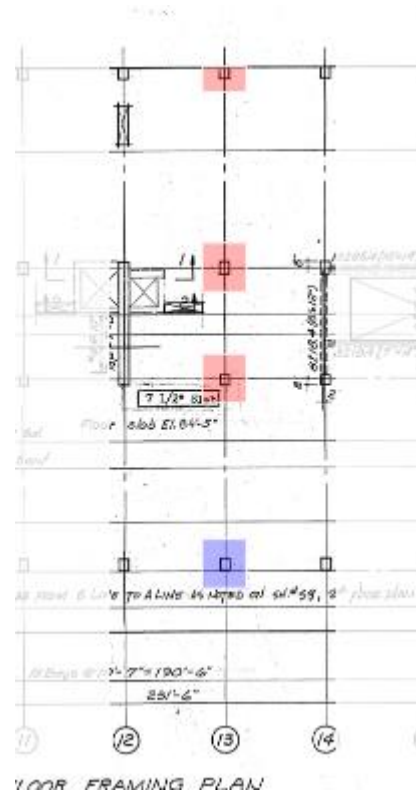
condition. All slab-to-column connections were found to have insufficient punching shear strength for the as-built condition.

Figure 4. Part plan view of representative area of 7th Floor slab indicating slab-to-column connections with inadequate punching shear strength for as-designed condition (highlighted in red). All slab-to-column connections fail in punching shear for the as-built condition.

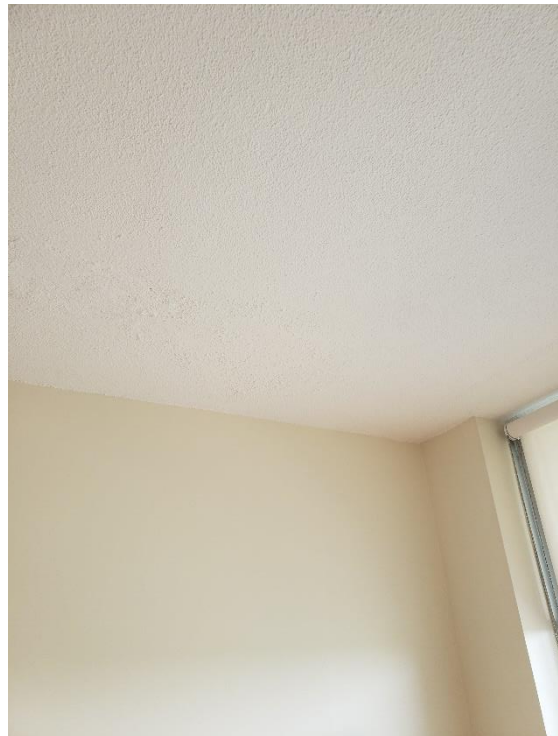
Photo 4: Typical interior wall and ceiling finishes with no cracking or deformation evident.

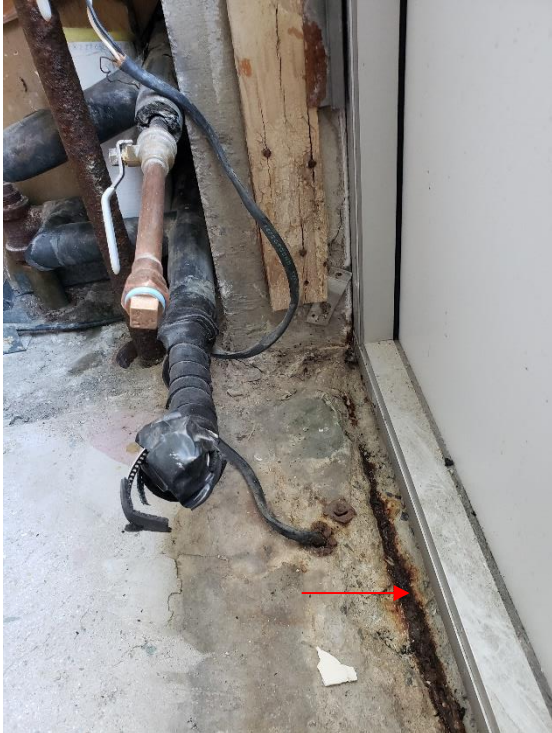
Photo 5: Concrete spalls and rebar corrosion near slab edge along Grid Line E.

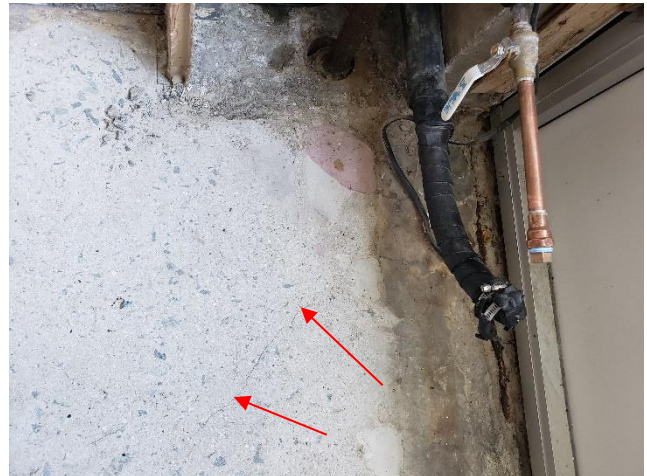
Photo 6: Hairline slab cracks in vicinity of a column along Grid Line E.

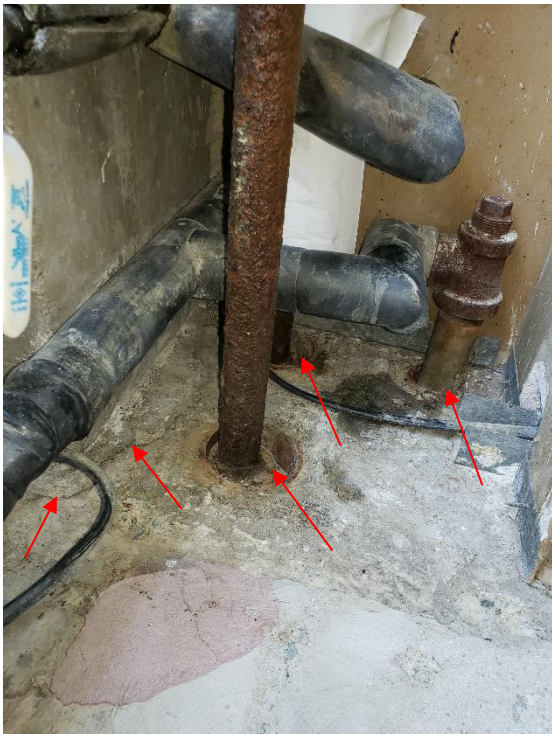
Photo 7: Typical slab-to-column connection exhibiting core holes and cracks around a column.

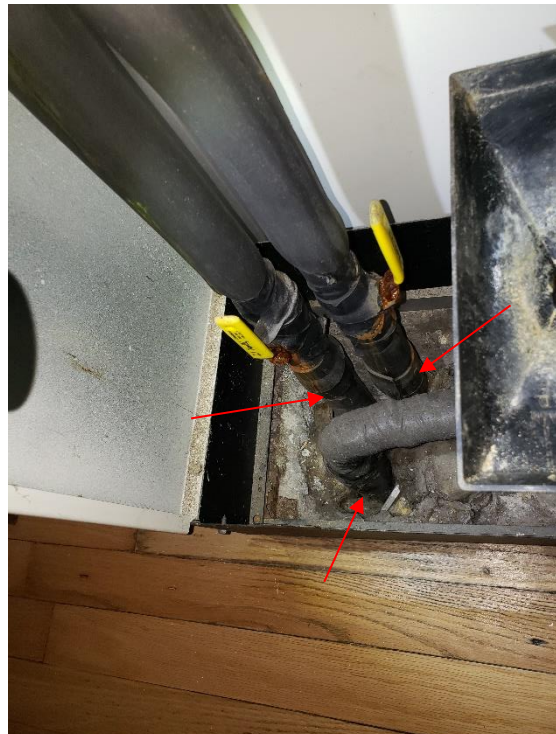
Photo 8: Slab-to-column connection exhibiting three core holes clustered together directly adjacent to the column face.

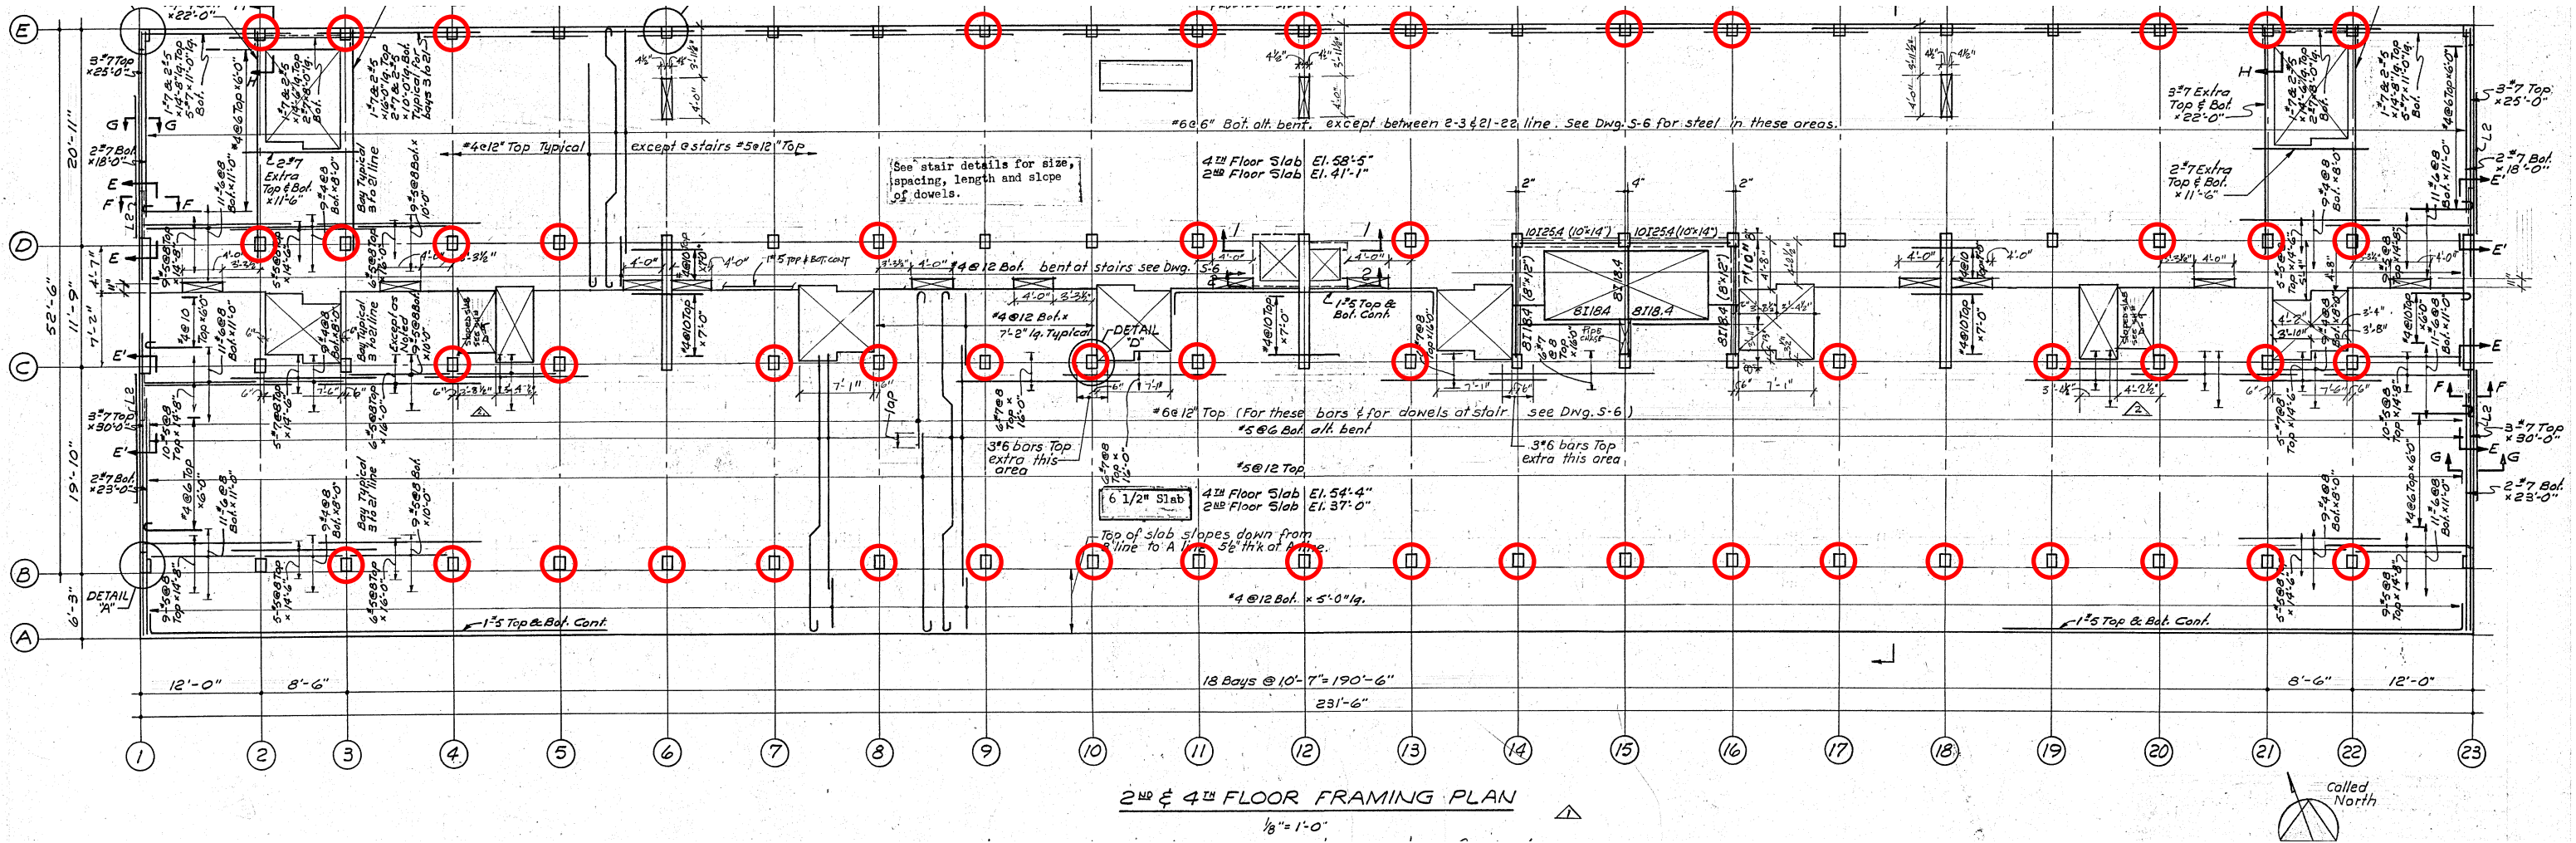
LEVEL 2

TT's structural analysis indicates that a substantial quantity of the as-built slab-to-column connections are classified as Category 1 requiring strengthening. The remaining slab-to-column connections are either classified as Category 2 not requiring strengthening, or do not have as-built structural information and were not evaluated.
