The Ragon Institute of MGH, MIT and Harvard
Proposed Demolition of 624 Main Street
10 September 2020

SUBJECT: Existing Conditions Summary
624 Main Street, Cambridge, Massachusetts

Subject 624 Main Street – Structural Engineering Report

624 MAIN STREET
REVIEW OF BUILDING CONDITION
AUGUST 18, 2020

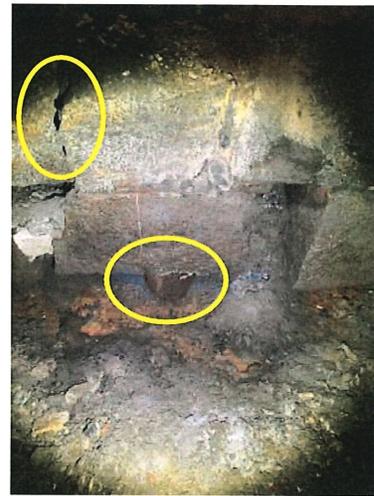
- Irregular and non-symmetrical footing foundations support interior piers. The picture (below left) indicates the extent of the spread footing foundation for an interior column and its

irregular nature. Given this condition and the amount of settlement of certain interior columns (below right), the interior column foundations appear to be undersized, overloaded, and/or founded on disturbed or unsuitable soils (e.g., Organic Deposits) which allowed settlement to occur.

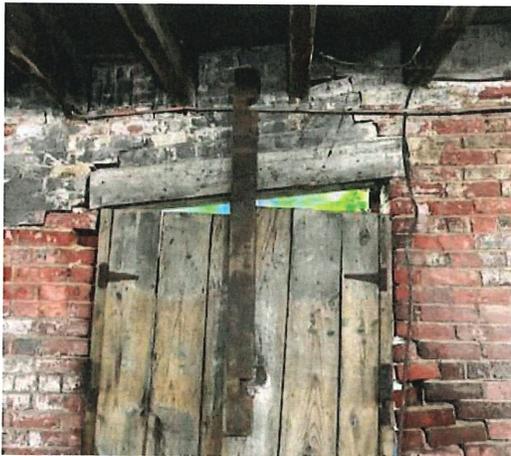
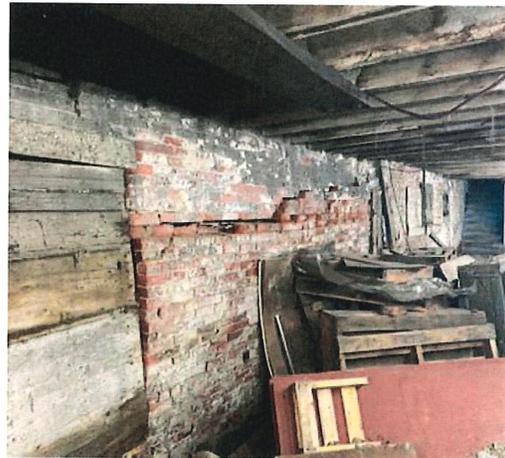
- The building's envelope has multiple openings and penetrations such that weather (since the building is unheated) and water have been able to adversely impact and promote deterioration (e.g., freeze/thaw, rot, mold growth, masonry spalling) of the building's foundation materials. This condition and related distress are noted in the photos below; exterior ground surface is about at the level of the horizontal crack in the foundation wall in the photo (below, right). Water and freeze/thaw have split the masonry and are bowing this foundation wall. The impact or water, freeze/thaw, and settlement are contributing to the failure of this opening in the exterior foundation wall (below, left).

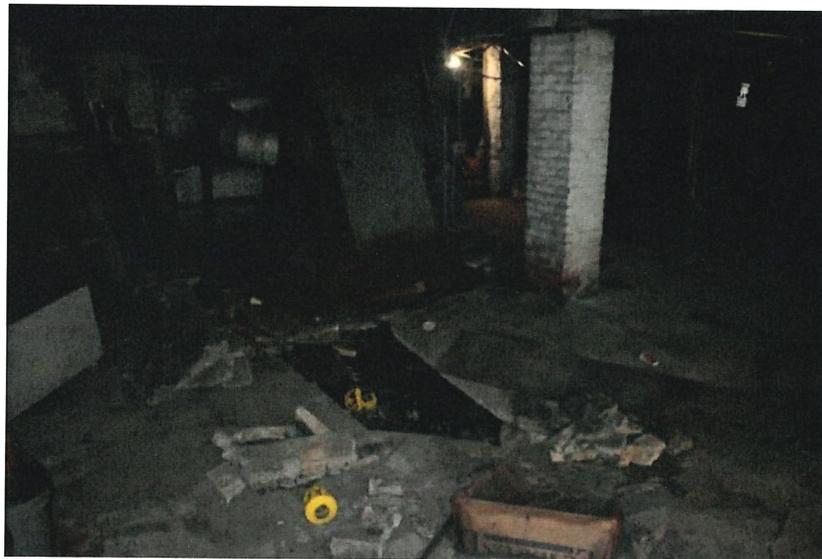
The slab on grade in the basement is cracked through the thickness of the concrete and broken apart in numerous places. The resulting segments of slab are typically not level or coplanar, and in some places are missing entirely.

Figure 1 Damaged slab on grade in basement

Under portions of the slab on grade, it was observed that the soil has settled away from the underside of the slab, meaning that continuous support is no longer provided to the underside of portions of the slab on grade. This soil settlement may have also contributed to the settlement of interior columns which was observed.

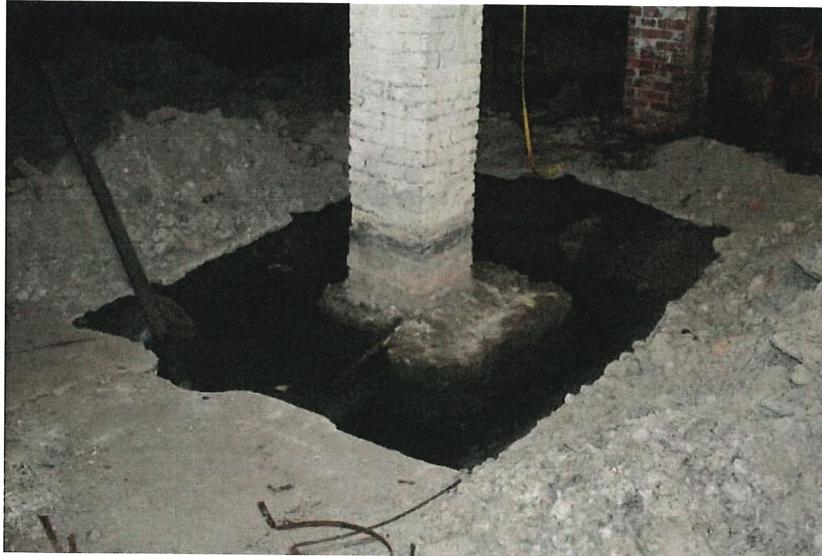
Figure 2 Exposed spread footing under brick pier in basement

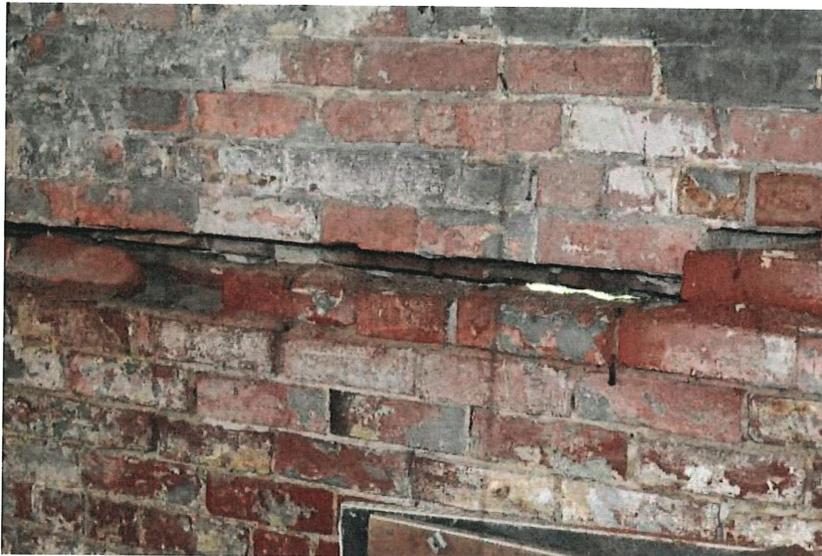
The lowest level of the bearing walls was observed to have large horizontal step cracks through the thickness of the wall. The planes of the brick were observed to be offset above and below these horizontal cracks. Brick lintels over basement windows were observed to have settled and no longer horizontal. This indicates that portions of the bearing walls have settled differentially to a significant degree. These observations indicate both the vertical and lateral load-carrying capacity of the brick walls are significantly compromised.

Figure 3 Horizontal gap in perimeter bearing wall

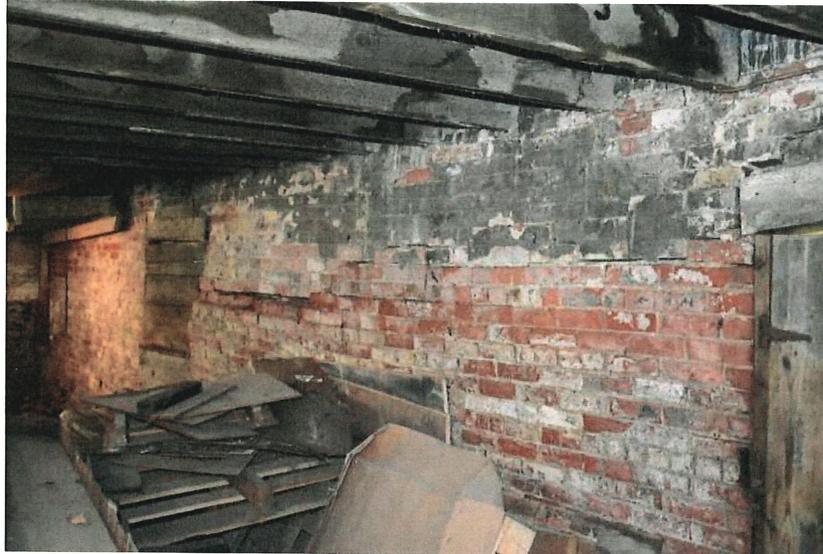
Figure 4 Step cracking along the length of the basement wall

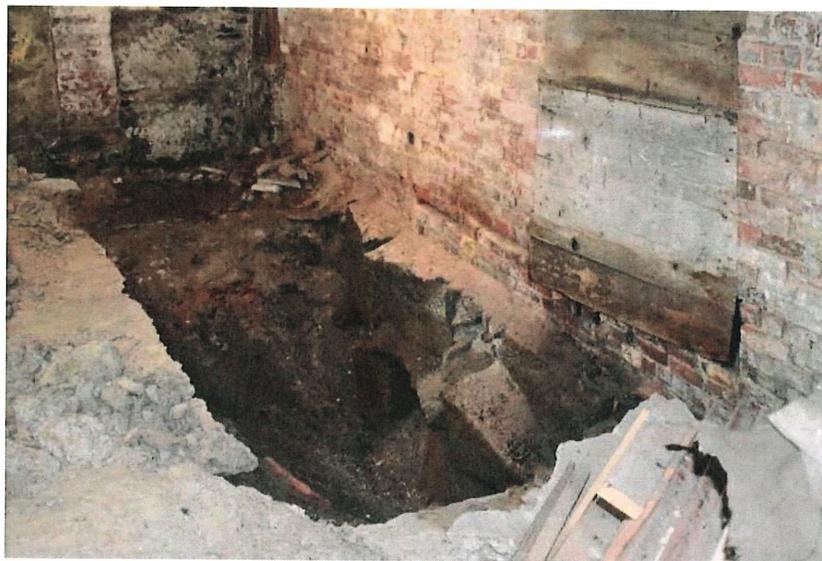
Figure 5 Bulging at base of perimeter bearing wall

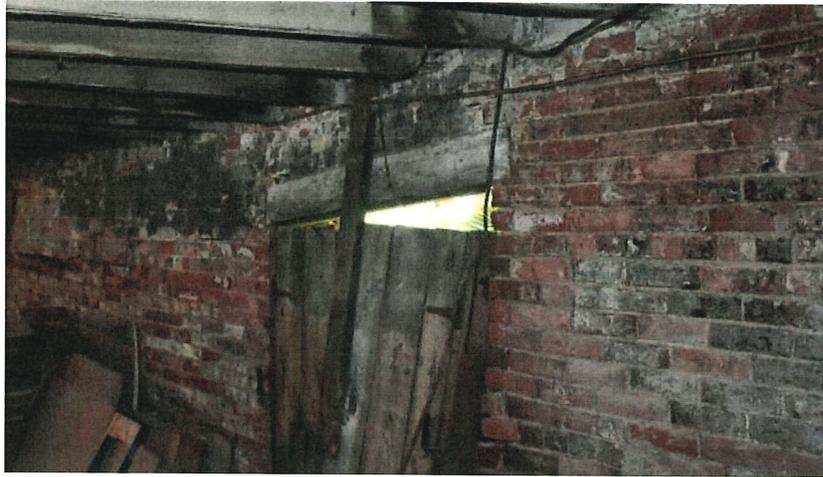
Figure 6 Lintel which is no longer horizontal

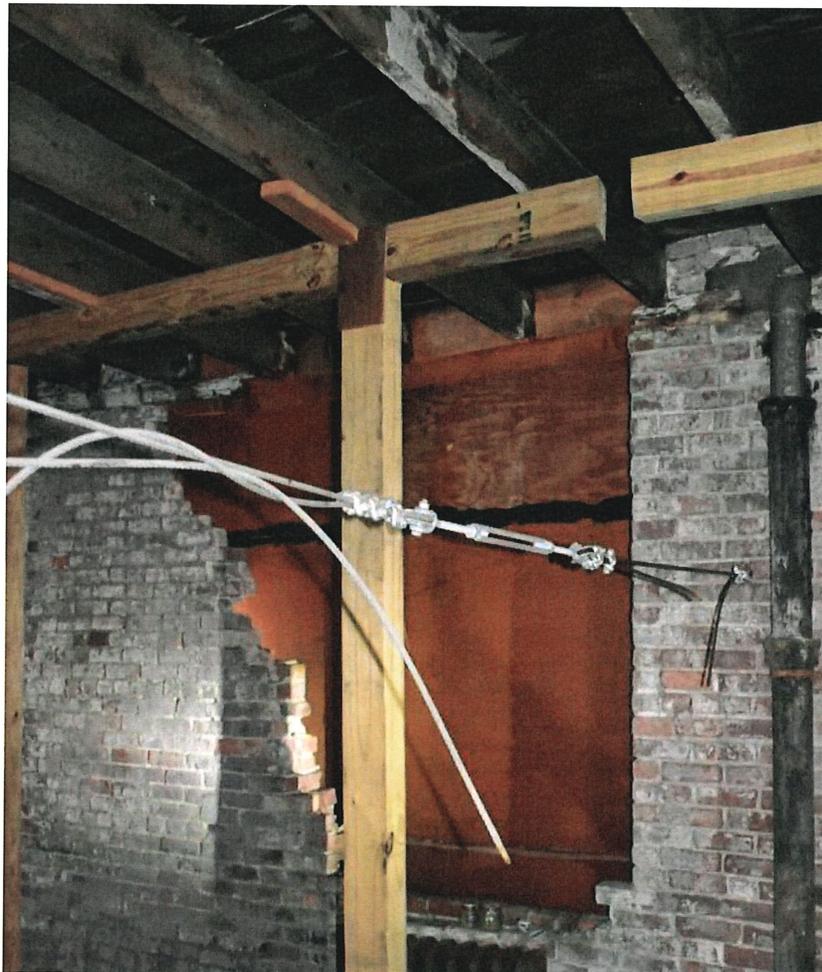
At the second floor, near the rear staircase, it was observed that the brick wall had partially collapsed, and portions of the wall were missing. The missing portions of the brick wall were located around existing window openings. Remaining portions of the wall in this area were observed to be restrained back to interior columns using post-installed steel rope and wood blocking to prevent further collapse.

Figure 7 Area of collapsed brick wall and shoring of roof joists

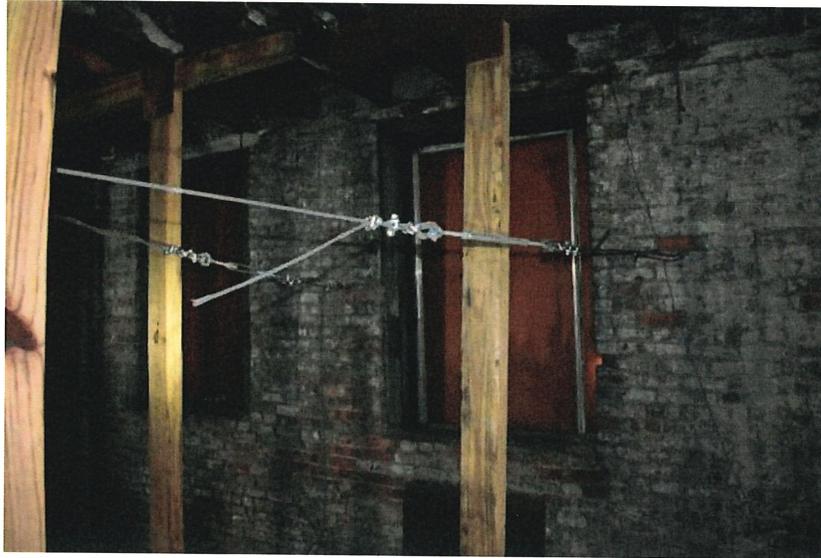
Figure 8 Steel rope support to brick wall and shoring of roof joists

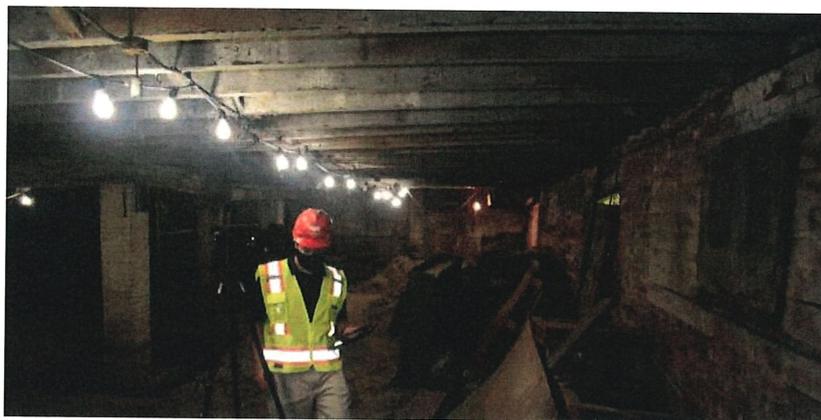
The entirety of the first suspended floor was observed to slope uniformly towards the center of the building. From observations made in the basement, it appears that the structural system of the building is two bearing walls oriented roughly perpendicular to Main Street, with a central line of columns parallel to the walls. These central columns appear to have settled differentially to the perimeter walls, resulting in the observed floor slopes. The primary wood beams which span between these central columns were also observed to have excessive deflection, likely result from a combination of the interior column settlement, long-term creep of the material, and water damage.

Figure 9 Joists supporting first floor, noting varying amounts of inclination off horizontal

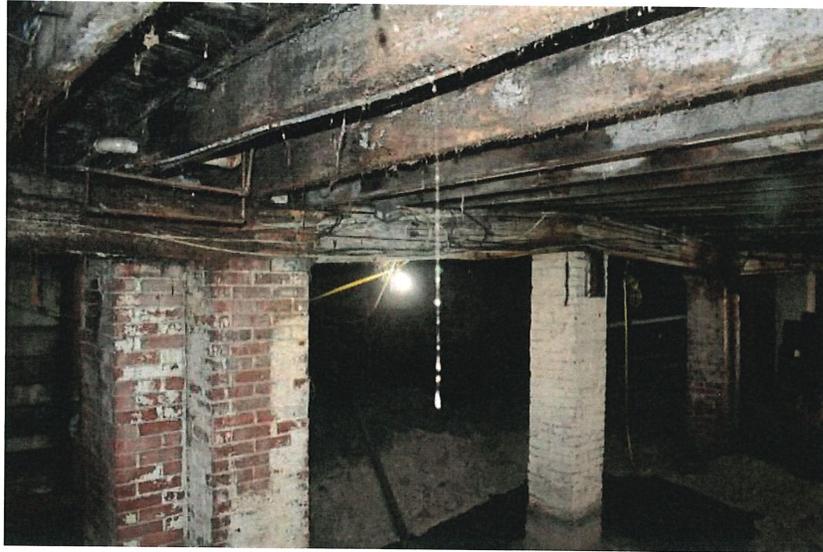
Figure 10 Central beam in basement

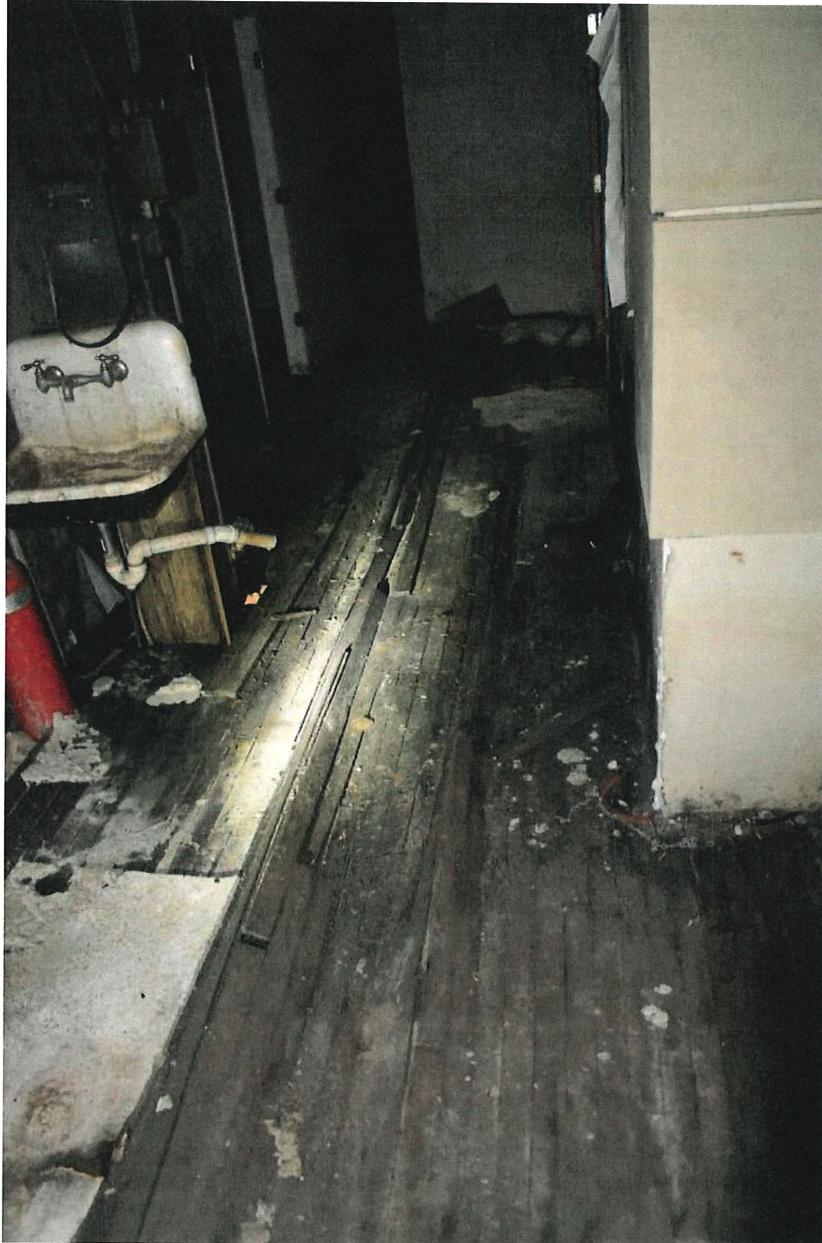
The walking surface of the first and second floors is very uneven. This unevenness could be the result of warping of the wood finished floor, or excessive deflection of the subfloor. Given the regular nature of the high and low points, and the parallel orientation of the high points, the uneven surfaces are likely the result of the subflooring deflecting excessively between the floor joists.

Figure 11 Uneven walking surface on first floor

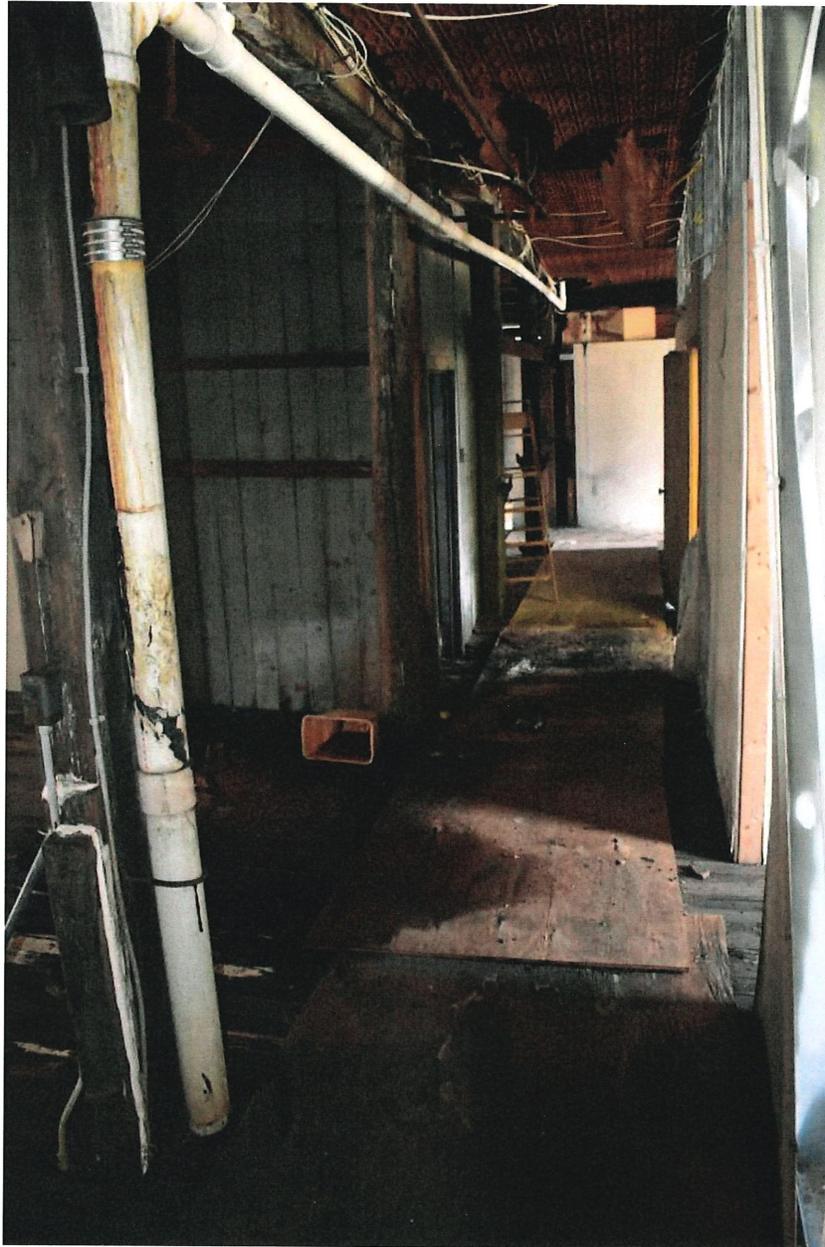
On the second floor, while walking between the rear staircase and the forward staircase, numerous soft spots were felt underfoot. This observation likely indicates weakening of the structural subfloor, possibly due to water ingress or other previous damage due to dropped or heavy objects.

Figure 12 Soft spots on the second floor, which been previously covered by plywood

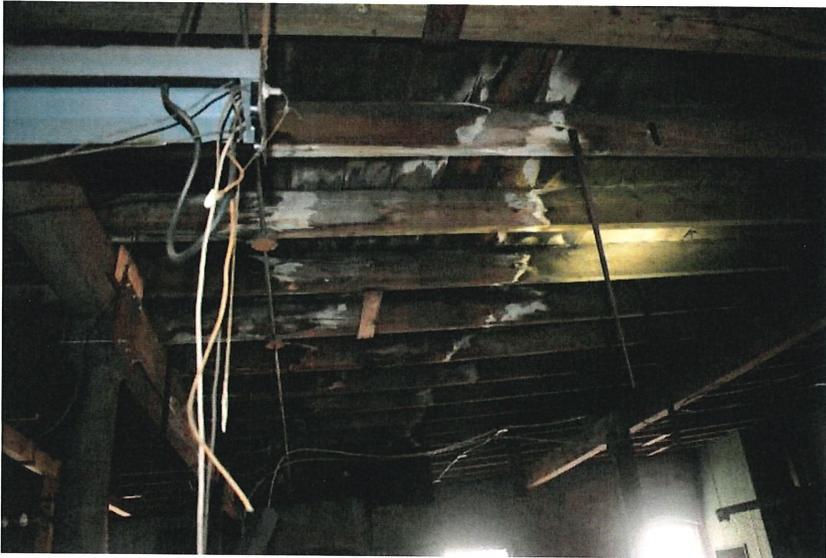
Evidence of water infiltration was observed in the form of water staining on the wood structure and finishes, as well as mold and mildew on drywall and ceiling finishes. Active water infiltration was observed during the site visit. It had rained the previous night, and water was actively dripping from the ceiling down to the basement. Active water was observed on all floors of the building. Persistent ingress of water into a wood structure is detrimental to structural integrity.

Figure 13 Water damage on roof joists

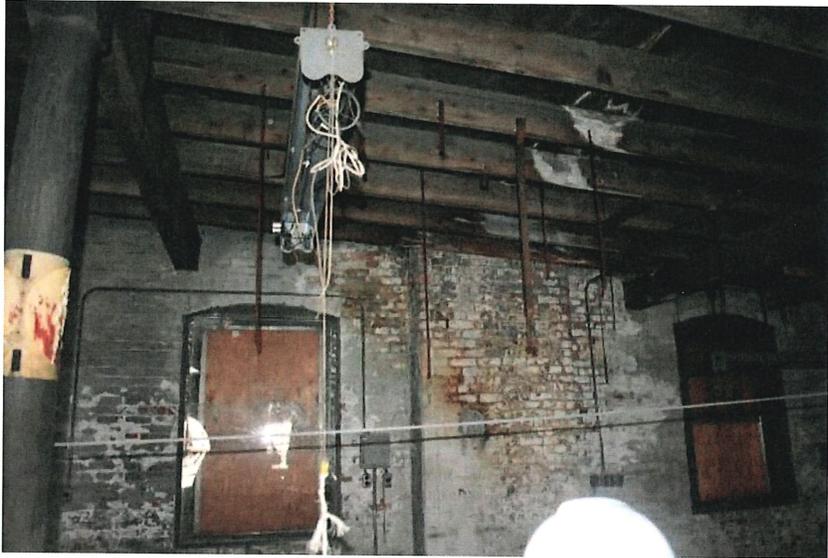
Figure 14 Water damage on roof joists and exterior walls

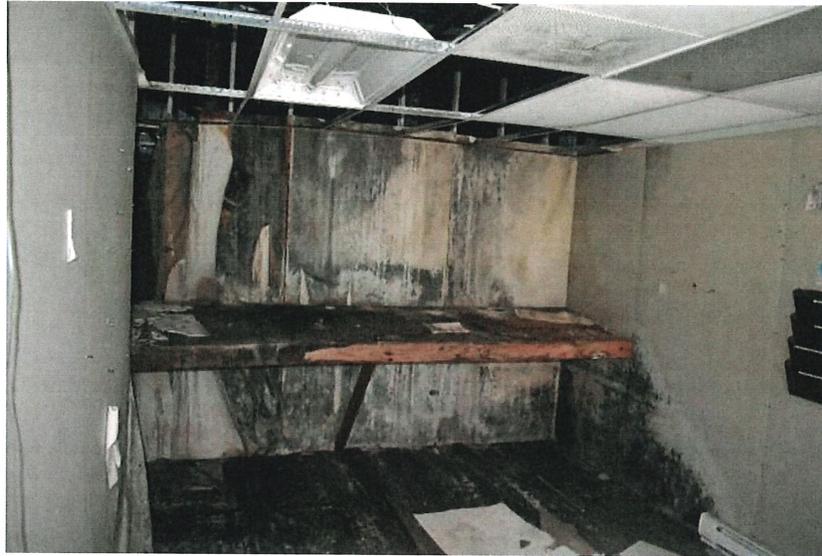
Figure 15 Water damage and mold on interior finishes

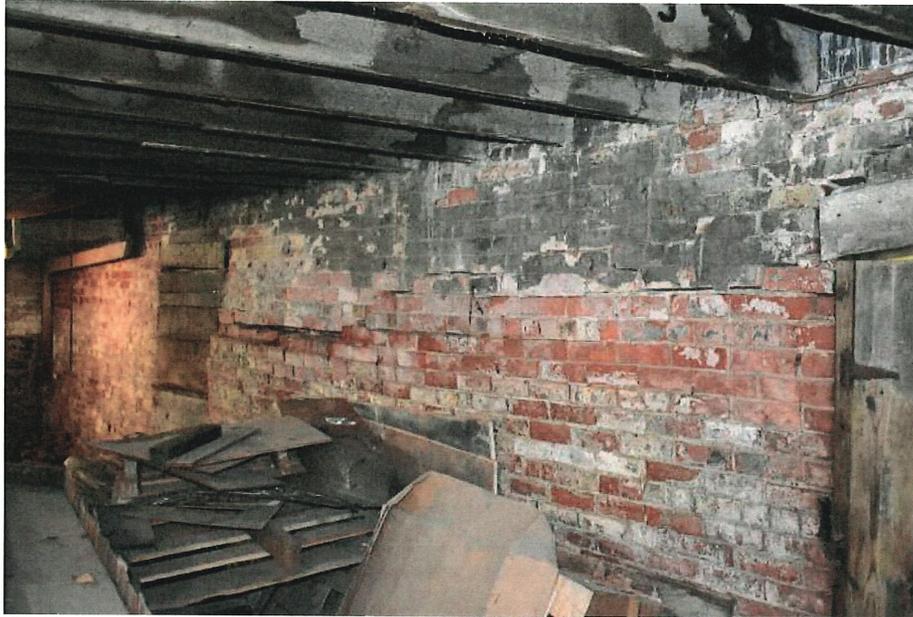
If it were possible to safely stabilize the structure by following the procedure described above, the asbestos, the other hazardous materials in the building, and the mold throughout the building would have to be removed. All workers would be required to wear full PPE suits and be fitted with respirators due to the extensive mold. All nonstructural elements in the building, including the floor and roof framing, would have to be removed since the framing members are likewise water-damaged with evidence of rot and other failures. The brick foundation wall on the east side of the building would need to be fully demolished and re-built, since it has already partially collapsed. (Photo below)

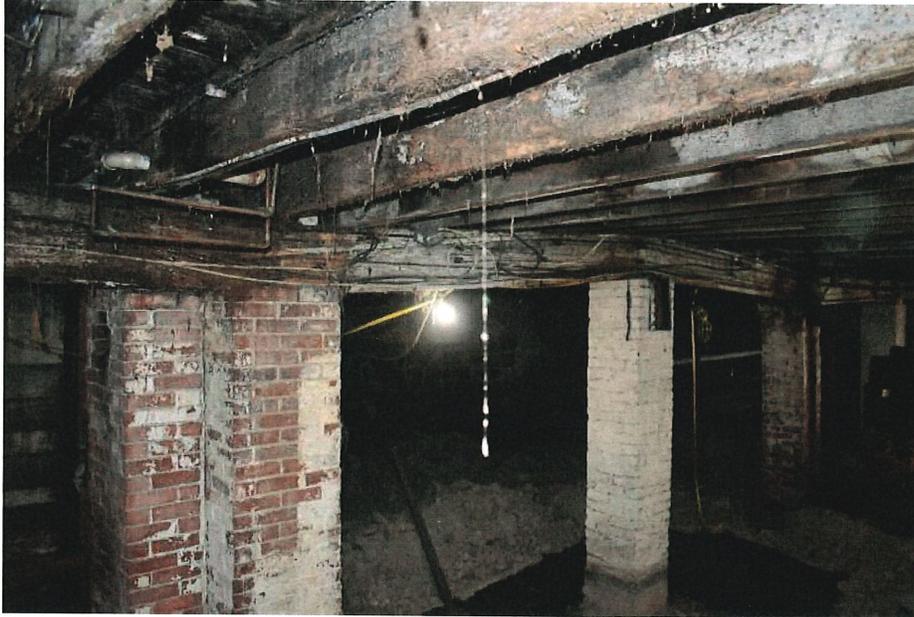
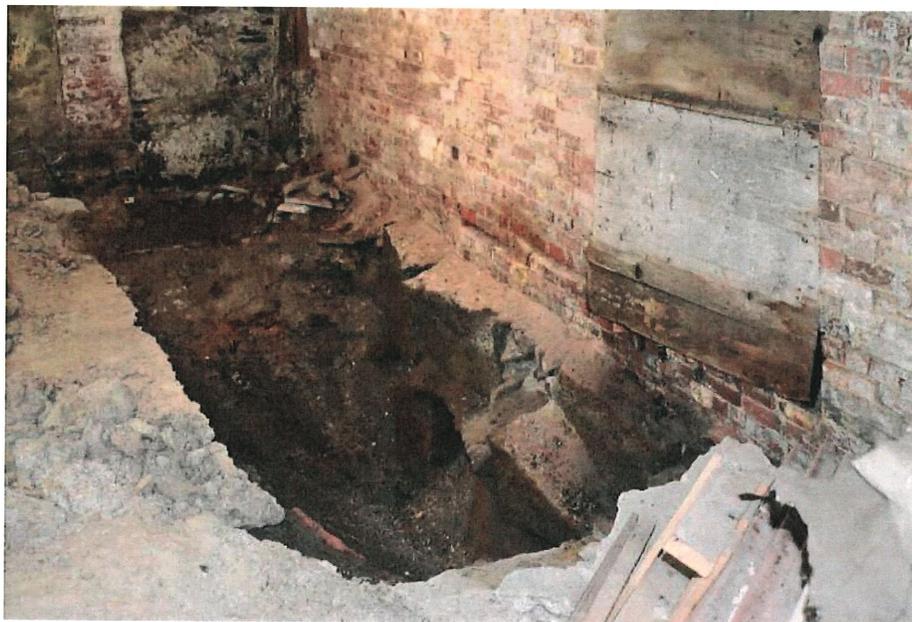
The existing footings which support the interior columns and the interior structural system at 624 Main Street have failed and have settled at significantly different rates, resulting in uneven, sloping floors and a significantly warped central beam that supports the entire interior timber framing of the original building (Photo Below). The existing slab on grade would have to be removed in its entirety and the existing footings would have to be replaced, the strength and depth of which would be determined by the geotechnical and structural engineers based on the existing soil conditions. Some sort of mini-piles would likely be needed to support the new footings and new columns. Temporary shoring to support the timber framing above would be required at each footing and column location in an attempt to stabilize the structure during this operation.

The existing stone foundation walls around the perimeter of the building would have to be underpinned to stabilize them and halt any settlement that may be continuing. However, in accordance with the geotechnical engineer's report (Haley & Adrich) and the structural engineer's report (Arup), the perimeter foundation walls cannot be underpinned or repaired in place but must be removed and replaced in their entirety. Because the unstable masonry walls sit directly on top of the stone foundation wall, the perimeter brick walls of the building would need to be demolished and rebuilt, as described in the next section entitled "Exterior Façade".

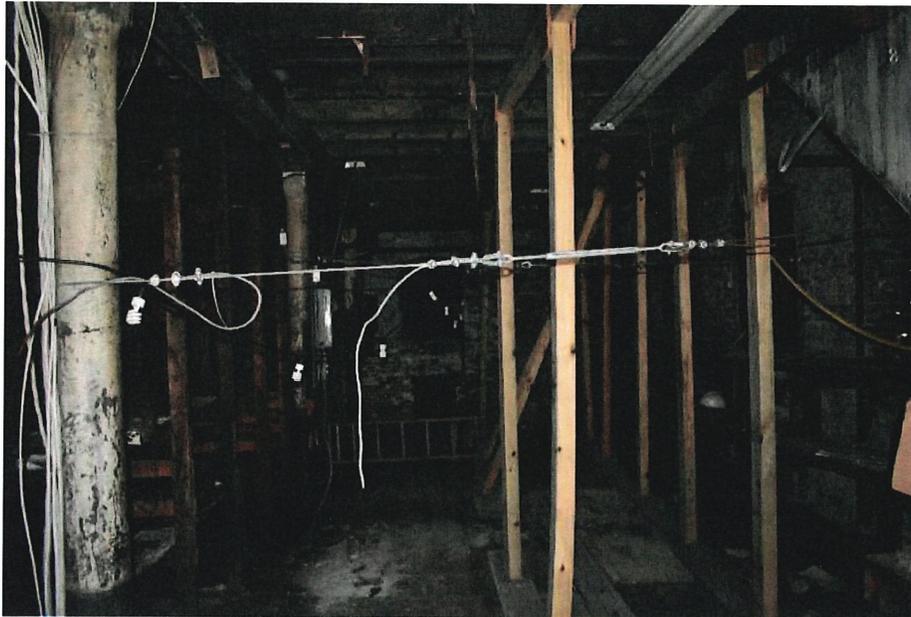
Currently the exterior façade is wrapped with a custom scrim preventing a thorough examination of the condition of the brick on the exterior. It is our understanding that this scrim was installed to protect the public from debris falling from the deteriorated brick façade of the building. There are pieces of brick along the base of the building around the perimeter indicating that the façade has been and continues to delaminate. In addition, the south exterior façade is currently being held in place by steel cables tied back to the interior structural columns in an attempt to hold the rest of the brick wall in place to prevent it from collapsing altogether (Photo Below). Even if the rest of the exterior walls could be saved, this location would need to be fully demolished and re-built in its entirety. It's not clear how this could be accomplished safely and without risking collapse of the building. However, since the perimeter foundation walls cannot be repaired or underpinned and must be demolished and rebuilt in their entirety as described in Haley & Aldrich's and Arup's reports, it is virtually impossible to retain the brick perimeter walls. This is because the brick walls sit directly on the foundation walls with no grade beam to hold up the walls if the foundation is demolished. The first floor framing members sit directly on top of the foundation walls set into pockets in the masonry. Therefore, it is virtually impossible to lift the building off its foundation, even if the existing masonry walls were stable and structurally sound. The situation would be even more difficult and precarious due to the many openings in the walls which would need to be cut in order to install a temporary stabilizing structure. Therefore, the brick exterior walls of the building would have to be removed and rebuilt in their entirety.
