# STRUCTURAL CONDITION ASSESSMENT REPORT

**Property Address:** 178–180 Elm Street, Cambridge, MA

**Prepared By:** Charles E Michaud P.E.

**Date:** March 3<sup>rd</sup>, 2026

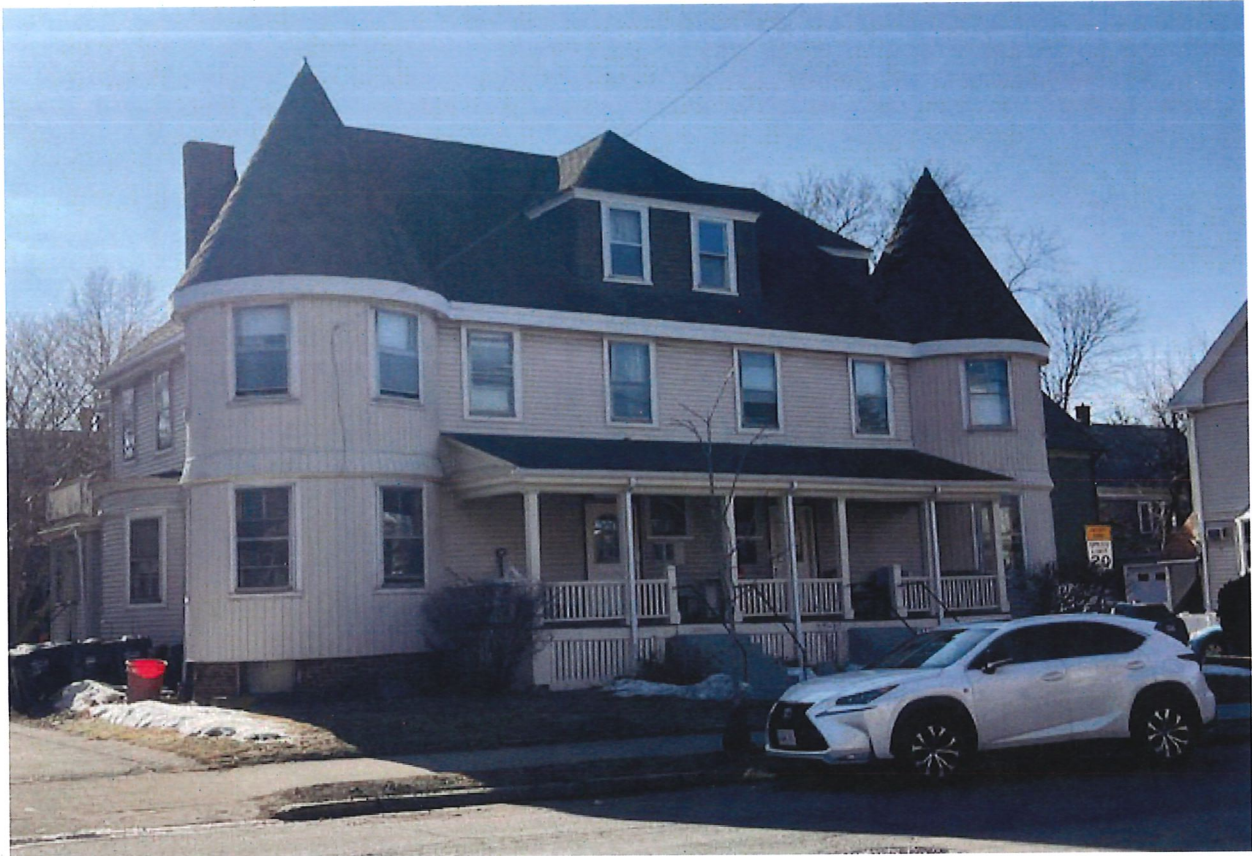
### **Overall Building Condition and Loss of Historic Integrity**

The image shows the front elevation of the primary structure, a multi-family residential building originally constructed in the early 1900s. While the overall massing and form of the building remain, the structure has undergone numerous alterations and repairs that have significantly diminished its historic integrity.

The exterior is clad in vinyl siding, which obscures original materials and detailing. The window assemblies consist largely of modern vinyl replacement units, with variations in size and configuration that are not consistent with the original design. This mix of alterations results in a façade that lacks architectural cohesion.

The front porch structure has been modified or reconstructed, with modern materials and detailing that differ from traditional historic construction. The cumulative effect of these changes—including siding replacement, window alterations, and porch modifications—has resulted in the loss of original craftsmanship, materials, and design intent.

Overall, while the building retains its general shape, it no longer conveys a strong sense of its original historic character. The extent of alterations and repairs has significantly reduced the structure's architectural integrity and its contribution to the historic context.

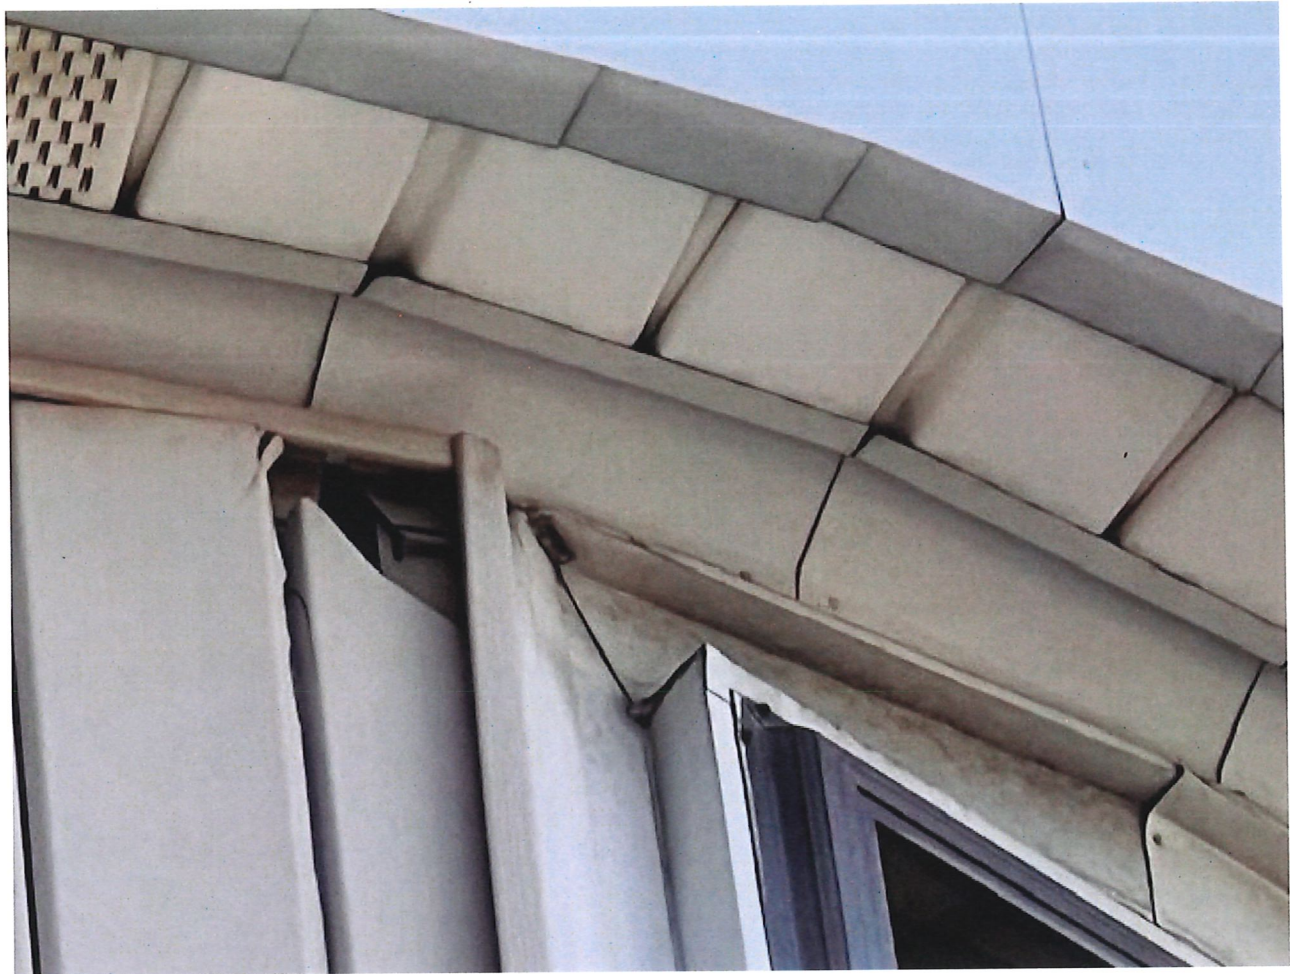
### **Exterior Envelope Deterioration and Pest Entry Points**

The image shows a close-up view of the upper exterior façade, specifically at the soffit and trim interface above a window. The vinyl siding and trim components exhibit visible separation, warping, and displacement. Gaps are present at multiple joints, particularly where trim members meet, indicating failure of fastening and/or underlying substrate deterioration.

There is clear evidence of openings at the soffit and trim connections, which create direct pathways into the building envelope. These gaps are consistent with observed pest intrusion conditions on site and provide access points for birds, squirrels, and rodents. Discoloration and staining along the soffit suggest prolonged moisture exposure and potential water infiltration.

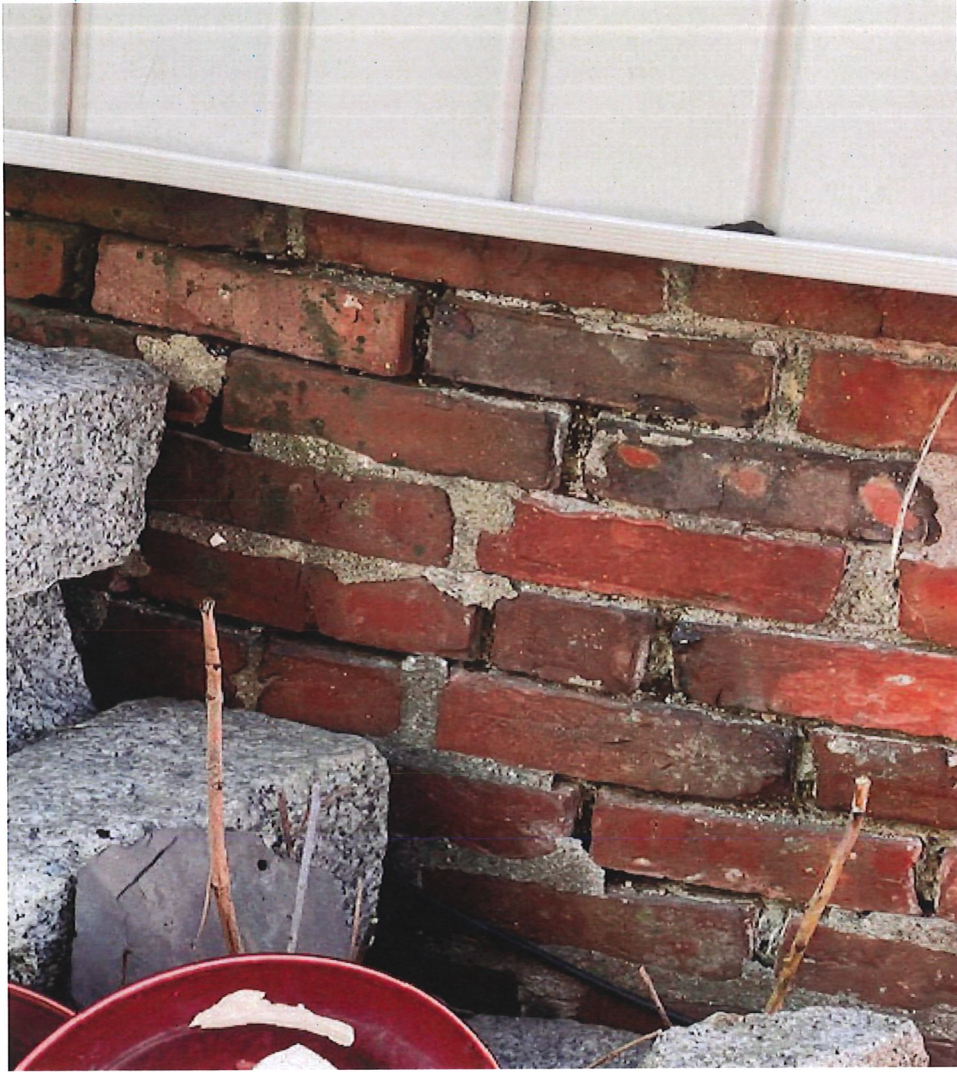
### **Foundation Wall Deterioration and Masonry Failure**

The image shows a section of the exterior foundation wall constructed of brick masonry beneath vinyl siding. The brickwork exhibits significant deterioration, including mortar loss, joint erosion, and displacement of individual bricks. Several bricks appear loose and misaligned, with visible gaps and voids in the mortar joints.

The condition indicates long-term moisture exposure and degradation of the mortar matrix, resulting in a loss of structural cohesion within the wall assembly. The uneven courses and localized bulging suggest movement consistent with settlement and/or lateral pressure.

Additionally, the interface between the vinyl siding above and the masonry below lacks proper sealing, creating potential pathways for water infiltration and pest entry. The observed deterioration compromises the load-bearing capacity and overall stability of the foundation wall.

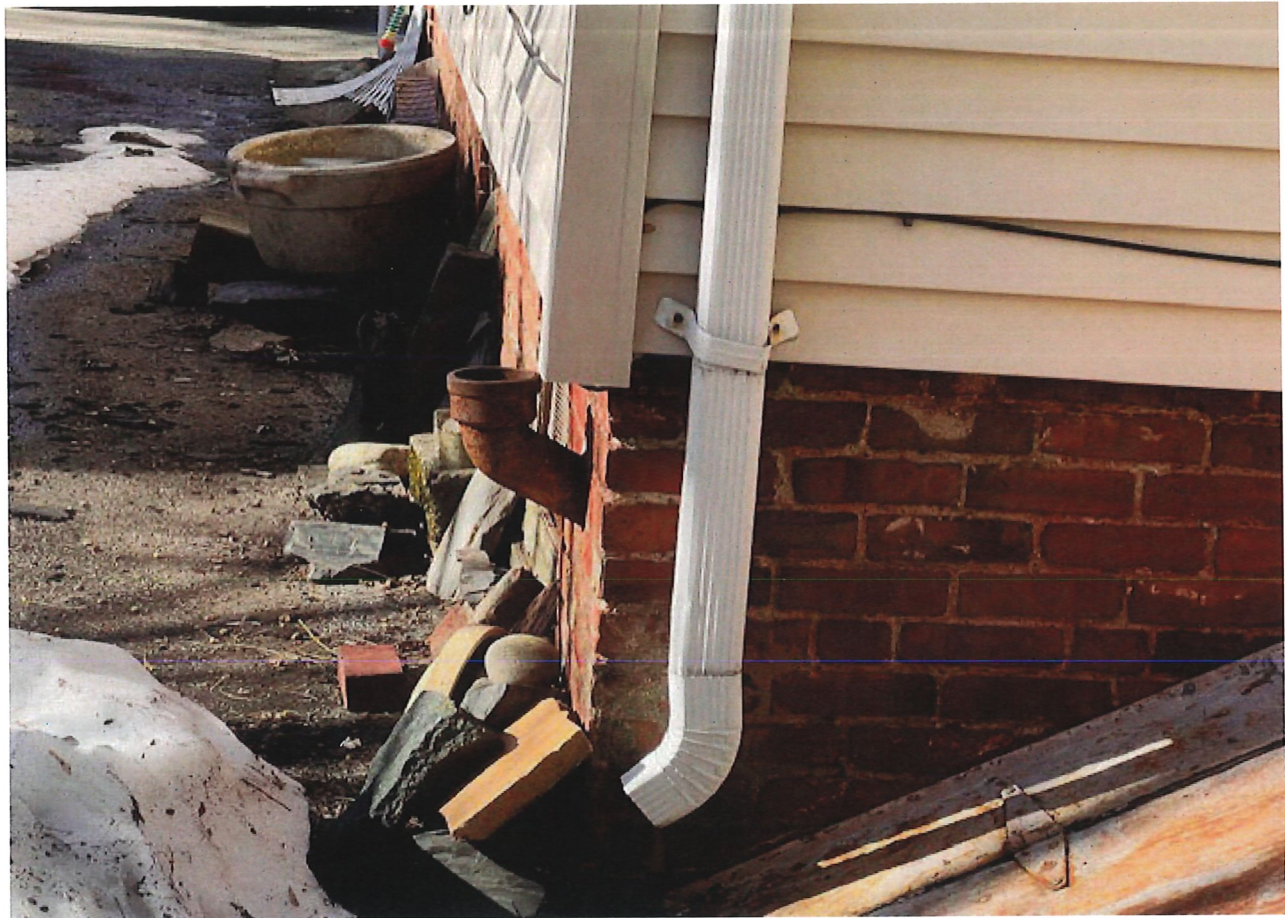
### **Foundation Wall Buckling and Displacement**

The image shows a section of the exterior brick foundation wall exhibiting visible deformation and displacement. The masonry courses are no longer level, with noticeable bulging and lateral movement of the wall plane. Several bricks are misaligned, and mortar joints show signs of separation and deterioration.

The wall appears to be bowing outward, consistent with structural distress caused by soil pressure, settlement, or loss of lateral support. The displacement is further evidenced by irregular joint spacing and localized rotation of individual bricks.

At the interface between the vinyl siding and the masonry foundation, there are gaps and misalignments, indicating differential movement between the superstructure and foundation. Adjacent site conditions, including uneven ground and debris accumulation, suggest poor drainage and potential contribution to ongoing foundation instability.

Overall, the observed conditions are indicative of foundation wall failure and compromised structural integrity, requiring full replacement rather than localized repair.

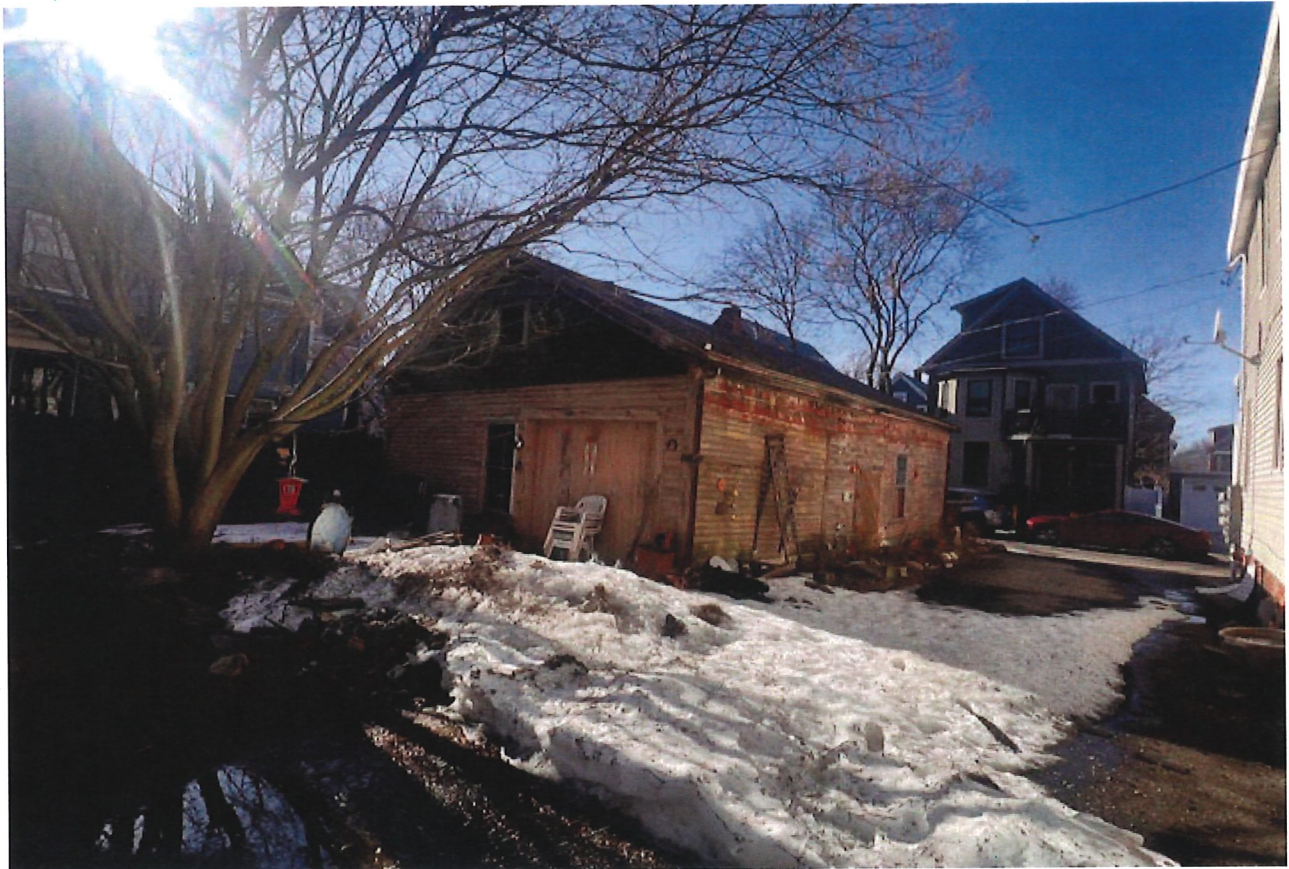
### **Accessory Structure (Barn) – Advanced Deterioration**

The image shows an existing detached wooden accessory structure (barn/garage) located at the rear of the property. The structure is wood-frame construction and is in a significantly deteriorating condition.

The exterior walls exhibit extensive weathering, material degradation, and loss of protective finishes. Portions of the wood siding are deteriorated, warped, or missing, exposing the underlying structure to the elements. The roof appears aged and inadequately maintained, with visible signs of wear that may allow water infiltration.

Based on site observations, the structure is supported on a primitive foundation system and includes a dirt floor, indicating the absence of a proper slab or modern foundation. This condition contributes to moisture intrusion, instability, and ongoing deterioration of structural members.

The overall condition of the structure suggests long-term neglect, exposure to environmental elements, and lack of structural integrity. Given the extent of deterioration, including compromised framing, lack of a proper foundation system, and continued exposure to moisture, the structure is considered beyond reasonable repair and not suitable for rehabilitation.

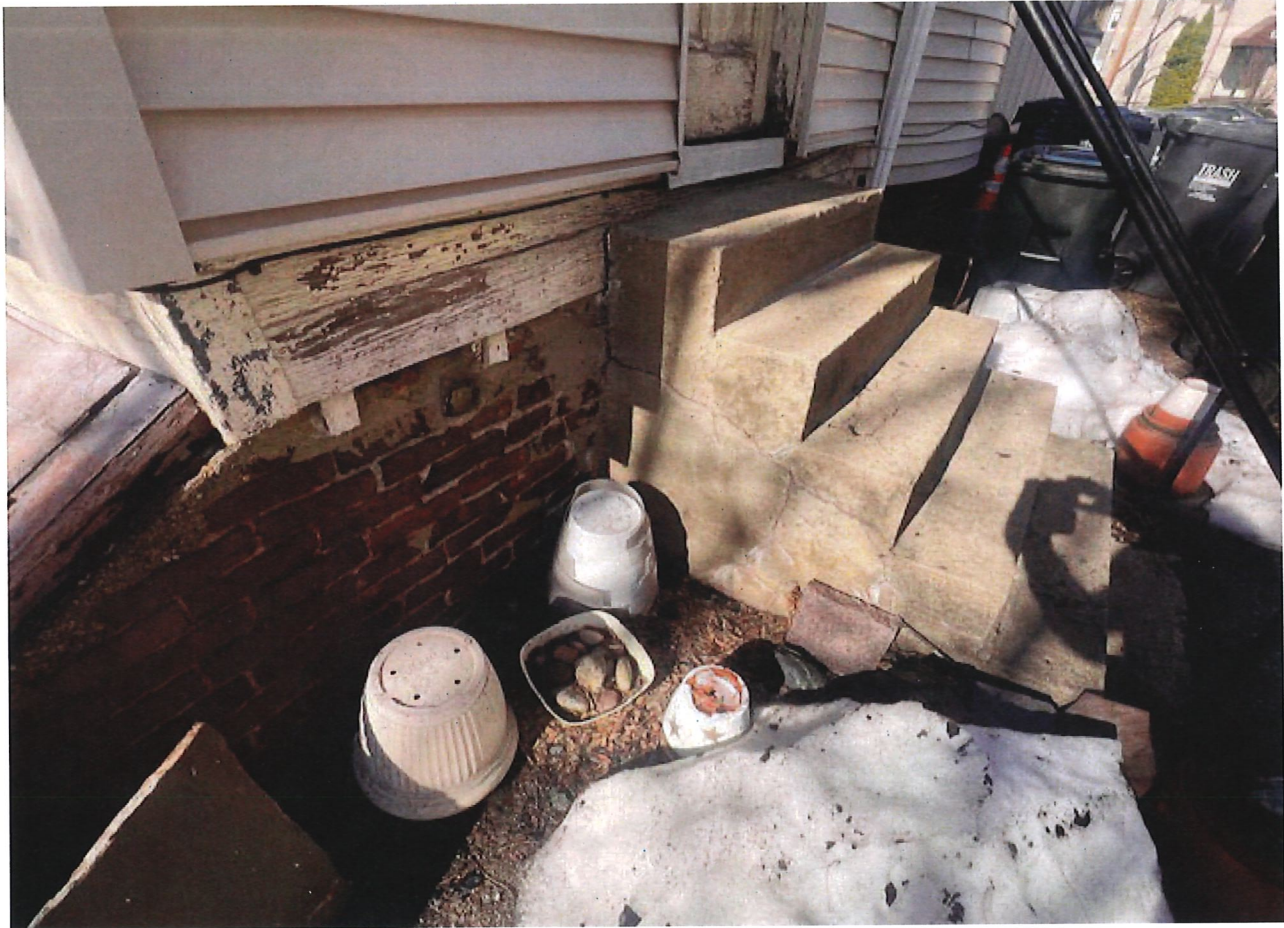
### **Foundation Cracking and Evidence of Repeated Repairs**

The image shows a section of the foundation wall and adjacent entry stairs where significant deterioration is present. The brick masonry foundation exhibits visible cracking, mortar loss, and localized displacement. Several areas show patching and repair attempts, indicated by inconsistent mortar joints and irregular surface finishes.

The concrete stair structure adjacent to the foundation also displays stress-related cracking, particularly along corners and bearing points, suggesting movement between the foundation and supported elements. The interface between the wood framing above and the masonry foundation shows deterioration, including peeling, rot, and separation, further indicating prolonged exposure to moisture and structural movement.

The presence of multiple repair attempts—evidenced by patched mortar joints, surface repairs, and mismatched materials—indicates ongoing and unresolved structural issues rather than isolated damage. These recurring repairs have not addressed the underlying causes, such as settlement and moisture intrusion.

Overall, the observed conditions are consistent with long-term structural distress, differential movement, and progressive degradation of both the foundation wall and supported elements.

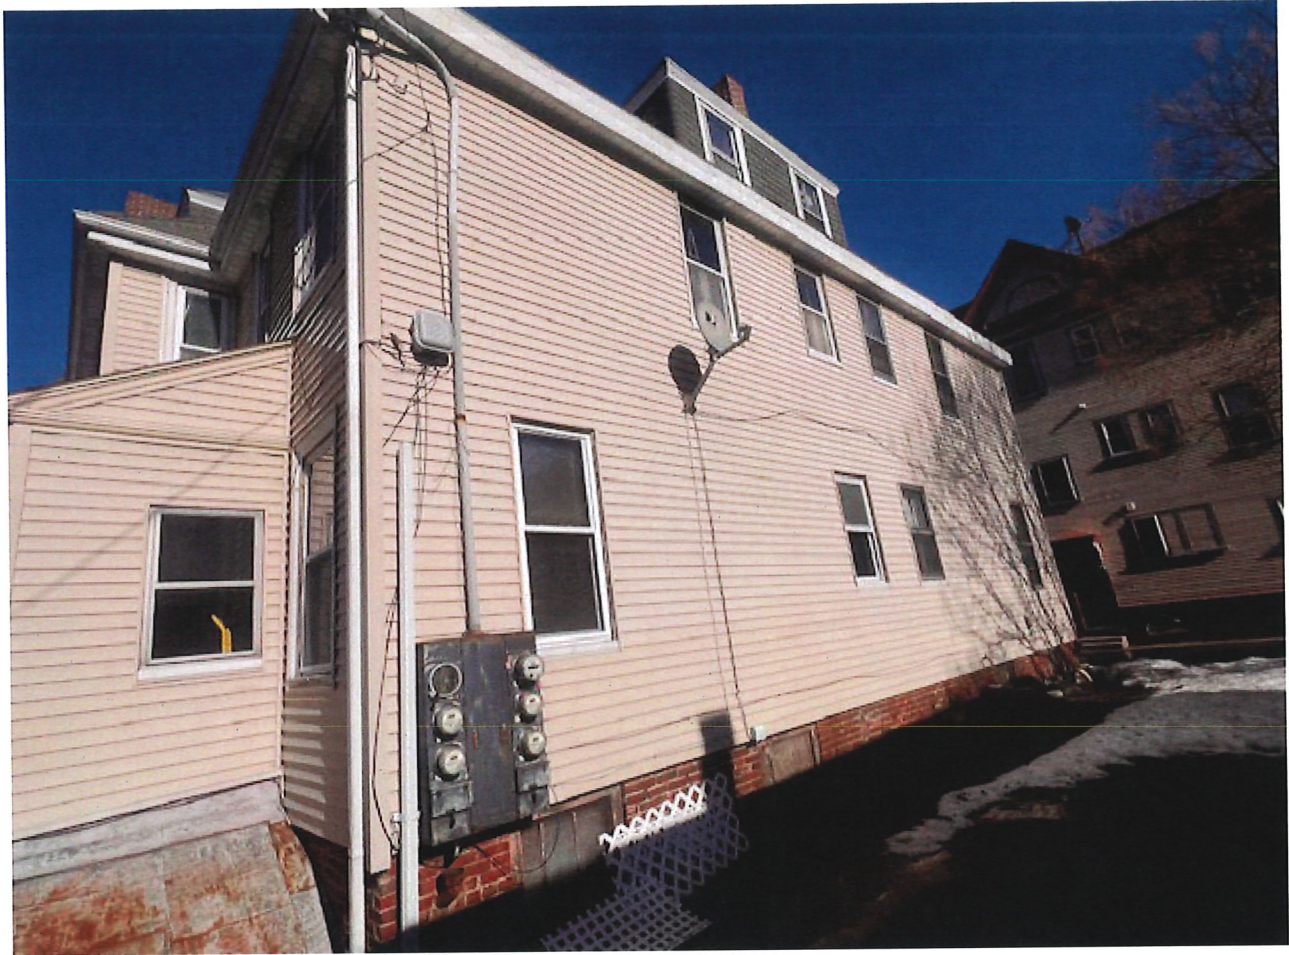
### **Exterior Siding Deformation and Non-Historic Window Replacement**

The image shows a side elevation of the structure clad in vinyl siding with multiple vinyl replacement windows. The siding exhibits visible signs of deformation, including warping, lifting, and uneven alignment along several horizontal courses. These conditions suggest improper installation and/or underlying structural movement consistent with differential settlement.

At various locations, the siding appears to be pulling away from the substrate, creating gaps that are allowing moisture intrusion and pest entry. The base of the wall, where the siding meets the masonry foundation, shows irregular transitions and potential discontinuities in the building envelope.

The windows visible in this elevation are modern vinyl replacements, which are not consistent with the original historic construction. The combination of replacement windows and deteriorating vinyl siding contributes to a loss of architectural cohesion and diminishes the building's historic character.

Overall, the observed conditions indicate both material degradation and underlying structural movement, as well as a compromised exterior envelope.

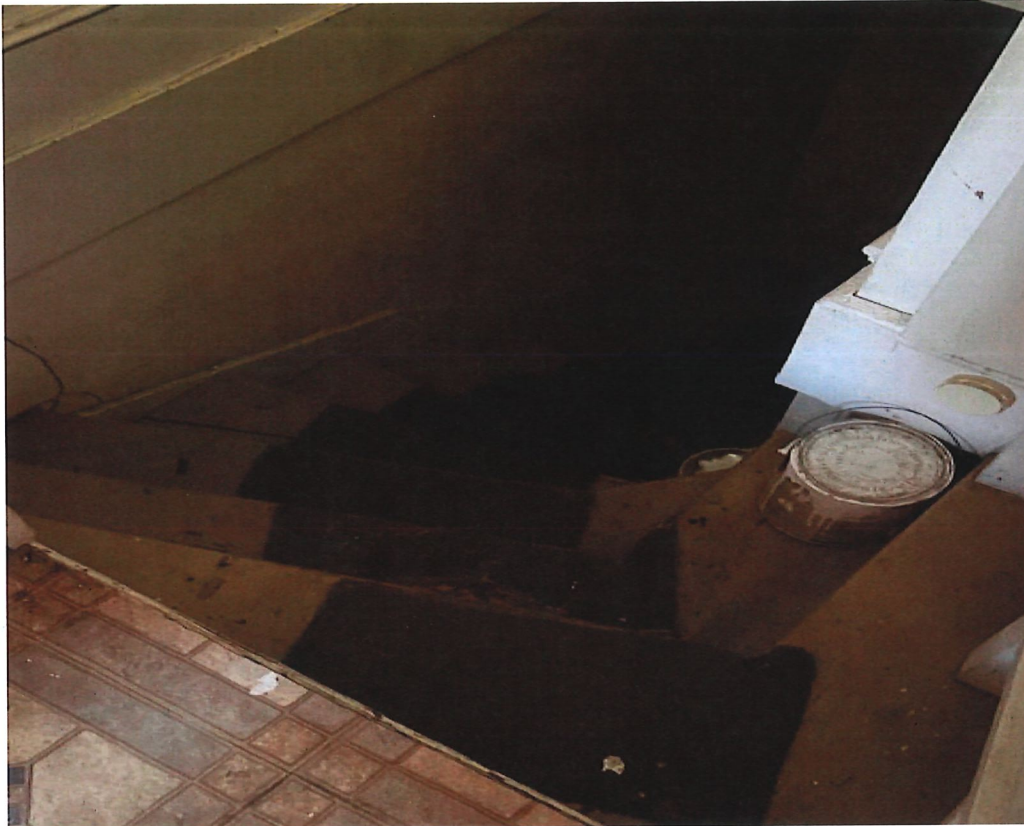
### **Non-Compliant Stairway and Structural Deterioration**

The image shows an interior stairway leading to a lower level, exhibiting multiple deficiencies related to both code compliance and material condition. The stair geometry appears irregular, with steep pitch, inconsistent tread depths, and narrow walking surfaces, which are not compliant with modern building standards under **780 CMR Section 1011 – Stairways** (including minimum tread depth, maximum riser height, and uniformity requirements).

The stair treads and supporting wood components show visible signs of wear, deterioration, and rot, particularly along the walking surfaces. Surface damage, material breakdown, and lack of proper finishes indicate prolonged moisture exposure and deferred maintenance. The surrounding wall surfaces also show staining and discoloration consistent with moisture infiltration.

Additionally, the stairs lack modern safety features, including code-compliant handrails and proper headroom clearance, further contributing to unsafe conditions. The overall configuration and condition present a significant safety hazard and do not meet current life-safety requirements.

These conditions indicate that the stair system is not only functionally obsolete but also structurally compromised, requiring full replacement rather than repair to meet current code standards.

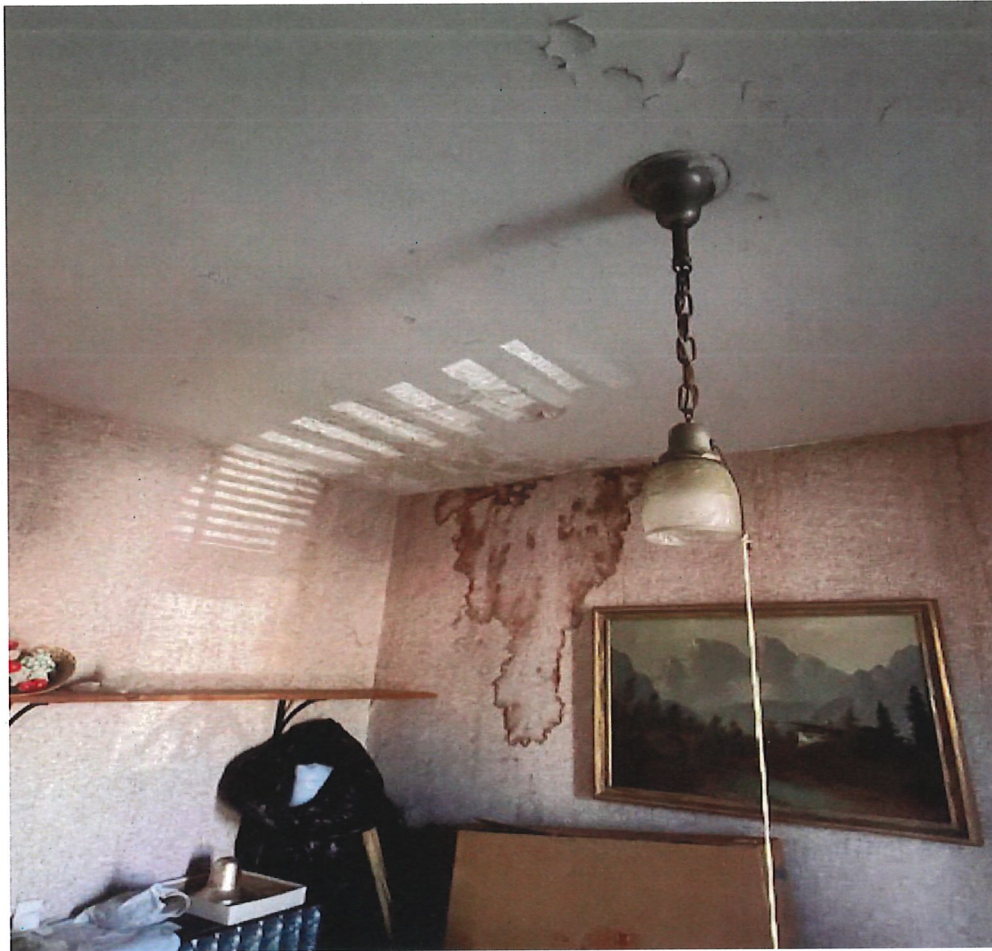
### **Ceiling and Wall Deterioration Due to Moisture Intrusion**

The image shows an interior room with visible signs of significant deterioration affecting both the ceiling and wall surfaces. The ceiling exhibits cracking, peeling paint, and localized surface delamination, indicating prolonged exposure to moisture and potential substrate failure.

The adjacent wall shows extensive water staining and material degradation, with clear evidence of active or historic moisture intrusion. The irregular staining pattern and discoloration suggest water infiltration from above, likely related to roofing or exterior envelope deficiencies. The wall finish appears compromised, with sections showing deterioration of the underlying plaster or wallboard.

These conditions are indicative of chronic moisture exposure, which can lead to deterioration of concealed structural elements, including framing members and ceiling joists. The presence of such damage raises concerns regarding potential rot, mold growth, and reduced structural integrity of the affected areas.

Overall, the observed ceiling and wall deficiencies reflect ongoing building envelope failure and deferred maintenance, contributing to the overall compromised condition of the structure.

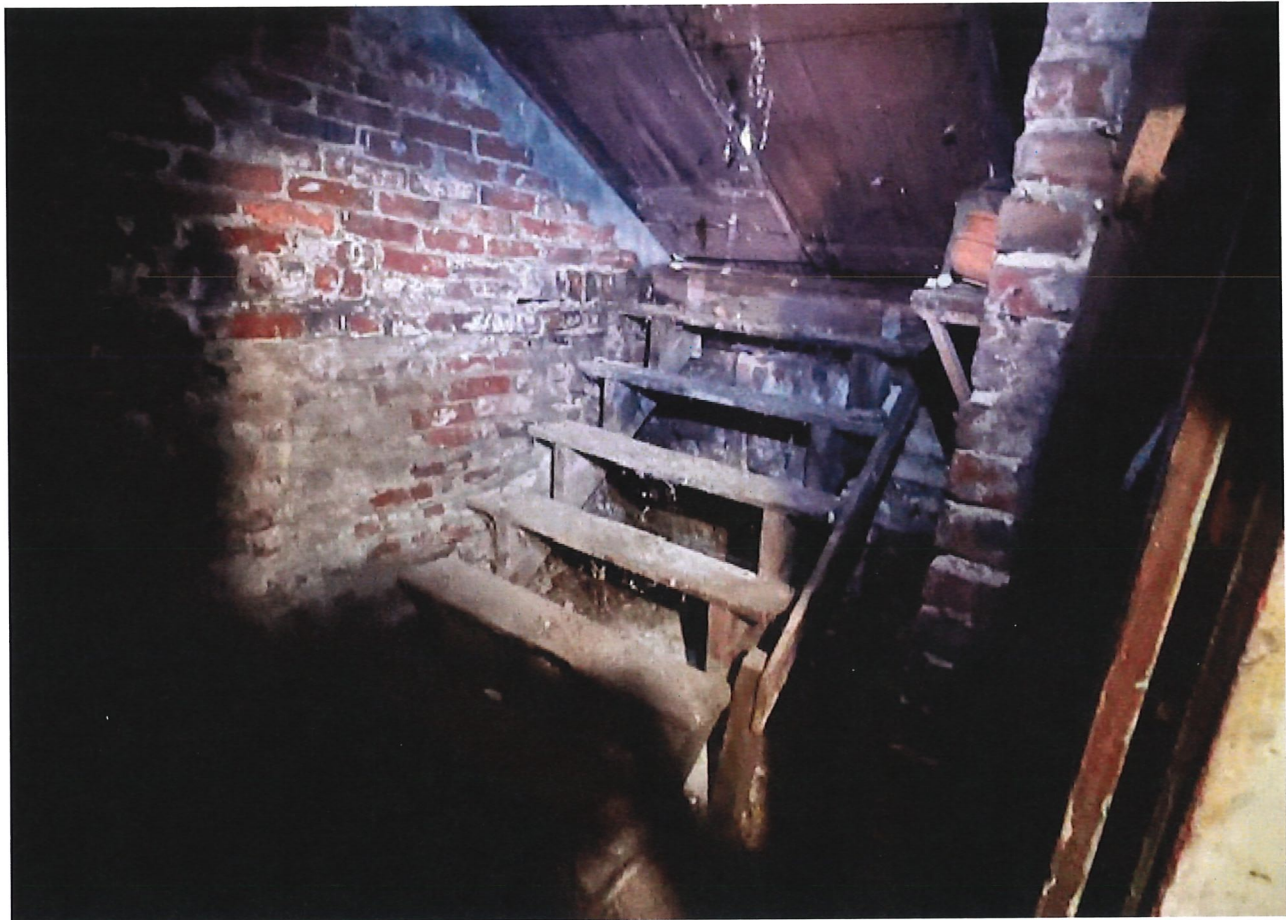
### **Basement Conditions: Dirt Floor, Failing Masonry, and Deteriorated Stair System**

The image shows a basement area with exposed dirt flooring and an aging brick masonry foundation wall. The absence of a concrete slab indicates a non-modern foundation system, contributing to ongoing moisture migration and unstable soil conditions.

The brick foundation walls exhibit significant deterioration, including mortar loss, surface erosion, and localized displacement of bricks. Evidence of prior patching or repair attempts is visible; however, these repairs are inadequate and have not addressed the underlying structural deficiencies. The masonry system shows signs of long-term degradation and reduced load-bearing capacity.

The stair assembly leading to the basement is constructed of wood and is in an advanced state of deterioration. The treads and supports appear worn, uneven, and structurally compromised, with visible damage consistent with rot and prolonged exposure to moisture. The stair configuration is irregular and does not meet current safety or code requirements.

Overall, the combined conditions—dirt floor, failing masonry foundation, and deteriorated stair system—indicate a structurally deficient basement environment that is not suitable for rehabilitation without full replacement of major structural components.

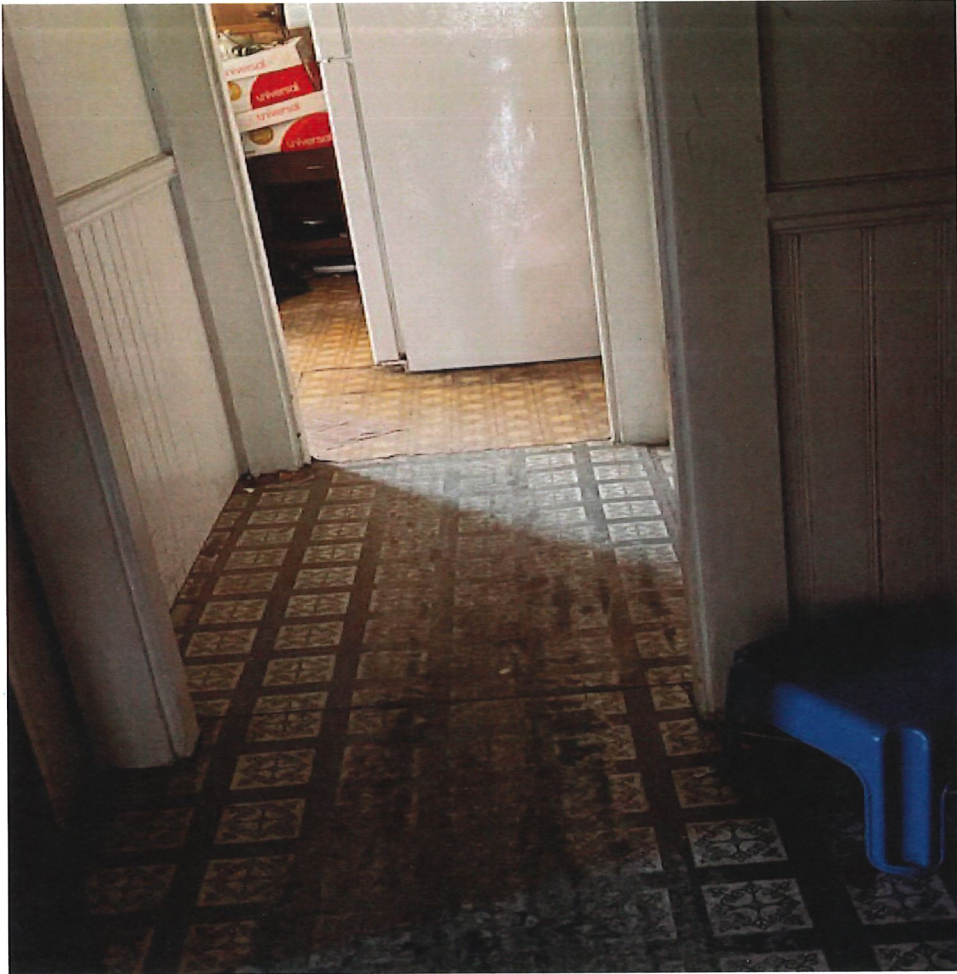
### **Floor Slope and Structural Settlement**

The image shows an interior hallway with visibly uneven and sloping floor surfaces. The flooring exhibits noticeable deflection and variation in elevation between adjacent rooms, consistent with significant structural movement.

Field observations indicate an approximate elevation differential of **4 to 6 inches** across the floor plane between rooms. This degree of slope far exceeds acceptable serviceability limits and is indicative of substantial differential settlement of the foundation system.

The deformation shows that the supporting floor framing has shifted out of alignment due to uneven bearing conditions below. This has resulted in overstressed joists, compromised connections, and disruption of the intended load path.

Such conditions present both a structural concern and a life-safety hazard, as the floor system is no longer performing as designed. The extent of displacement is consistent with advanced foundation failure and supports the conclusion that the structure is not suitable for rehabilitation without complete reconstruction of the supporting system.
