**TO:** Catherine Daly-Woodbury,  
Cambridge DPW

**FROM:** David VanHoven (Stantec)  
Zachary Halstead (Stantec)

**SUBJECT:** CAM004 Illicit Connection Survey

**REF:** CAM004 Sewer Separation and  
Surface Improvements Projects

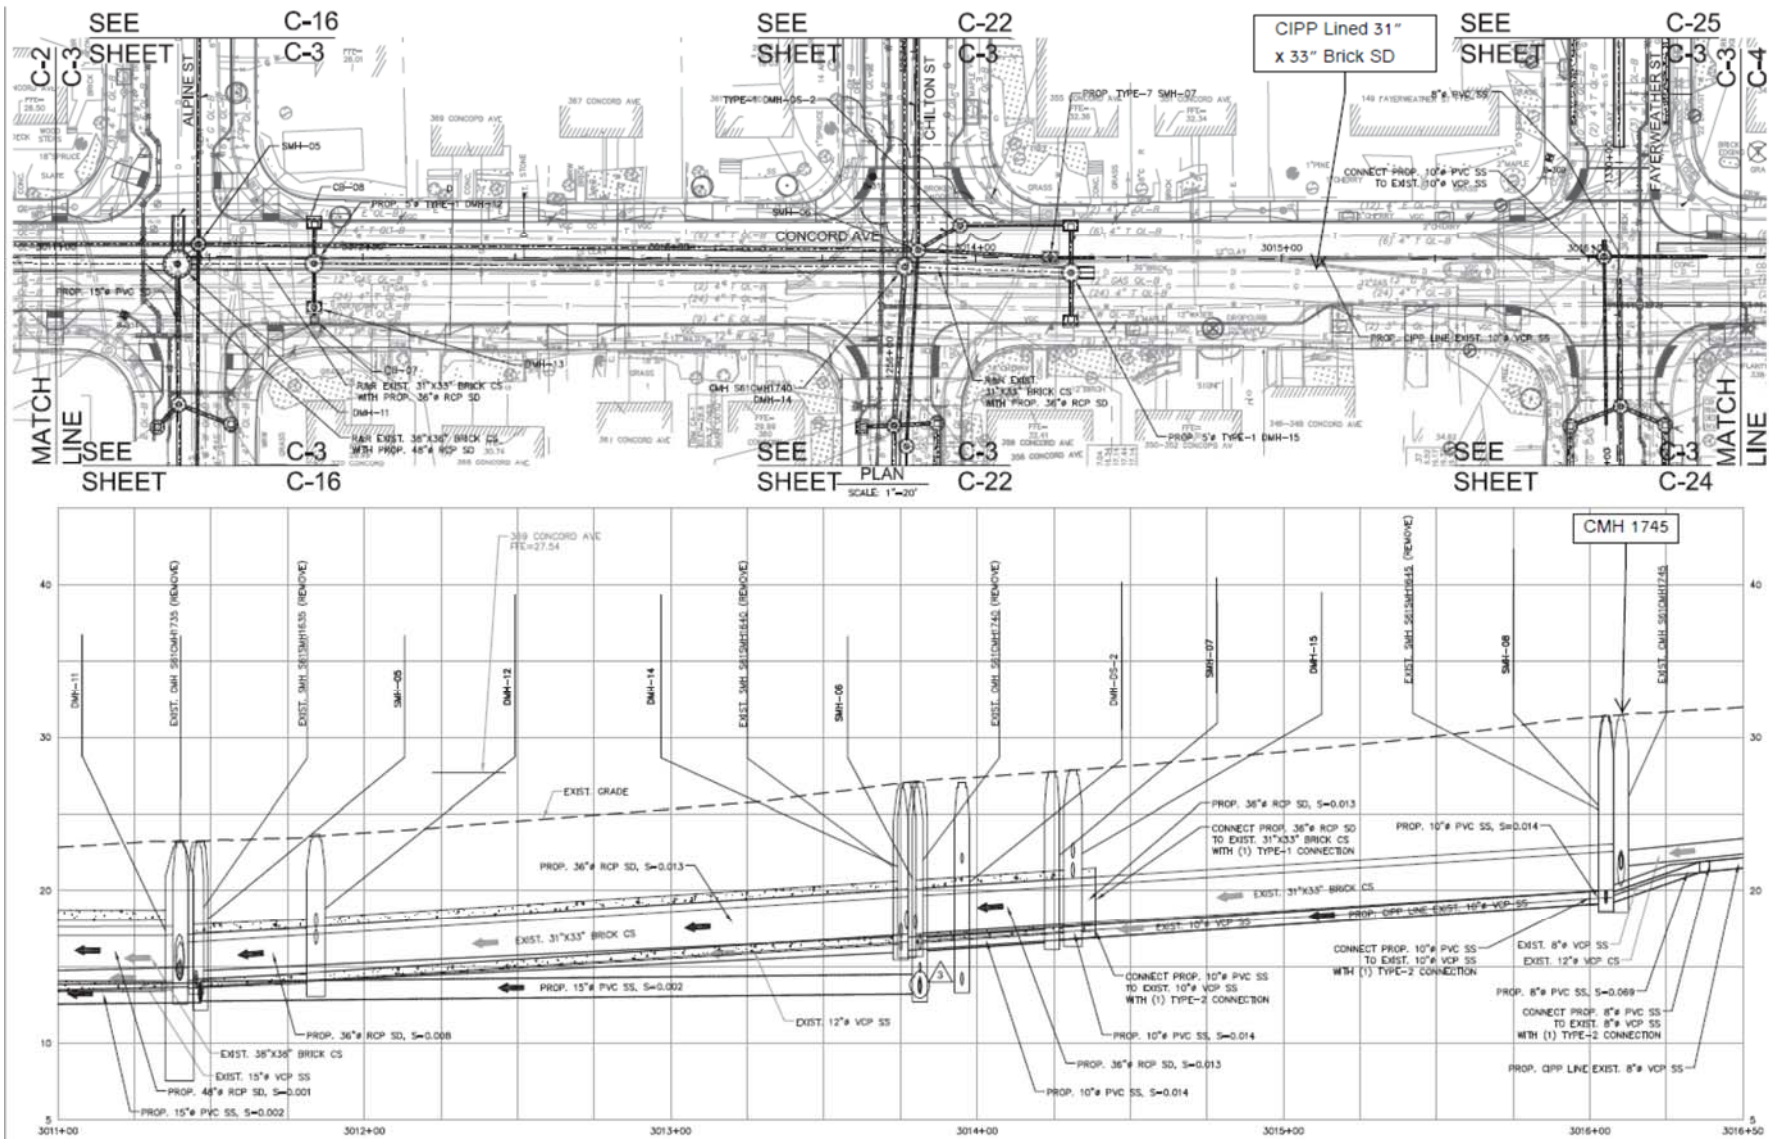
Figure 1. Concord Avenue storm drain reach from Alpine to Fayerweather; pipe size, manholes, and properties referenced in the text

- c. Sampling on 12/7/15:
  - 1. At Alpine (DMH-11) fails to pass. E. Coli -> 4,300 cfu/100m, Ammonia 1.58 mg/L
  - 2. At Chilton (DMH-14) fails to pass. E. Coli -> 400,000 cfu/100m, Ammonia 26.2 mg/L

- 3. At Fayerweather (DMH-1745) fails to pass. E. Coli -> 2400 cfu/100m
  - 4. Between Fayerweather and Walden (DMH-17) fails to pass. E. Coli 690 cfu/100m

- d. Corrective measure adopted: CCTV'ed all lateral connections along the non-compliant reaches. A total of three connections were found between Fayerweather Street (DMH-1745) and DMH-1750 (in front of 319 Concord Ave). One connection was capped, another service at the Fayerweather intersection ran about 20 feet into a wall of dirt and the third one went all the way into the basement of 320/322 Concord Ave. Dye testing of every fixture at 320/322 was performed and were confirmed to be connected to the sanitary sewer. The lateral for 320/322 was redirected to the sanitary sewer and the lateral at the Fayerweather intersection was properly capped. No more laterals were identified and therefore, the possibility of a direct illicit connection was fully discarded at this point. Further pipe cleaning was performed. Adjacent side streets were re-tested even though they had previously passed. These side streets once again passed.

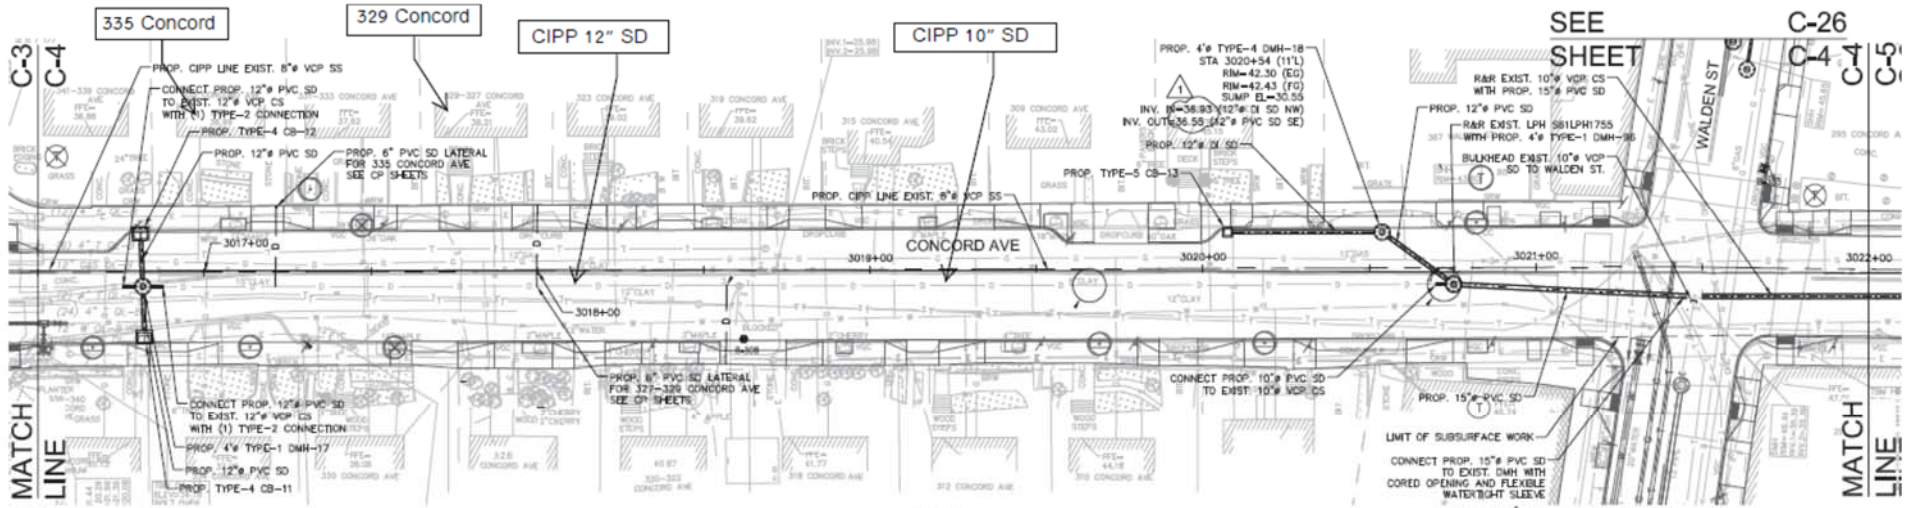
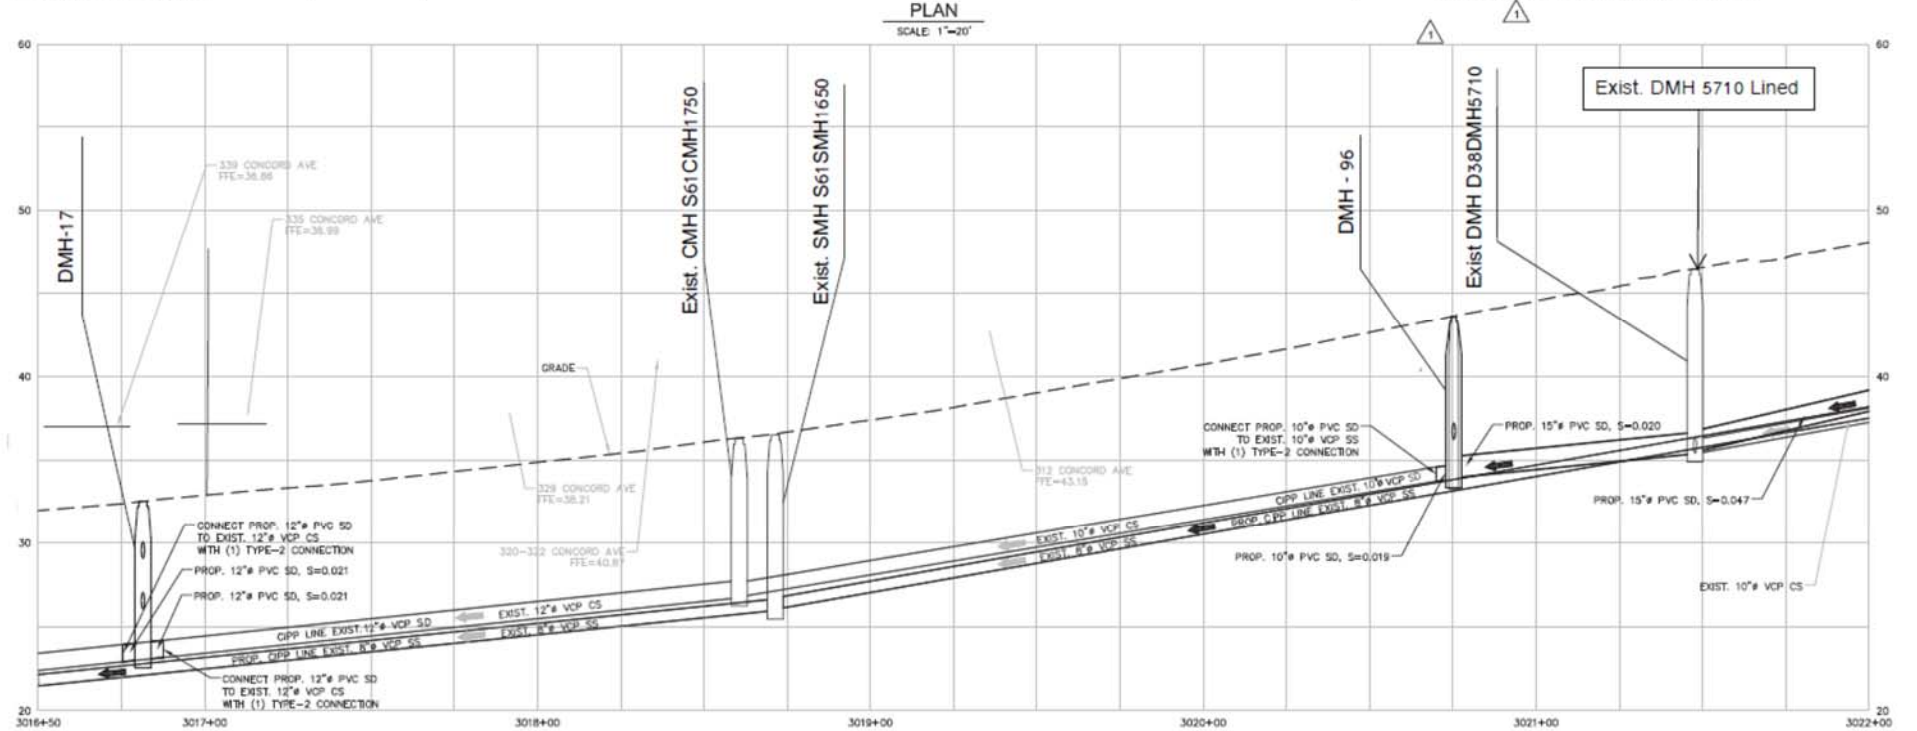
Figure 2. Concord Avenue storm drain reach from Fayerweather to Walden; pipe size, manholes, and properties referenced in the text

3. At Fayerweather (DMH-1745) fails to pass. E. Coli -> 10,000 cfu/100m, Ammonia .612 mg/L
  4. Between Fayerweather and Walden (DMH-17) fails to pass. E. Coli 20,000 cfu/100m, Ammonia 1.09 mg/L

- c. Corrective measure adopted: Focused on upstream stretch between Walden and Fayerweather. CCTV'ed all sewer service laterals with in this stretch to assess condition of pipe in an effort to identify a potential source of exfiltration from a sewer lateral with infiltration to the storm drain. No laterals with in this stretch were found to be collapsed. Two laterals were found to have slightly offset joints. After directing the contractor to repair these joints it was found that the joints were not accessible due to utility conflicts. This effort was abandoned. Another round of cleaning was performed and a retest of Fayerweather St from Concord to Walden was done as well as another test on Concord from Fayerweather to Walden.

2. Fayerweather reach (DMH-1745) no standing water observed, section passes.
  - c. Corrective measure adopted: The 10 to 12-inch drain between Walden St (DMH-96) and Fayerweather St (DMH-1745) was CIPP-lined in order to prevent potential infiltration inflows from damaged building sewer laterals crossing over the drain or other sources of contaminated inflows infiltrating the storm drain.

- b. Sampling on 3/7/16 at Fayerweather (DMH-1745) fails to pass. E. Coli 690 MPN/100ml, Ammonia 12.2 mg/L
- c. Special Note: The E.Coli concentration was reduced by two orders of magnitude and it was very close to compliance in relative terms (E.Coli concentration was 10,000MPN/100mL and 3,900MPN/100mL one and two months before lining and 690MPN/100mL after CIPP-lining). The surfactants concentration was compliant with the Class B water standard. The ammonia concentration, however, was very high at 12.2mg/L, which remains a concern.

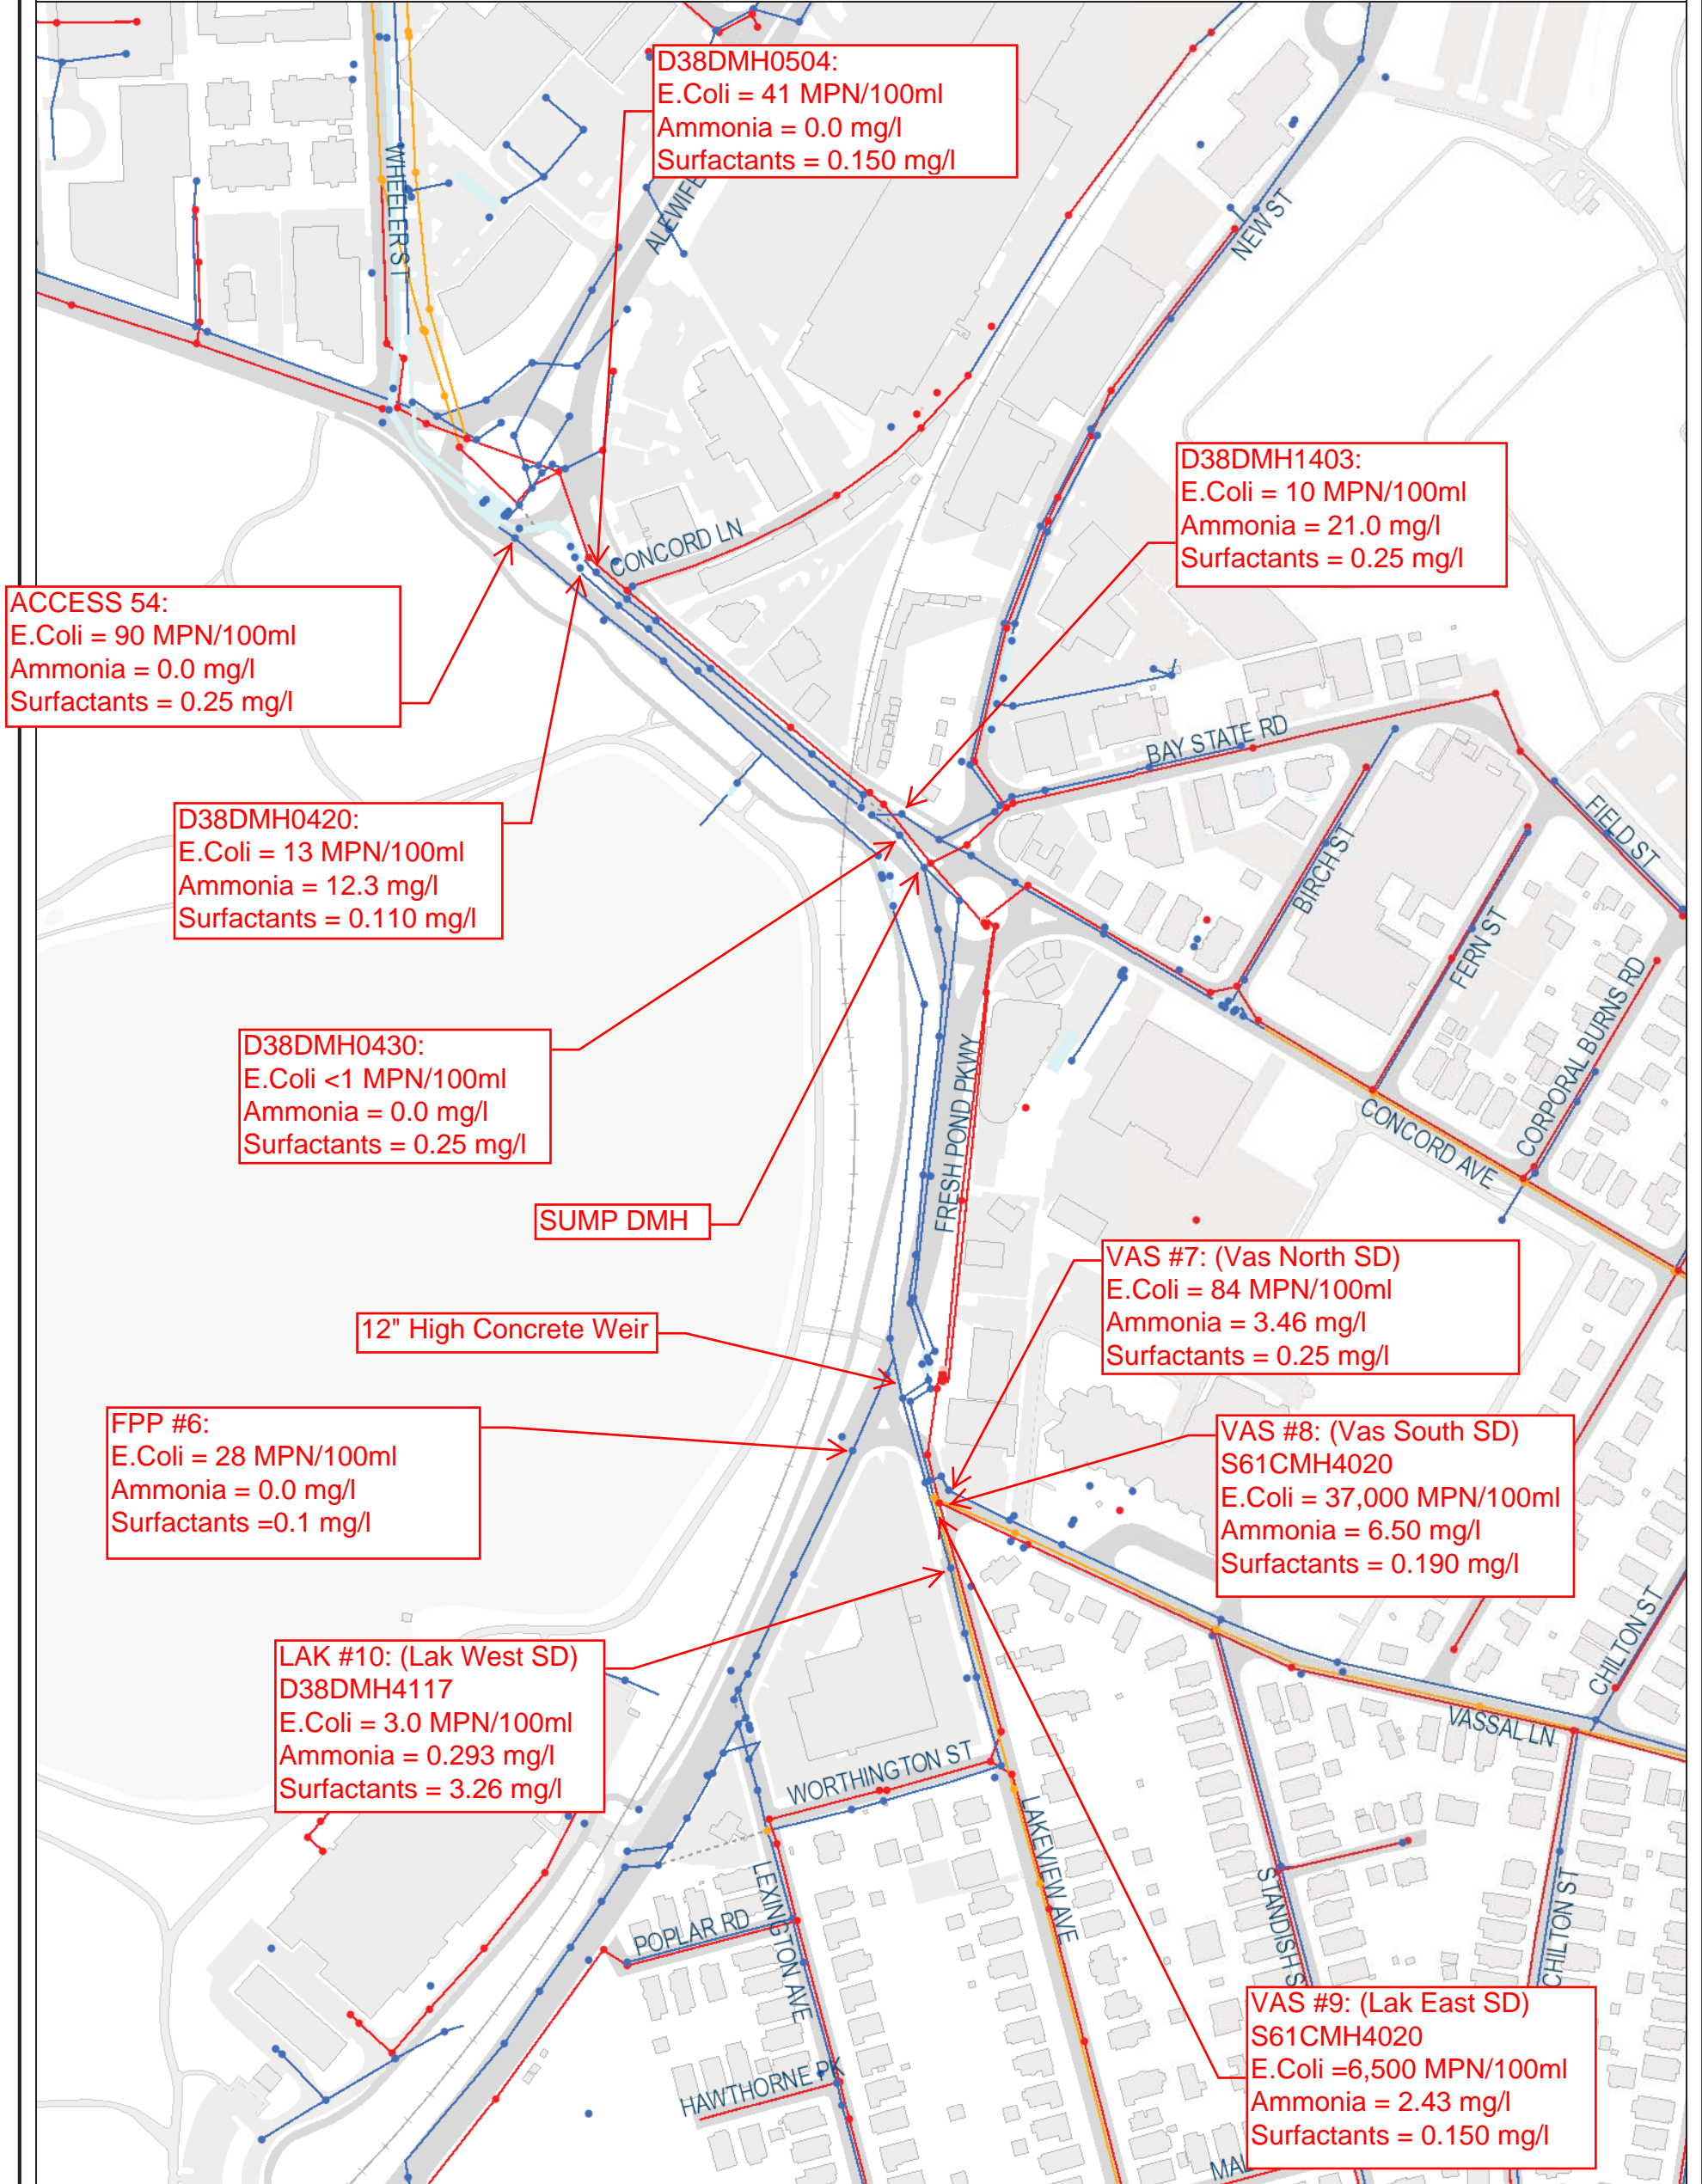
**Appendix D**  
**Downstream Sampling Figure**

The sample collected from Drain Vault No. 5 was collected on September 11, 2017 and serves as the representative sample for the entire upstream collection area. The concentrations of E. Coli (980 MPN/100mL) and surfactants (0.11 mg/L) were found to be just above the designated allowable

concentrations with ammonia levels (6.4 mg/L) high as has been consistent throughout the larger catchment sampling. Based on these results, the upstream drain is believed to be free of sanitary sewer connections and the ammonia is suspected to be generated from decaying matter and sediment in the system. It should be noted that the contract closeout cleaning of the drainage system had not occurred prior to the sample being collected at Drain Vault No. 5.

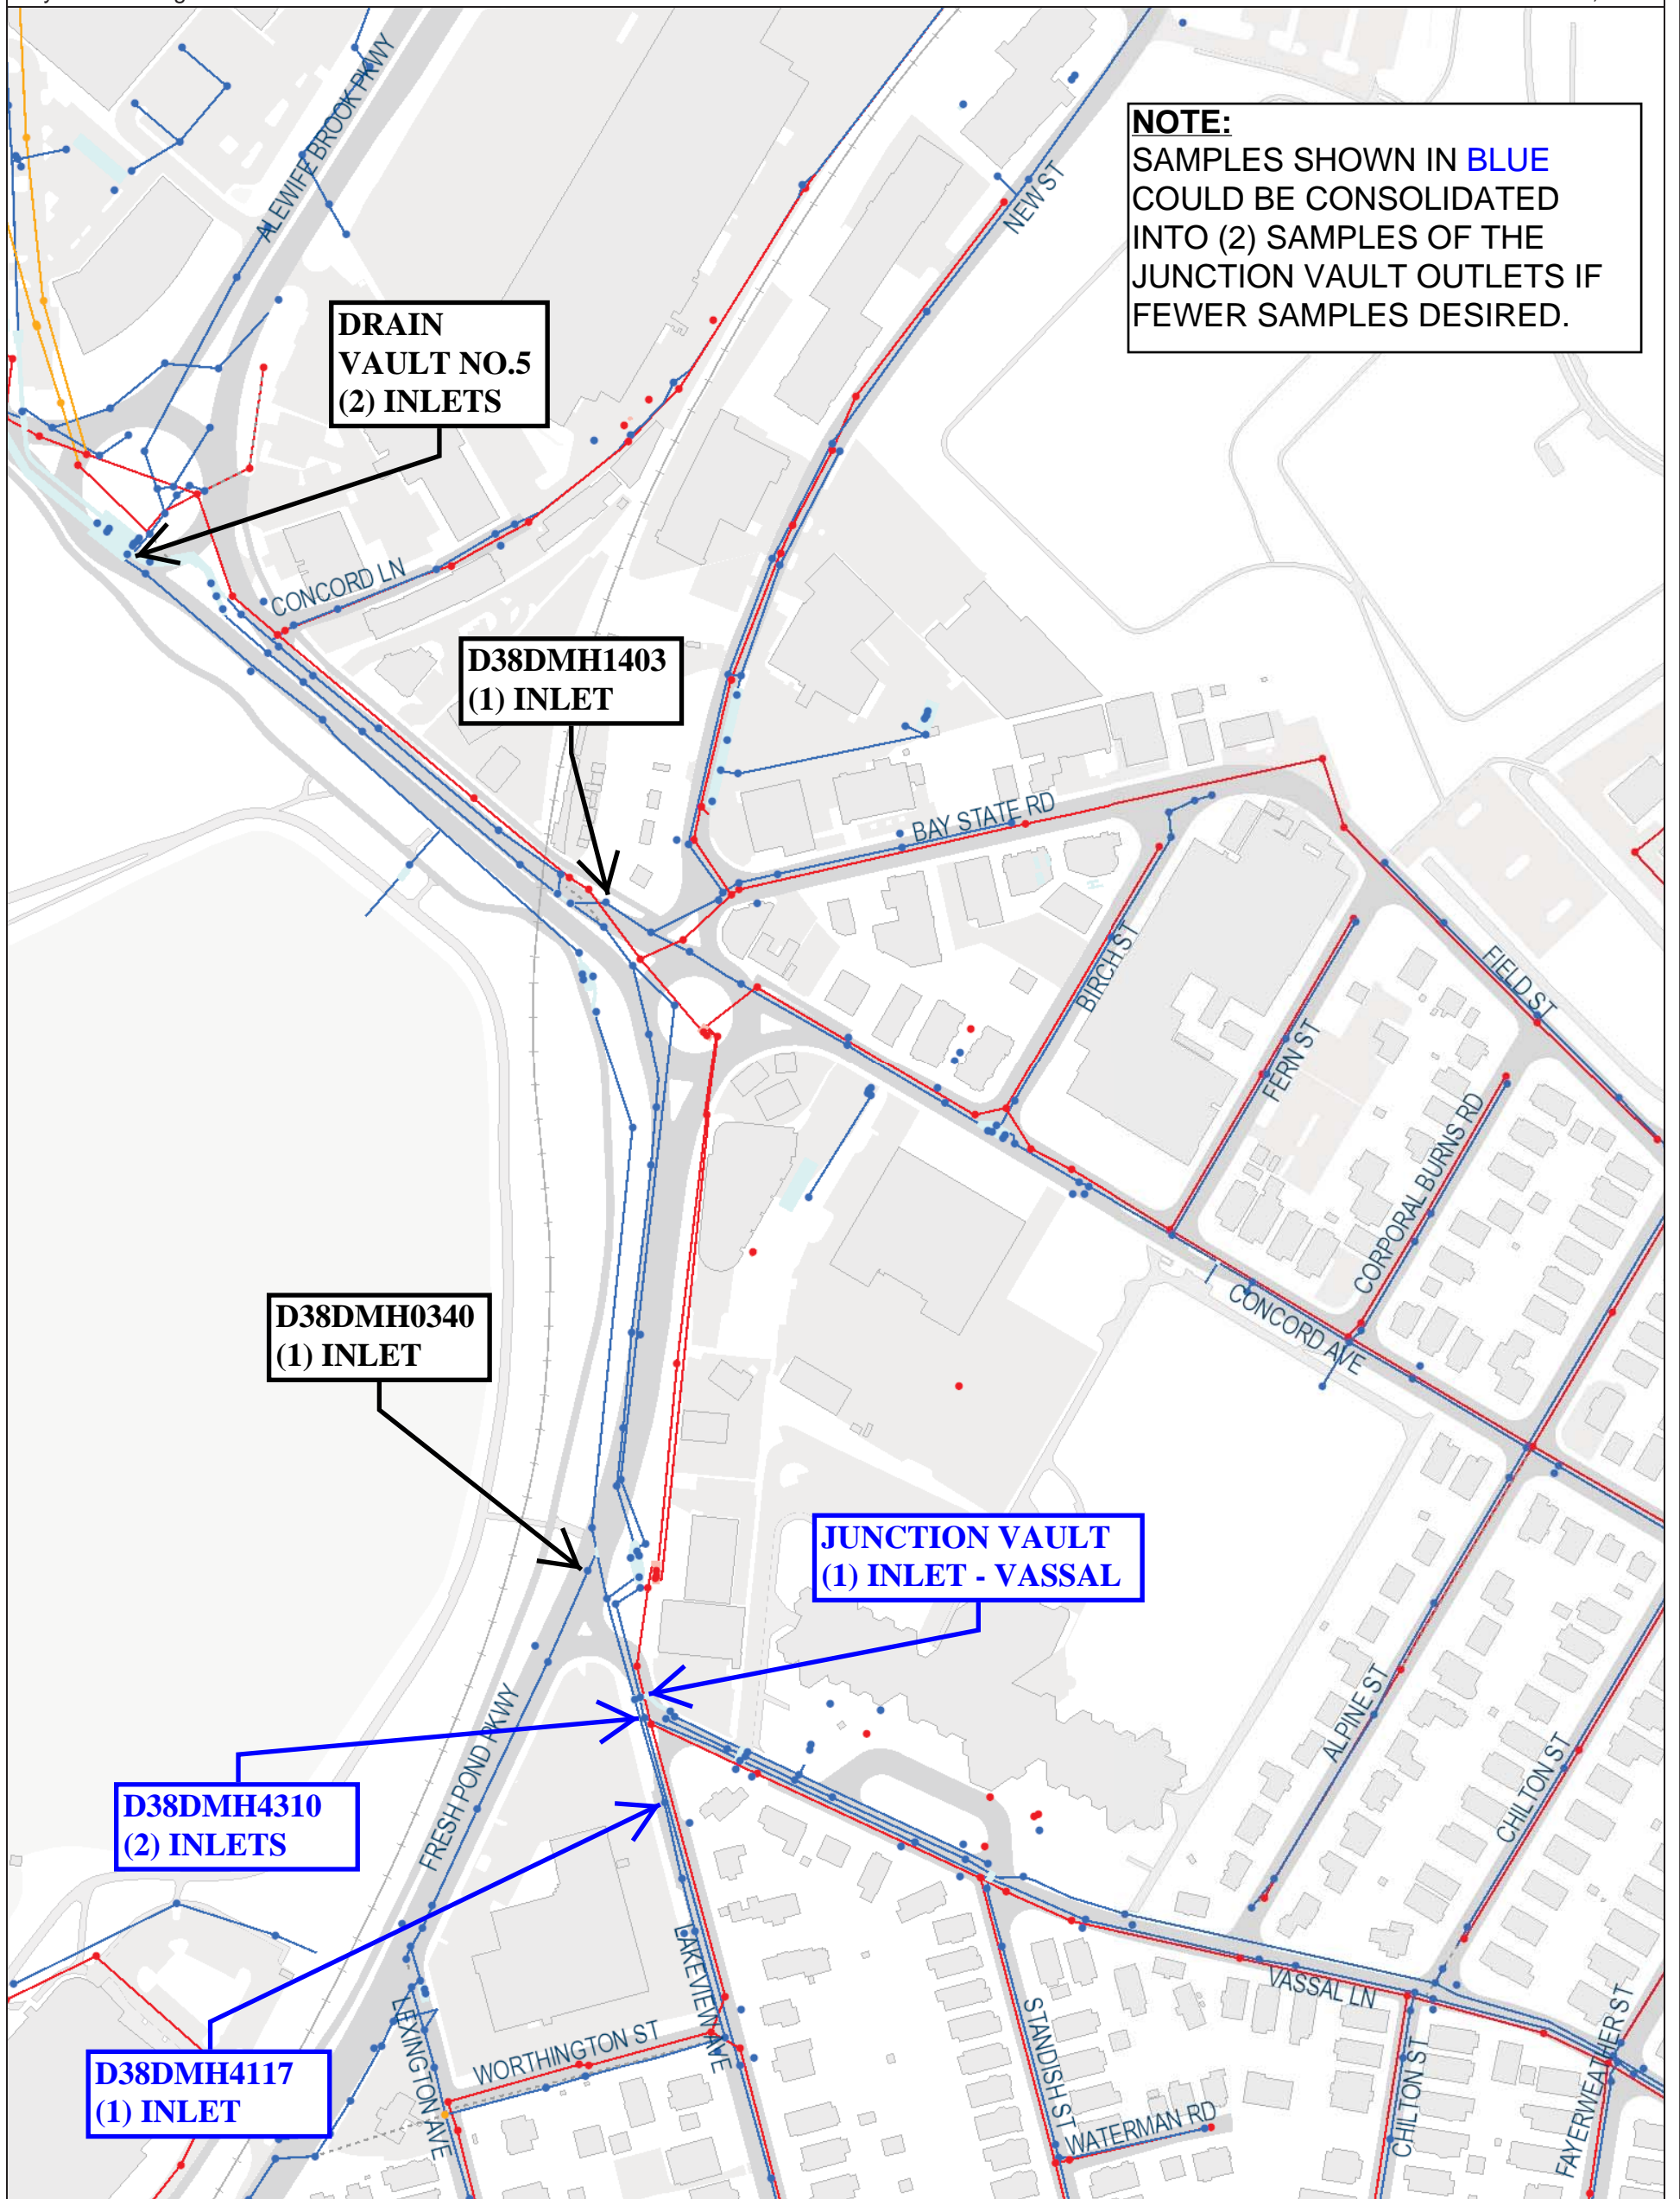
**Appendix E**  
**Sampling Monitoring Figure**

**NOTE:**  
 SAMPLES SHOWN IN **BLUE**  
 COULD BE CONSOLIDATED  
 INTO (2) SAMPLES OF THE  
 JUNCTION VAULT OUTLETS IF  
 FEWER SAMPLES DESIRED.

Additional sampling is recommended to continue to monitor the bacteria levels within the entire CAM004 catchment. If possible, this sampling is recommended to be completed after the closeout cleaning that is scheduled for the Huron B and Concord contracts. A sampling monitoring figure has been included in **Appendix E** that depicts locations where the City can further isolate each project area and continue to monitor the system. Six structures have been identified as potential sampling locations with a total of eight samples being collected. These locations were selected to isolate catchments and differentiate between the Huron A, Huron B and Concord contracts. The sampling locations could be modified to add sampling locations for greater isolation or to merge some locations if fewer samples are desired. The current schematic does not differentiate Concord Lane and New Street from the other project areas so additional sampling locations could be added if this separation is desired. Alternatively, the four samples at the Lakeview Avenue and Vassal Lane intersection (Shown in blue within **Appendix E**) could be condensed into two samples within the junction vault to sample both outlets. This however would not differentiate between the Huron A and Huron B catchment areas.
