Main Library Expansion Project

Cambridge, Massachusetts

Existing Conditions Report and Preservation Recommendations

January 31, 2003

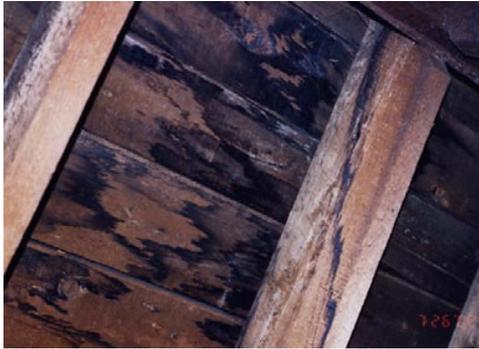
Water Stains, Attic, 2002

b. Copper Roofing. There are several areas of active water infiltration inside the building. The worst of these occur in the junction between the 1889 Reading Room and the 1894 Wing under the copper roof. The roofer positively identified that loose and improperly installed step-flashing along the perimeter of the chimney at this location is allowing water to enter the building. This is the cause of significant plaster damage inside the Sakey Lecture Room and in the Genealogy Library above it. In addition, there is evidence that weak or open seams in the copper roof itself may be drawing moisture into the attic.

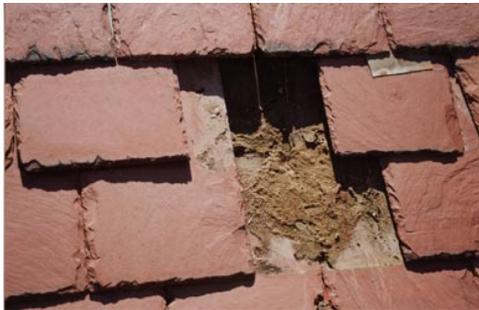
Roof Probe, 2002

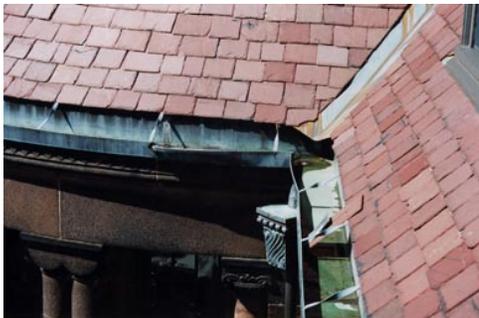
Gutter Damage, 2002

c. Gutters and Downspouts. As noted, the formed copper gutters, ornamental conductor heads and downspouts appear to be original. These all are in good physical condition. However, there is typically standing water in most sections of gutter. Downspouts appear to be clogged in many locations. Typically, enclosed areas where birds tend to congregate seem to be the most difficult areas to maintain. There is evidence of water problems at the northeast corner of the stack wing that appear to be related to the adjacent rain leaders.

- Install new membrane roof over apsidal end of Stack Wing.
- Clean out and maintain gutters and downspouts on a regular basis, at least twice a year.
- Upgrade current bird deterrent systems.
- Repair step-flashing along chimney at copper roof.
- Repair open joints in copper roof.
- Repair flashing at parapet above west wall of Cambridge Room.
- Consider phased plan for total replacement of slate roof and associated copper ridges, valleys and flashing.
- Establish a cost estimate for total replacement of flat seam copper roofing and slate roofing with associated copper ridges, valleys and flashing.

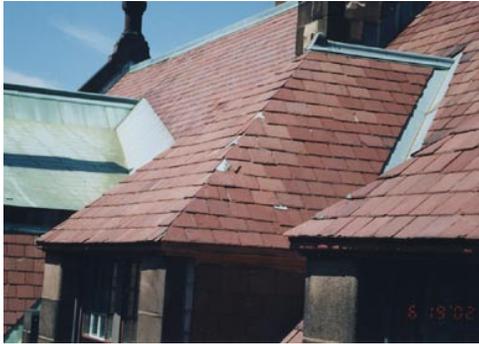
a. Slate Roof. The red slate roofing, copper ridge caps and flashing appear to be generally in good condition and have benefited from appropriate maintenance and repair. However, after 114 years, the roof shows inevitable signs of age and may be reaching the end of its expected life span. The slate roof was physically examined with a representative from Gilbert & Becker. The attics under these roofs were also surveyed. In four areas, slates were removed in order to inspect the condition of the flashings, roofing felt and wood sheathing. Ridge caps and valleys are weathered but appear to be appropriately detailed and functional. Step-flashing at dormers is generally in good working order. Plaster damage on the west wall of the Cambridge Room suggests that step-flashing at parapets requires attention. An examination of the roofing felt indicated that, in areas receiving direct sunlight, this material is all but disintegrated. According to the roofer, there is now limited second means of defense against moisture should a slate become loose or missing. The risk of developing leaks in the future is great. In the attic, areas of staining indicate a history of numerous leaks. The rafters and wood sheathing, however, appear to sound, indicating that past leaks have not caused significant damage. (Refer to discussion of open mortar joints in Section 2.3 as an additional source of moisture infiltration).

Patched Slate at Dormers, 2002

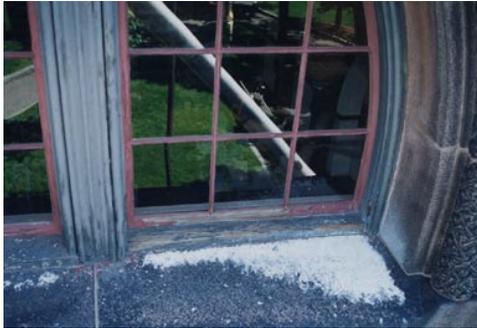
Damaged Stone Sill, 2002

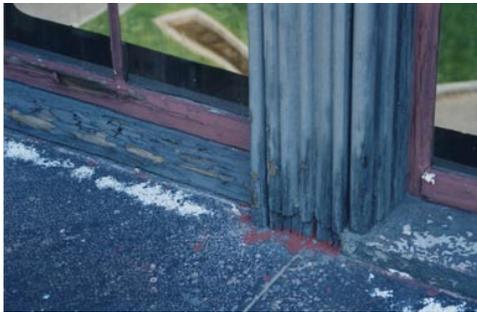
Rotted Sill, 2002

Window of the historic building are double-hung wood sash and frame. They were extensively repaired in 1986 and 1987. In general, the windows appear to be in fair condition, except in exposed areas such as the east sides of the Stack Wing and the 1894 Wing, where sills are severely rotted. The frames have peeling paint and cracked or missing epoxy. In several locations, the sills have been removed. Most of the windows are still operable, but several have broken sash cords. Cracked glass is a continuing problem, with some areas being replaced with wire glass. Screens were installed when the windows were last repaired, but there are no storm windows.

- Preserve existing wood sash and frames. Replace rotted sills. Replace broken glass. Consolidate sash as required and repaint. Replace broken or missing window screens.
- The addition of storm windows or complete window replacement should be considered if it is determined that it would have a significant impact on the overall heating and cooling of the expanded facility. In less visible areas, replacement with metal sash may be an option but new thermally-glazed, wood windows are preferred. Replacement windows must match the original details and configurations. The addition of thermally glazed windows would eliminate the need for storm windows.
- If the historic elevations are to be restored, the windows removed in 1967 must be replaced.
- Replace doors at the main entrance with doors that are historically appropriate.
- Repair remaining original doors at lecture hall and stack wing.

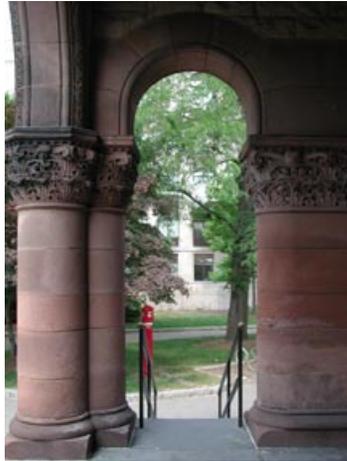
Added railing at portico
