**The Ragon Institute of MGH, MIT and Harvard**  
**Proposed Demolition of 624 Main Street**  
**10 September 2020**

SUBJECT: Existing Conditions Summary  
624 Main Street, Cambridge, Massachusetts

**Subject** 624 Main Street – Structural Engineering Report

624 MAIN STREET  
**REVIEW OF BUILDING CONDITION**  
AUGUST 18, 2020

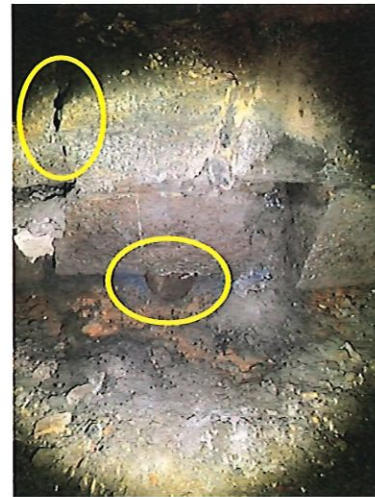
- Irregular and non-symmetrical footing foundations support interior piers. The picture (below left) indicates the extent of the spread footing foundation for an interior column and its

irregular nature. Given this condition and the amount of settlement of certain interior columns (below right), the interior column foundations appear to be undersized, overloaded, and/or founded on disturbed or unsuitable soils (e.g., Organic Deposits) which allowed settlement to occur.

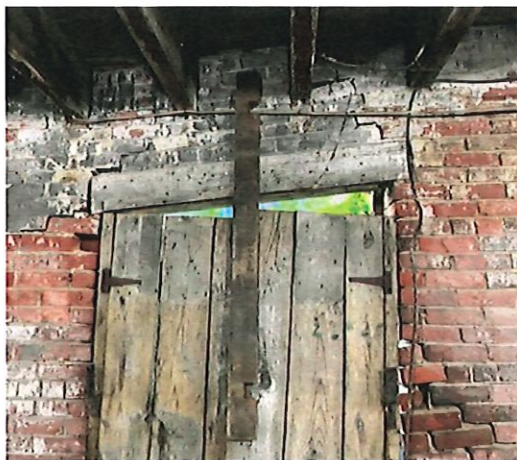
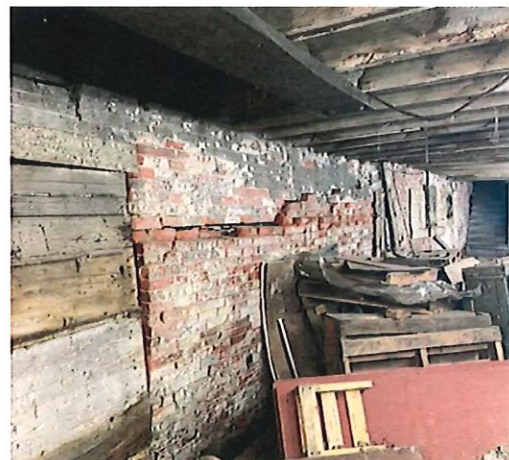
- The building's envelope has multiple openings and penetrations such that weather (since the building is unheated) and water have been able to adversely impact and promote deterioration (e.g., freeze/thaw, rot, mold growth, masonry spalling) of the building's foundation materials. This condition and related distress are noted in the photos below; exterior ground surface is about at the level of the horizontal crack in the foundation wall in the photo (below, right). Water and freeze/thaw have split the masonry and are bowing this foundation wall. The impact or water, freeze/thaw, and settlement are contributing to the failure of this opening in the exterior foundation wall (below, left).

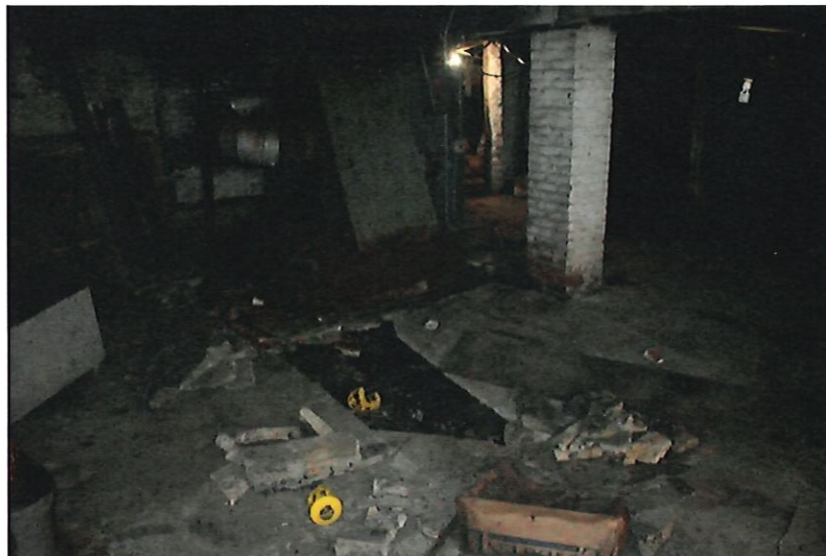
The slab on grade in the basement is cracked through the thickness of the concrete and broken apart in numerous places. The resulting segments of slab are typically not level or coplanar, and in some places are missing entirely.

*Figure 1 Damaged slab on grade in basement*

Under portions of the slab on grade, it was observed that the soil has settled away from the underside of the slab, meaning that continuous support is no longer provided to the underside of portions of the slab on grade. This soil settlement may have also contributed to the settlement of interior columns which was observed.

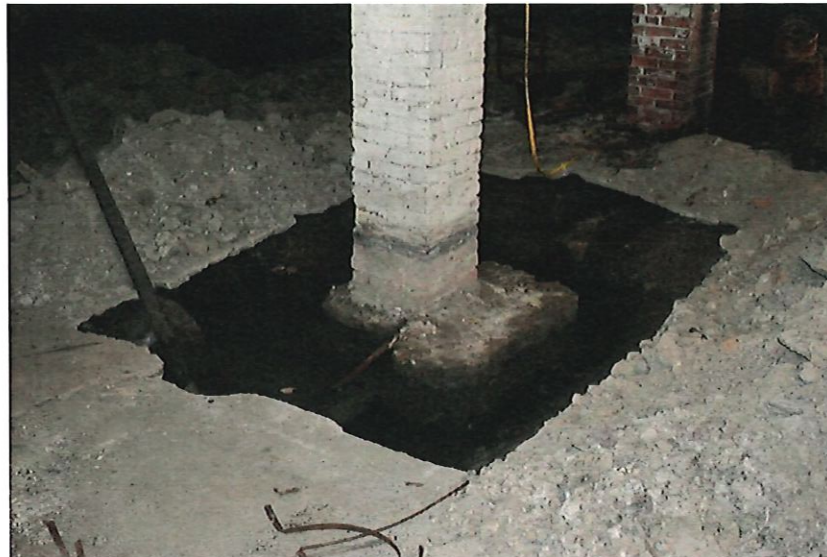
*Figure 2 Exposed spread footing under brick pier in basement*

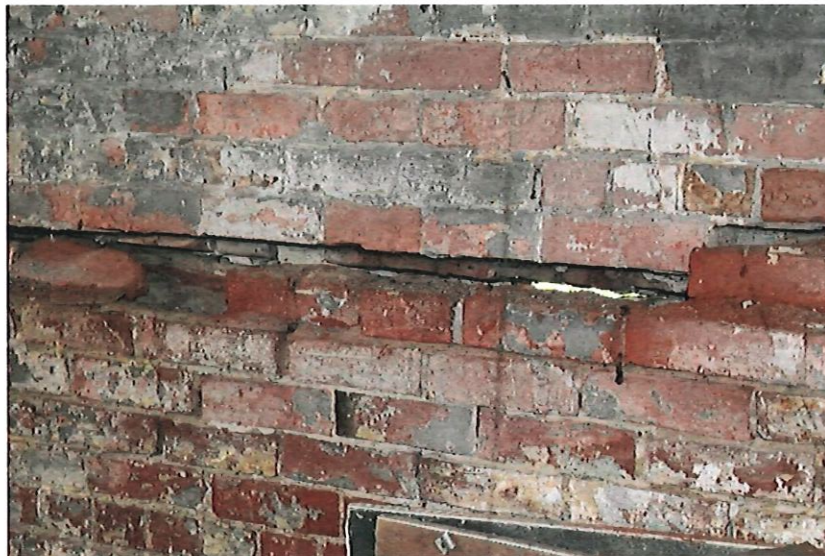
The lowest level of the bearing walls was observed to have large horizontal step cracks through the thickness of the wall. The planes of the brick were observed to be offset above and below these horizontal cracks. Brick lintels over basement windows were observed to have settled and no longer horizontal. This indicates that portions of the bearing walls have settled differentially to a significant degree. These observations indicate both the vertical and lateral load-carrying capacity of the brick walls are significantly compromised.

*Figure 3 Horizontal gap in perimeter bearing wall*

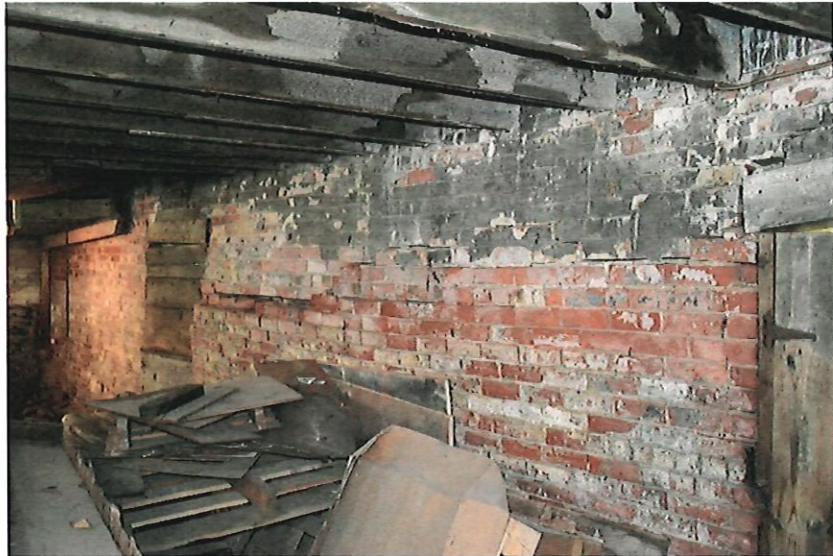
*Figure 4 Step cracking along the length of the basement wall*

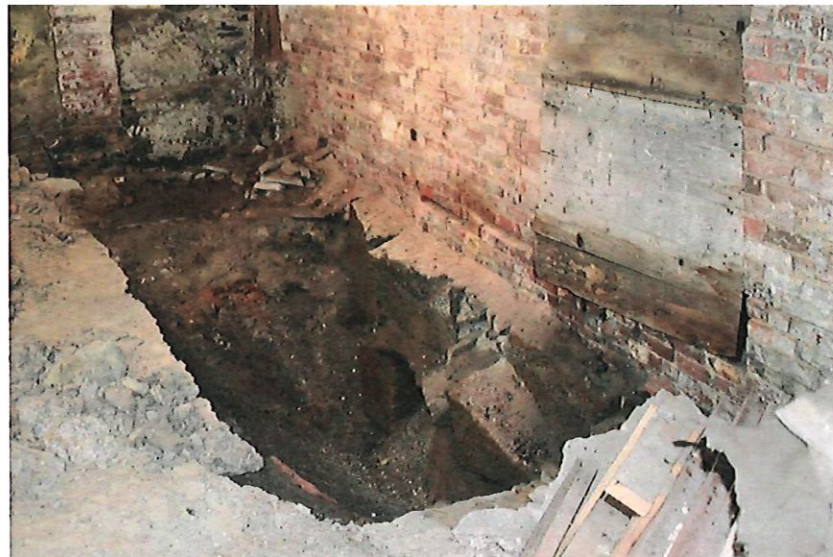
*Figure 5 Bulging at base of perimeter bearing wall*

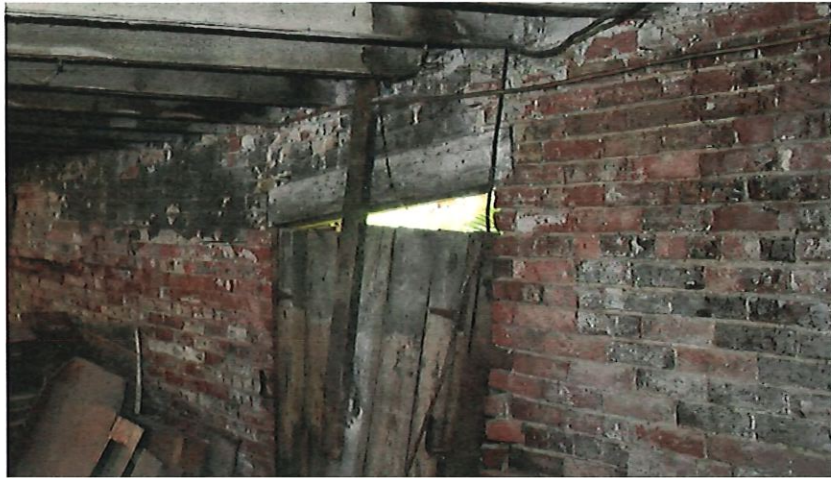
*Figure 6 Lintel which is no longer horizontal*

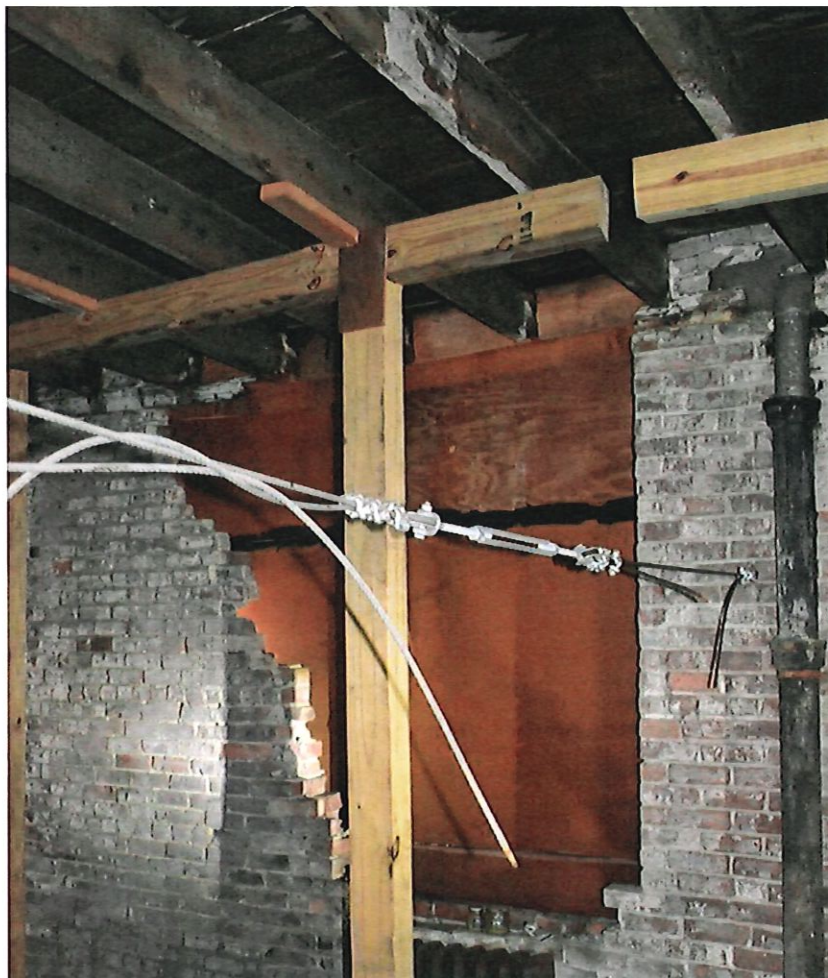
At the second floor, near the rear staircase, it was observed that the brick wall had partially collapsed, and portions of the wall were missing. The missing portions of the brick wall were located around existing window openings. Remaining portions of the wall in this area were observed to be restrained back to interior columns using post-installed steel rope and wood blocking to prevent further collapse.

*Figure 7 Area of collapsed brick wall and shoring of roof joists*

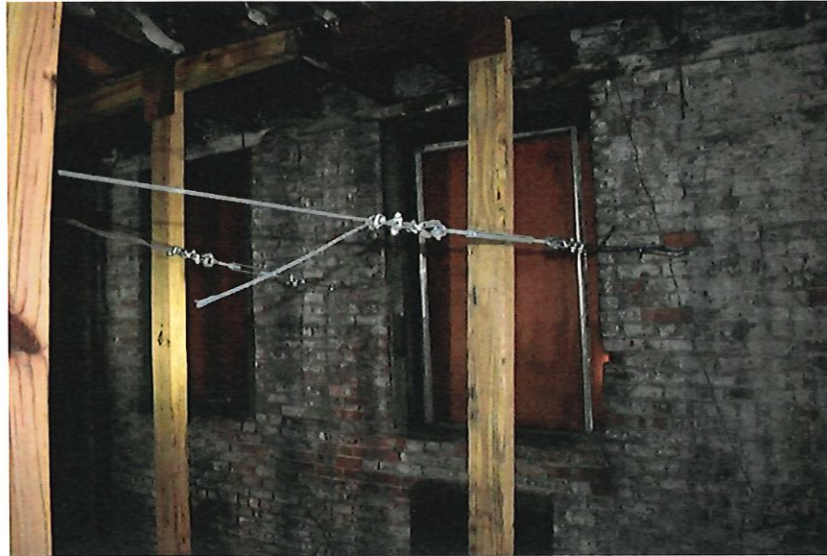
*Figure 8 Steel rope support to brick wall and shoring of roof joists*

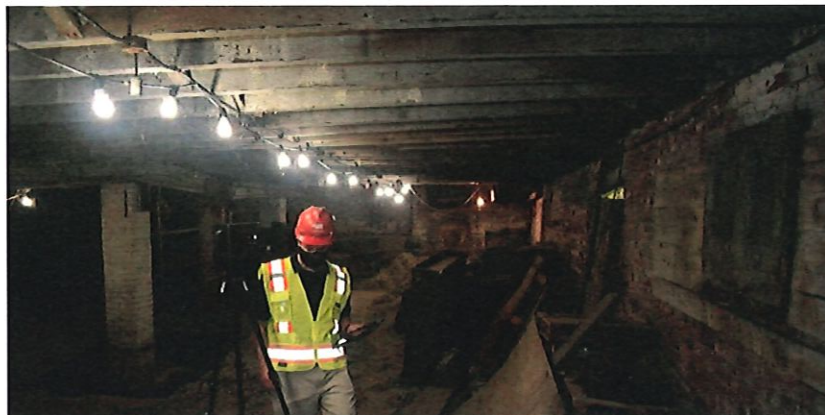
The entirety of the first suspended floor was observed to slope uniformly towards the center of the building. From observations made in the basement, it appears that the structural system of the building is two bearing walls oriented roughly perpendicular to Main Street, with a central line of columns parallel to the walls. These central columns appear to have settled differentially to the perimeter walls, resulting in the observed floor slopes. The primary wood beams which span between these central columns were also observed to have excessive deflection, likely result from a combination of the interior column settlement, long-term creep of the material, and water damage.

*Figure 9 Joists supporting first floor, noting varying amounts of inclination off horizontal*

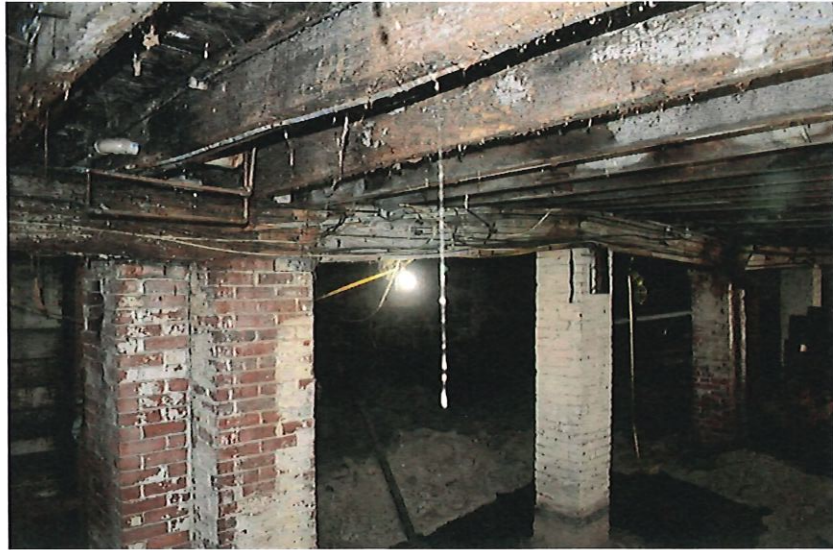
*Figure 10 Central beam in basement*

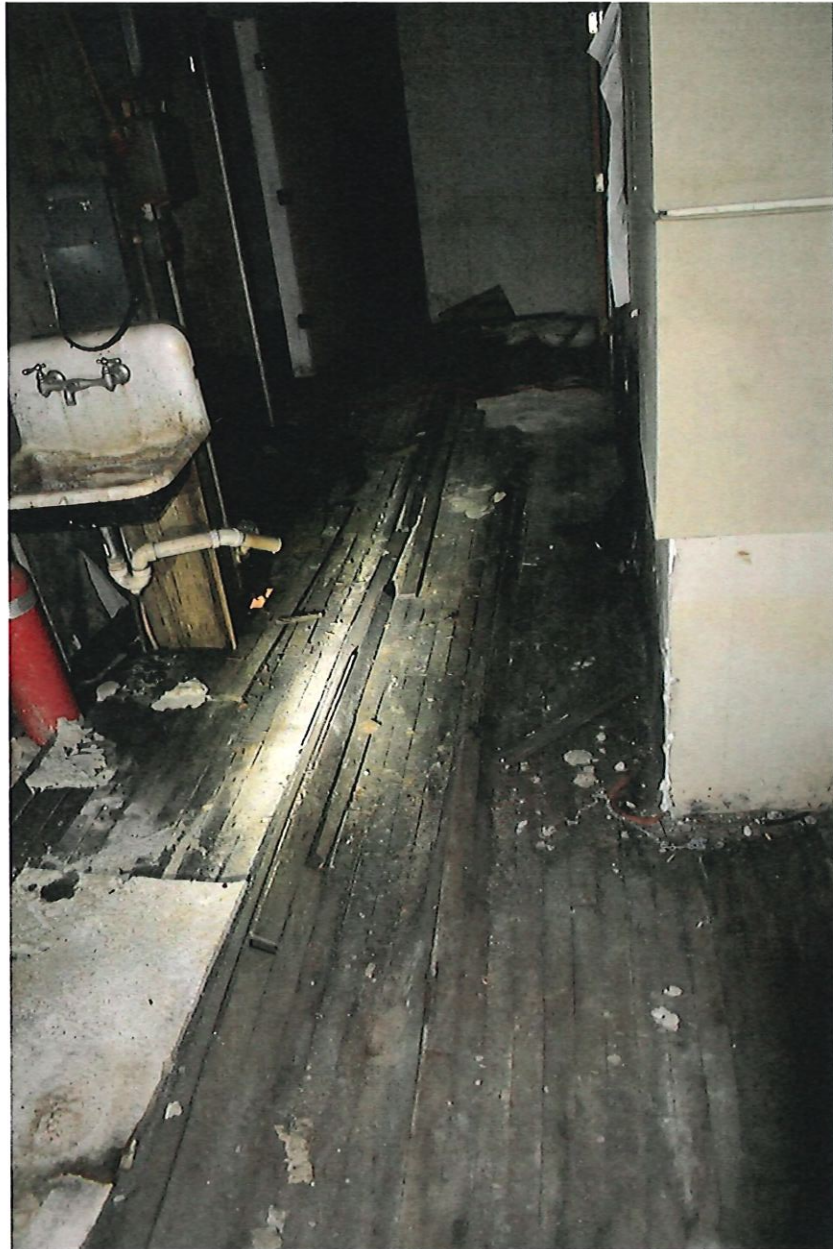
The walking surface of the first and second floors is very uneven. This unevenness could be the result of warping of the wood finished floor, or excessive deflection of the subfloor. Given the regular nature of the high and low points, and the parallel orientation of the high points, the uneven surfaces are likely the result of the subflooring deflecting excessively between the floor joists.

*Figure 11 Uneven walking surface on first floor*

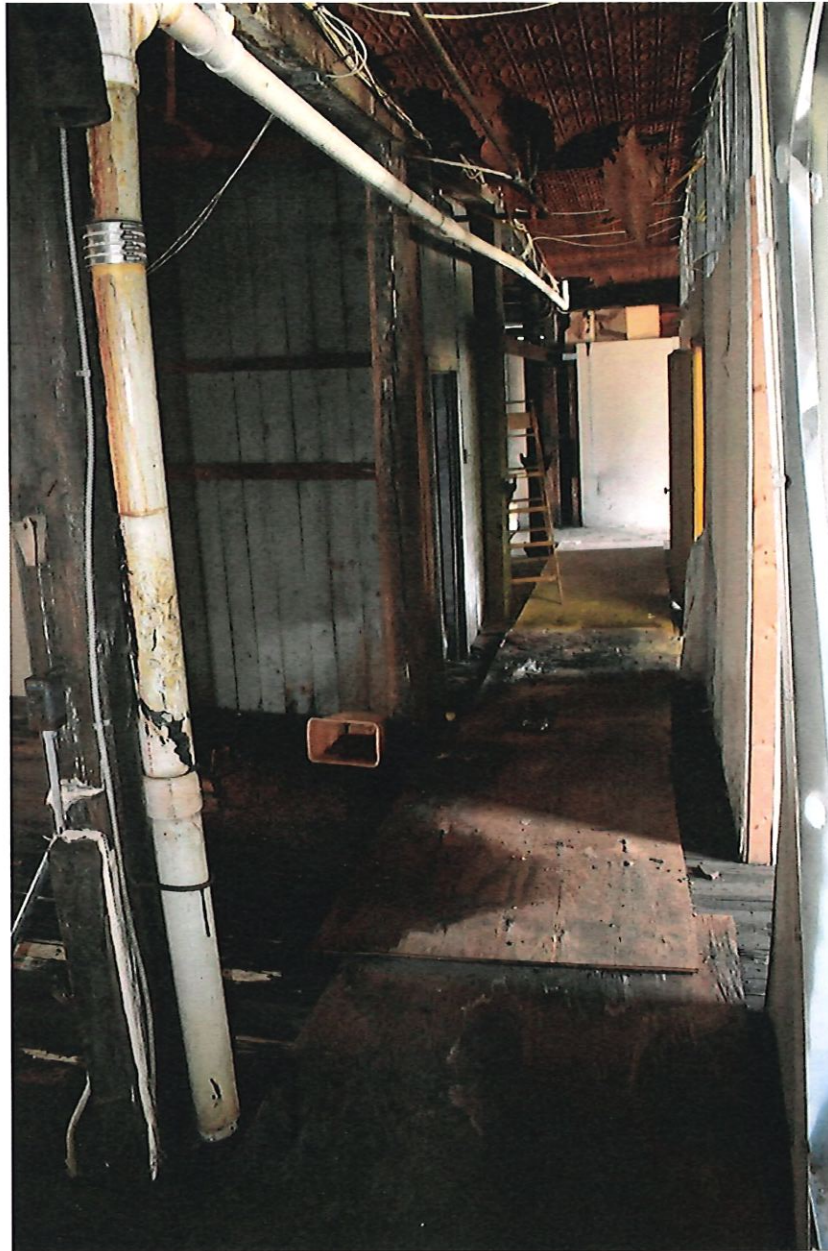
On the second floor, while walking between the rear staircase and the forward staircase, numerous soft spots were felt underfoot. This observation likely indicates weakening of the structural subfloor, possibly due to water ingress or other previous damage due to dropped or heavy objects.

*Figure 12 Soft spots on the second floor, which been previously covered by plywood*

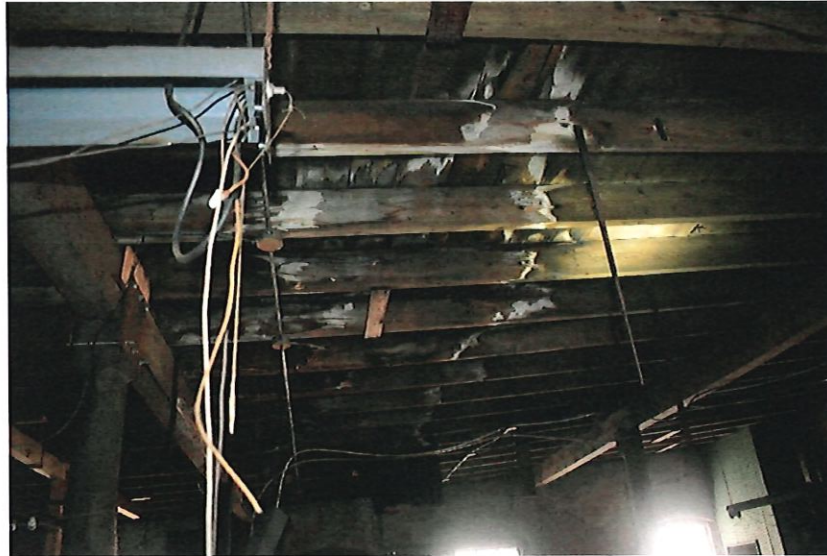
Evidence of water infiltration was observed in the form of water staining on the wood structure and finishes, as well as mold and mildew on drywall and ceiling finishes. Active water infiltration was observed during the site visit. It had rained the previous night, and water was actively dripping from the ceiling down to the basement. Active water was observed on all floors of the building. Persistent ingress of water into a wood structure is detrimental to structural integrity.

*Figure 13 Water damage on roof joists*

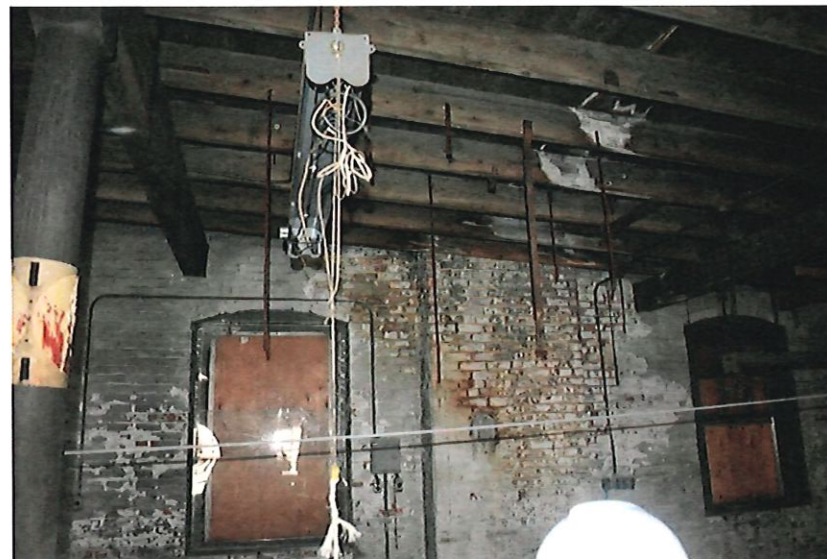
*Figure 14 Water damage on roof joists and exterior walls*

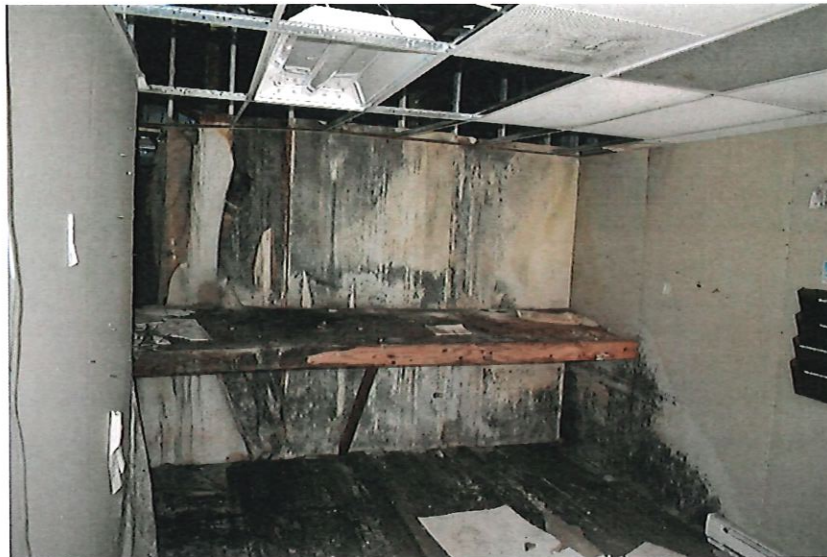
*Figure 15 Water damage and mold on interior finishes*

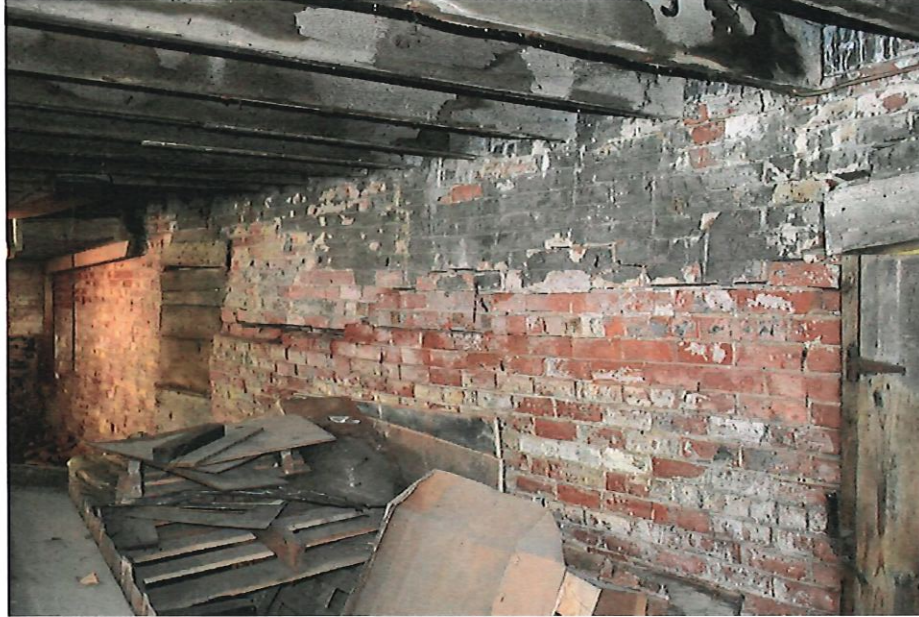
If it were possible to safely stabilize the structure by following the procedure described above, the asbestos, the other hazardous materials in the building, and the mold throughout the building would have to be removed. All workers would be required to wear full PPE suits and be fitted with respirators due to the extensive mold. All nonstructural elements in the building, including the floor and roof framing, would have to be removed since the framing members are likewise water-damaged with evidence of rot and other failures. The brick foundation wall on the east side of the building would need to be fully demolished and re-built, since it has already partially collapsed. (Photo below)

The demolition effort would likely uncover additional areas that would need additional temporary shoring to try to reduce the risk of collapse and allow interior demolition, abatement, and mold remediation to proceed.

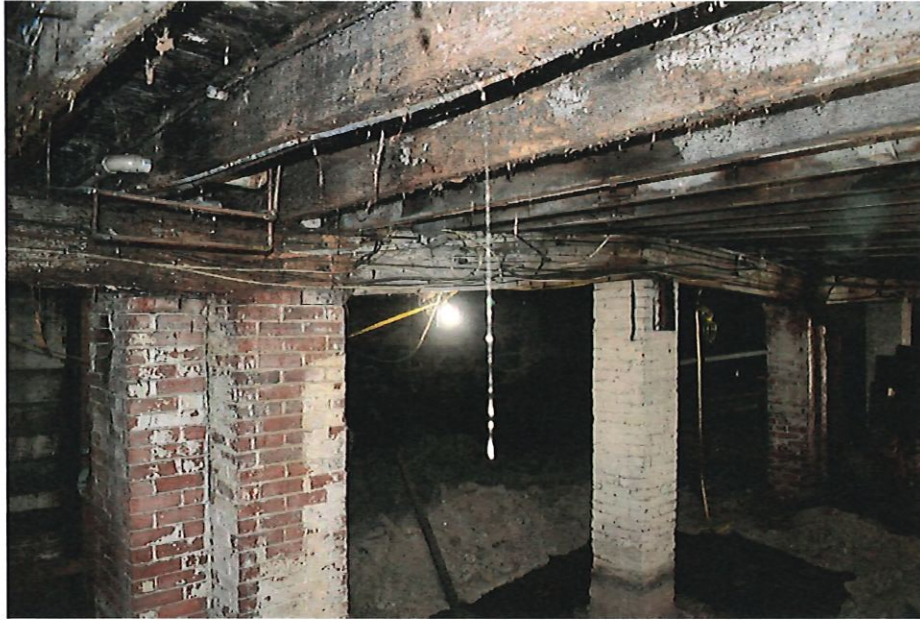
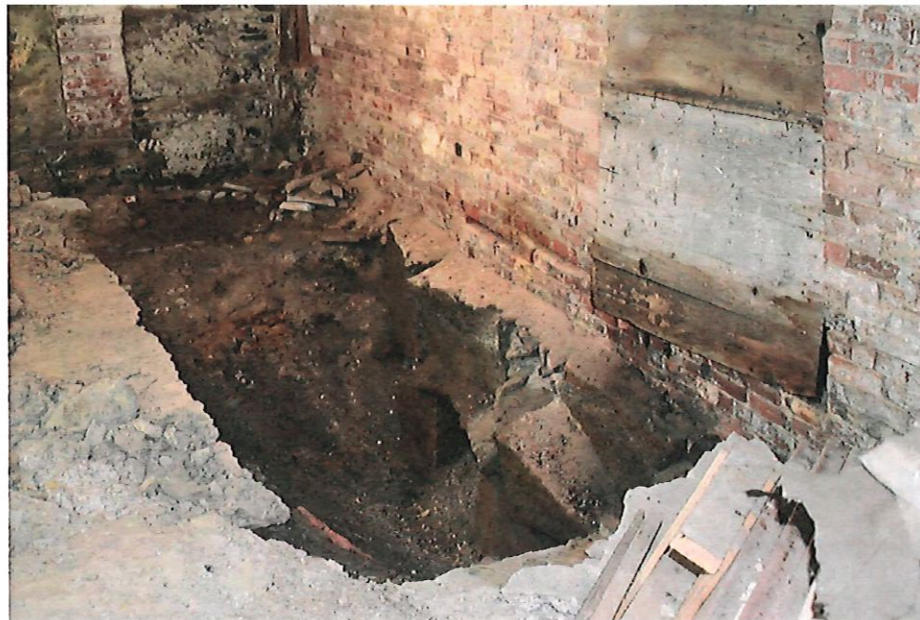
The existing footings which support the interior columns and the interior structural system at 624 Main Street have failed and have settled at significantly different rates, resulting in uneven, sloping floors and a significantly warped central beam that supports the entire interior timber framing of the original building (Photo Below). The existing slab on grade would have to be removed in its entirety and the existing footings would have to be replaced, the strength and depth of which would be determined by the geotechnical and structural engineers based on the existing soil conditions. Some sort of mini-piles would likely be needed to support the new footings and new columns. Temporary shoring to support the timber framing above would be required at each footing and column location in an attempt to stabilize the structure during this operation.

The existing stone foundation walls around the perimeter of the building would have to be underpinned to stabilize them and halt any settlement that may be continuing. However, in accordance with the geotechnical engineer's report (Haley & Adrich) and the structural engineer's report (Arup), the perimeter foundation walls cannot be underpinned or repaired in place but must be removed and replaced in their entirety. Because the unstable masonry walls sit directly on top of the stone foundation wall, the perimeter brick walls of the building would need to be demolished and rebuilt, as described in the next section entitled "Exterior Façade".

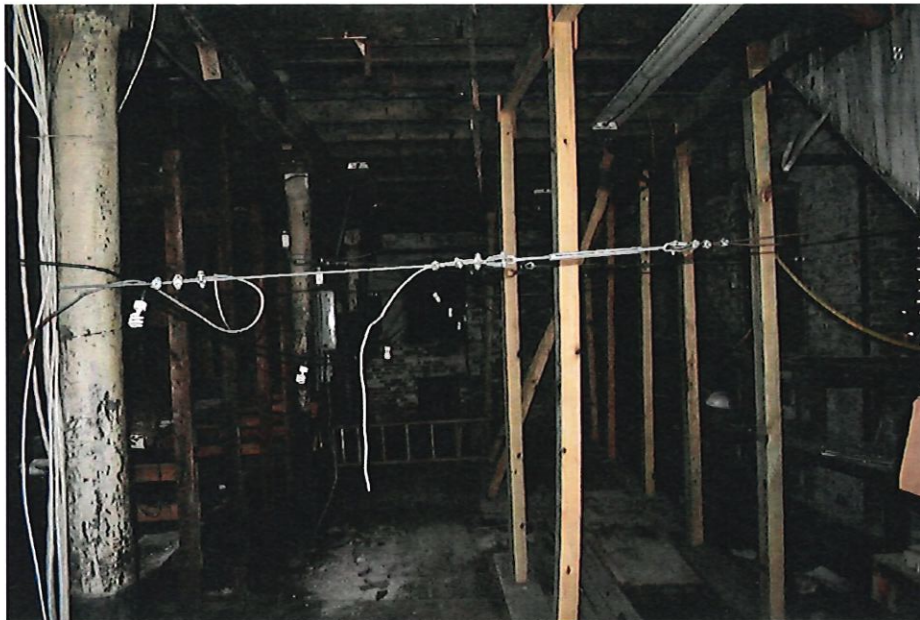
Currently the exterior façade is wrapped with a custom scrim preventing a thorough examination of the condition of the brick on the exterior. It is our understanding that this scrim was installed to protect the public from debris falling from the deteriorated brick façade of the building. There are pieces of brick along the base of the building around the perimeter indicating that the façade has been and continues to delaminate. In addition, the south exterior façade is currently being held in place by steel cables tied back to the interior structural columns in an attempt to hold the rest of the brick wall in place to prevent it from collapsing altogether (Photo Below). Even if the rest of the exterior walls could be saved, this location would need to be fully demolished and re-built in its entirety. It's not clear how this could be accomplished safely and without risking collapse of the building. However, since the perimeter foundation walls cannot be repaired or underpinned and must be demolished and rebuilt in their entirety as described in Haley & Aldrich's and Arup's reports, it is virtually impossible to retain the brick perimeter walls. This is because the brick walls sit directly on the foundation walls with no grade beam to hold up the walls if the foundation is demolished. The first floor framing members sit directly on top of the foundation walls set into pockets in the masonry. Therefore, it is virtually impossible to lift the building off its foundation, even if the existing masonry walls were stable and structurally sound. The situation would be even more difficult and precarious due to the many openings in the walls which would need to be cut in order to install a temporary stabilizing structure. Therefore, the brick exterior walls of the building would have to be removed and rebuilt in their entirety.
