# ROOME & GUARRACINO, LLC

Reference: 207 LakeView Ave - Cambridge, MA

Subject: September 15<sup>th</sup>, 2020 Structural Review

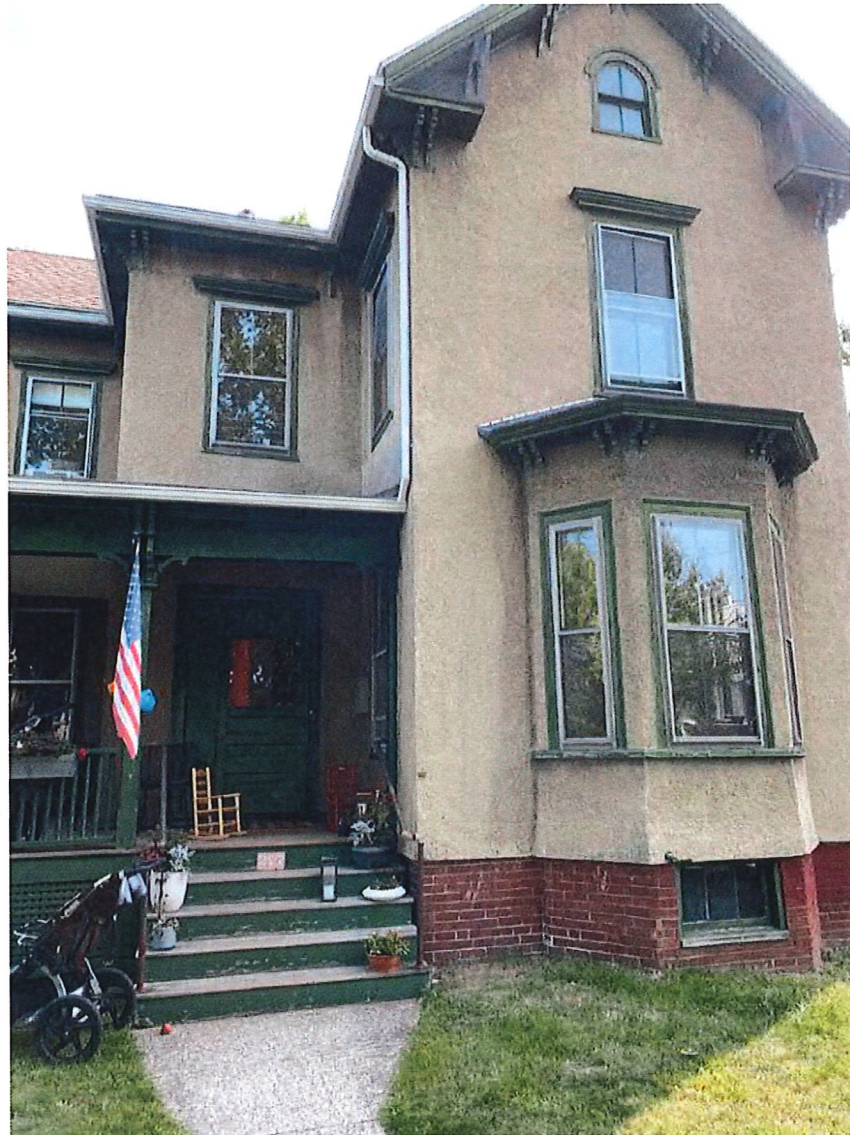
Picture 1.

The house is a two-story wood framed Italianate Victorian with a basement built in 1876. See picture 1. The review took place from inside and outside and at the basement level. I proceeded onto the property and to the rear to enter the basement level and immediately noted that the sides and rear foundation walls are in poor condition. See pictures 2. and 3. The foundation walls consist of stone for the lower portion and masonry for the upper portion. Mortar and masonry deterioration are evident throughout with voids in the stones and evidence of significant moisture infiltration. The masonry mortar joints have deteriorated in the brick and stone and there are areas where the masonry itself has deteriorated beyond repair.

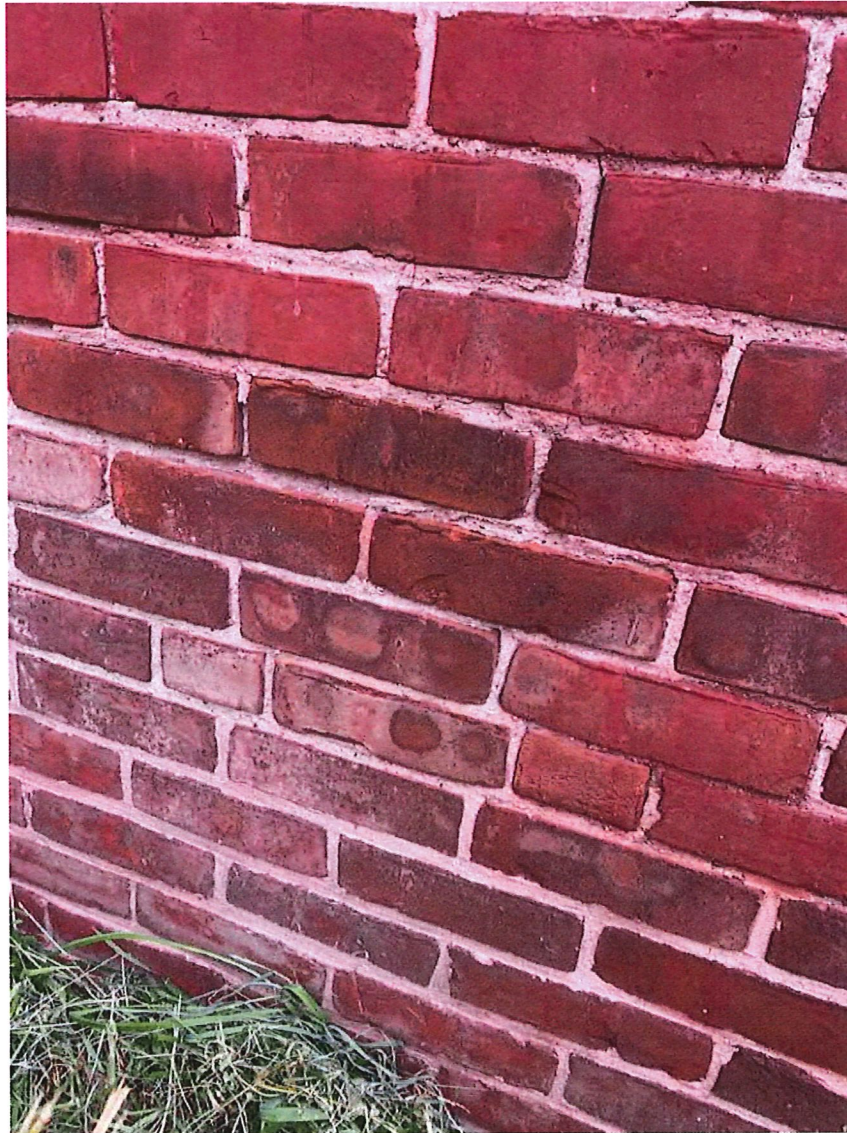
Picture 7.

I proceeded outside to view the exterior of the house. I noted the portion of masonry foundations above grade. Although it appears there has been some re-pointing, the mortar joints in many areas are in need of repair. See picture 7. Also the masonry at the rear entryway into the basement has bricks which have displaced. See picture 8.
