859 MASSACHUSETTS AVENUE
FEASIBILITY STUDY
CAMBRIDGE, MA

JULY 18, 2016

STRUCTURAL REPORT

859 Massachusetts Ave.
Cambridge, MA
Existing Conditions Systems Report
J#831 057 01.00
L#51790/Page 1/April 20, 2016

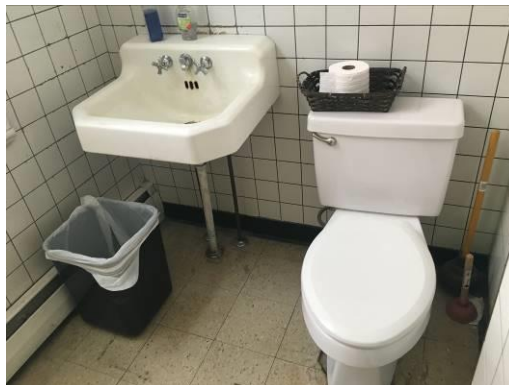
The water closets are tank type floor mounted vitreous china. The fixtures are in poor condition.

Tank Type Toilet and Typical Lavatory

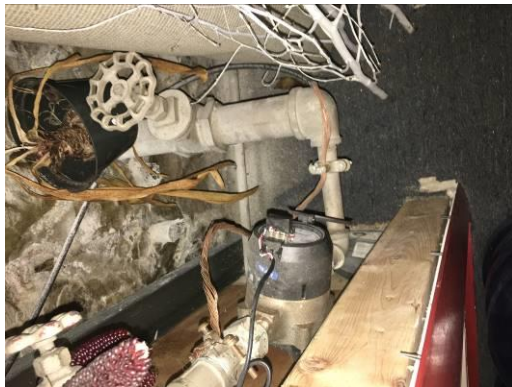
The main domestic water service enters the basement a storage closet. The service appears to be 1-1/2" in size and a water meter. The main domestic cold-water distribution is 3/4" in size.

Domestic Water Service & Meter

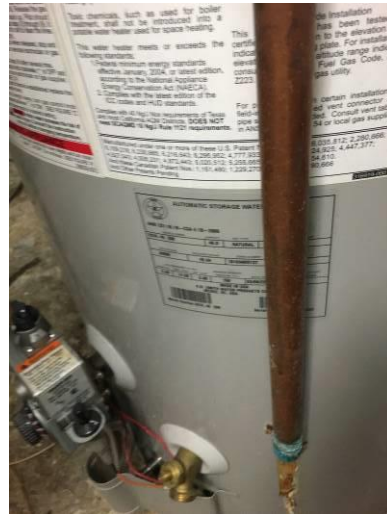
Domestic hot water is generated through a gas fired tank type water heater. There is a thermostatic mixing valve on the system. Water heater has a 40-gallon storage capacity manufactured by AP Smith. The system is in fair condition.

Domestic Hot Water System

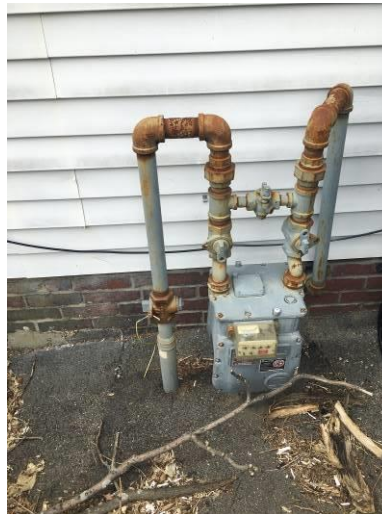
Gas Service

There is a single gas service present on one meter. The service is in fair condition. The gas meters were originally located in basement but have been removed and now is located outside.

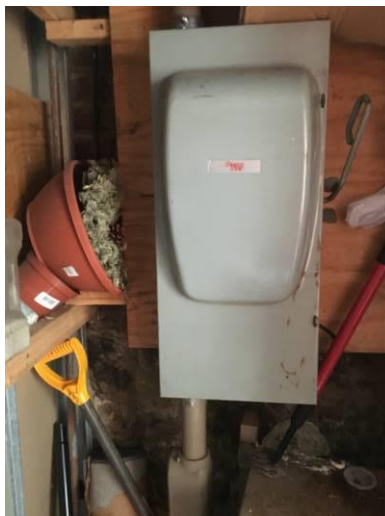
There is one service present at the facility. The service is rated at 200A, 120/240V, 1Ø, 3W. There is a 200 amp main switch in a closet in the basement that feeds a trough with (4) tenant meters near boiler. The equipment is relatively old and in poor condition. The equipment is manufactured by FPE.

Main Switch

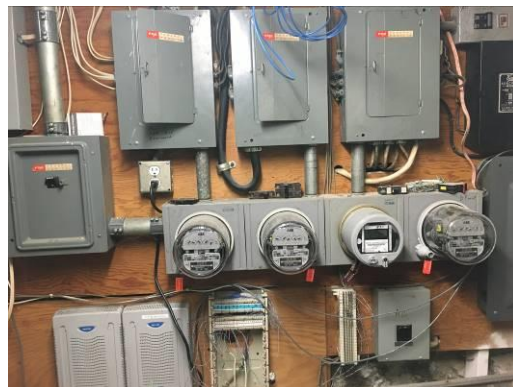
Each tenant panel is rated at 10A, 120/240V, 1 phase, 3 wire.

Sub Panel

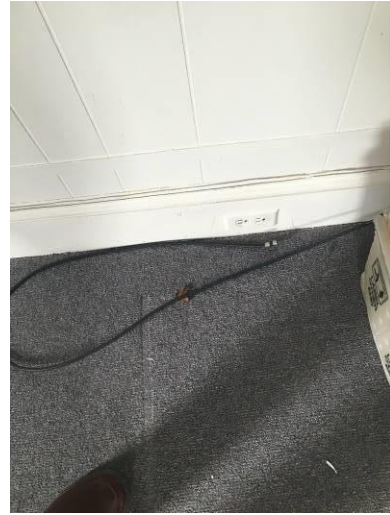
In the offices there are flush-mounted receptacles on each wall. The quantity of receptacles appears adequate. Some receptacles are mounted below ADA guidelines.

Outlets in Baseboard (non-ADA)

Most outlets throughout the building are in poor condition due to age.

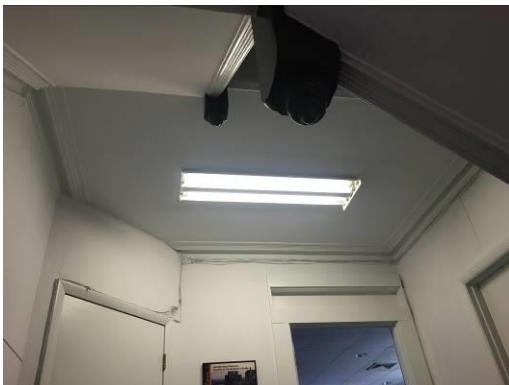
Lighting in corridors, stairway, toilets, display area, and office is generally surface-mounted fluorescent fixtures which are 1'x4' - 2 lamp prismatic lenses. The fixtures are in poor condition.

Typical Surface Fixtures

Lighting throughout the facility is in poor condition. New lighting with more energy efficient LED source should be provided as part of renovation.

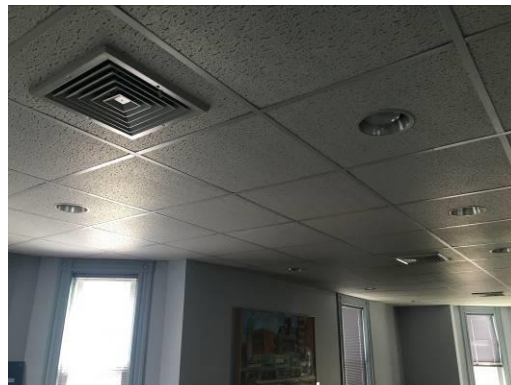
The chambers room consists of recessed incandescent downlights.

Chamber Room Lighting

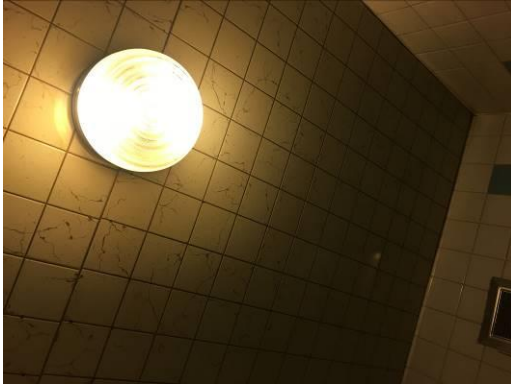
Toilet Lighting

In general, the existing lighting throughout the building is in poor condition.

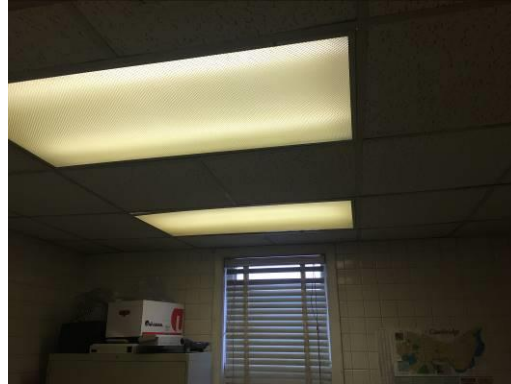
Office Lighting
