ADAMS & RAFFERTY

ATTORNEYS AT LAW

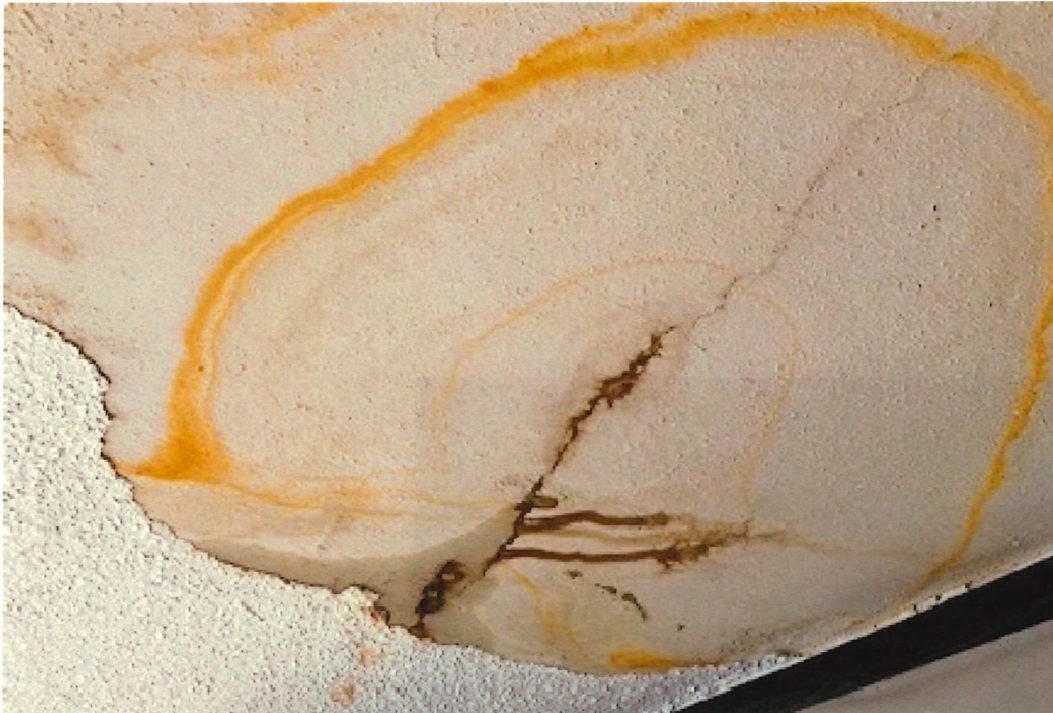
Due to the compounding issues summarized above, at various locations throughout the building, there is a very low (to potentially zero) safety factor when the slabs are subject to code-required loads. Slab strengthening is required based on applicable Building Codes. We developed a slab-strengthening approach along with a Conceptual Design Package that has an order-of-magnitude cost equal to approximately \$74M (prepared by Consigli). The Riverview Board should continue to investigate the Repair, Reconstruction, and Redevelopment Options and take into account future capital renewal costs until a preferred option to address the structural issues is selected.

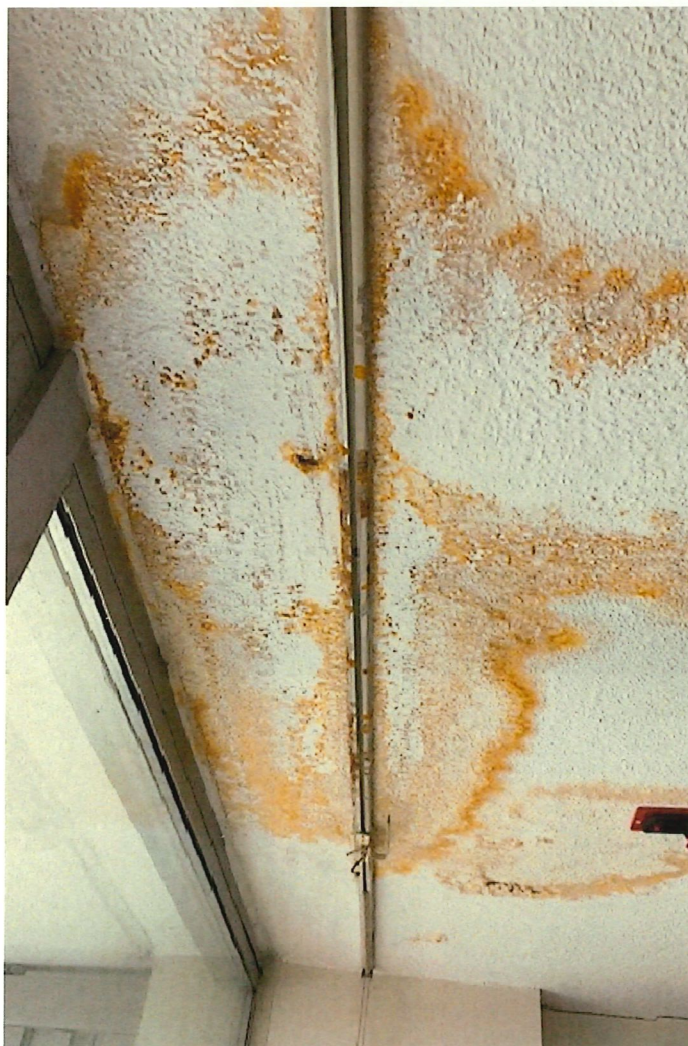
(Photo from 18 November 2020 during SGH Water Leak Investigation.)

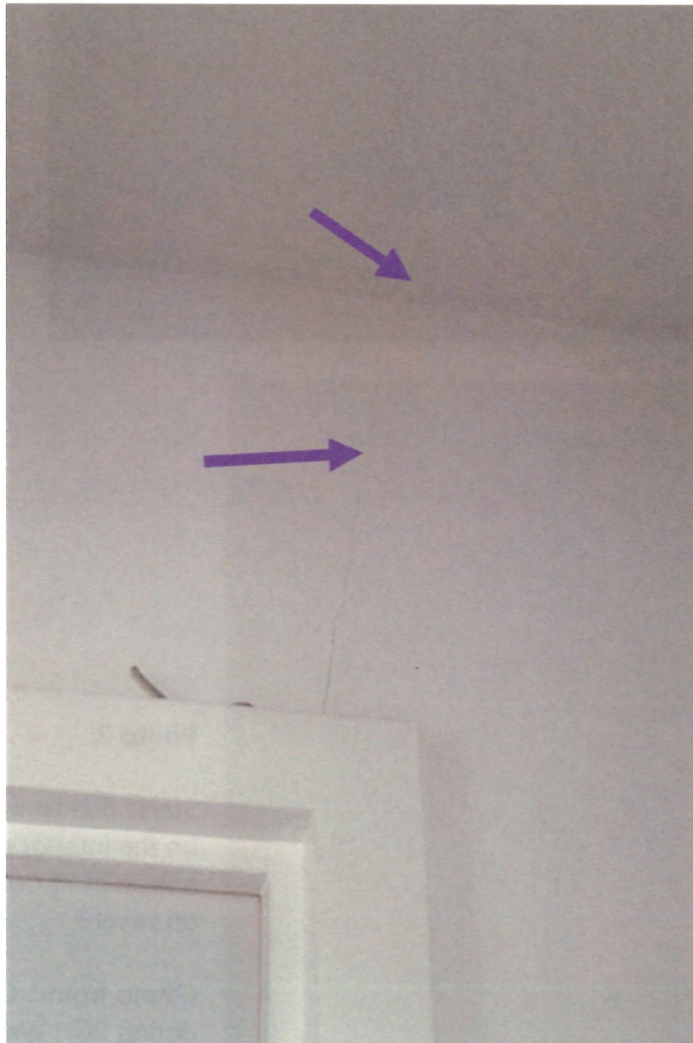
(Photo from 1 October 2020 during SGH Water Leak Investigation.)

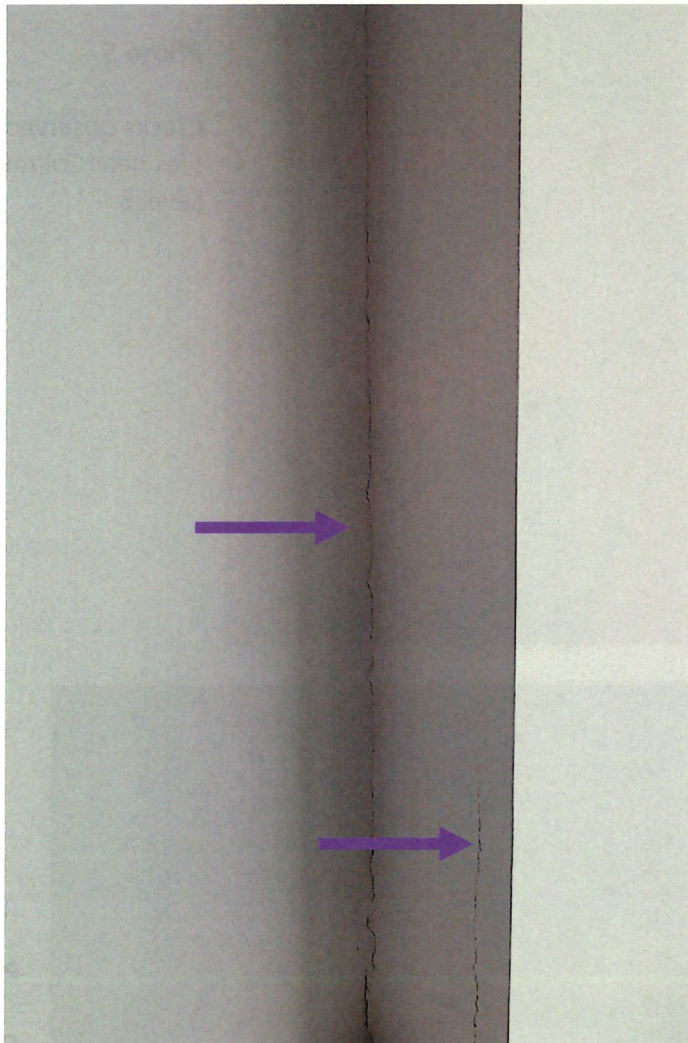
Crack in drywall above door propagates into ceiling in Unit 705.

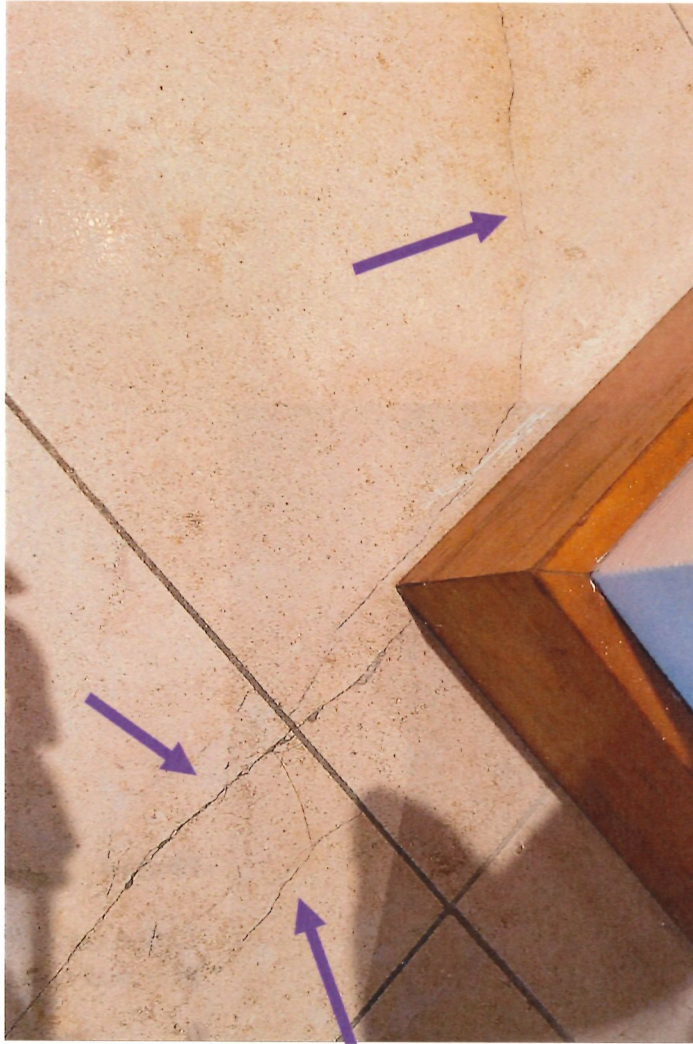
Typical cracks and separation in drywall near columns.

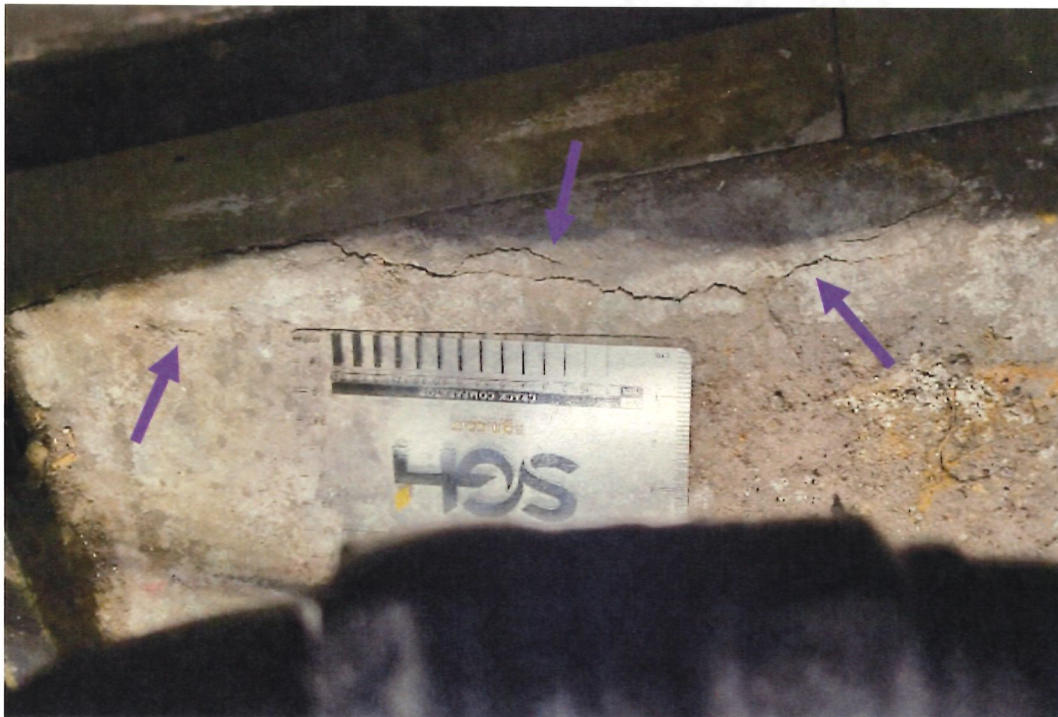
Cracks observed in bathroom tiles near Column D11 on Level 6.

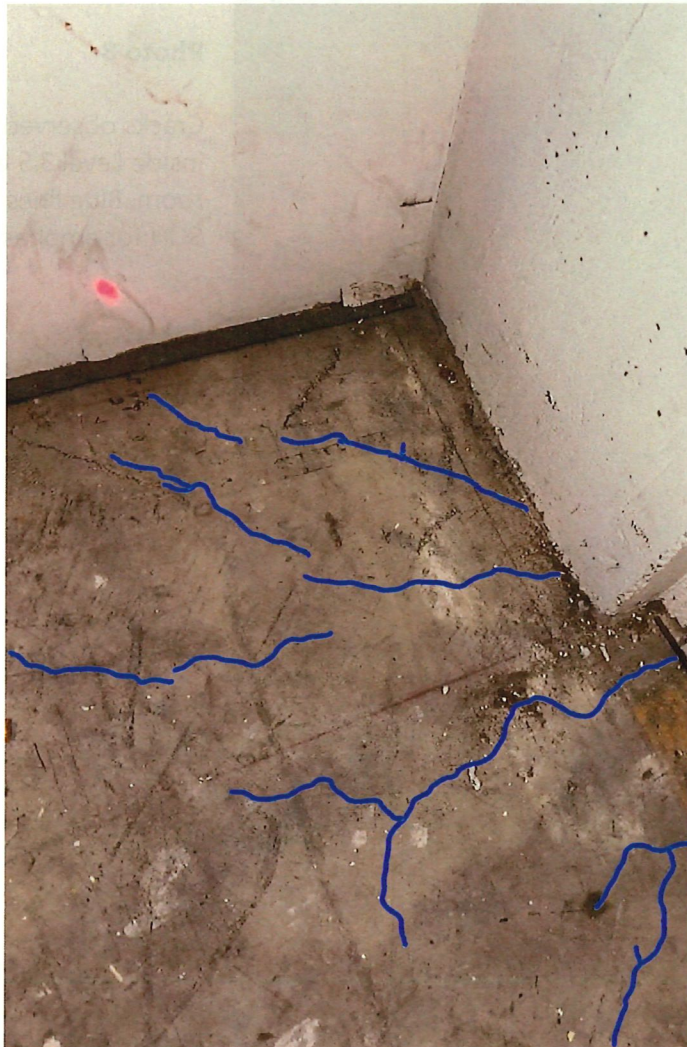
Cracks observed in a fan coil unit at Column Line E.

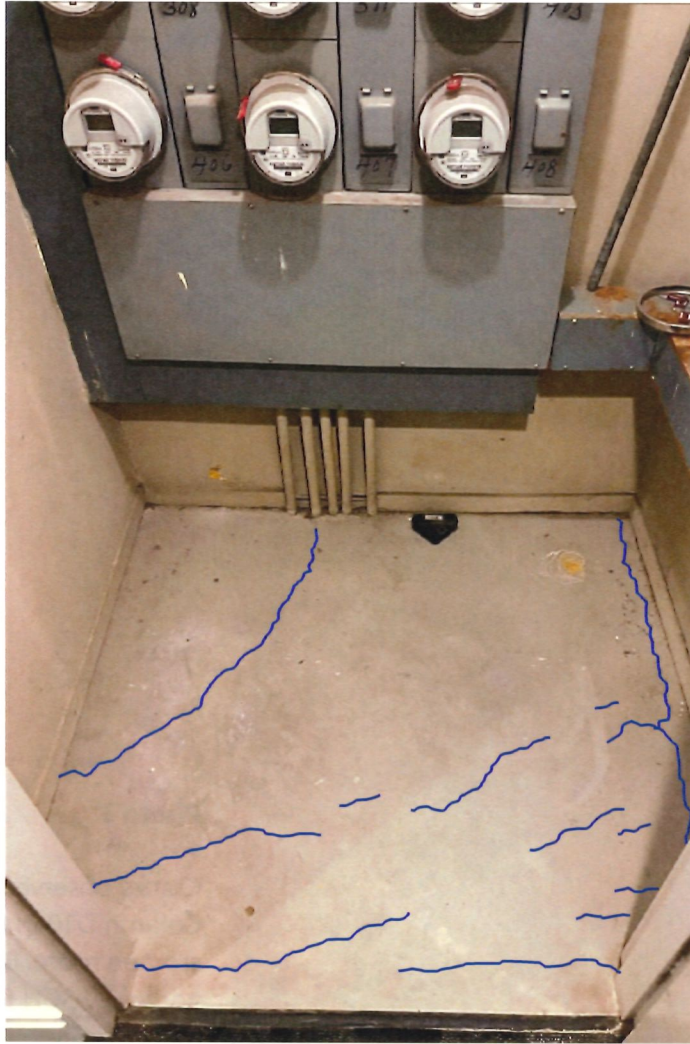
Cracks observed at Column D10 in the Level 8 storage room. Blue lines added by SGH for emphasis.

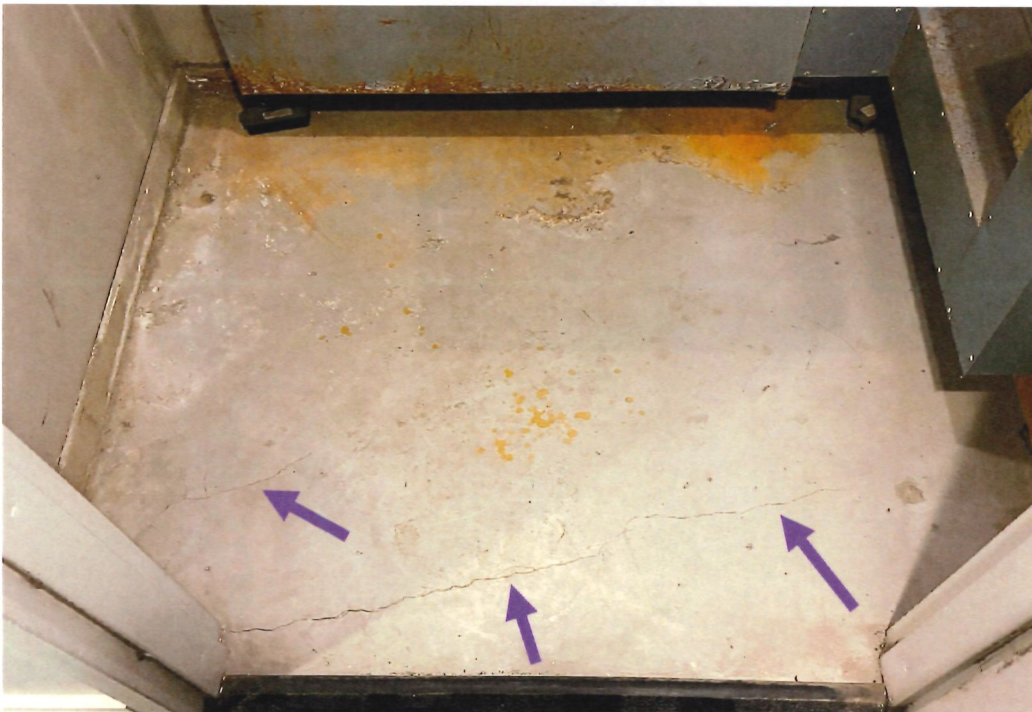
Cracks observed at shear wall inside Level 3.5 electrical room. Blue lines added by SGH for emphasis.

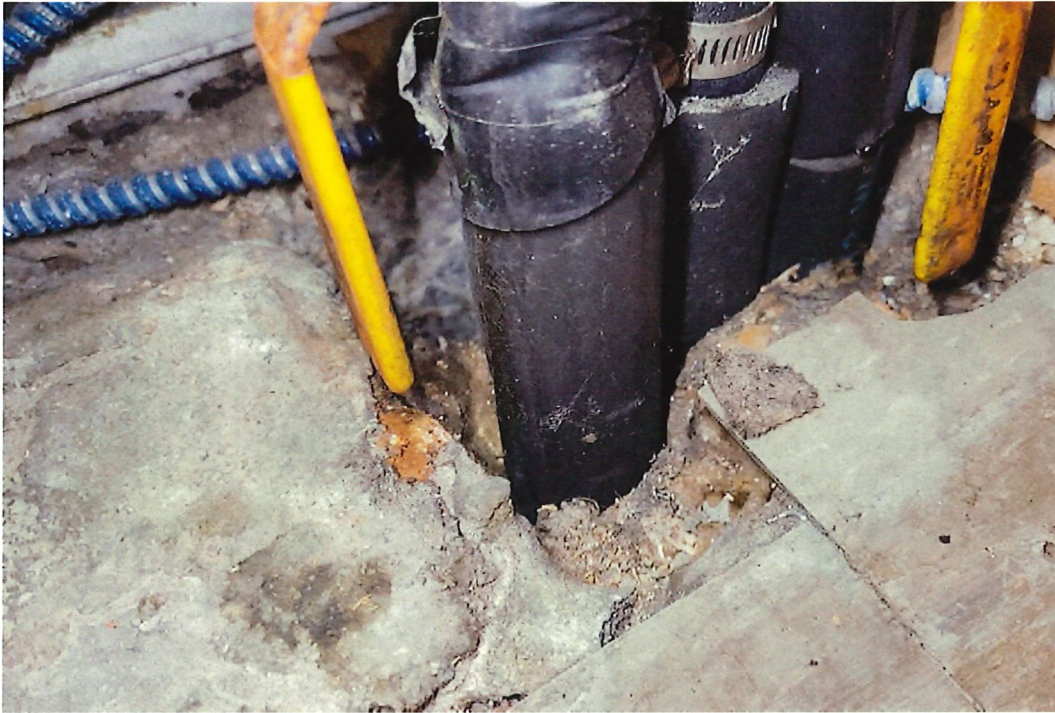
Cracks observed at shear walls inside electrical rooms.

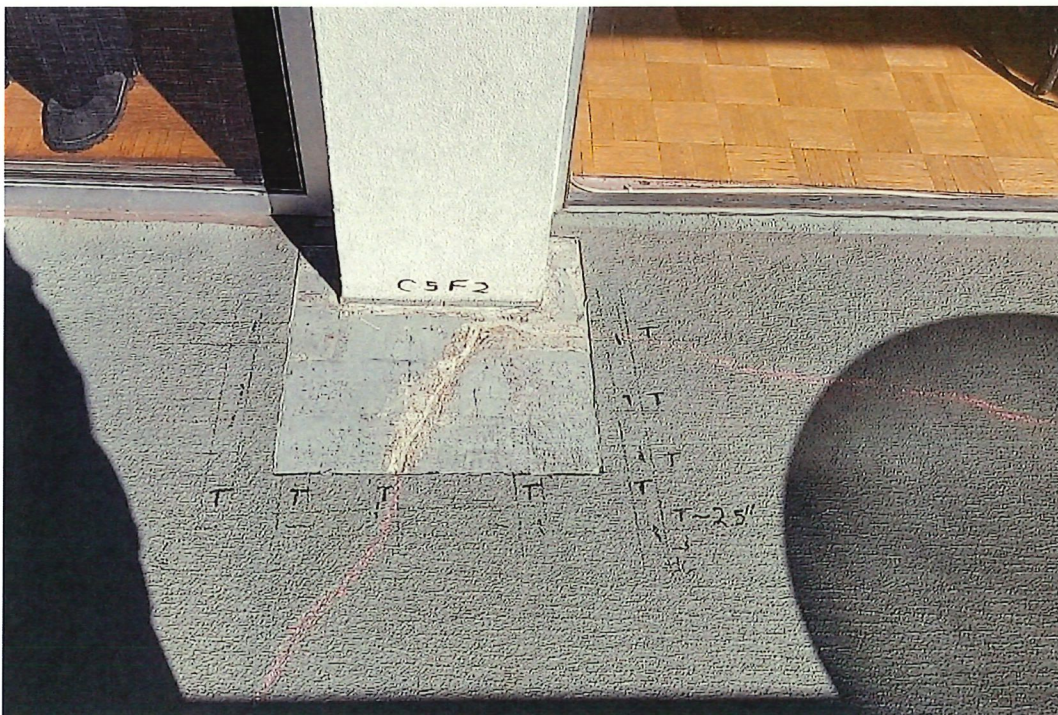
Typical riser pipe penetration at fan coil units on Levels 1.5, 3.5, and 5.5.

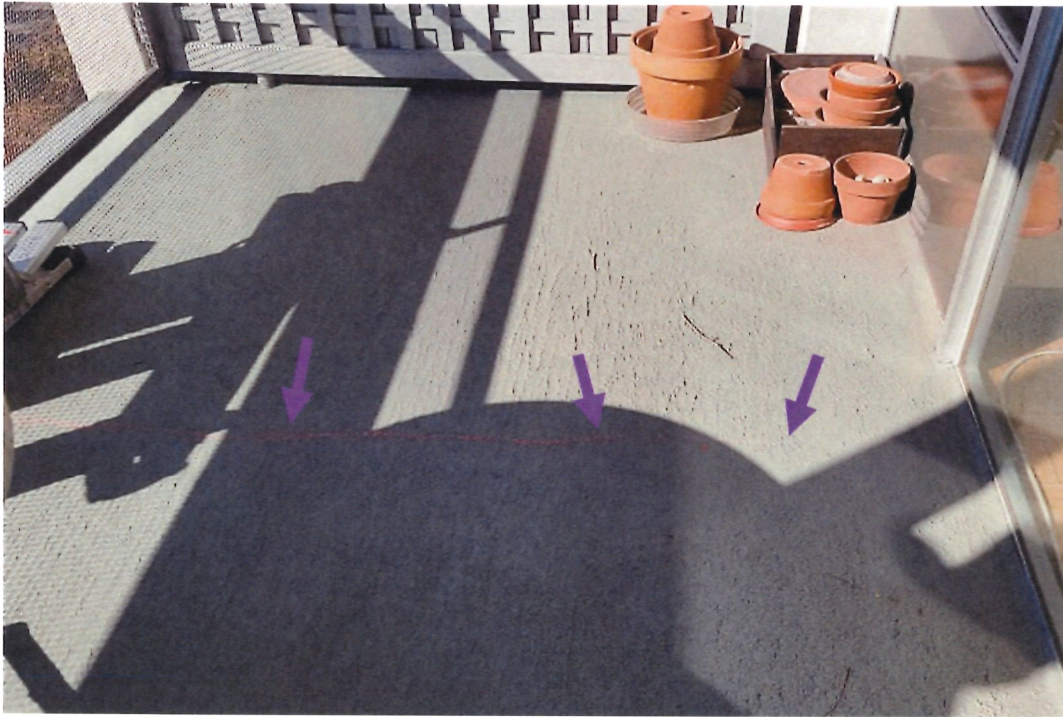
Balcony coating removal revealed preexisting cracks that were previously routed and sealed. SGH outlined the cracks through the coating in red chalk prior to taking the photograph.

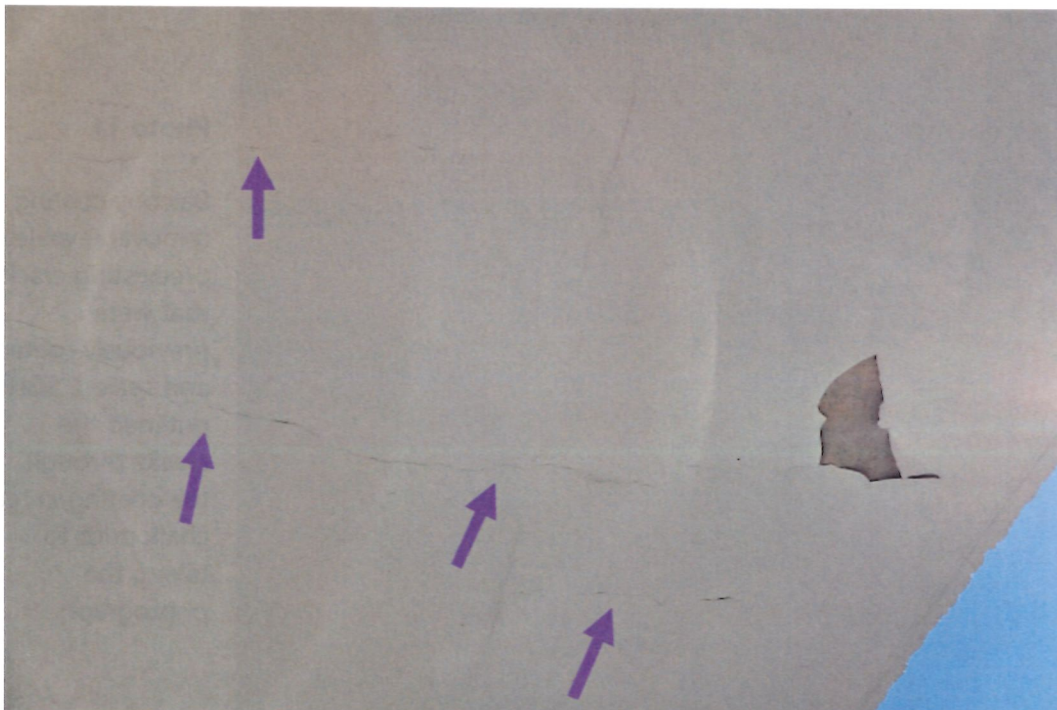
Typical NS cracks extending the full balcony width (purple arrows). SGH outlined the crack in red chalk prior to taking the photograph.

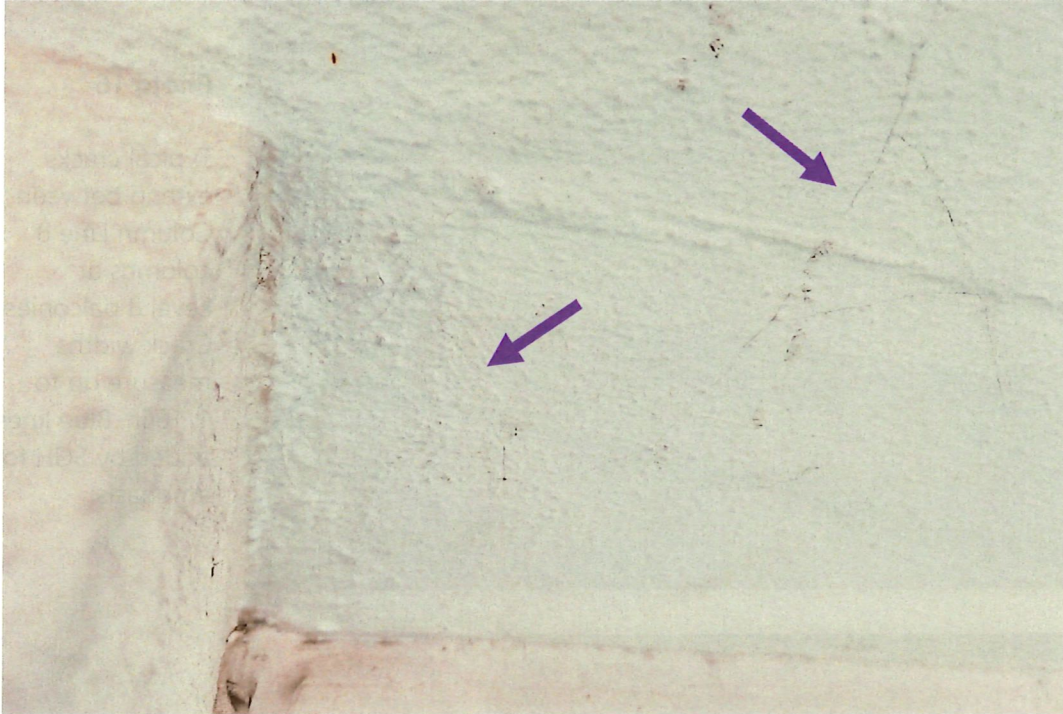
Typical NS cracks extending the full balcony width visible from the underside.

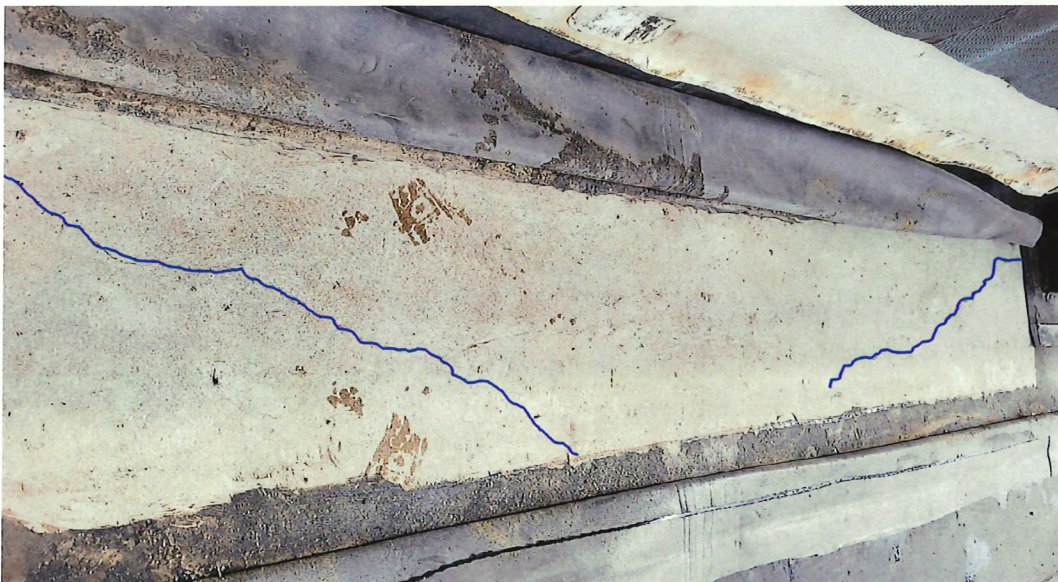
Cracks observed at underside of Level 8 slab at balcony columns.

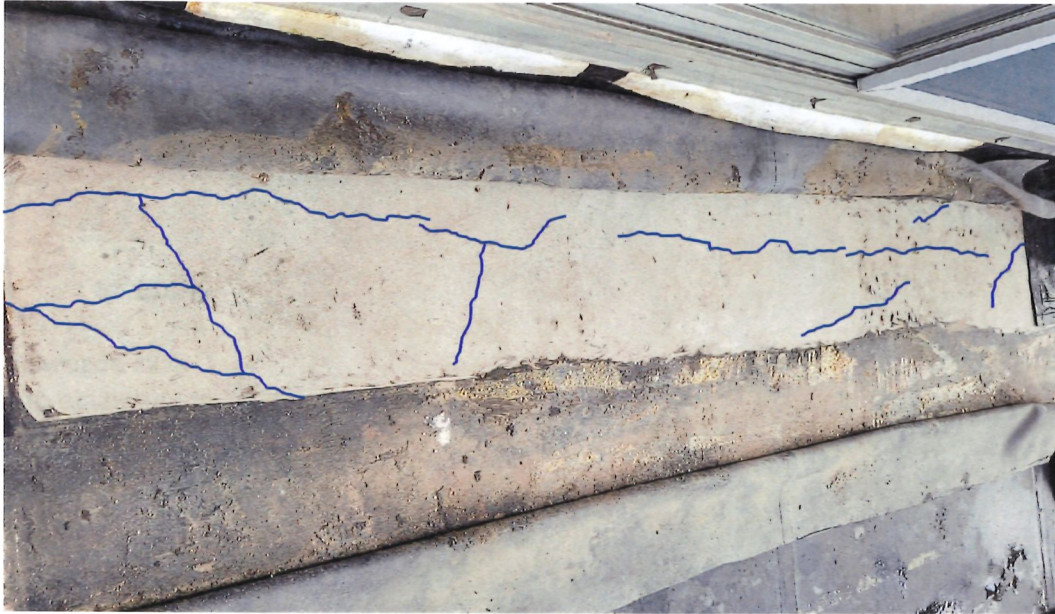
Typical cracks extending between Column Line B columns at Level 8 balconies. Blue lines added by SGH for emphasis.

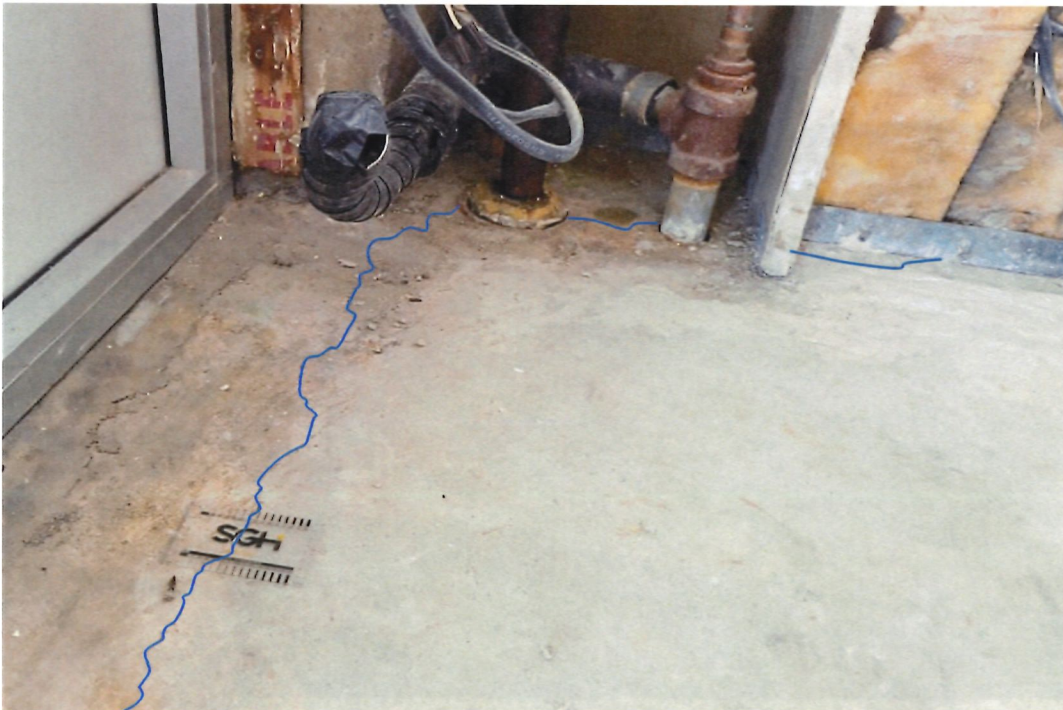
Typical cracks extend between Column Line B columns at Level 8 balconies. Crack widths measure up to 1/16 in. Blue lines added by SGH for emphasis.

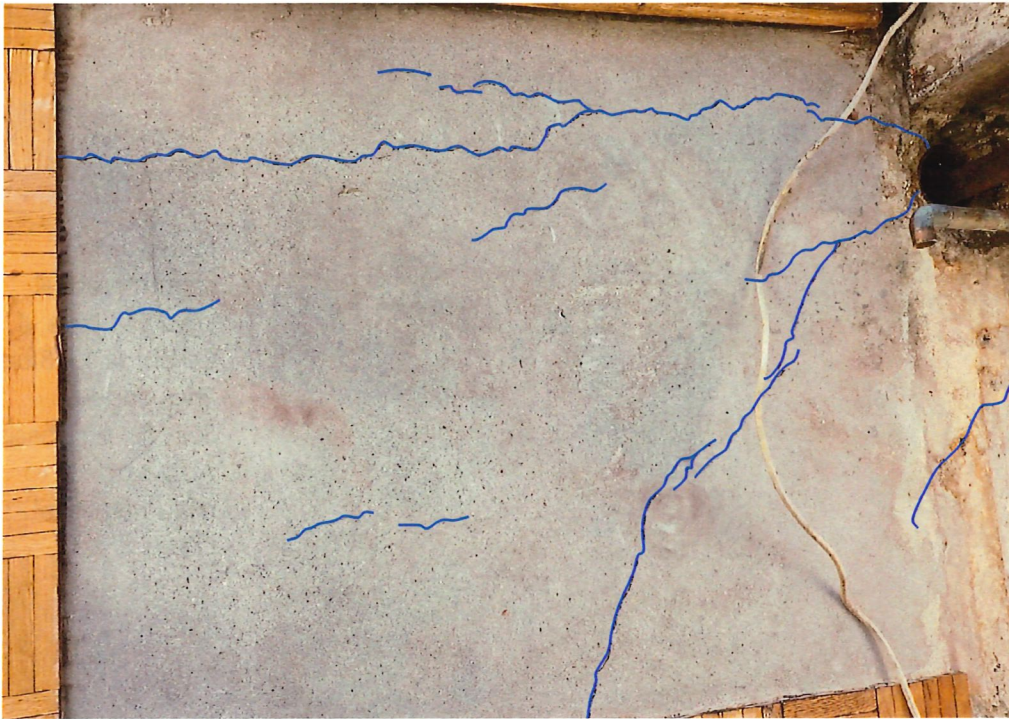
Typical cracks observed at exploratory openings. Blue lines added by SGH for emphasis.

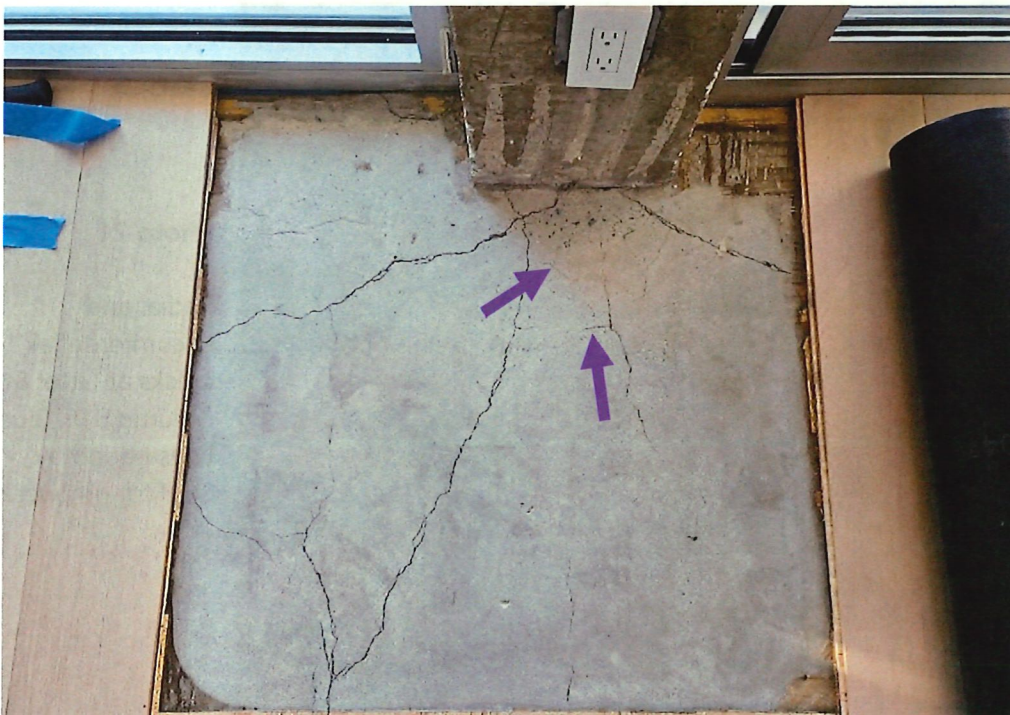
Typical radial cracks observed at exploratory openings. Blue lines added by SGH for emphasis.

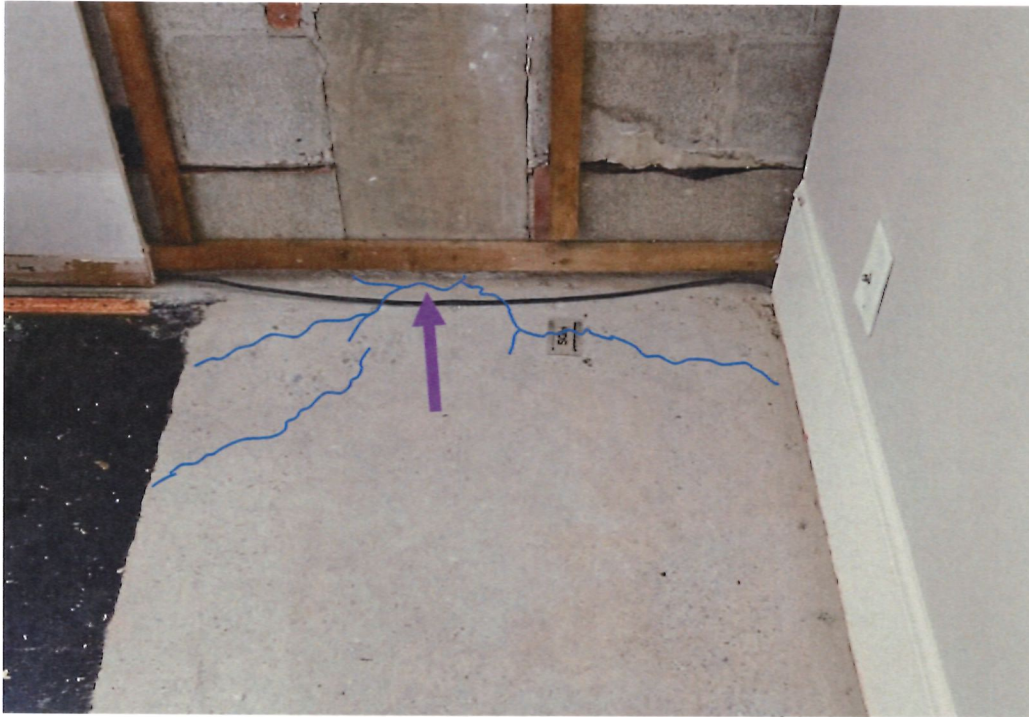
Radial and circumferential cracks at Level 5 Column B5. Arrows point to circumferential cracks.

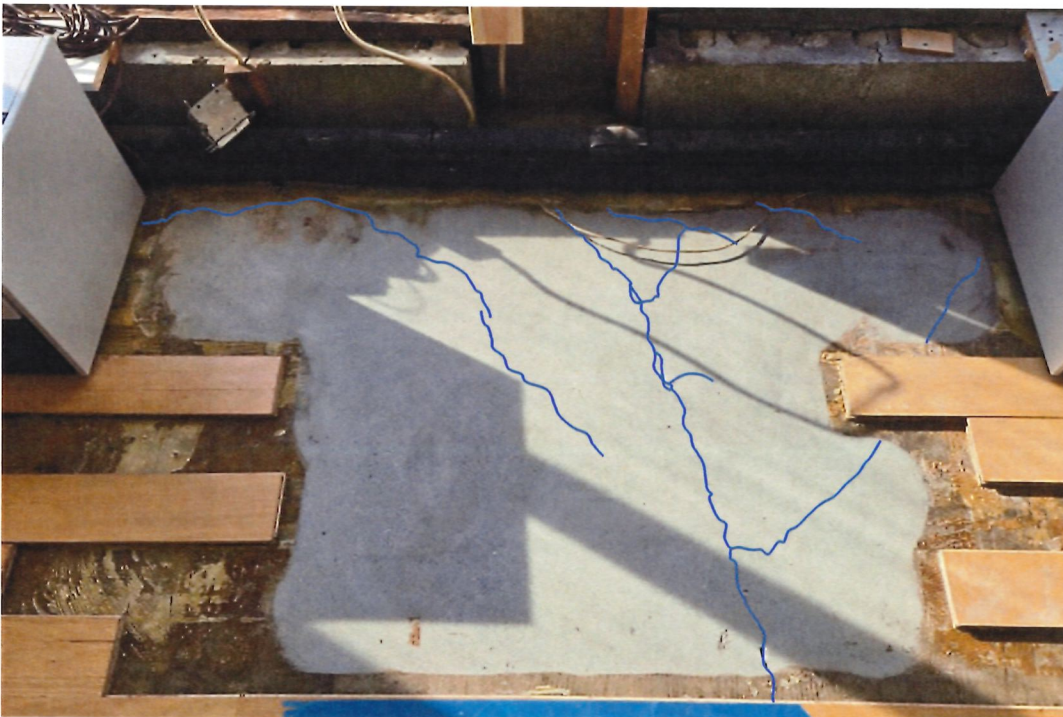
Radial and circumferential cracks at Level 4 Column E15. Blue lines added by SGH for emphasis. Arrow points to circumferential crack.

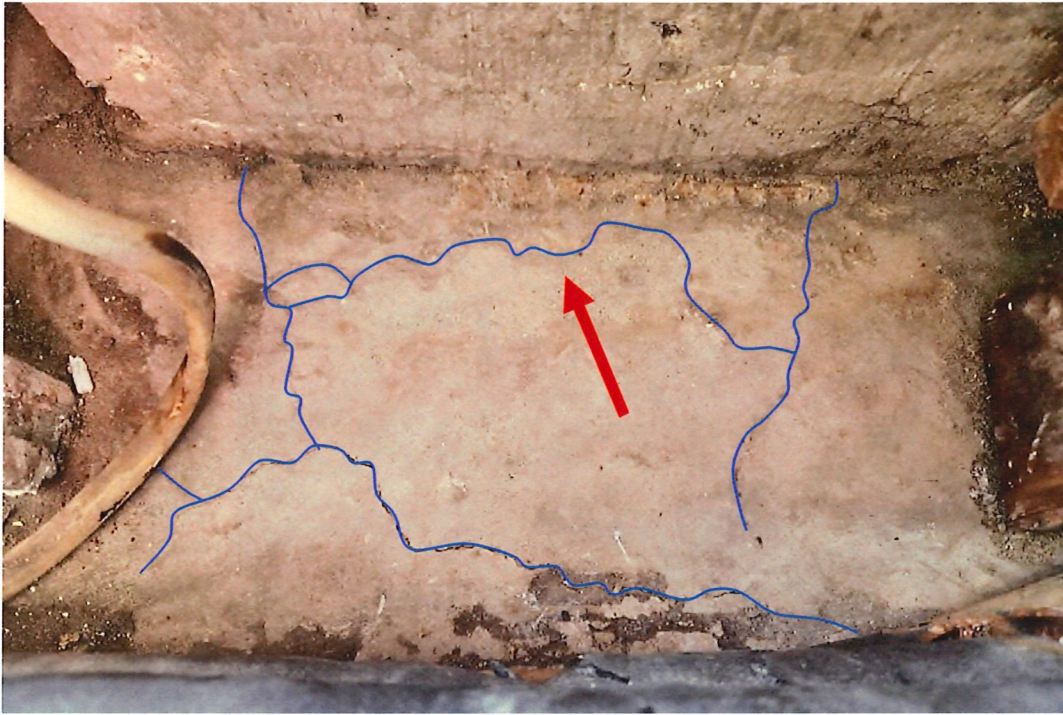
Radial and circumferential cracks at Level 8 Column B16. Blue lines added by SGH for emphasis.

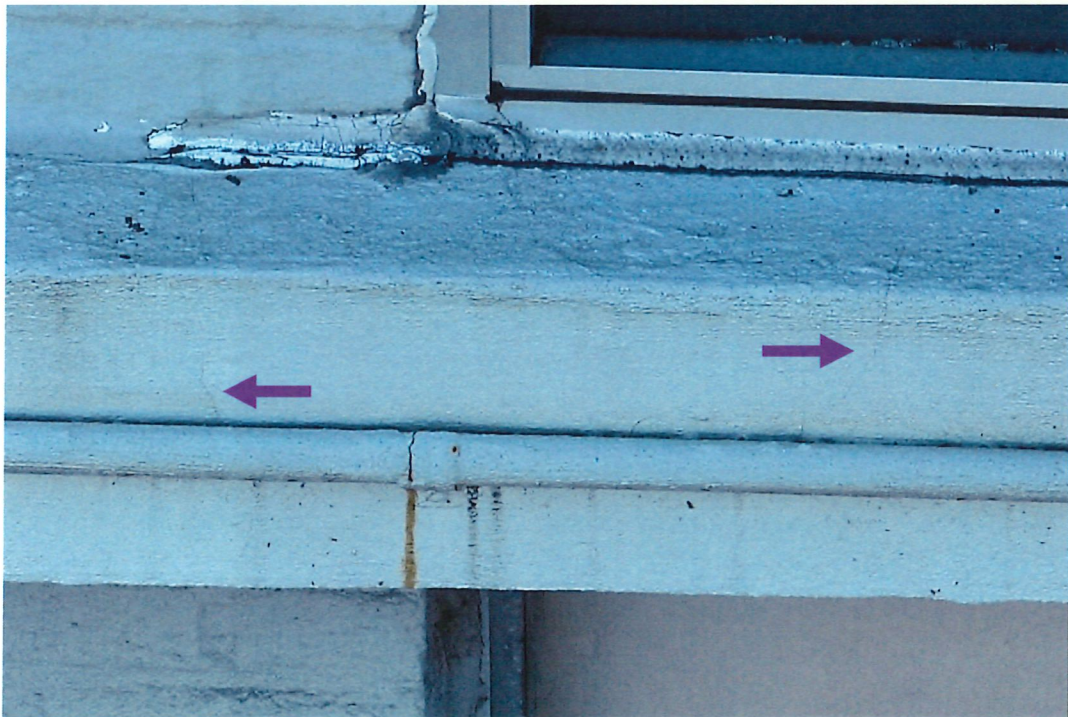
Radial and circumferential cracks (red arrow) at the face of Level 8 Column B16. Blue lines added by SGH for emphasis.

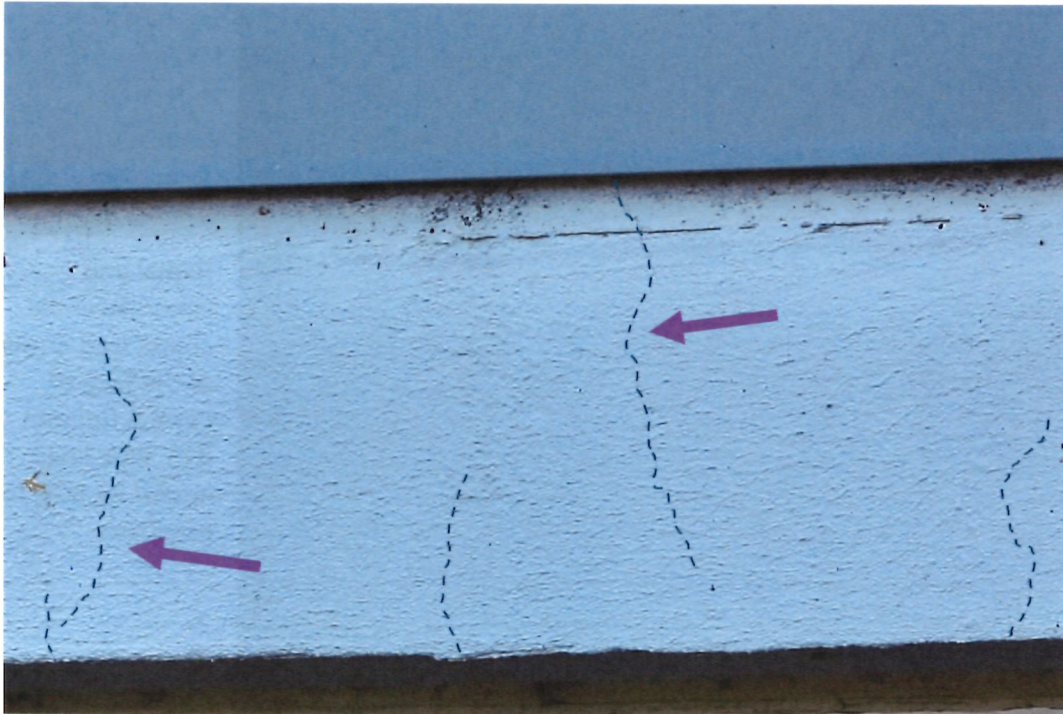
Vertical cracks at the Level 4.5 slab edge between Columns E15 and E16.

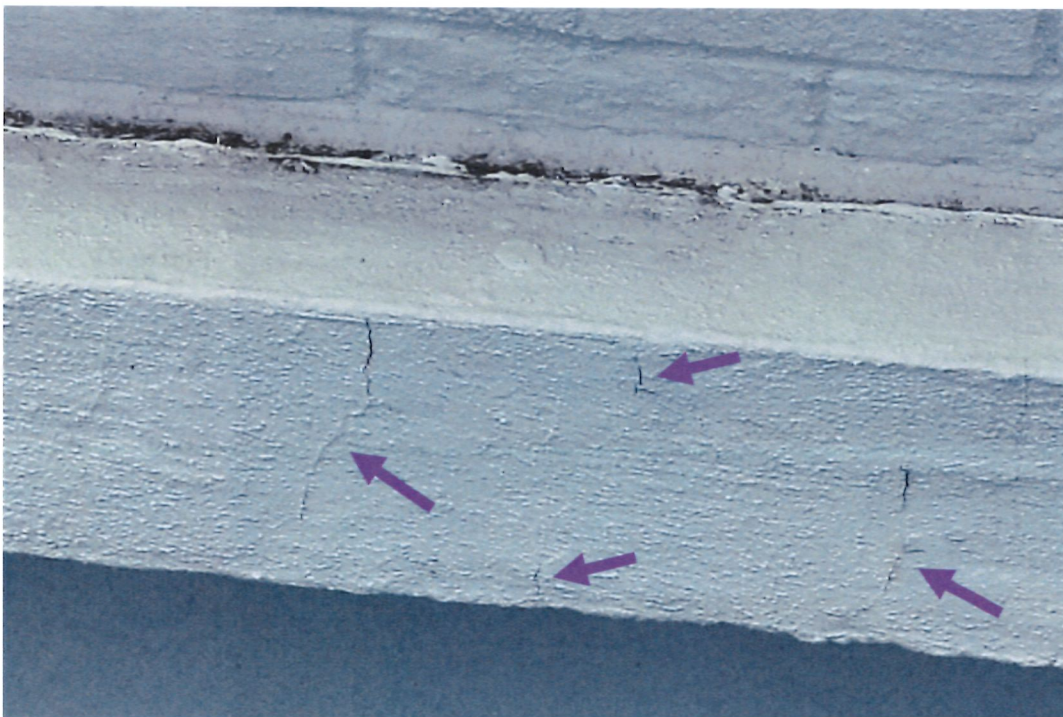
Vertical cracks at the Level 8 slab edge between Columns E20 and E21. Dashed lines representing the observed cracks added by SGH for emphasis.

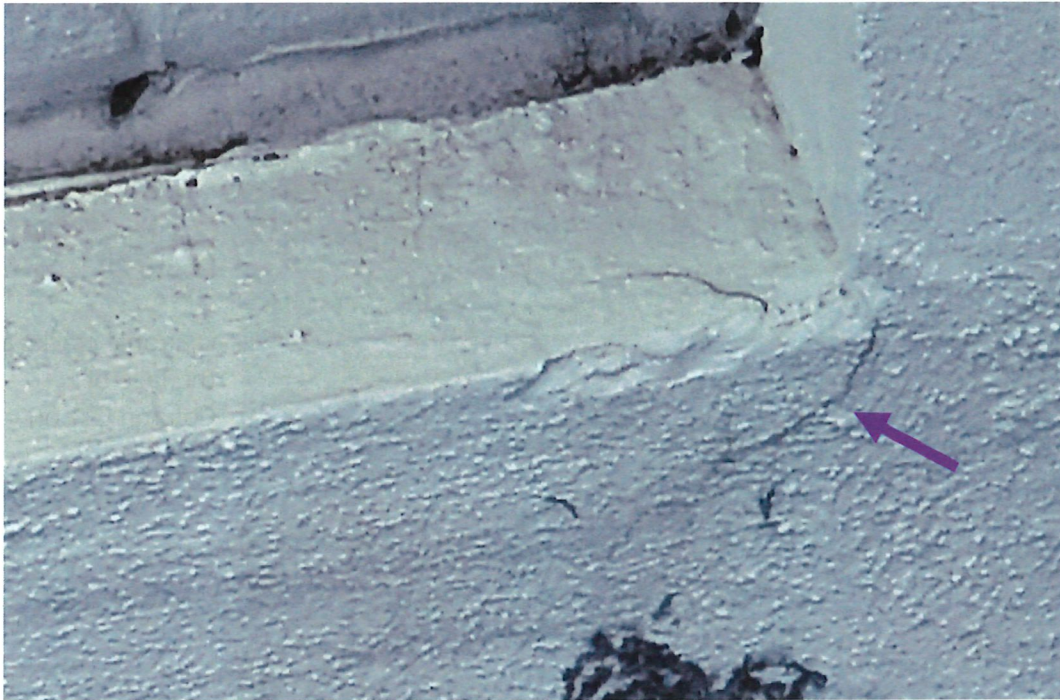
Vertical cracks at Level 1.5 slab edge between Columns E6 and E7.

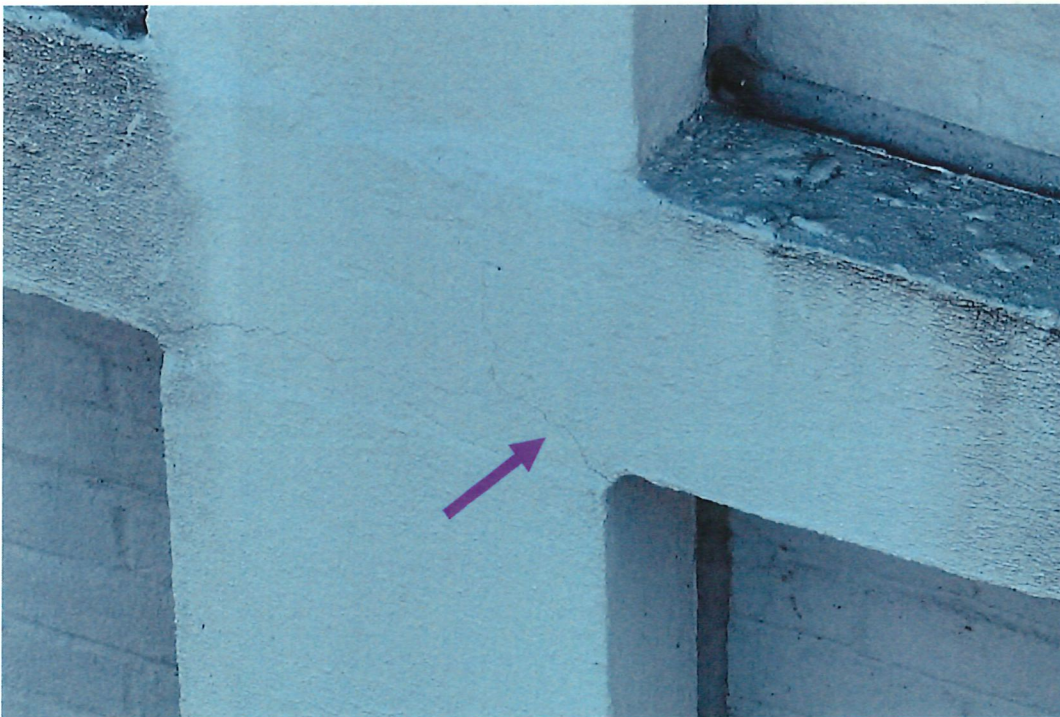
Diagonal crack at the face of Column E5 on Level 2.5.

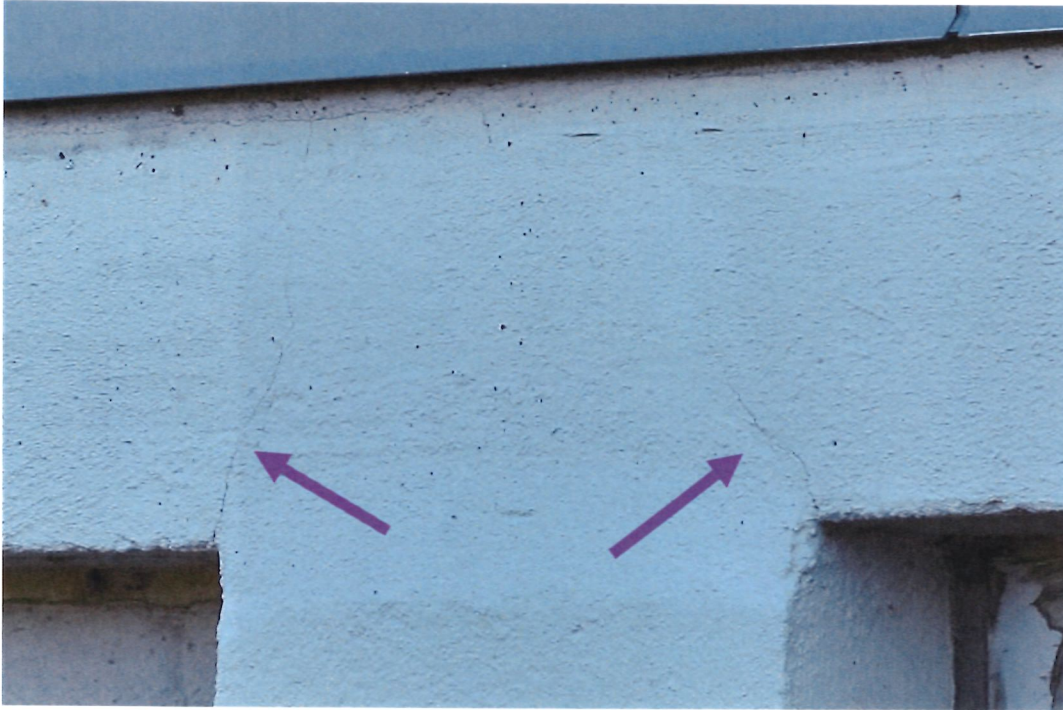
Diagonal cracks at the face of Column E19 on Level 7.

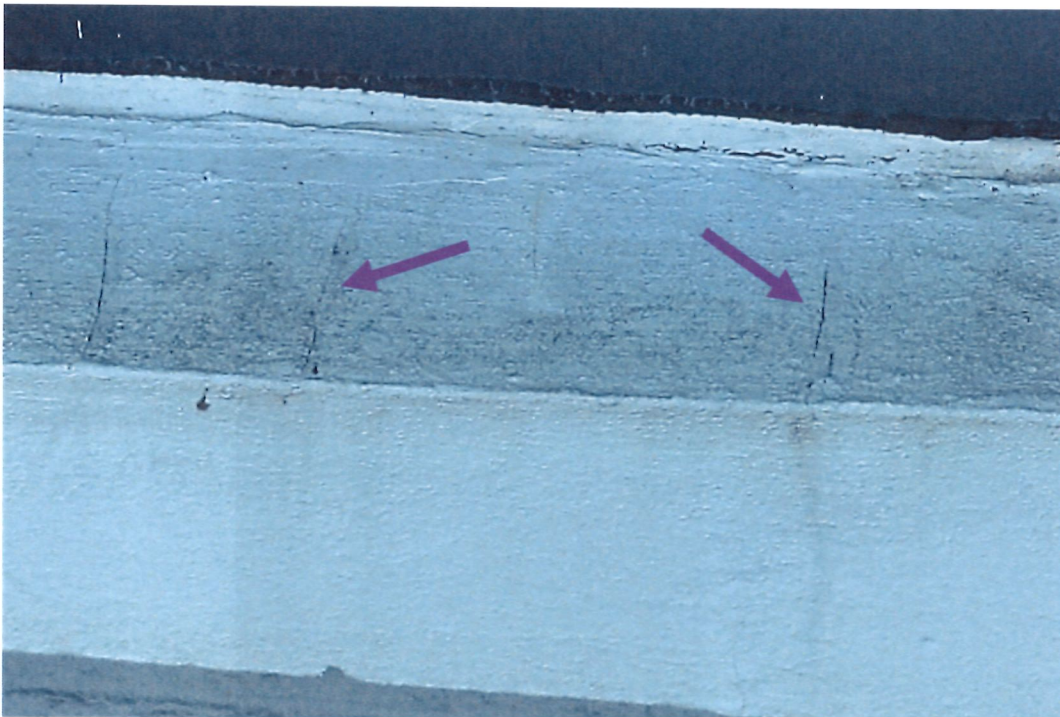
Diagonal cracks at the face of Column E21 on Level 8.

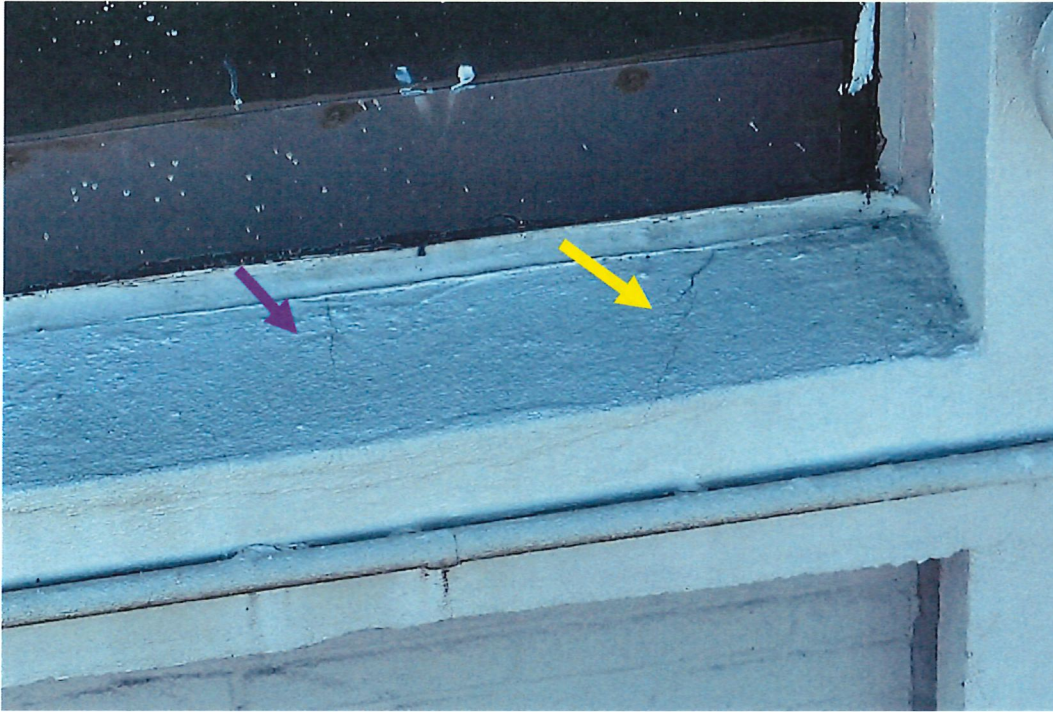
Topside cracks perpendicular to the wall at Level 2.5 slab edge between Columns E11 and E12.
