ADAMS & RAFFERTY

ATTORNEYS AT LAW

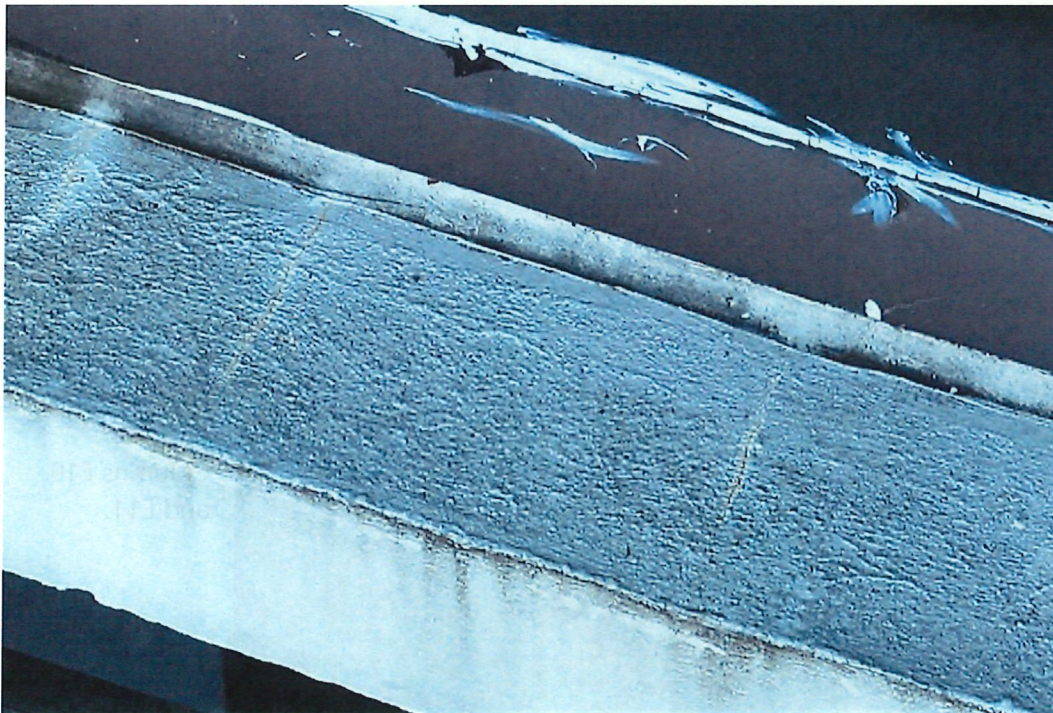
Topside crack perpendicular to the wall (purple arrow) and topside crack at an angle to the wall (yellow arrow) at Level 4.5 slab edge between Columns E12 and E13.

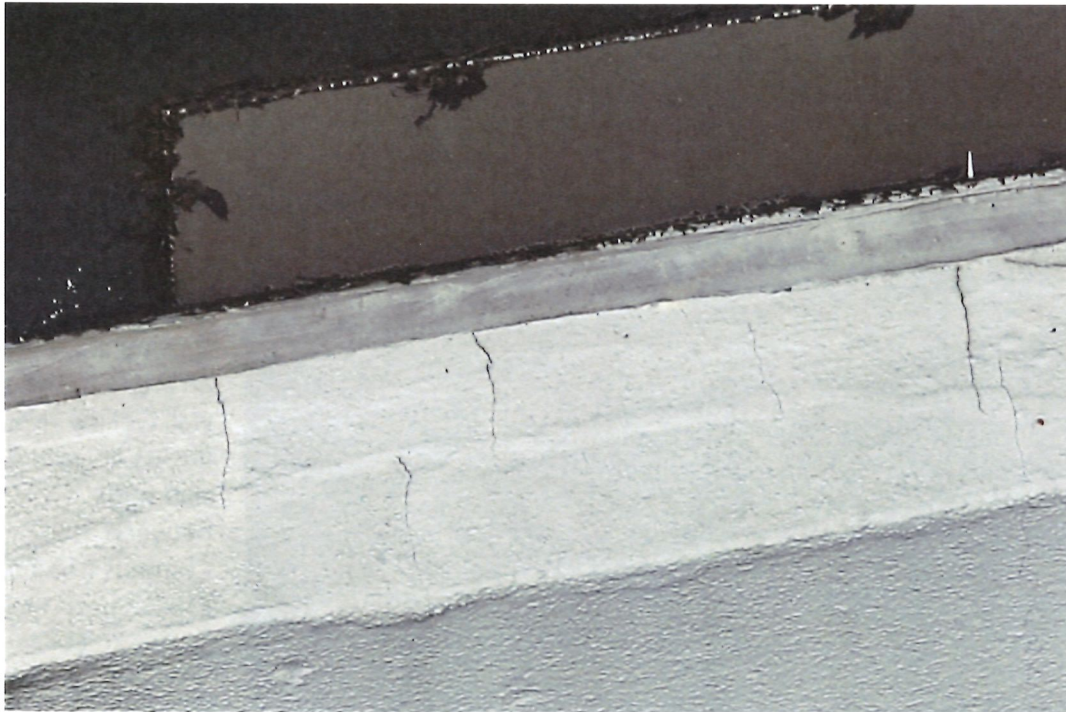
Topside cracks perpendicular to the wall at the Level 7 slab edge between Columns E20 and E21.

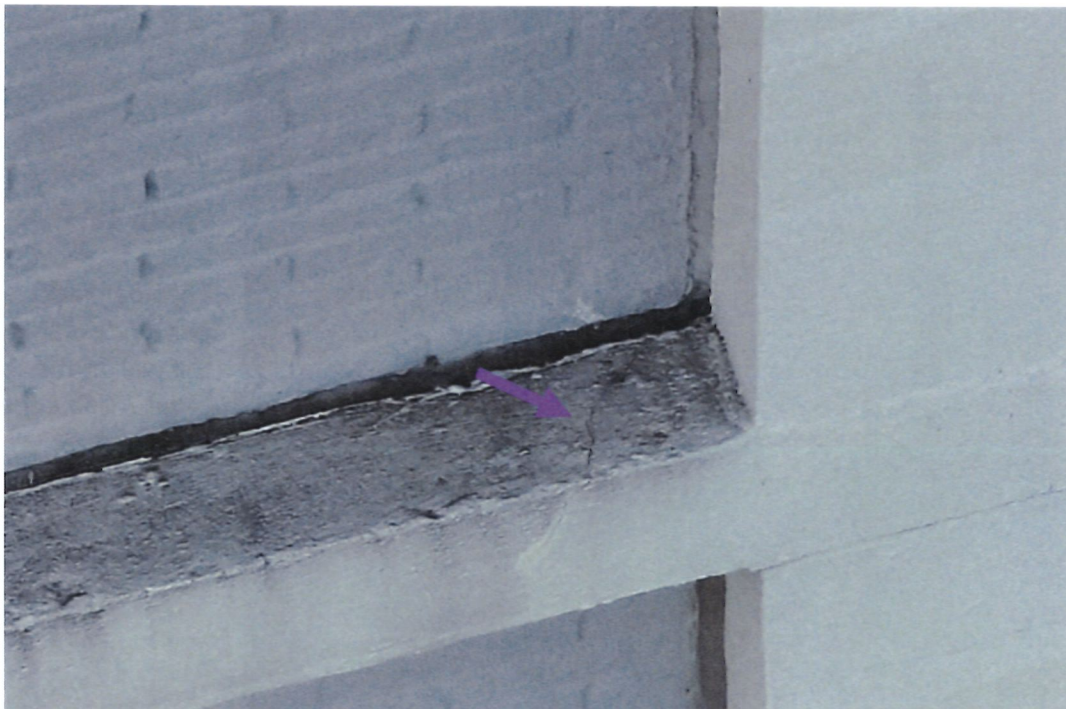
Topside cracks perpendicular to the wall at the Level 5.5 slab edge between Columns E3 and E4.

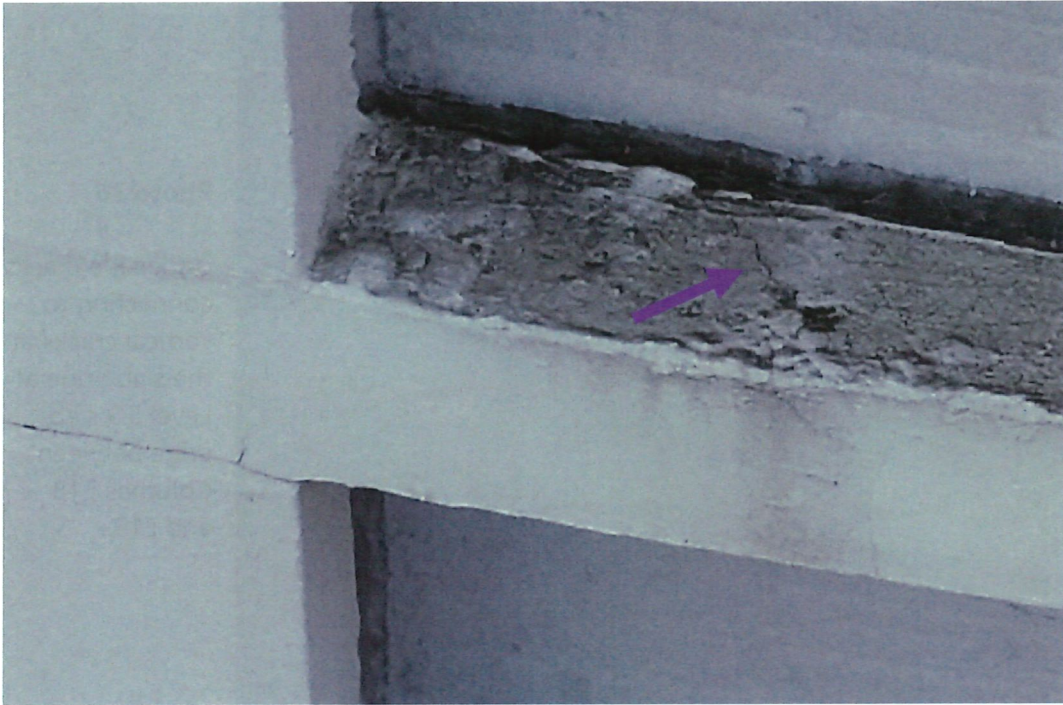
Topside cracks at an angle to the column at the Level 7 slab edge between Columns E10 and E11.

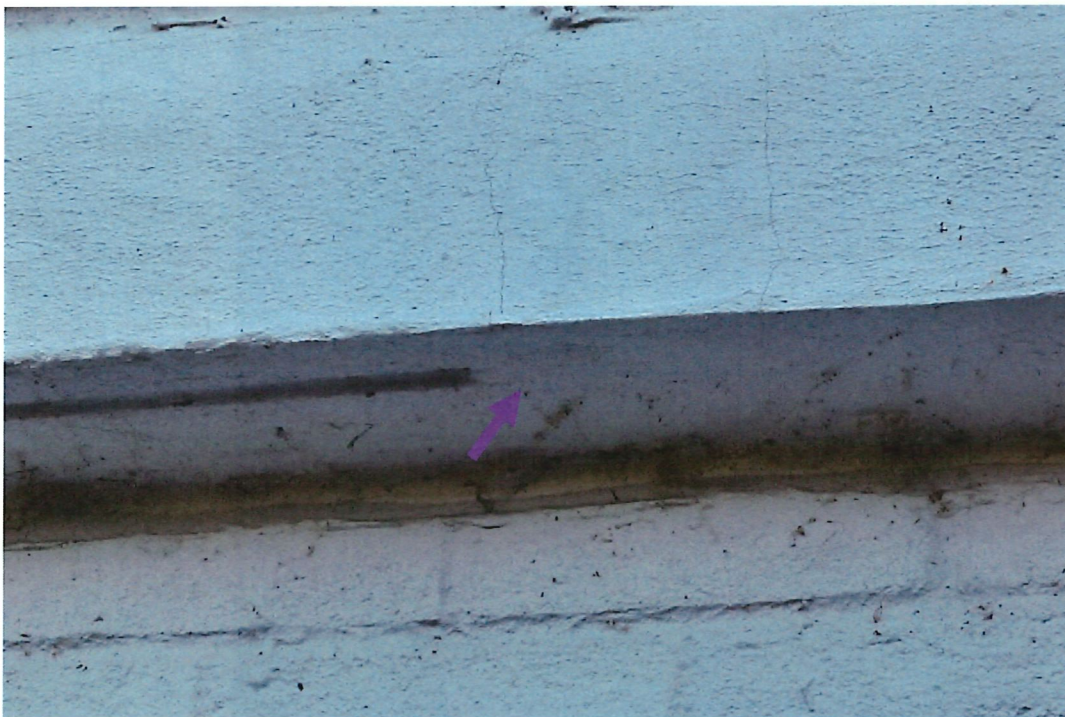
Topside cracks at an angle to the column at the Level 7 slab edge between Columns E10 and E11.

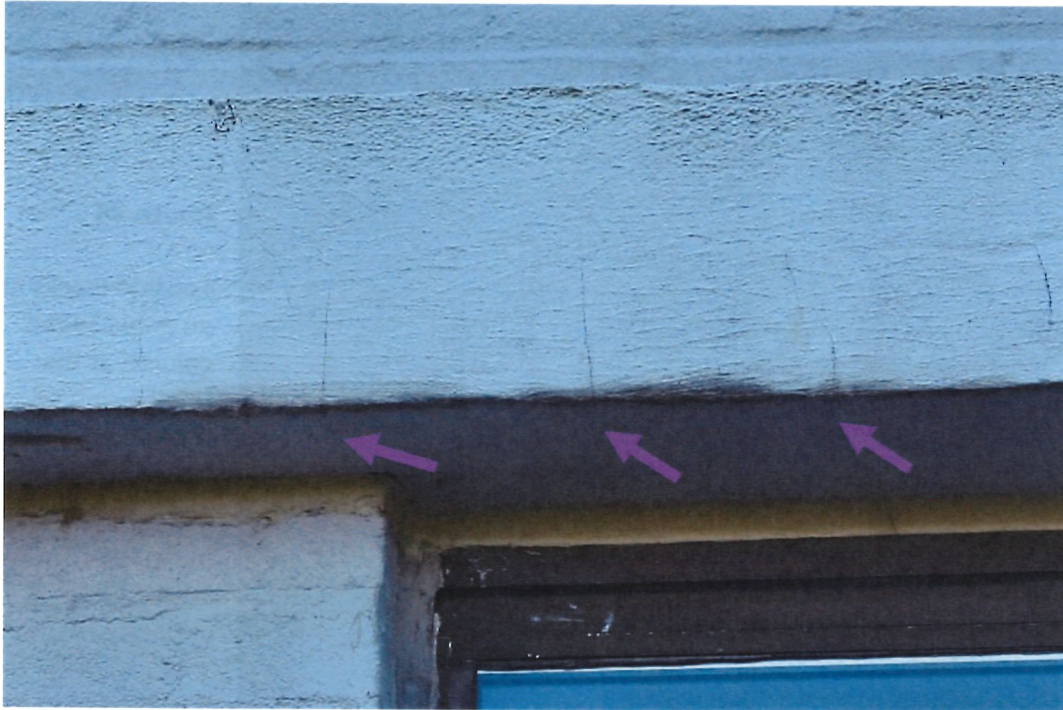
Underside cracks connecting to vertical cracks at the slab edge at Level 8 between Columns E21 and E22.

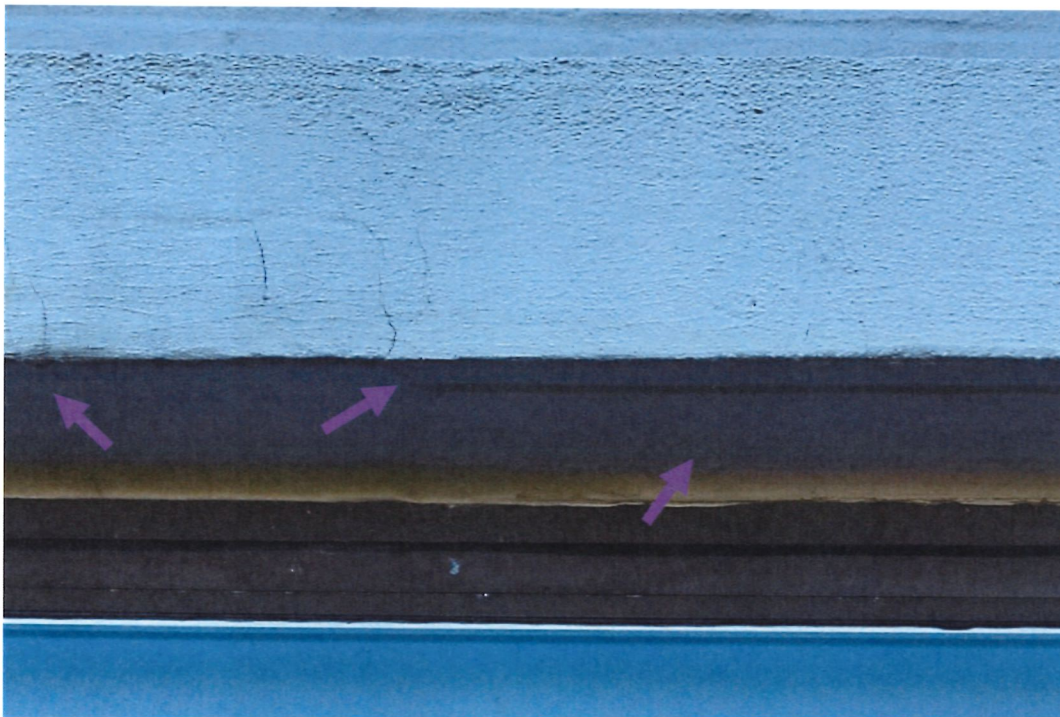
Underside cracks connecting to vertical cracks at the slab edge at Level 5.5 slab edge between Columns E18 and E19.

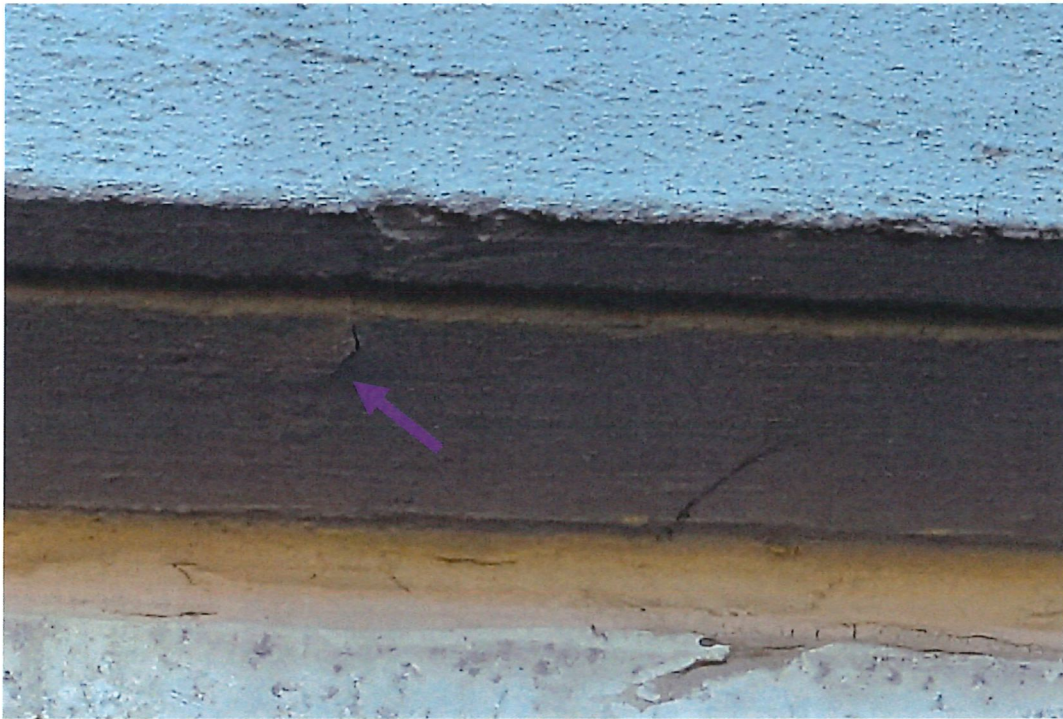
Underside cracks connecting to vertical cracks at the slab edge at Level 5.5 between Columns E18 and E19. The rightmost arrow identifies an isolated underside crack.

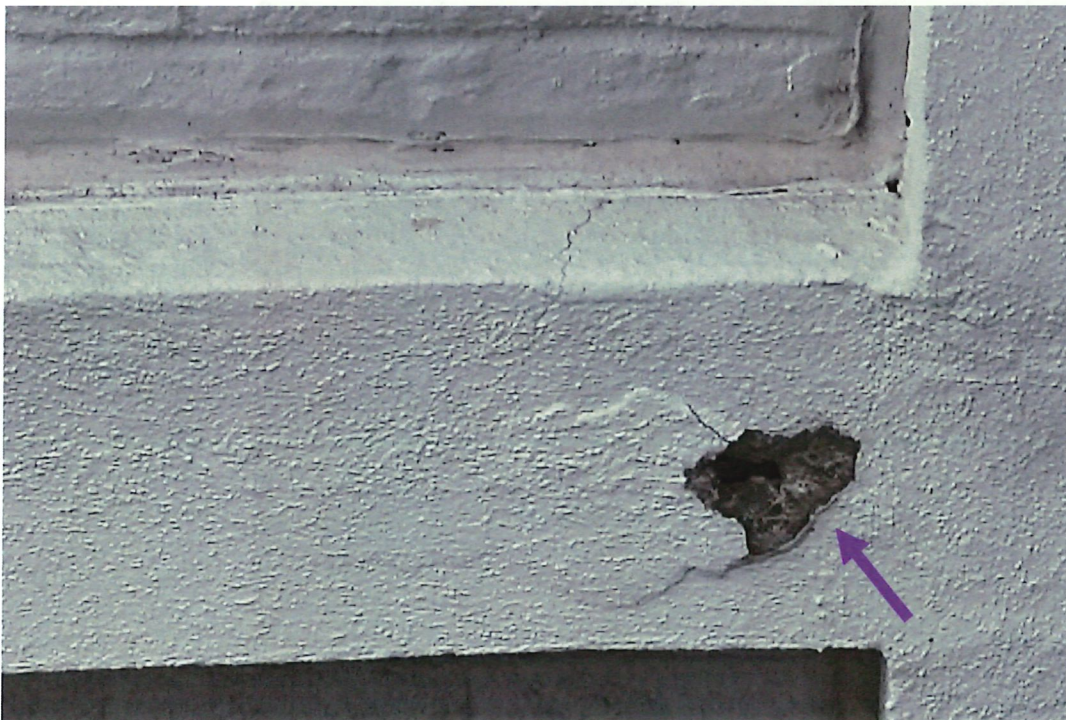
Underside crack connecting to vertical cracks at the slab edge at Level 6.5 between Columns E15 and E16.

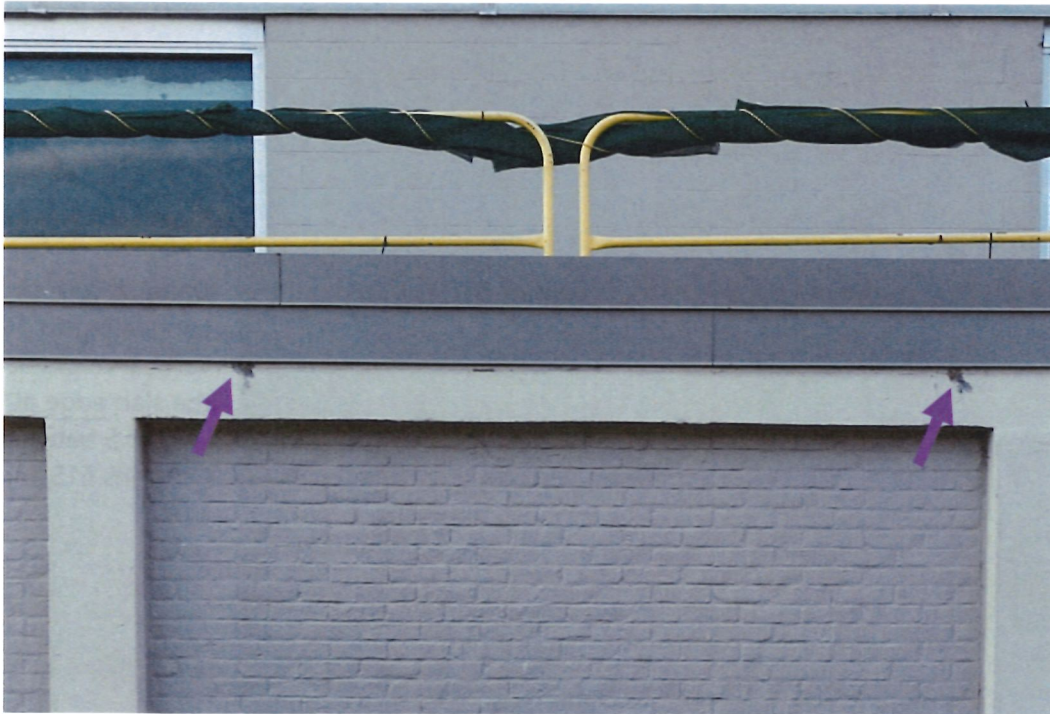
Spall at Level 2.5 slab edge between Columns E4 and E5. Corroded reinforcement is visible. An incipient spall is adjacent to the left of the exposed corroded reinforcement.

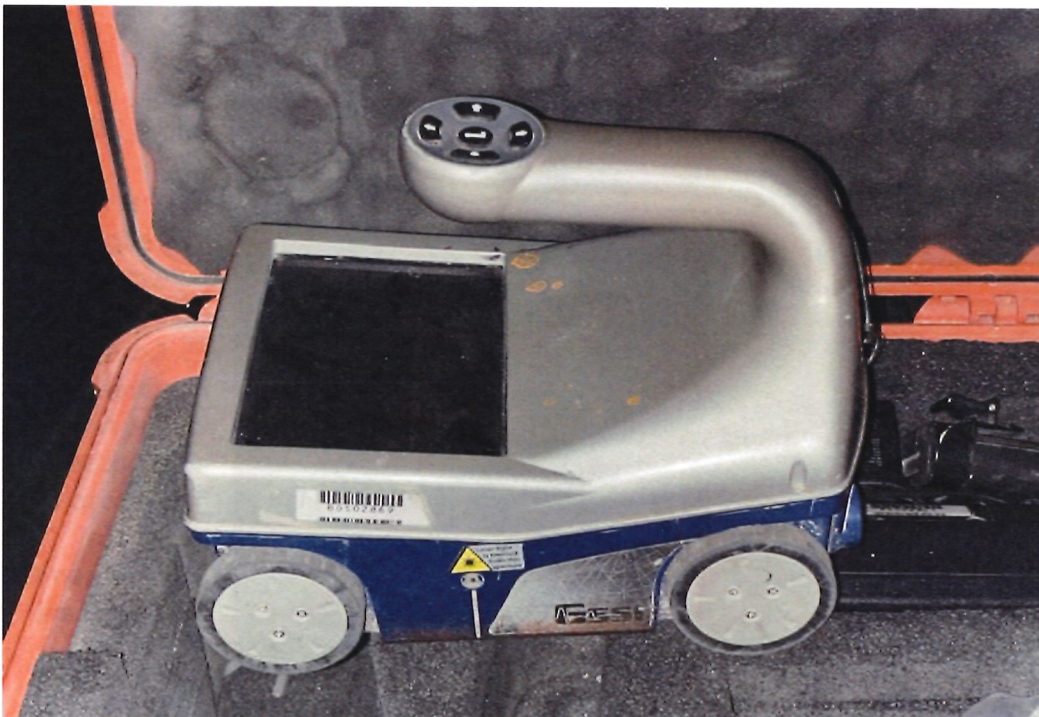
Spalled concrete at the Level 8 slab edge between Columns E13 and E14.

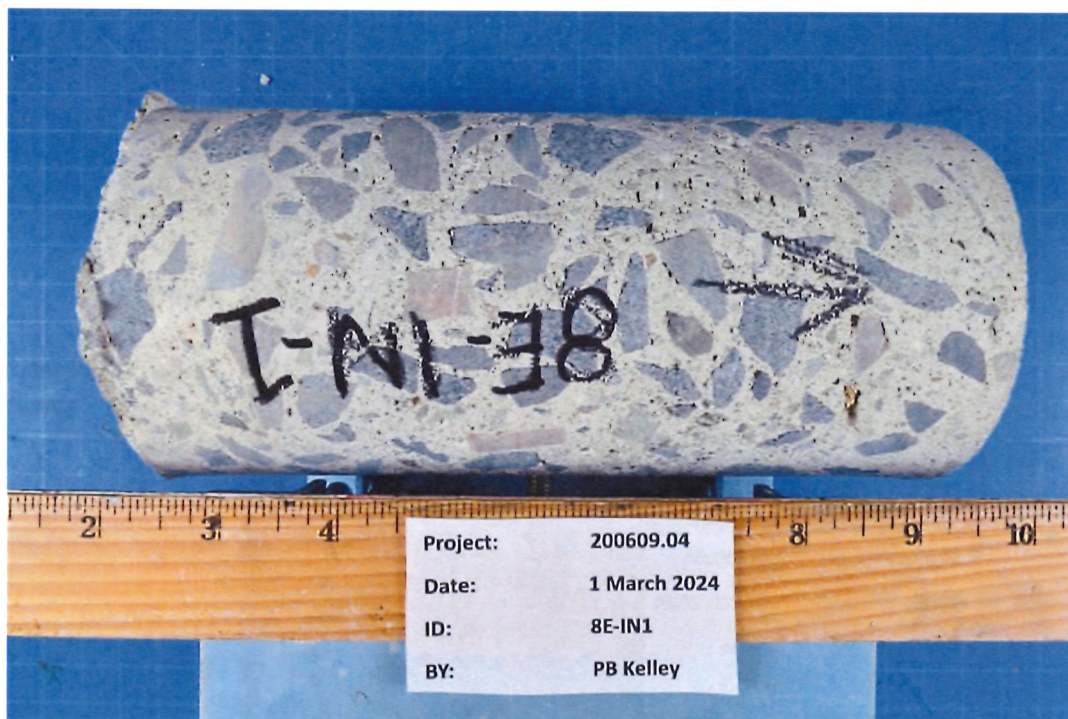
Core 7E-IN from the Level 7 East stairwell.

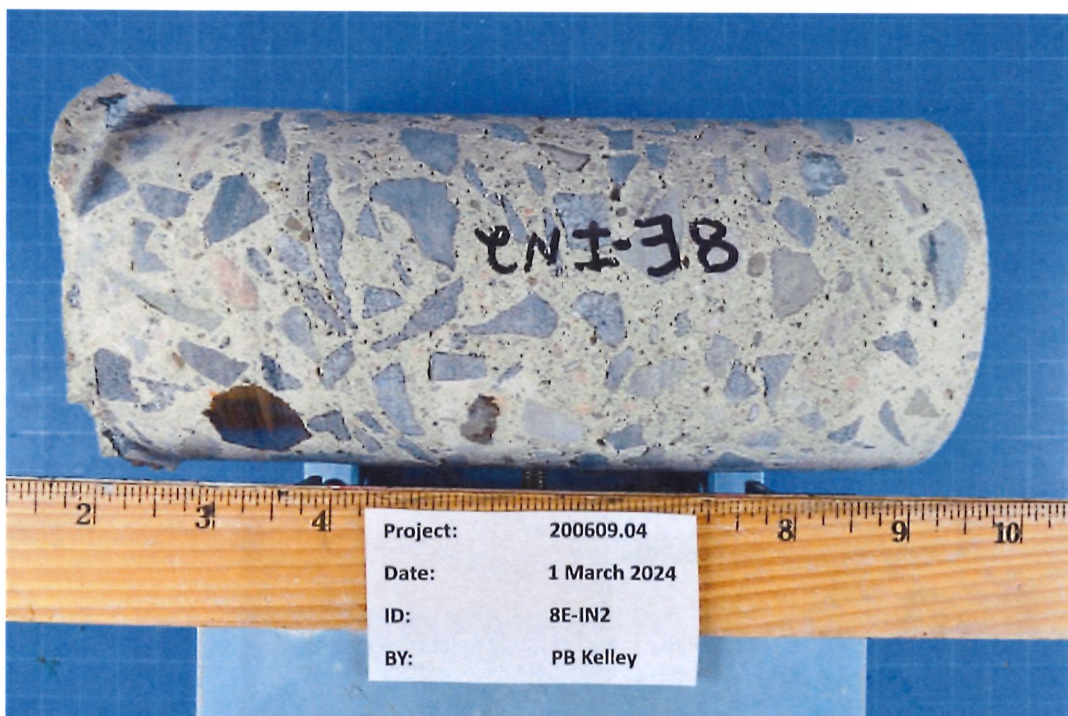
First core 8E-IN-1 from the Level 8 East stairwell. The arrow points towards the wearing surface side.

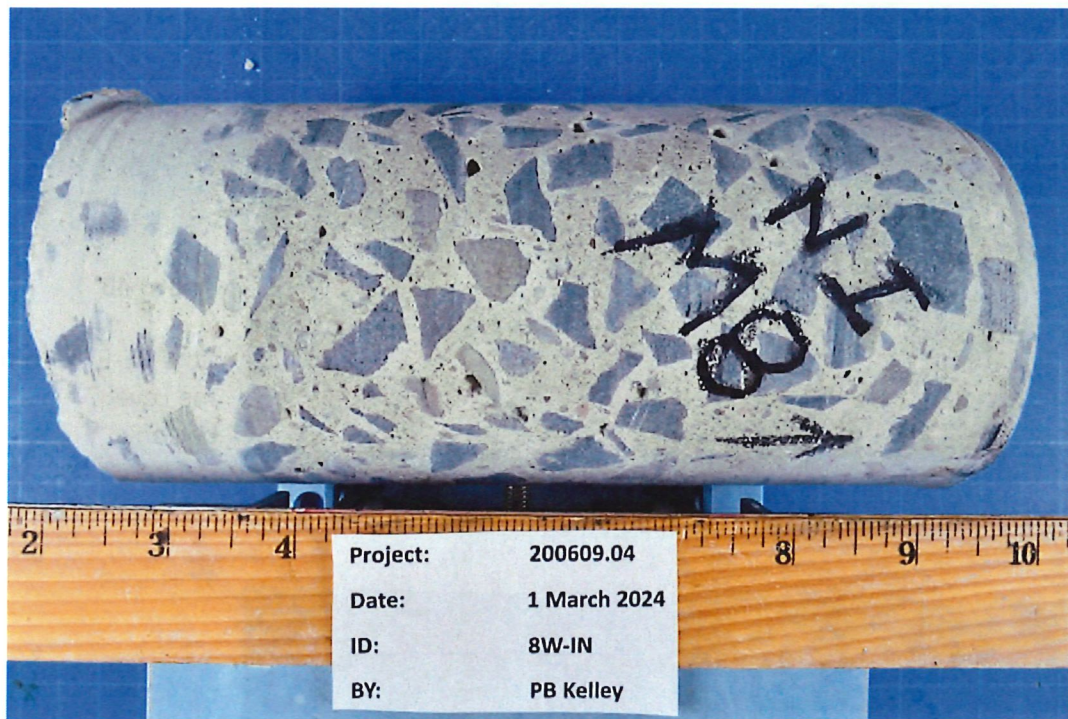
Second core 8E-IN-2 from the Level 8 East stairwell.

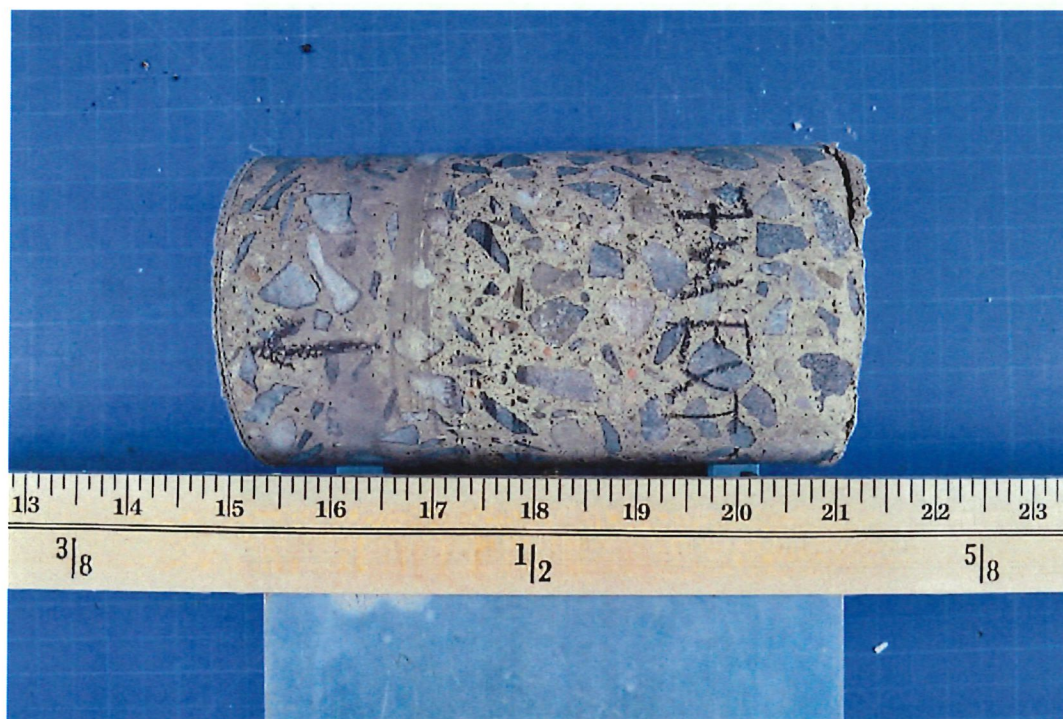
Core 8W-IN from the Level 8 West stairwell. The arrow points towards the wearing surface side.

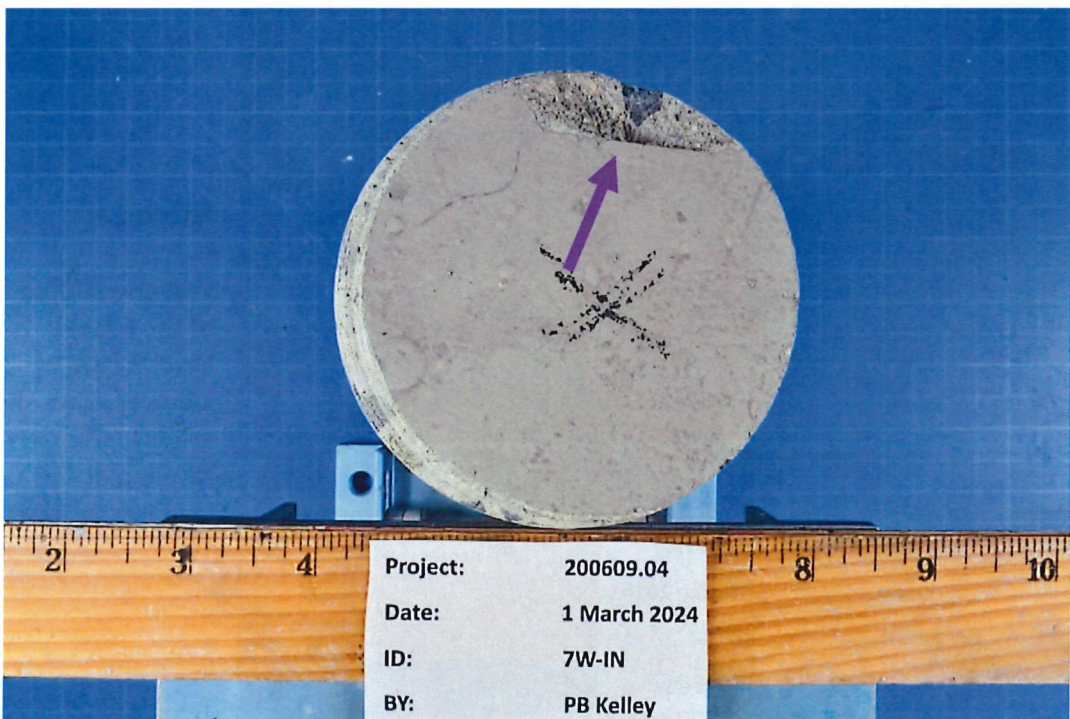
Core 8E-EXT from the Level 8 balcony.

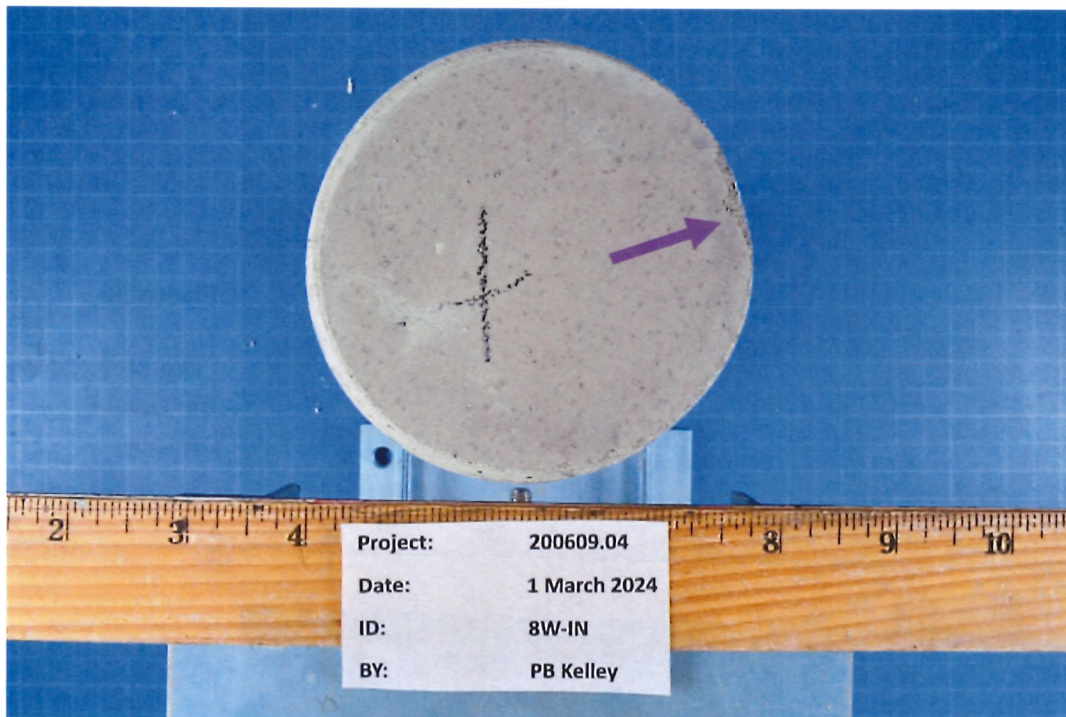
Wearing surface of the Level 7 West stairwell core. The arrow indicates raveling at the wearing surface.

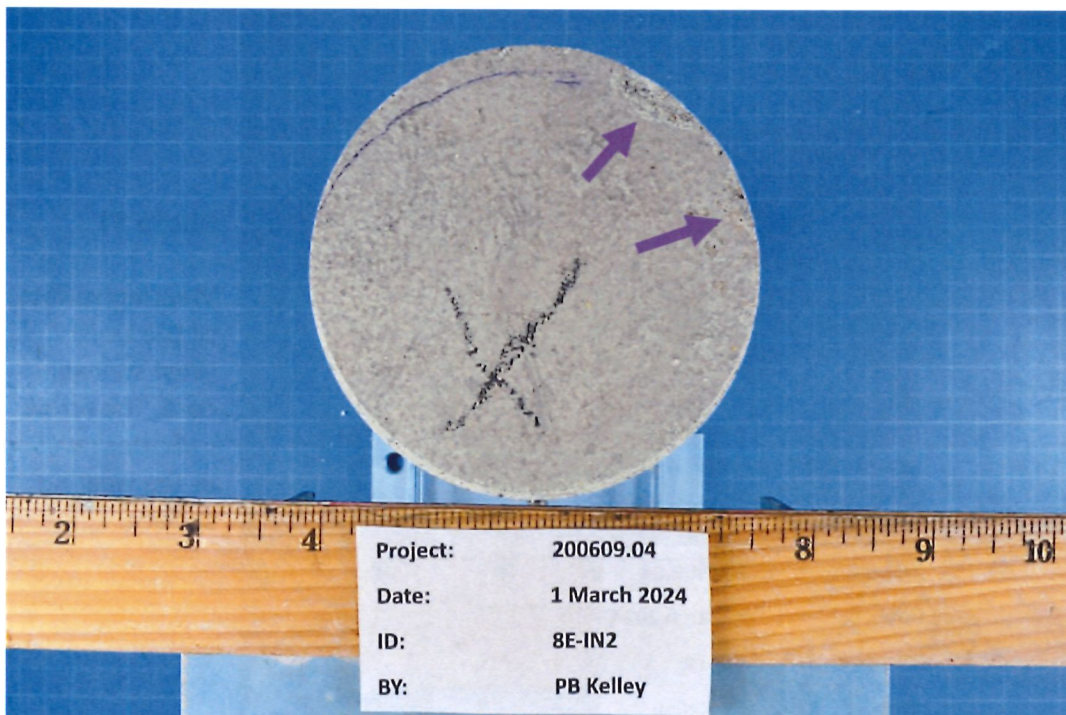
Wearing surface of the Level 8 West stairwell core. The arrow indicates raveling at the wearing surface.

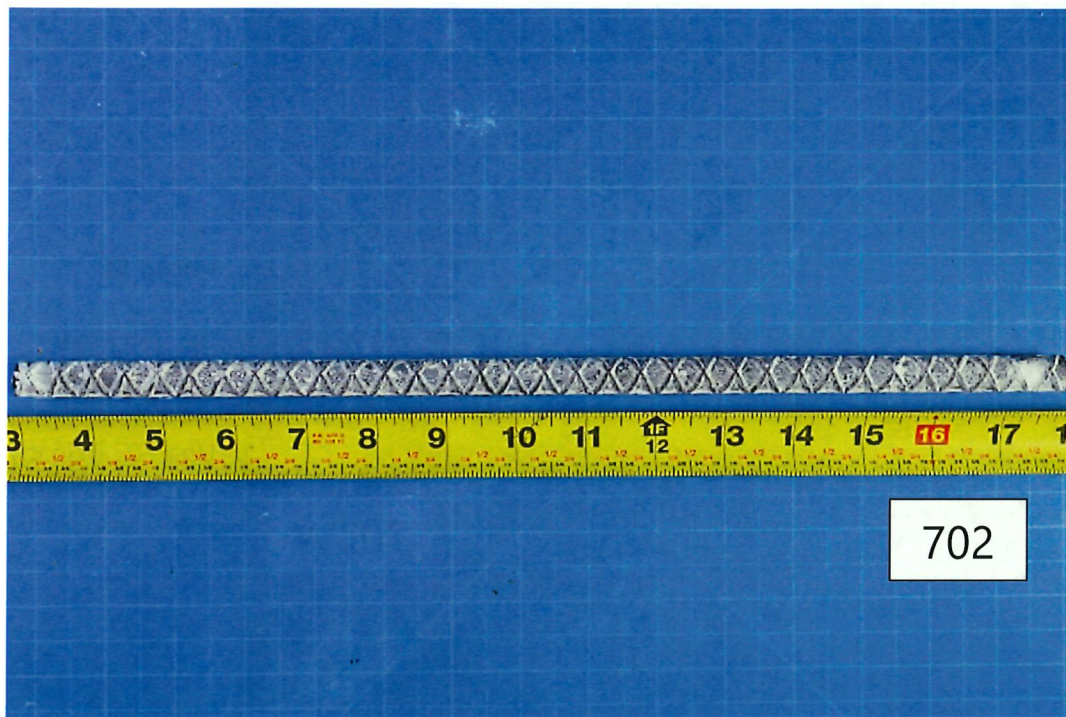
Wearing surface of the second Level 8 East stairwell core. The arrows indicate raveling at the wearing surface.

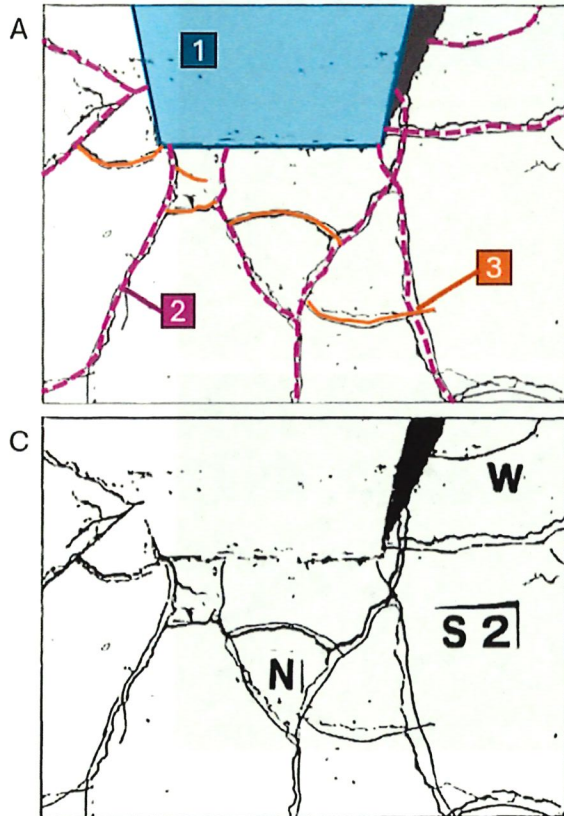
Riverview Slab – Level 5 Column B5

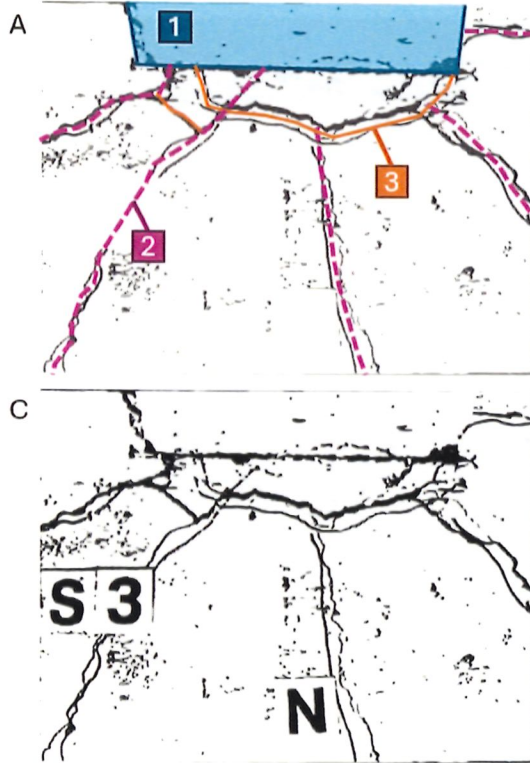
Riverview Slab – Level 4.5 Column E13

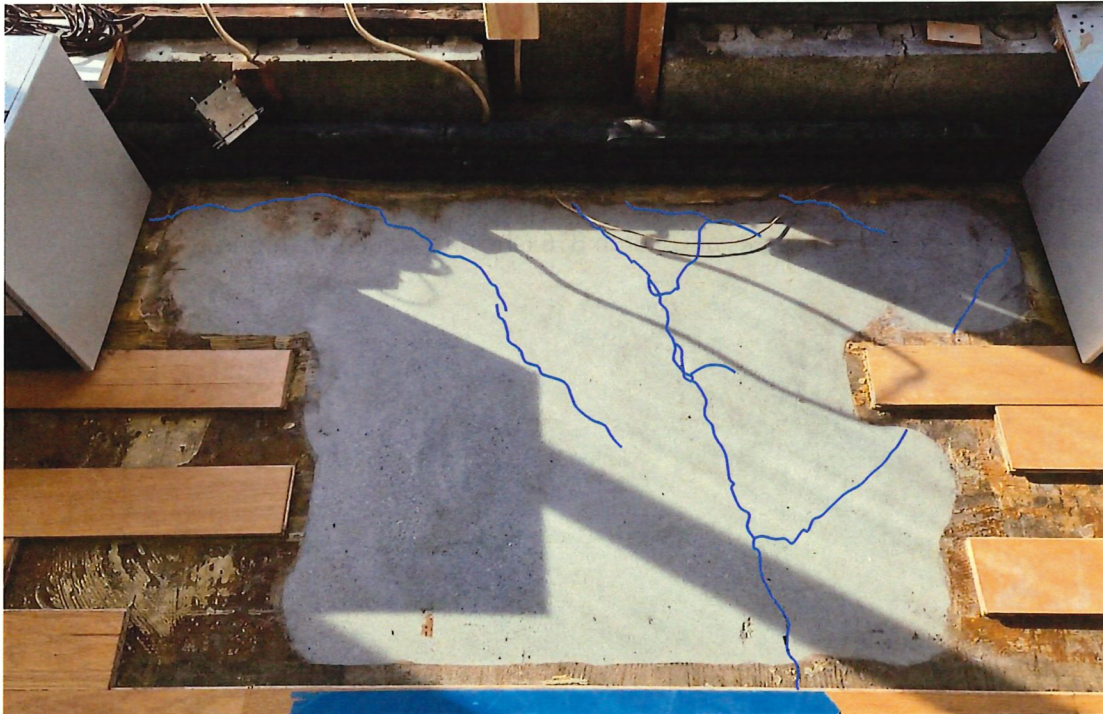
We observed the slab-column connection at Column B16 on Level 8 inside Unit 802 on 4 October 2024.

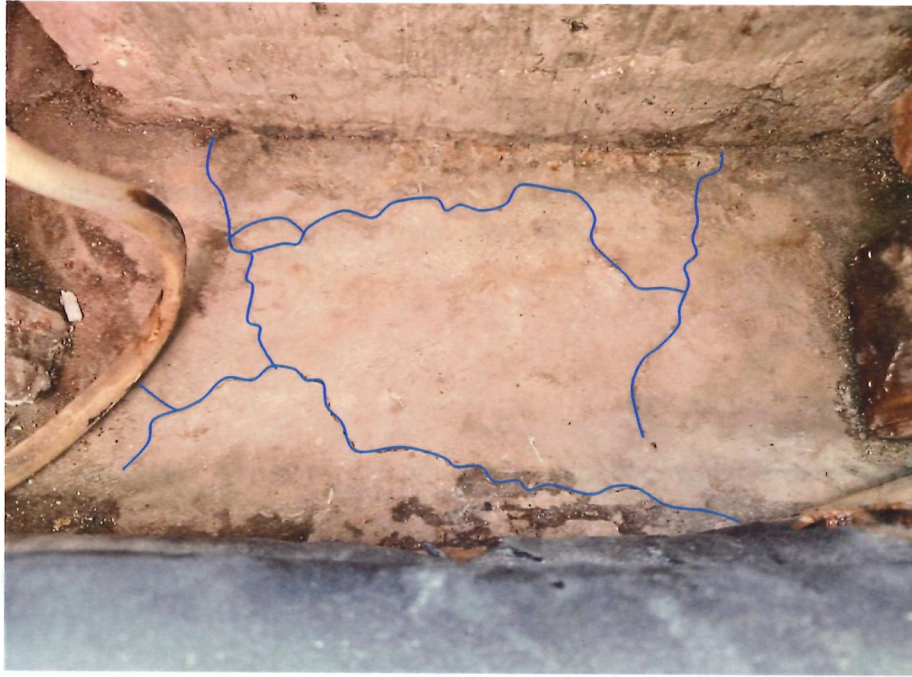
Radial and circumferential cracks are present (shown in blue for emphasis). Crack widths ranged from 0.008 to 0.04 in.

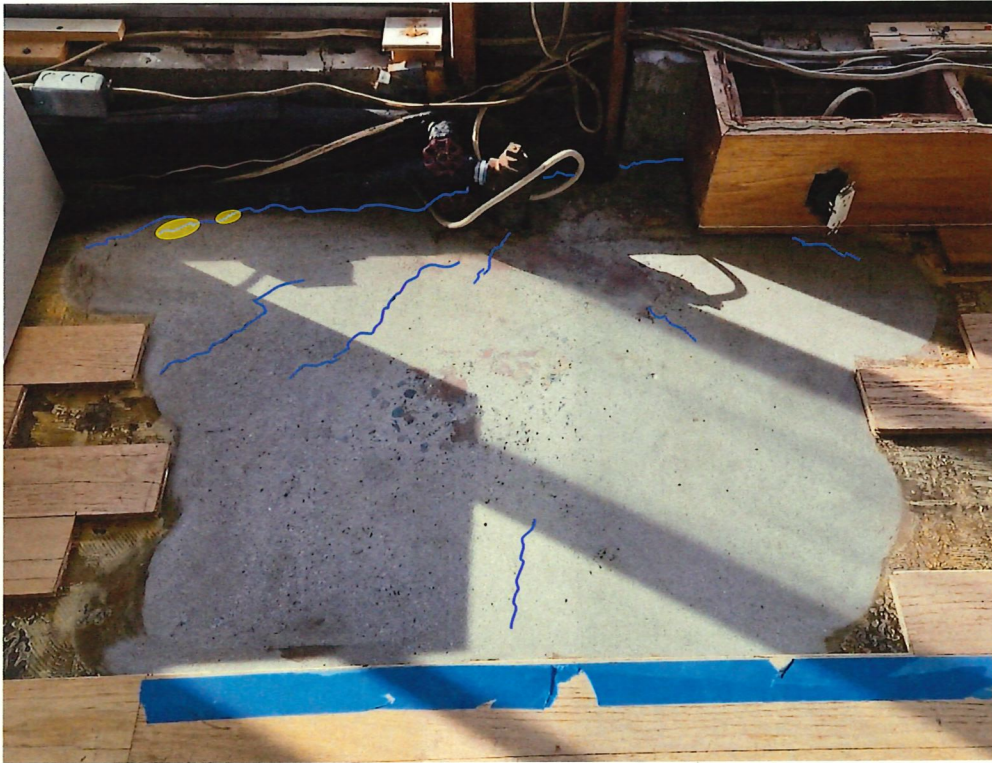
We observed the slab-column connection at Column B18 on level 8 inside Unit 802 on 4 October 2024.

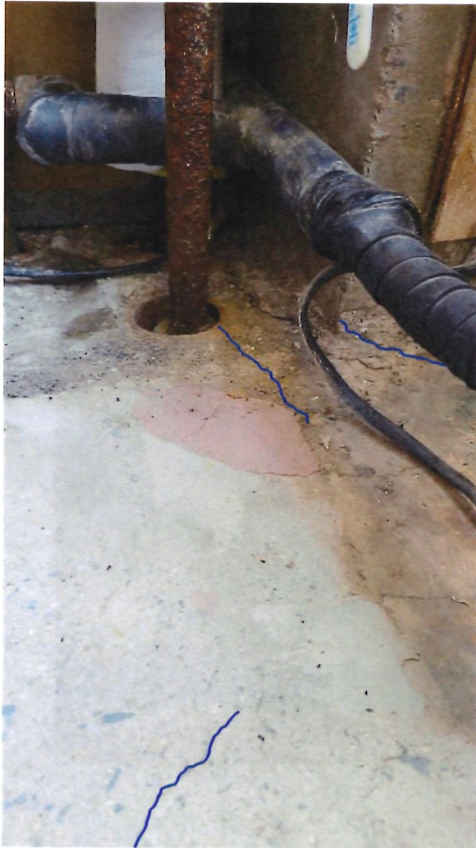
We observed the slab-column connection at the east side of Column E15 on Level 7 inside Unit 706 on 26 June 2024.

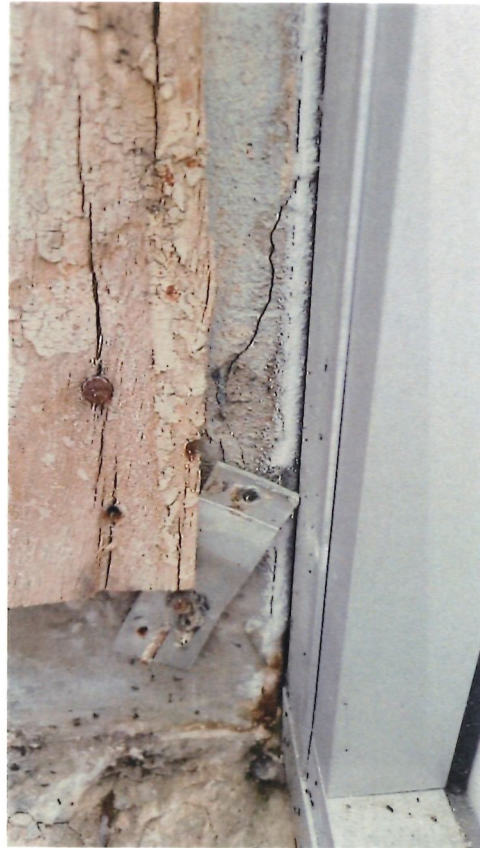
Riser pipes and radial cracks are present (shown in blue for emphasis).

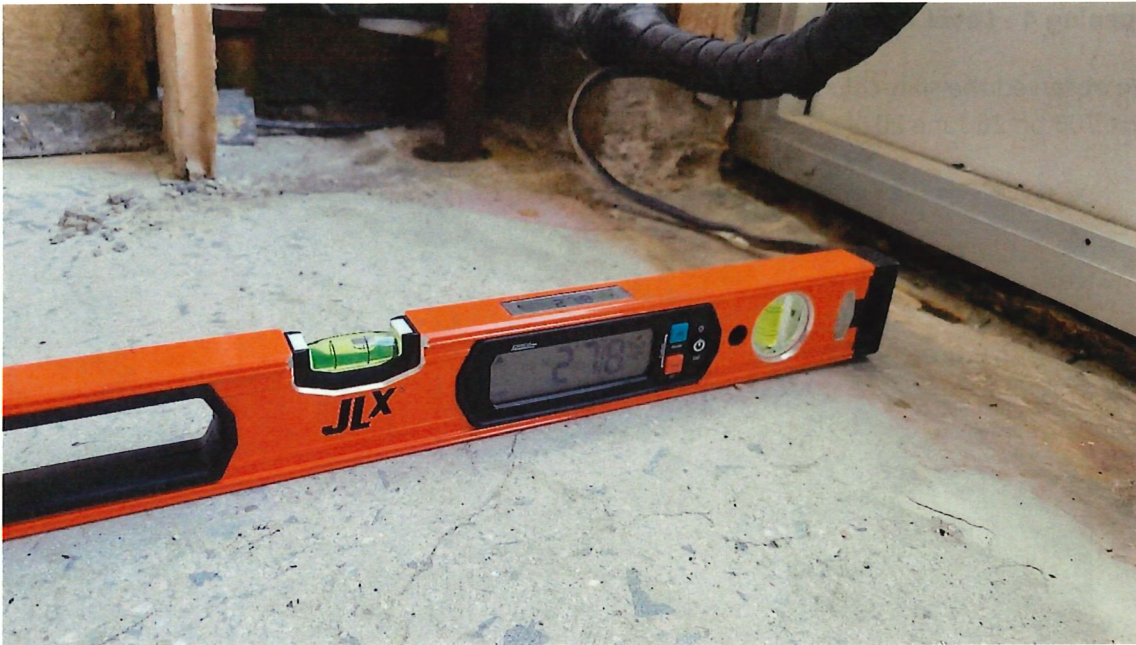
We observed a vertical crack on the east face the column.

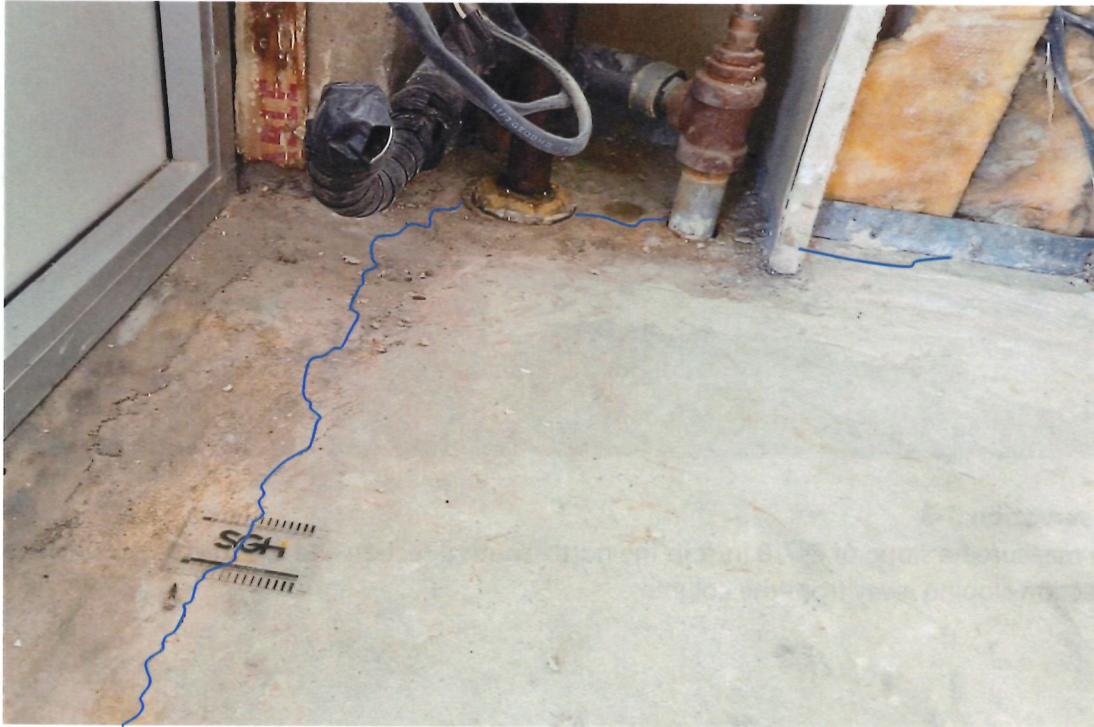
Observation 4-1 (East Side of Opening)

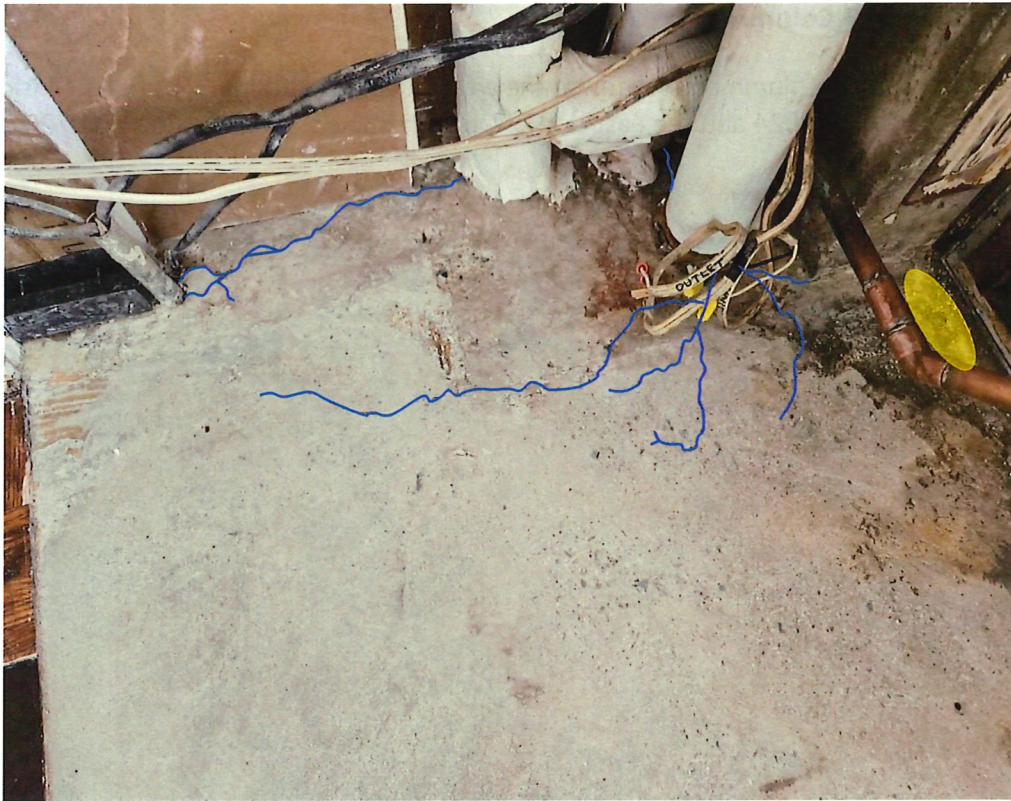
Observation 4-2 (West Side of Opening)

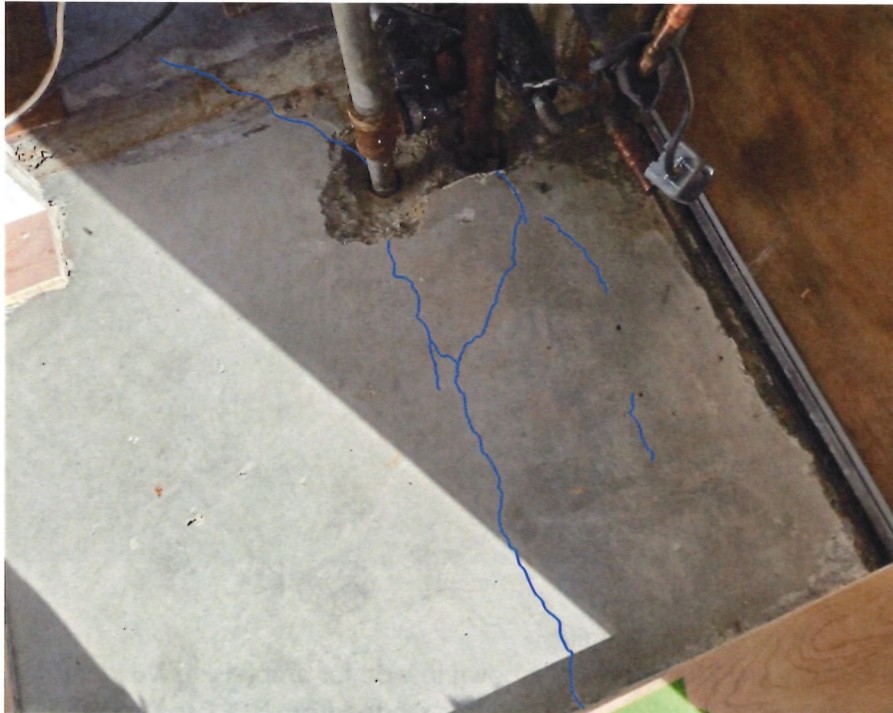
Observation 5-1 (West Side of Opening)

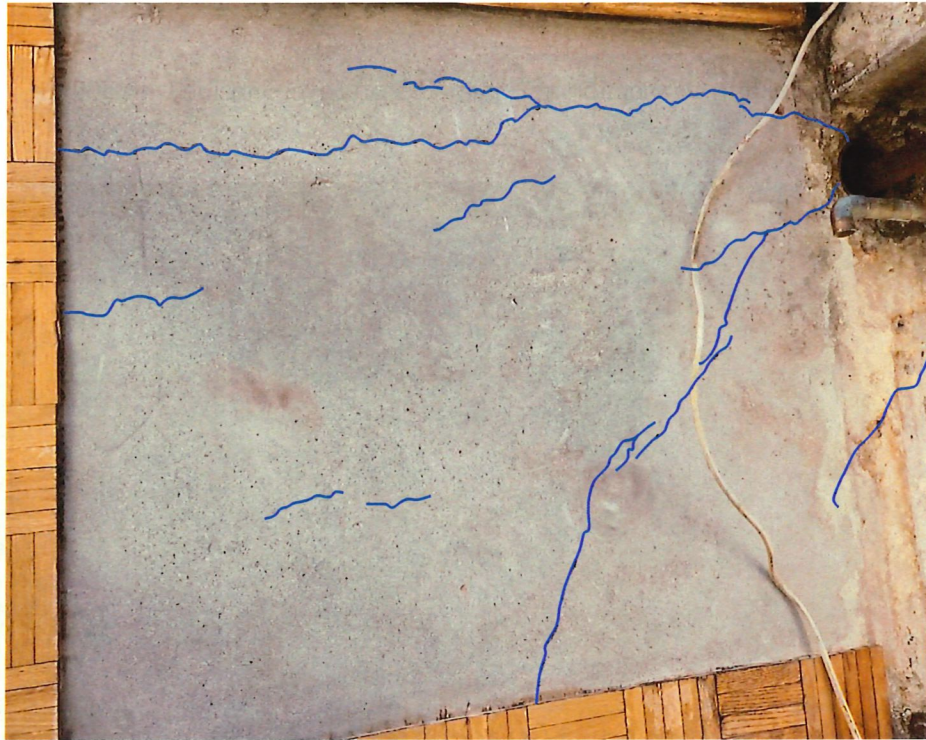
Observation 5-2 (East Side of Opening)
