ADAMS & RAFFERTY

ATTORNEYS AT LAW

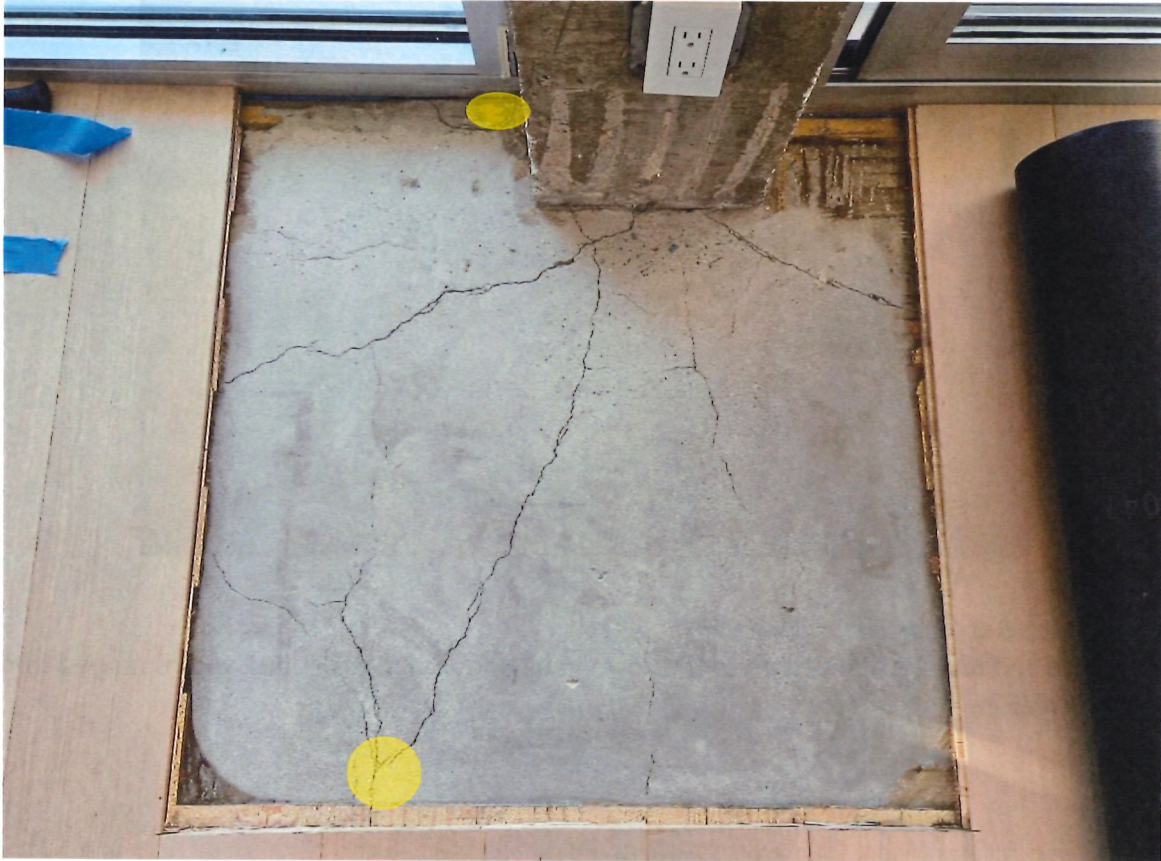
We observed the slab-column connection at Column B5 on Level 5 inside Unit 502 on 10 October 2024.

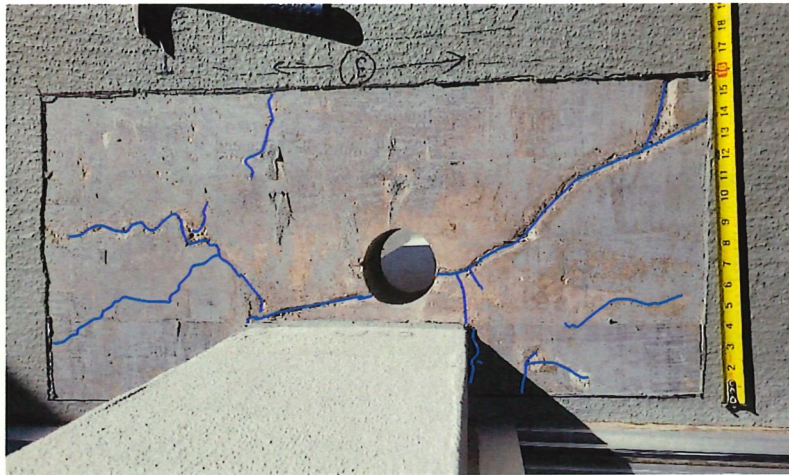
Radial and circumferential cracks are present. We identified two small delaminations highlighted in yellow. Crack widths ranged from 0.012 to 0.035 in.

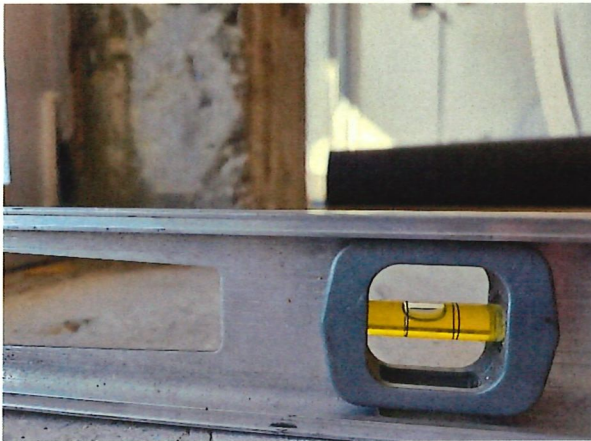
One of the downloader cores from 16 February 2023 is at Column B5 at Level 5. Aiken removed the coating on 1 March 2023. Radial and circumferential cracks are present (shown in blue for emphasis).

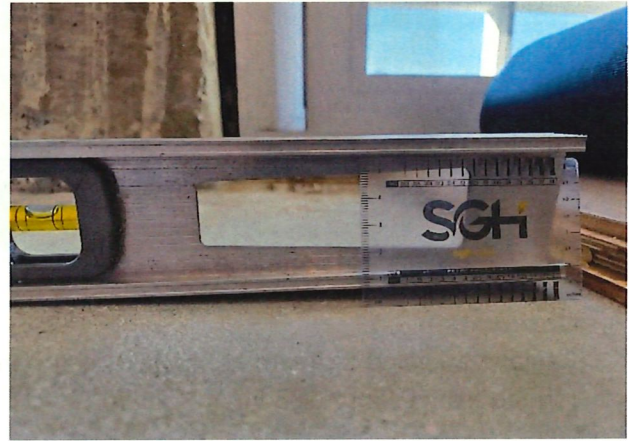
We put a level on the slab and noted that it slopes down away from the column in both the north-south and east-west directions. Pictured here is north-south.

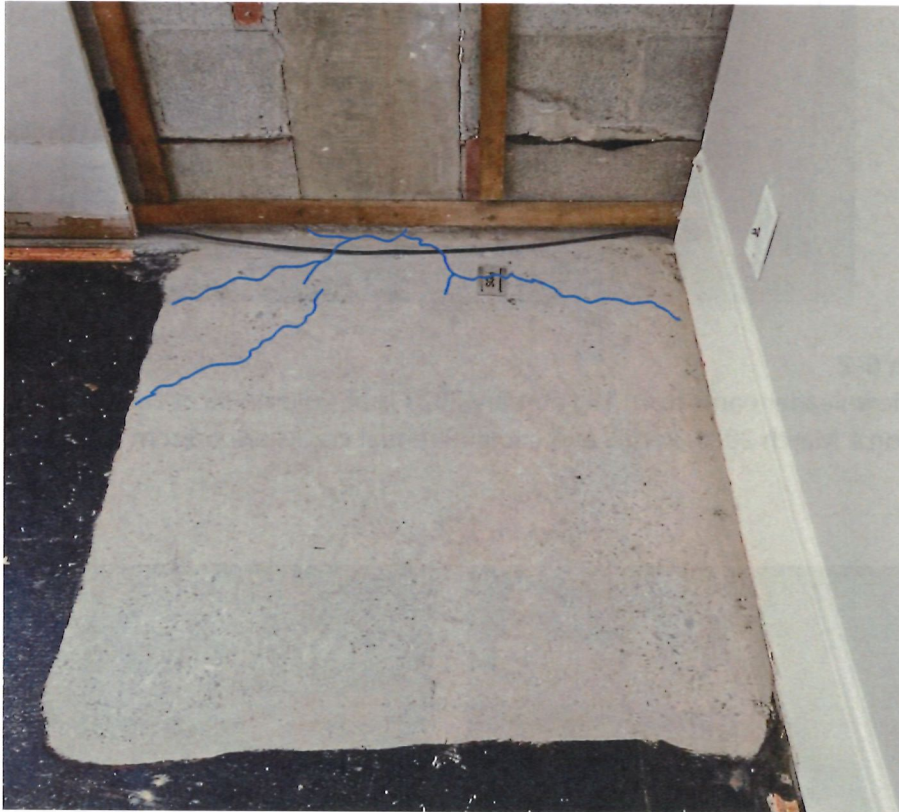
We observed the slab-column connection at Column E13 on Level 4 inside Unit 405 on 4 October 2024.

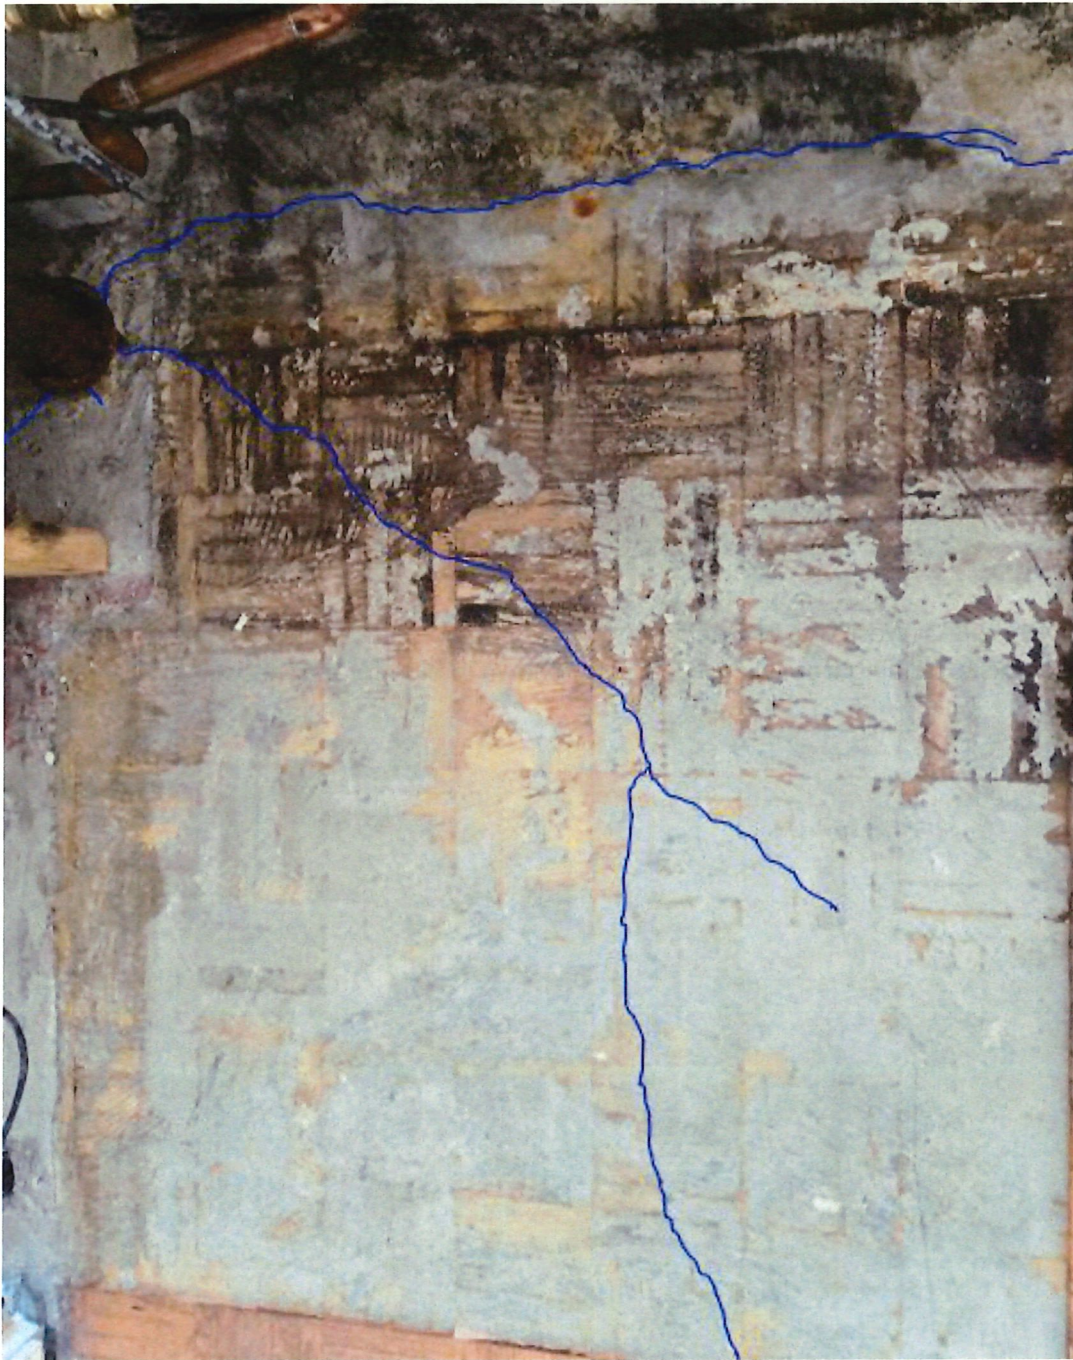
Observation 8-1 (West Side of Opening)

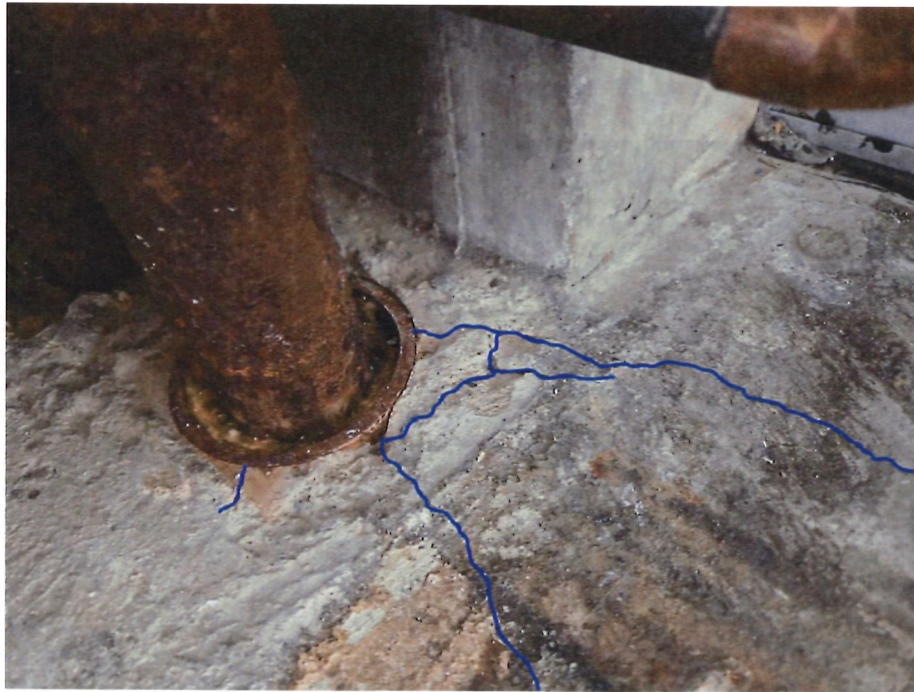
Observation 8-2 (West Side of Opening)

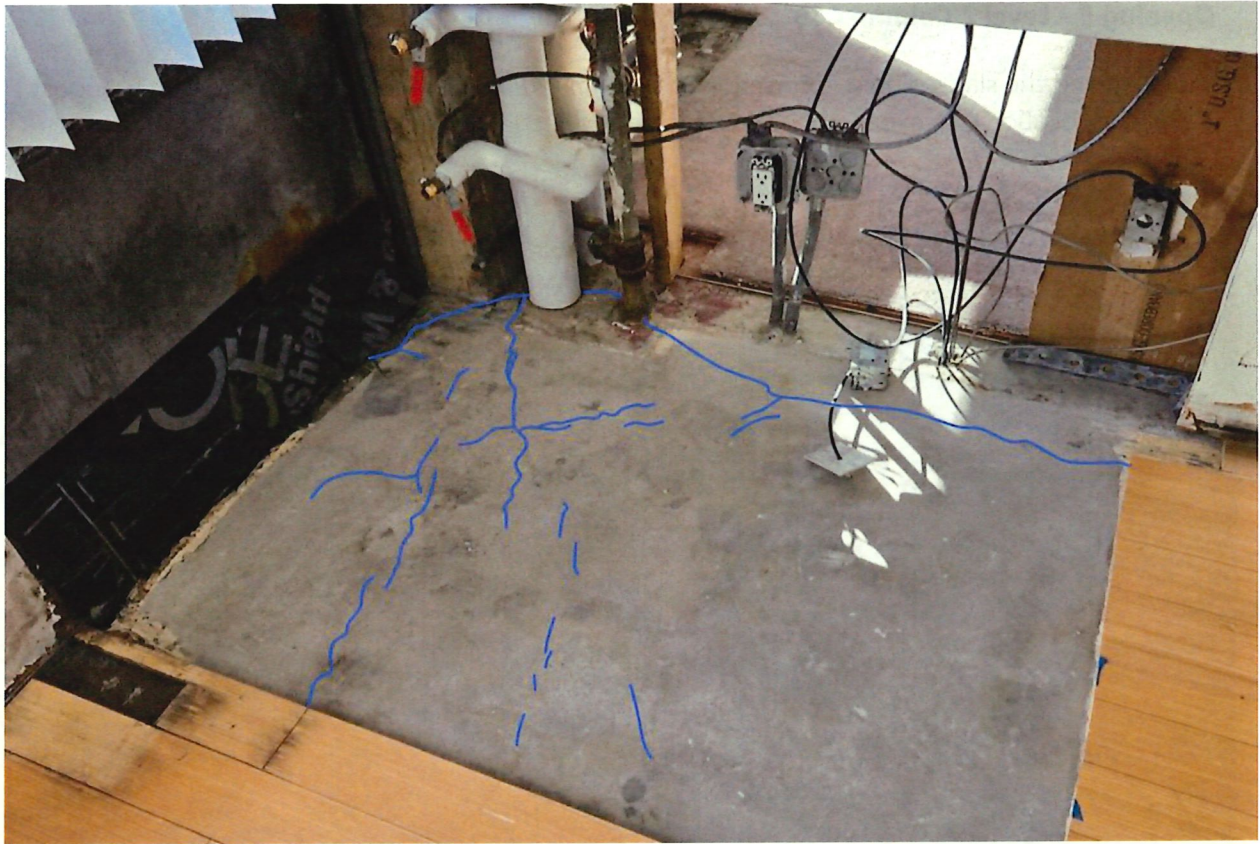
Observation 8-3 (East Side of Opening)

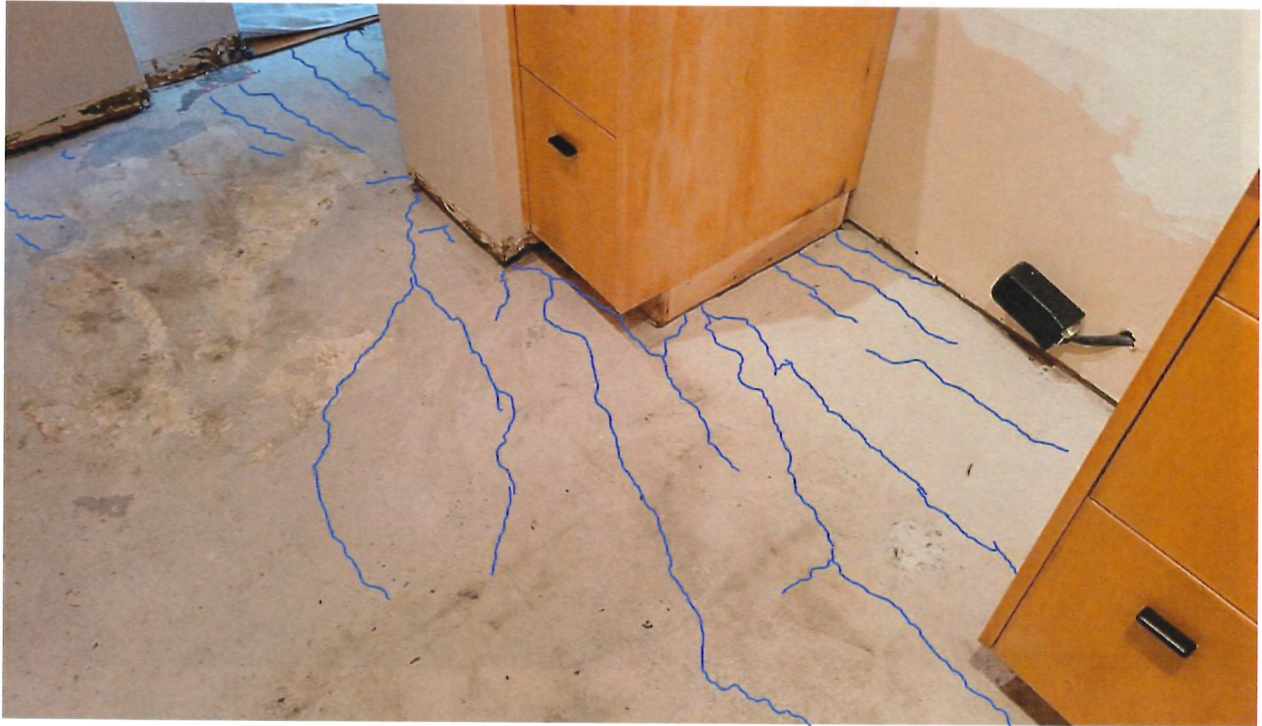
We observed the slab-column connection at Column C19 on Level 2 inside Unit 207 on 9 August 2024. This location was exposed due to a pre-scheduled kitchen renovation.

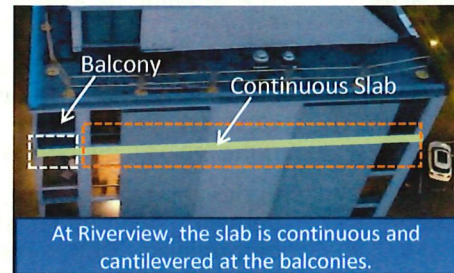
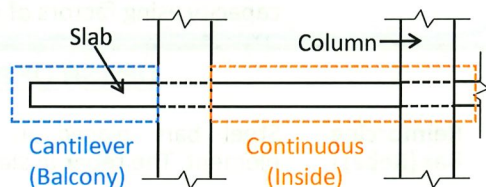
Structural System	The collection of elements that transfer loads. Riverview's primary structural system consists of reinforced concrete slabs and columns .
Structural Elements	The individual parts of the structural system. For Riverview, the floor is a reinforced concrete slab that supports its self-weight and the weight of people and items in the apartments and transfers the loads to the columns . The columns transfer the weight of the slab, people, and items to the foundation.
Support Conditions	The structural elements are supported when the forces can transfer to the foundation. At Riverview, the slab has two common support conditions: Cantilevered , where there is one supported end; and Continuous , where there are multiple supports. The columns support the slab.

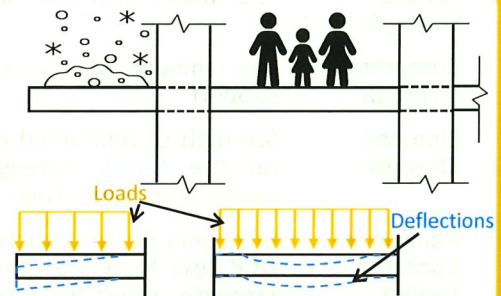
Engineers use idealized shapes (above) to represent the structural elements, loads, and deflections.

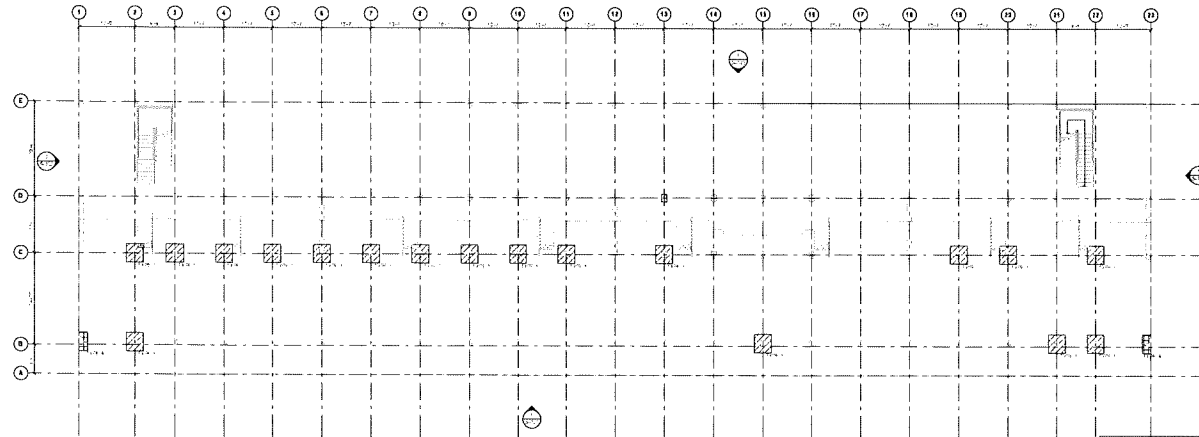
1 CONCRETE REPAIRS - LEVEL 1

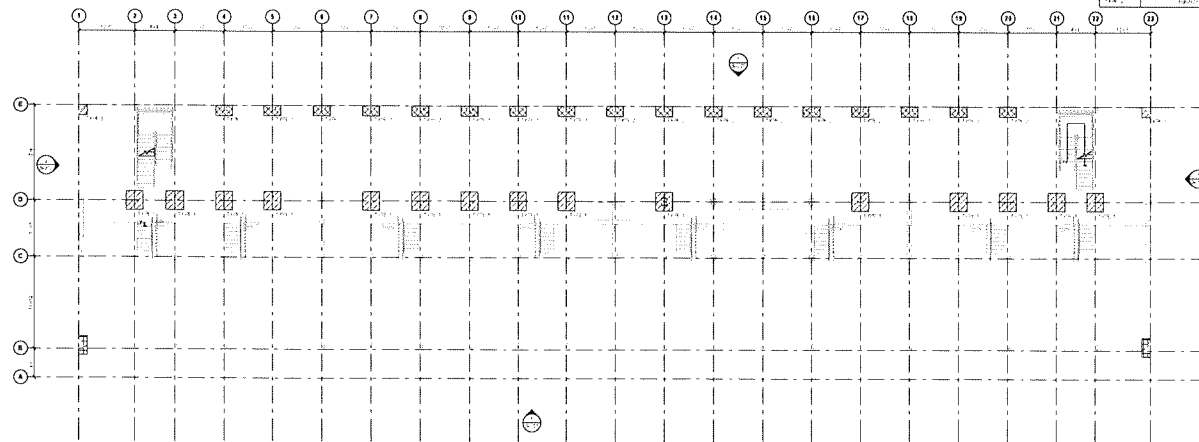
2 CONCRETE REPAIRS - LEVEL 1.5

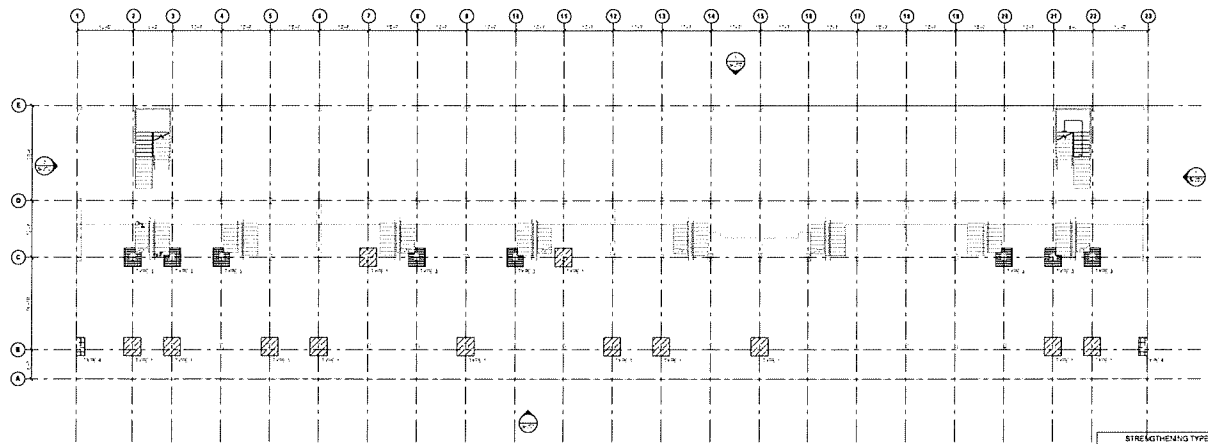
1 CONCRETE REPAIRS - LEVEL 2

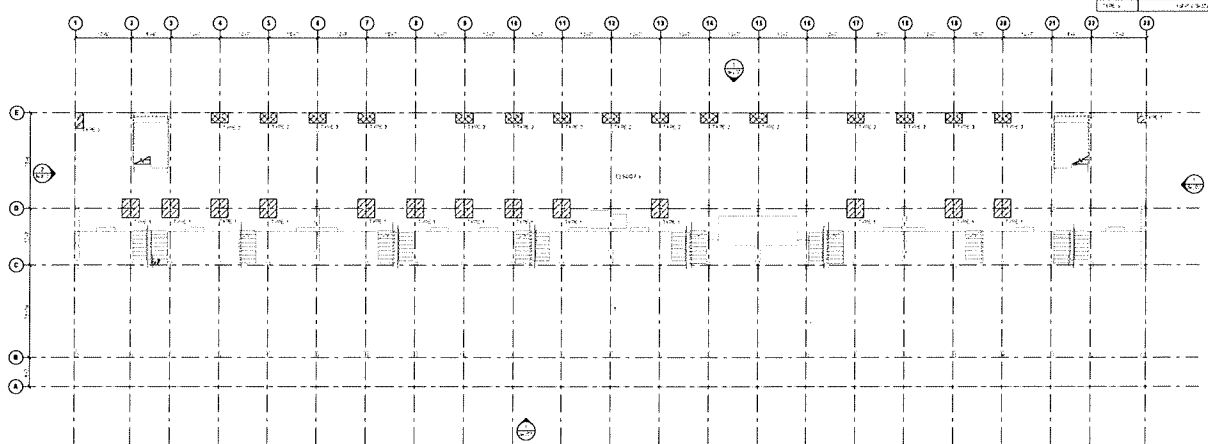
2 CONCRETE REPAIRS - LEVEL 2.5

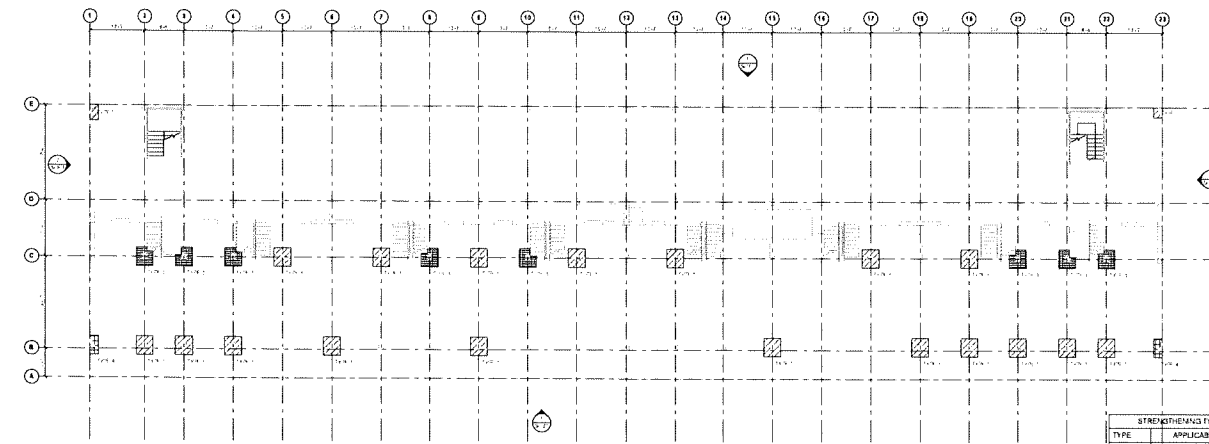
1 CONCRETE REPAIRS - LEVEL 3

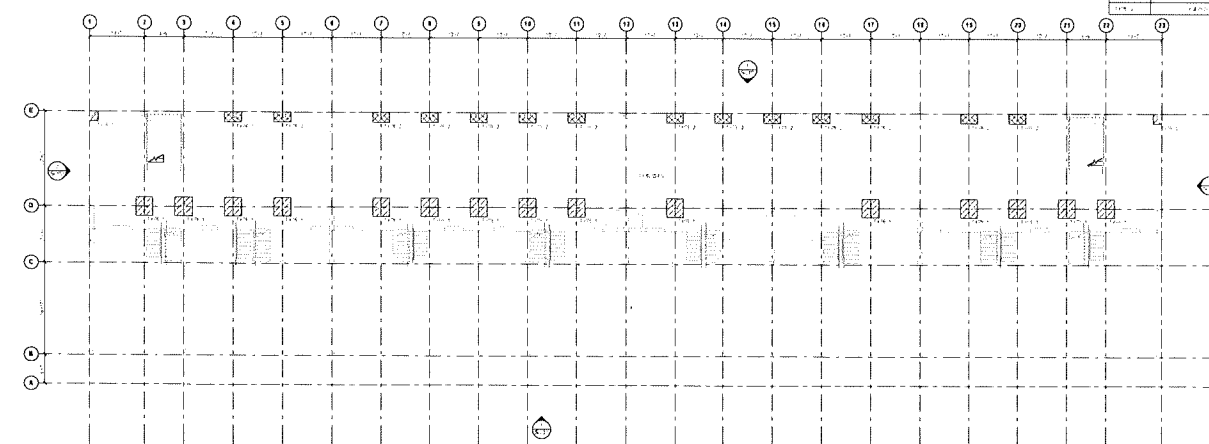
2 CONCRETE REPAIRS - LEVEL 3.5

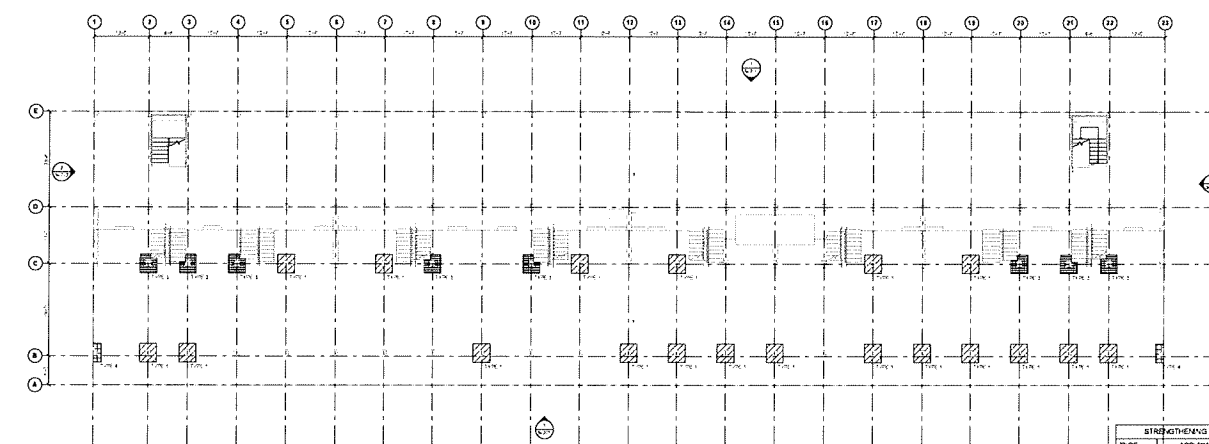
1 CONCRETE REPAIRS - LEVEL 4

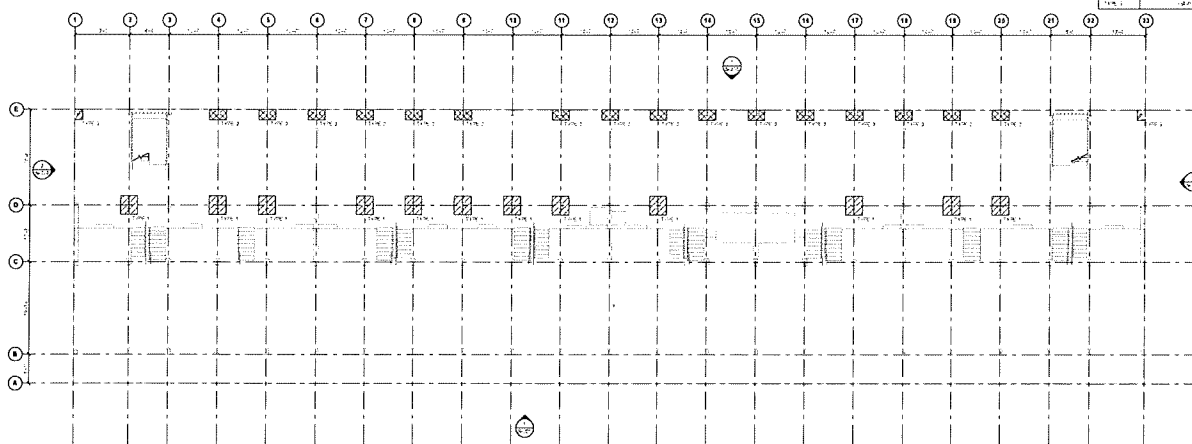
2 CONCRETE REPAIRS - LEVEL 4.5

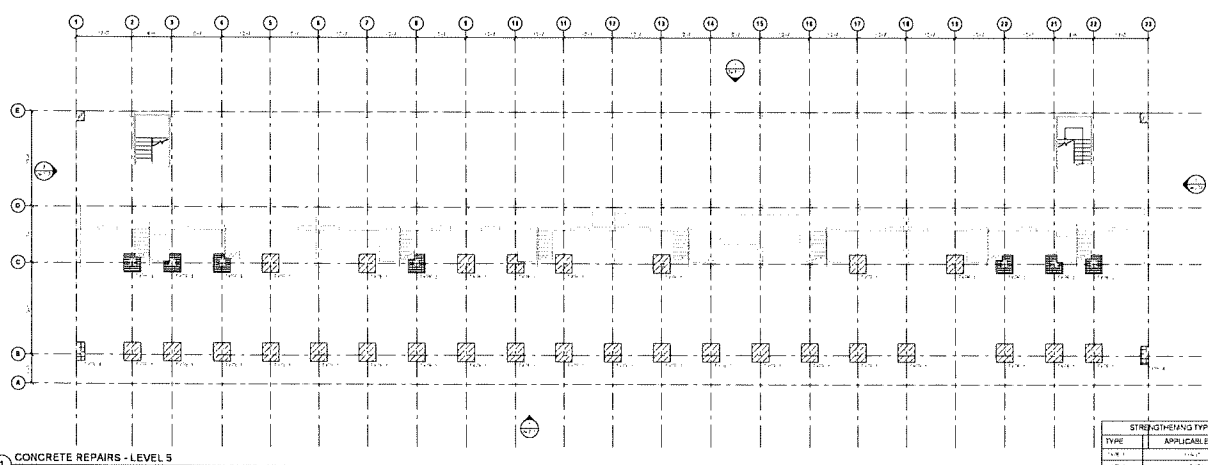
STRENGTHENING TYPE LEGEND	
TYPE	APPLICABLE DETAILS
TYPE 1	CONCRETE REPAIR
TYPE 2	CONCRETE REPAIR
TYPE 3	CONCRETE REPAIR
TYPE 4	CONCRETE REPAIR
TYPE 5	CONCRETE REPAIR

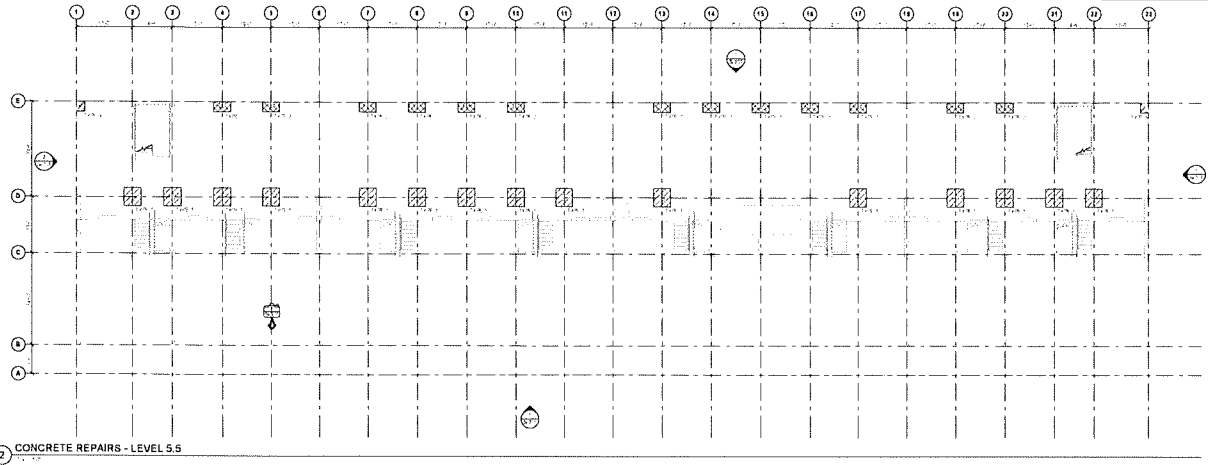
10/1/10
10/1/10
10/1/10

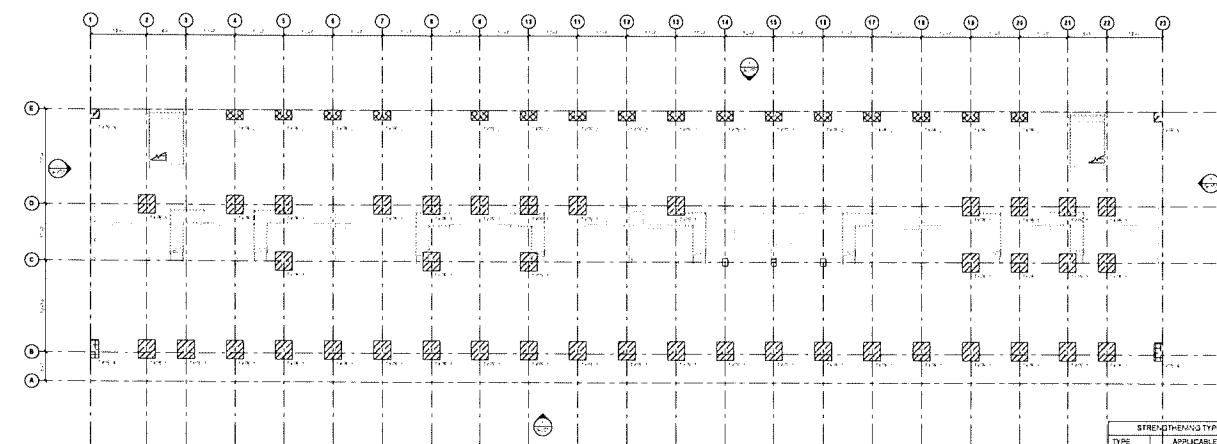
1 CONCRETE REPAIRS - LEVEL 7

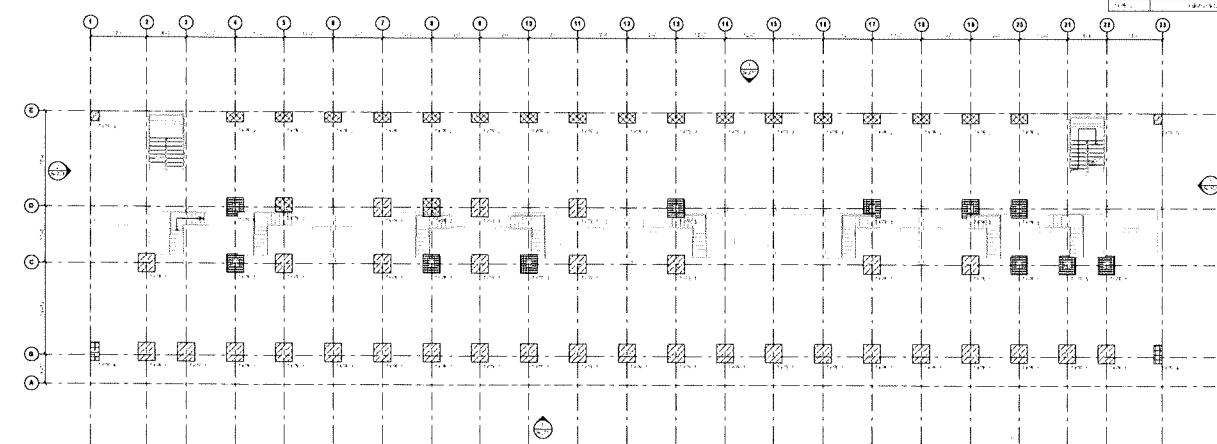
2 CONCRETE REPAIRS - LEVEL 8 (ROOF 1)

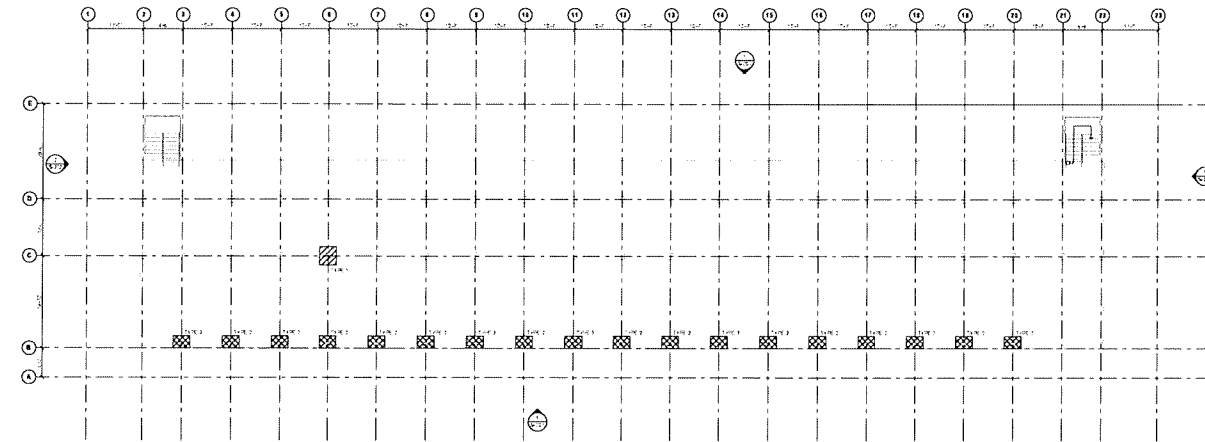
1 CONCRETE REPAIRS - LEVEL 9 (ROOF 2)

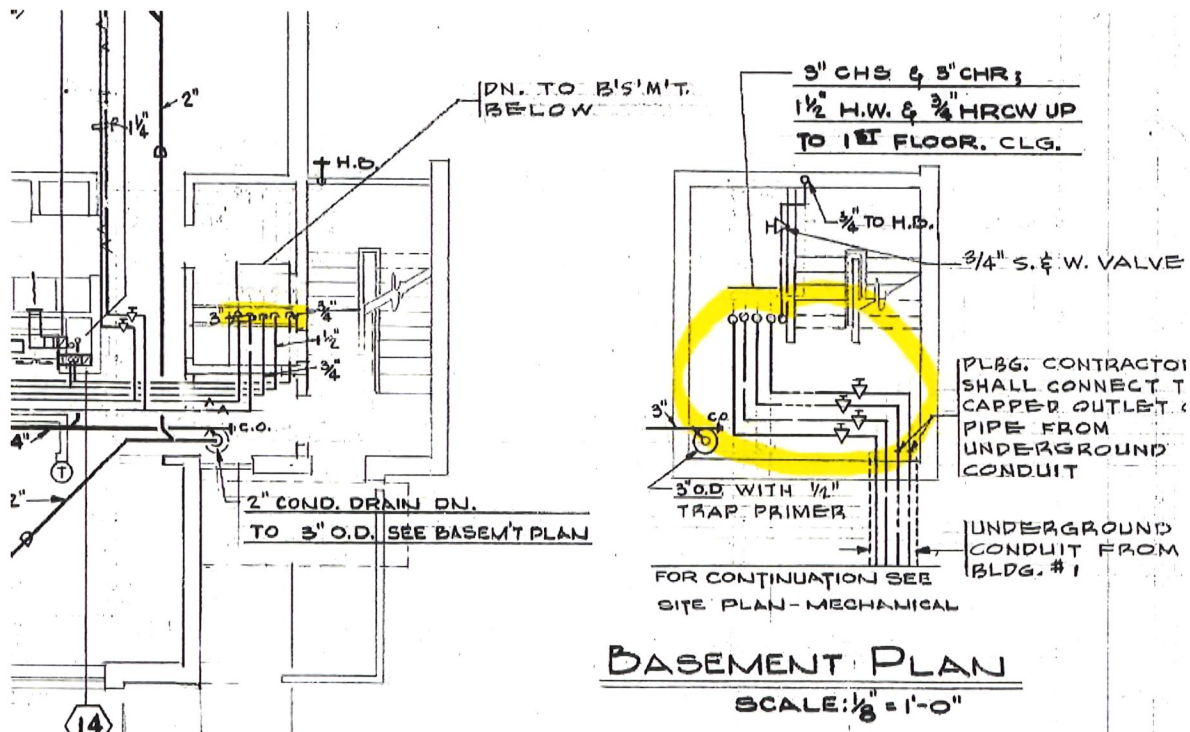
All the above scope including various options, conditions and Alternates is illustrated in Appendix A at the end of this Study.
