CAMBRIDGE HISTORICAL COMMISSION PRESENTATION

15 MT AUBURN STREET PROJECT

HARVARD UNIVERSITY NATIVE AMERICAN PROGRAM

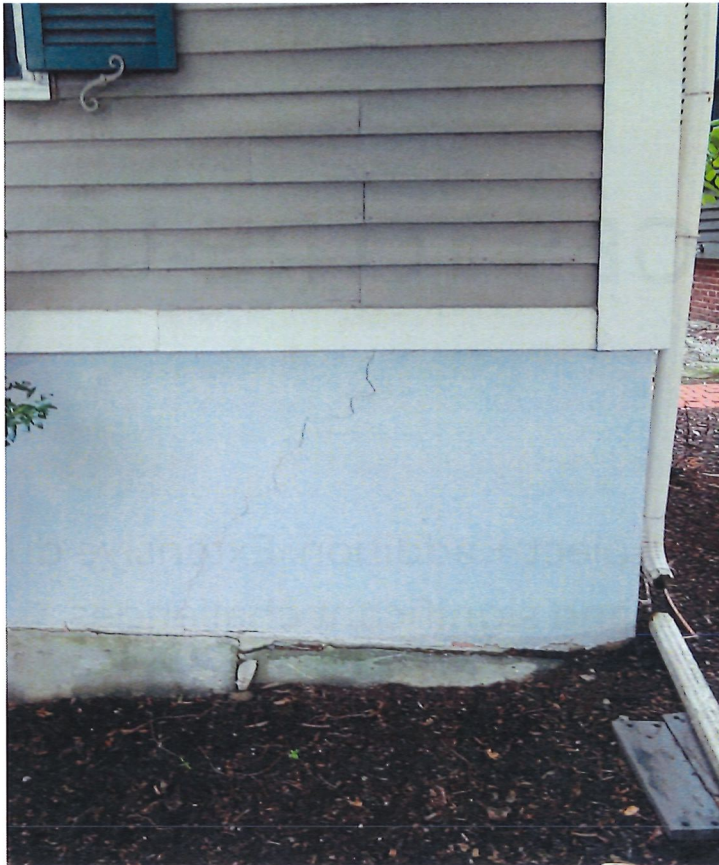
- Basement
 - Ceiling height does **not meet building code** (6'-3" to 7'-0")
 - **Water infiltration** on slab observed
- Existing foundation walls
 - Bricks over rubble stone
 - **Poor to fair conditions**
 - Shallow
 - SE and NE corner settled, with existing underpinning and shoring to remediate
 - East foundation wall bowing

EXISTING FOUNDATION CRACKS/ BILLOWING

- Would need extensive work of **foundation underpinning** to make basement functional in a challenging tight site **6' away** from the residential abutter

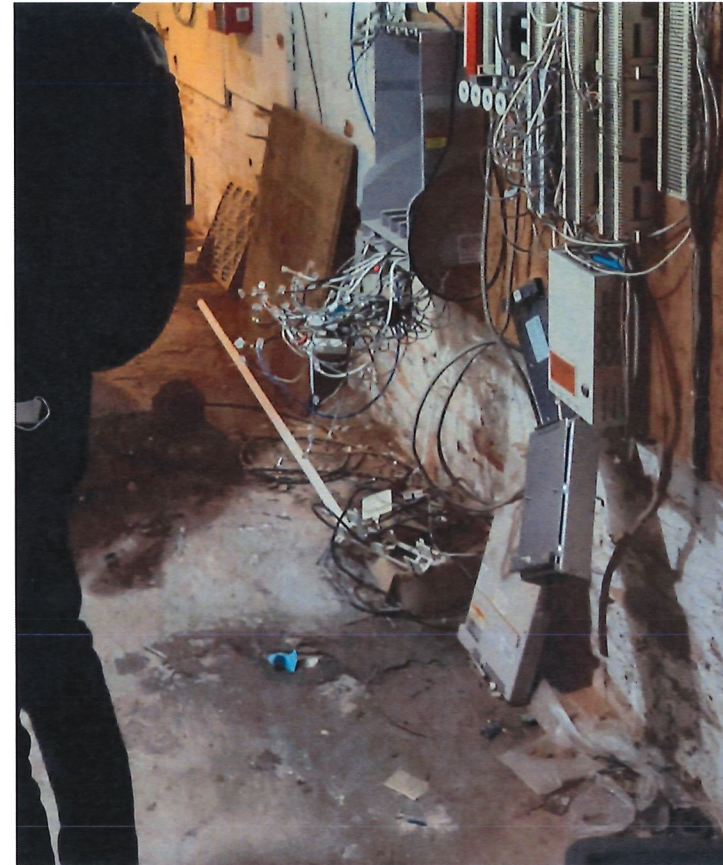
WATER INFILTRATION AT SLAB

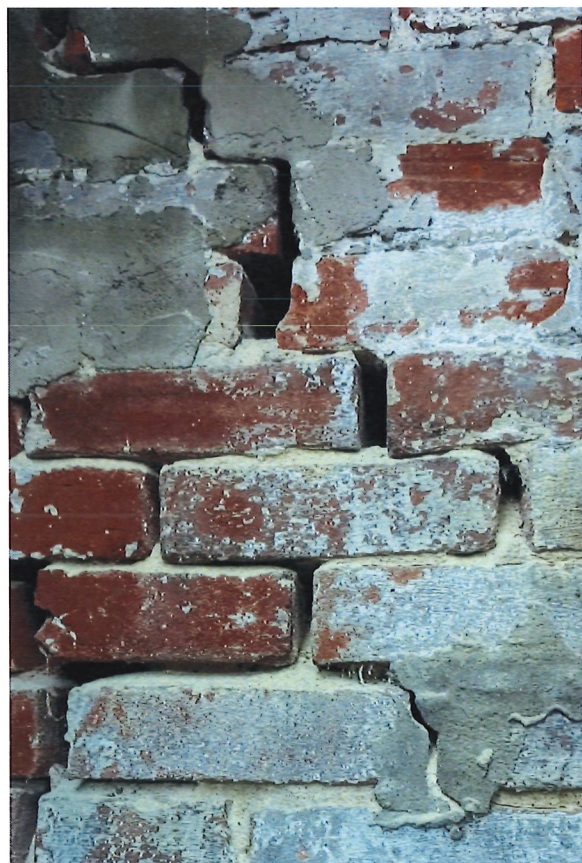
DETERIORATED MASONRY AT
FOUNDATION WALL

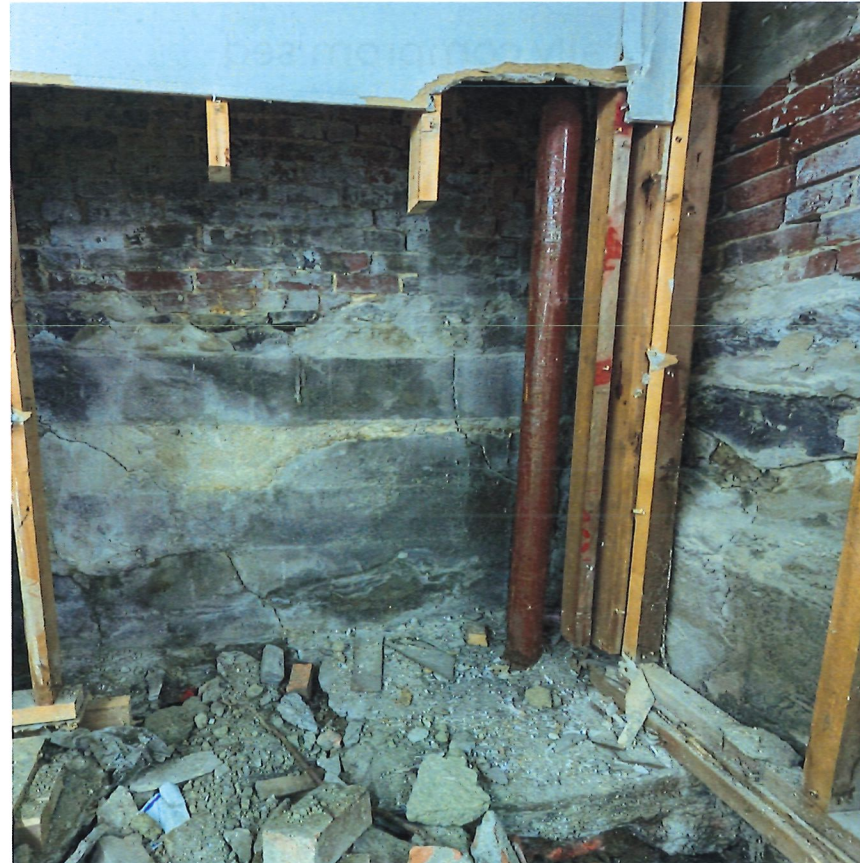
PREVIOUS UNDERPINNING/ REPAIR AT SE CORNER

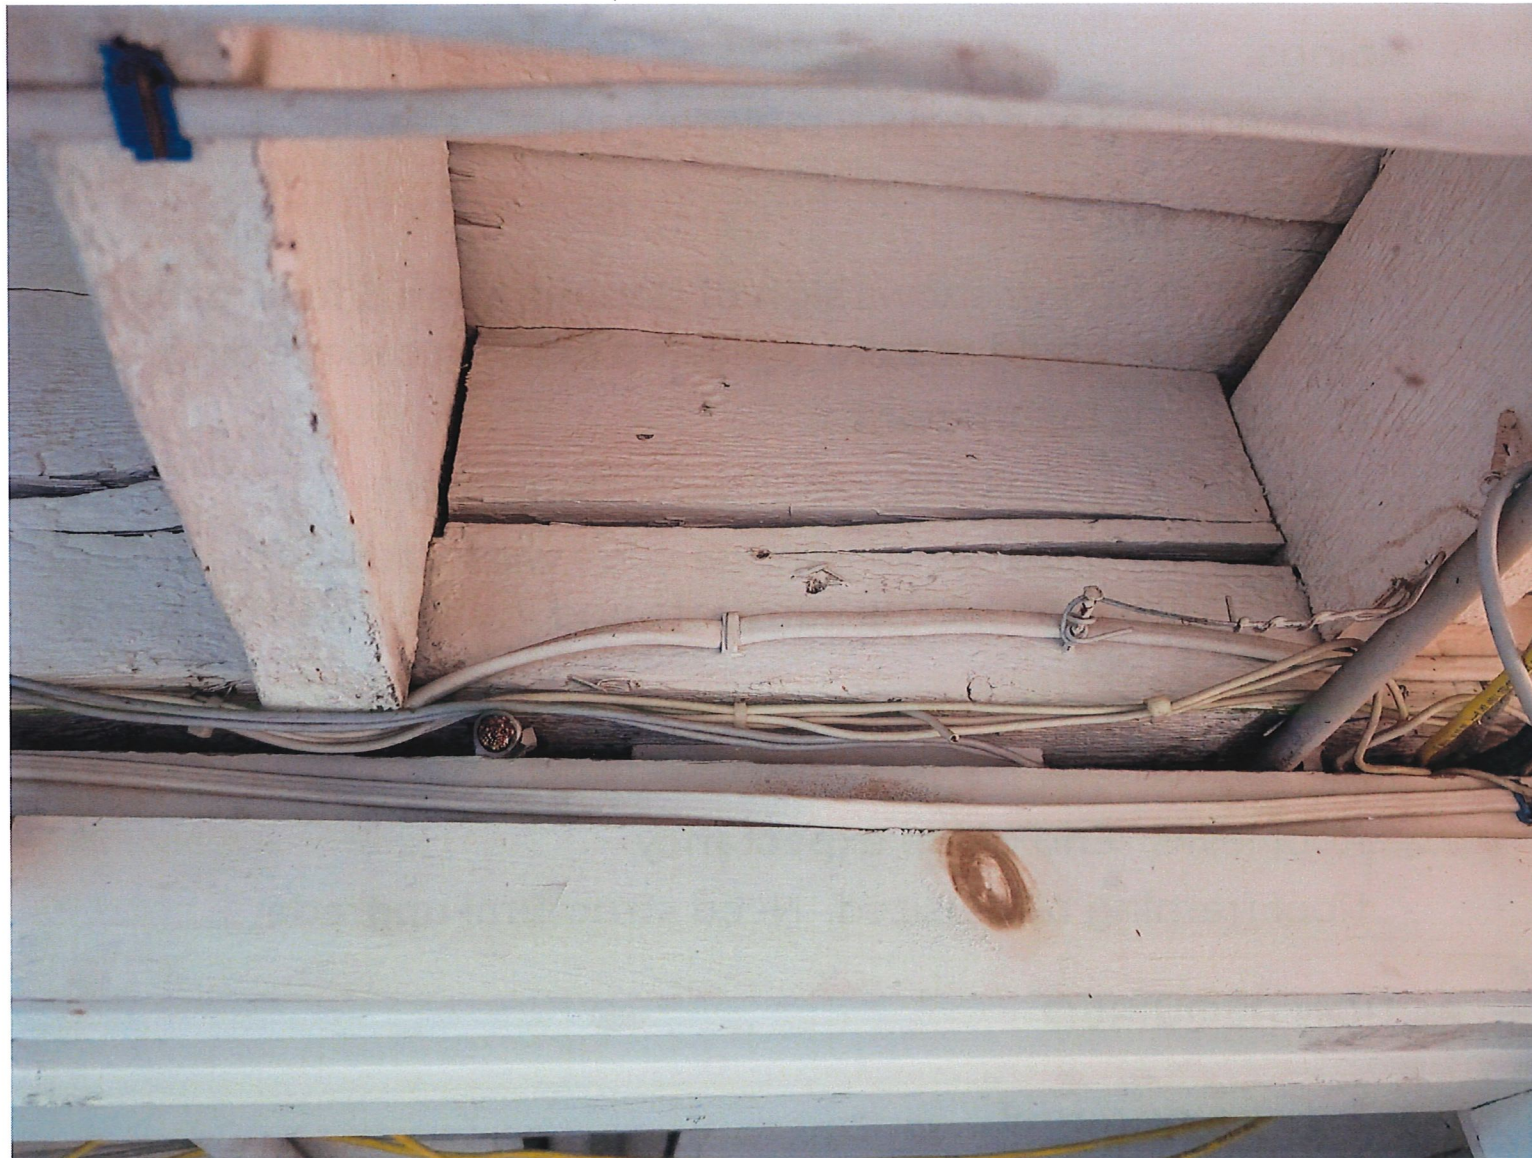
COMPROMISED FLOOR FRAMING BEAM

- Floors
 - Sagging with noticeable dips at various locations
- Beams | Floor joists
 - Connection = Lap joints, not joist hanger
 - Main beam has split along the length at various locations
 - **Compromised structural integrity and performance**

- Would need **reinforcement or replacement** to make it code compliant and meet safety standard.

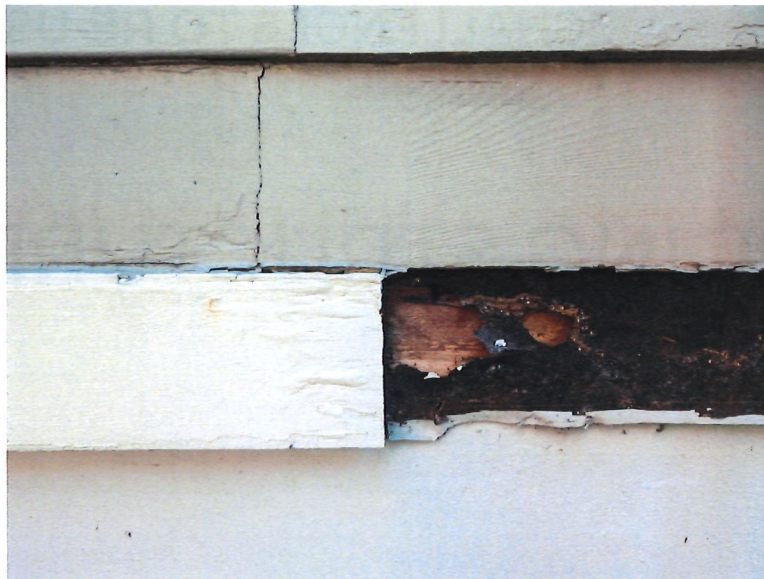
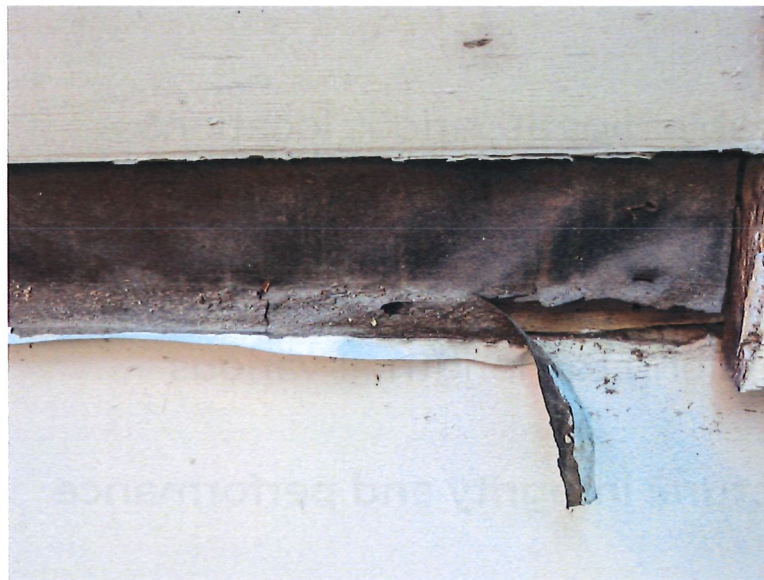
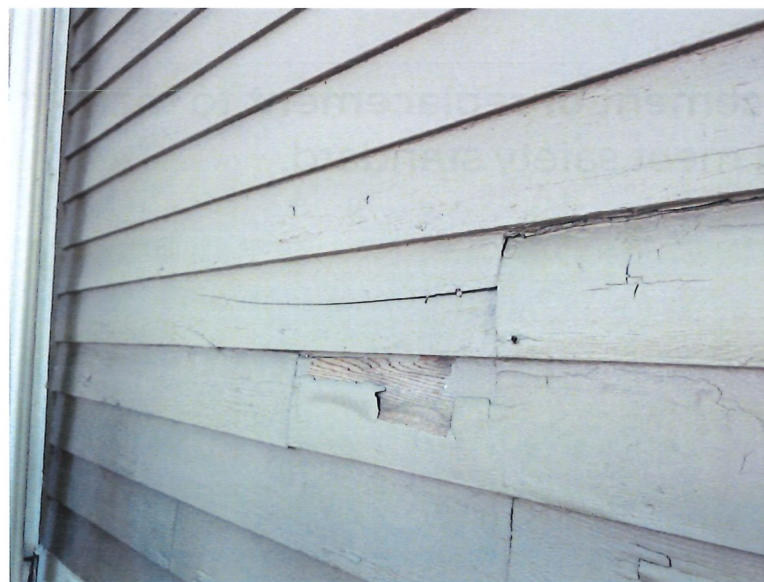
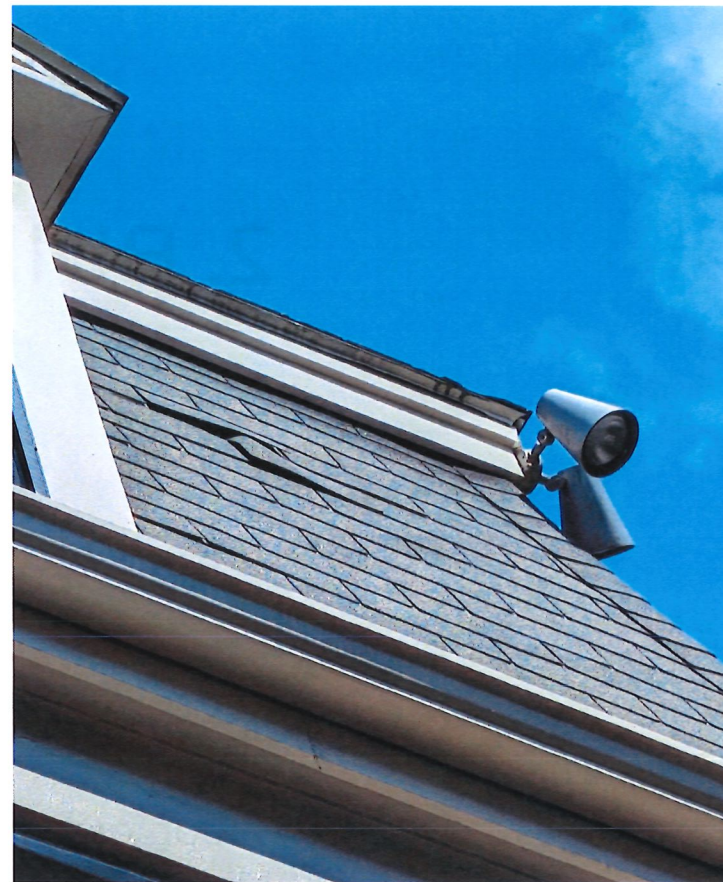
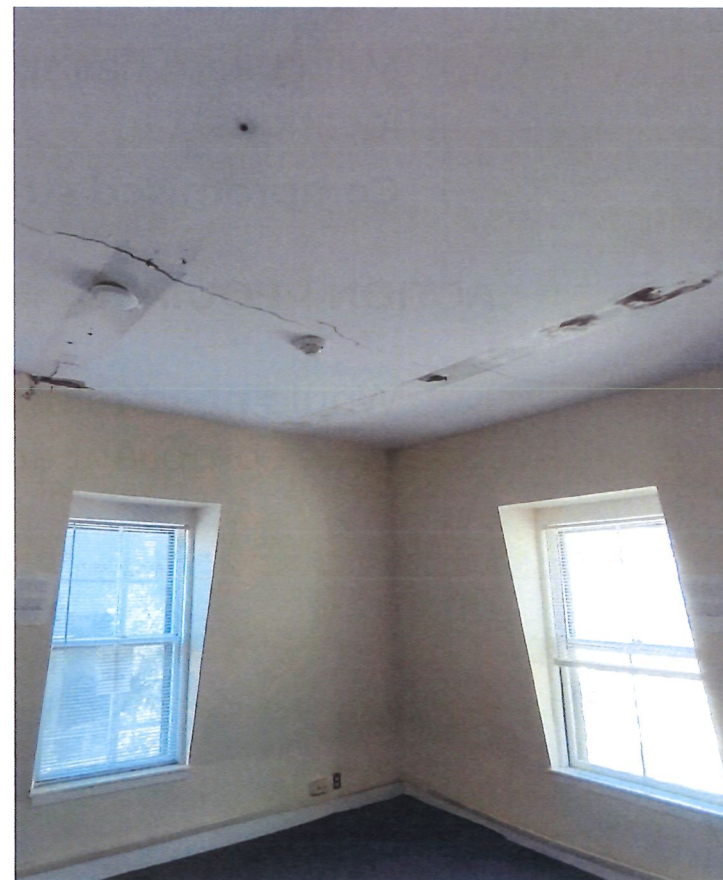
- Siding
 - Deteriorated and require replacement at many locations
- Facade substrate
 - Air/ Water barrier shows **sign of deterioration & failure**, but repairing it would require replacing existing cedar siding
 - Insulation is **insufficient**
 - Framing is undersized, requires **reinforcement**
 - Adding new insulation to meet code will increase freeze-thaw cycles within the facade substrate and increase **risk of further deterioration**
- Roof
 - Roof leaks. **End of life expectancy**
 - Roof framing undersized. Need **structural upgrade**

DETERIORATED SIDINGS, BUILDING PAPER, ROOF SHINGLES, AND CEILING

- Install a **new roof**
- Provide **reinforcement at every facade framing stud location to meet code**
- **Rebuild facades entirely**

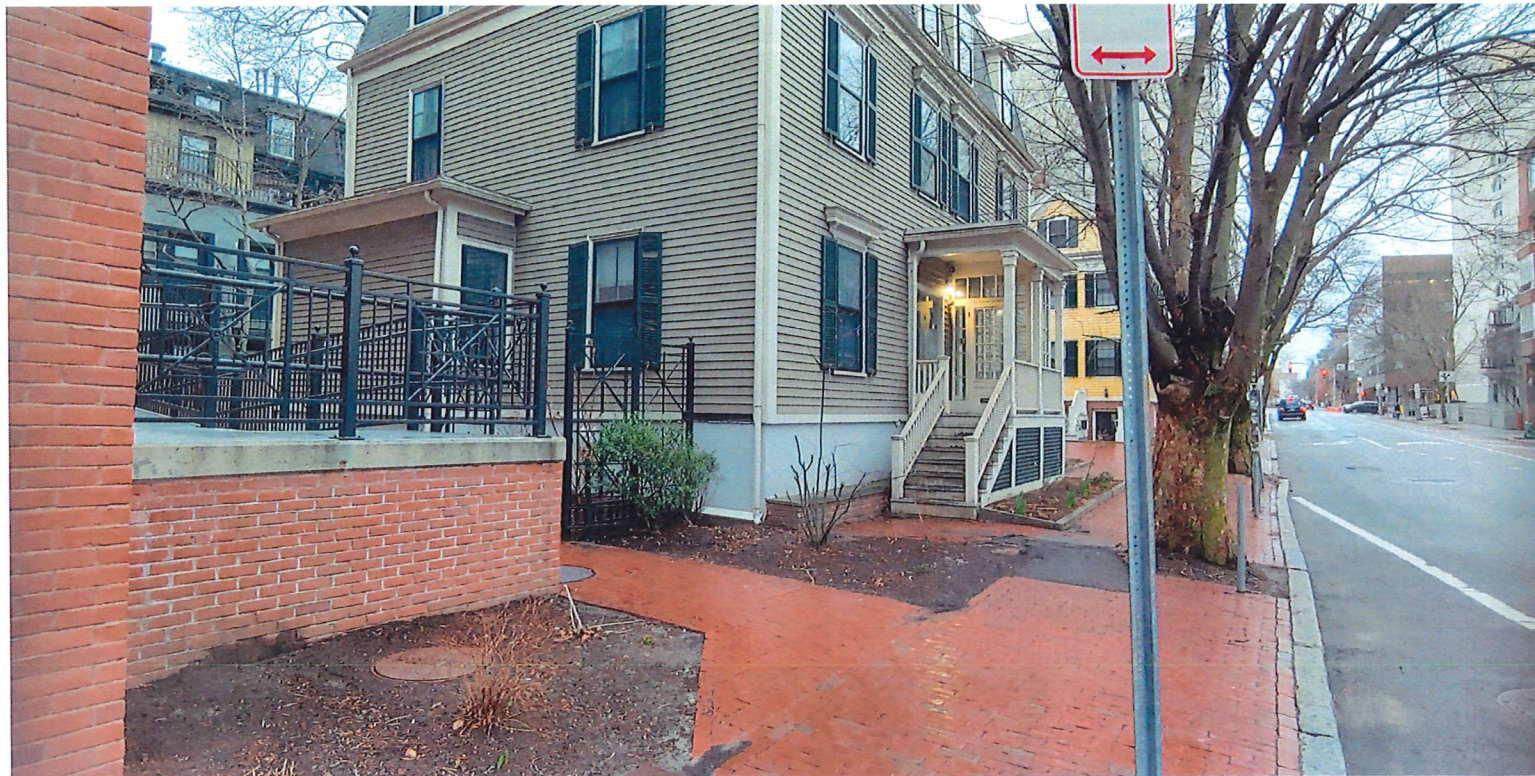
- Site conditions
 - Existing site constraints - size, setback, trees
 - Current conditions do not naturally provide accessible path
 - Not universally accessible from front or back
 - No elevator
 - Building should be universally accessible but site constraints do not allow for accessible ramp at front entrance

STREET ENTRANCE AND PORCH

- Install mechanical lift at front porch
- Install ADA ramp at back yard
- Install elevator

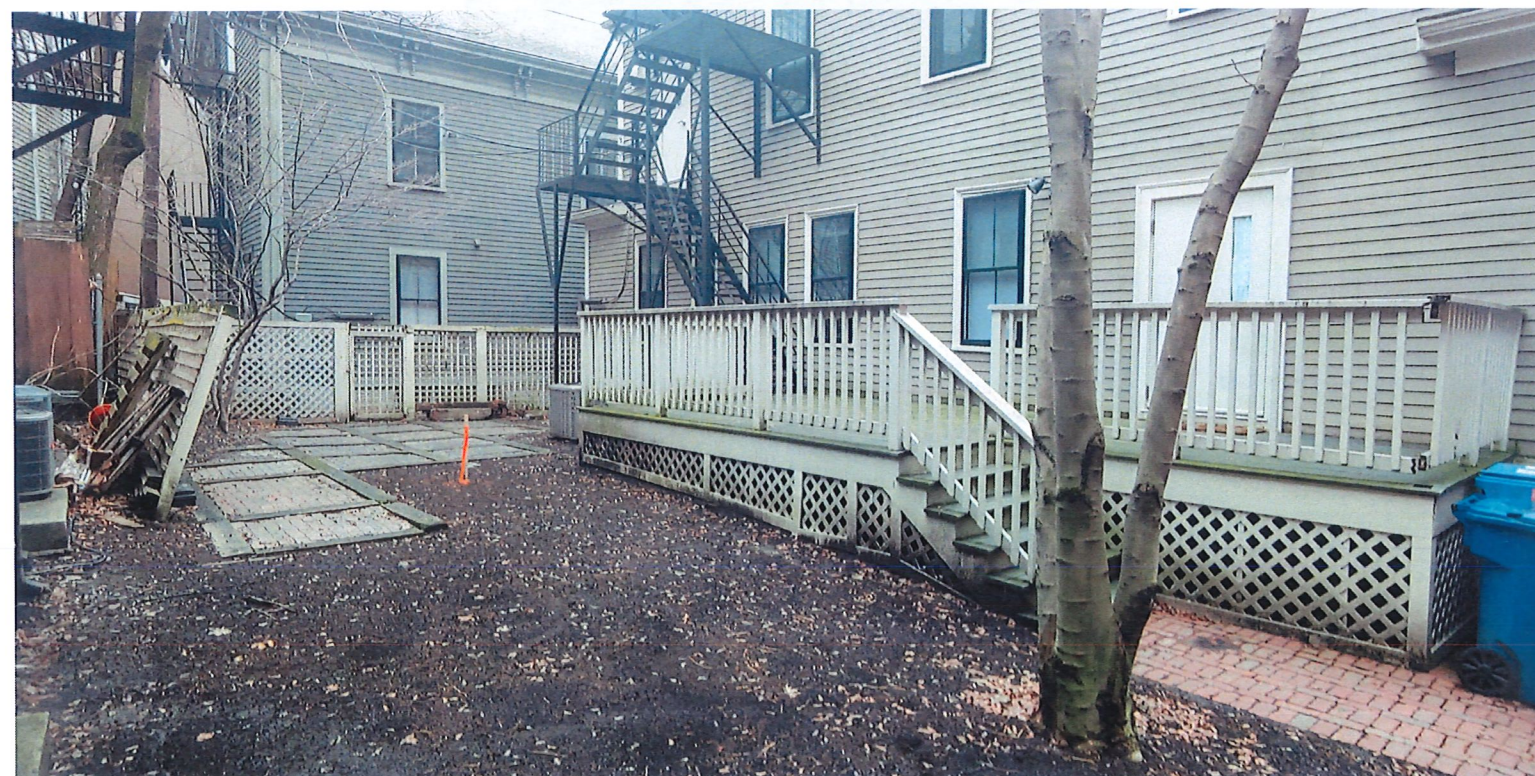
GARDEN ENTRANCE AND DECK

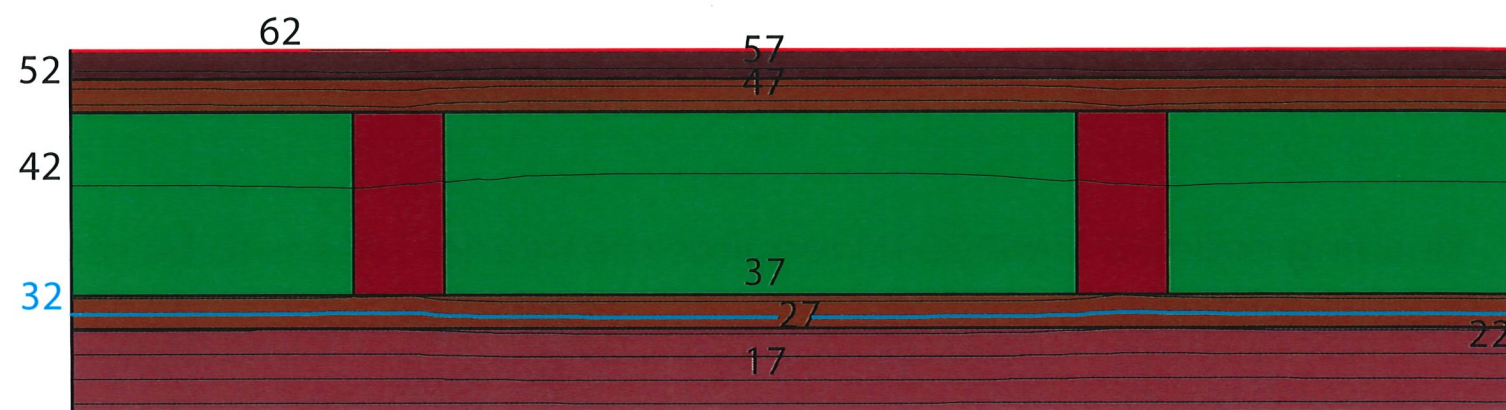
ISOTHERMS DIAGRAM @ EXISTING FACADE (TOP OF WALL)

As observed with the existing conditions on site and anticipated with the age and type of the facade materials used, we have concerns of the integrity and performance of the existing weather restive barrier (building paper) at the 3 existing facades that are to remain per the historic easement.

Air, water and moisture pass through the deteriorated barrier and reach the wood plank sheathing and other elements. Water and moisture can only dry out towards the exterior with the presence of a new vapor barrier installed on the warm side of insulation (interior side). As the facades are to be much better insulated and sealed, very little amount of heat is expected to escape the interior to dry out the moisture. Condensation would occur at the inside of the facade built-up, as shown on the isotherms diagrams on the left.

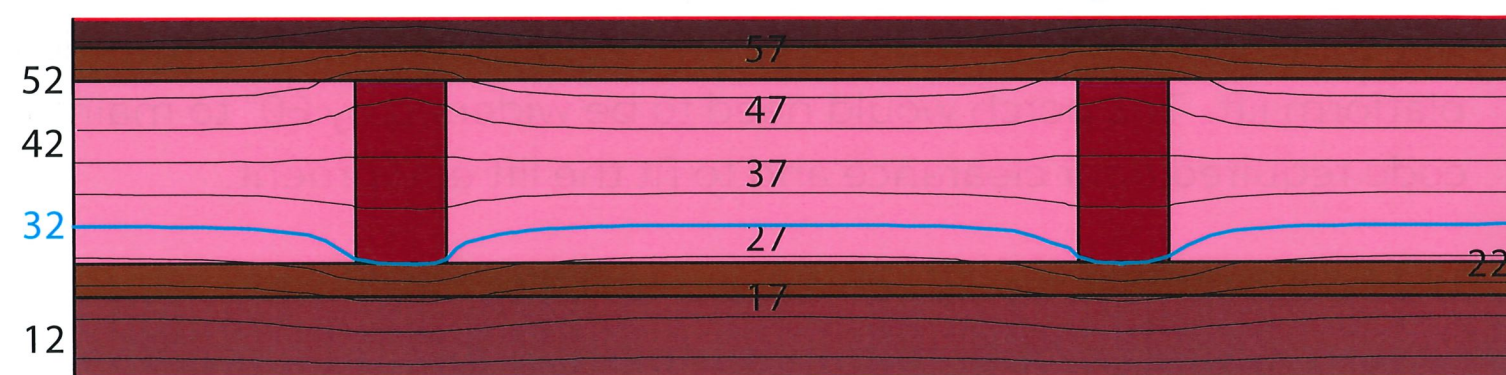
ISOTHERMS DIAGRAM @ EXISTING FACADE (BOTTOM OF WALL)

The results were then used to quantify how many times the wood planks would be exposed to freeze-thaw cycles in a period of 24 hours. The proposed design, due to the added insulation, undergoes 73 freeze-thaw cycles in a year, while the existing detail, sees a range of 5 freeze-thaw cycles (no insulation) to 51 freeze-thaw cycles (R-4).

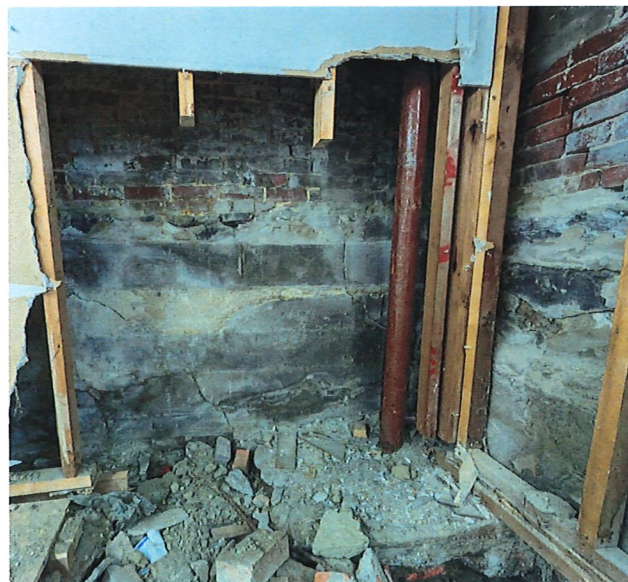
COMPROMISED
FOUNDATION WALL

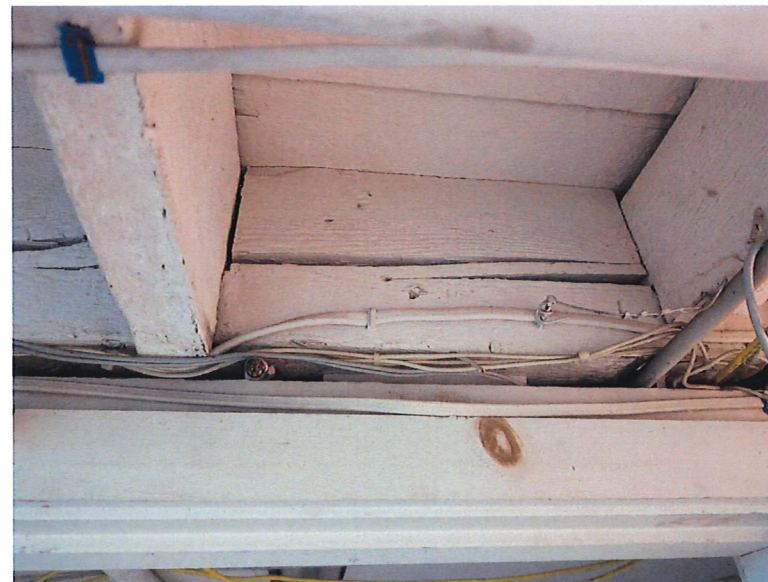
COMPROMISED STRUCTURE

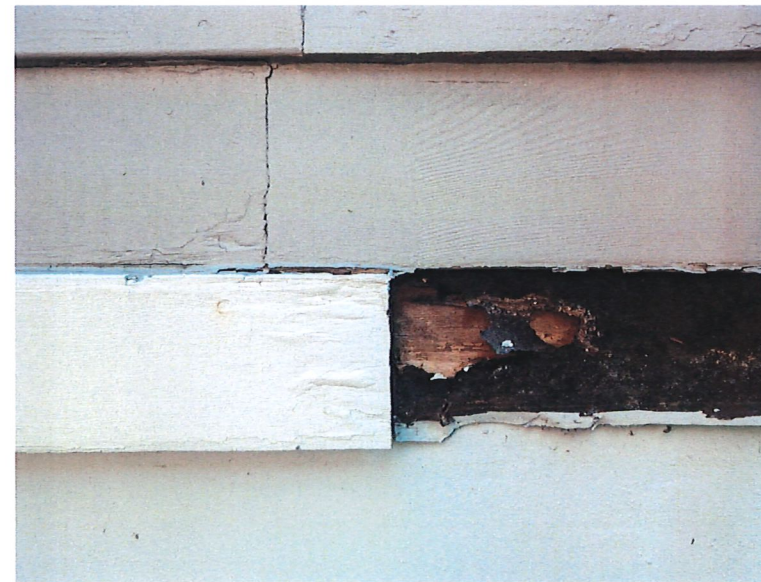
DETERIORATING FACADE

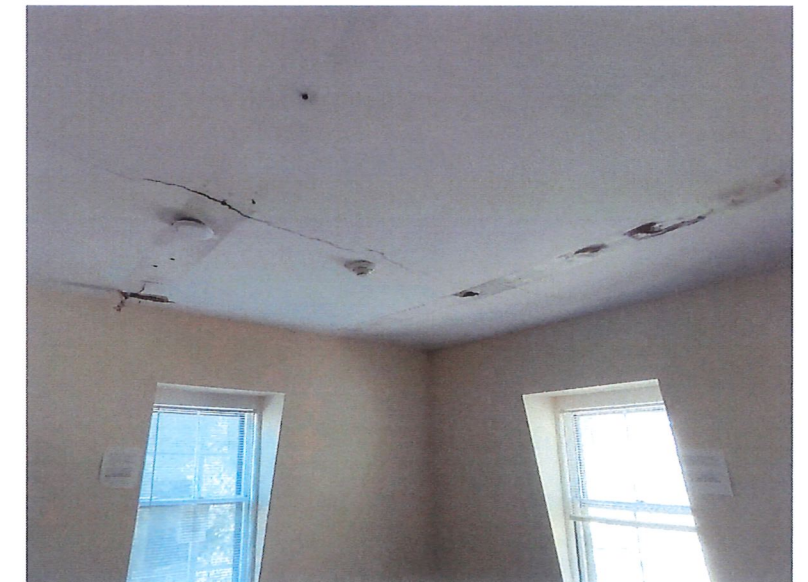
FAILED ROOF
