CAMBRIDGE HISTORICAL COMMISSION HEARING APPLICATION

Updated Materials for October 9, 2025 public hearing

15 MT AUBURN STREET PROJECT

HARVARD UNIVERSITY NATIVE AMERICAN PROGRAM

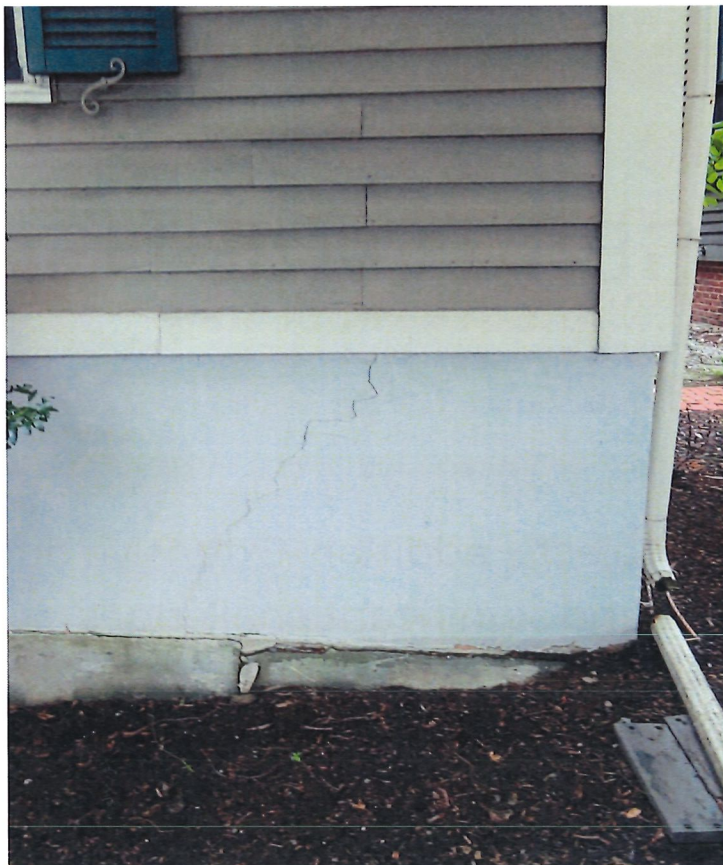
EXISTING FOUNDATION CRACKS/ BILLOWING

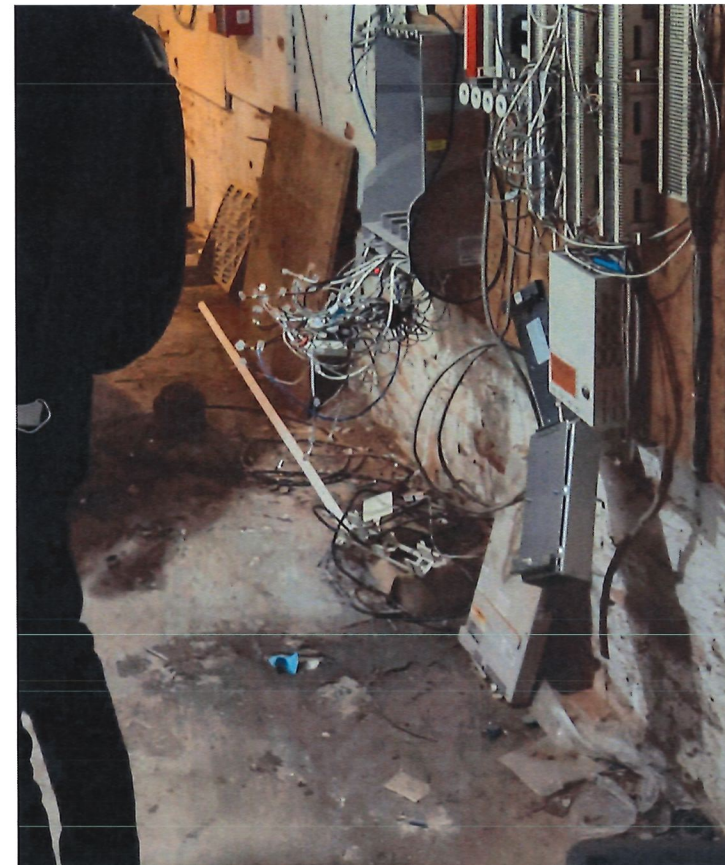
WATER INFILTRATION AT SLAB

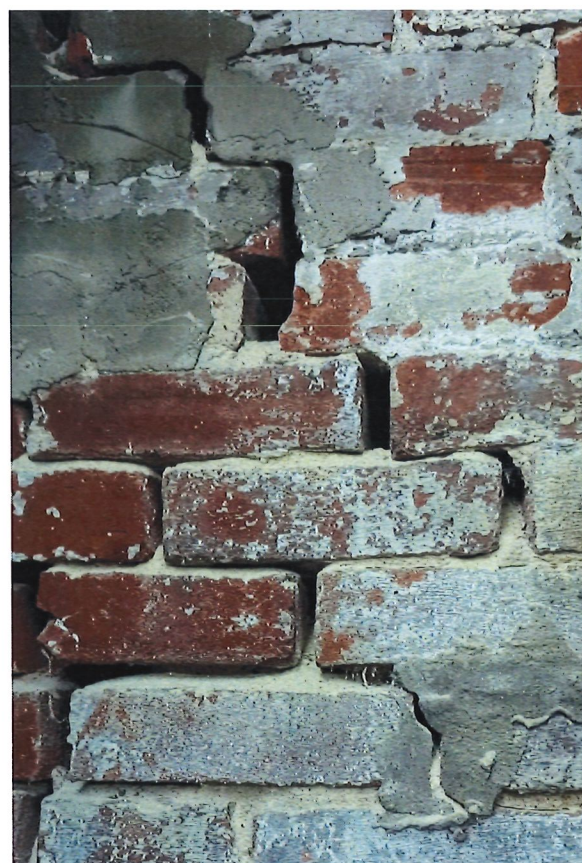
DETERIORATED MASONRY AT FOUNDATION WALL

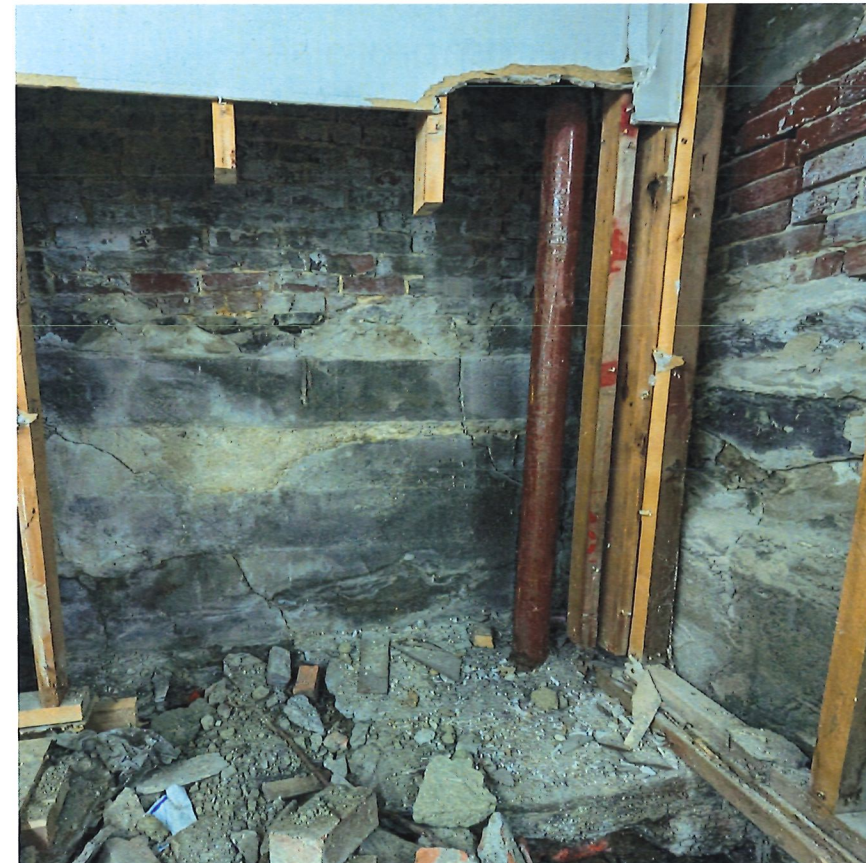
PREVIOUS UNDERPINNING/ REPAIR AT SE CORNER

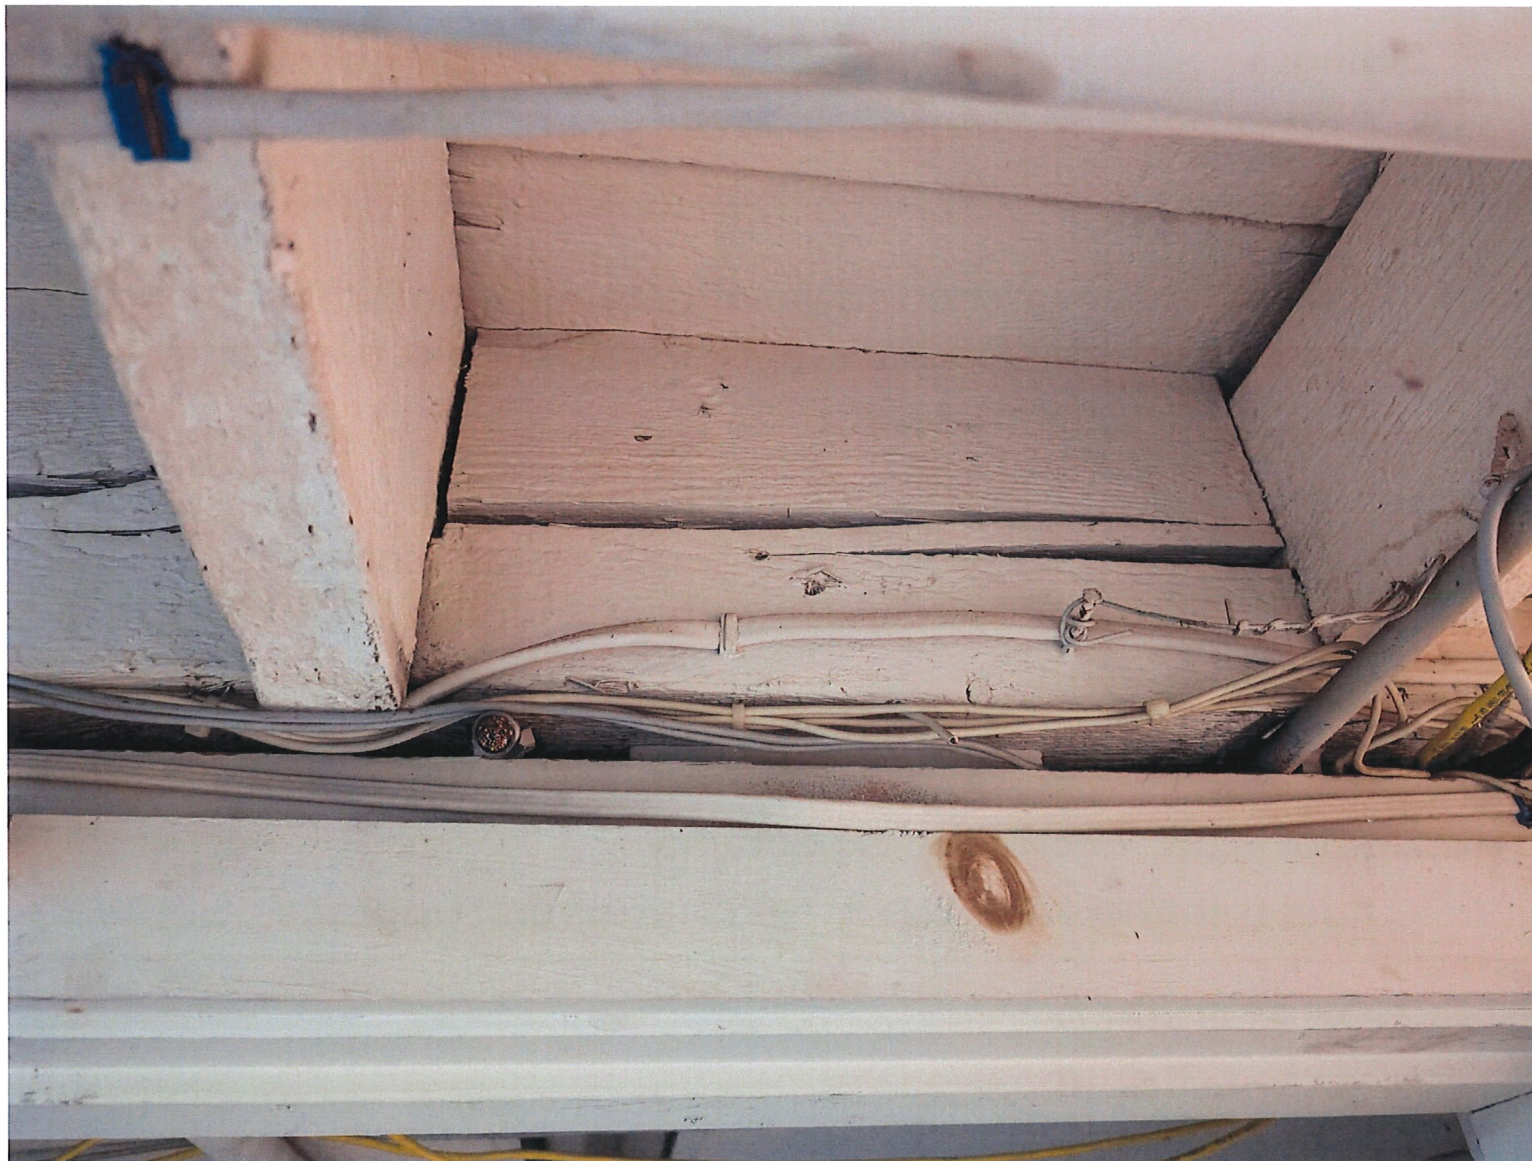
COMPROMISED FLOOR FRAMING BEAM

- Floors
 - Sagging with noticeable dips at various locations
- Beams | Floor joists
 - Connection = Lap joints, not joist hanger
 - Main beam has split along the length at various locations
 - **Compromised structural integrity and performance**

- Would need **reinforcement or replacement** to make it code compliant and meet safety standard.

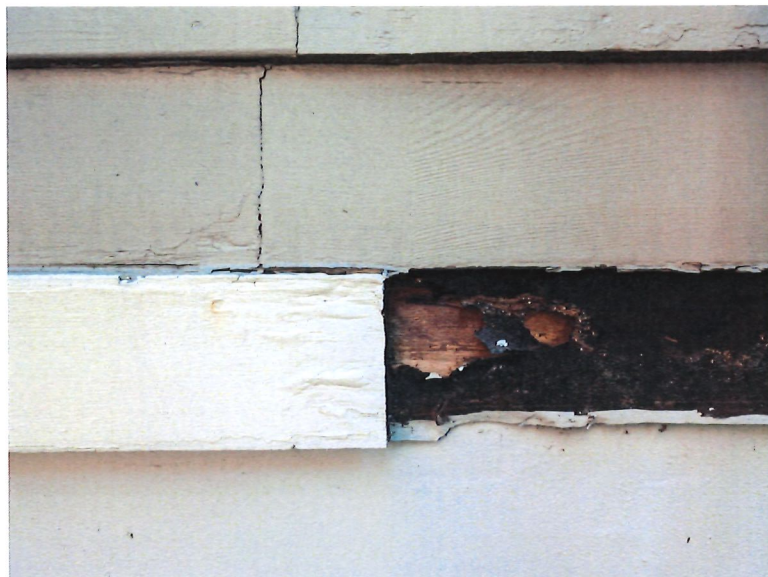
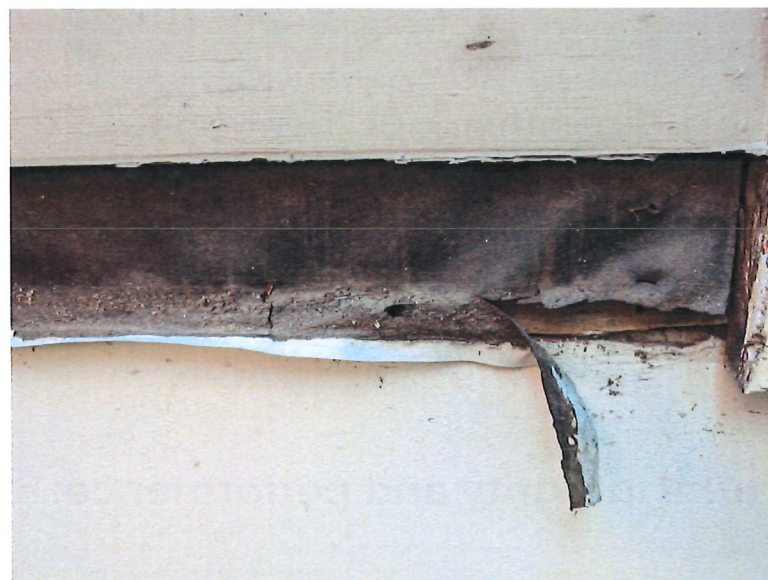
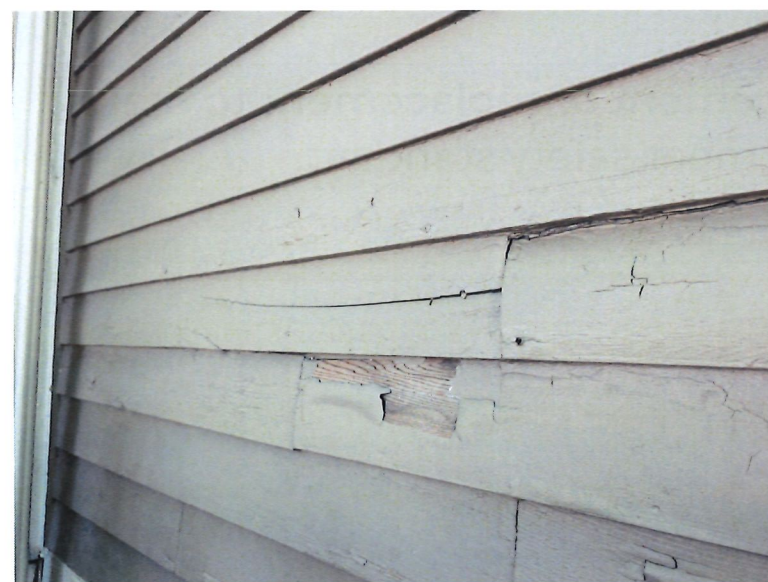
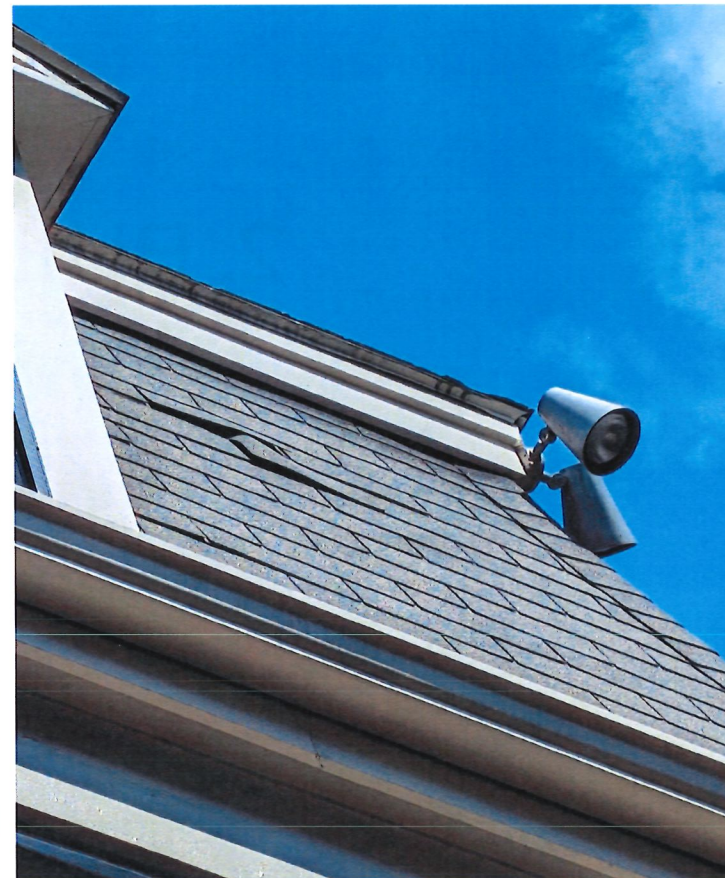
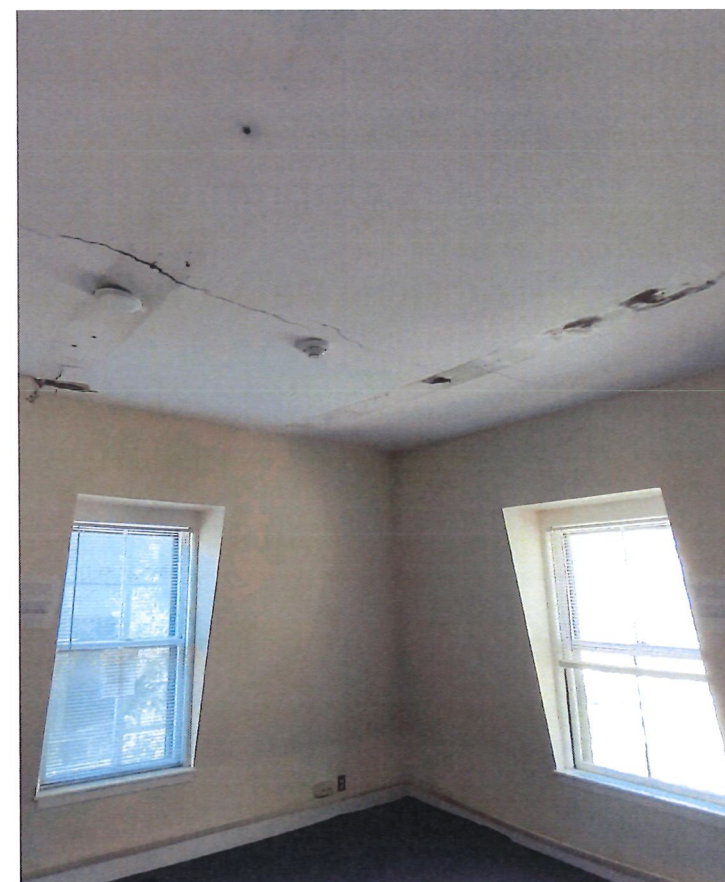
- Sidings
 - Deteriorated and require replacement at many locations
- Facade substrate
 - Air/ Water barrier shows **sign of deterioration & failure**, but repairing it would require replacing existing cedar siding
 - Insulation is **insufficient**
 - Framing is undersized, requires **reinforcement**
 - Adding new insulation to meet code will increase freeze-thaw cycles within the facade substrate and increase **risk of further deterioration**
- Roof
 - Roof leaks. **End of life expectancy**
 - Roof framing undersized. Need **structural upgrade**

DETERIORATED SIDINGS, BUILDING PAPER, ROOF SHINGLES, AND CEILING

- Install a **new roof**
- Provide **reinforcement at every facade framing stud location to meet code**
- **Rebuild façades entirely**

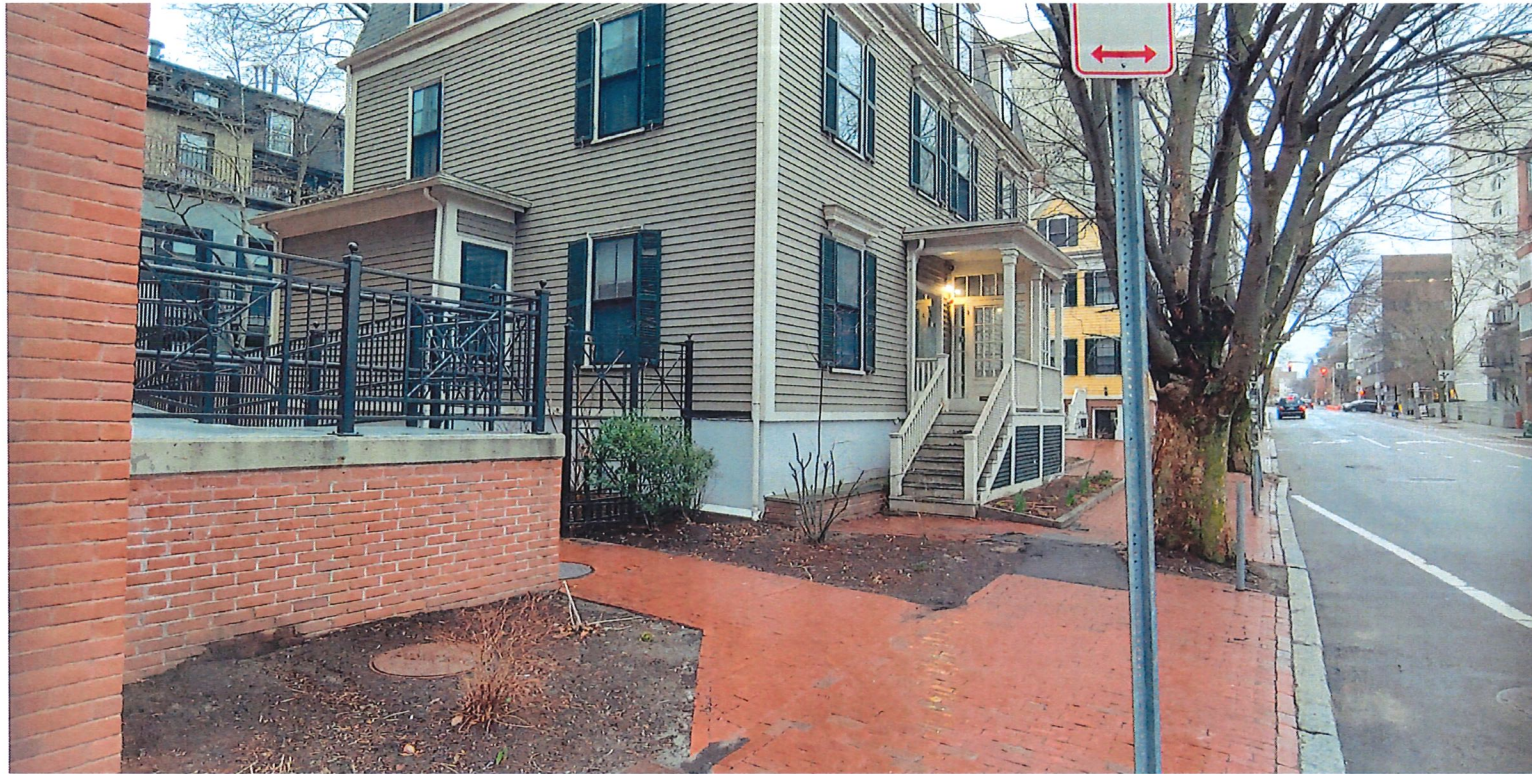
STREET ENTRANCE AND PORCH

- Site conditions
 - Existing site constraints - size, setback, trees
 - Current conditions do not naturally provide accessible path
 - Not universally accessible from front or back
 - No elevator
 - Building should be universally accessible but site constraints do not allow for accessible ramp at front entrance

- Install mechanical lift at front porch
- Install ADA ramp at back yard
- Install elevator

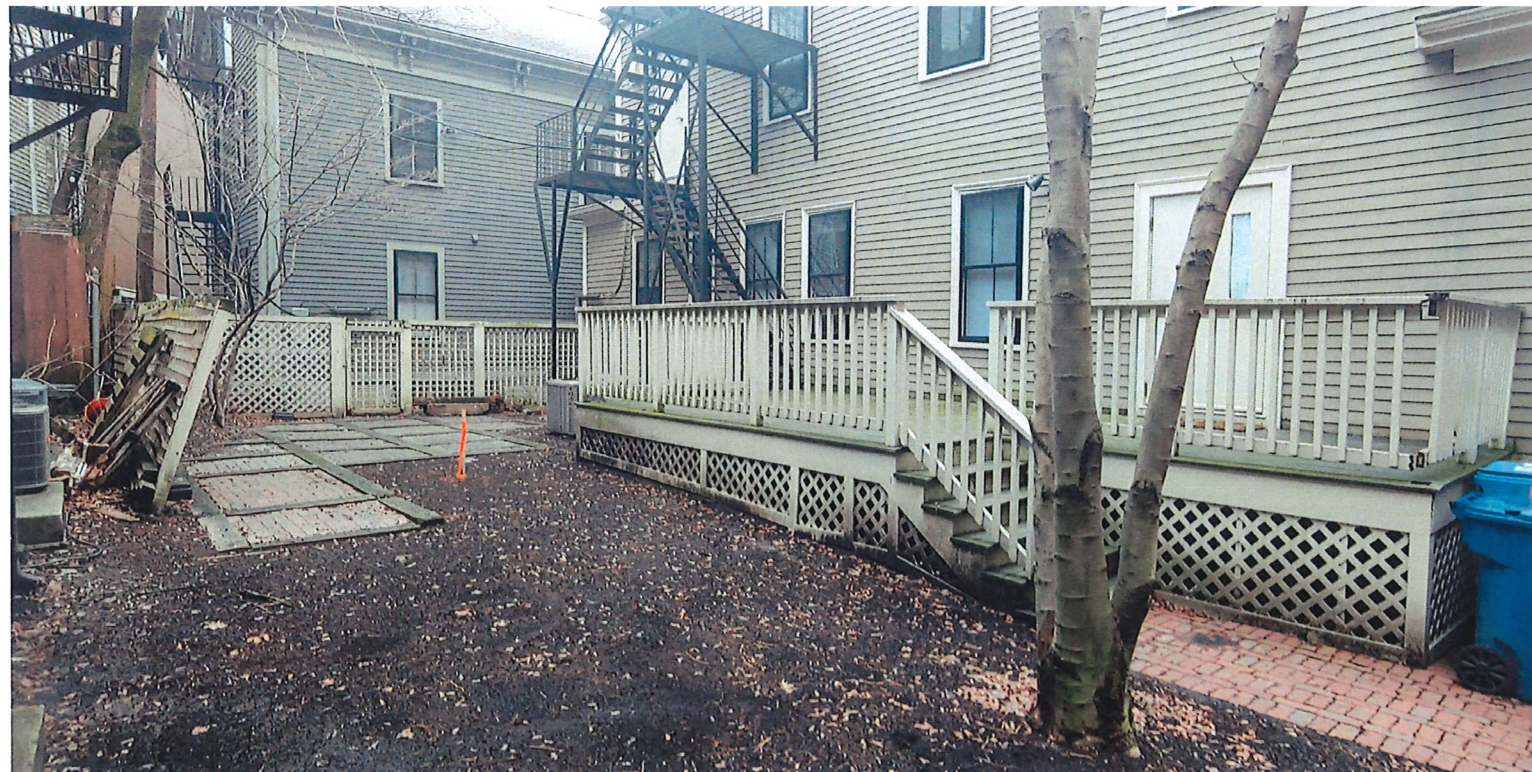
GARDEN ENTRANCE AND DECK

The back entrance would achieve accessibility via a ramp.

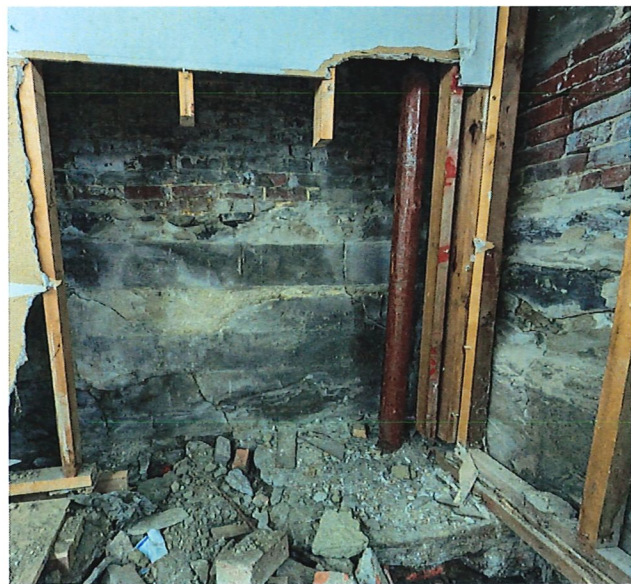
COMPROMISED
FOUNDATION WALL

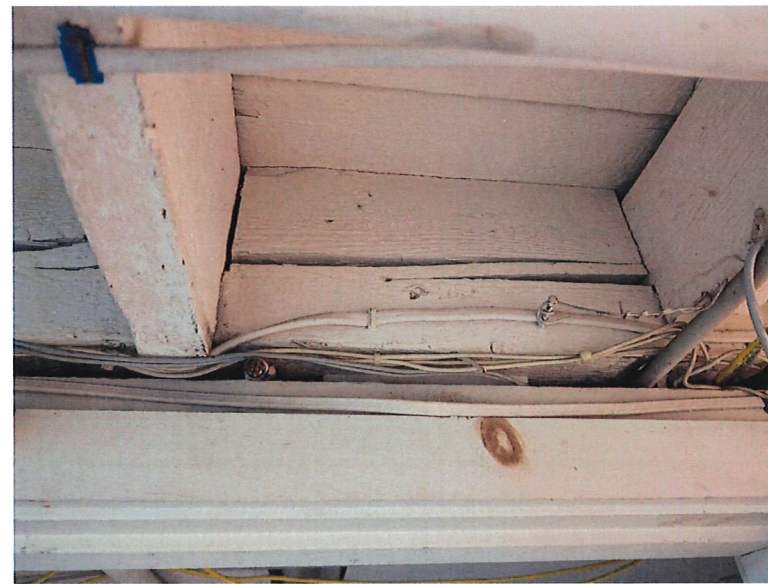
COMPROMISED STRUCTURE

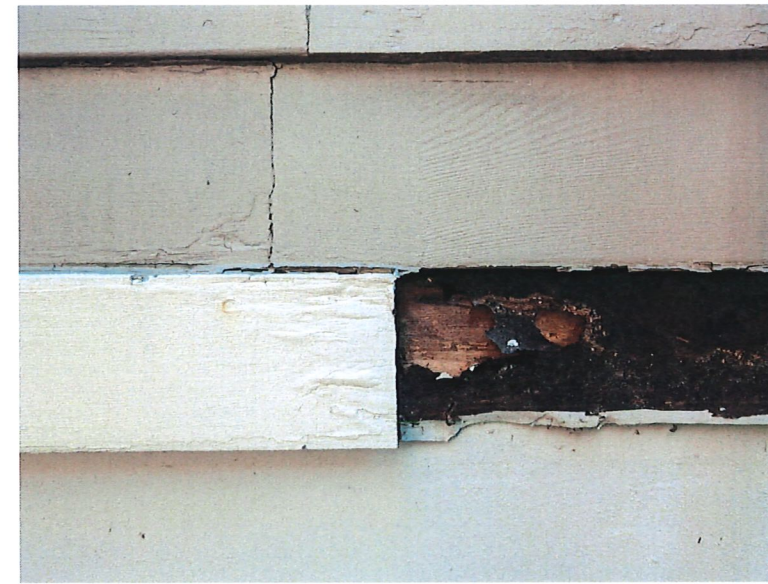
DETERIORATING FACADE

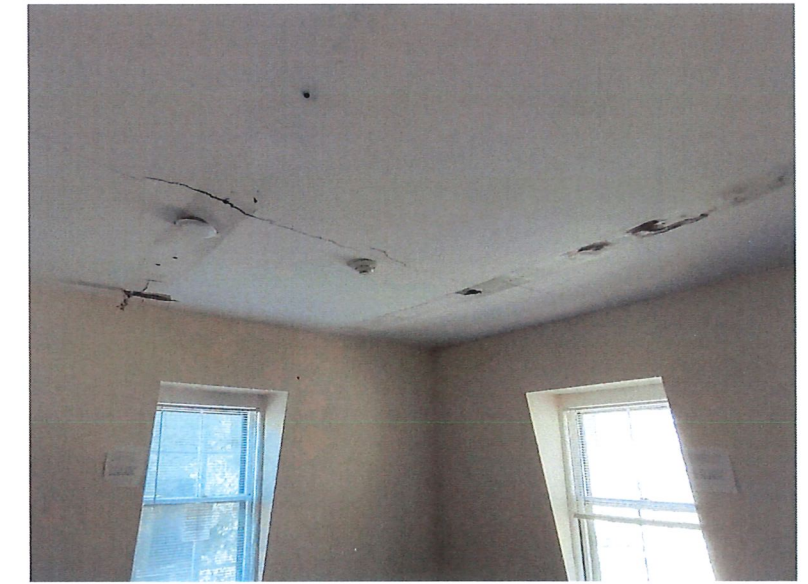
FAILED ROOF
