# MEMORANDUM

DATE:February 23, 2016TO:CAM 004 Project FileFROM:Dennis Carr, MWHCC:Catherine Woodbury, Cambridge DPW; Richard Burns, MWRASUBJECT:Summary of Critical Tasks Involved in Separating the CAM 004 CSO RegulatorPROJECT:Concord Ave (Contract 9) Sewer Separation and Surface Improvements<br/>Project

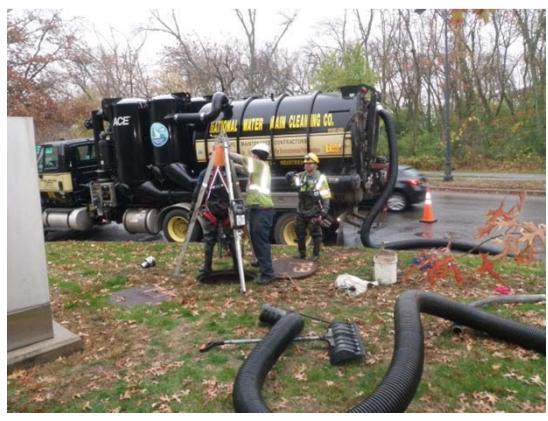
P1 Cleaning crew preparing to enter pump chamber

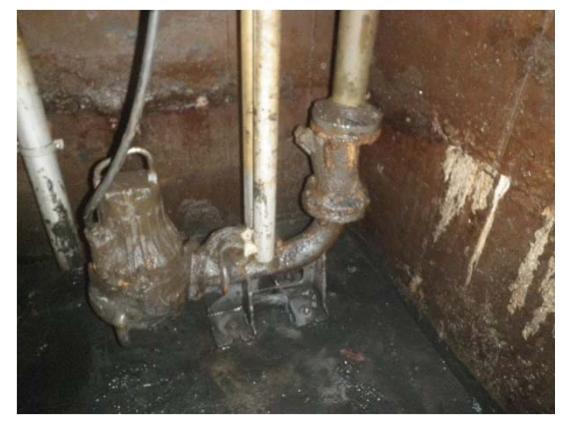
P2 Pump chamber after removal of sediments

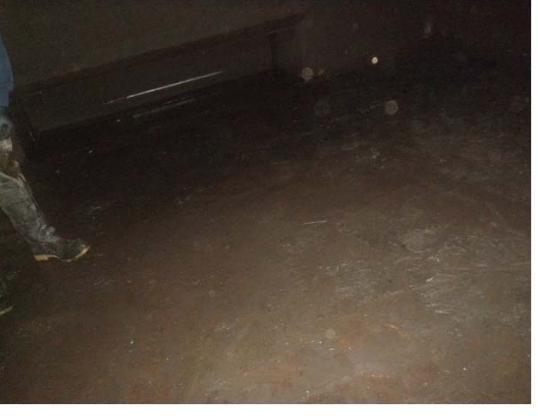
P3 Storage tank after removal of sediments. Upstream side of flush gate at upper left

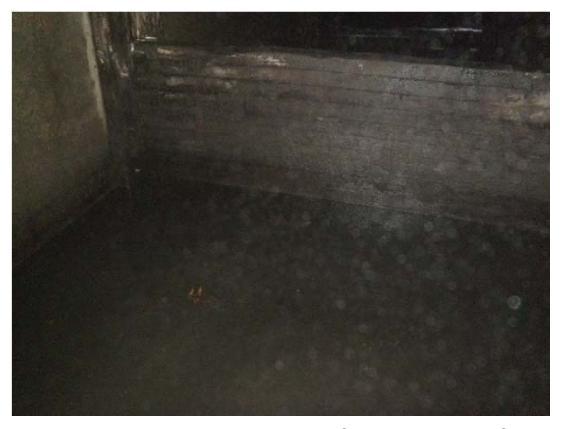
P7A Looking upstream before removal of 3' high wooden CSO weir

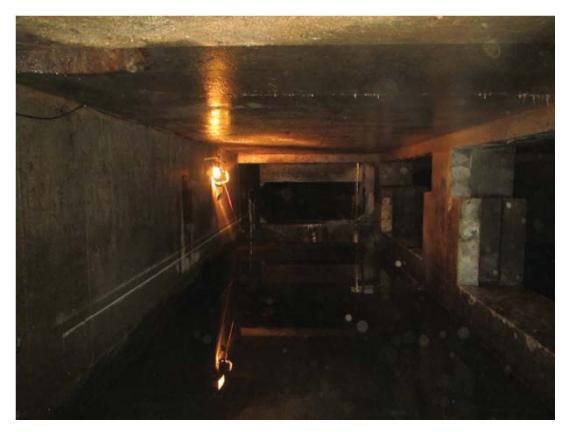
P4B Looking upstream after removal of 3' high wooden CSO weir

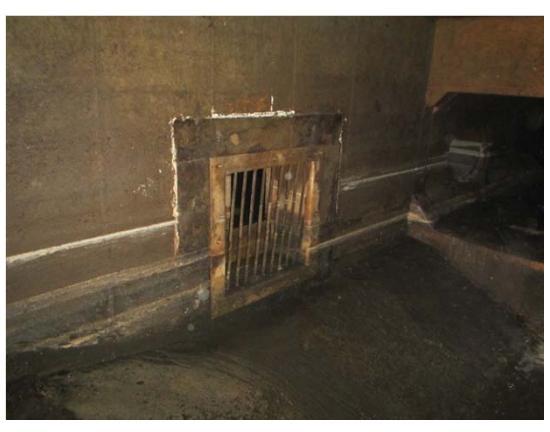
P5 Bar rack leading to pump chamber after removal of 15" PVC pipe and wooden cover

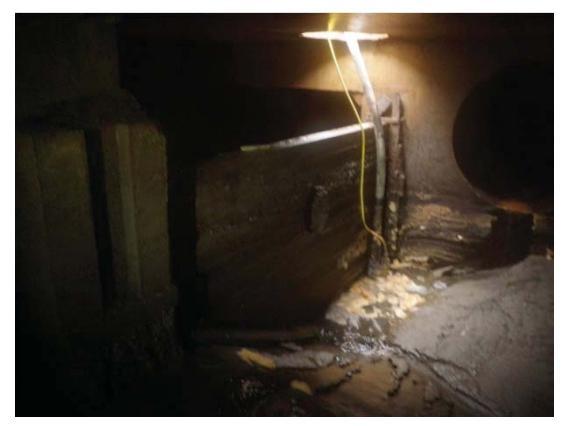
P6A Looking upstream at sumps before removal of wooden CSO weir

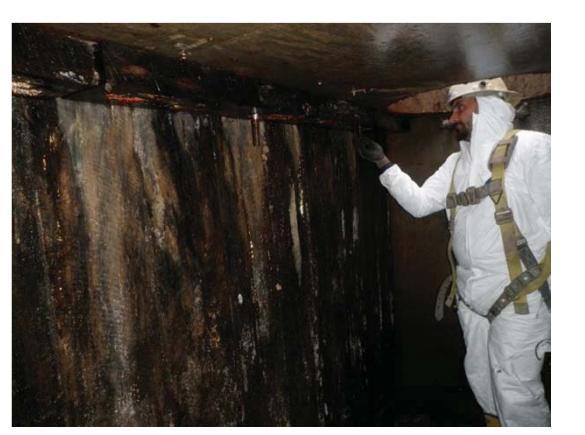
P7A Looking downstream at wooden bulkhead leading to 4'x12' culvert

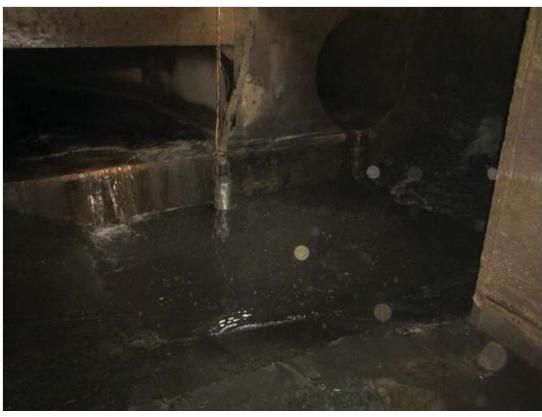
P6B Sumps restored after removal of wooden CSO weir

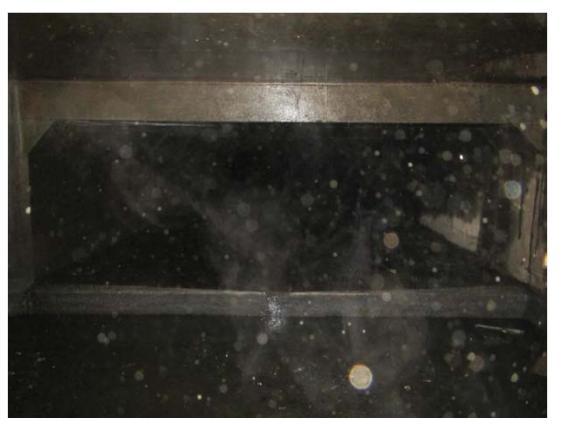
P7B Looking downstream at 4'x12' culvert after removal of wooden bulkhead

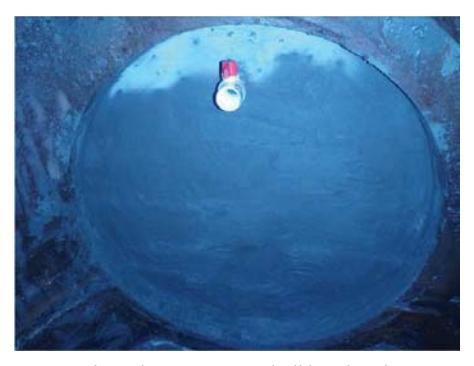
P9 Looking downstream at bulkhead with air vent at end of MWRA's sewer in rotary

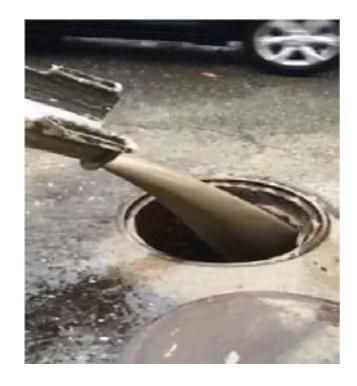
P10 – Flow-filling into manhole On MWRA's 48" sewer

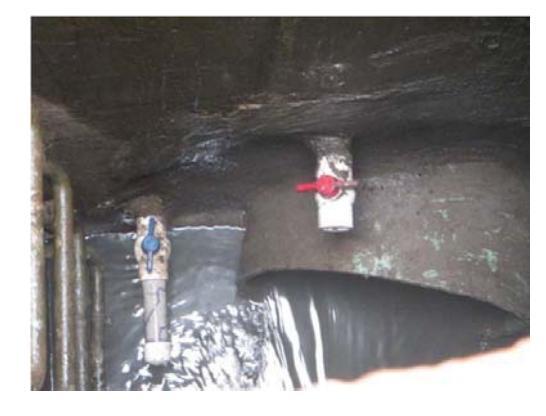
P11 Looking upstream at bulkhead with air Vents in MWRA's 48" sewer on Wheeler St.

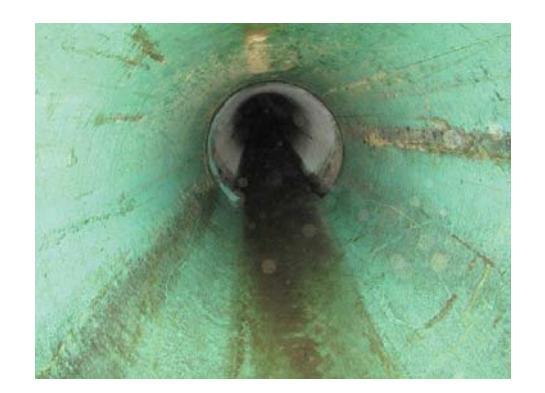
P15 Looking upstream into newly installed 24" PVC pipe inserted into existing bell

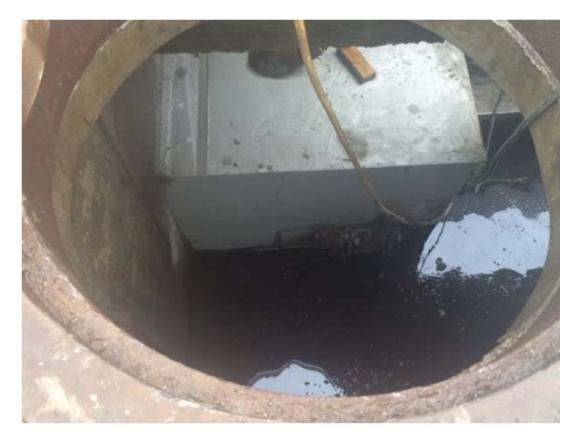
P12 Looking upstream at elevated weir with flap gate at outlet of vortex throttle

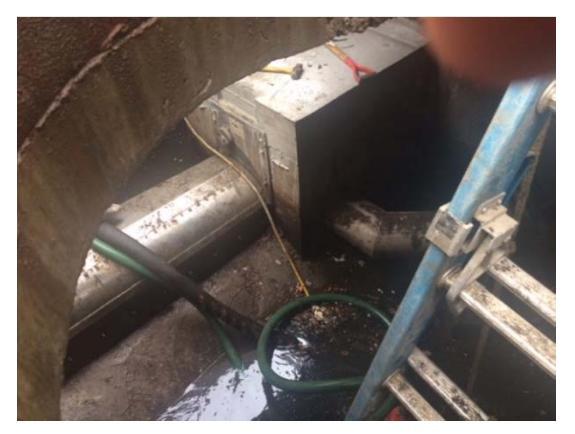
P13 Looking downstream at elevated weir with bending weir (left)and vortex throttle (right)

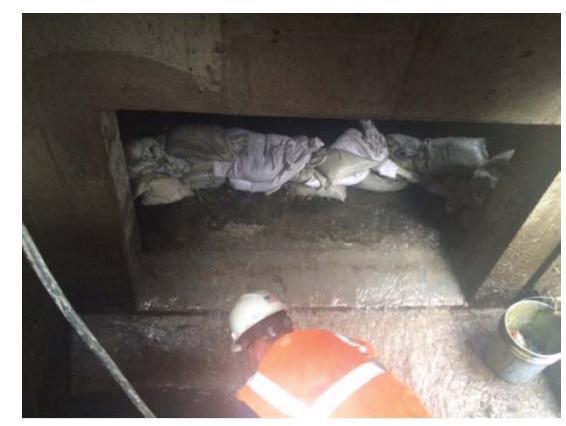
P14 Bulkhead removed between 72" drain and 4'x8' box culvert
