APPLICATION FOR CERTIFICATE

72 Mount Auburn Street

Exterior Restoration

72 Mount Auburn Street – Exterior Restoration

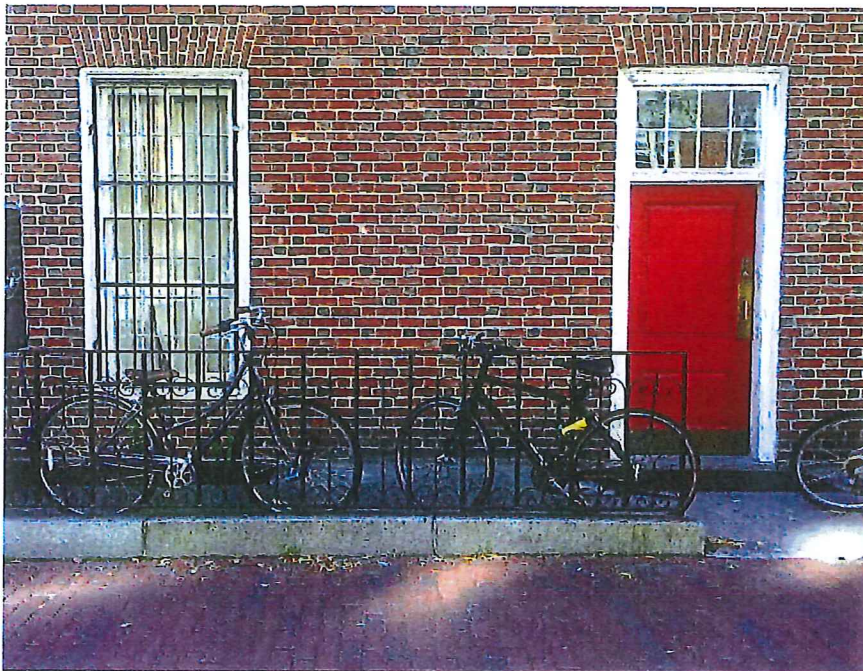
Existing conditions at secondary entrance – proposed for accessibility reconfiguration

In order to achieve this, the threshold of the existing grade level non-original front door will be lowered to meet the level of the building interior. The existing transom will be removed and restored and reinstalled within a newly constructed custom wood door frame and trim to match the existing, with the exception being that it will be longer to correspond with the lowered threshold. The existing door will be removed and be replaced with a new 2 panel door with decorative lever hardware and will be painted to match the existing door. The existing concrete apron in front of the building will be removed and replaced with a concrete ramp that will provide access down to the new level of the doorway. Simple, post mounted steel ADA compliant handrails will be installed at either side of the ramp.

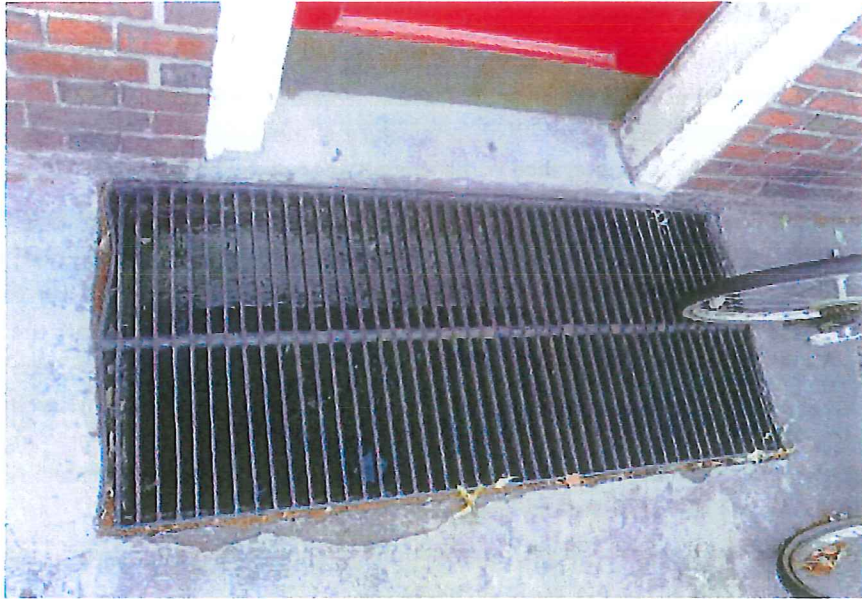
Existing grate at secondary entrance; grating material to be changed to conform to accessibility requirements

New, ADA compliant, bar grating will be installed in the same location as the existing grating to maintain the existing light well areaways to the basement.

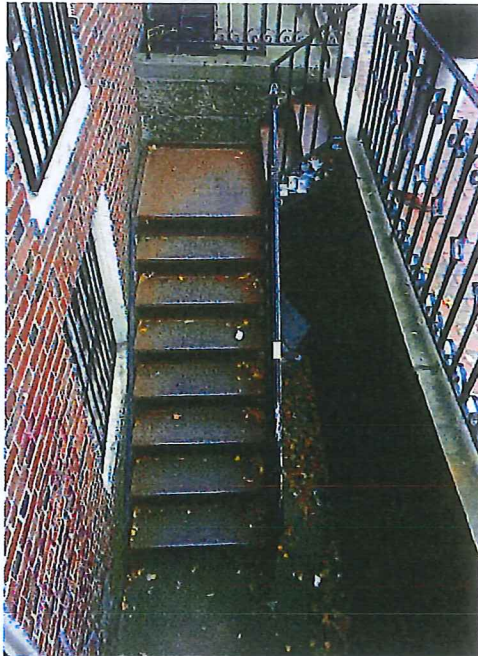
Existing stairway to basement entrance. Existing non-compliant handrail to remain. New compliant handrail to be installed and run along wall.

The existing steel access stair from the street will remain and be power tool cleaned and repainted black to match the existing stair and adjacent metal work. Per MAAB regulations, a compliant handrail must be provided on one side of the stair. At the upper stair run a new decorative steel picket and handrail system will be installed on top of the existing steel stair stringer on the right side of the stairway to match the existing system on the opposite side of the stair. At the lower below grade stair run, a new decorative handrail will be wall mounted to the building with the minimum number of brackets as possible. The handrail ends will be capped with a decorative volute, appropriate for this era of building.

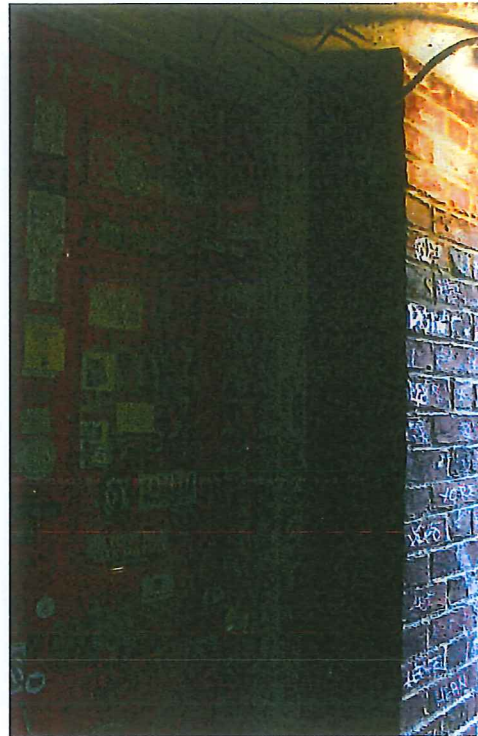
Basement entrance door

To provide safe, code compliant egress from the basement level, the existing below grade non-original six-panel basement door and frame will be replaced with a new outswing six-panel door and frame. The existing door is 3'-6" wide and will be replaced with a 3'-0" wide door to allow an outswing below the arch of the stairs above. The threshold will also be lowered approximately 4" to align with the interior floor level and is necessary to allow the outswing door to miss the overhead arch of the stairs above. The difference in dimension will be trimmed with wood trim profiles to match those of the other doors and windows on the building.

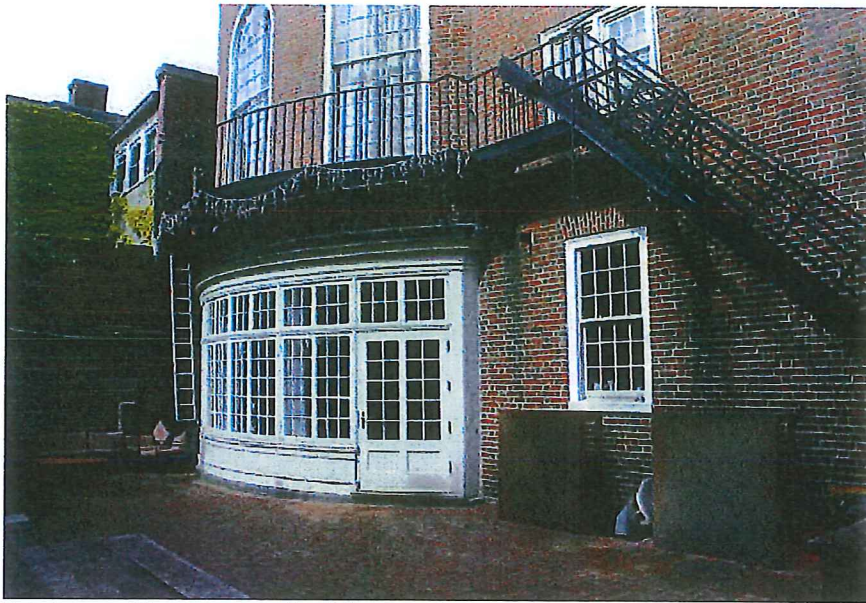
Existing conditions – rear patio with step up into interior

To comply with MAAB regulations, the existing brick rear patio must be made accessible for the disabled from the interior of the building. In order to achieve this, a low-profile ramp will be constructed out of salvaged bricks in a similar herringbone pattern and will curve around the rear circular bay window. The slope will be such that handrails or guardrails will not be required.

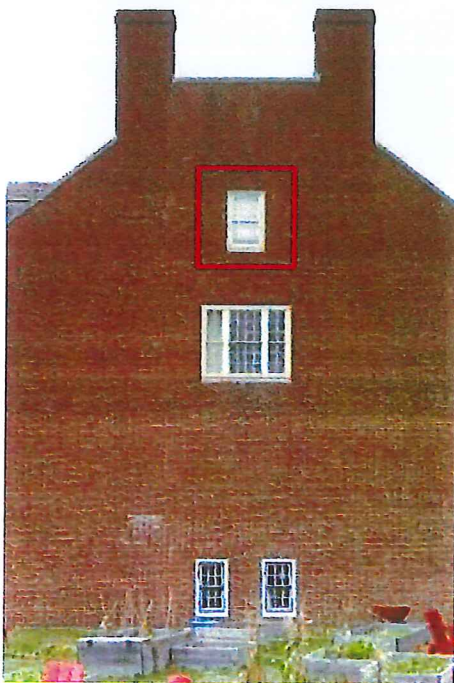
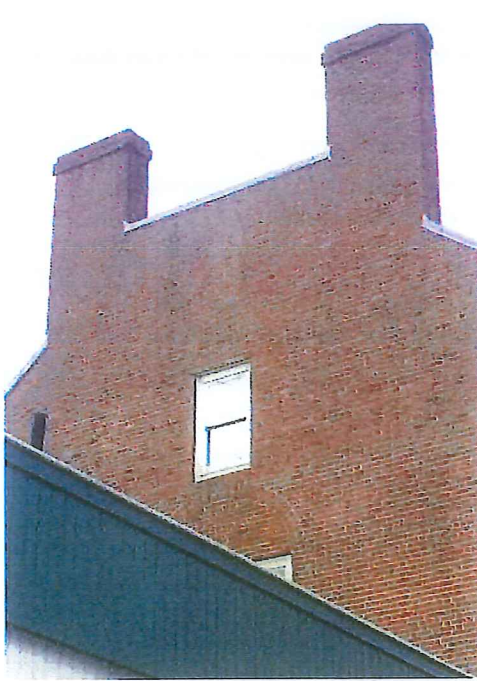
A window opening at the attic level was added at some unknown time after 1916. A vinyl one-over-one window in poor condition is located at this opening. In order to provide for appropriate ventilation in conjunction with necessary HVAC upgrades during Phase 2 of the project, a louvered opening is requested for this location. The louvers would match the color of the existing trim.

East elevation showing window at attic level

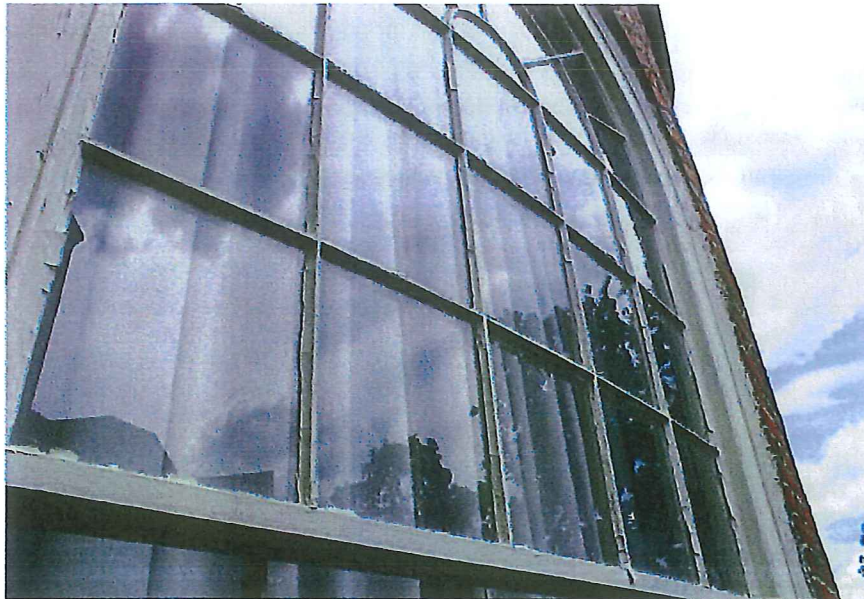
Typical sash conditions of original wood windows

In the two-story bow, the first floor includes five pairs of original casement sash topped by casement transoms. An additional casement transom is located above the door. At the second floor, there are three original arch-top, curved, double-hung windows. These original windows will be restored with dutchman repairs, new glazing putty and new paint (matching existing). Reinstallation of the restored sash will include the installation of spring bronze weather stripping and sash cord or chain.

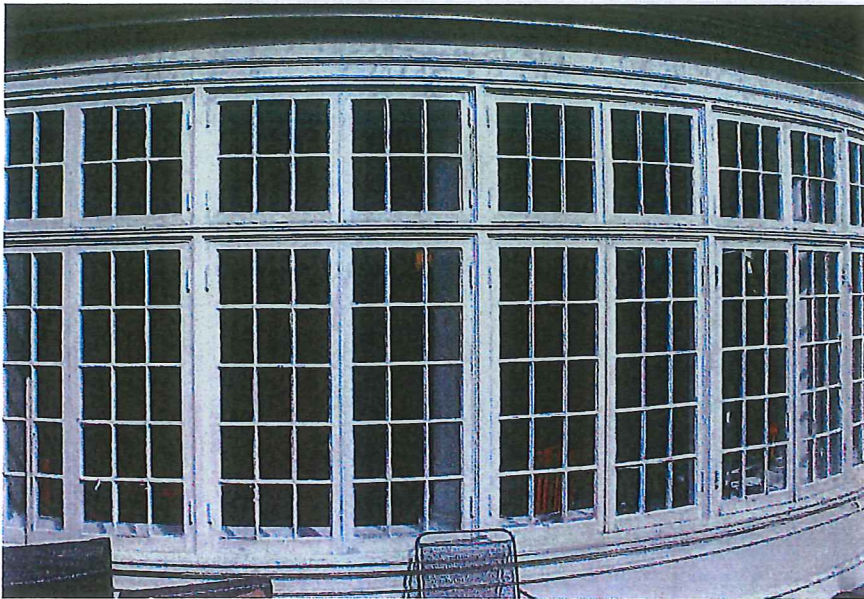
Overall conditions of casement units at bow on rear elevation

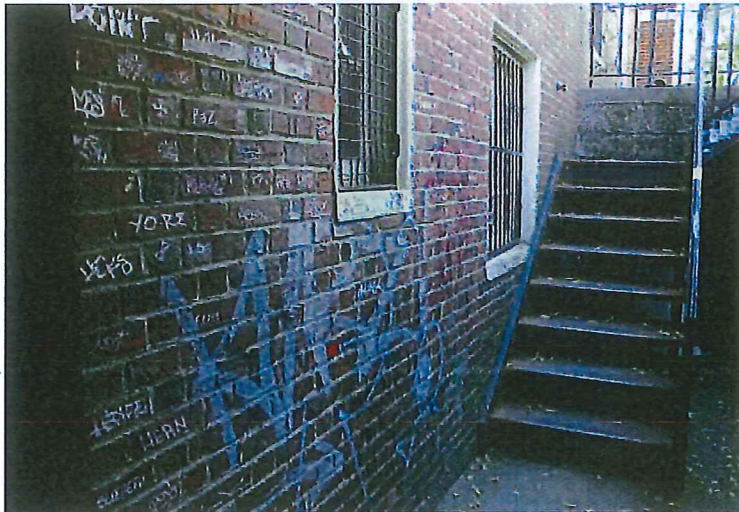
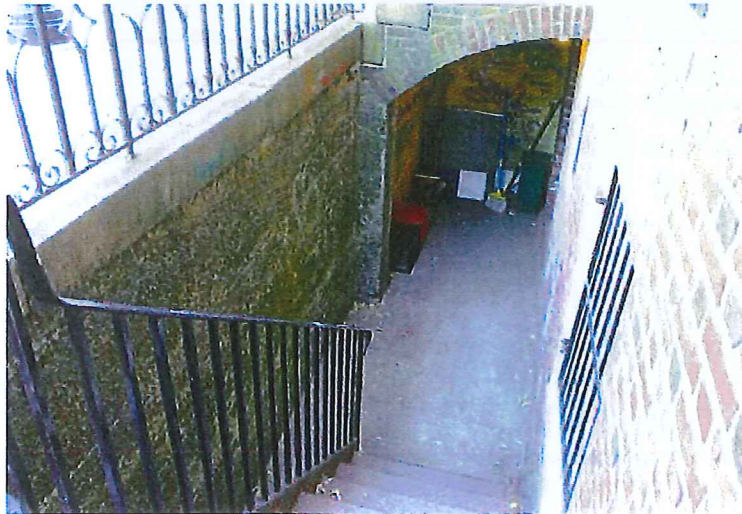
Graffiti visible on walls of front elevation below grade

The graffiti on the stair walls leading below grade will be cleaned to the extent possible, using the gentlest means possible. Recommended cleaners include Prosoco EK Restoration Cleaner (general environmental cleaning), Prosoco Graffiti Remover (graffiti removal), Prosoco Sure Klean 800 Stain Remover (metal staining) or approved equivalent, following manufacturer’s specifications. Washing will be done with low pressure, implementing appropriate waste collection as required. No high-pressure washing will be permitted.

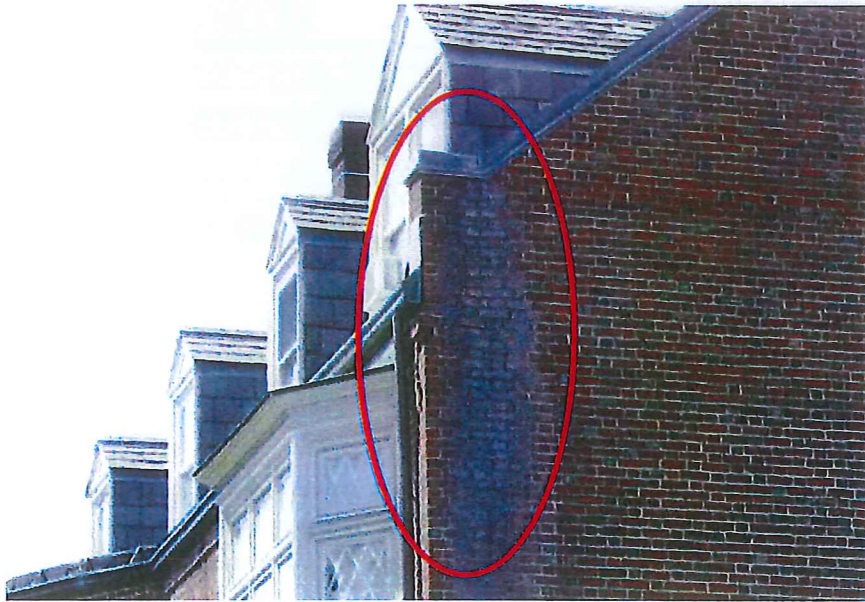
Location of brick repair and example of typical area to be cleaned

Phase 2 work incorporates brick masonry repairs at the upper southeast corner and general cleaning at the upper elevations. Repair work will include brick replacement (matching existing in kind, color, and dimension). Mortar will match existing in color, composition and aggregate. Mock-ups for bricks and mortar will be reviewed in consultation with Cambridge Historical Commission. Recommended cleaners include Prosoco EK Restoration Cleaner (general environmental cleaning), Prosoco Graffiti Remover (graffiti removal), Prosoco Sure Klean 800 Stain Remover (metal staining) or approved equivalent, following manufacturer's specifications. Washing will be done with low pressure, implementing appropriate waste collection as required. No high-pressure washing will be permitted.

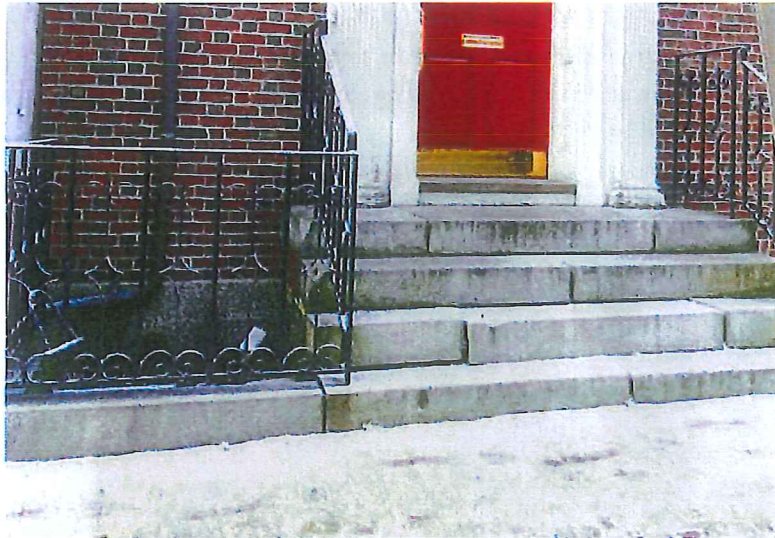
At the front elevation, granite curbing and front steps exhibit staining. The front steps have also shifted slightly over time. Cleaning tests will be done to identify the most effective and safest cleaning product in the Prosoco line. The steps will be reset to be level and plumb and minimize trip hazards.

General conditions of granite curbing and steps

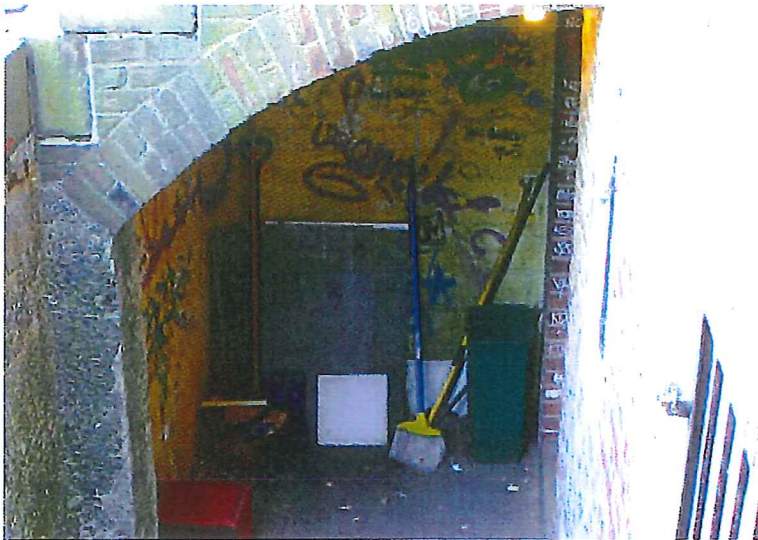
The concrete walls and arch under the main front steps are coated with a cementitious parging that is in poor condition. Existing loose material will be removed, and new material will be applied and finished to an even level with a slightly sanded finish. The material will be coated with a mineral silicate coating, matching the existing color. The recommended product is KEIM Granital.

General conditions of parging coating under front step arch

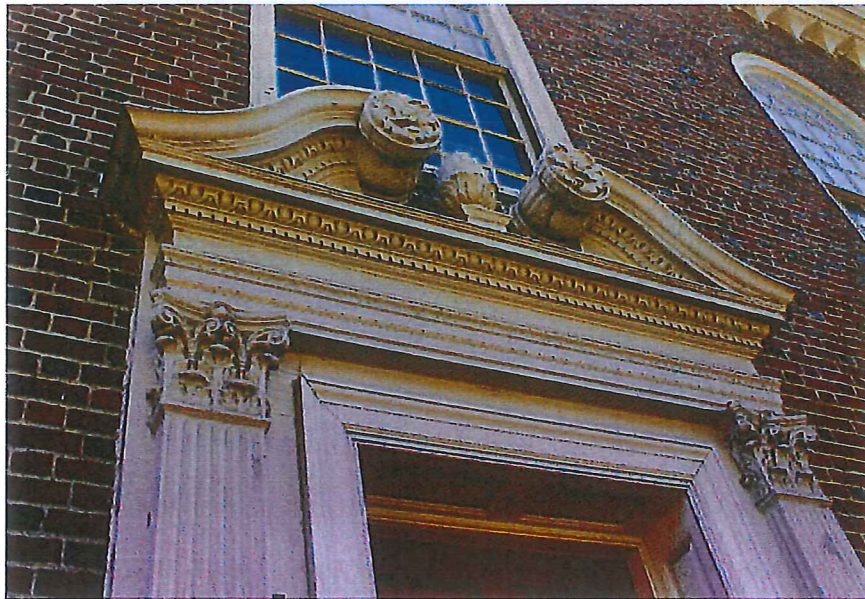
The wood trim elements suffer from varying degrees of paint failure with areas of deterioration requiring repairs. All loose paint will be removed. Small cracks will be filled with epoxy-based wood filler (Advanced Repair Technology FlexTec or approved equivalent). Deteriorated areas greater than 1/2" square inch will be repaired with wood dutchman matching dimension and profile details of adjacent material. A species change for wood replacements is expected with recommended alternates of cypress, Spanish cedar or African mahogany. All repairs to use 100% heartwood regardless of species. Adhesive for dutchman repairs will be West System epoxy or approved equivalent.

General paint conditions of front entrance surround

Woodwork will be repainted with exterior acrylic latex, semi-gloss; color to match existing.

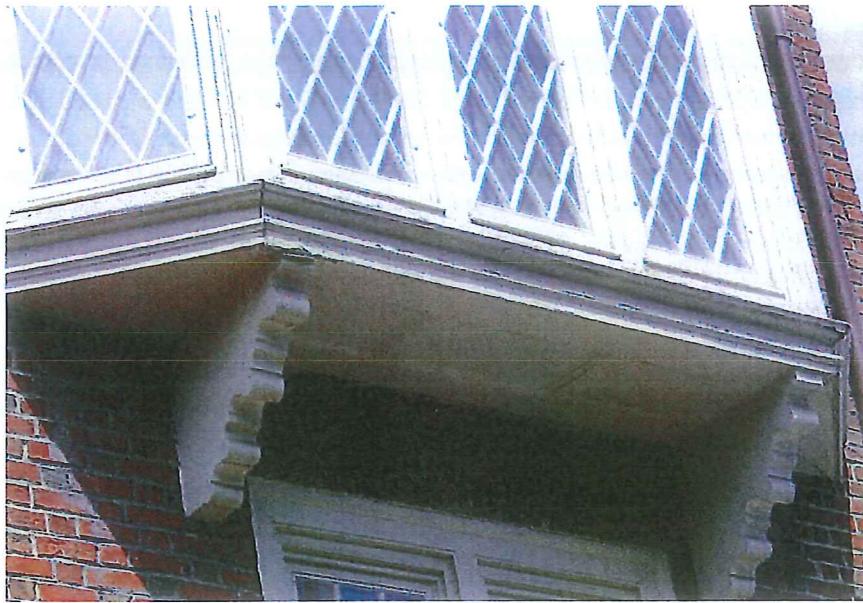
General paint conditions at rear elevation bay window structure

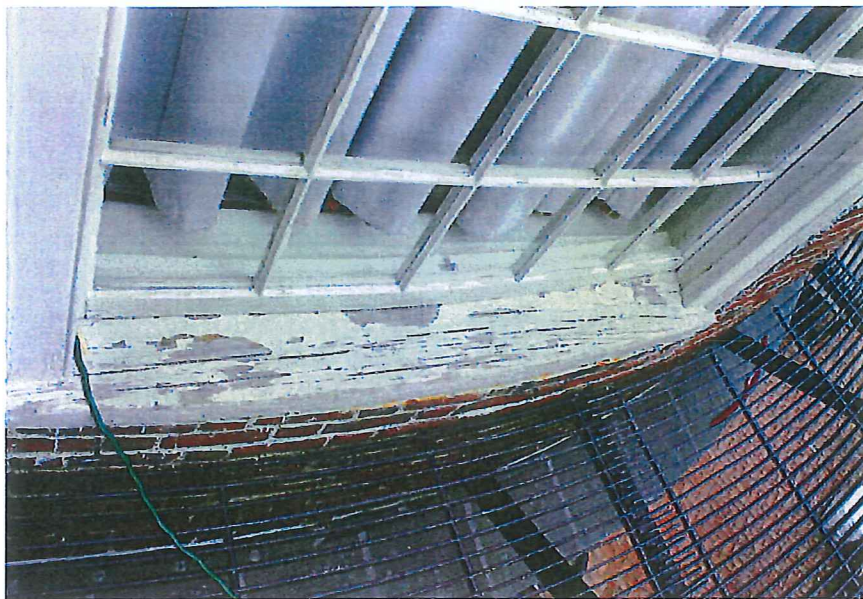
General conditions of wood window sills

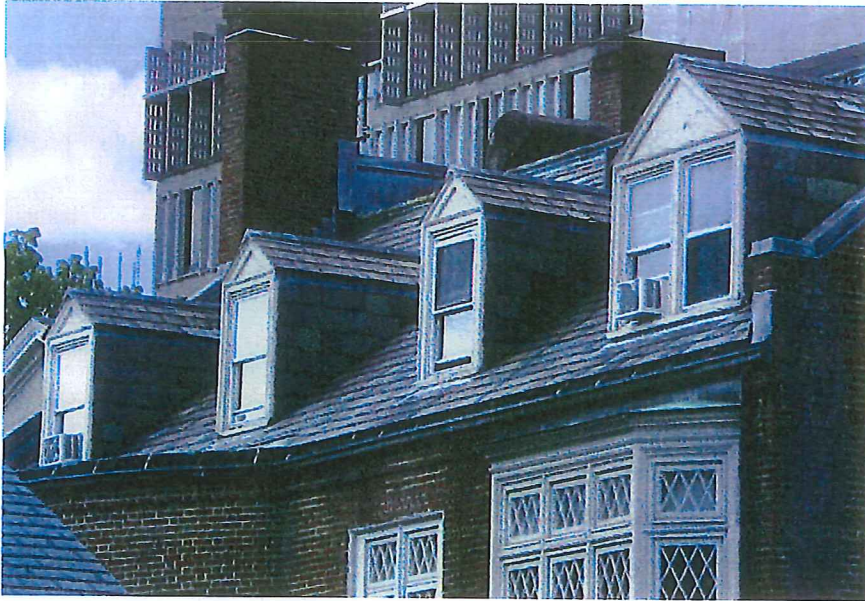
Some slate roof tiles have broken or slipped. Broken tiles will be replaced matching existing which is a mix of weathering green and purple slate.

Mix of existing roof slate colors
