**OPTION 1: RENOVATION / ADDITION**  
TOBIN MONTESSORI VASSAL LANE SCHOOL

**OPTION 2: WINGS**  
TOBIN MONTESSORI VASSAL LANE SCHOOL

**OPTION 3: PAVILIONS**  
TOBIN MONTESSORI VASSAL LANE SCHOOL

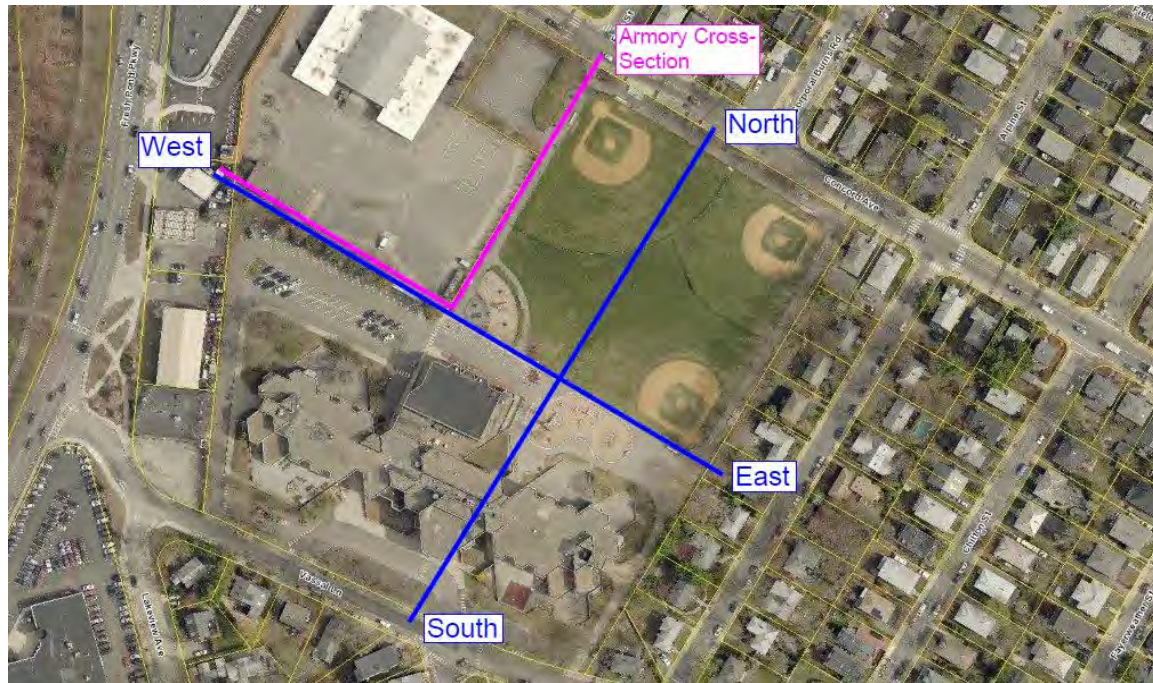
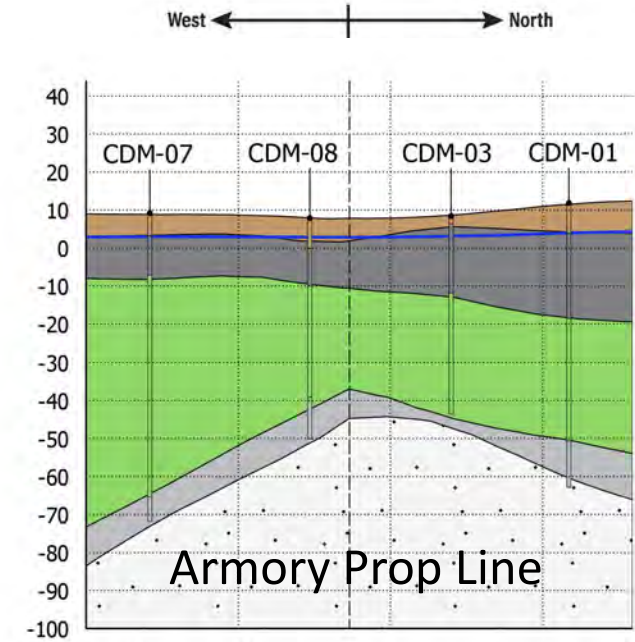
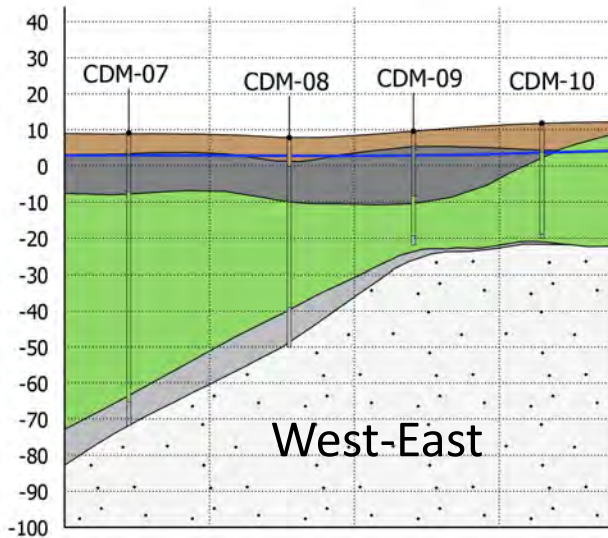
# Subsurface Conditions - Strata Cross Section

-   Water Table
-   Granular Fill
-   Waste (Misc. Fill)
-   Clay and Silt
-   Glacial Till
-   Bedrock

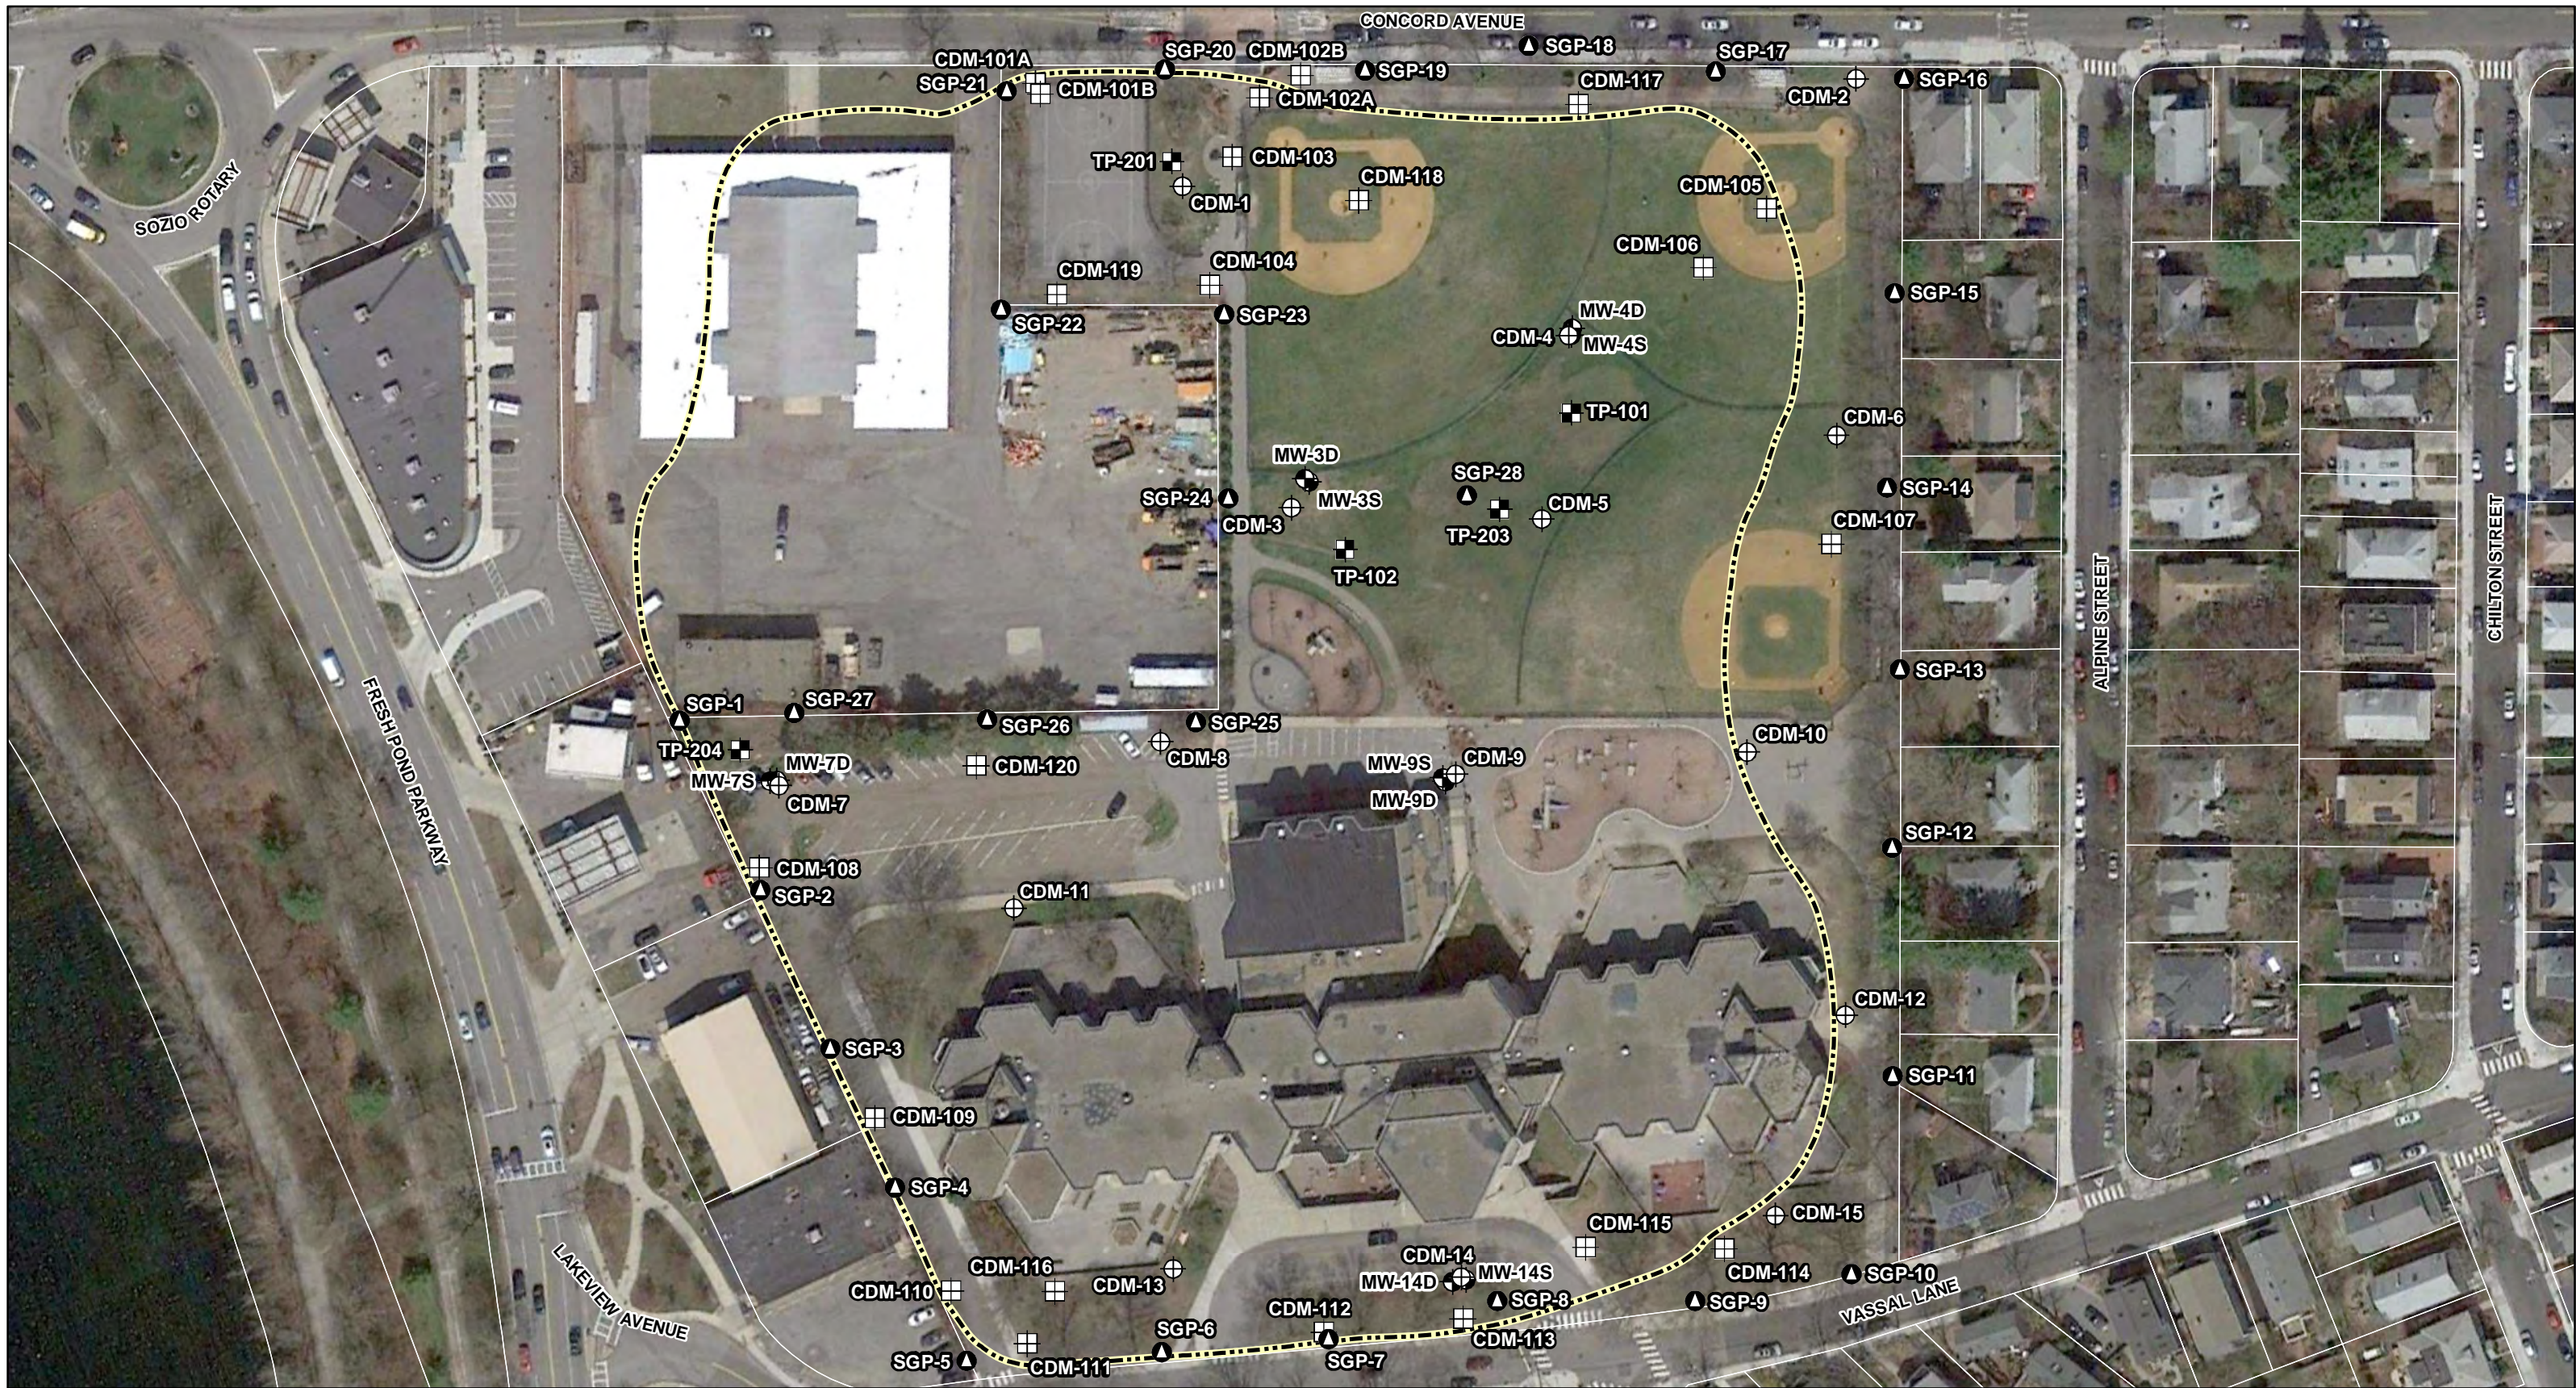
**Environmental Site Investigation Locations**  
**2017-2018**

- Gas Probe Location (August 2017)
- Test Pit Location (December 2017 and February 2018)
- Geotechnical/Environmental Boring Location (Jan-Feb 2018)
- Geotechnical/Environmental Boring Location (July-August 2017)
- Groundwater Monitoring Well Couplet Installation Location (July-August 2017)
- Approximate Boundary of Former Clay Pit/Edge of Waste (updated April 2018 for Tobin School Property Only)

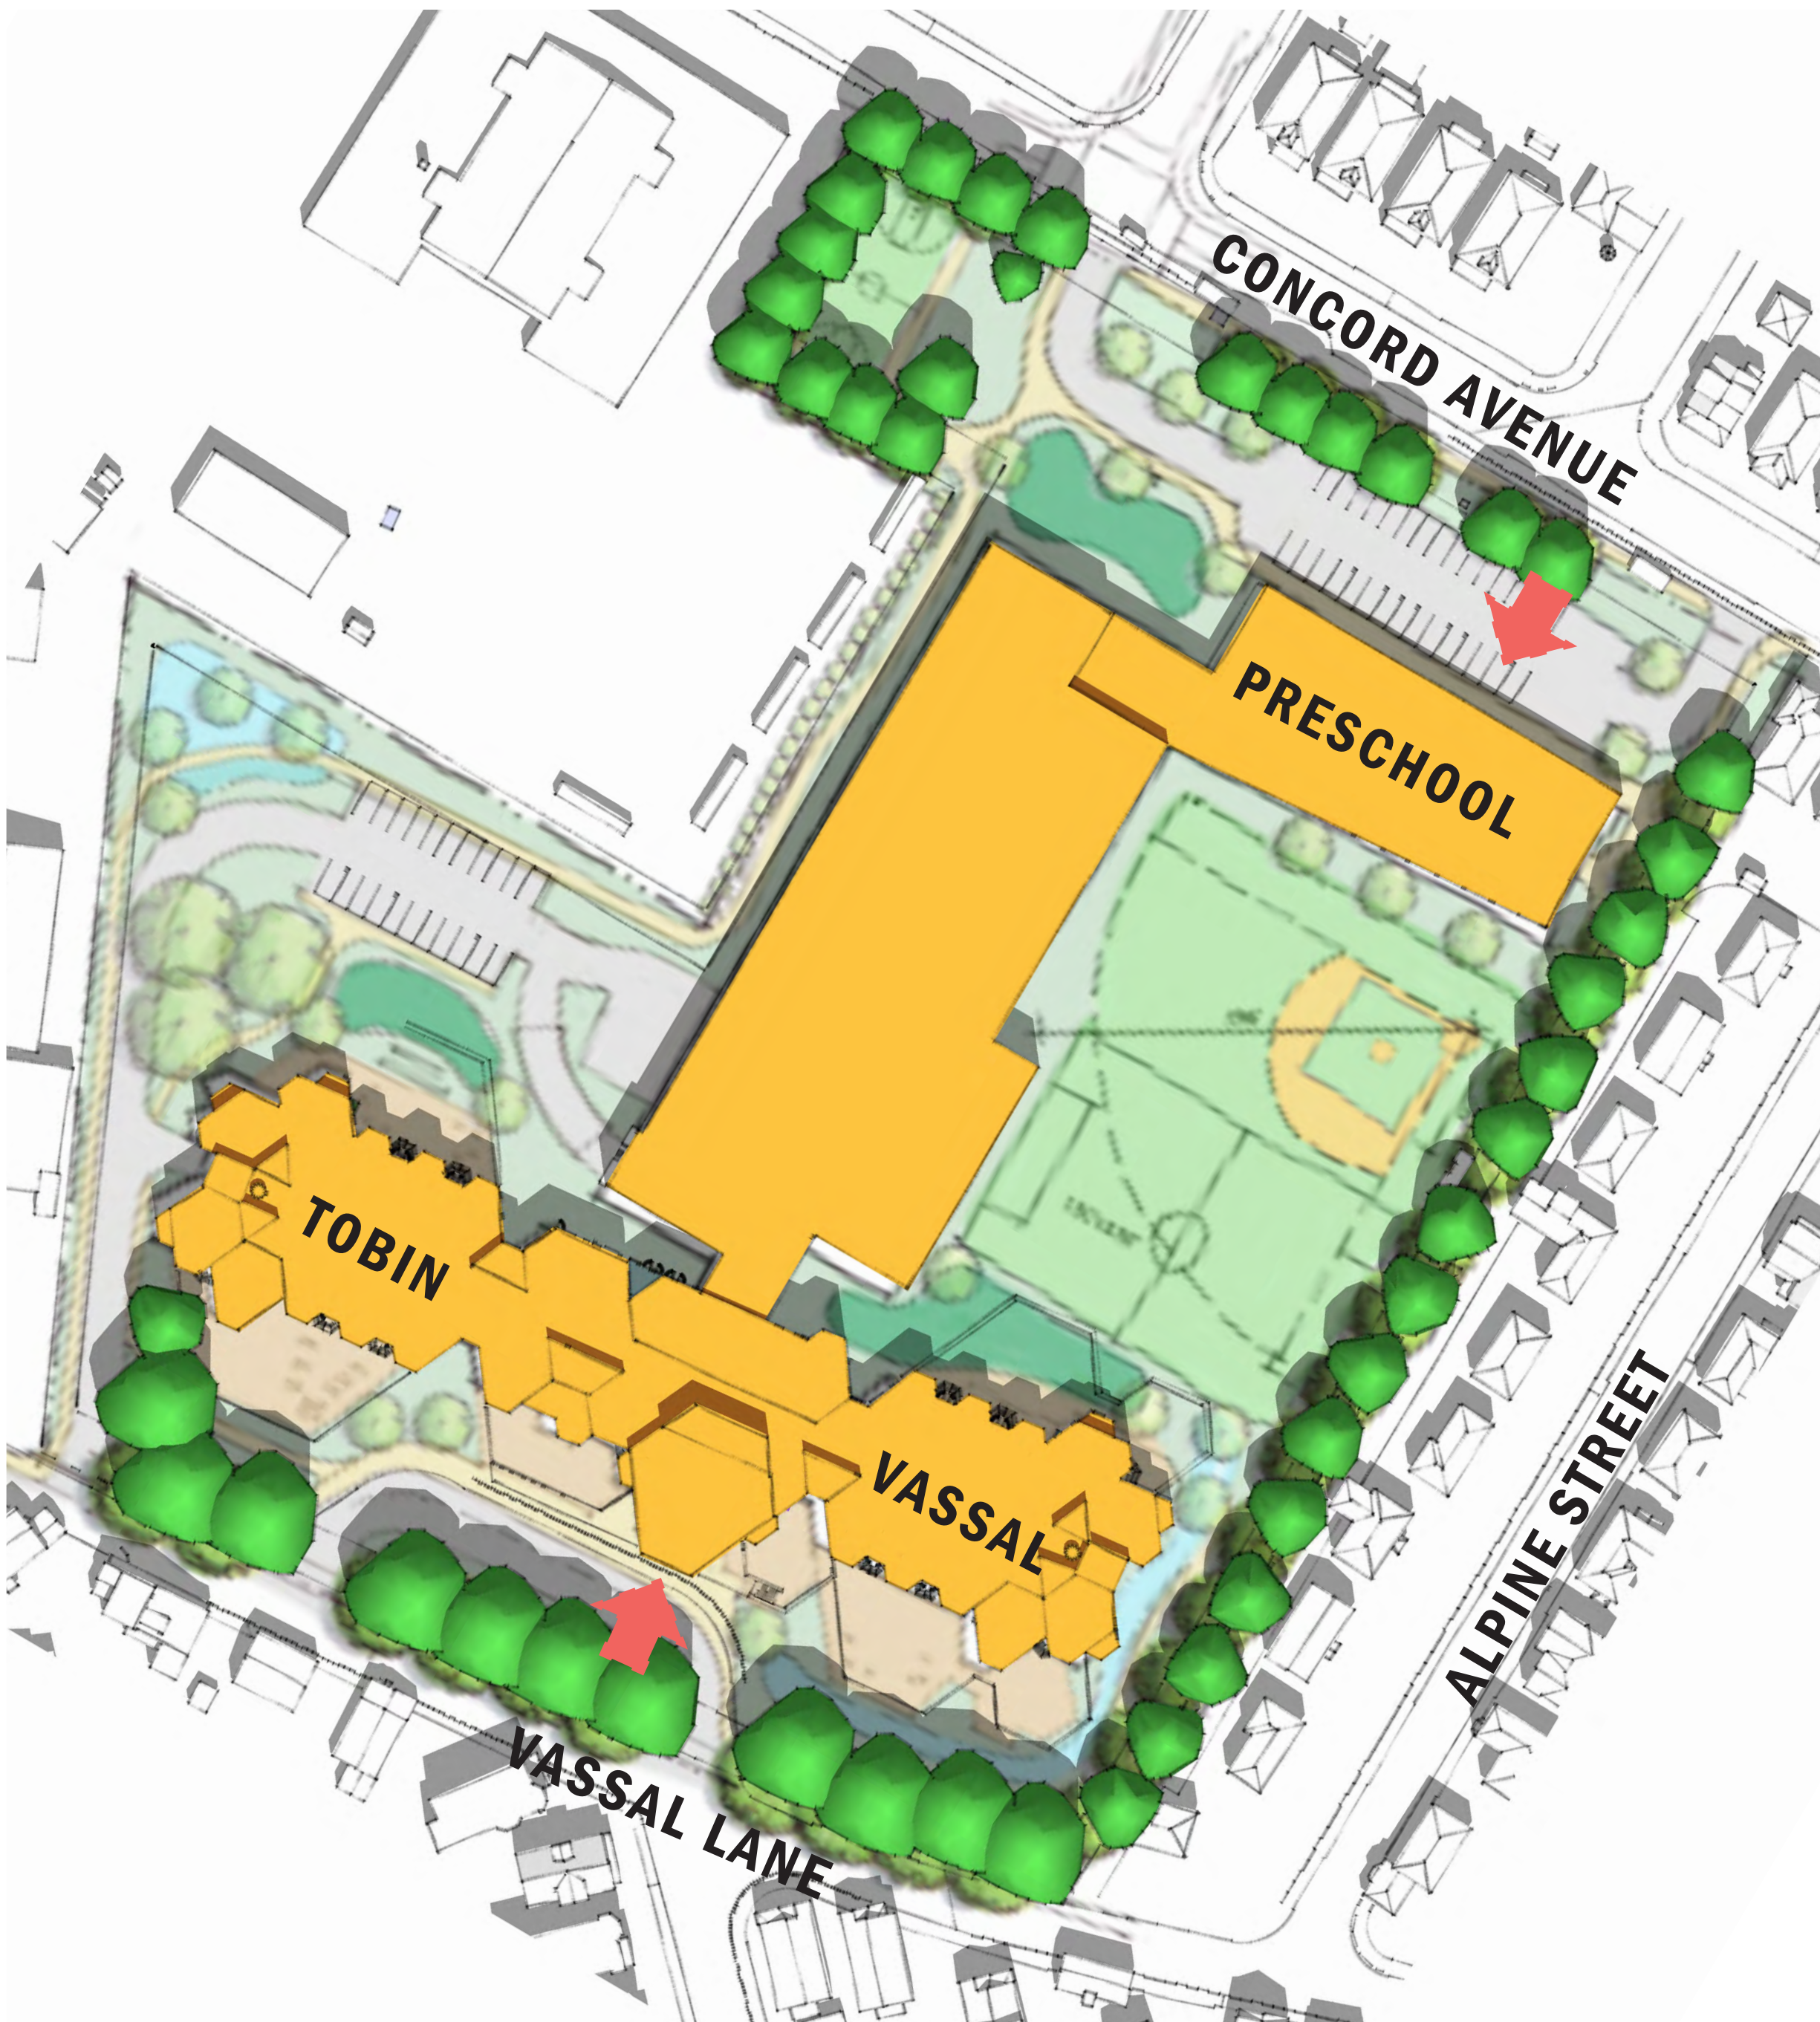
**RENOVATION / ADDITION**  
 TOTAL BUILDING AREA (GROSS SQ. FT.) = 316,900  
 BUILDING FOOTPRINT (SQ. FT.) = 116,700  
 VEHICULAR CIRCULATION (SQ. FT.)= 46,600  
 OPEN SPACE (ACRES)= 5.4

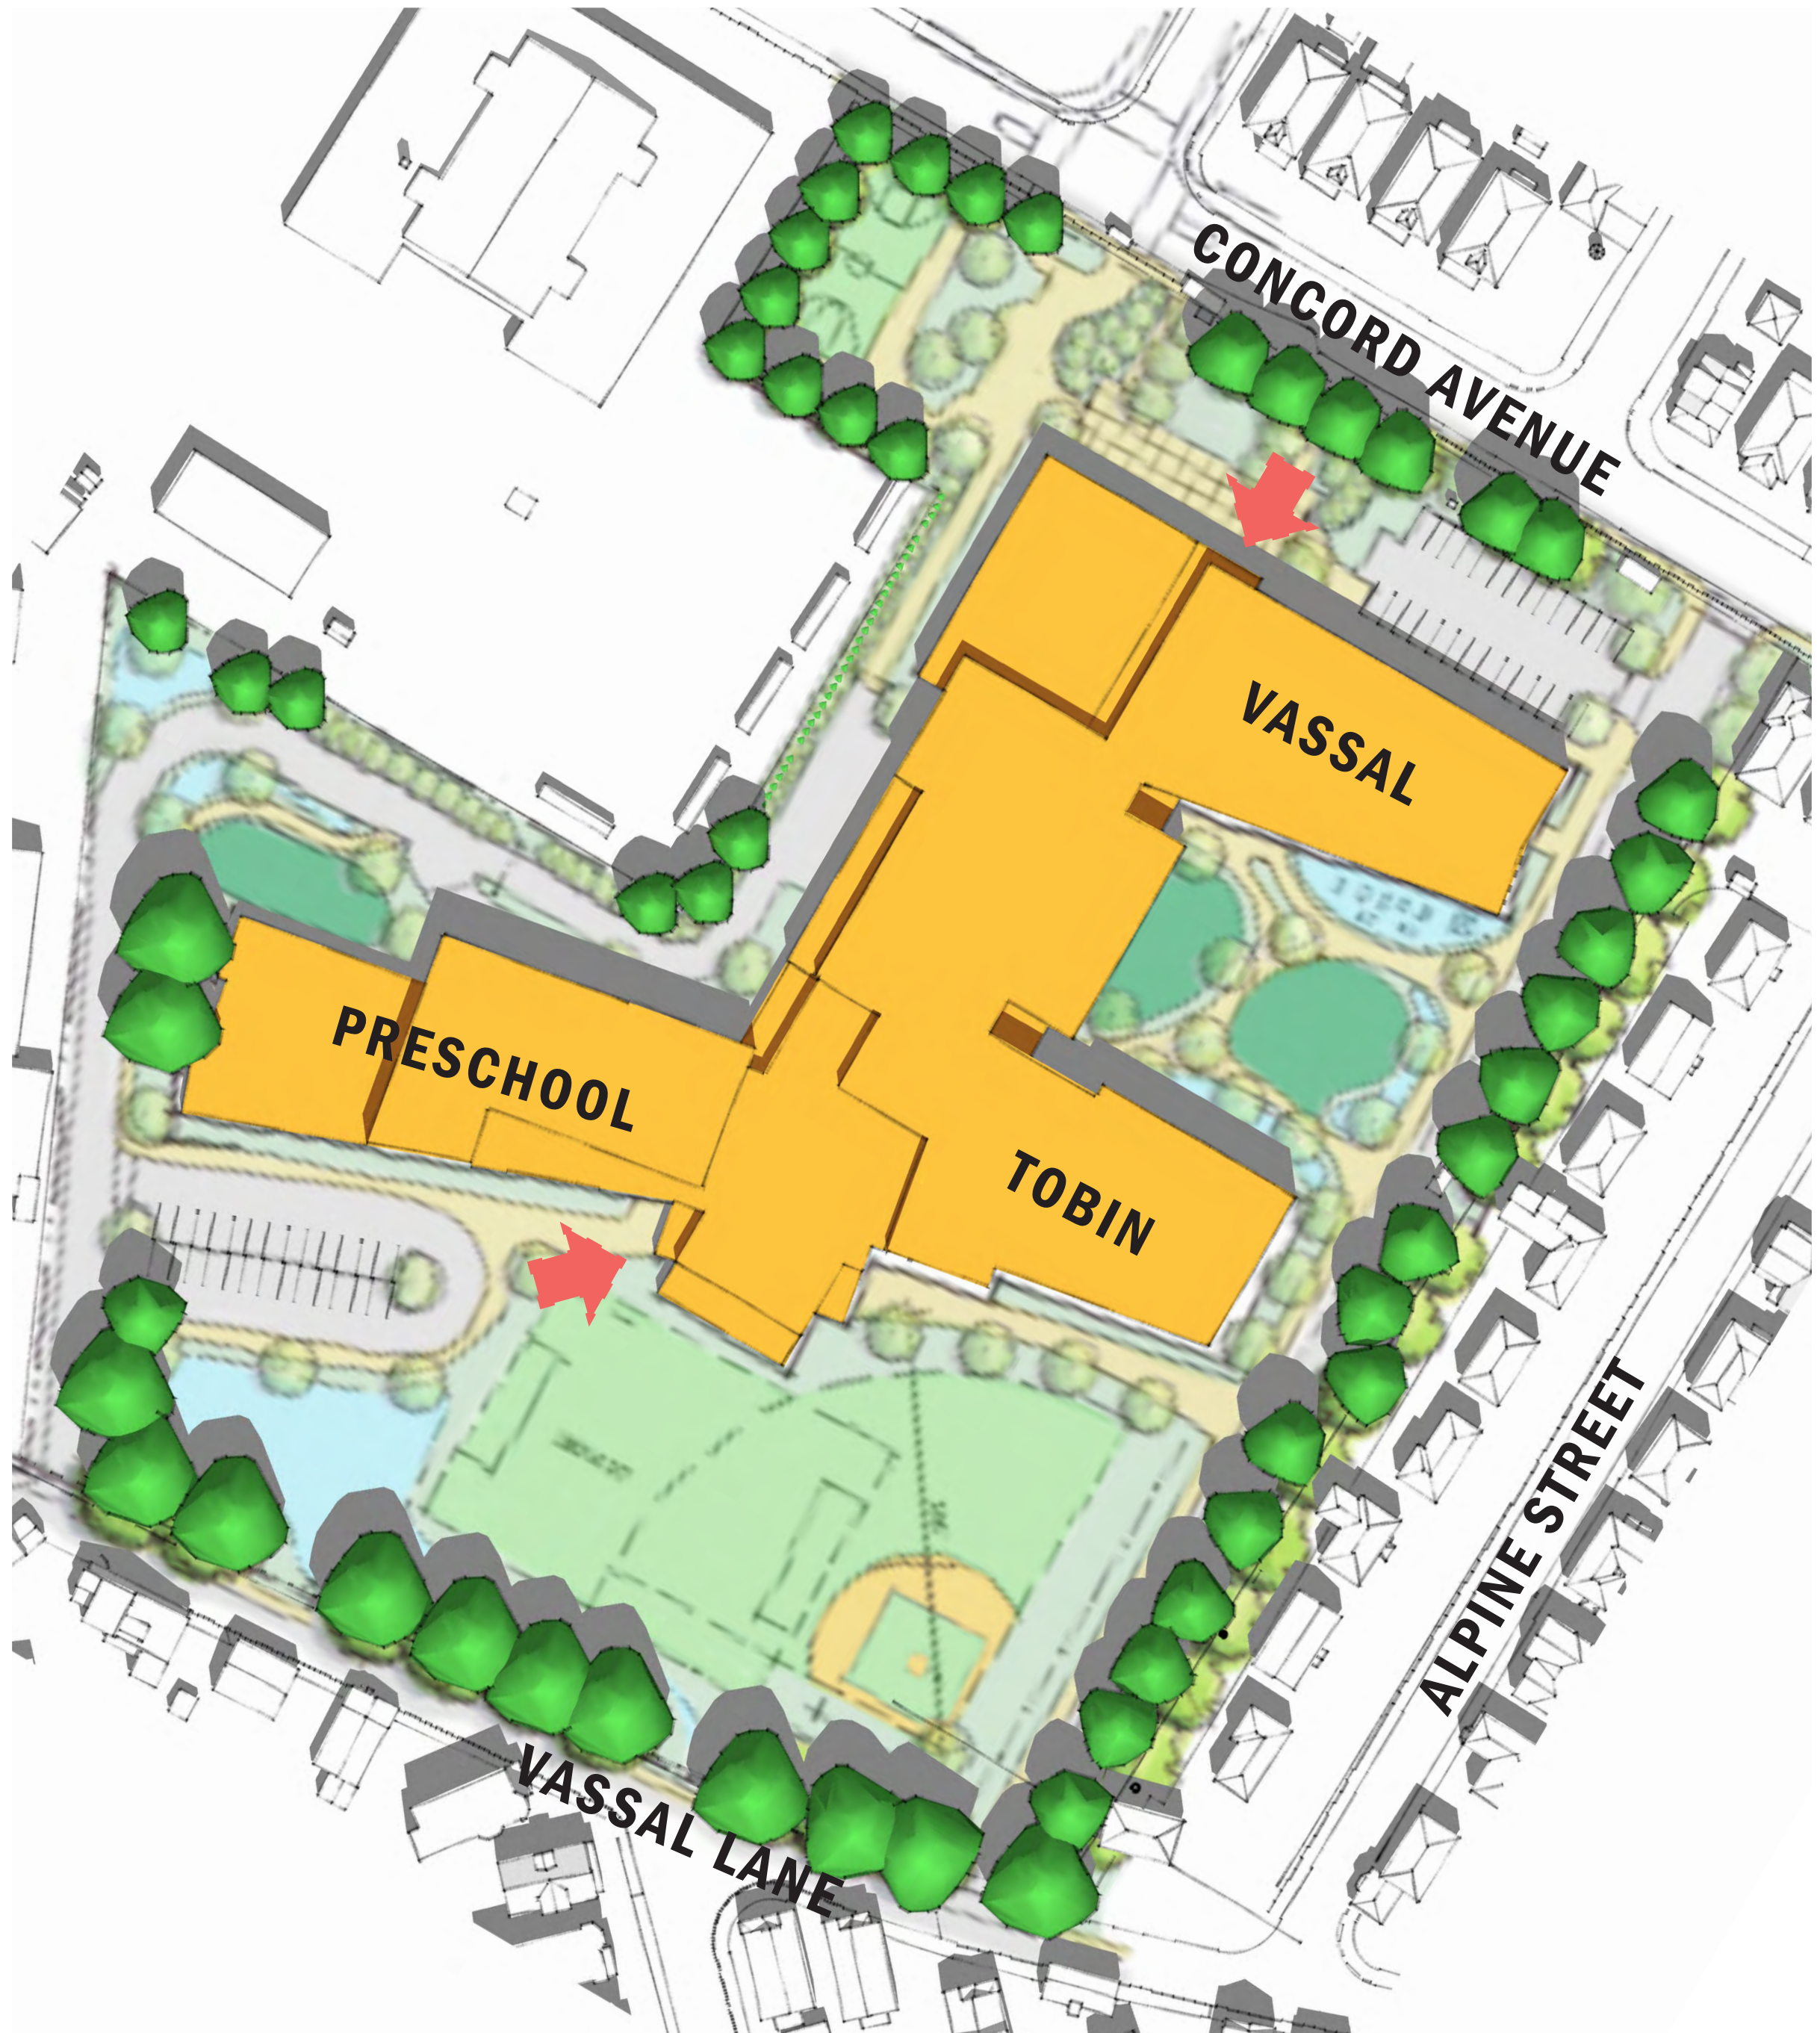
**WINGS**  
 TOTAL BUILDING AREA (GROSS SQ. FT.) = 278,000  
 BUILDING FOOTPRINT (SQ. FT.) = 106,500  
 VEHICULAR CIRCULATION (SQ. FT.)= 58,400  
 OPEN SPACE (ACRES)= 5.4

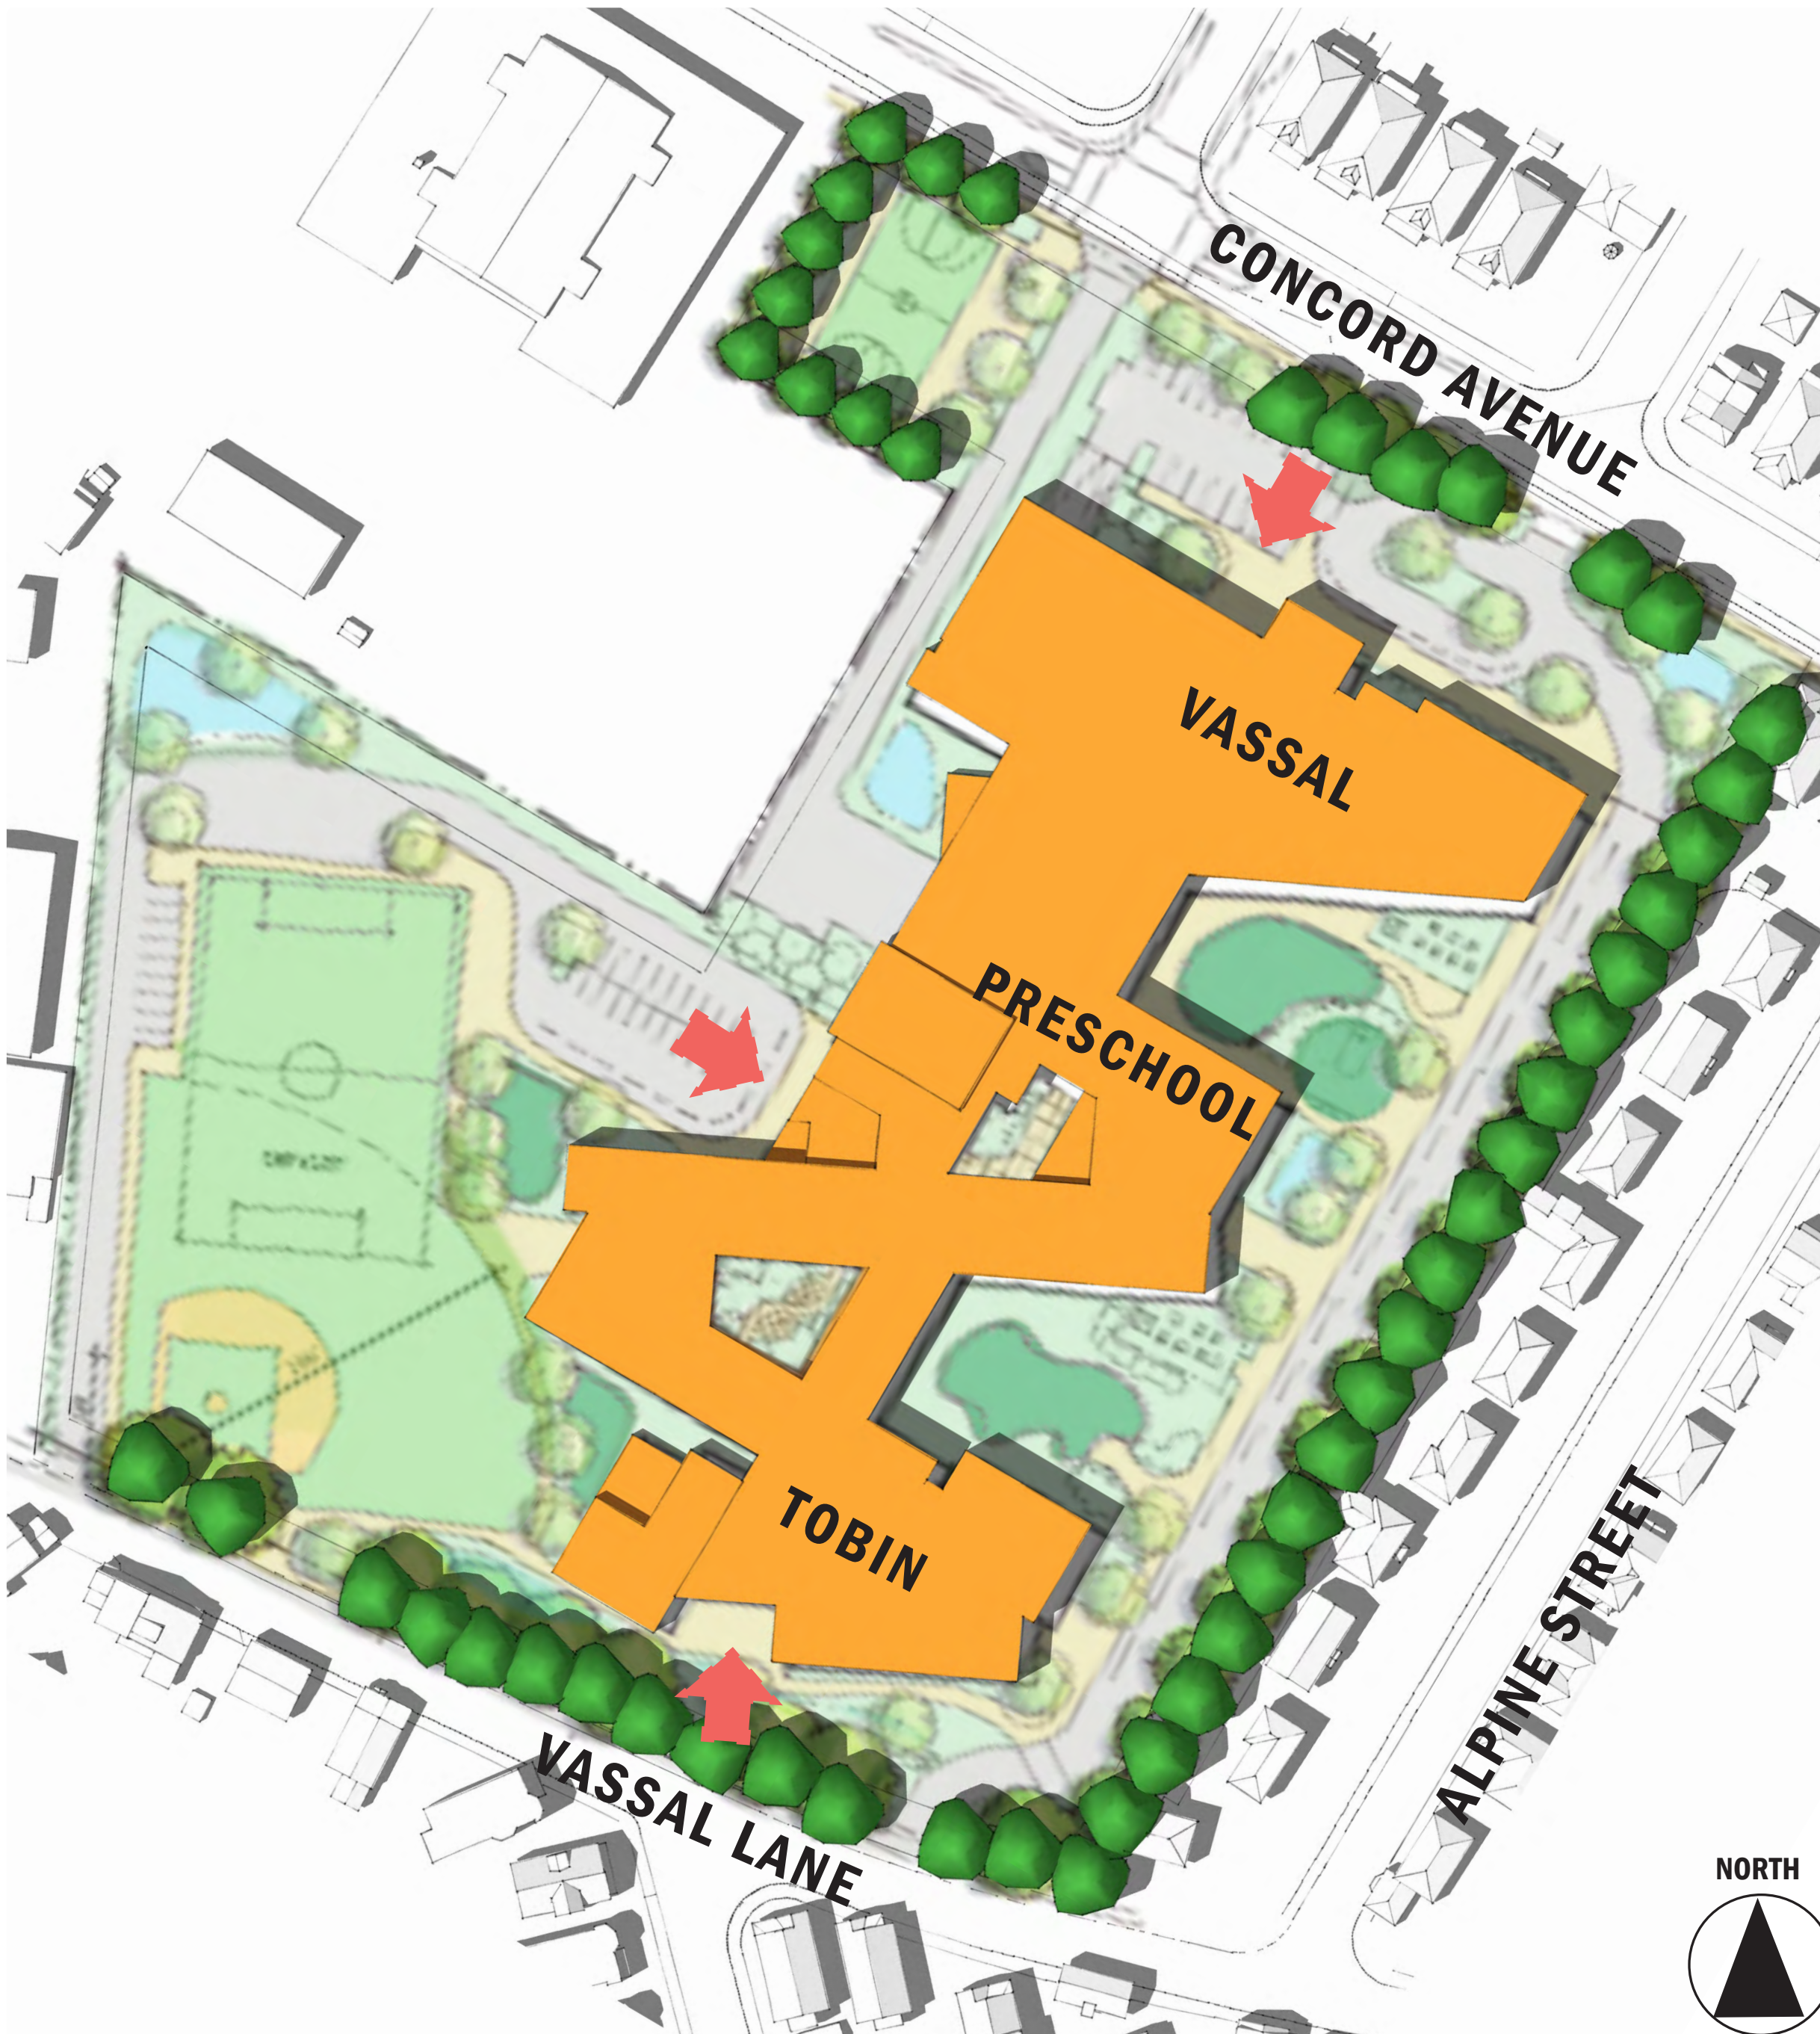
**PAVILIONS**  
 TOTAL BUILDING AREA (GROSS SQ. FT.) = 297,400  
 BUILDING FOOTPRINT (SQ. FT.) = 108,800  
 VEHICULAR CIRCULATION (SQ. FT.)= 62,600  
 OPEN SPACE (ACRES)= 5.2

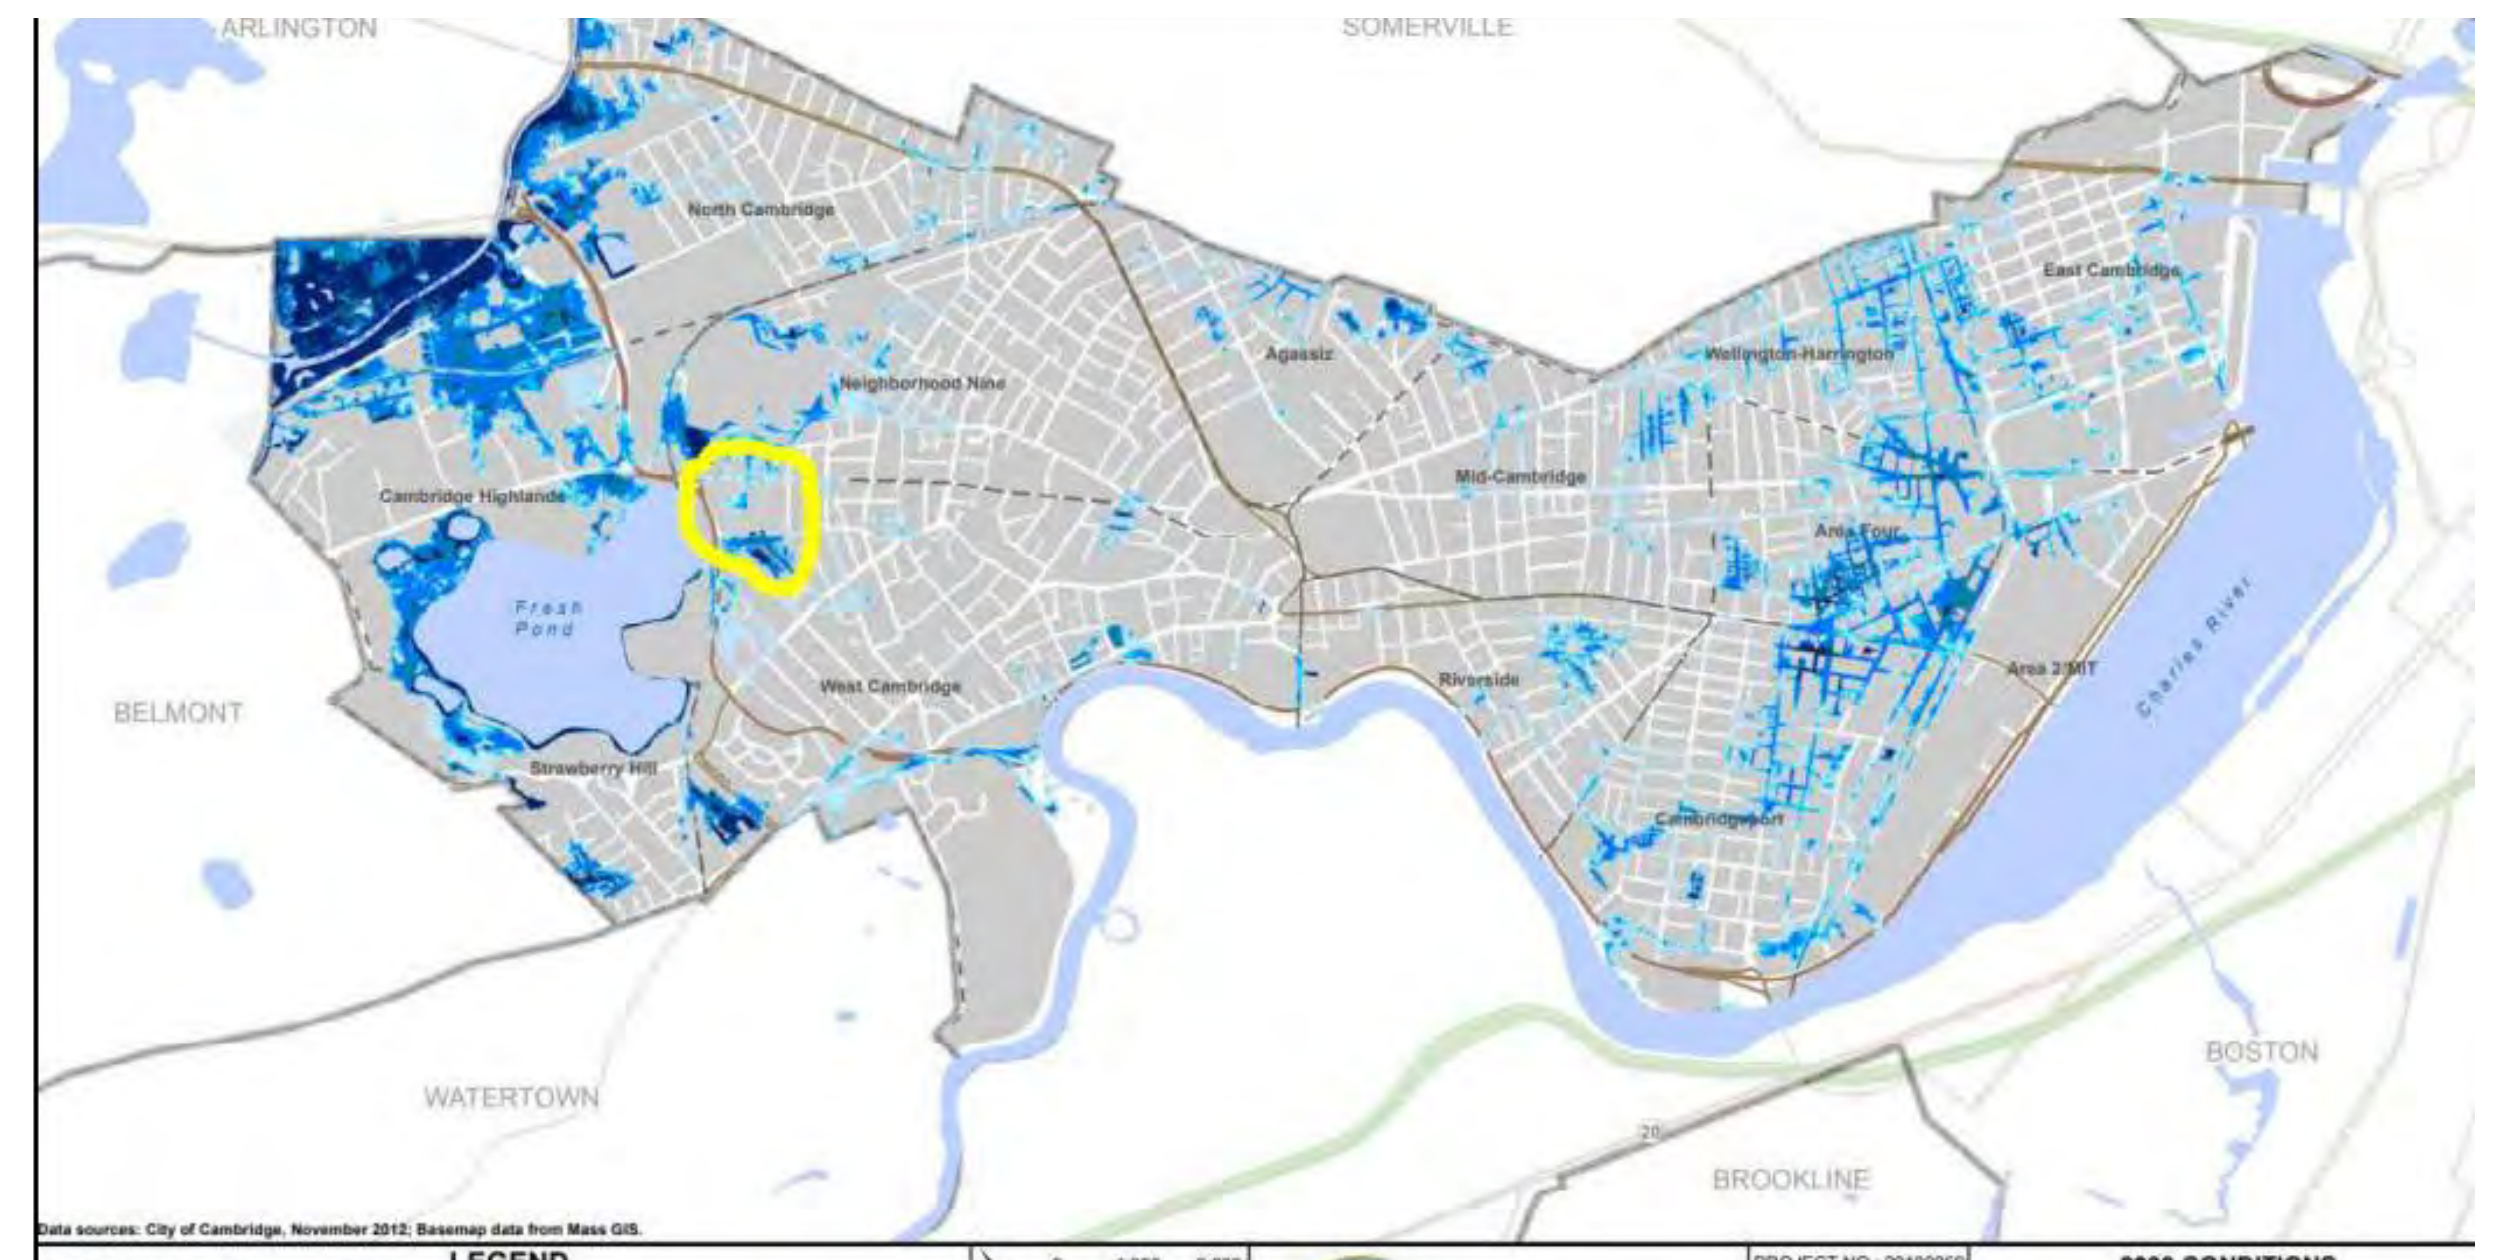
CLIMATE CHANGE VULNERABILITY ASSESSMENT FOR 100-YEAR 2030 CONDITIONS
