**OPTION 1: RENOVATION / ADDITION**  
TOBIN MONTESSORI VASSAL LANE SCHOOL

**OPTION 2: WINGS**  
TOBIN MONTESSORI VASSAL LANE SCHOOL

**OPTION 3: PAVILIONS**  
TOBIN MONTESSORI VASSAL LANE SCHOOL

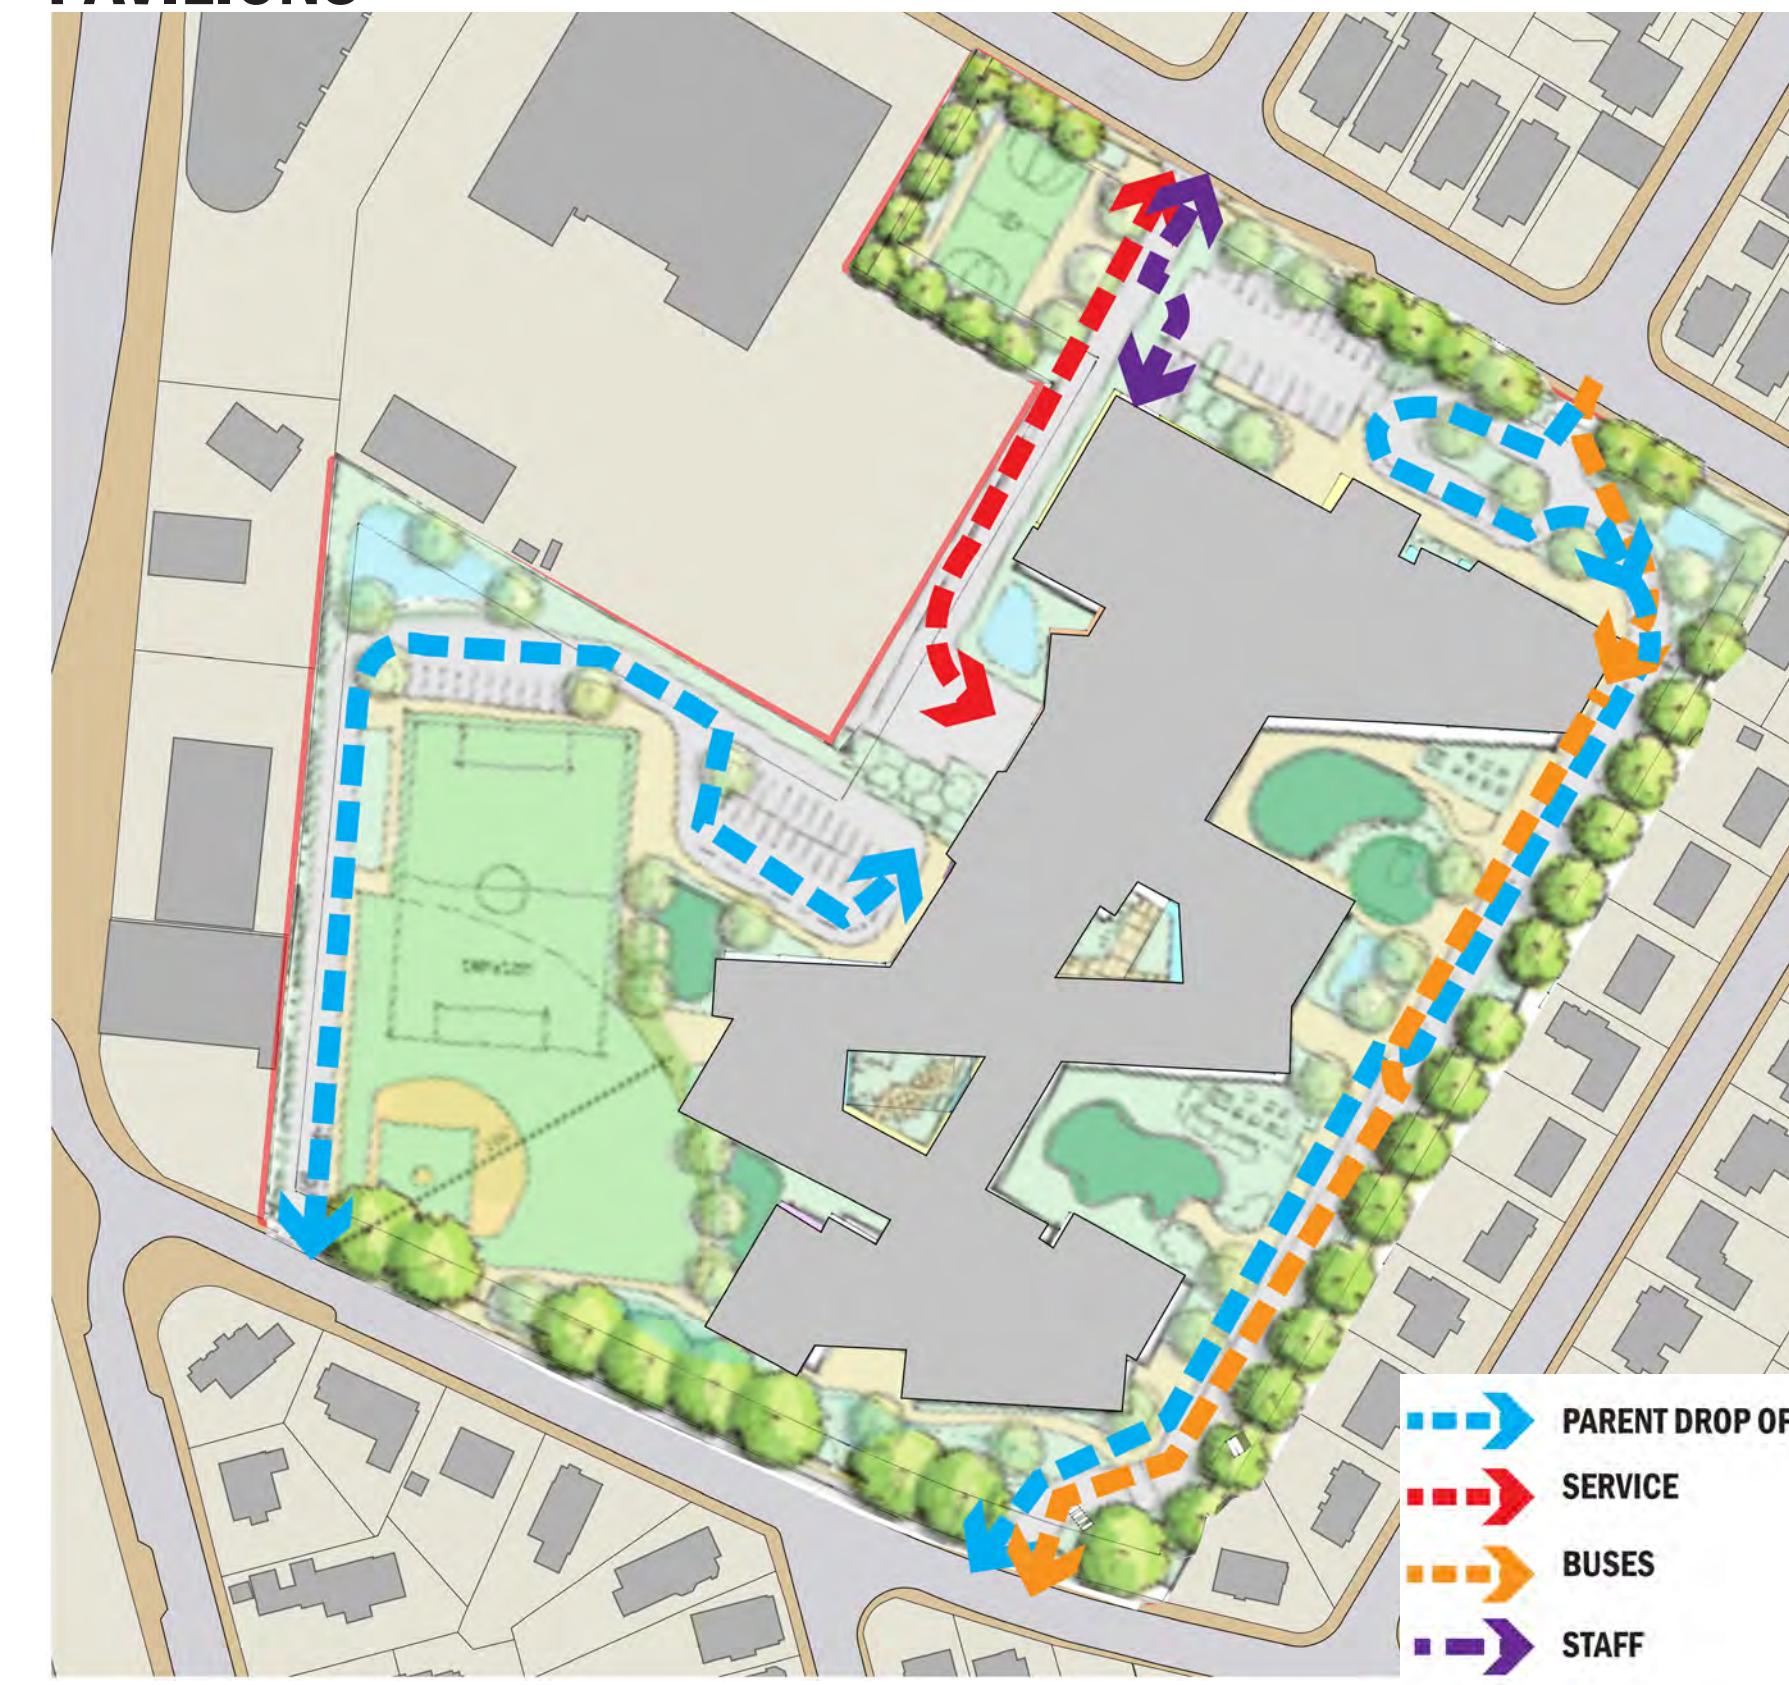
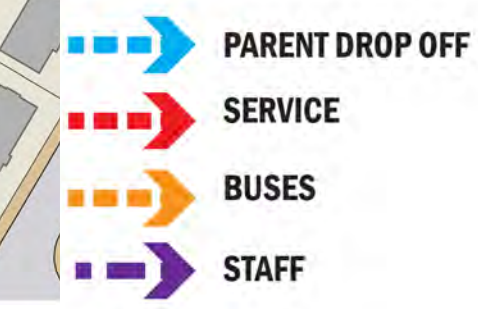
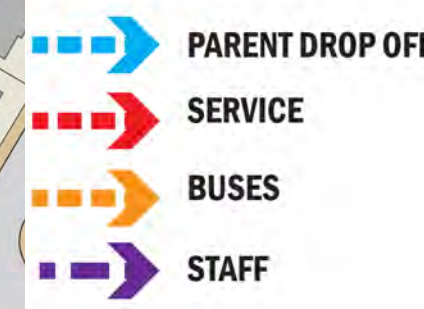
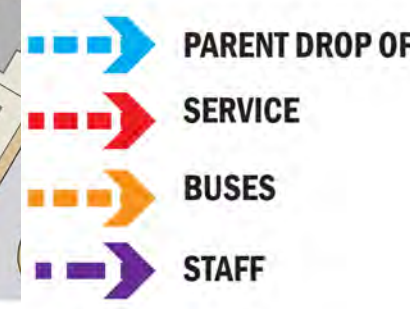
**TRAFFIC FLOW**

Infrastructure Type	Existing Condition	Incremental Change	Proposed Condition
Morning Peak Period	Parent Drop-Off/Pick-Up (Short-Term Parking)	Up to 12 vehicles	11 Additional Spaces	Up to 23 vehicles
	School Bus Staging	Up to 24 vehicles	15 Additional Spaces	Up to 39 vehicles
	Van Staging	Up to 2 Buses	No Expected Increases	Up to 2 Buses
	Parent Drop-Off/Pick-Up (Short-Term Parking)	Up to 2 Vans	No Expected Increases	Up to 2 Vans
Afternoon Peak Period	Parent Drop-Off/Pick-Up (Short-Term Parking)	Up to 20 vehicles	6 Additional Spaces	Up to 26 vehicles
	School Bus Staging	Up to 6 Buses	No Expected Increases	Up to 6 Buses
	Van Staging	Up to 3 Vans	No Expected Increases	Up to 3 Vans
	Pedestrian Amenities	Pedestrians dispersed throughout and from the neighborhood during arrival/dismissal times	No Change	Suggest maintaining similar pedestrian circulation and accommodating pedestrians in a safe environment separate from vehicular activity

Staff Parking	Approximately 80 Vehicles Parked	20 Additional Vehicles Parked	100 Parking Spaces to Serve Staff
