# Little Fresh Pond Shoreline Access Restoration Project

2020 Existing  
Conditions Photo

13 April 2021

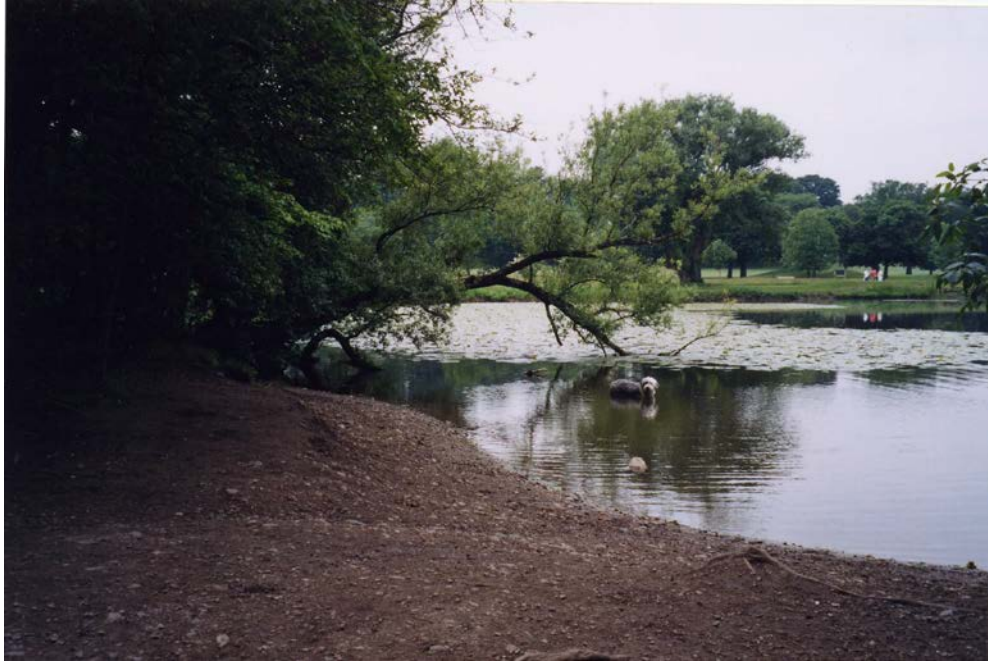
PHOTO OF ERODED AND COMPACTED CONDITIONS  
(2004)

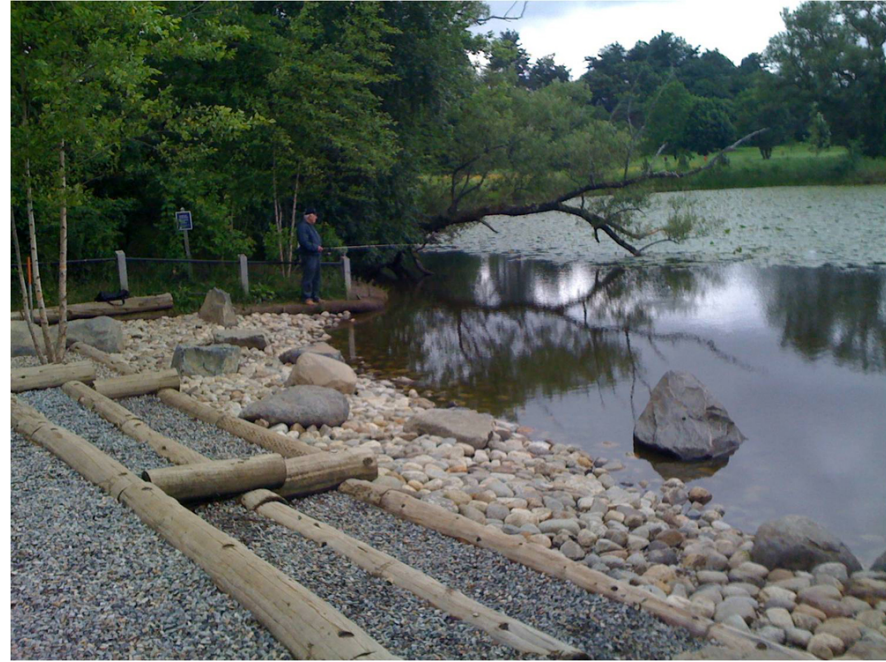
PHOTO OF NEWLY CONSTRUCTED SHORELINE  
(2007)

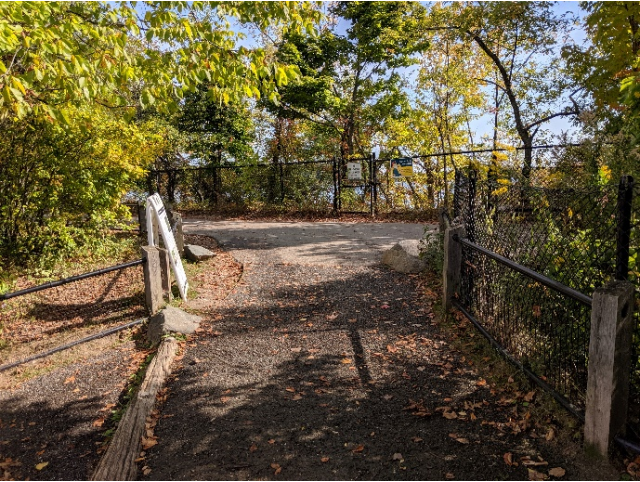
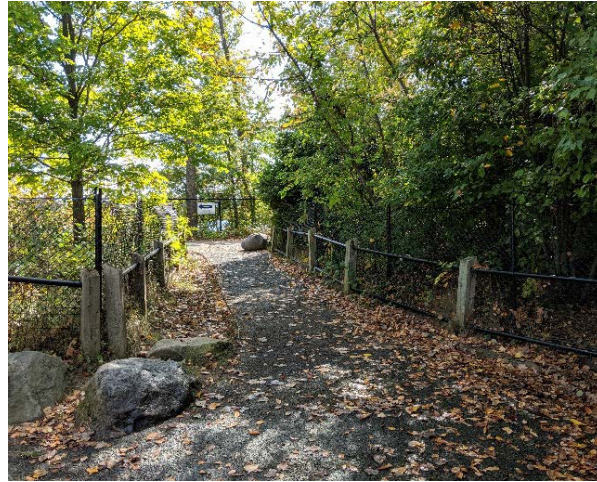
ACCESS POINTS FROM PERIMETER ROAD SHOWING FLEXIBLE  
POROUS PAVING PATH

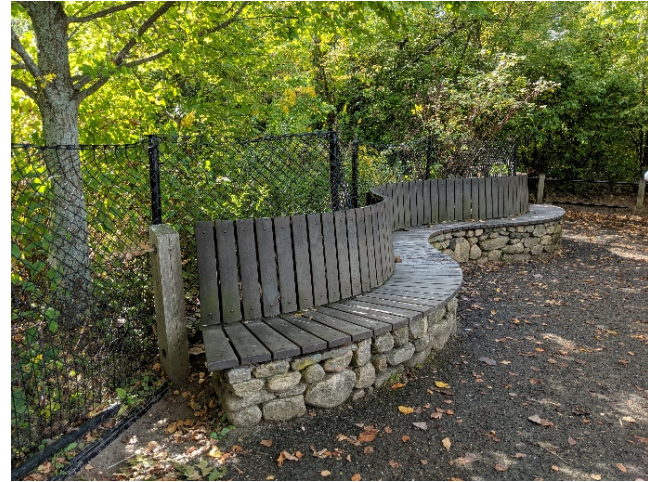
TIMBER AND STONE BENCH

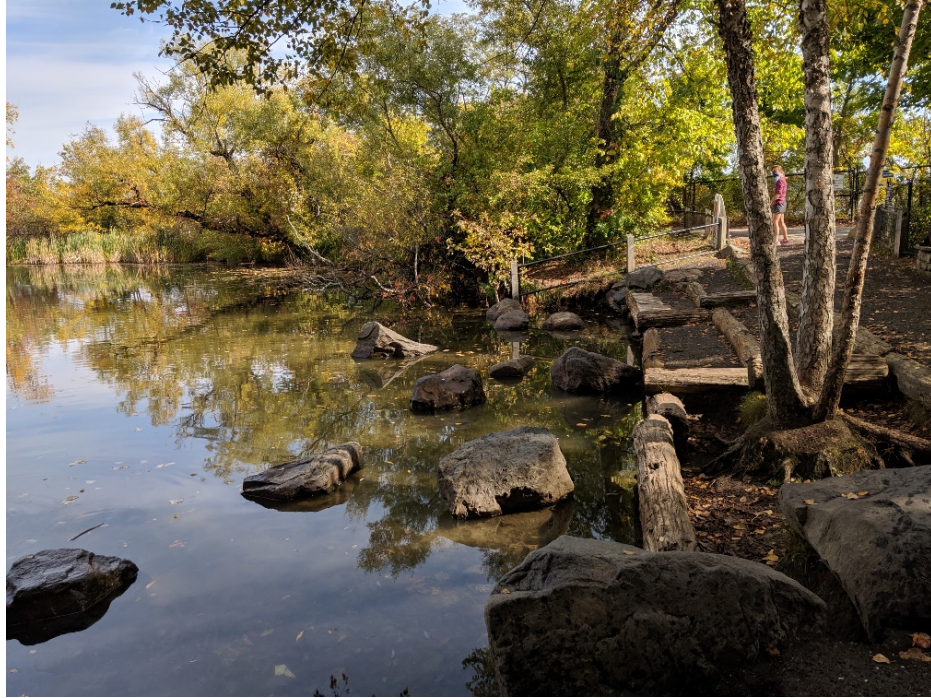
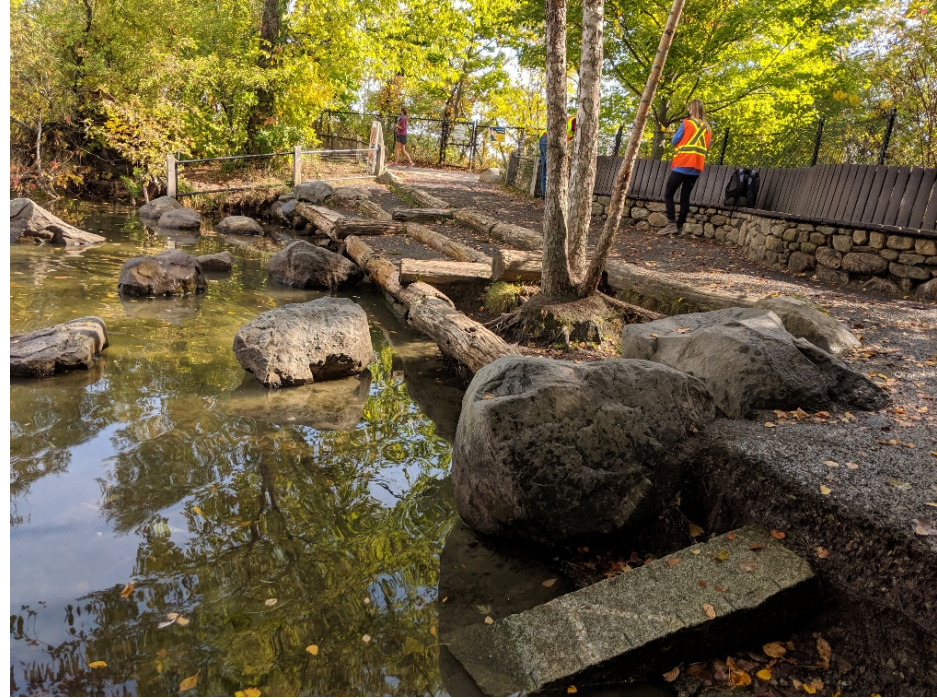
SHORELINE CONDITIONS WITH DESTABILIZED CEDAR LOG AND GRANITE CURB EDGING (2020)

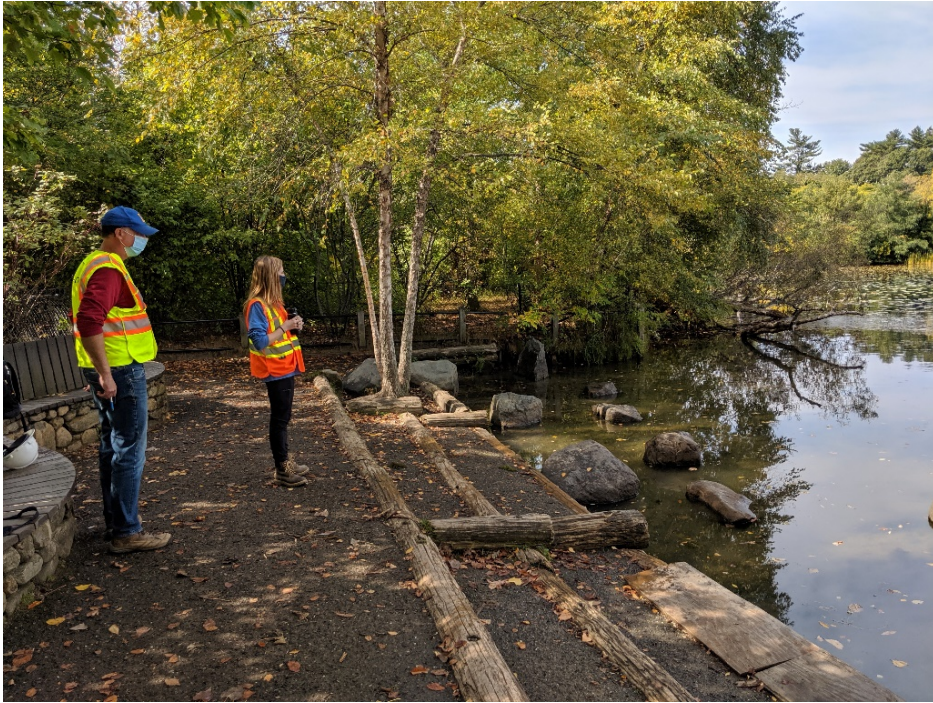
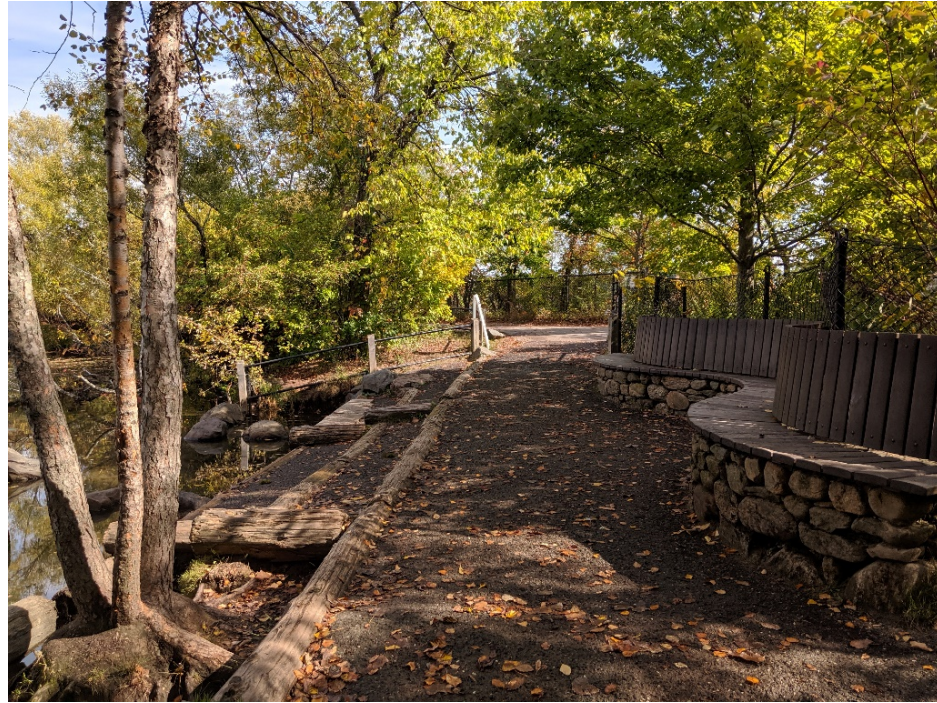
SHORELINE CONDITIONS WITH DESTABILIZED LOG AND GRANITE CURB EDGING (2020)

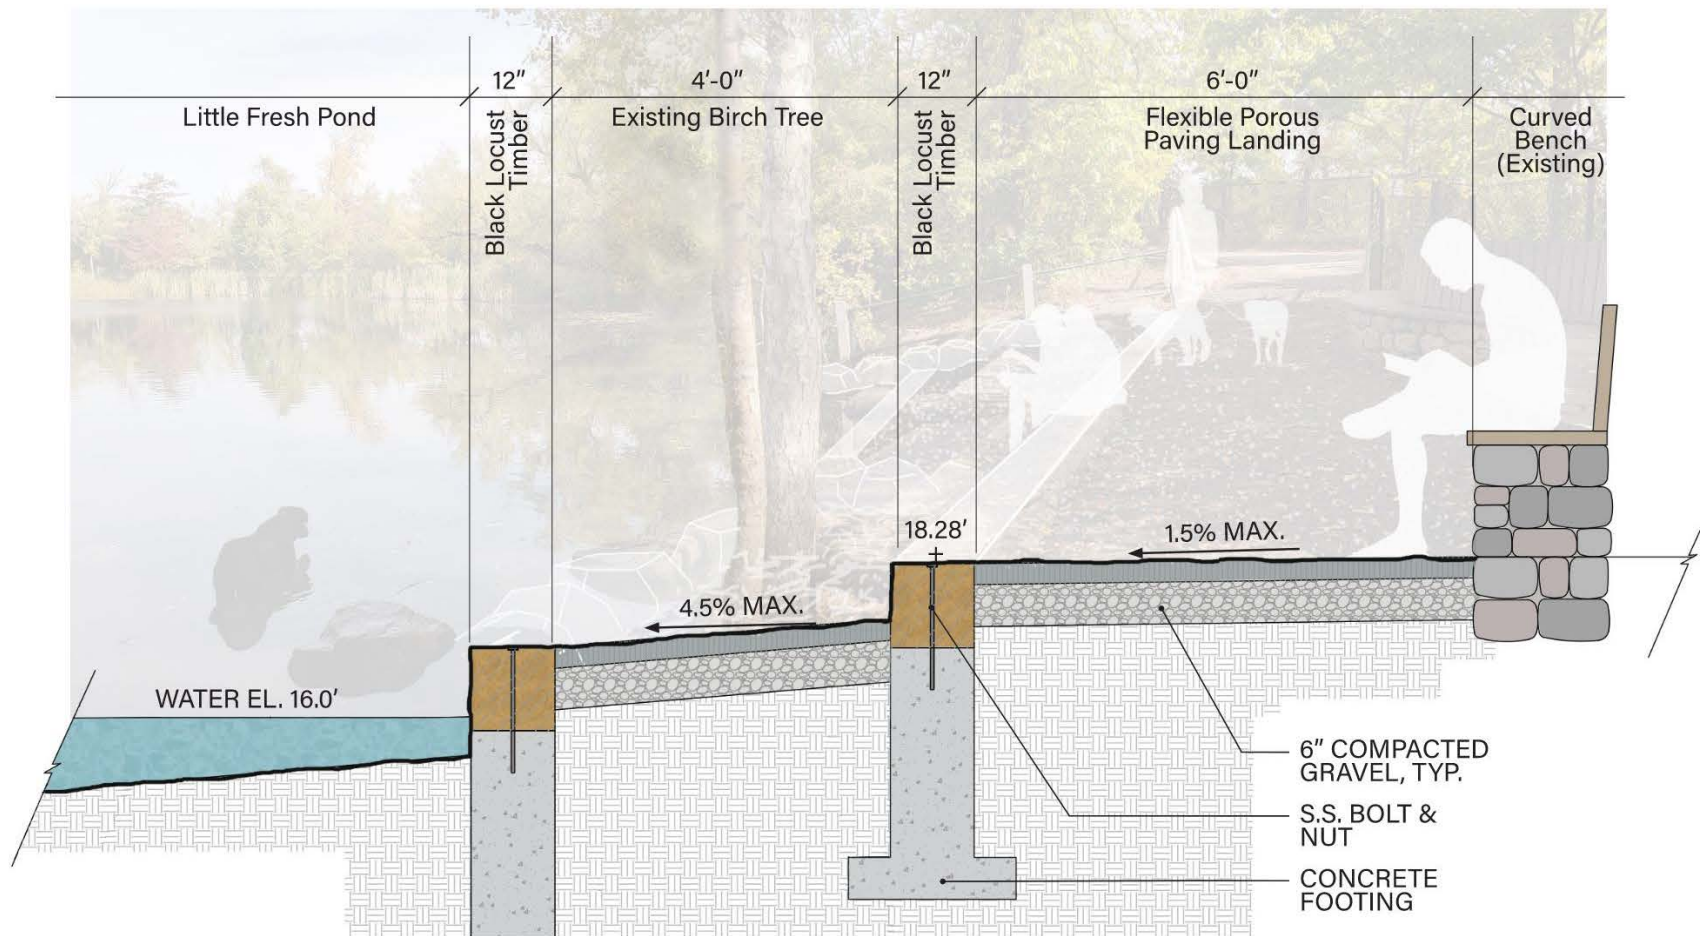
**PERFERRED OPTION - SECTION AT LITTLE FRESH POND DOG BEACH**
