**PRELIMINARY
LANDMARK DESIGNATION REPORT**

**Lechmere National Bank Building
225/227 Cambridge Street, East Cambridge, Mass.**

Sarah Burks
Cambridge Historical Commission
December 21, 2017

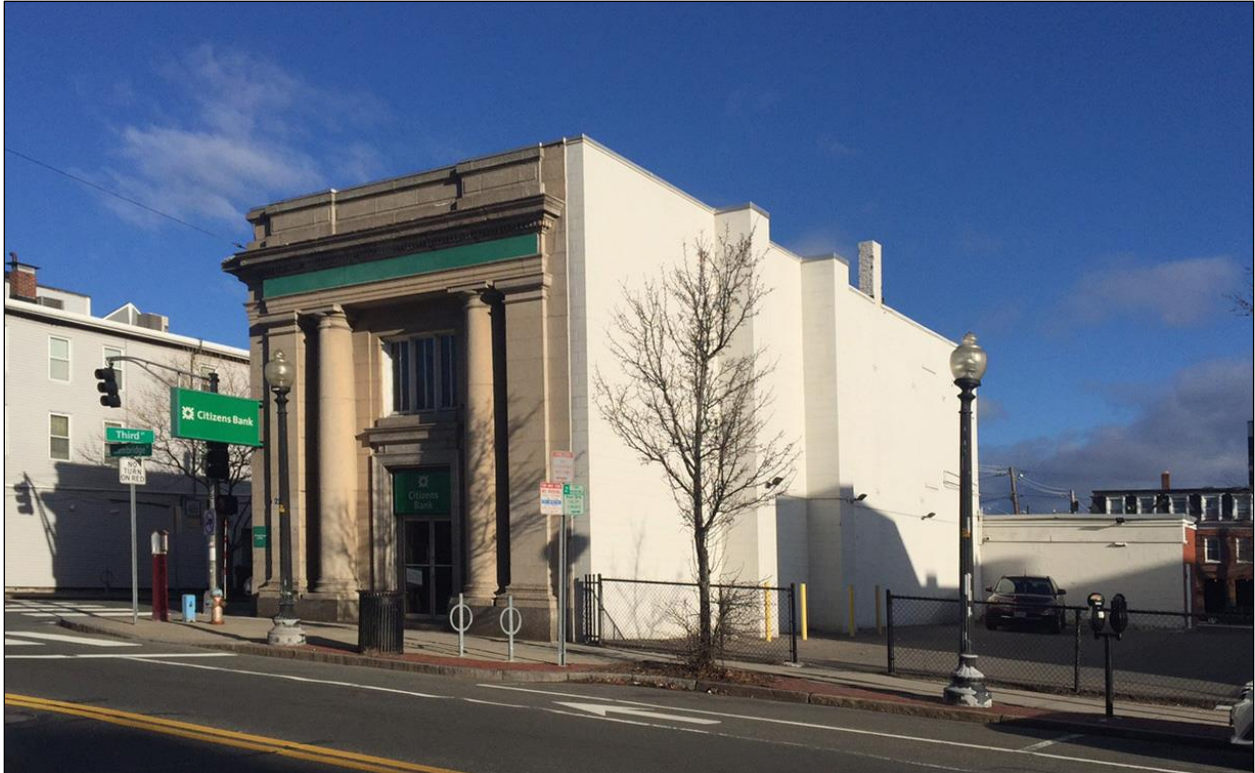
South (front) and east elevations, February 2017.

This one story, 30' high cast stone building has frontage of 27 feet on Cambridge Street and 71 feet on Third Street. The bank entry is flanked by monumental Doric columns and pilasters. The base course and door trim are polished Deer Isle granite. A large three-part wood transom is centered over the doors. The classical temple design continues on the west side facing Third Street with four full-height divided-light windows providing light to the banking hall. The east wall, which was once a party wall with another bank building, is windowless. A projecting cornice with a dentil band is topped by a two-course paneled parapet. The bank was designed by architect Thomas M. James and built for Lechmere National Bank in 1917-18. James also designed the East Cambridge Savings Bank at 292 Cambridge Street in 1931. A low addition constructed on the rear (north) wall in 1961 served a drive-in teller and provided an entrance from the parking lot. This addition was designed by architects Voltz & Kimberley.

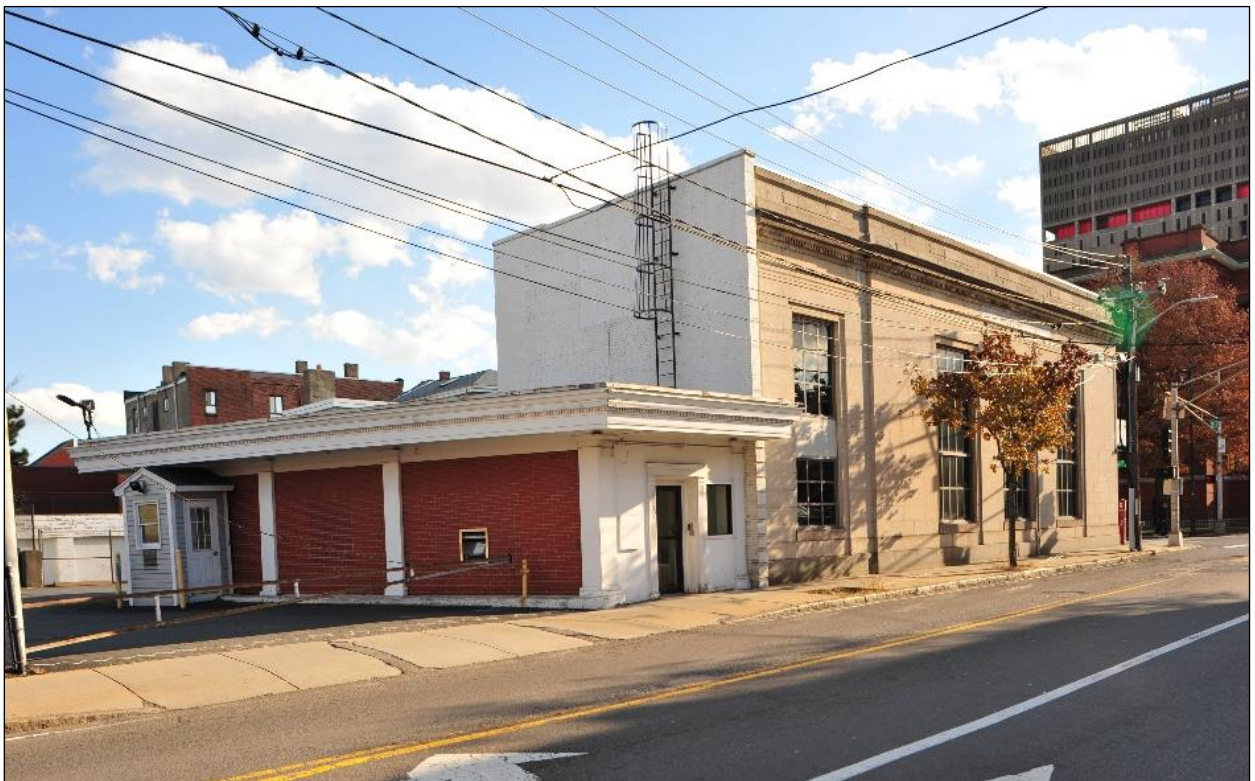
North (rear) elevation, November 2017. Rear addition (1961) is to be removed.

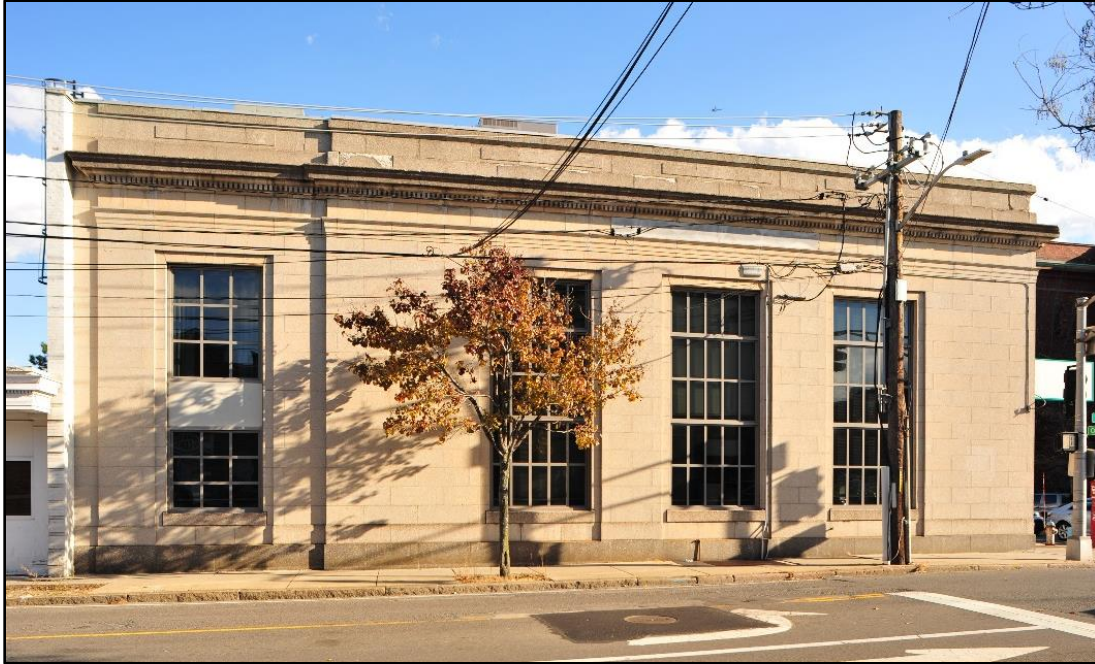
West elevation, November 2017. Cornice deterioration from water damage is evident.

The bank is in good condition with the exception of water damage to the parapet and cornice, which is most evident on the west side. The cast stone, called “composite granite” in the contemporary newspaper descriptions, has badly weathered in some areas, but not in a way that impacts the structural stability of the building. The original incised signs above the entry and along Third Street have been covered with later sign boards.

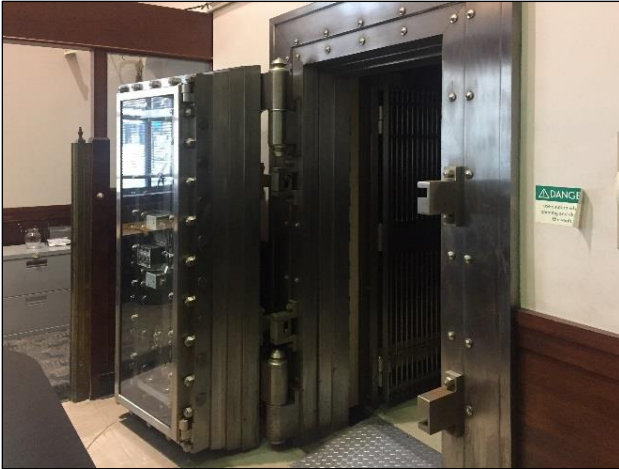
Bank vault.

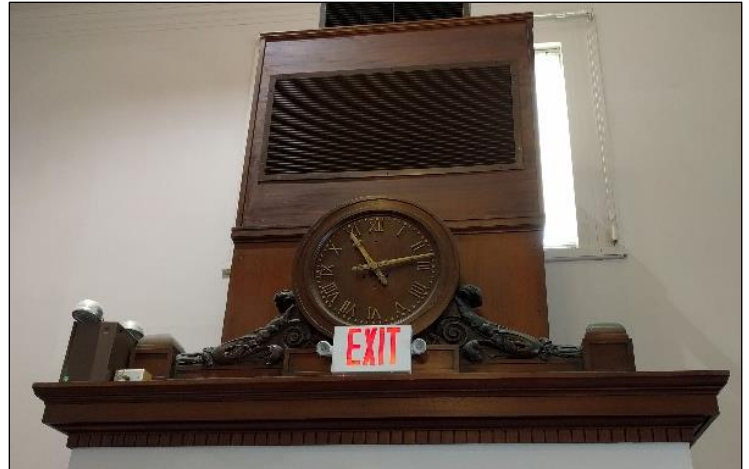
Clock over entry doors (top right) and vault (middle).

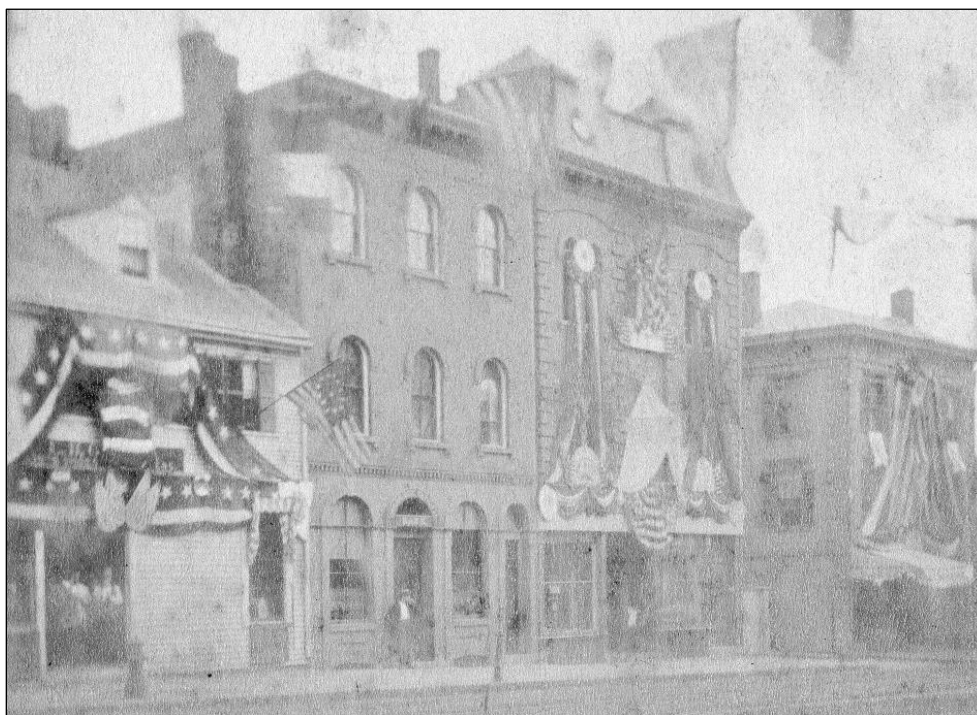
North side of Cambridge Street, corner of Third in an 1875 stereopticon view.

Hovey's grocery store is at left. The Cambridge National Bank is shown with round arched windows. The Odd Fellows hall at center has a mansard roof, and 207-209 Cambridge Street (Gould House and Bakery) is at the far right.

The “missing teeth” in the block today, between the bank and 207-209 Cambridge Street, include the three-story brick building constructed for the Cambridge National Bank in 1864 at 221 Cambridge Street and a three-story Mansard social hall built for the International Order of Odd Fellows in 1862 at 215-217 Cambridge Street. These two buildings were demolished in 1971 and another four-story brick building of 1889 at 203 Cambridge was demolished in 1976. When these buildings were replaced by parking lots, the block lost its grandeur and the remaining buildings were left without their commercial context.

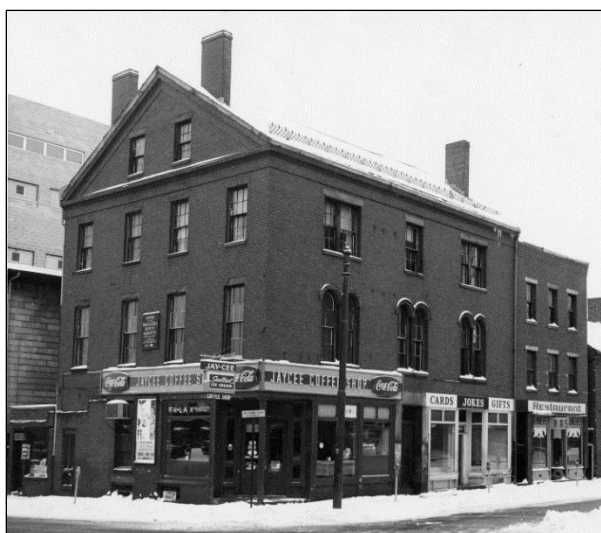
Original Lechmere Bank (1853) at 18-22 Second Street. (Moved from 172 Cambridge Street in 1895).

In 1895, when Middlesex County acquired the site for the present Registry of Deeds, the [original Lechmere] bank was moved to the southeast corner of the same intersection and turned so its original Cambridge Street façade faced Second Street. It was demolished in 1965.

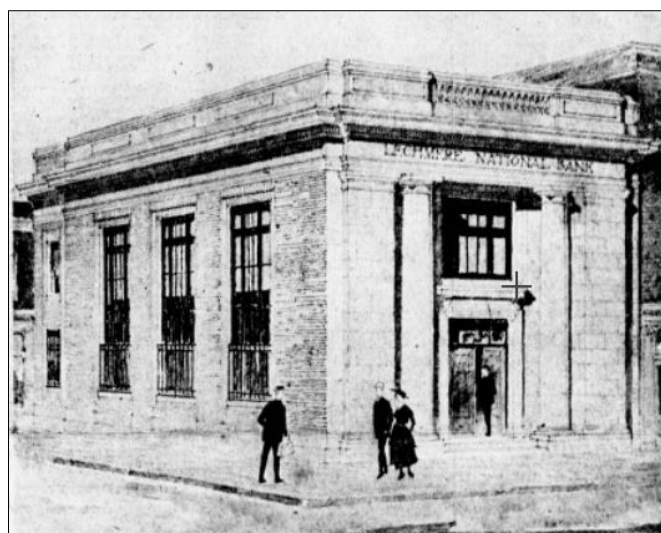
Lechmere National Bank as originally designed. (Cambridge Chronicle, April 14, 1917)

James provided a structure of cast stone in imitation of white limestone, with monumental Doric columns. This Roman temple is the very image of conservative dignity that banks on almost every Main Street sought to emulate in the 1920s. In 1936, Lechmere merged with the National Bank of Malden and the Everett Bank & Trust to form the Middlesex County National Bank, which in turn evolved into BayBank/Middlesex [and eventually into Citizens Bank, the most recent occupant].
