#### Memorandum

Subject: Geotechnical Field Exploration Program and Environmental Site Assessment Tobin School Assessment Cambridge, Massachusetts

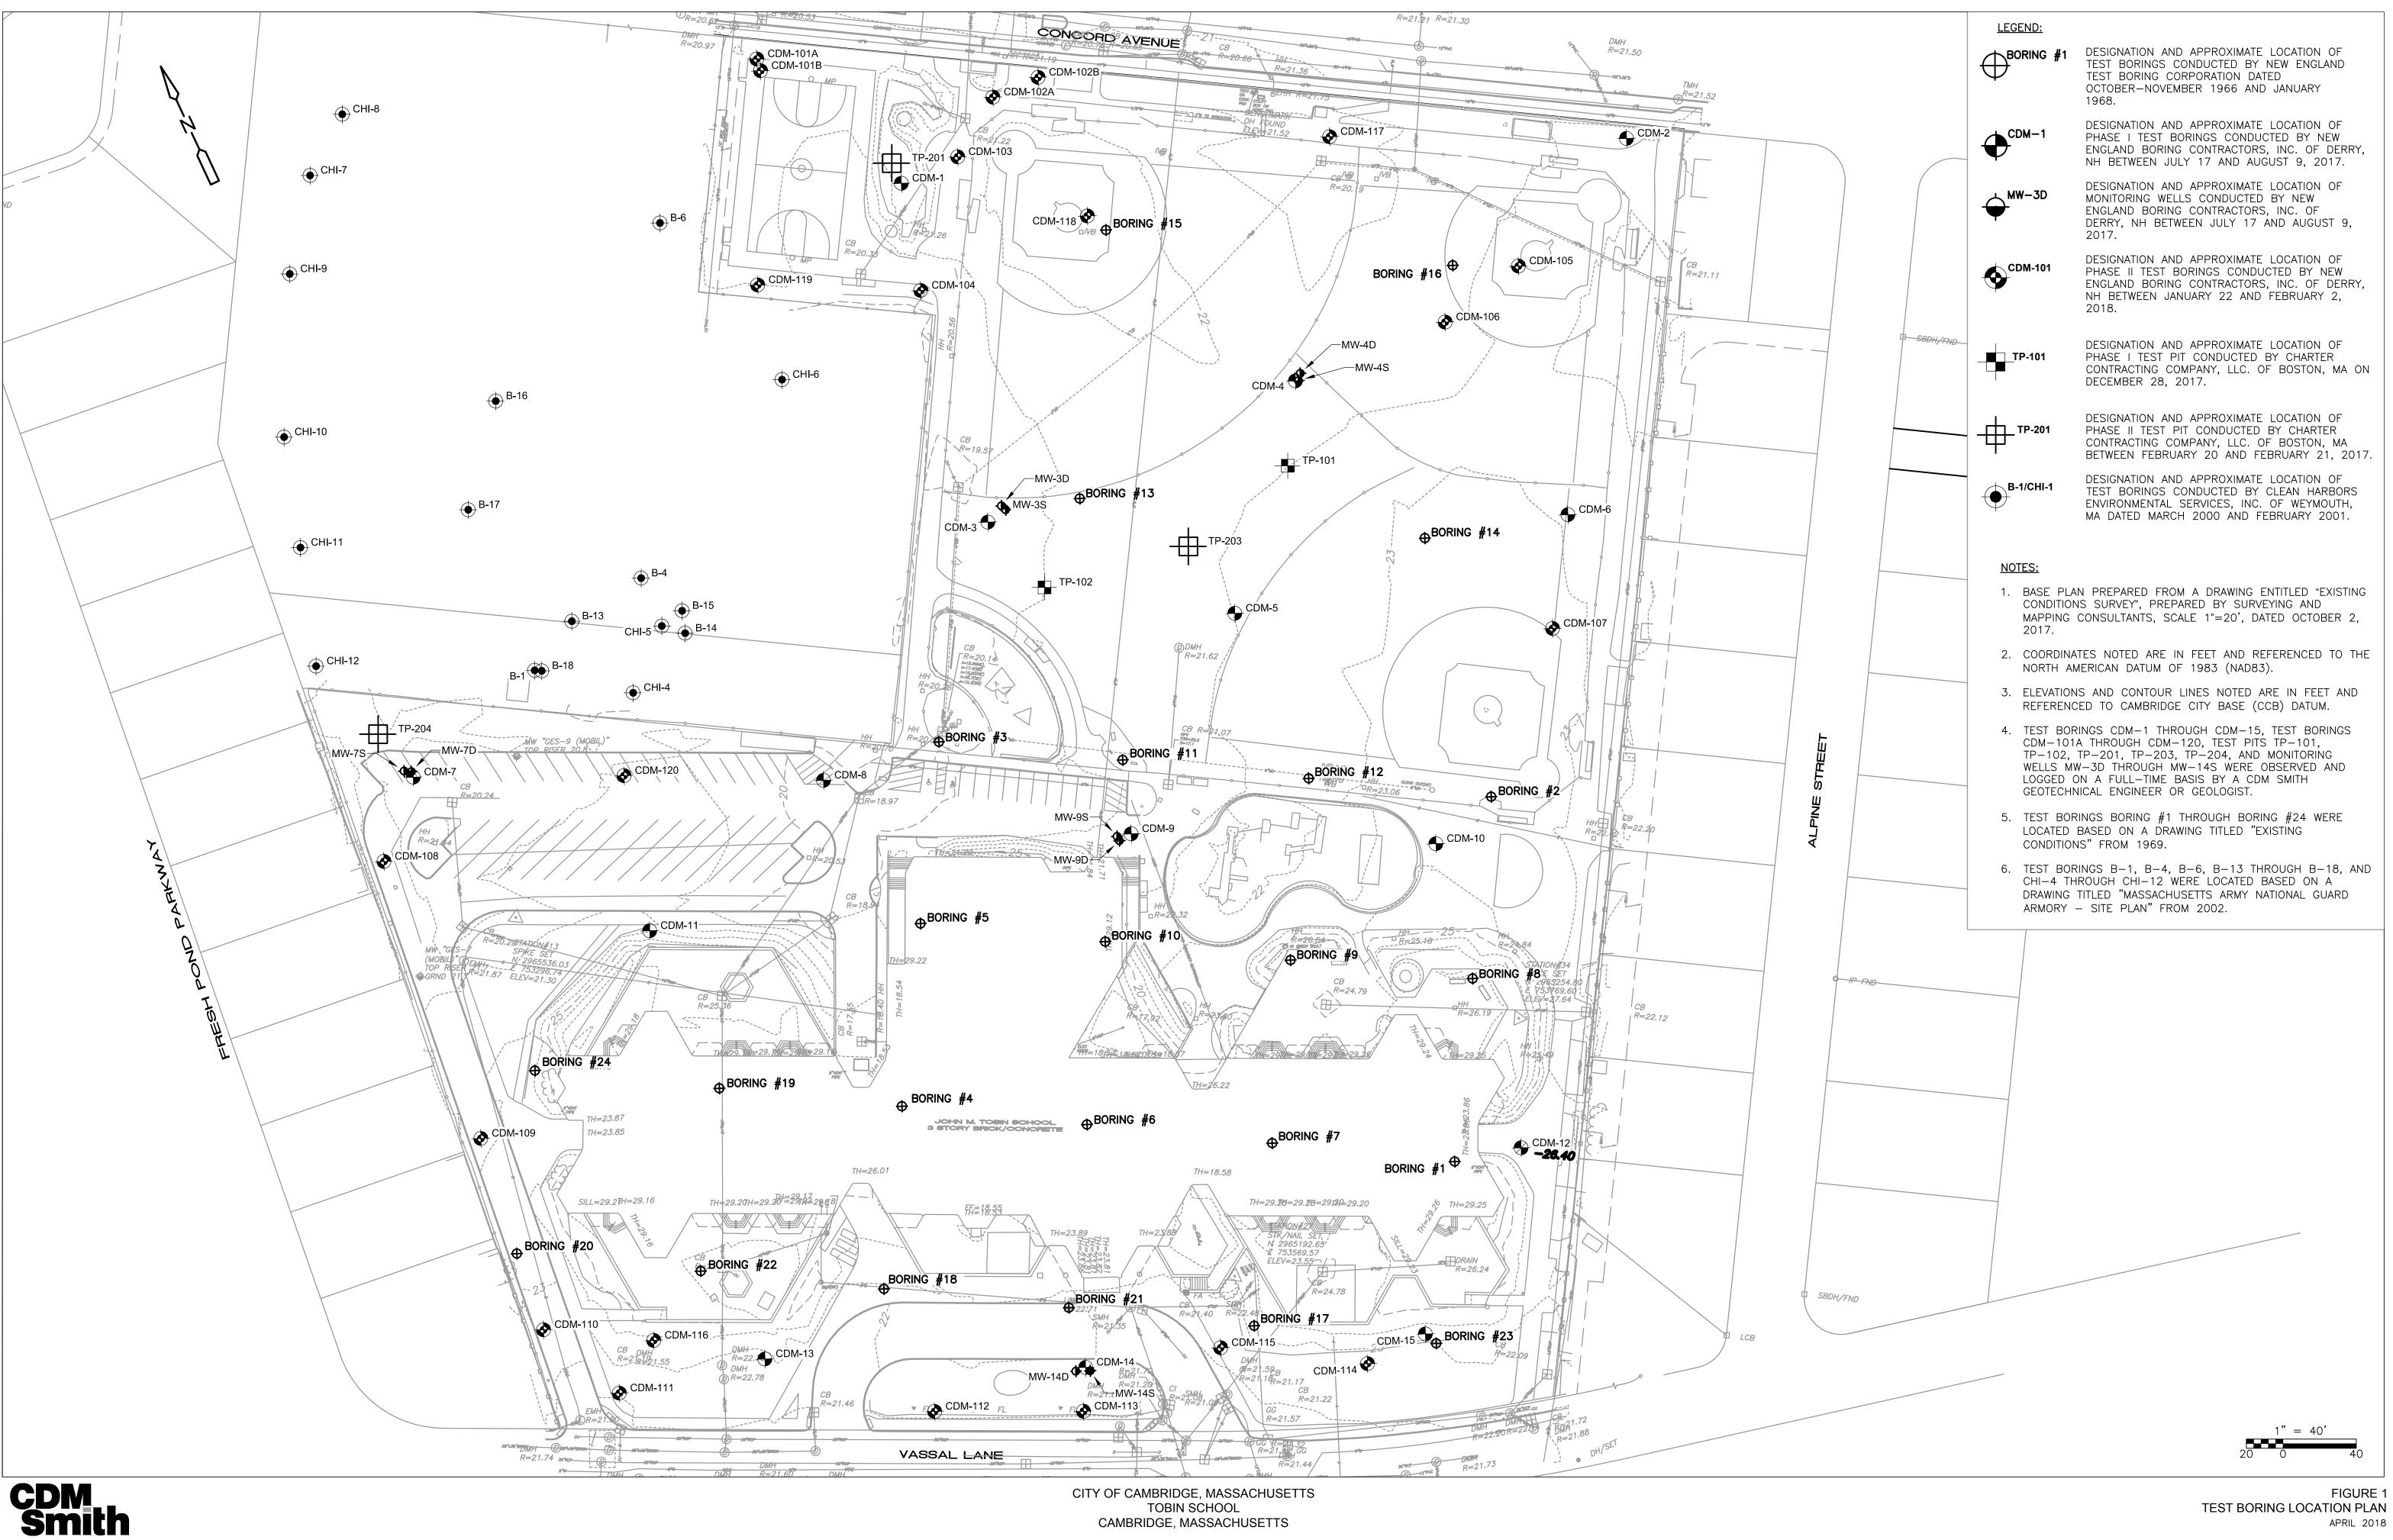
FIGURE 1 TEST BORING LOCATION PLAN APRIL 2018

The approximate locations of the 1966 and 1968 test borings were scaled from available drawings and are shown on **Figure 1**. Test boring logs from the 1966 and 1968 subsurface exploration programs are included in **Attachment B**.

The approximate locations of the 2000 and 2001 test borings were scaled from available drawings and are shown on **Figure 1**. Geoprobe and test boring logs from the 2000 and 2001 subsurface exploration program are included in **Attachment B**.

A two-phase subsurface exploration program was conducted at the site to further investigate the subsurface soil, rock and groundwater conditions at the site, identify the extent of waste materials and collect samples for geotechnical and environmental laboratory testing. The as-drilled test boring locations for Phase 1 were located in the field by survey, Phase 2 locations were located in the field by taping and line of sight from existing site features and are shown on **Figure 1**.

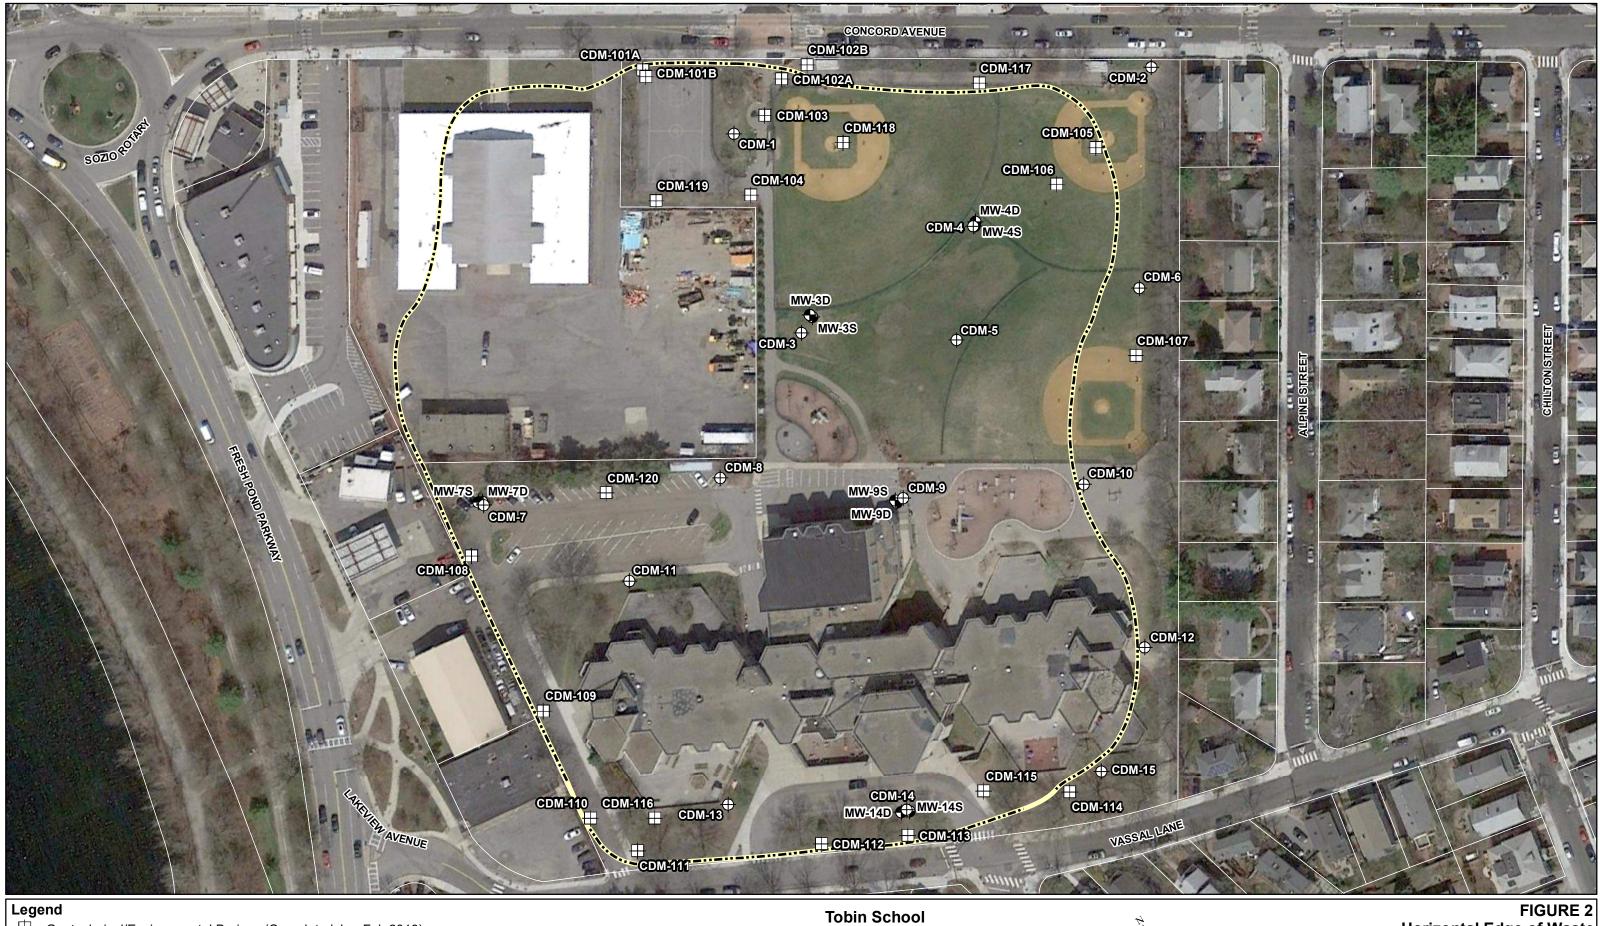
To further investigate and identify the limits, physical composition, and extent of subsurface fill and waste materials, a two-phase test pit program was conducted in December 2017 and February 2018. Test pit locations were located in the field by taping and line of sight from existing site features and are shown on **Figure 1**.

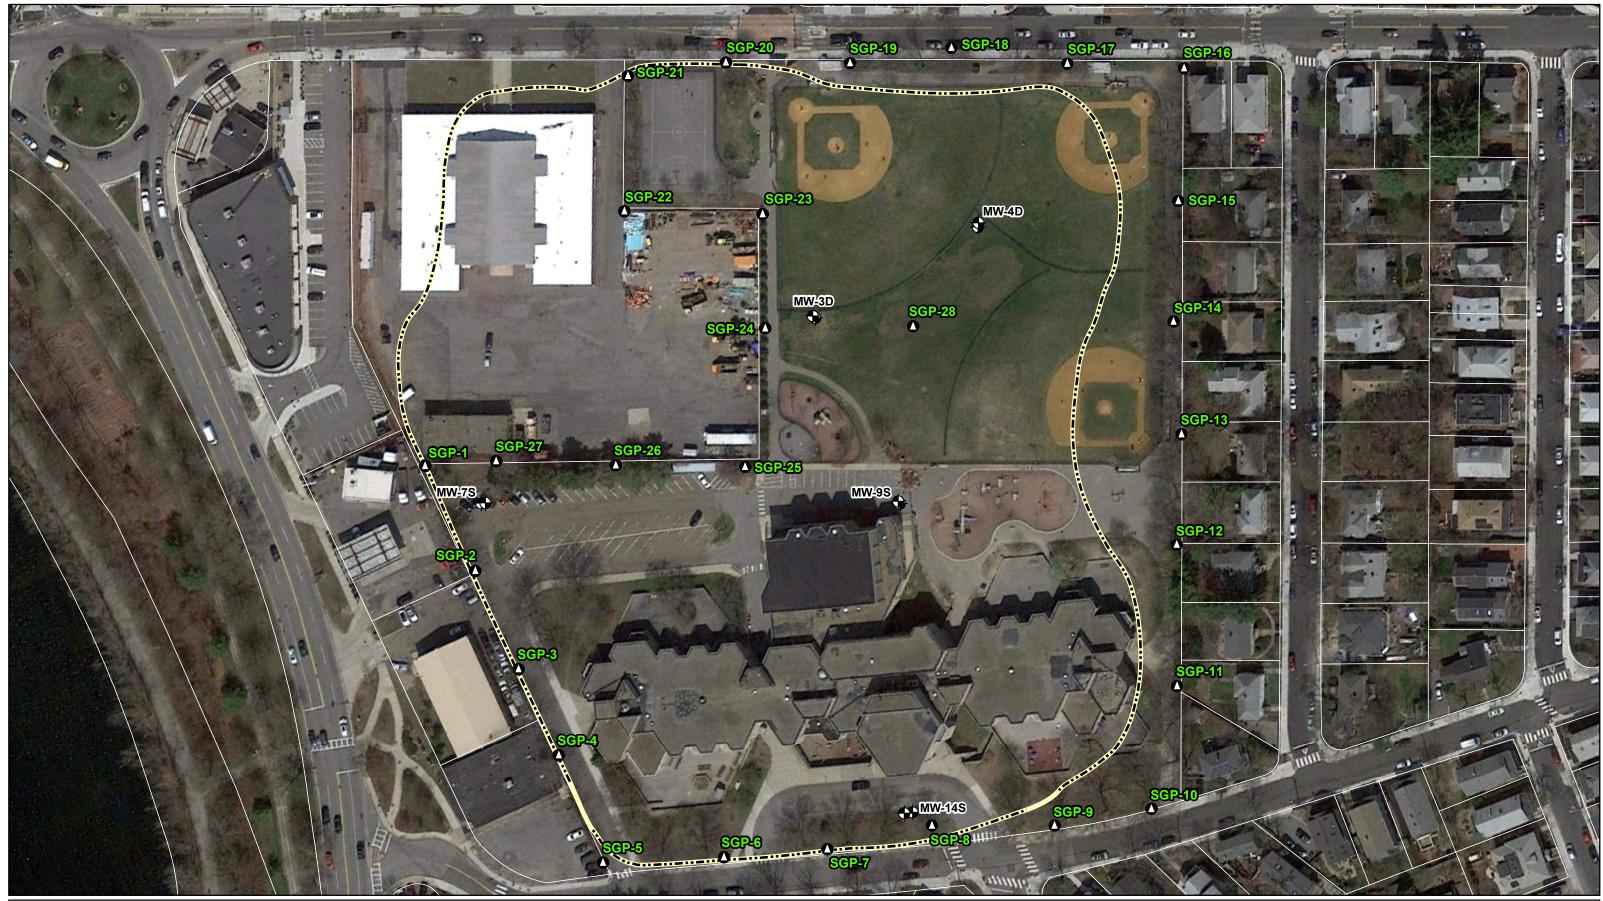
FIGURE 4 Landfill Gas Probe Monitoring Locations July-August 2017

**Legend** Gas Probe Location

- Groundwater Monitoring Well Couplet Installation Location
- Approximate Boundary of Former Clay Pit/Edge of Waste (updated April 2018)
