# SITE PHOTOS — BIRCH GROVE FOUNTAIN

# **EXISTING CONDITIONS**

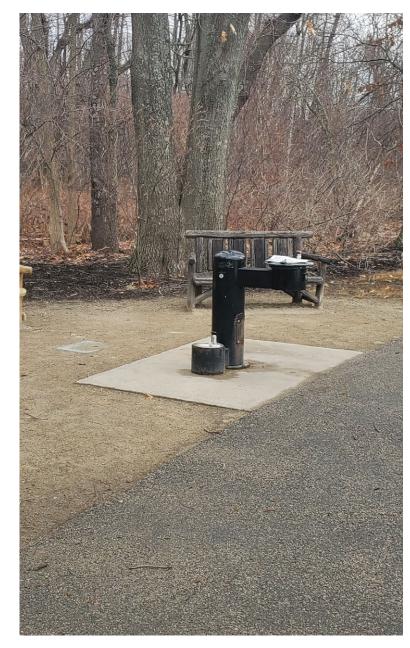
FOUNTAIN & SERVICE BOX

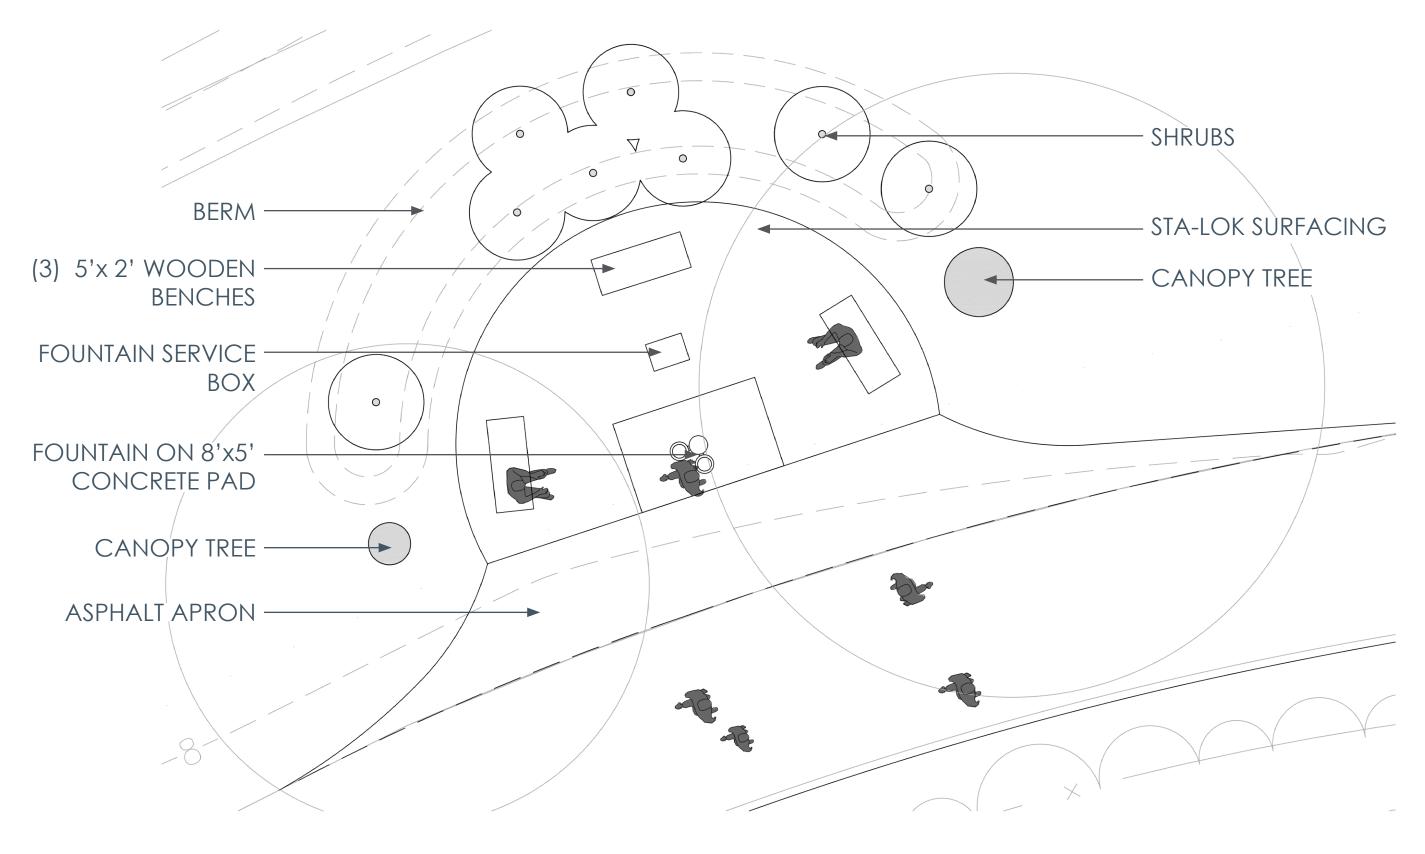
IMPERVIOUS AREA: 570 SF

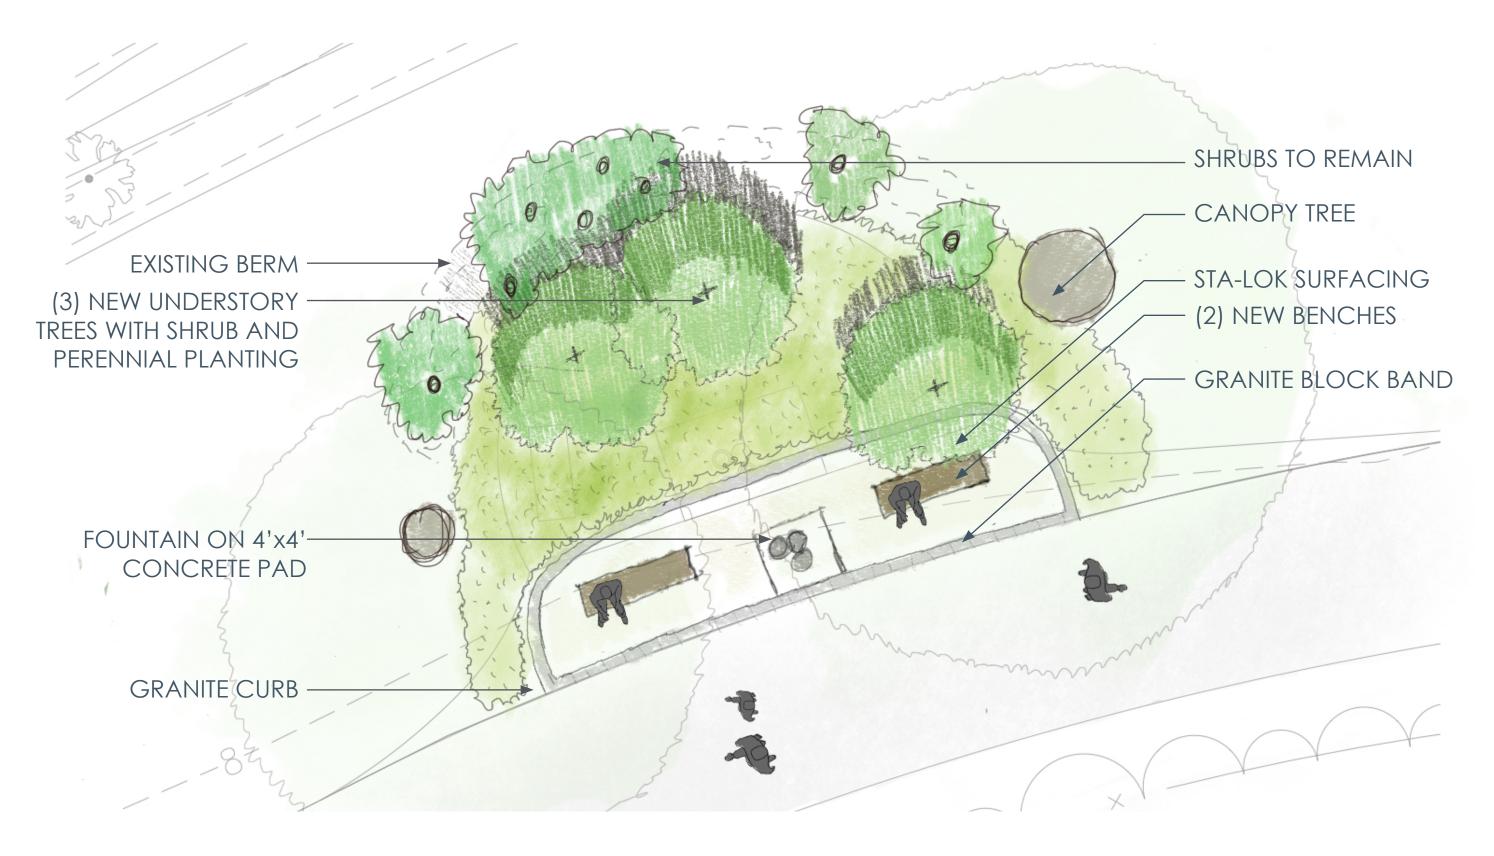
# **ORIGINAL CONCEPT PLAN**

EXISTING IMPERVIOUS AREA: 570 SF PROPOSED IMPERVIOUS AREA: 200 SF

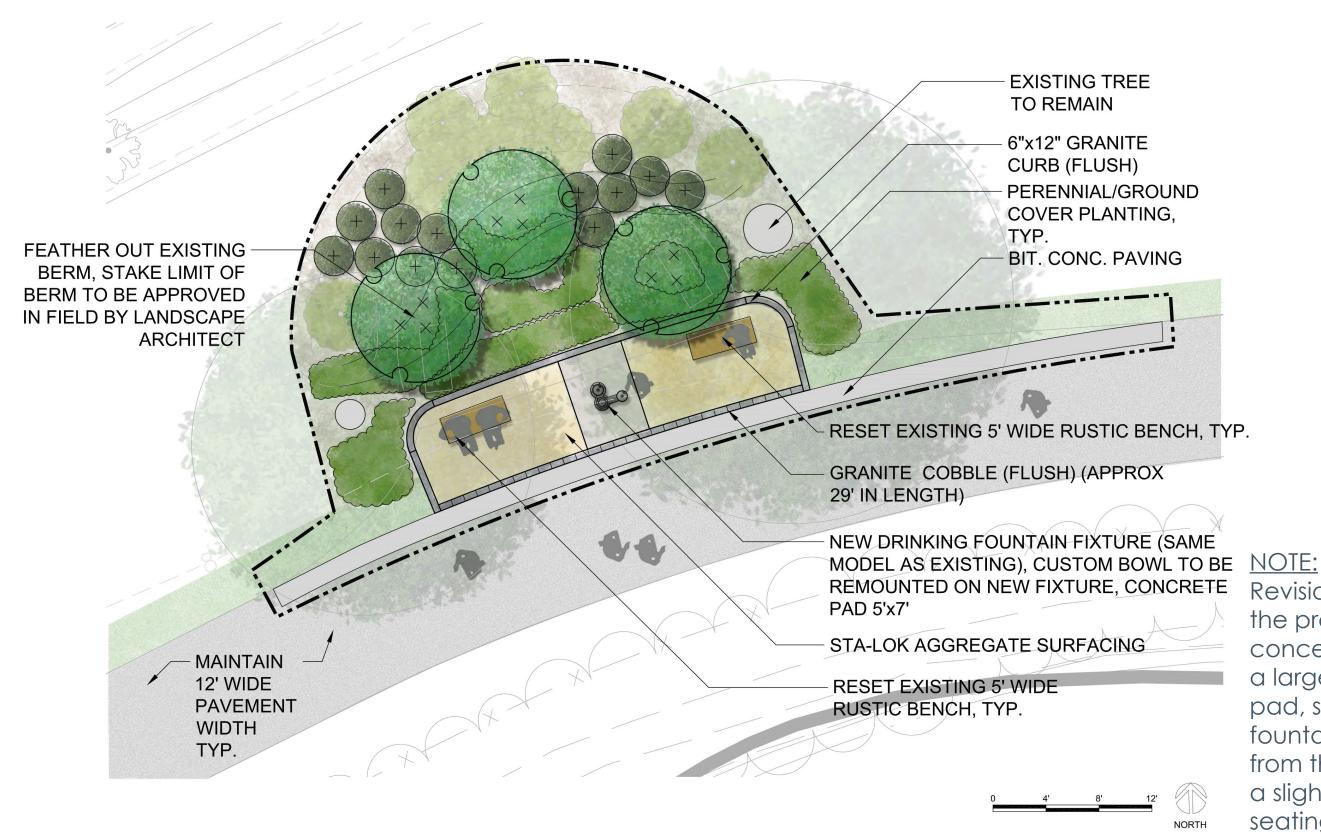
## **REVISED CONCEPT PLAN**

EXISTING IMPERVIOUS AREA: 570 SF PROPOSED IMPERVIOUS AREA: 240 SF

Revisions from the previous concept include a larger fountain pad, shifting the fountain away from the path, and a slightly deeper seating area.
