# Agenda – Glacken Slope Phase 6

# Glacken Slope Restoration - Overview of Phases 1-5

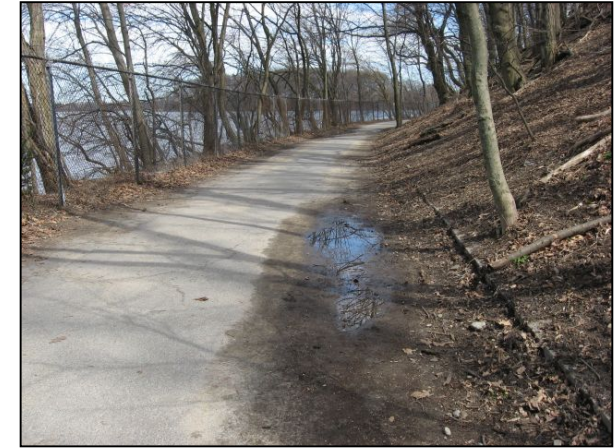
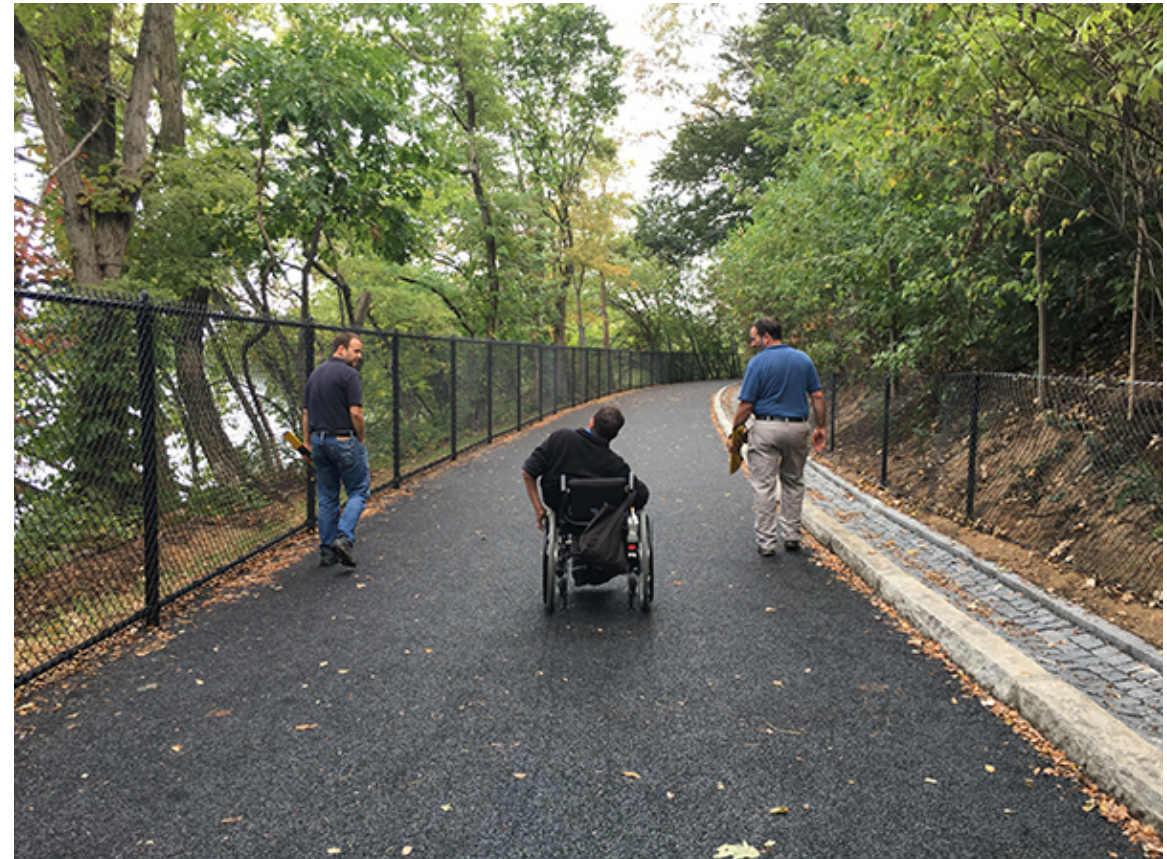
# Slope Restoration (Phase 5)

## Drainage Improvements to Perimeter Road

1. Cobble Swale
2. Porous Bituminous Concrete Perimeter Road

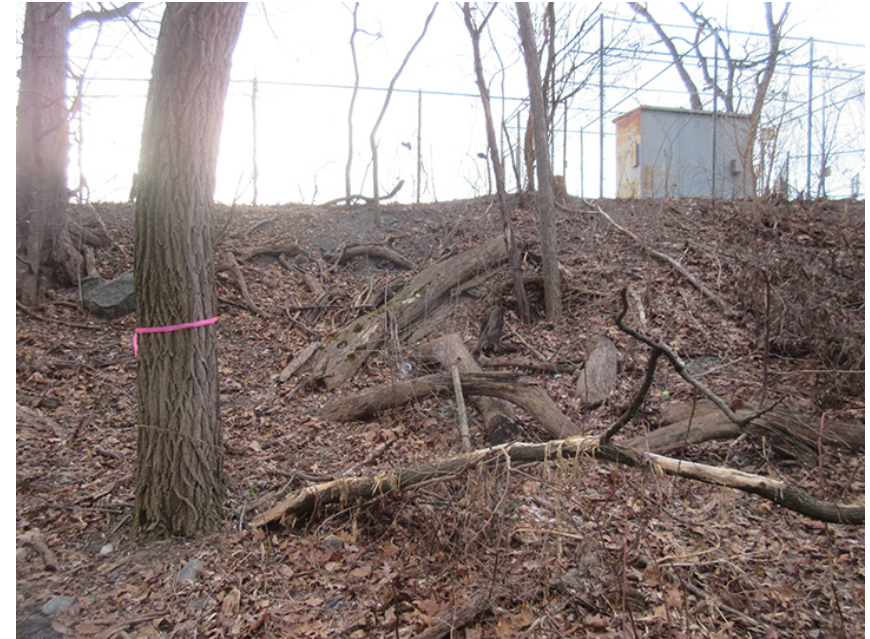
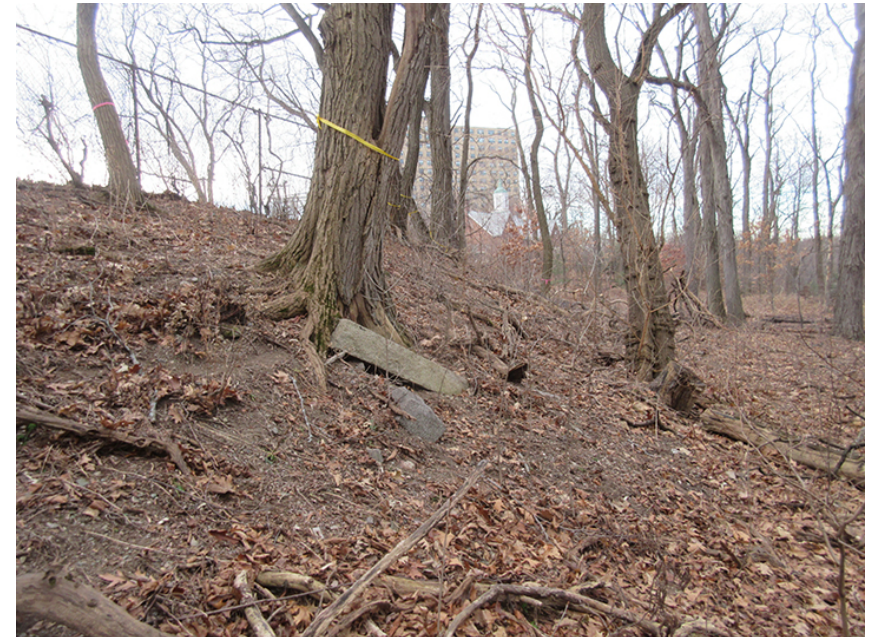
# Site Inventory - Slopes

1. Three Categories:
  - 0 to 5%
  - 5 - 33%
  - 33% and steeper
2. Historic erosion / less stable
3. Urban Fill soils

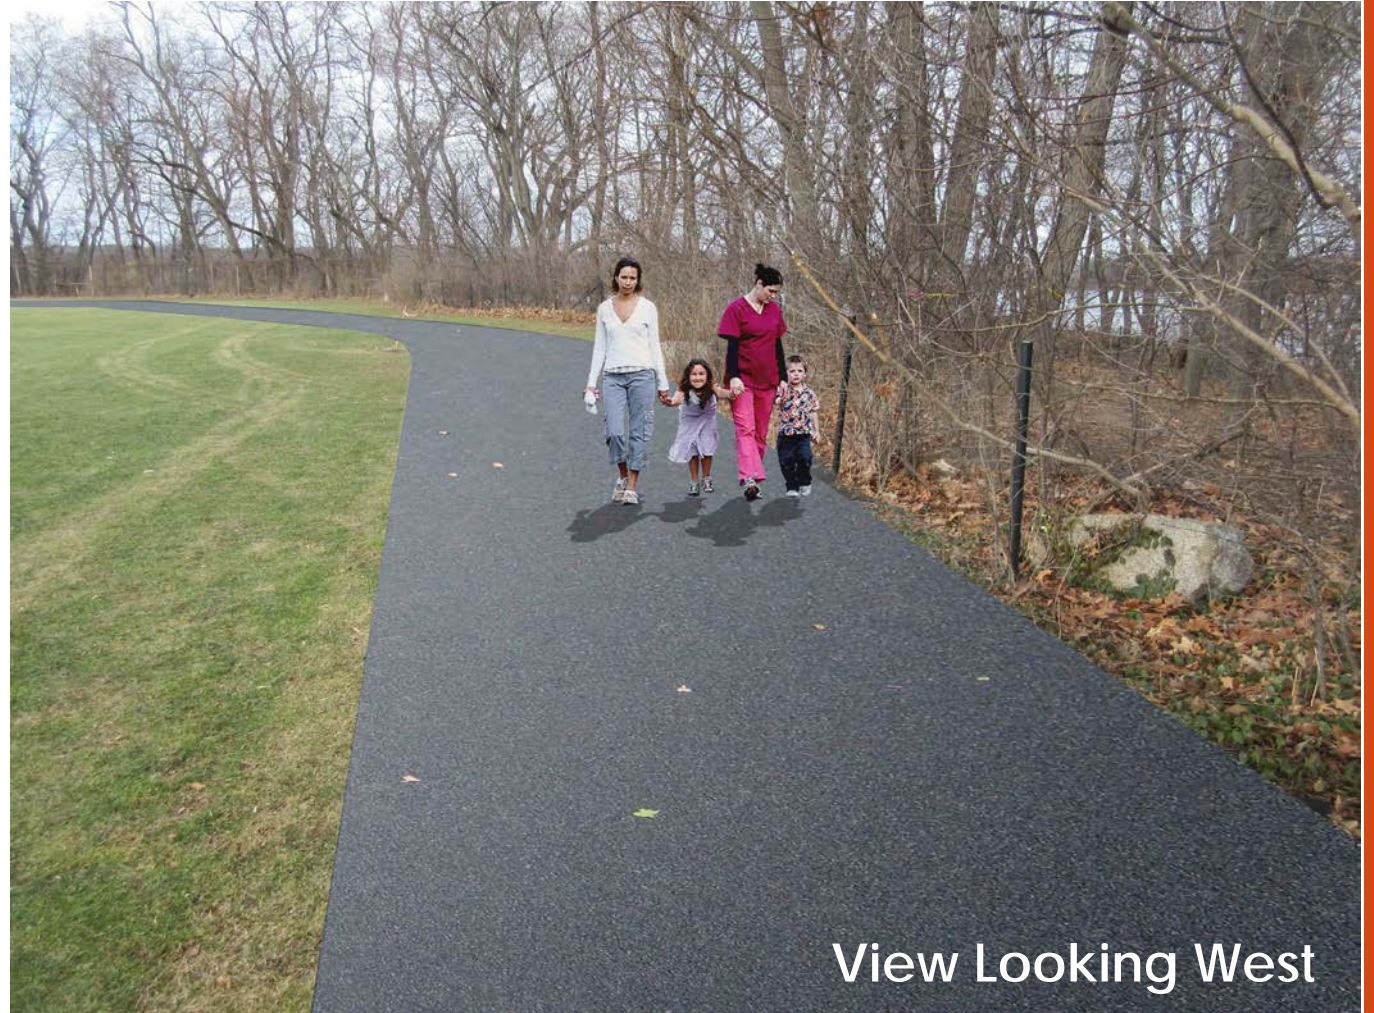
# Proposed Path Alignment

## All Alternatives

1. Ten foot (10') width
2. ADA-compliant
3. Porous bituminous concrete paving
4. Drains away from Fresh Pond
