# Pine Grove Restoration and Perimeter Road Improvements

Fresh Pond Advisory Board  
16 November 2023

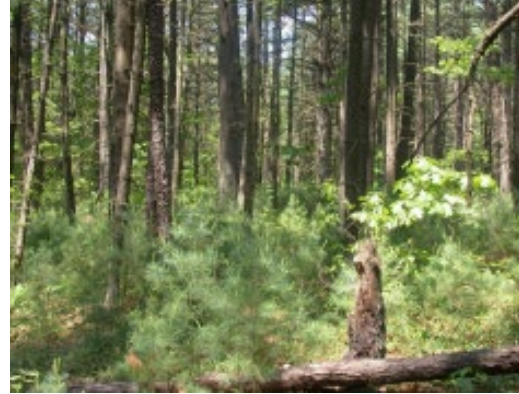
White Pine Regeneration

1. Maintain pine grove to prevent & control pests, disease, and damage.
2. Redesign primary trails to reduce impacts of erosion and compaction.
3. Redirect secondary trail traffic to primary trails; revegetate secondary trails.
4. Remove invasive plant species, i.e. buckthorn.

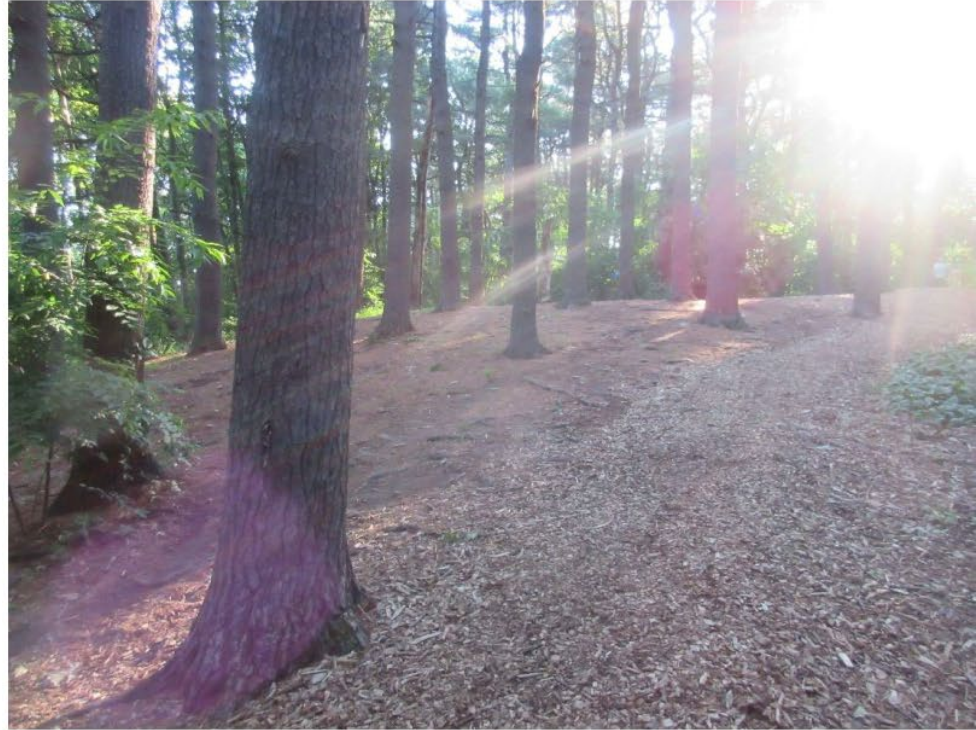
## Overstory/Canopy:

1. Core samples – 80 to 100 years old.
2. White Pines possible transplants from Kingsley Park.
3. No white pine saplings, seedlings, or pine cones observed.
4. Very few oaks observed.

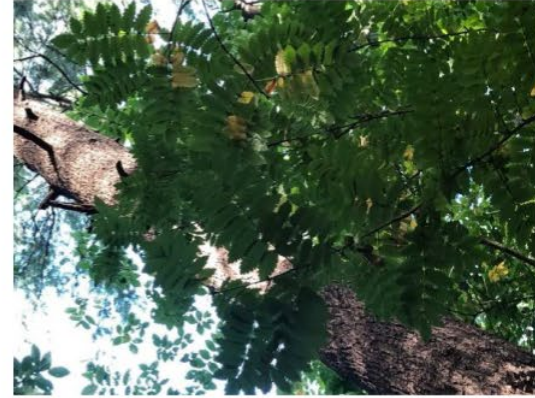
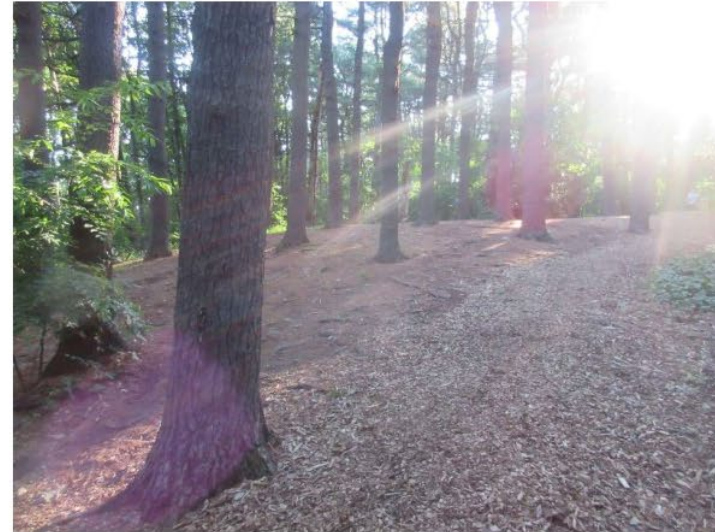
## Understory (Woody):

1. Gaps in canopy promote invasive tree and shrub growth.
2. Dominant species buckthorn, Norway maple and black cherry.
3. Subdominant species include hornbeam, black birch, black walnut, mountain ash, ground hemlock, honeysuckle, and Russian olive.

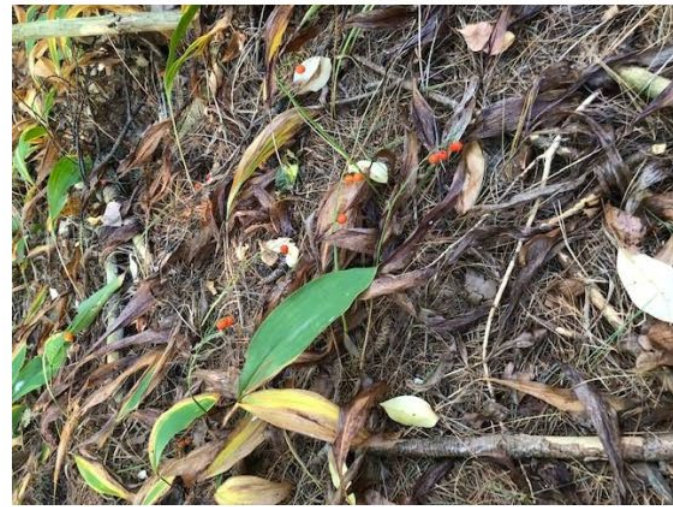
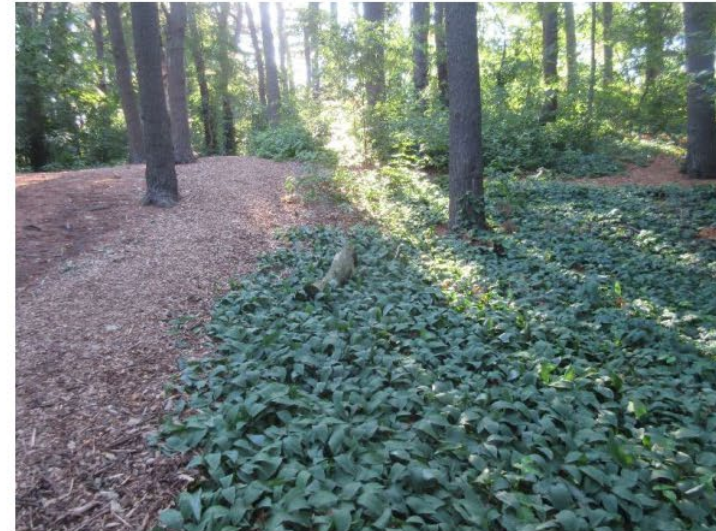
## Understory (Herbaceous):

1. Dominant species include Lily of the Valley (introduced) and poison ivy (native).
2. Subdominant species include white wood aster, nightshade, false Solomon's seal, avens, Virginia creeper, and pokeweed.
3. Red maple and black cherry seedlings.

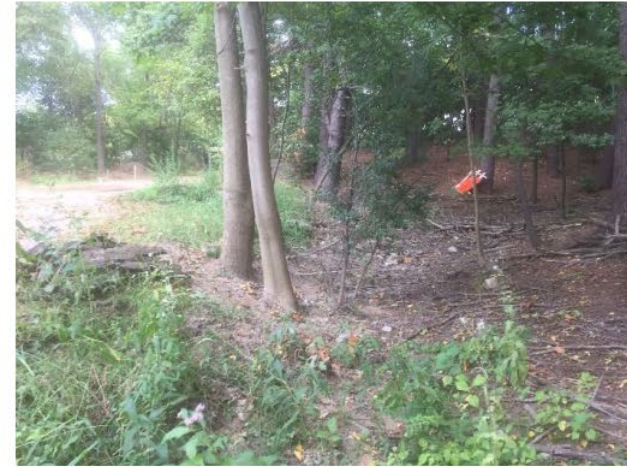
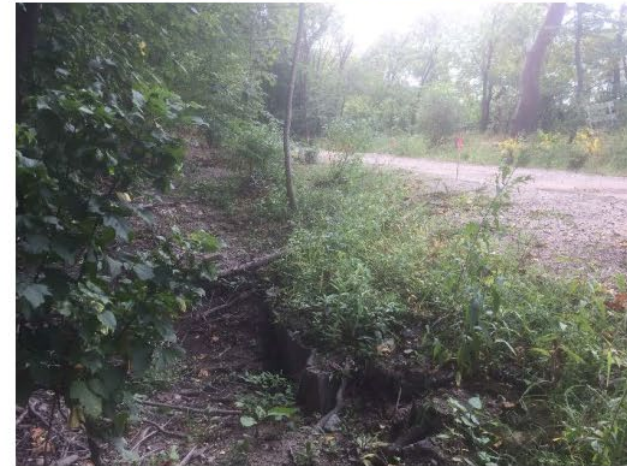
## Edge Habitat – Trees and Shrubs:

1. Same species as Pine Grove.
2. Additional native species include slippery elm, bird cherry, sugar maple, N. red oak, black locust, white ash, and shagbark hickory.
3. Additional non-native species include tree of heaven, red mulberry, and Japanese knotweed.

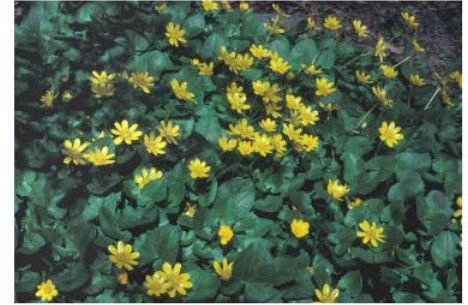
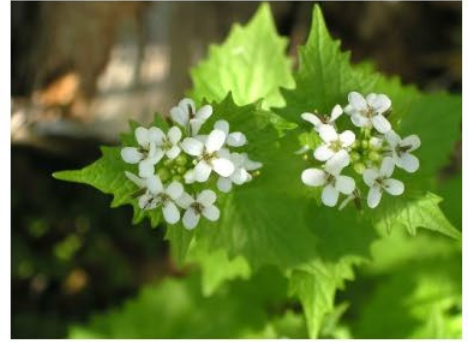
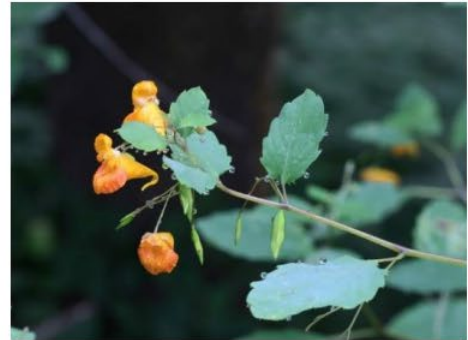
## Edge Habitat - Groundcovers:

1. Same species as Pine Grove.
2. Additional native species include three-sided mercury & jewelweed.
3. Additional non-native species include celandine, goutweed, garlic mustard, and ragweed.

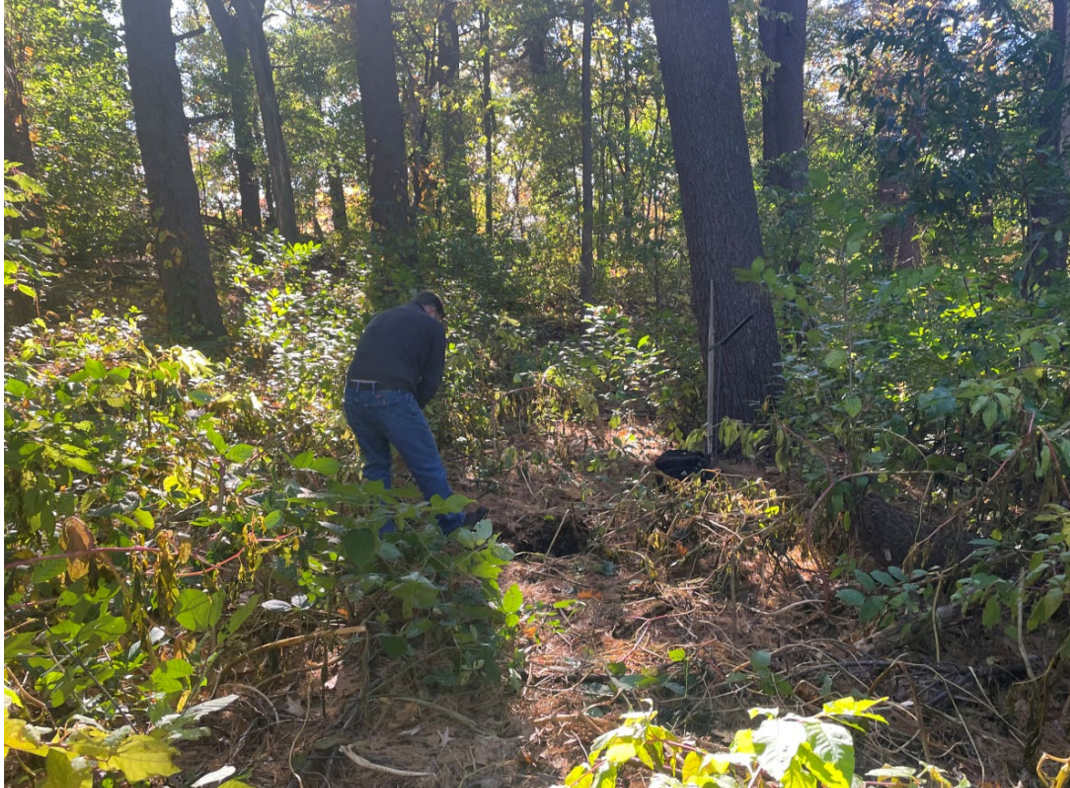
## Test Pit #1

# Test Pits and Soil Analysis

1. 2" thickness of O-horizon forest duff (typ.).
2. A-horizon topsoils (6"-8" depth) consisting of uniformly graded sands and silts (some clay).
3. B-horizon subsoils (12"-14") same as A-horizon.
4. Soil density low to moderate, with compaction increasing with depth.
5. Subsoils at 24" depth highly compacted, with a higher percentage of silt and clay.
6. The soil fines, particularly the clay fraction, increases significantly w/ sampling depth.

7. Little gravel/coarse sand present.
8. Soils well-aerated and well-drained (ideal for plant growth).
9. Plant rooting deep and dense; healthy tree roots at 24" depth and deeper (blow-overs).
10. Upper soils (0-8" depth) capable of rapid infiltration (up to 20"/hour); mid-soils 3.6"/hour; and lower soils 0.3"/hour.
11. Minimum planting soil infiltration capacity (accepted) = 1"/hour.
12. Earthworms and other macrofauna observed.
13. Fungal hyphae observed in both O- and A- horizons.

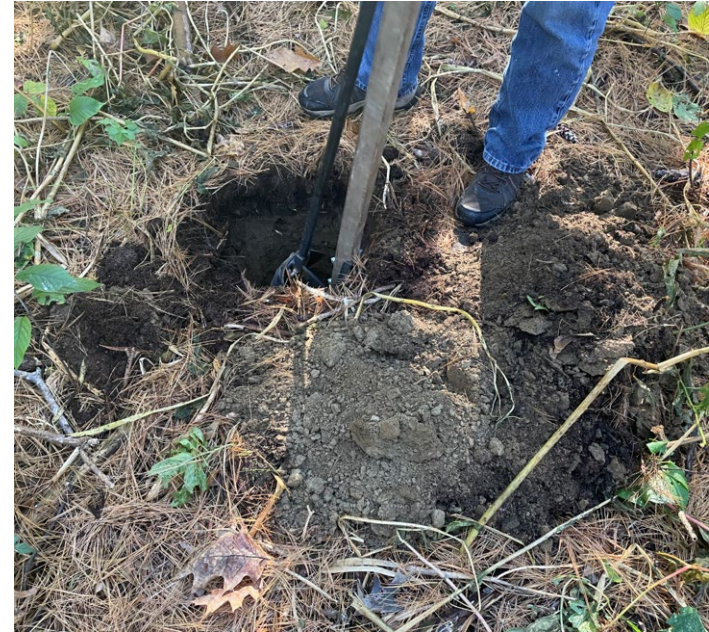
## Field Investigation Findings

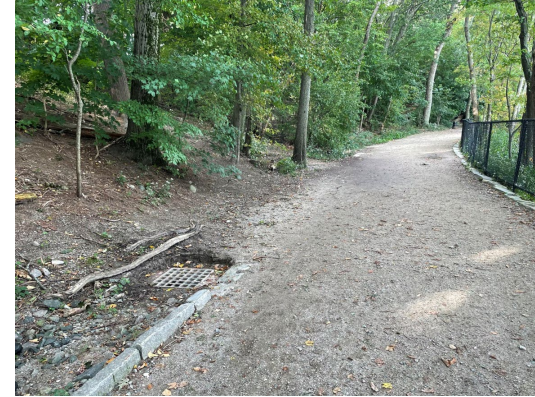
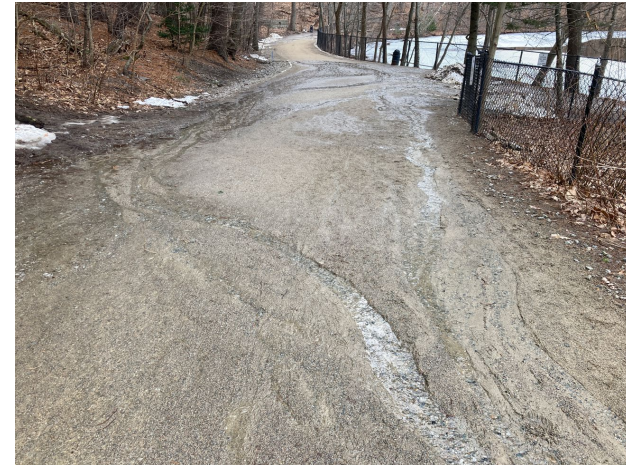
# Perimeter Road Drainage Strategies

1. Provide positive drainage.
2. Minimize standing water.
3. Infiltrate runoff (where feasible).
4. Utilize existing stormwater BMP's and structures.
5. Identify all maintenance requirements and alternatives.

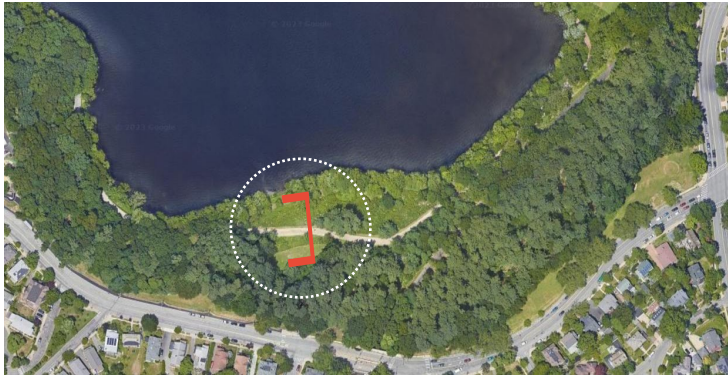
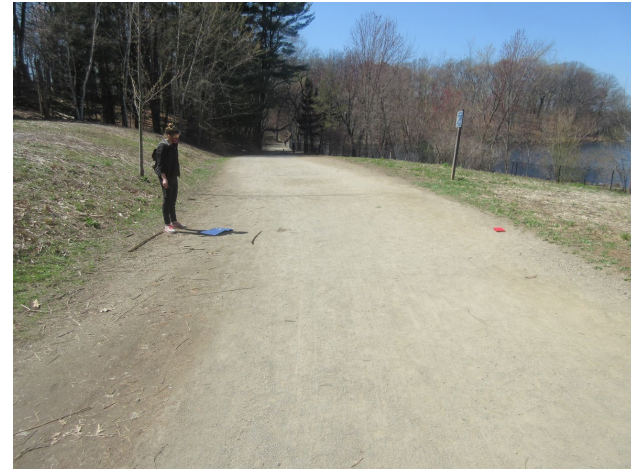
# Perimeter Road at Weir Meadow

## Existing Conditions

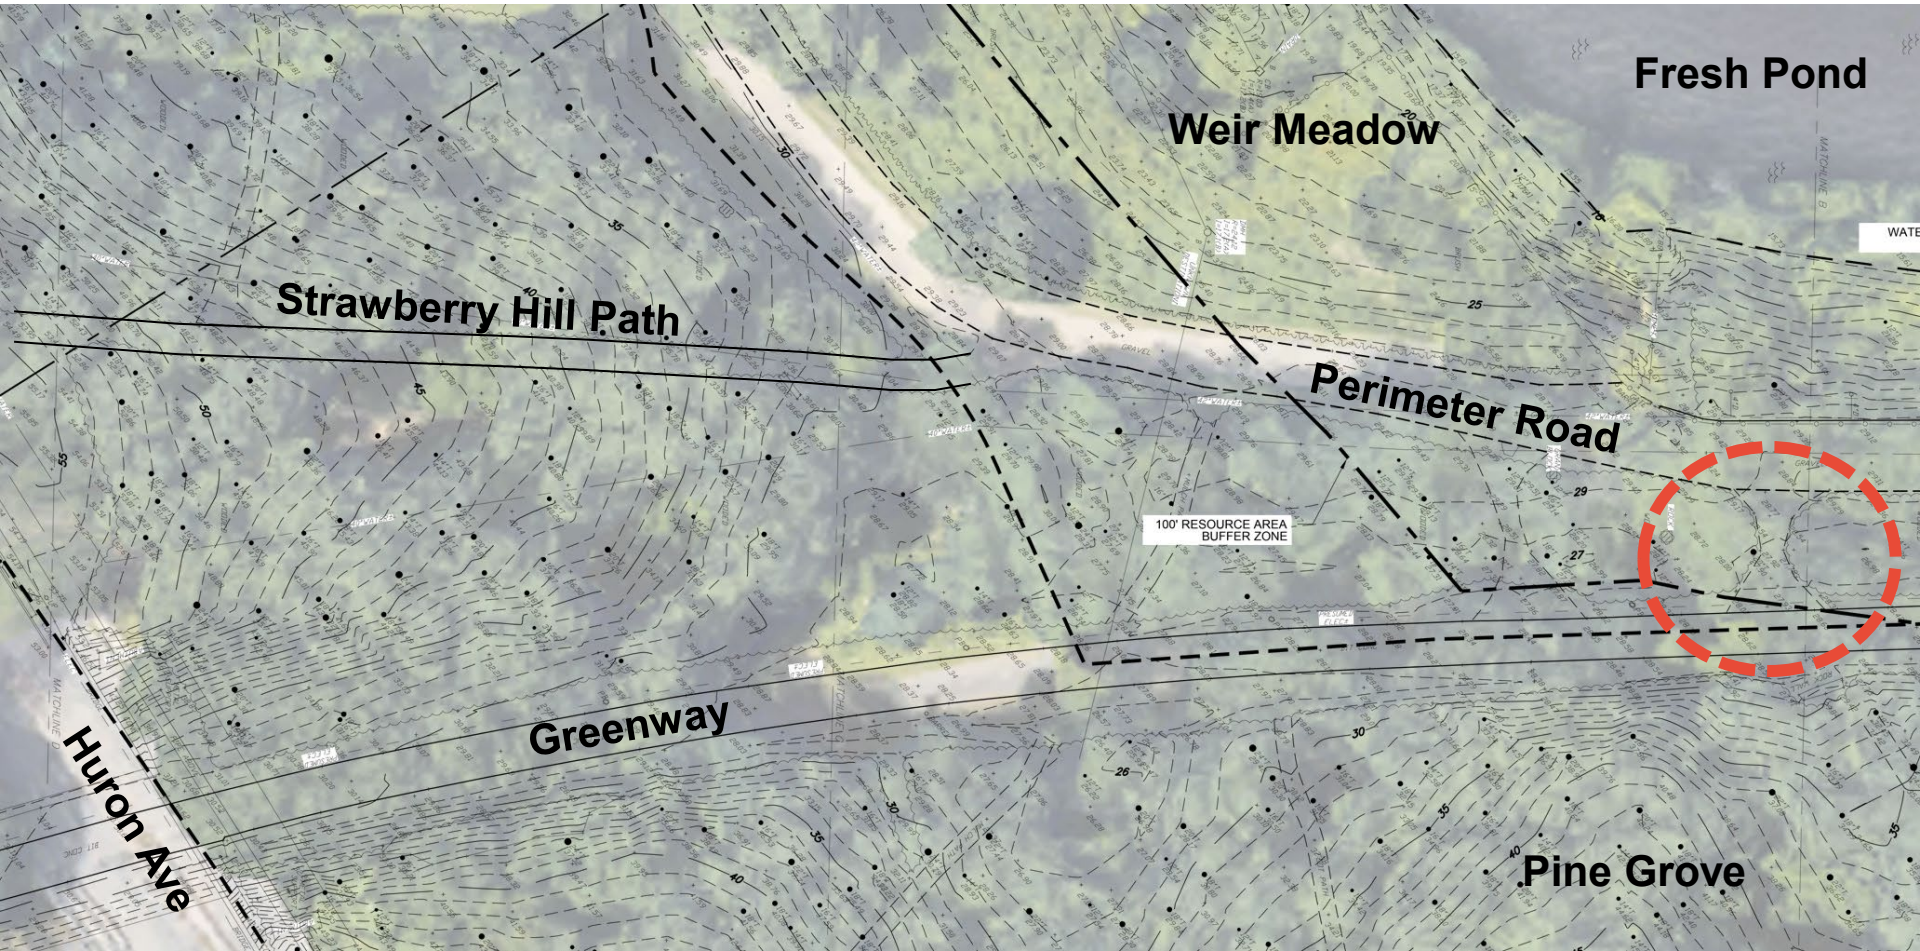
# Proposed Connection Perimeter Road to Greenway

1. Raised connection (asphalt to asphalt).
2. MUTCD and AASHTO bicycle signage and striping (Greenway only).
3. Drainage culvert for greenway swale.
4. Snow plowed (CWD).
5. Reservation signage.

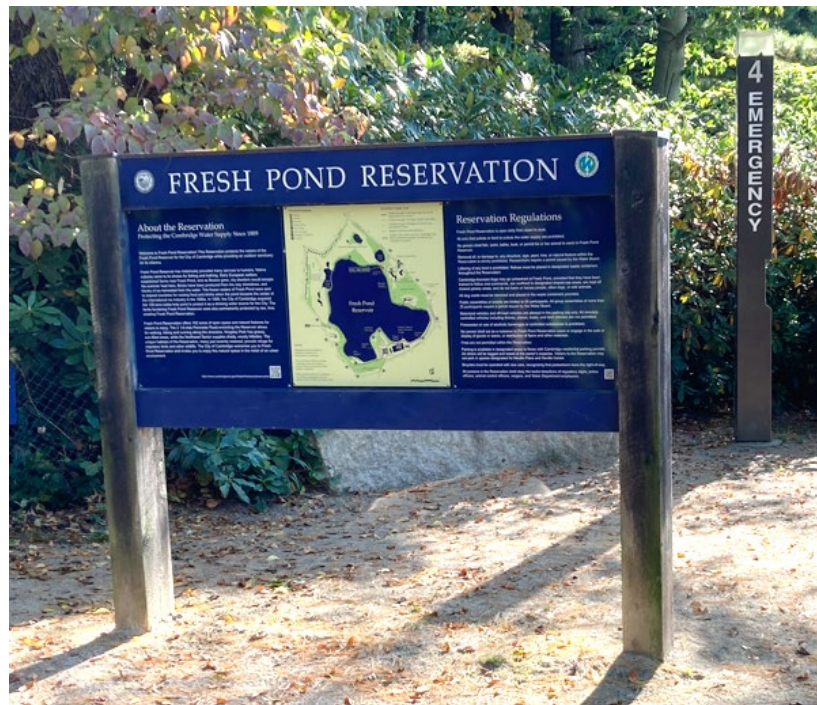
# Perimeter Road / Greenway Connection Signage

1. Best location and siting option.
2. Communicate FPR regulations, goals and vision statement.
3. Wayfinding map; historical, recreational and ecological components (2-sided).

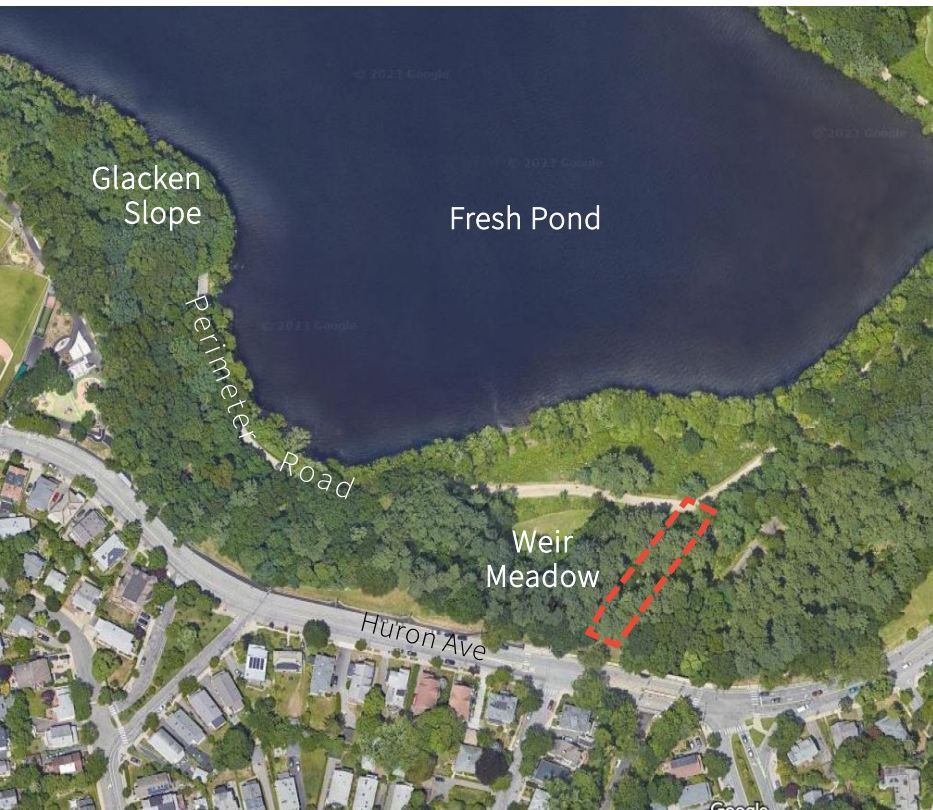
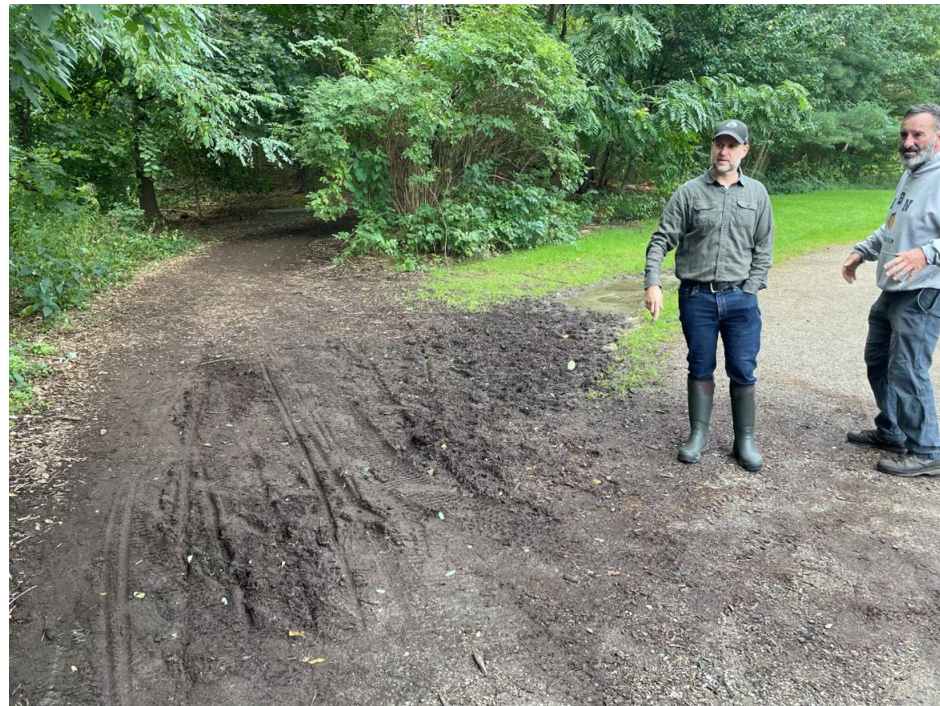
# Strawberry Hill ROW to Perimeter Road (Existing)

1. Existing steep slope +/- 10% (ADA = <5%).
2. Approximately 250-feet in length.
3. +/- 10-foot width.
4. Unpaved surface.

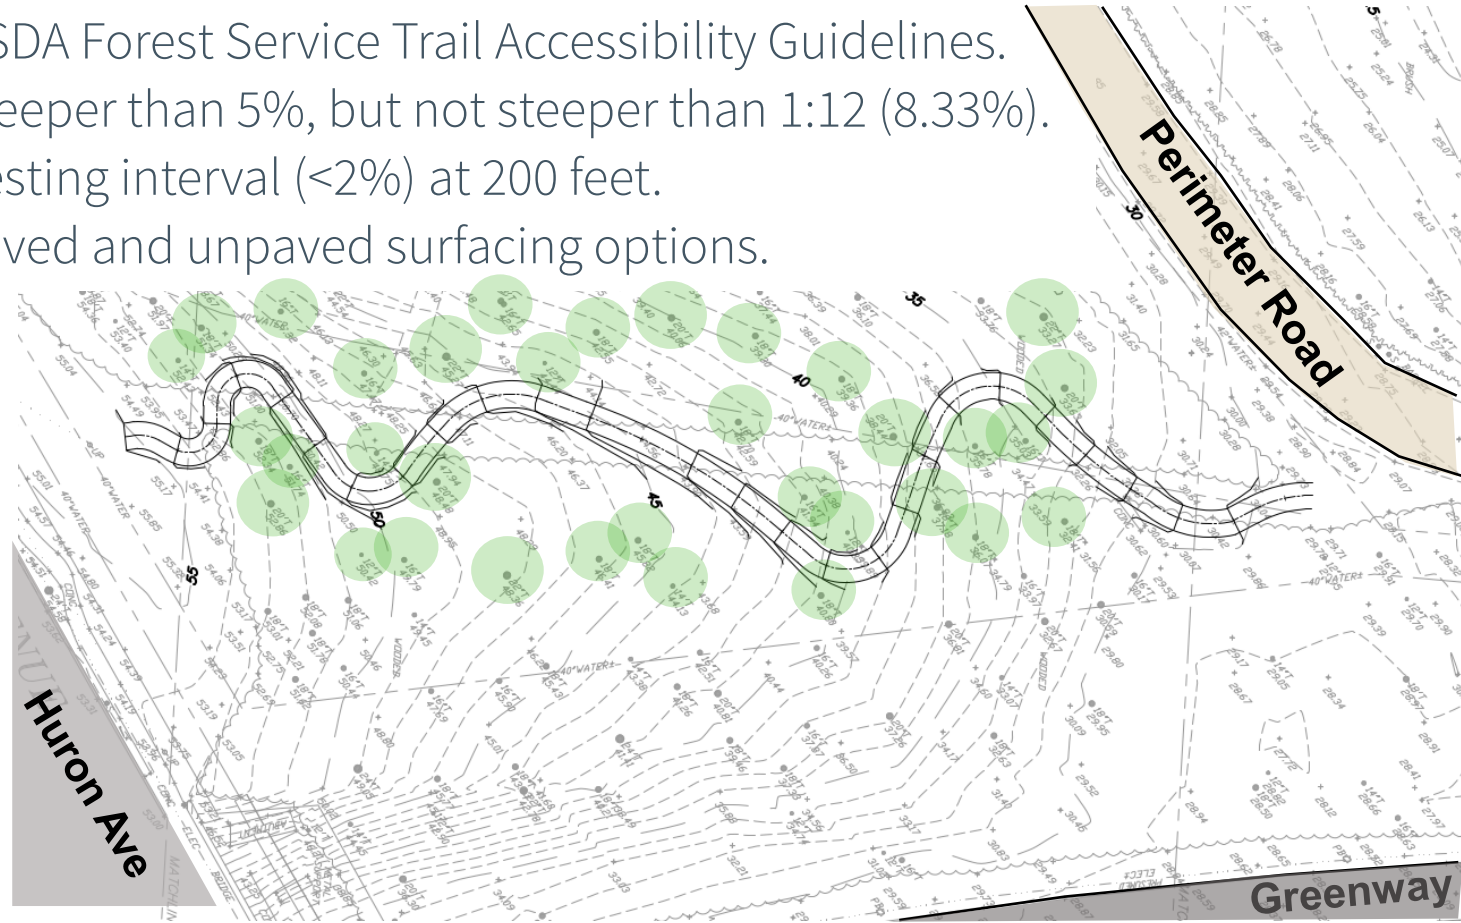
# Strawberry Hill Trail to Perimeter Road

1. USDA Forest Service Trail Accessibility Guidelines.
2. Steeper than 5%, but not steeper than 1:12 (8.33%).
3. Resting interval (<2%) at 200 feet.
4. Paved and unpaved surfacing options.

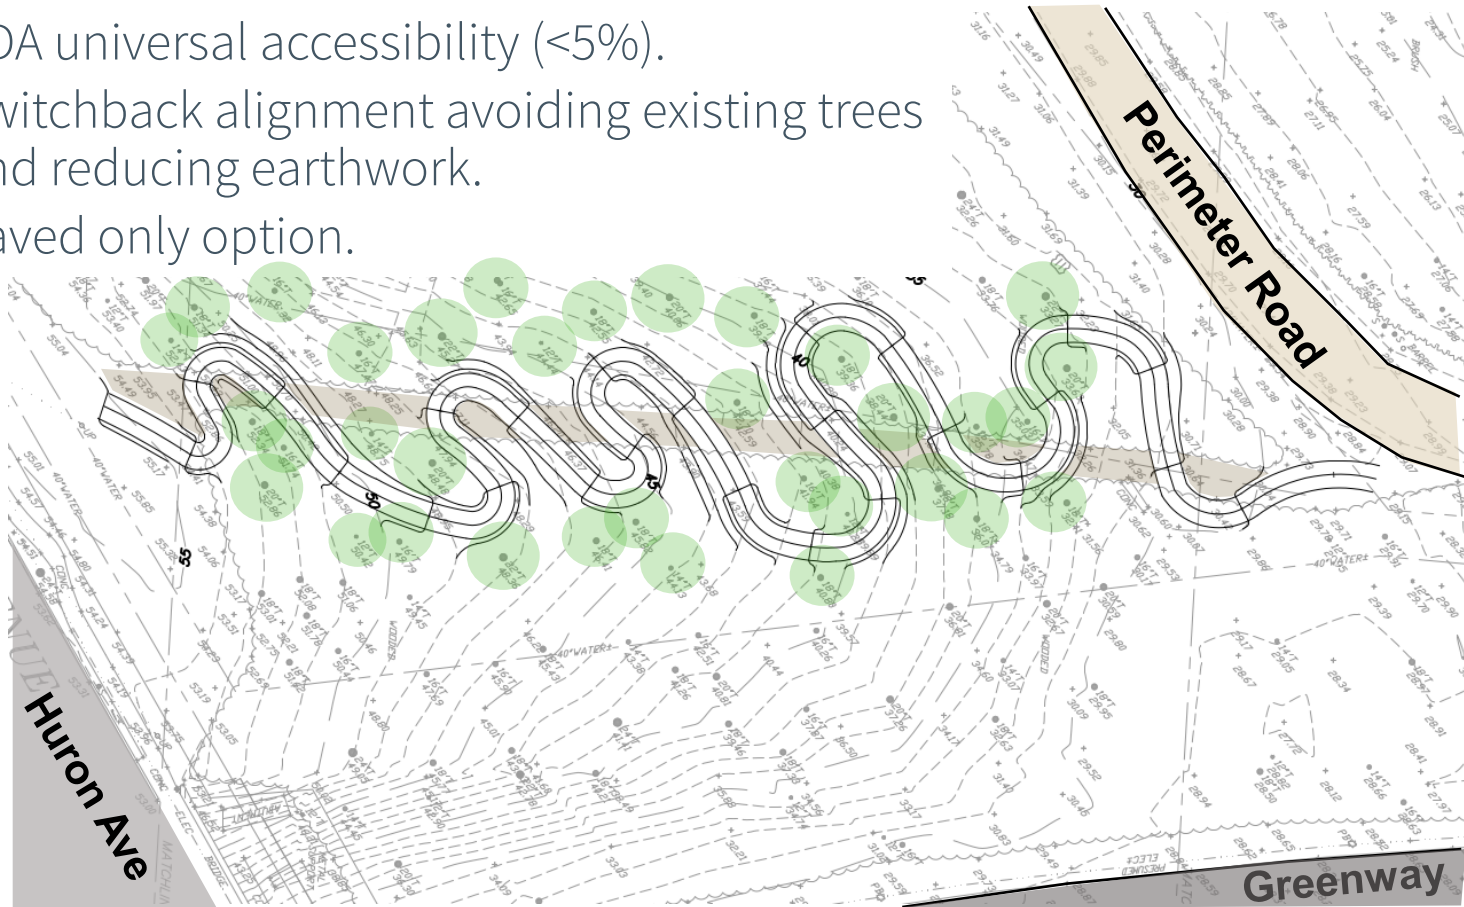
# Strawberry Hill Path to Perimeter Road

1. ADA universal accessibility (<5%).
2. Switchback alignment avoiding existing trees and reducing earthwork.
3. Paved only option.

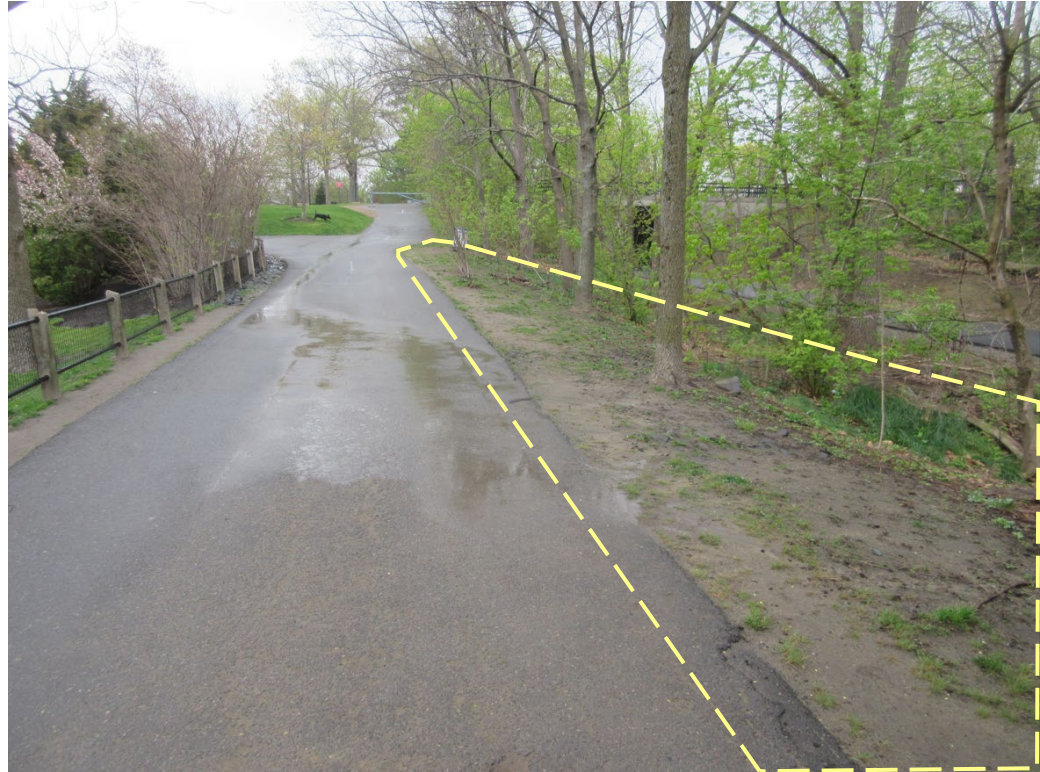
# Vegetated Buffer Improvements

1. Remove Invasive Trees, Shrubs and Groundcovers
2. Amend Soils
3. Plant Native Understory Species
4. Install Plant Protection Fencing
