## OUT OF TOWN NEWS - Historic Restoration

### PUBLIC WORKS: BUILDINGS - HARVARD SQUARE KIOSK INFRASTRUCTURE IMPROVEMENTS

FY16 PROJECT DESCRIPTION						CITY COUNCIL GOALS
<p>FY16 funding of \$600,000 will fund the renovations design for the Out of Town News Kiosk Building and the adjacent plaza area in Harvard Square. The overall goals of the project are to open up the historic kiosk building for more public use, enhance the historic character of the building, and build on its iconic presence in Harvard Square. The surrounding plaza area will be reconstructed to make it more inviting, to enhance pedestrian usage, and to improve accessibility.</p>

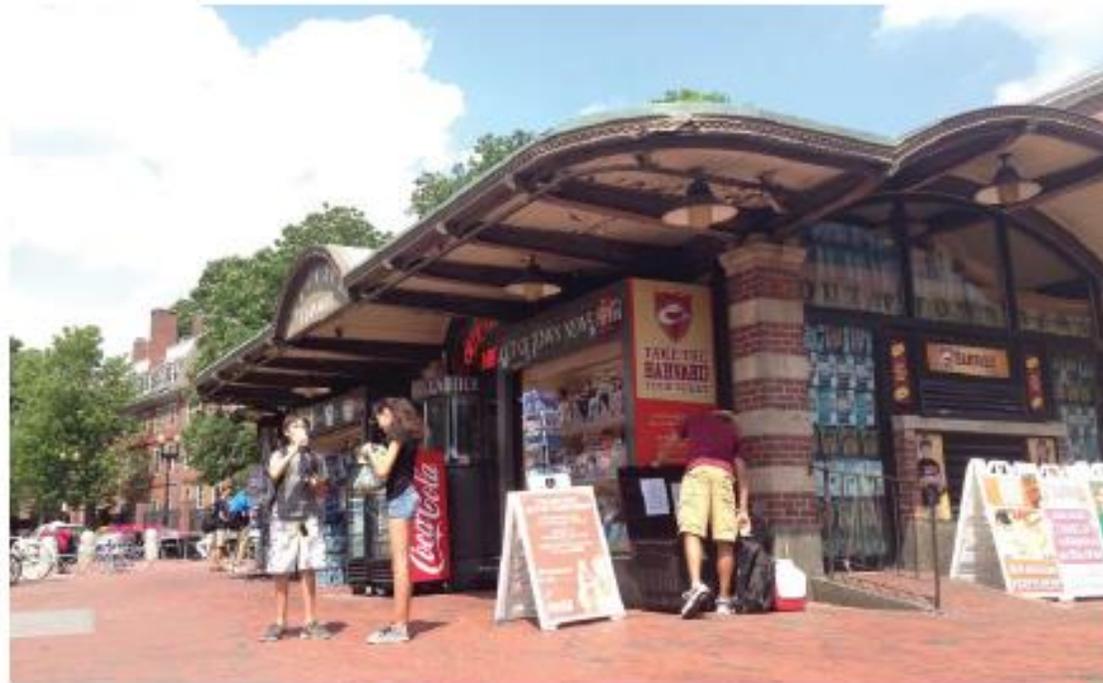
Brattle Street Facade - 2014

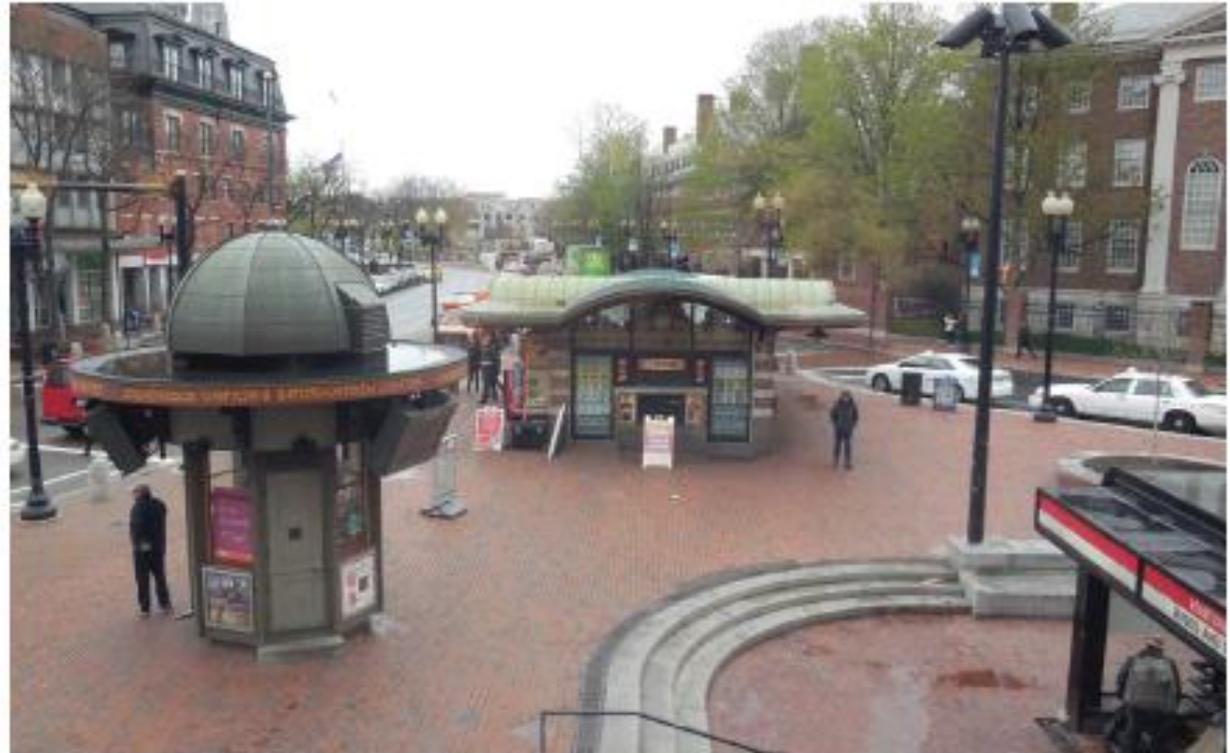
MBTA-Side Facade - 2014

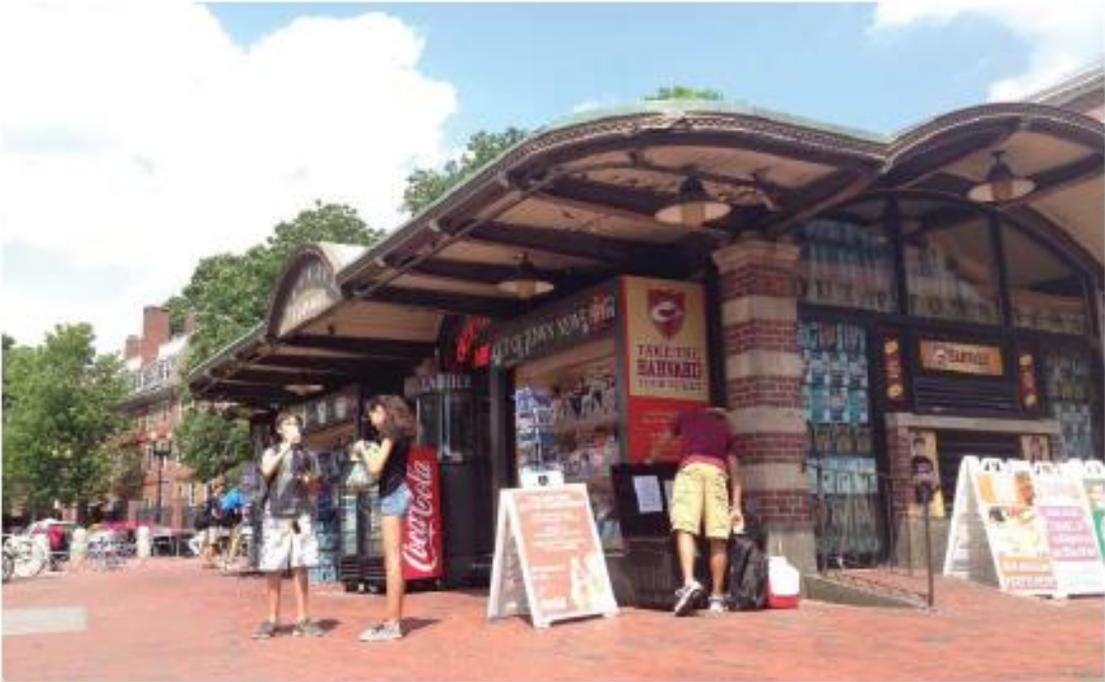
Brattle Street Facade - 2014

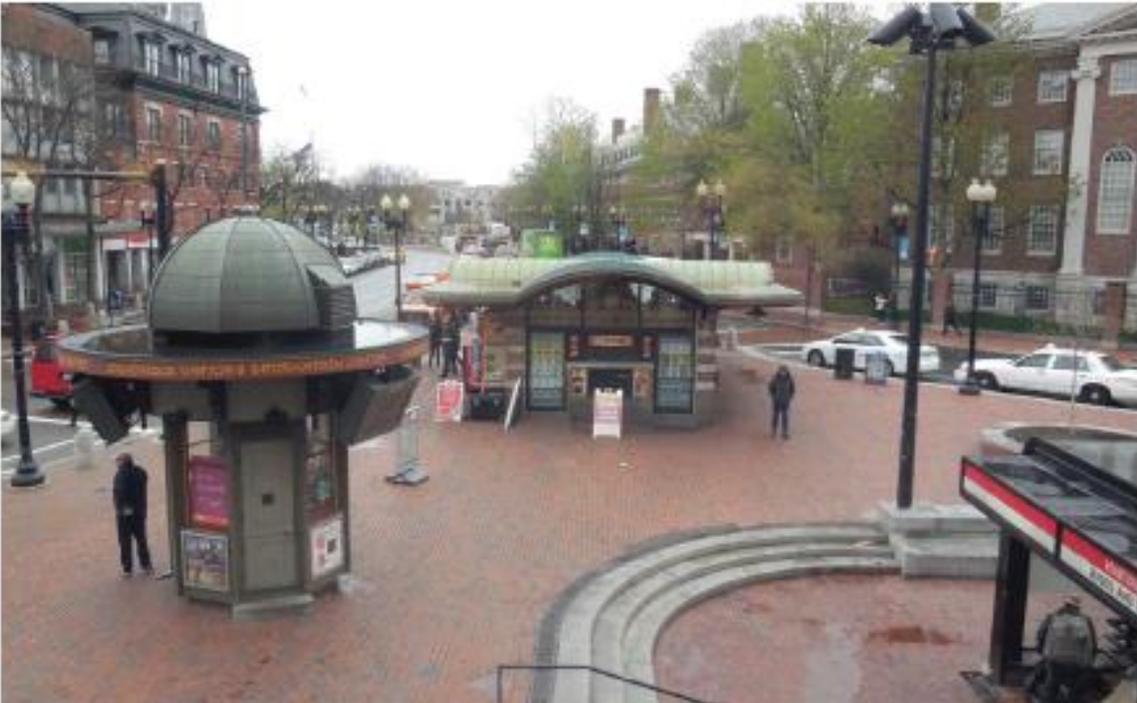
MBTA-Side Facade - 2014

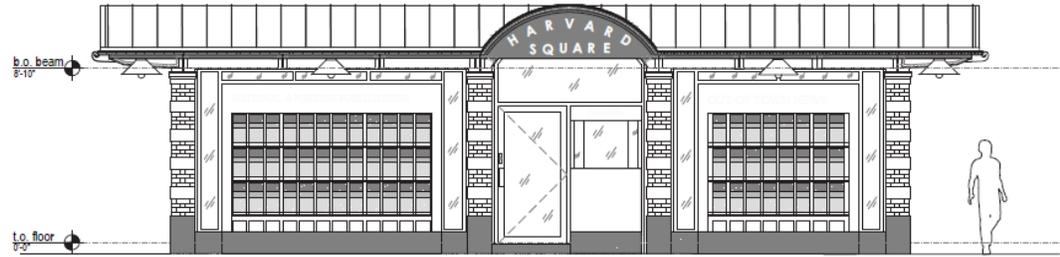
① Elevation - Brattle Street

Existing Conditions Exterior Elevations

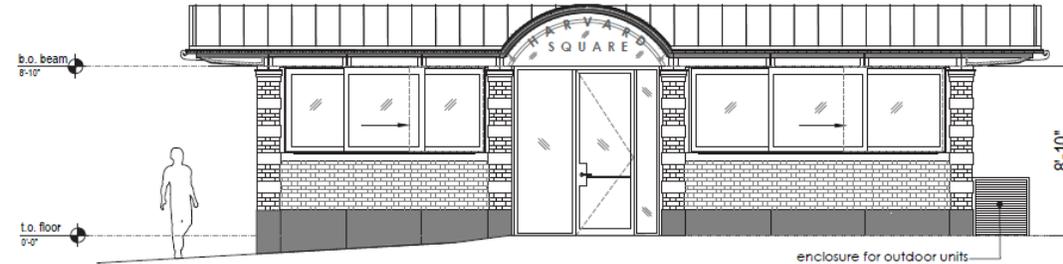
② Elevation - Massachusetts Avenue

Proposed Exterior Elevations

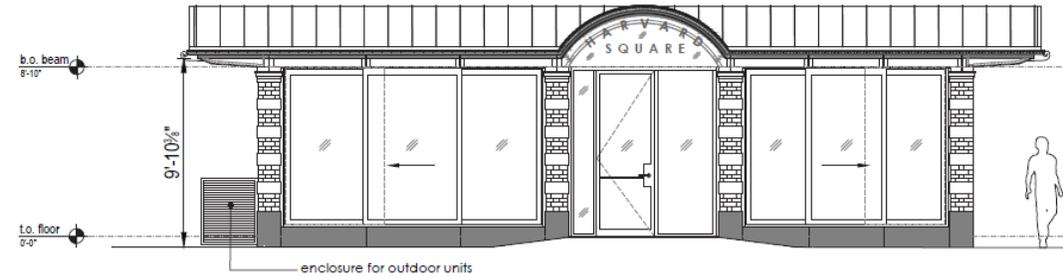
① Elevation - Brattle Street

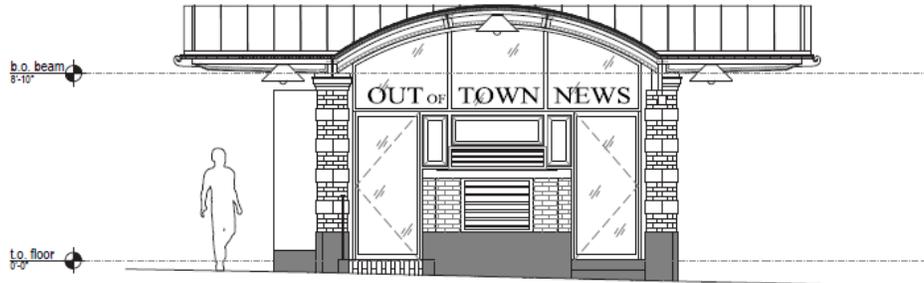
② Elevation - Facing Harvard Square MBTA Station

Existing Conditions Exterior Elevations

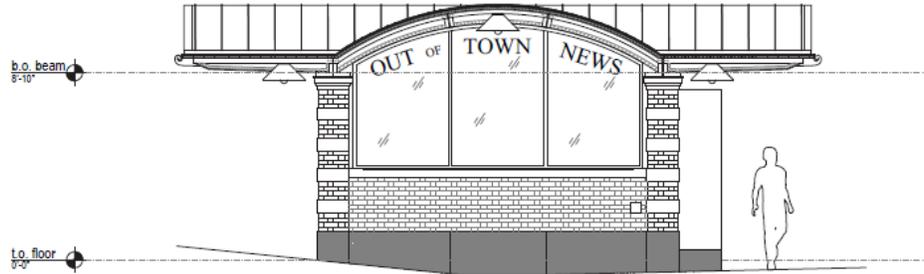
① Elevation - Facing Harvard University

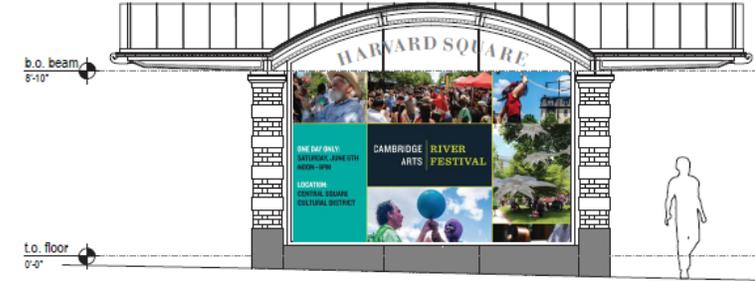
② Elevation - Facing Harvard Square MBTA Station

Proposed Exterior Elevations

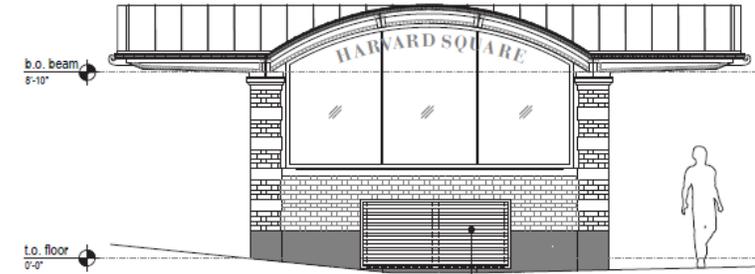
① Elevation - Facing Harvard University

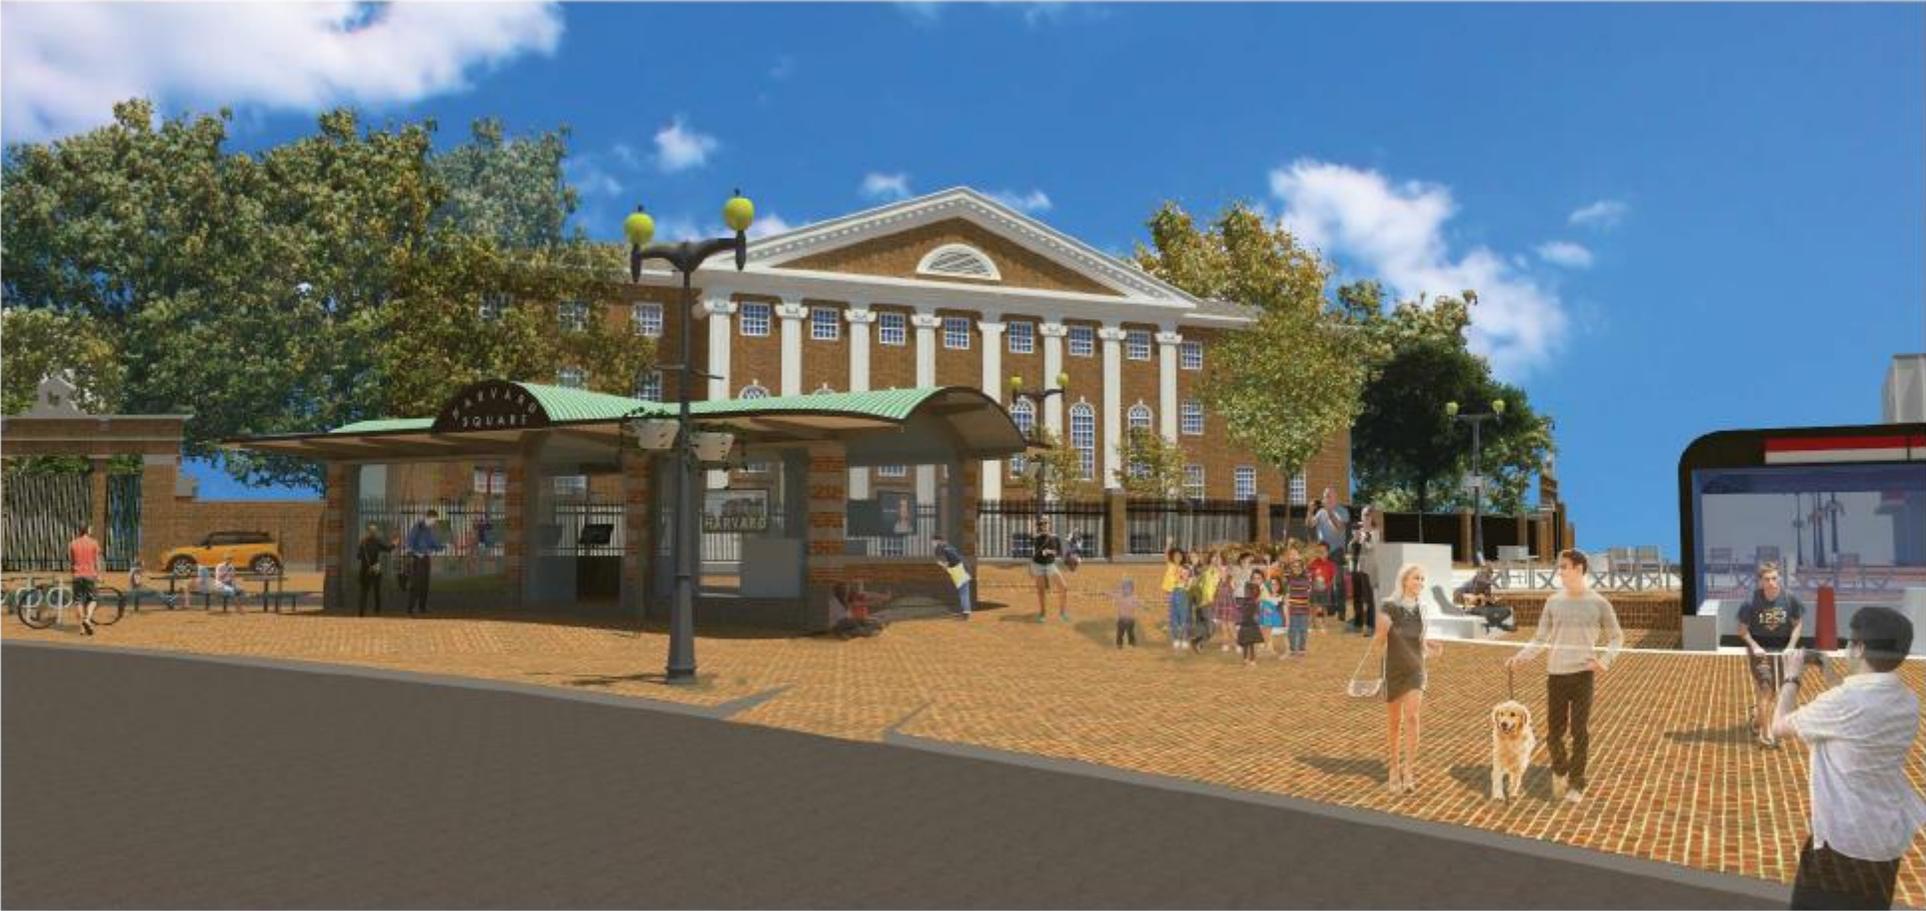
Rendering Brattle Street

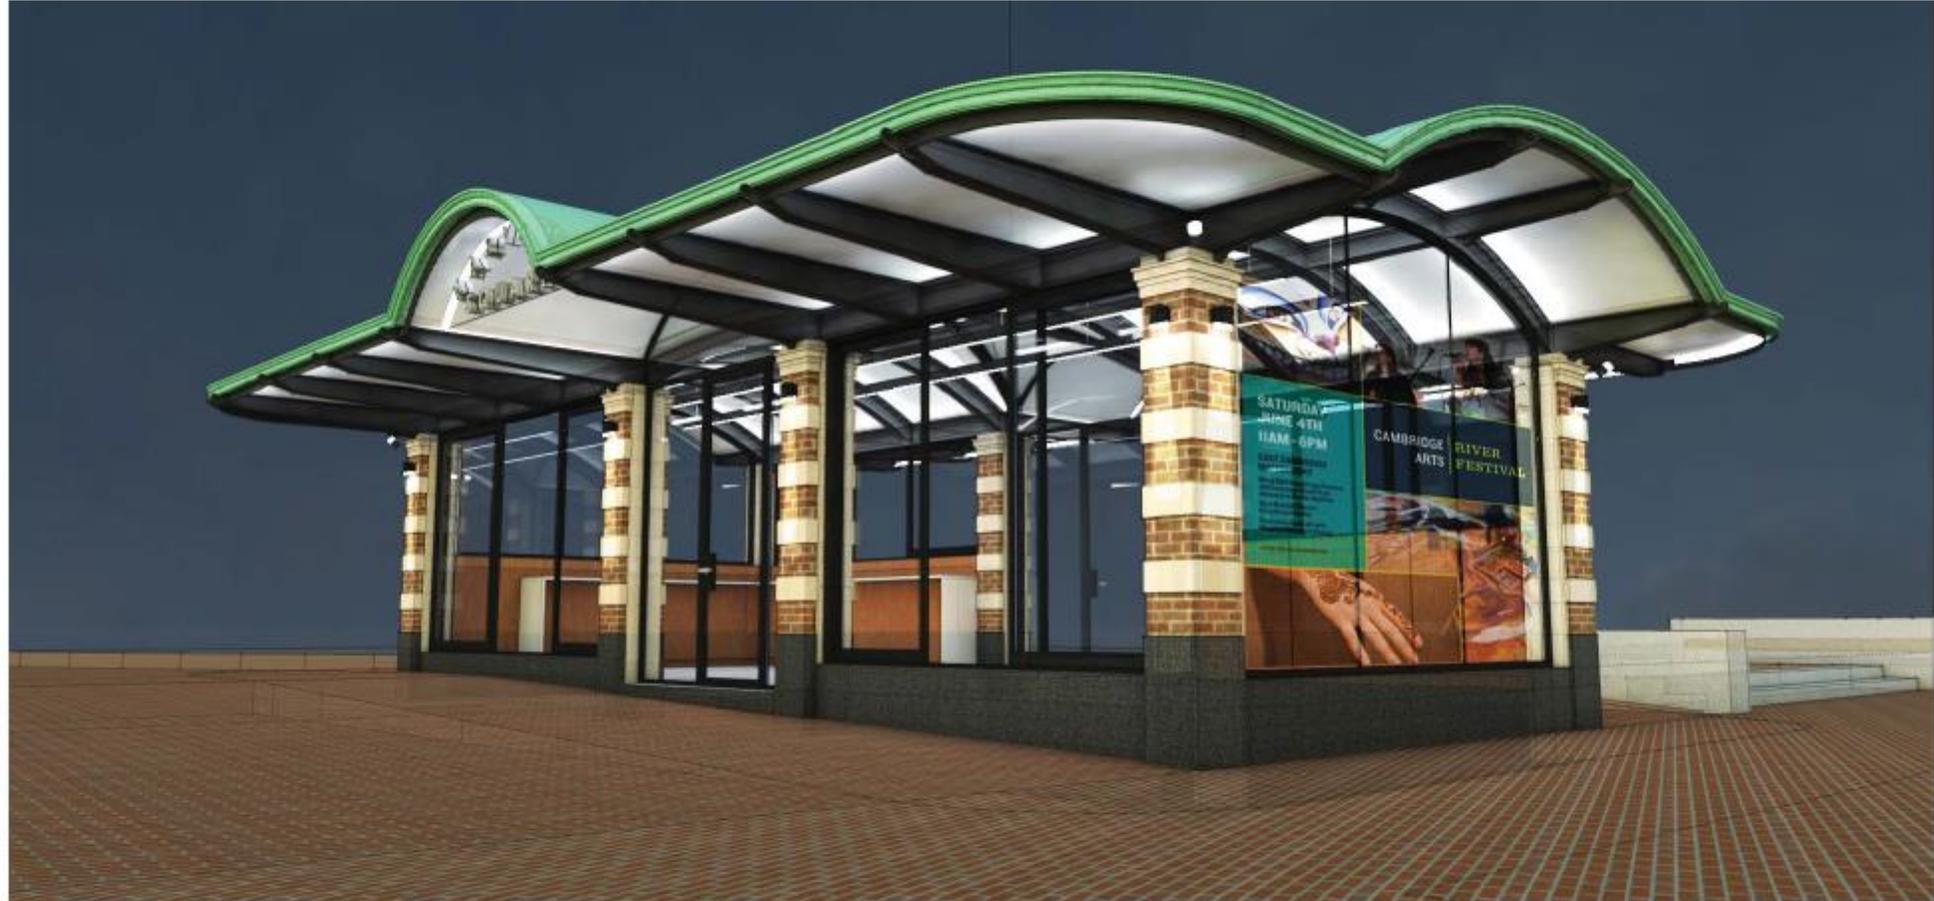
Rendering Brattle Street

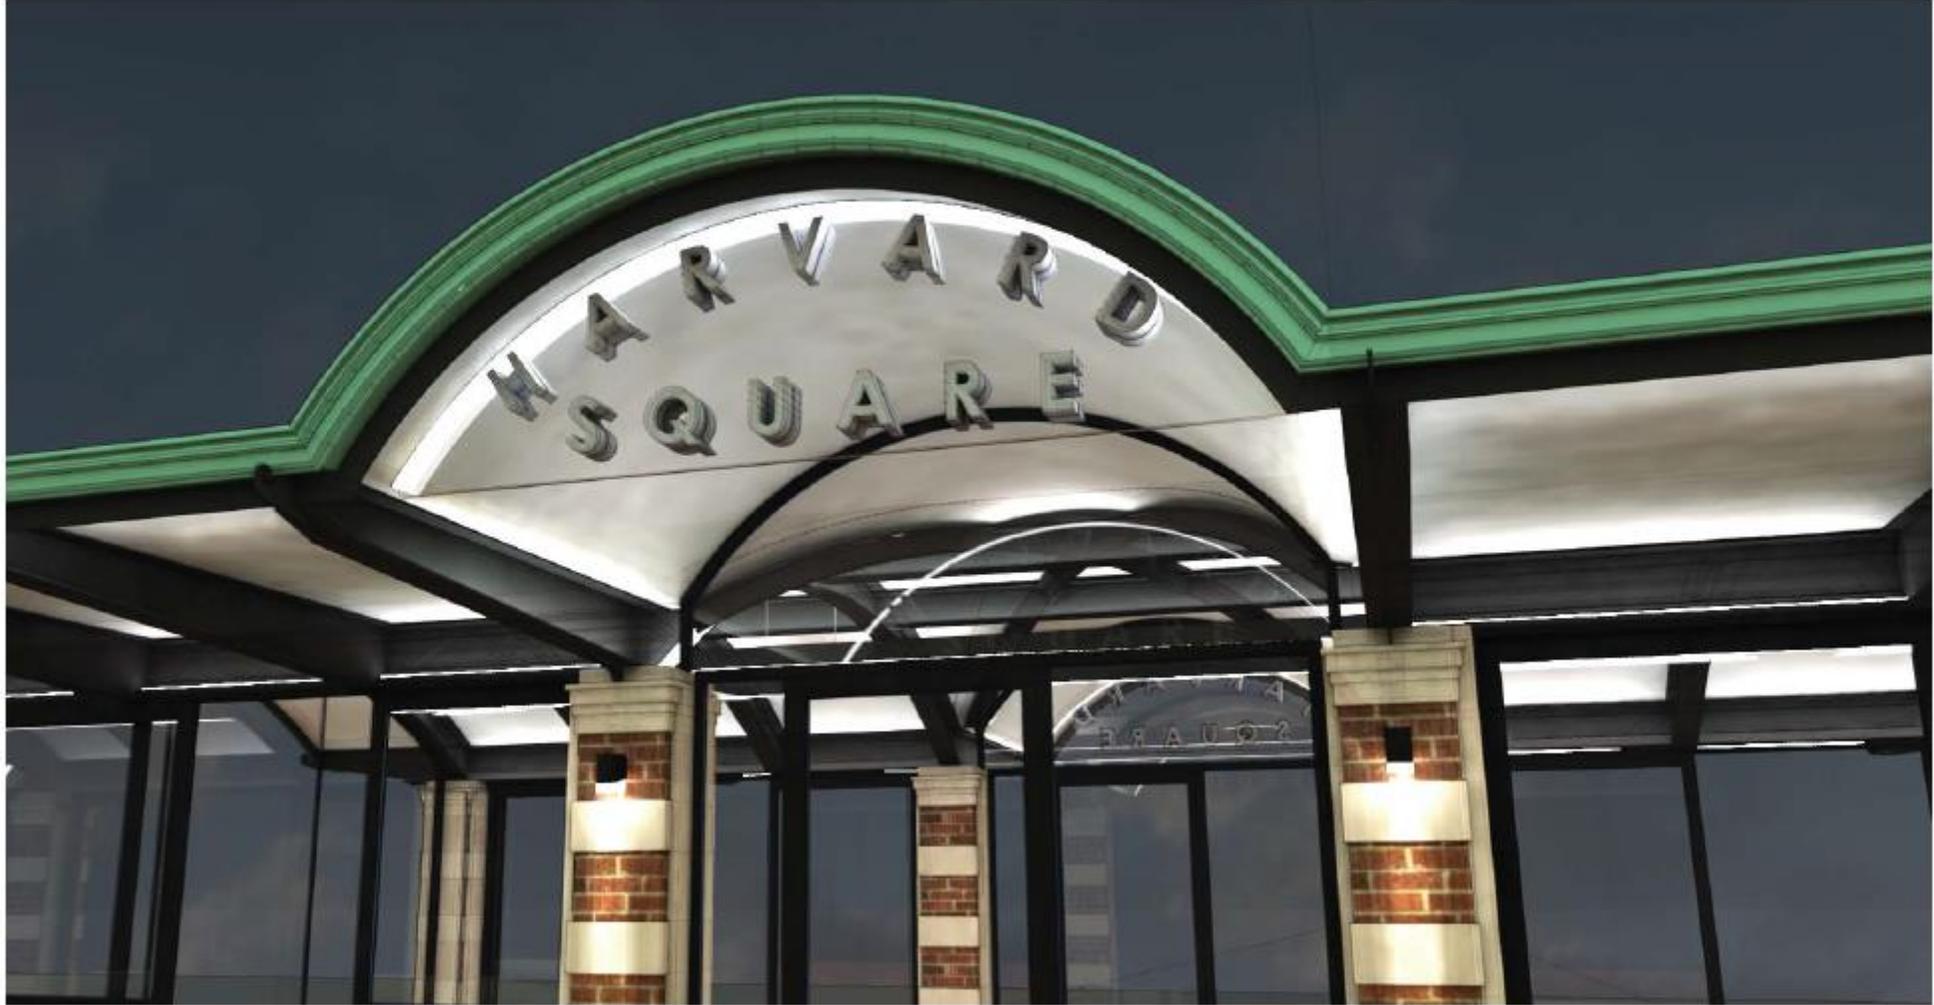
Integrated Building Signage

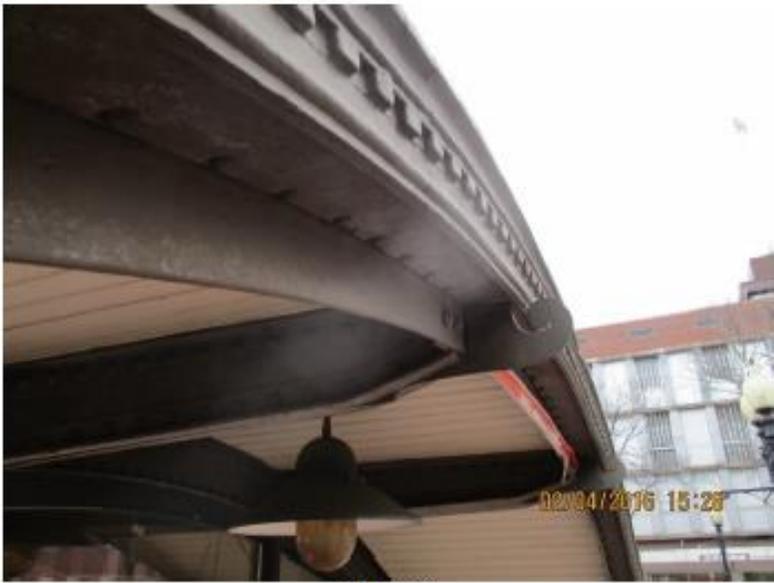
Photo 21  
North elevation: Detail of decorative lead coated copper cornice and steel framing.

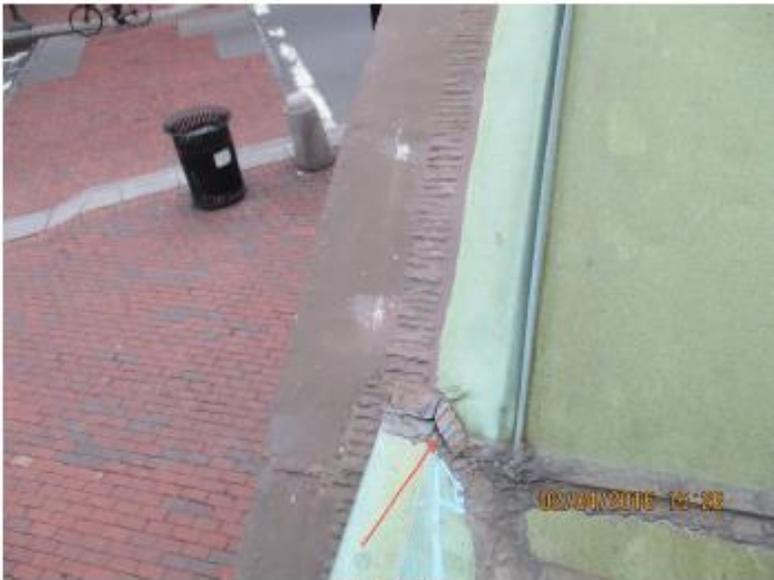
Photo 22  
North elevation: Detail of transition between the standing seam copper roof and decorative cornice. Note failed solder joint.

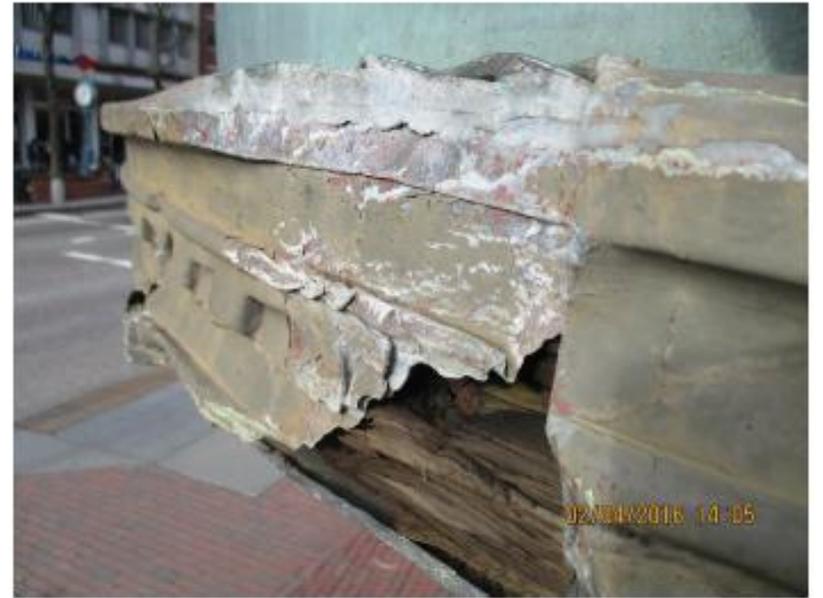
Photo 25  
Southwest decorative cornice damage and wood blocking.

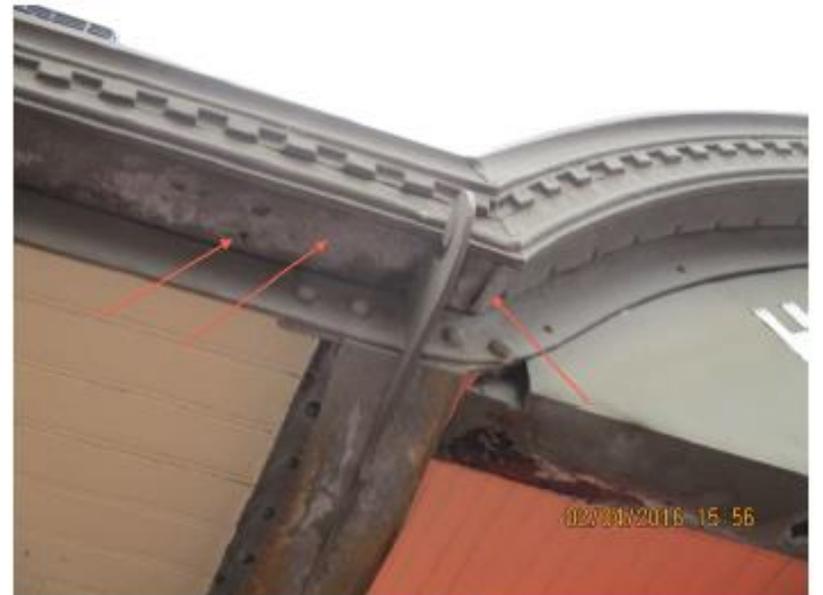
Photo 26  
West elevation: Decorative cornice detail. Note accelerated oxidization of the lead coating.

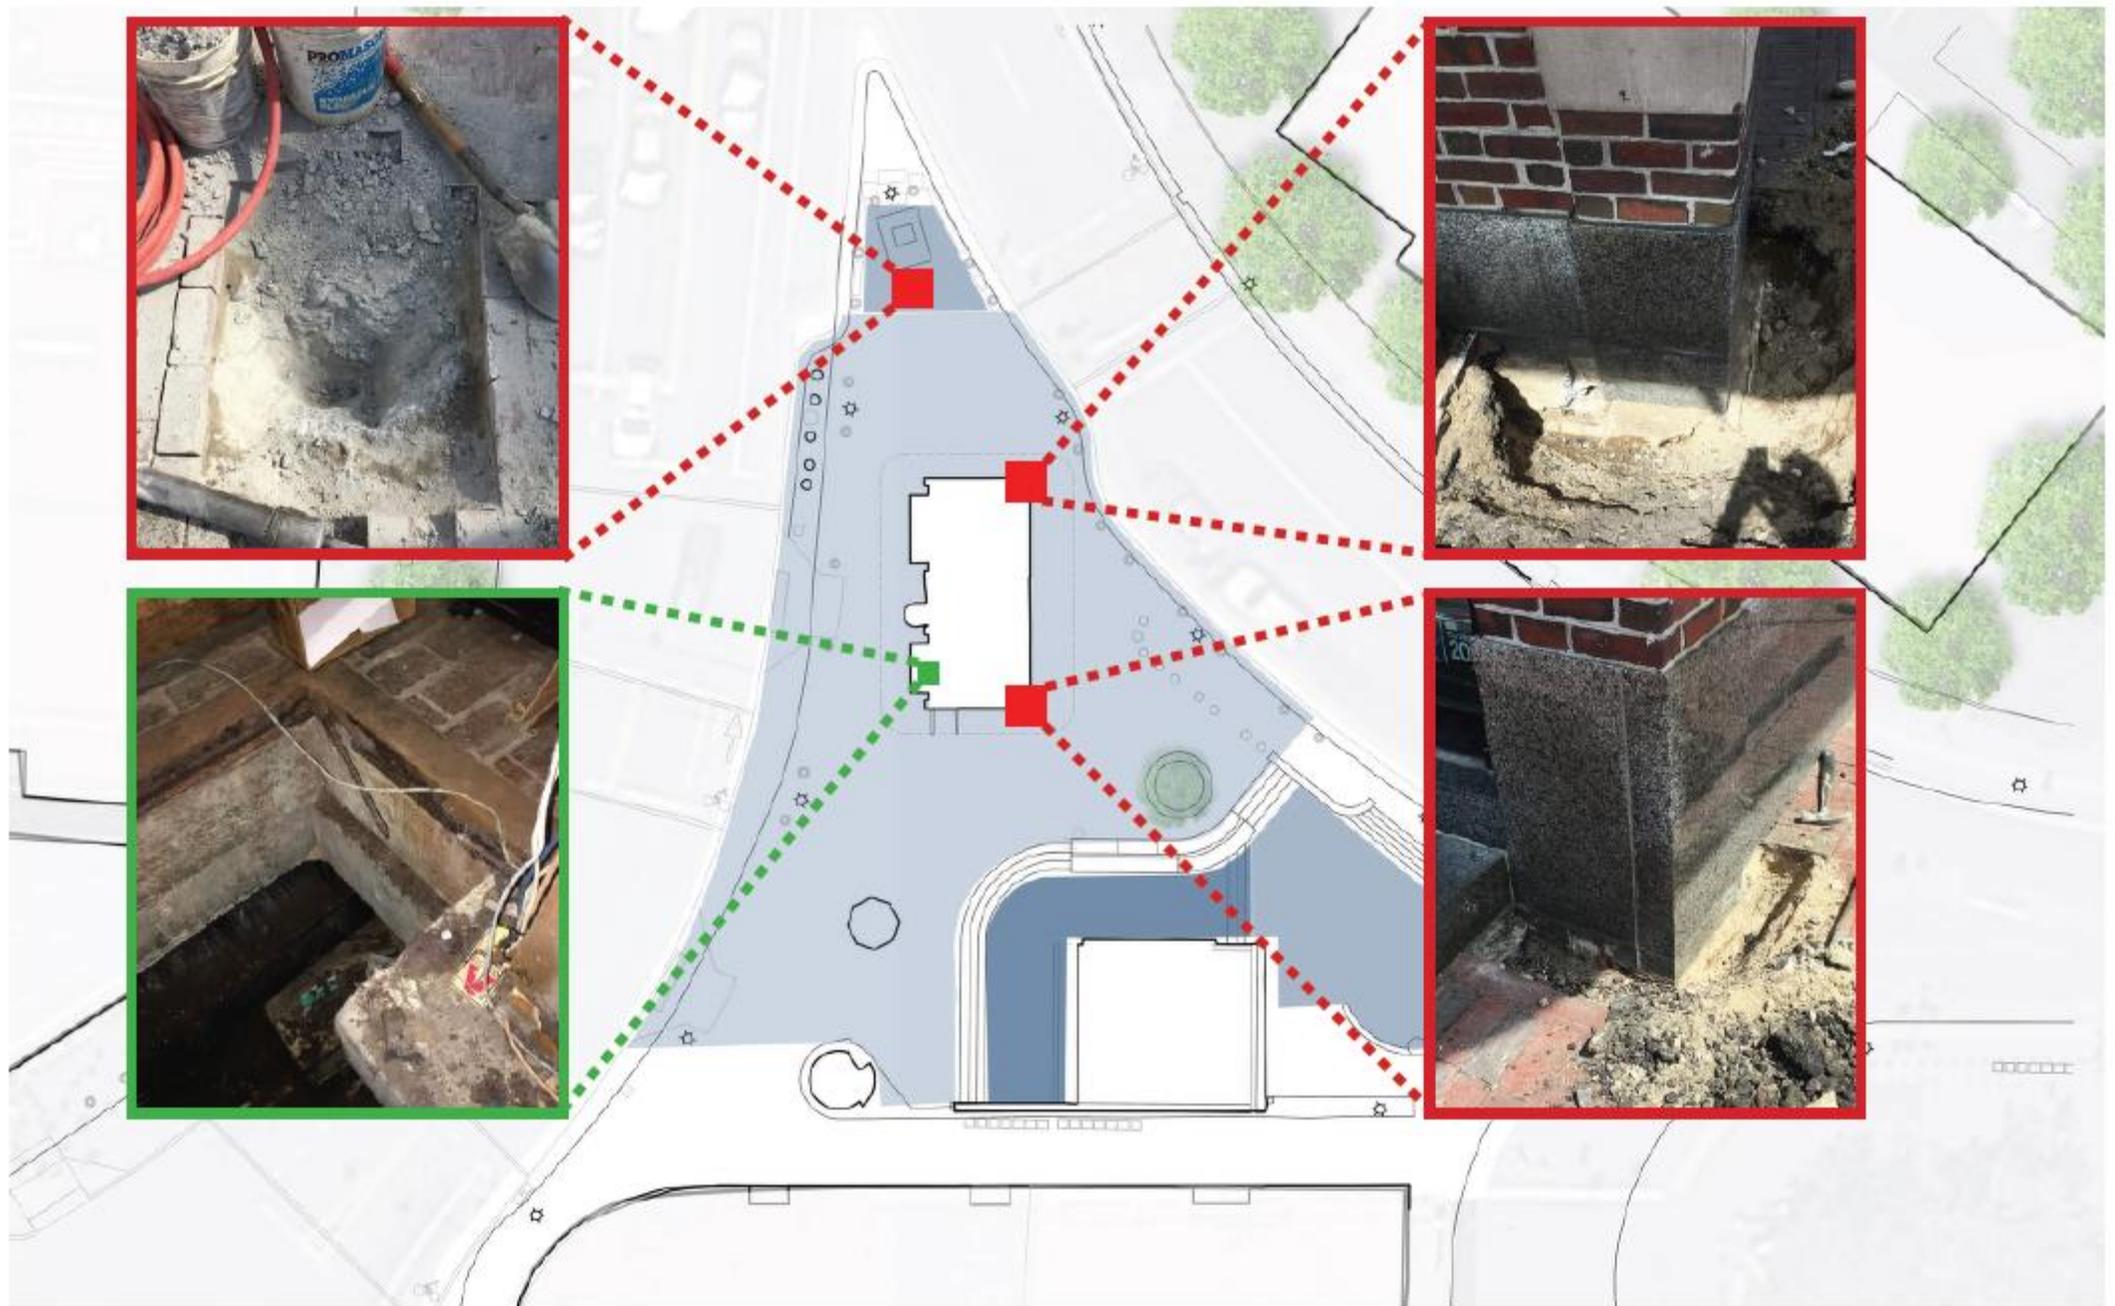
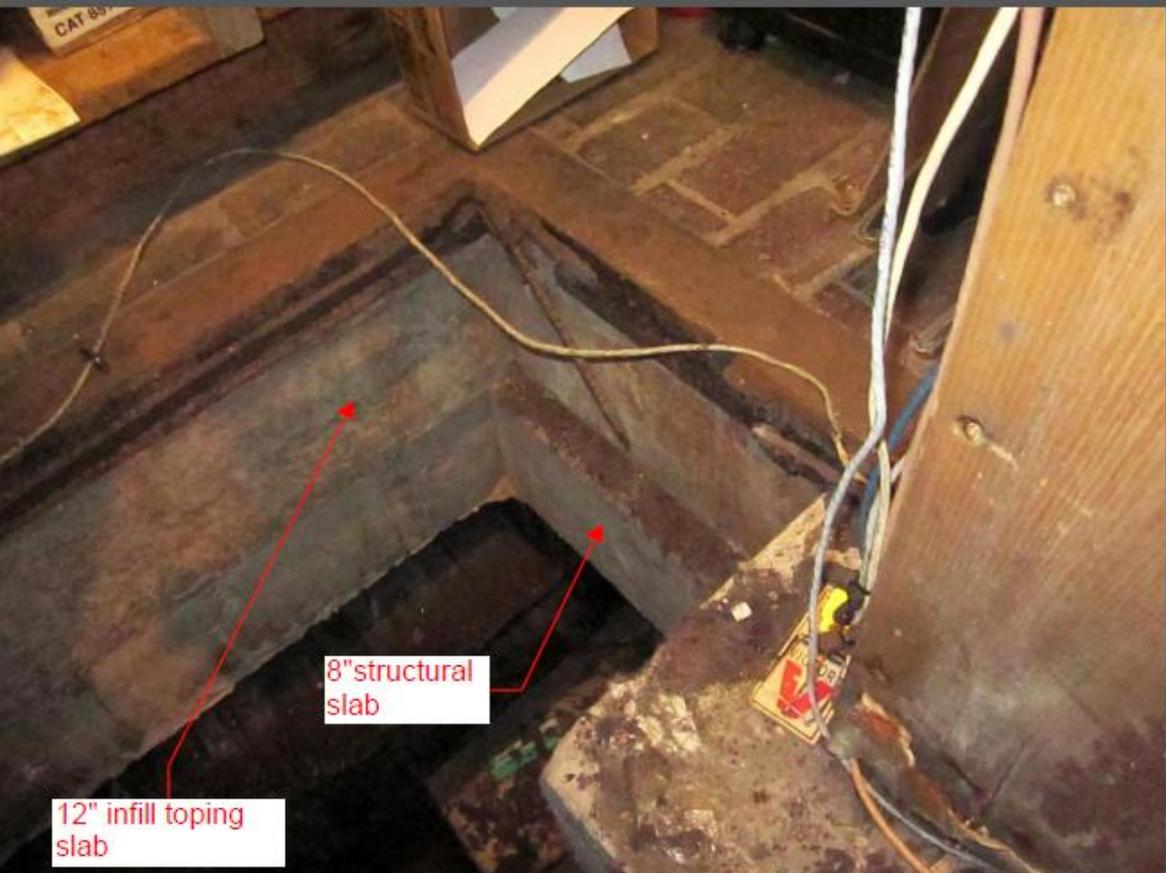
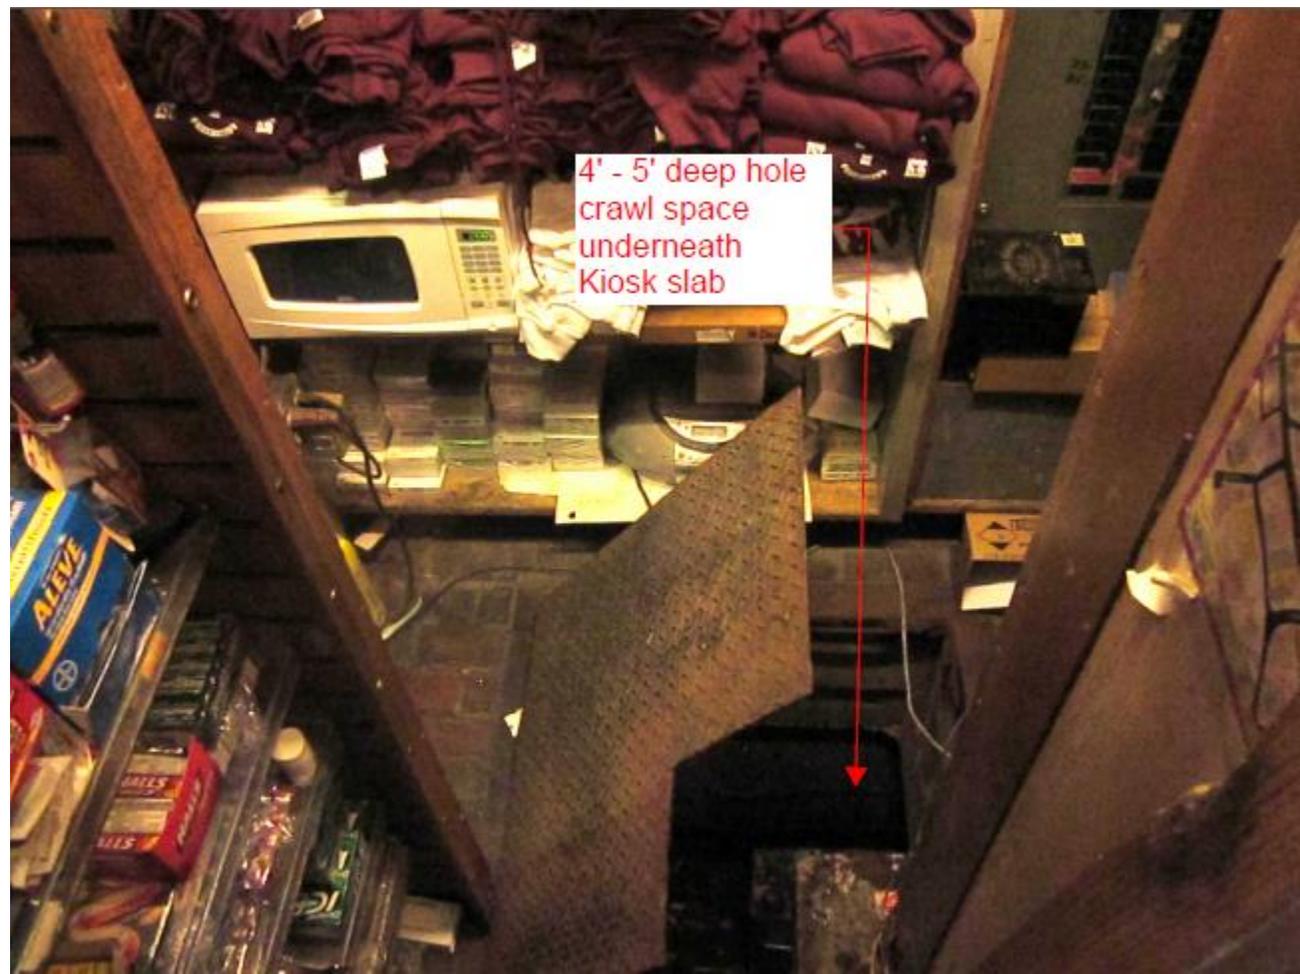
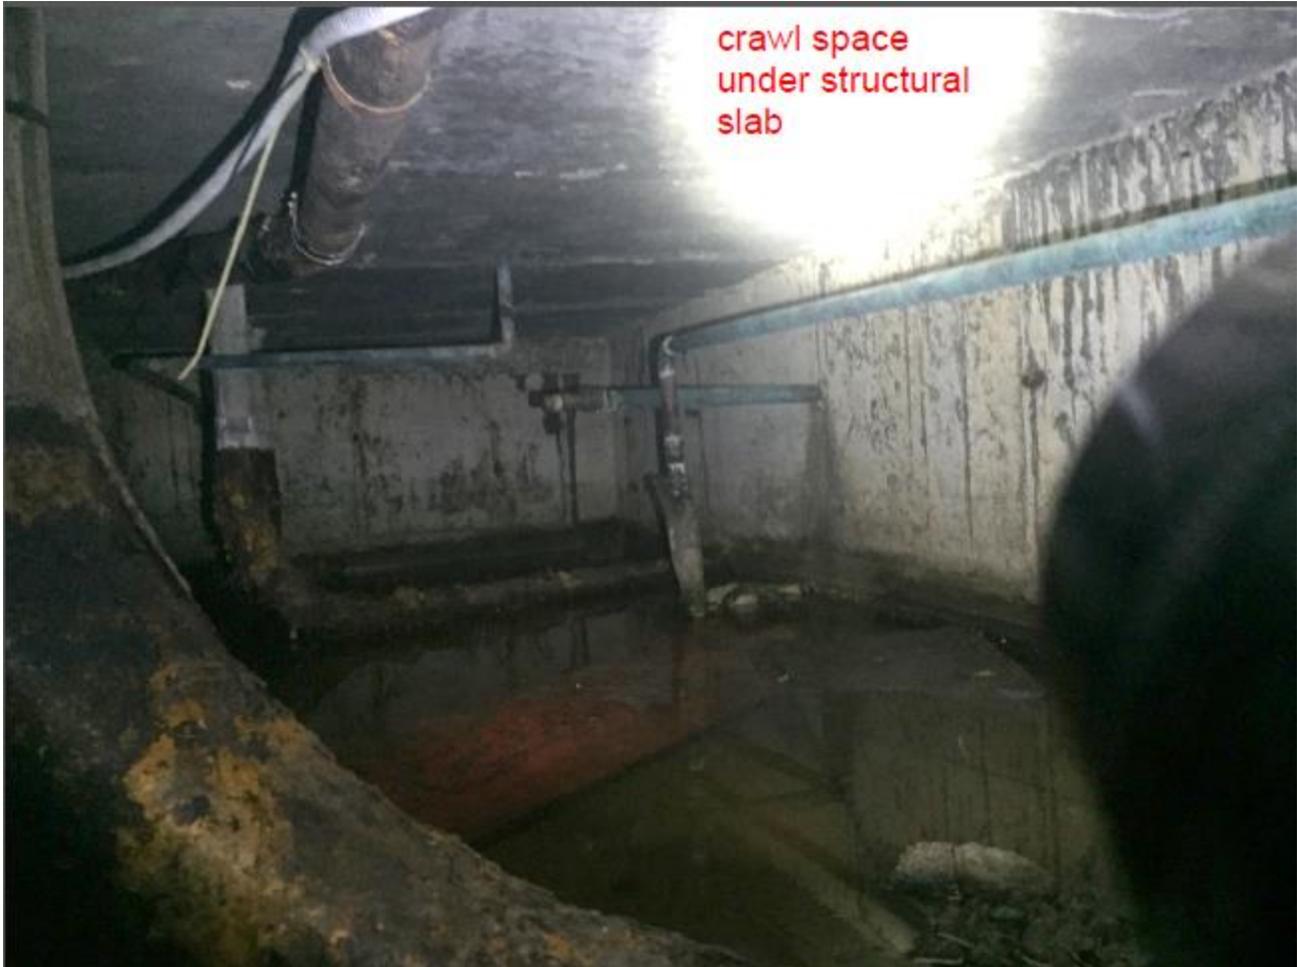
crawl space  
under structural  
slab

1. INITIAL SUBSURFACE INVESTIGATIONS DEPICT EXISTING GROUND CONDITIONS FOR THE OUT OF TOWN NEWS AS THE FOLLOWING FROM SURFACE DOWN (SEE ATTACHED PHOTOS):
  - 2.5" BRICK LAYER
  - 10-12" CONCRETE FILL
  - 8-10" CONCRETE STRUCTURAL SLAB
  - 4" ANNUALR SPACE
  - STATION ROOF
2. GPR INVESTIGATION LIMITS AROUND OOTN BUILDING TO DETERMIN EXACT LIMITS OF STRUCTURAL SLAB.
3. GPR INVESTIGATION LIMITS TO DETERMIN LIMITS AND DEPTI OF UNKNOW SLAB DISCOVERED DURING PREVIOUS SUBSURFACE INVESTIGATIONS

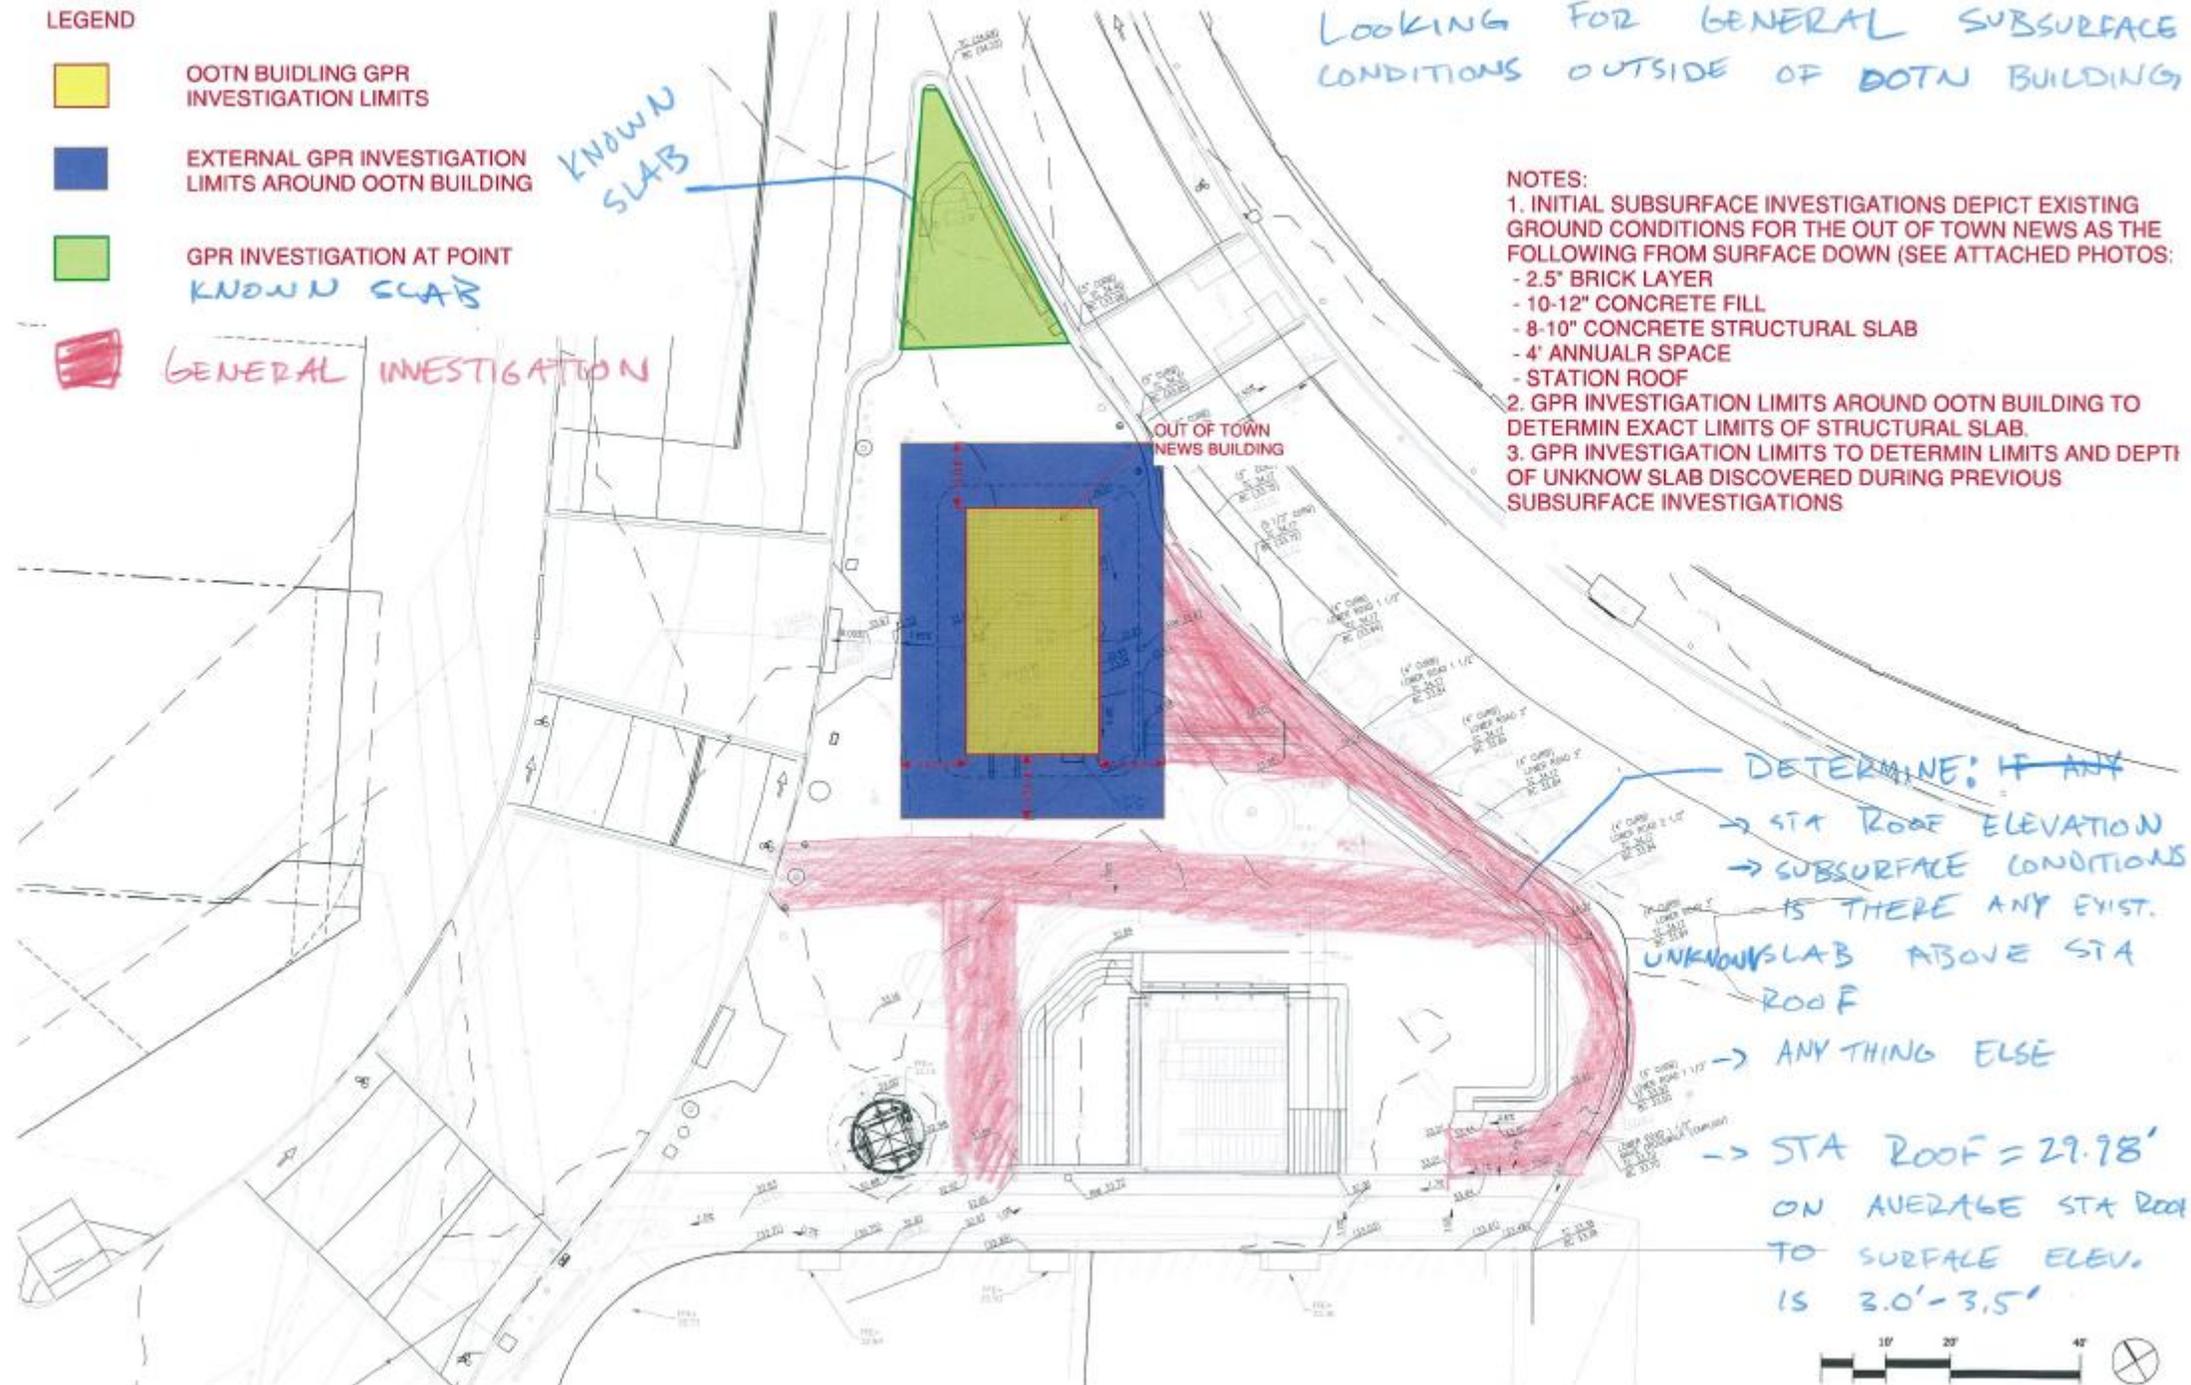
DETERMINE: IF ANY  
 → STA ROOF ELEVATION  
 → SUBSURFACE CONDITIONS  
 IS THERE ANY EXIST.  
 UNKNOW SLAB ABOVE STA  
 ROOF  
 → ANYTHING ELSE  
 → STA ROOF = 29.98'  
 ON AVERAGE STA ROOF  
 TO SURFACE ELEV.  
 IS 3.0'-3.5'
