## OUT OF TOWN NEWS - Historic Restoration

### PUBLIC WORKS: BUILDINGS - HARVARD SQUARE KIOSK INFRASTRUCTURE IMPROVEMENTS

FY16 PROJECT DESCRIPTION						CITY COUNCIL GOALS
<p>FY16 funding of \$600,000 will fund the renovations design for the Out of Town News Kiosk Building and the adjacent plaza area in Harvard Square. The overall goals of the project are to open up the historic kiosk building for more public use, enhance the historic character of the building, and build on its iconic presence in Harvard Square. The surrounding plaza area will be reconstructed to make it more inviting, to enhance pedestrian usage, and to improve accessibility.</p>

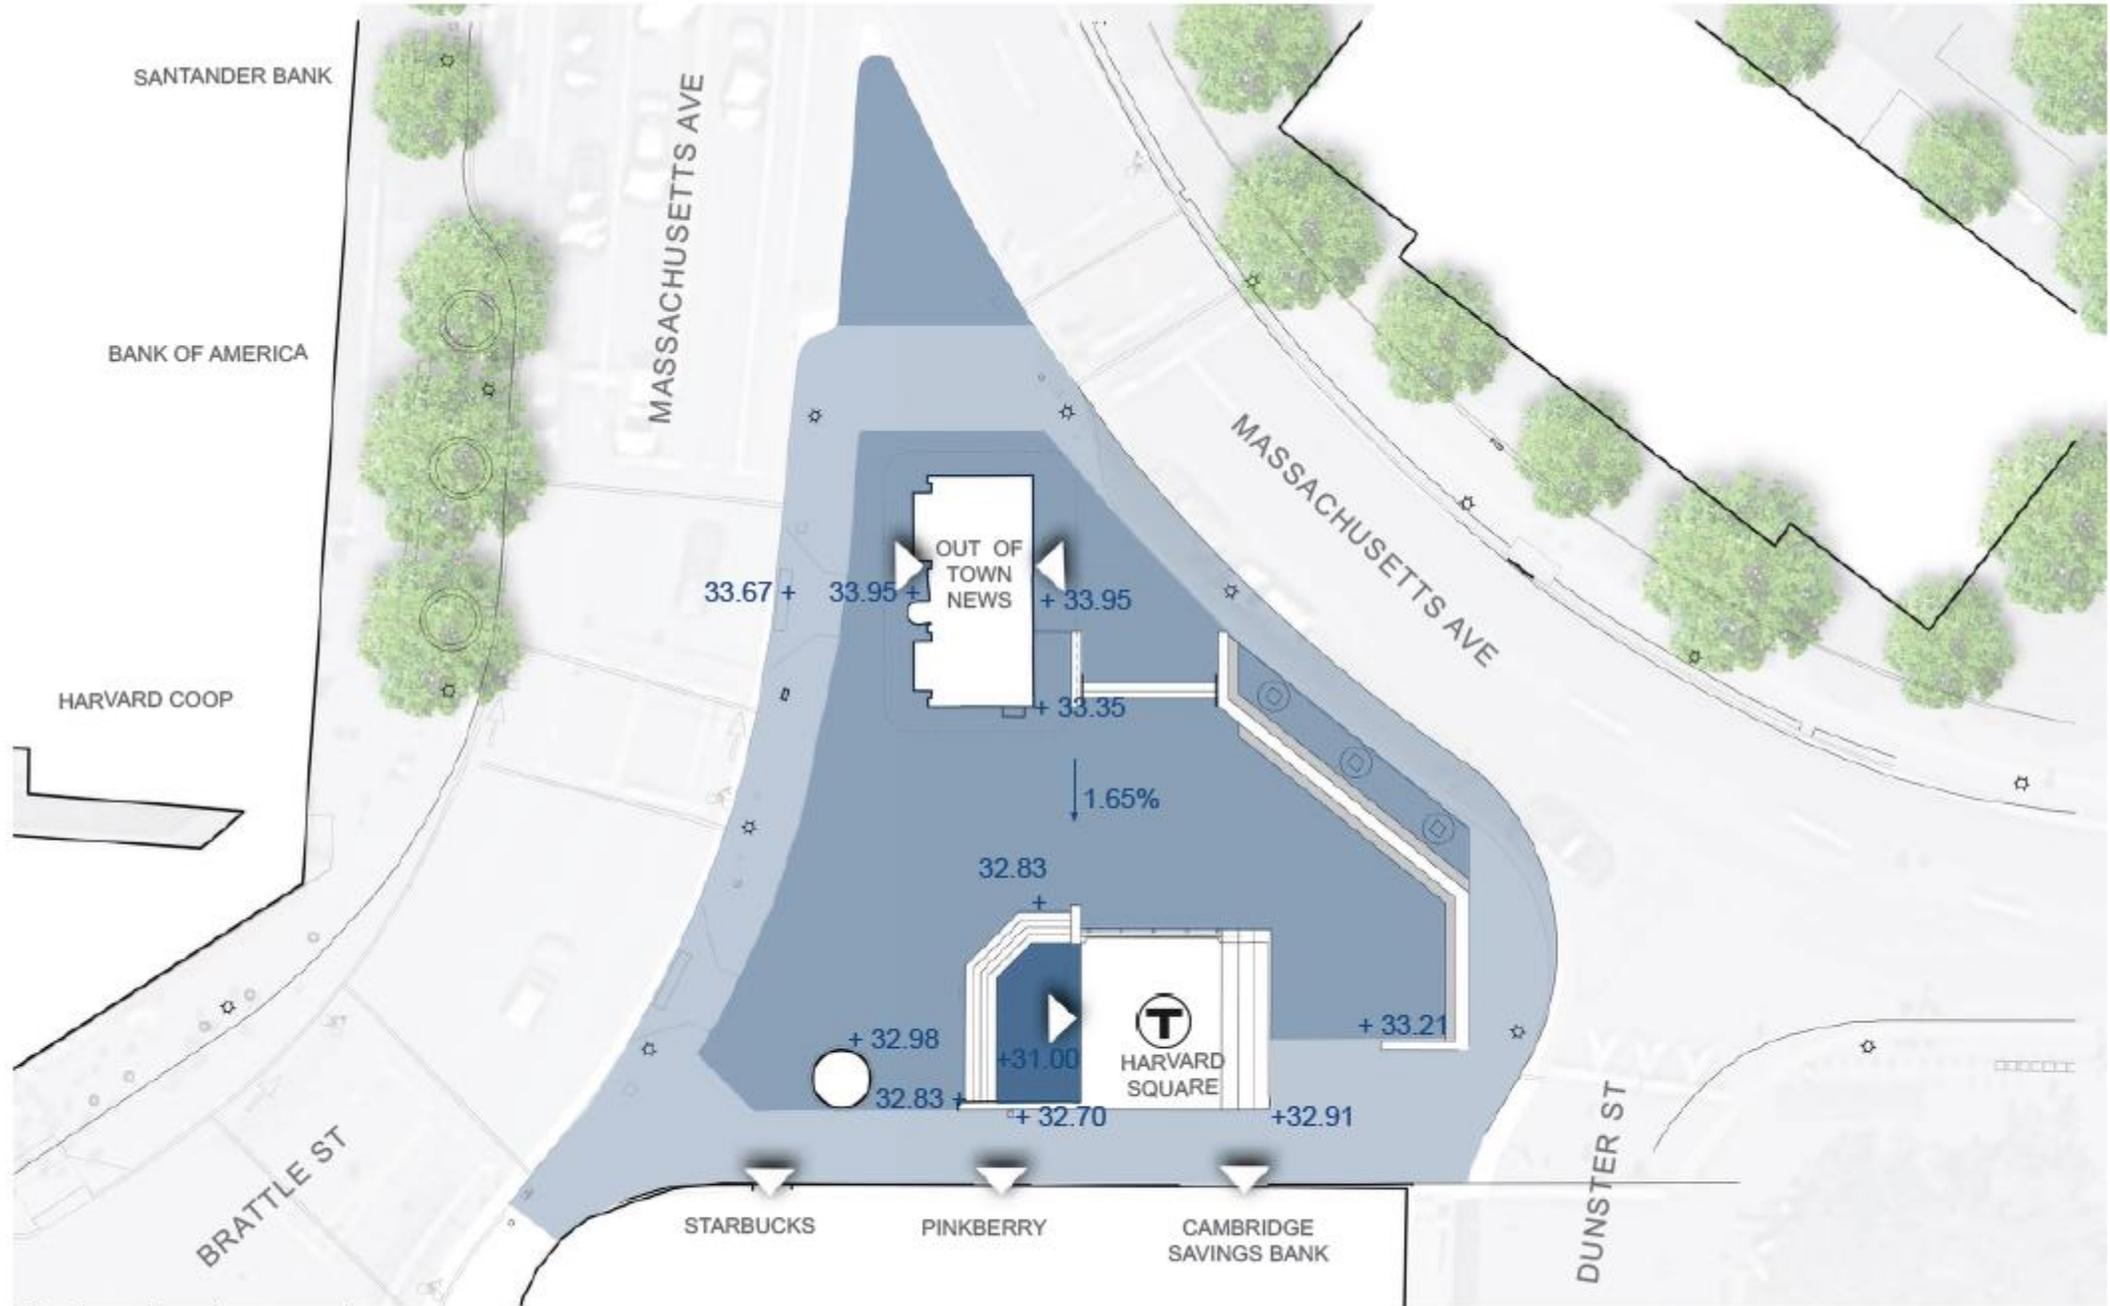
PROPOSED ELEVATION DIAGRAM - OOTN 6" LOWER

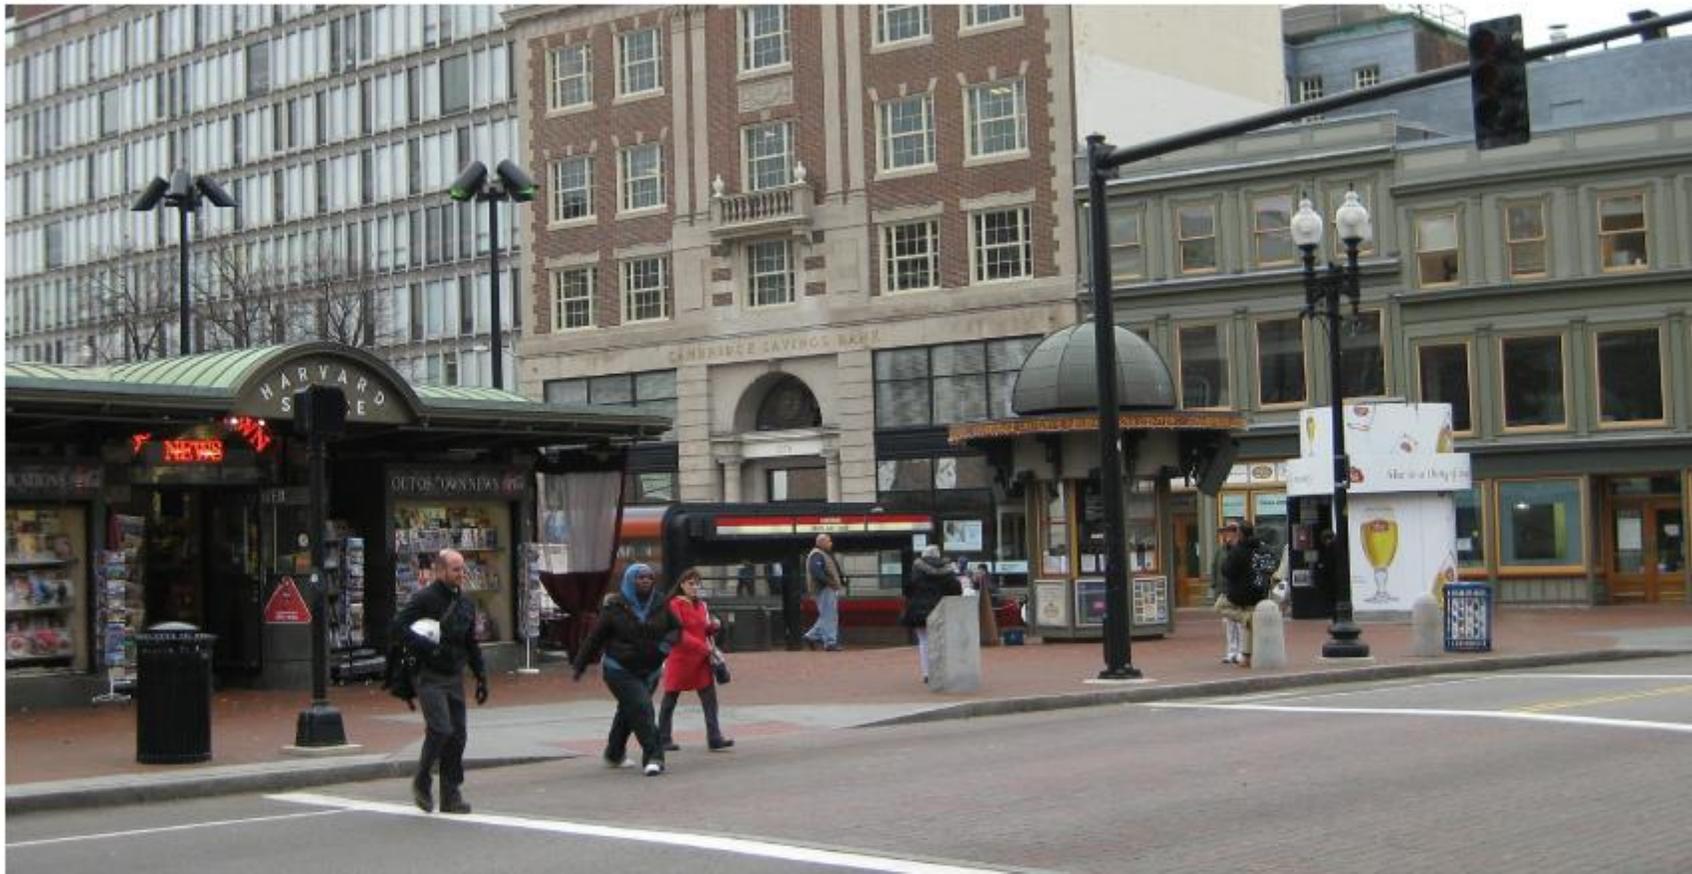
Harvard Square Station  
Existing Plaza Level  
January 2013
