# PORTER SQUARE - POST CONSTRUCTION EVALUATION STUDY

**CAMBRIDGE, MA**

### TECHNICAL MEMORANDUM

**RE:** Porter Square – Post Construction Evaluation

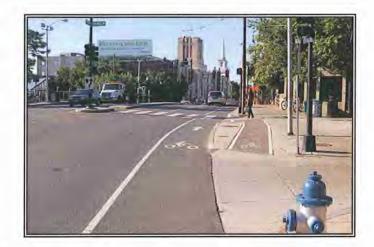
New Bike "Jug-Handle"

- Provide a signalized bike crossing for the southbound left turn from Massachusetts Avenue to Somerville Avenue via a "Bike Jug-Handle".
- Add bicycle lanes along Massachusetts Avenue and the portion of Somerville Avenue in Cambridge.
- Increase the sidewalk area by moving the curb six (6) feet between Porter Road and the bridge over the commuter rail. On street parking was removed and relocated to accomplish this. Curb extensions were also added at the corner of Upland Road and Beech Street.
- Provide new traffic signal equipment and controllers at the intersections of Massachusetts Avenue at Somerville Avenue and Upland Road and a new traffic controller and additional pedestrian heads at Massachusetts Avenue at Beech Street
- Provide coordination between the three signalized intersections to improve vehicular progression through Porter Square and reduce traffic congestion.

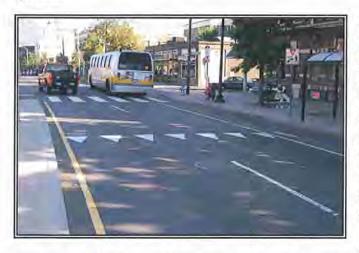
Both the Allen Street and Davenport Street crosswalks have been constructed with advance yield markings painted on the roadway approaches to the crosswalks to provide motorists with a visual indication of where to stop or yield when pedestrians are present. The yield markings are meant to enhance the compliance with the state law requiring motorists to yield to pedestrians. The behavior of drivers at the Allen Street crossing of Massachusetts Avenue was observed in October of 2007 and June of 2008. Based on the studies

prepared by the City of Cambridge Traffic Parking and Transportation Department, an average of twenty-seven percent (27%) of the drivers were observed to yield to pedestrians in the crosswalk at this location.

It should be noted that along the southbound Massachusetts Avenue approach to Davenport Street, the Dashed White Center line was not removed between the yield line and the crosswalk. The combination of the yield line and dashed line combine to form a directional arrow northbound in the southbound travel lane which should be avoided in future installations.
