Project Overview: A high priority in the Fresh Pond Reservation Master Plan, the focus of Glacken Slope Restoration is to stabilize the slope, improve soil infiltration, control storm water runoff, and enhance habitat quality. A phased restoration approach, this project involves slope stabilization and gully repair, community-based restoration plantings, and improving drainage to the Perimeter Road.

Glacken Slope Restoration Phases 4 & 5

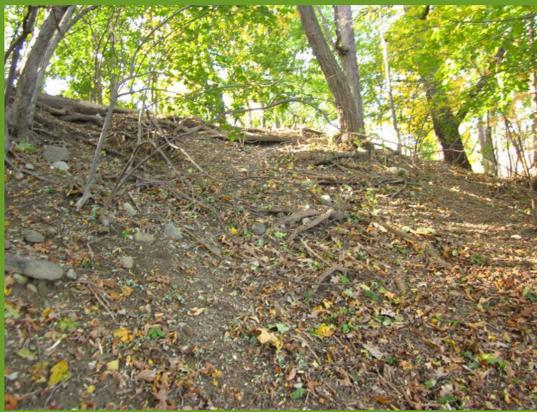
Erosion on slope

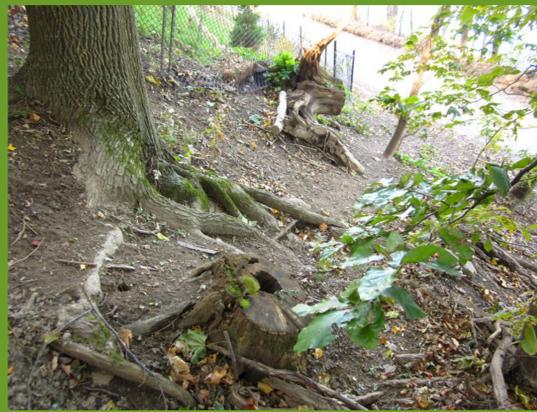
Exposed tree roots as a result of soil erosion

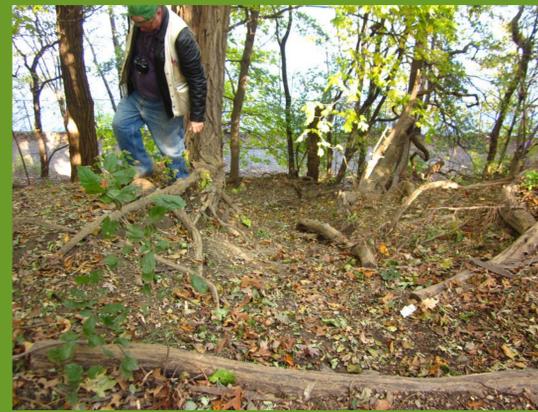
Gullies cause sediment to accumulate at toe of slope

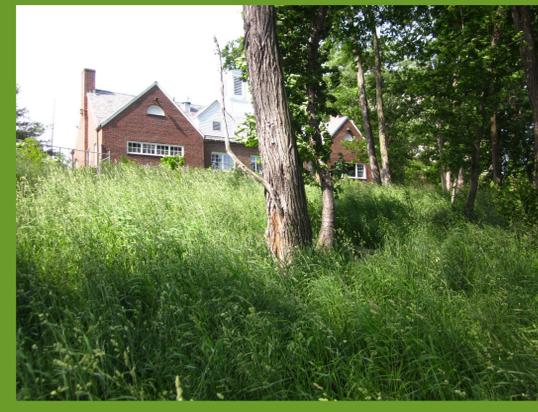
Slope stabilized and replanted below the golf course club house

Prior Work: Phases 1 - 3 included improving stormwater infiltration by installing a level spreader, a bioretention swale, a rain garden, and porous pavement on the golf course clubhouse patio. Fallen logs found on site were reused for wildlife habitat and edging, and invasive trees and vegetation were replaced with native forest plant species including trees, shrubs and herbaceous groundcover.

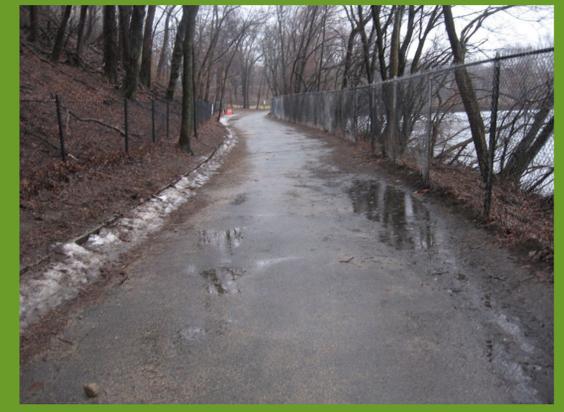
Porous pavement on the Perimeter Road will improve drainage

Project Schedule: Beginning this summer, Phase 4 continues along the Lower Slope moving further away from the golf course with slope stabilization, gully repair and planting. After completion of Phase 4 work, access will be restricted through the use of temporary fencing to allow vegetation to get fully established. Next summer 2013, Phase 5 will use porous paving to enhance runoff infiltration at the bottom of the slope and improve Perimeter Road surface and drainage. The damaged fence along the Perimeter Road will be replaced and the curb re-set.

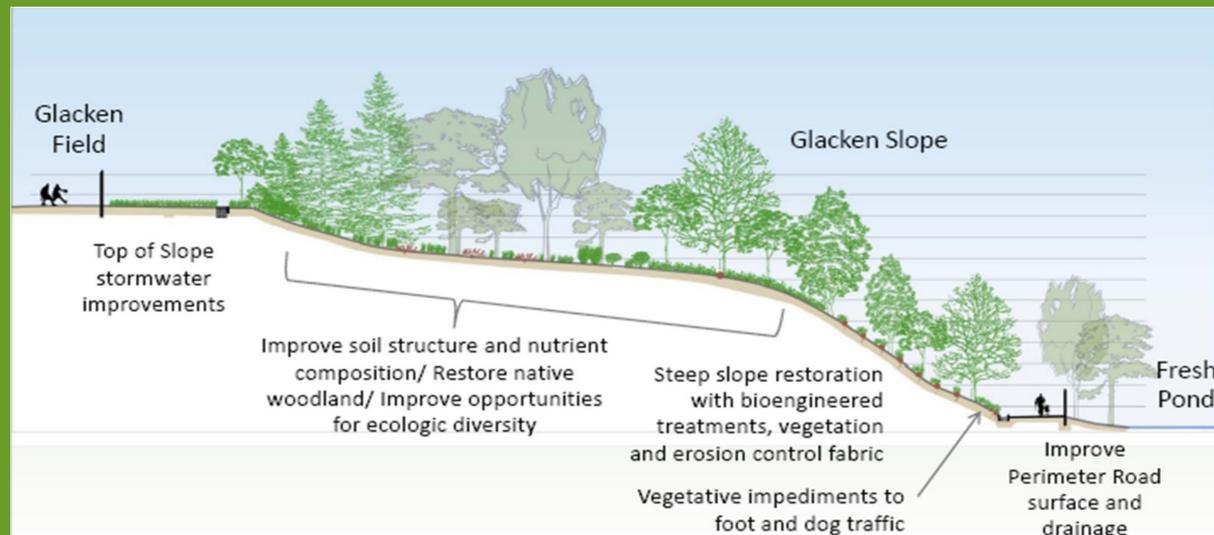
Renovation and reconstruction of Glacken Slope enhancing ecological structure and user experience
