Project 200609.05 – Vibration Monitoring Data Report – 15 to 21 March 2026, Riverview
Condominiums, 221 Mt. Auburn Street, Cambridge, MA

APPENDIX A

APPENDIX B

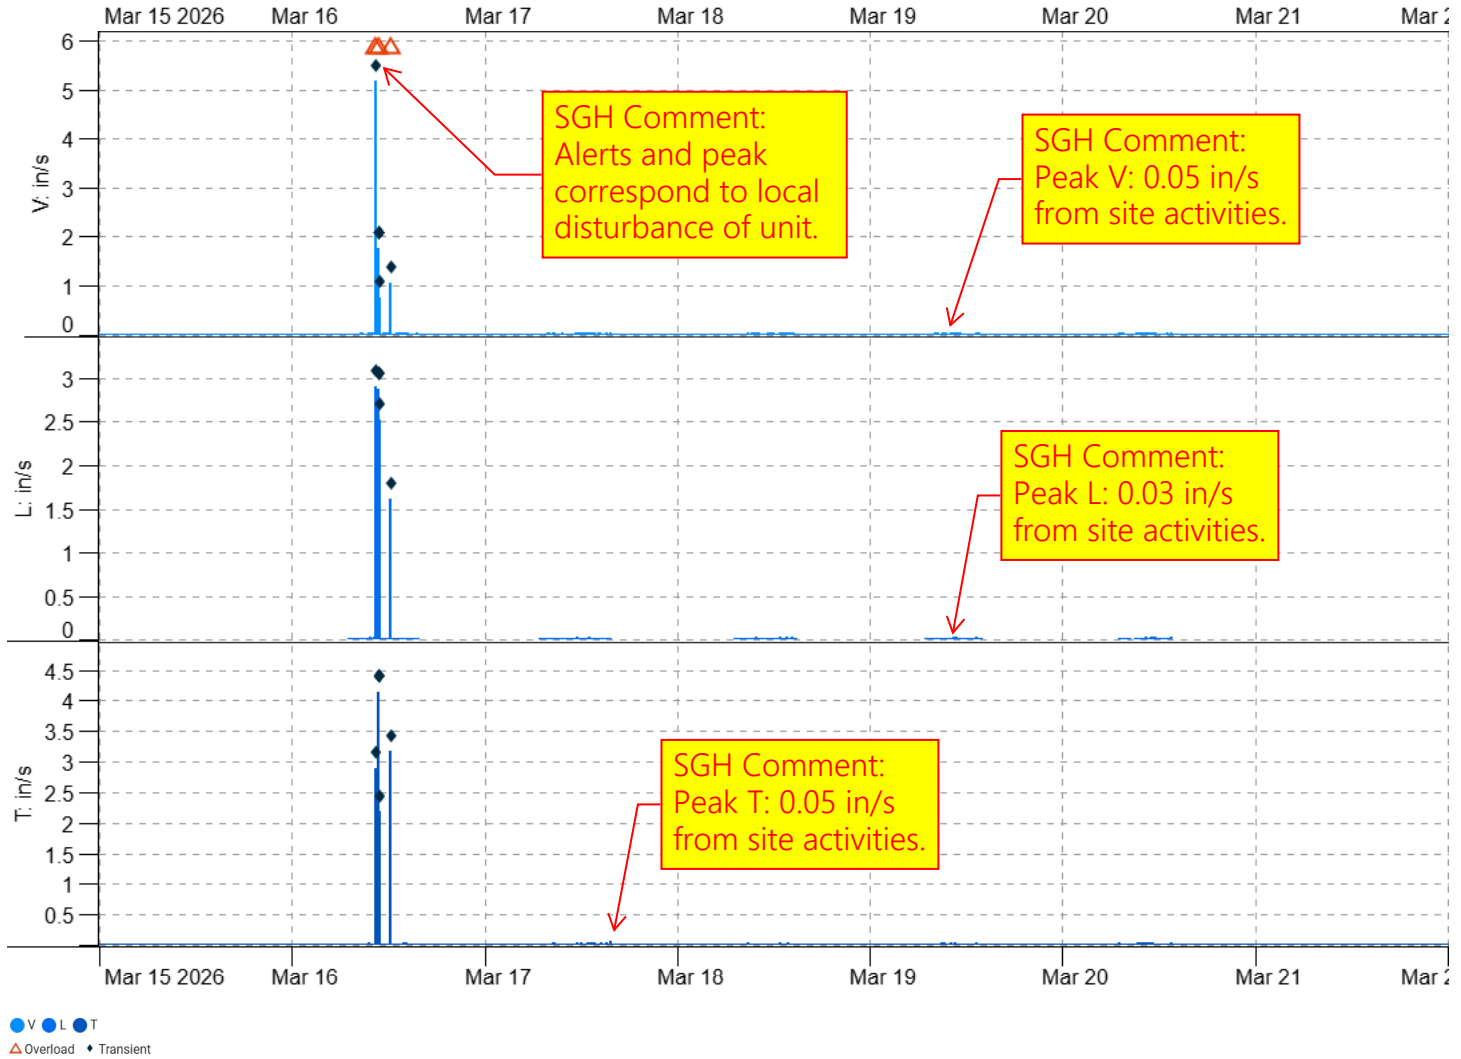
Riv5, 7 Sparks St., Cambridge, MA, C22, Serial number: 104002, Calibrated: 2025-07-02,

For the week of 15 to 21 March 2026, the project team received multiple notifications of “triggering” events at 7 Sparks Street on 16 March 2026, where the maximum PPVs are listed in parentheses in Table 1. We attach the automatically generated reports showing the associated data for these events in Appendix B. This monitoring unit is weighed down with sandbags rather than anchored to the slab to prevent damage to finishes. We determined the exceedances to be a local incident unrelated to site activities at 221 Mt. Auburn Street for the following reasons:

- The waveforms of the exceedances on 16 March 2026 are consistent with the unit being disturbed.
- The exceedances occurred between 10:00 a.m. and 12:30 p.m. when work was active on site, but no other units showed elevated readings. The project team confirmed with 7 Sparks Street that there were workers hired by the property owner in the vicinity of the unit during the vibration exceedance events.

The elevated readings are localized to the individual unit and do not represent vibrations due to site activities.

X-span	2026-03-15 00:00 - 2026-03-22 00:00		
Y-span	V: 0 - 5.16 in/s, L: 0 - 2.9 in/s, T: 0 - 4.14 in/s		
	V	L	T
Max	5.16 in/s	2.9 in/s	4.14 in/s
Date	2026-03-16	2026-03-16	2026-03-16
Time	10:22:30	10:22:30	10:47:30
Hz	1.45	1.65	2.6

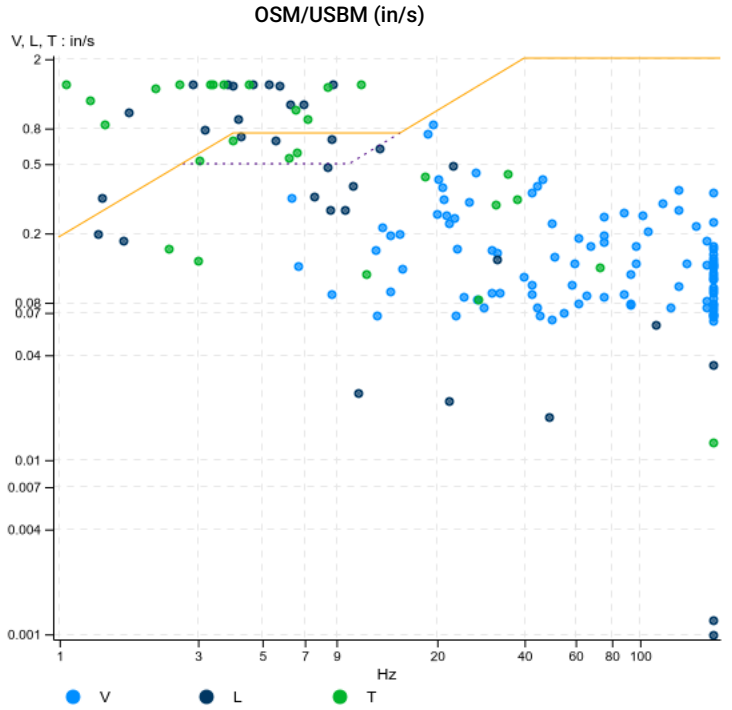
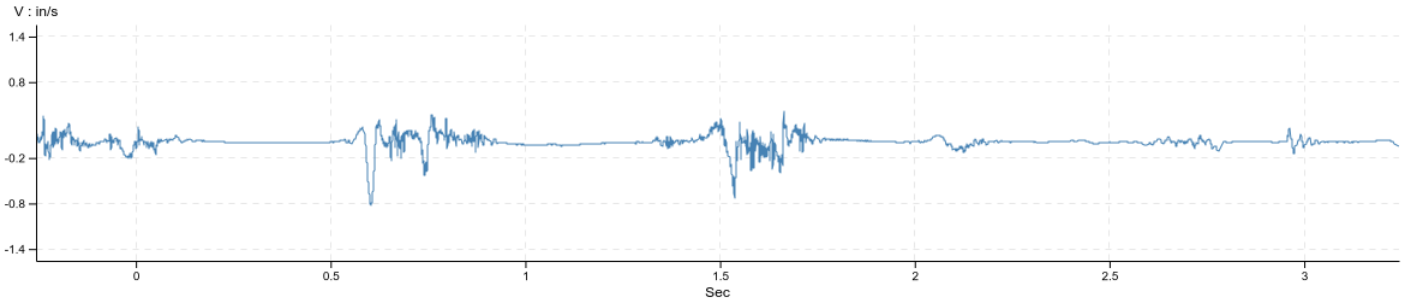
Measuring point Riv5
Description 7 Sparks St., Cambridge, MA
Sensor serial no. 104002
Latest calibration 2025-07-02
Standard text (51B) ISEE Seismograph 1 in/s 2-250Hz

Channel	V	L	T
Sensor	C22	C22	C22
Serial number	104002	104002	104002
Trigger type	internal	internal	internal
Max values	0.826 in/s 0.43 g 12.01 mil 19.5 Hz	2.59 in/s 0.29 g 222.3 mil 2.91 Hz	4.14 in/s 0.48 g 170.97 mil 3.39 Hz
Date and time	2026-03-16 10:46:57	2026-03-16 10:46:57	2026-03-16 10:46:57
Geophone check	passed	passed	passed
Sensor tilt check	na

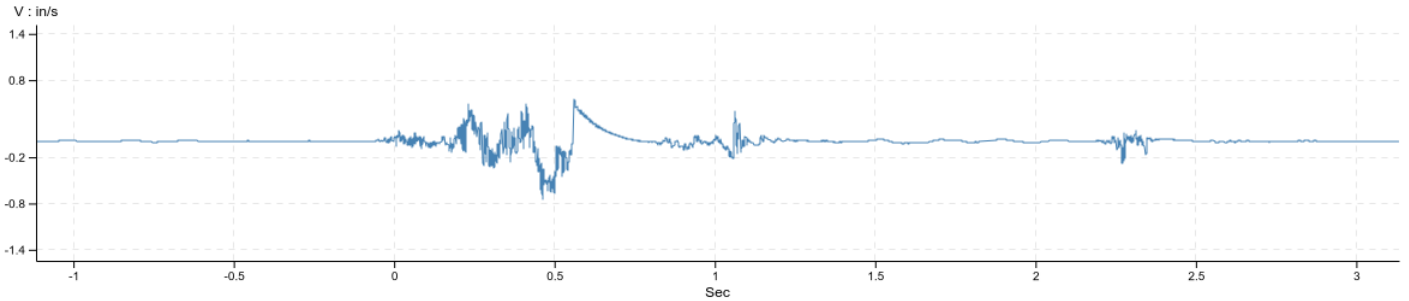
Measuring point Riv5
Description 7 Sparks St., Cambridge, MA
Sensor serial no. 104002
Latest calibration 2025-07-02
Standard text (51B) ISEE Seismograph 1 in/s 2-250Hz

Channel	V	L	T
Sensor	C22	C22	C22
Serial number	104002	104002	104002
Trigger type	internal	internal	internal
Max values	0.754 in/s 0.37 g 28.88 mil 4.08 Hz	2.52 in/s 0.13 g 121.8 mil 2.79 Hz	2.17 in/s 0.11 g 132.2 mil 2.28 Hz
Date and time	2026-03-16 10:51:33	2026-03-16 10:51:33	2026-03-16 10:51:33
Geophone check	passed	passed	passed
Sensor tilt check	na

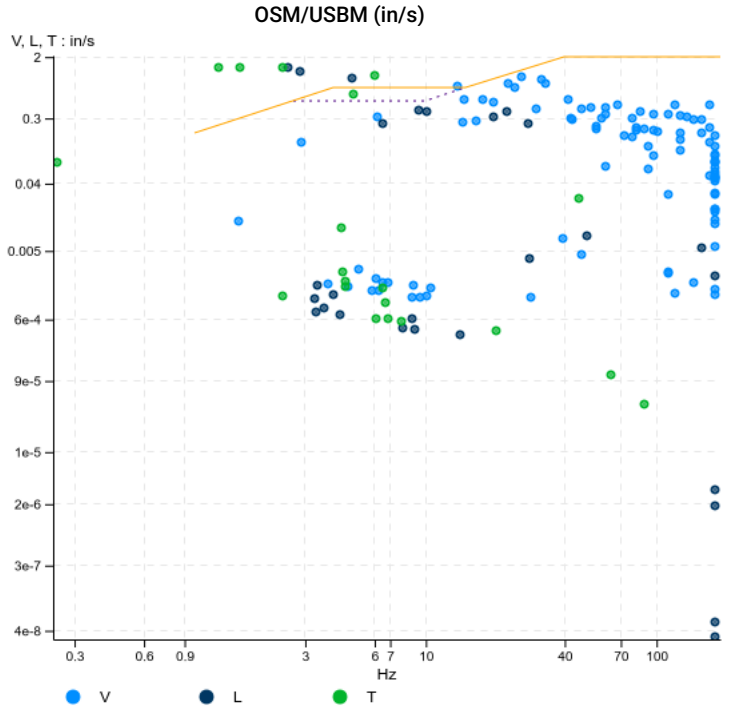
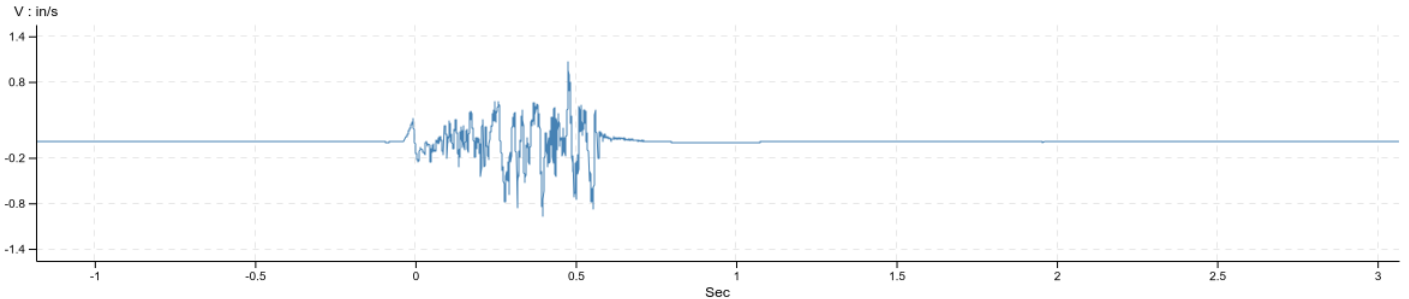
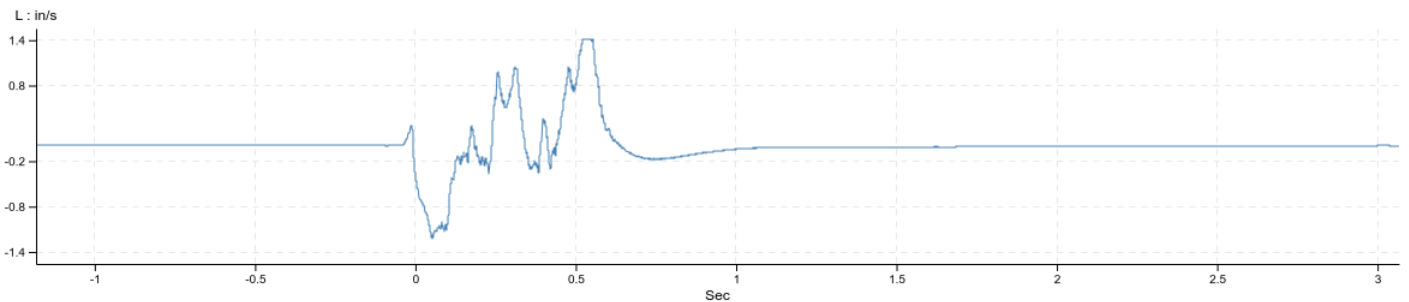
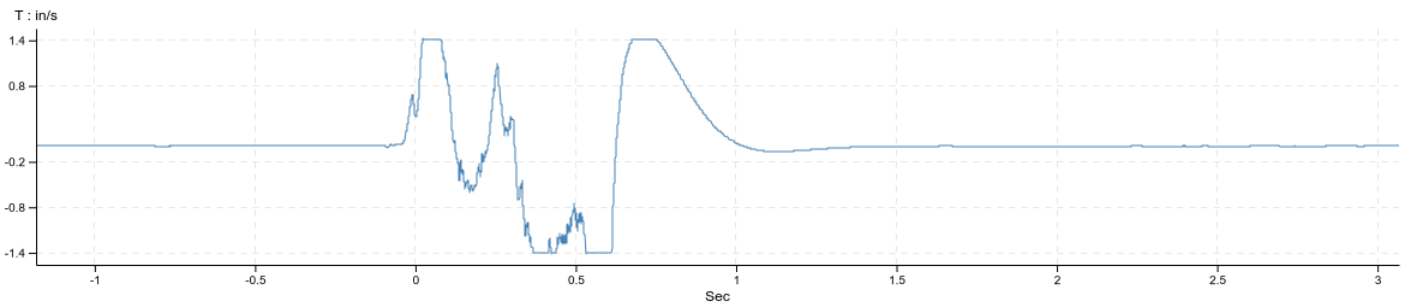
Measuring point Riv5
Description 7 Sparks St., Cambridge, MA
Sensor serial no. 104002
Latest calibration 2025-07-02
Standard text (51B) ISEE Seismograph 1 in/s 2-250Hz

Channel	V	L	T
Sensor	C22	C22	C22
Serial number	104002	104002	104002
Trigger type	internal	internal	internal
Max values	1.05 in/s 0.48 g 13.59 mil 26.26 Hz	1.61 in/s 0.15 g 121.6 mil 2.54 Hz	3.16 in/s 0.22 g 251.11 mil 2.0 Hz
Date and time	2026-03-16 12:17:14	2026-03-16 12:17:14	2026-03-16 12:17:14
Geophone check	passed	passed	passed
Sensor tilt check	passed
