Residential Architecture

19th-Century House Types

19th-Century Residential Styles

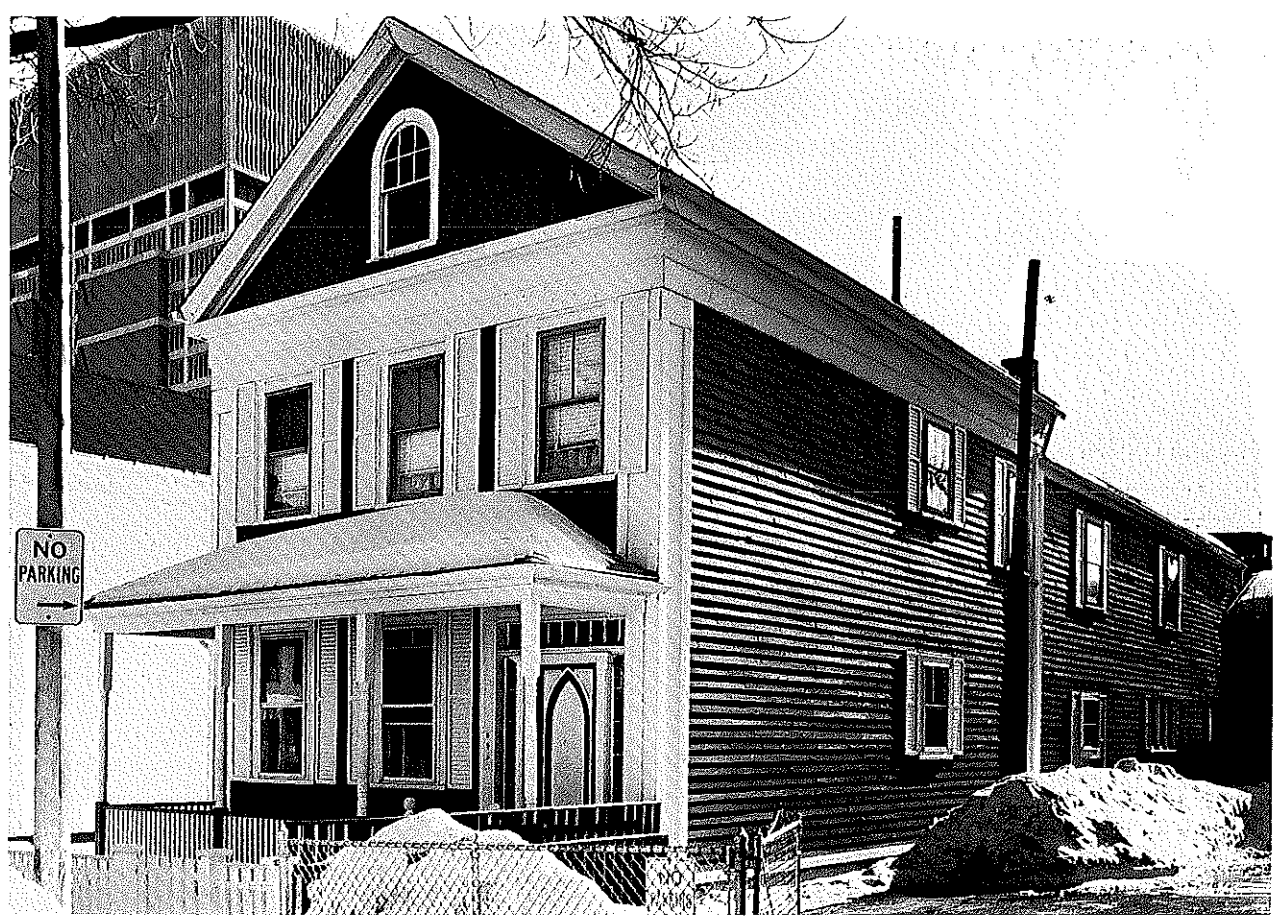
143. Type A, 467 Cambridge Street, 1824-25. Photograph 1964

Type A was a continuation of the large 18th-century Georgian house, variations of which were built all along the Eastern seaboard (Fig. 143). Four-square and box-like in mass, this house was rigidly formal both inside and out, a heritage of the English Palladian tradition. The facade, oriented about a central, axial entrance, had five openings per floor (center door and four windows on the first floor, five windows on each of the upper floors). The plan consisted of four more or less square rooms per floor — two on each side of the center stair hall, which extended to the back of the house. Fireplaces were either on the outside wall (in which case there were four chimneys) or in the partition between the rooms (two chimneys). Sometimes subsidiary wings were attached to the side or rear, served by their own chimneys.

Four-room central-hall houses (Type A) were unusual in this district of modest living accommodations. One example remains at 467 Cambridge Street, but the windows and doors have been removed, and it is hidden behind a later commercial block (see Fig. 143). Built in 1824–25, the main entrance of this once imposing house had sidelights and a customary if somewhat clumsy elliptical fan (Fig. 151). There were also good but simple Federal fireplaces in both the first- and second-floor rooms (Fig. 152).

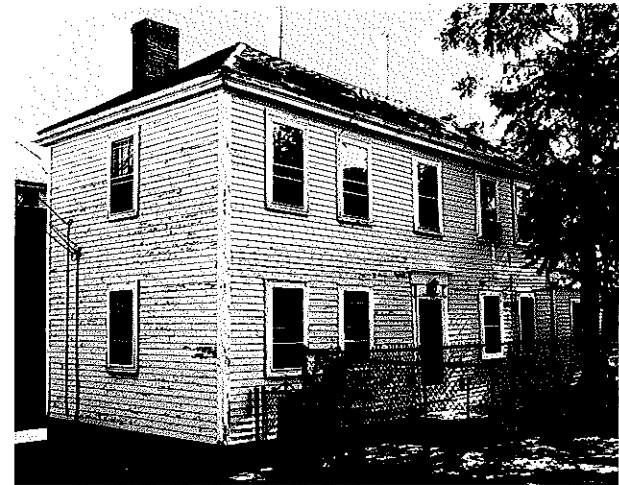
144. Type B, 42A Lopez Avenue, c. 1825. Moved, original location unknown 12 e 7 / 30

Type B, also surviving from the 18th century, was a smaller version of the center-hall plan (Fig. 144). It can be seen as a halving of the four-room model parallel to the front elevation; the same symmetrical five-opening facade was there, but the house was only one room

Type B houses in East Cambridge were nearly always built with the narrow end to the street and with the symmetrical entrance facade facing the side of the lot. The earliest examples, from the 1820s, often had low hip roofs, but in the Greek Revival style, beginning in the 1830s, gable roofs were used exclusively. The type was at its apogee in America in the Late Georgian or Federal period; by the 1830s and '40s, it was used only for the most vernacular examples. Thus, Type B houses in East Cambridge are the smallest, least architectural of all the types. The small, free-standing, end-to-street version of the type is called in this book the worker's cottage, because it represents the simplest level of single-family housing during the first half of the century. Whole series of these worker's cottages still exist, particularly along Winter Street, punctuating the streetscape with their jagged silhouettes, which vary from one and a half to three stories high (see Fig. 167).

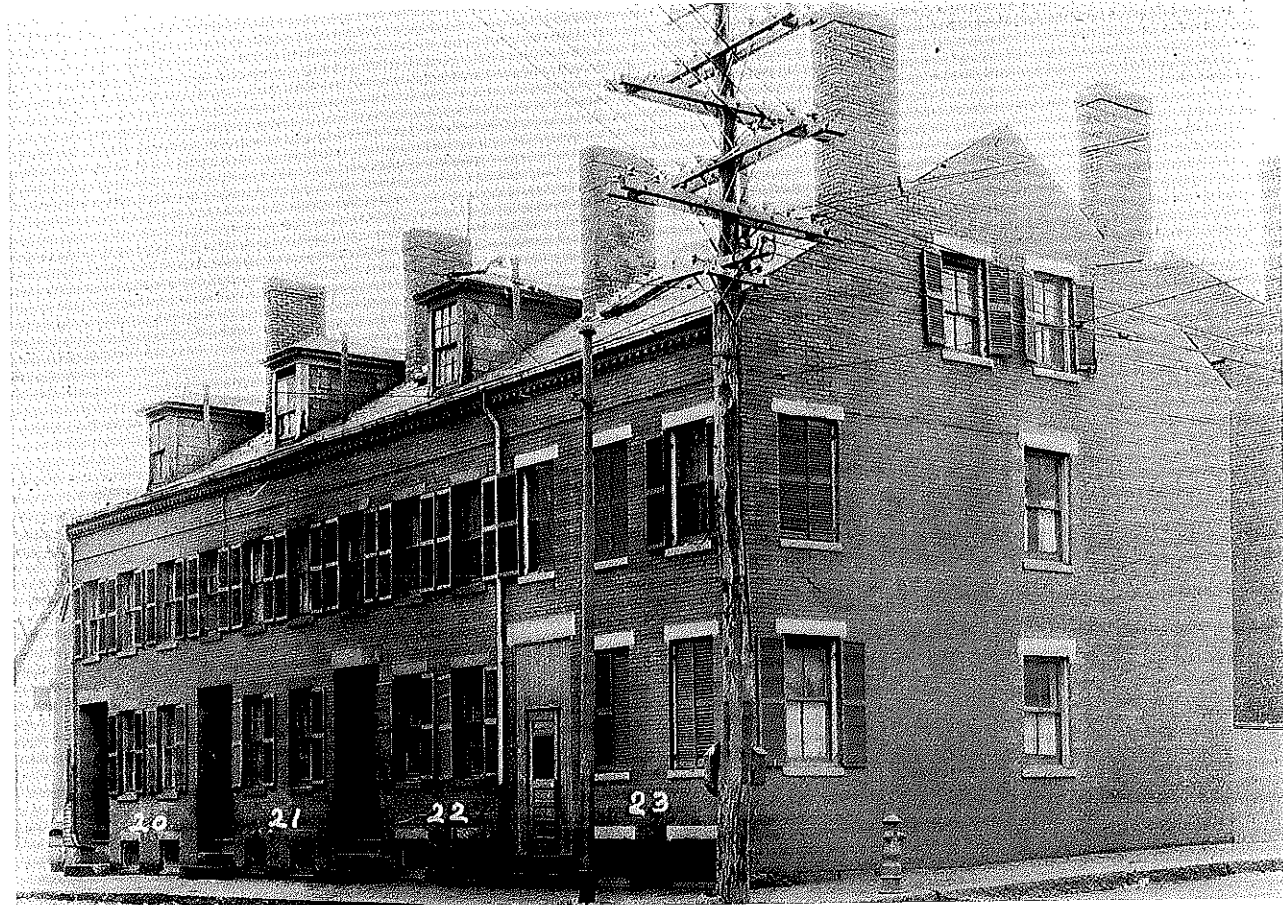
146. Type B double house, 98-100 Spring Street, 1840. Photograph 1964

Type B adapted itself particularly well to a double house (Fig. 146). The two halves were placed back to back, with entrances on the long, side facades and with party-wall chimneys rising up in the center; the roof was nearly always a gable, with its end facing the street. The type was not suited for row houses, except at the ends of rows, where the entrance could be around the corner (see Fig. 160).

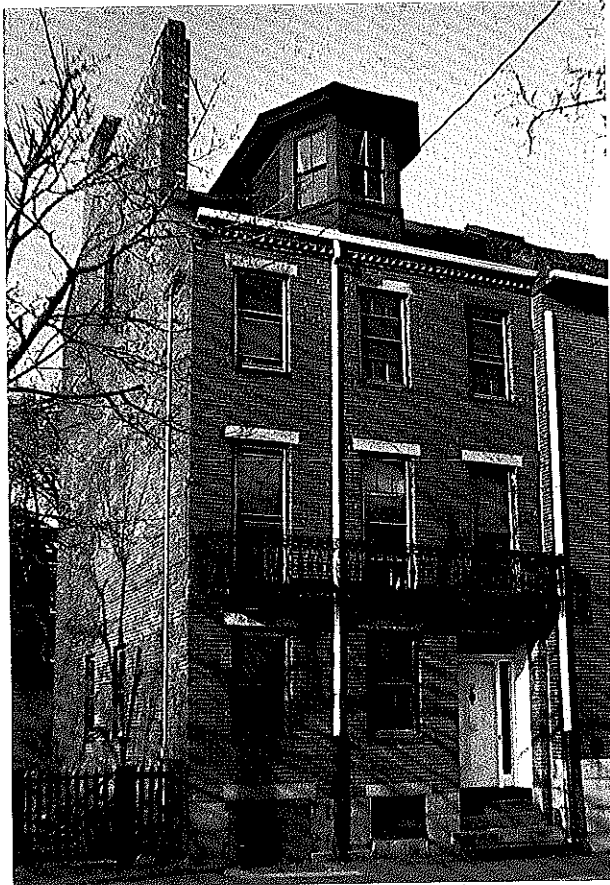
155. 59 Thorndike Street, 1827-28 1277/6

The area's most striking surviving Late Georgian buildings are brick. Most are Type C (side-hall plan): a substantial town house at 59 Thorndike Street (1827) (see Fig. 155), a six-house row at 204–214 Third Street (1826–27) (see Fig. 163), and a simple dwelling with brick ends but wooden flanks at 96 Thorndike Street (1826–27) (Fig. 153); a few such as 200 Bridge Street (1825) follow Type B (see Fig. 158). In these examples, the familiar sheer plane of the facade controls the design, and the attenuation and refinement characteristic of the Federal style are evident. The main cornice is created by the slight projection of a few

One of the best examples of a Late Georgian brick house that survives in East Cambridge is 59 Thorndike Street (1827-28); it was built by Atherton Stevens, a prominent Cambridge merchant and a descendant of the 17th-century settler Atherton Haugh (Fig. 155). In 1827, when the Third Congregational Society of Cambridge purchased a lot for a church at the corner of Thorndike and Third streets, it sold the west part of the lot to Stevens to help cover the cost of construction. Stevens occupied 59 Thorndike Street for six years and then sold the property to W. S. Rodgers, who, in 1843, sold it to John L. Sherriff; his brush factory was one of East Cambridge's most prominent early industries.

Following the pattern established by the church, 59 Thorndike Street is built close to the sidewalk, thus reserving open space at the rear of the lot; its generous side yard provides rare open space in the densely built neighborhood. The narrow brick town house, with its low pitched roof and double end chimneys, is a striking example of the Late Georgian in East Cambridge. The sheer plane of the facade controls the design, and the attenuation and refinement characteristic of the style are evident. A wooden octagonal dormer on a paneled base projects from the center of the front slope of the roof above a handsome sawtooth brick cornice. The windows on the first and third floors contain standard six-over-six sash; the second-floor windows extend to the floor, indicating the main living floor of the house. An elaborate cast-iron balcony extends across the second floor, further emphasizing the major rooms at this level (Fig. 156). The recessed entrance has a six-panel door with etched sidelights and a rectangular top light, characteristic of the style (Fig. 157). The window sills are wood but the lintels are granite; they were originally painted to simulate brownstone. The foundation also is granite.

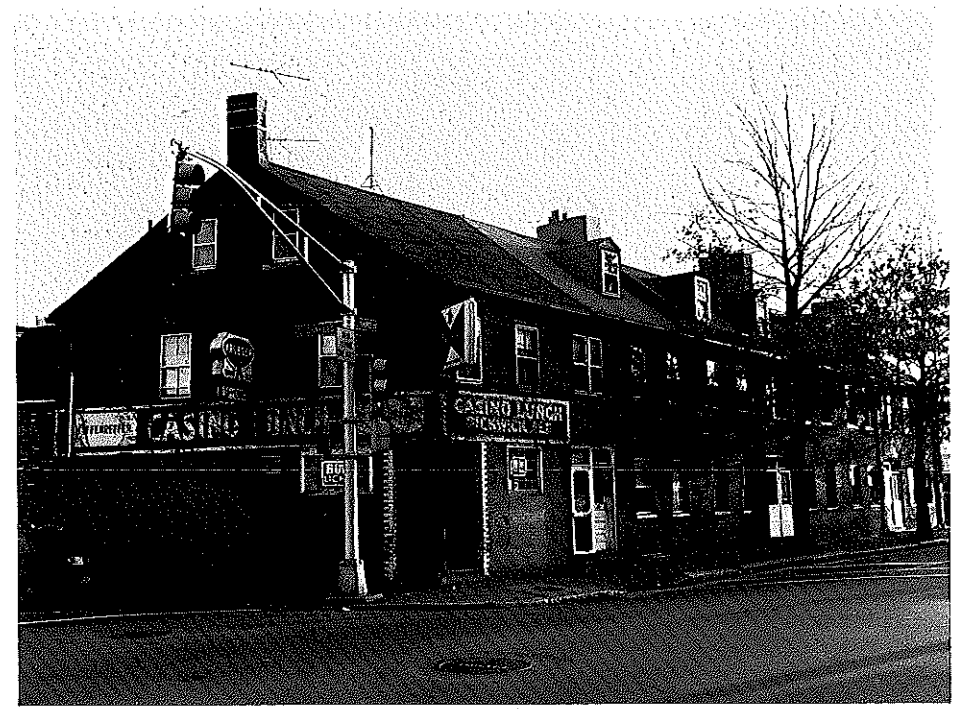
163. 204-214 Third Street, 1826 12.8421/29

A six-house brick row from 1826 still stands at 204-214 Third Street (Fig. 163). The owners, Edmund Munroe, a former proprietor of the Lechmere Point Corporation, and Deming Jarves were both principals in the New England Glass Company. Located along the lower part of what was then known as Court Street, which provided the only access from Cambridgeport and the West Boston Bridge to the courthouse, this row was fairly isolated from the settled part of East Cambridge. It was conveniently close, however, to the New England Glass Bottle Company, which Munroe and Jarves established in 1826 just southeast of the houses, and the row became known as the Bottle House Block (see p. 187). It is not known whether this

row was originally built to house glassworkers; the company closed in 1845, and the corner house of the row became a tavern, as it remains today. To date, three of the units have been restored.

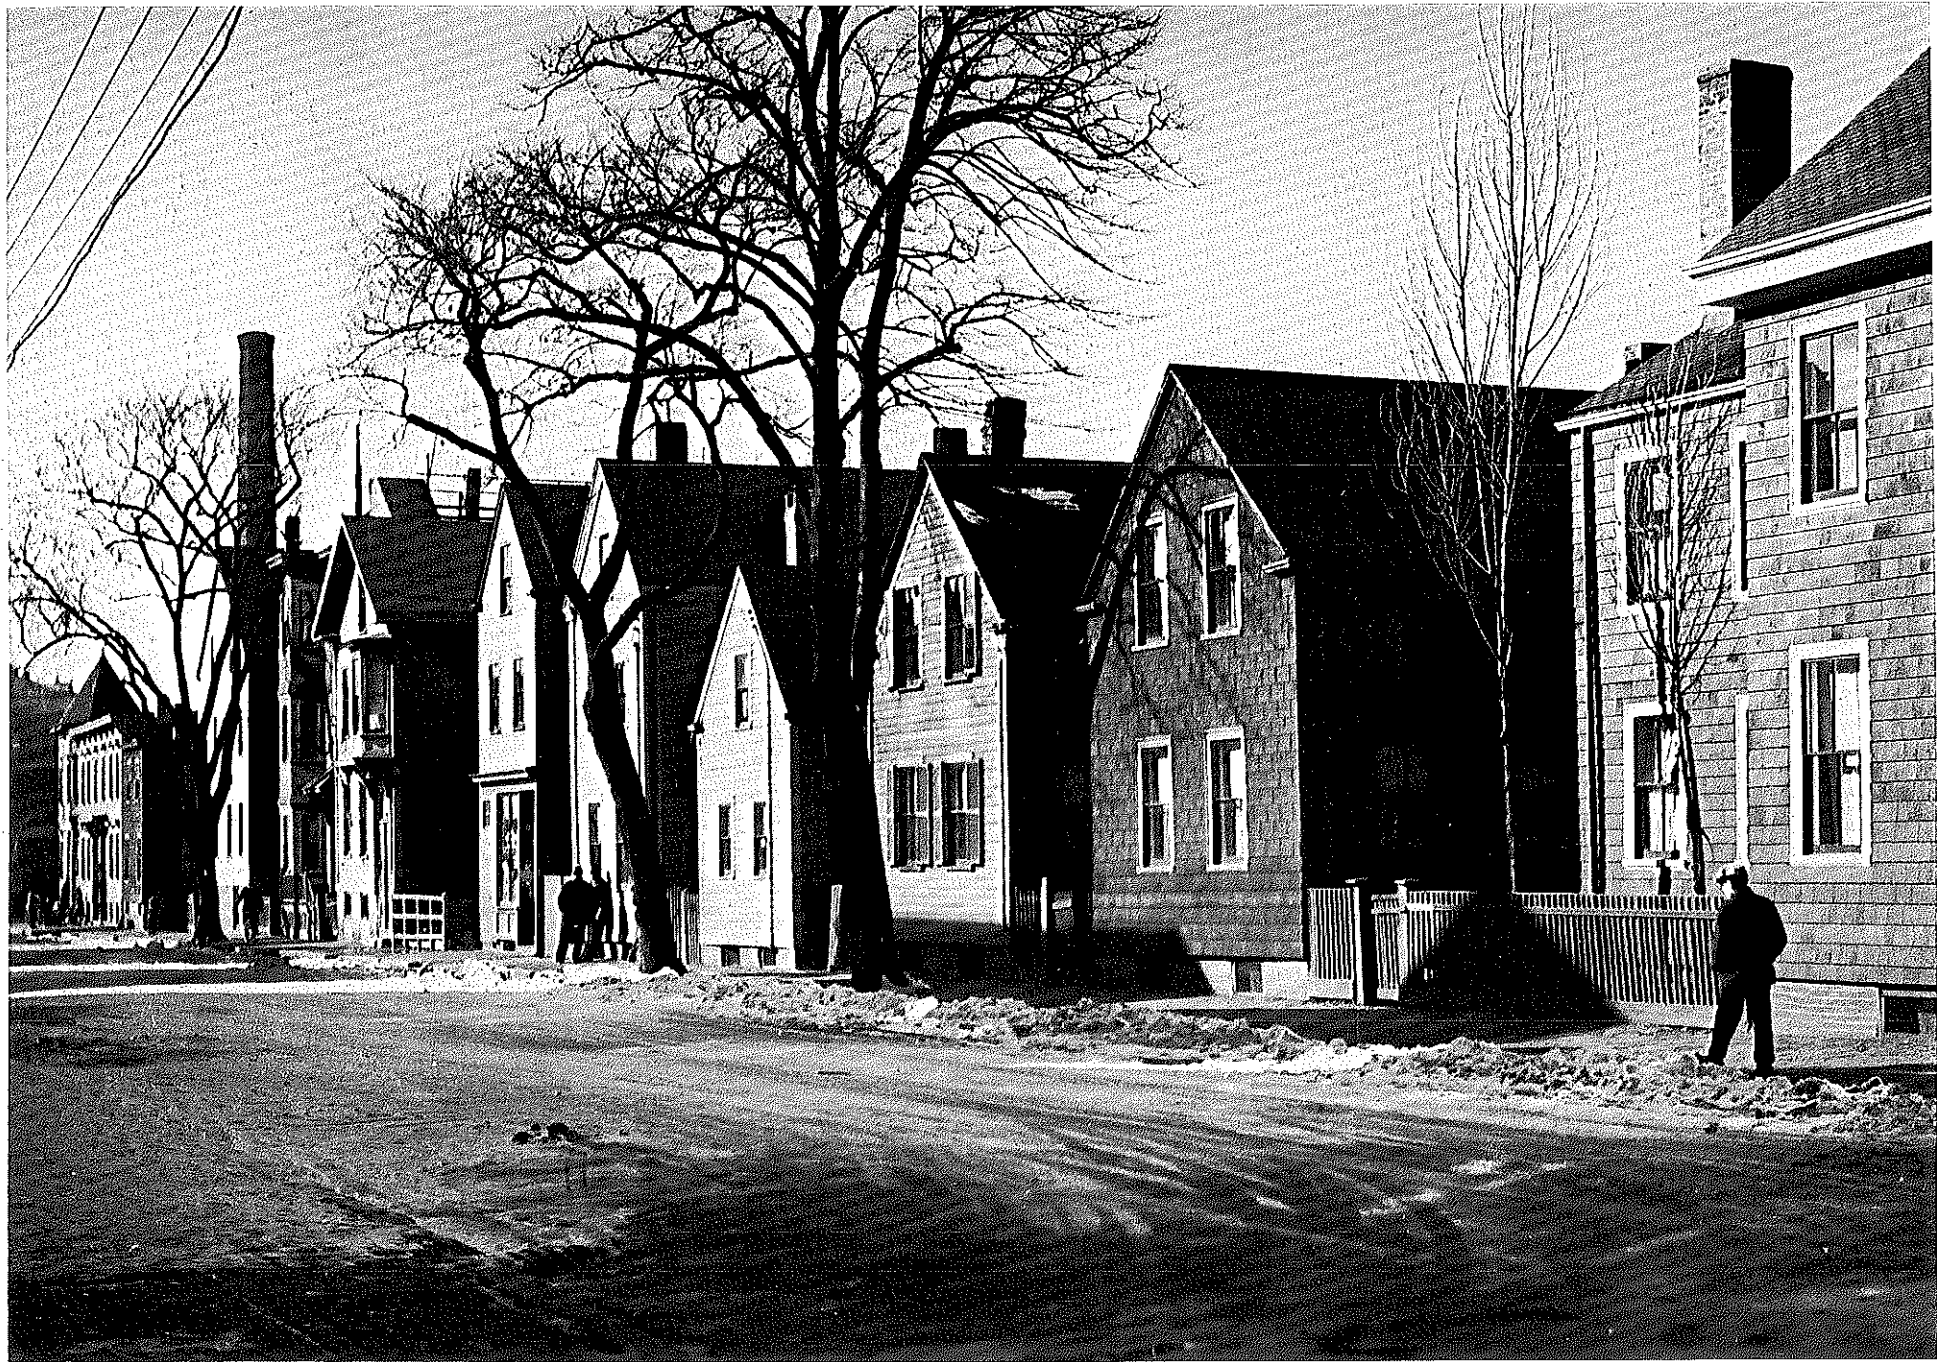
167. Winter Street worker's cottages, c. 1940
missing

light cornice marking the intersection of the facade and sloping roof (Fig. 167). The cornice generally projects a bare 4 inches, but it is augmented by a wooden rain trough that returns at the end of the facade. The upper-story window caps fit tightly against the eaves, a hold-over from the 18th century (see Fig. 150). Sometimes the wooden mouldings that support the cornice are interrupted by the window opening; in other instances, the moulding breaks forward over the window frame. The gable ends are finished with a crown moulding on the raking cornice that projects about 3 inches from the wall. These light but nicely scaled cornices emphasize the geometric content of the building mass.

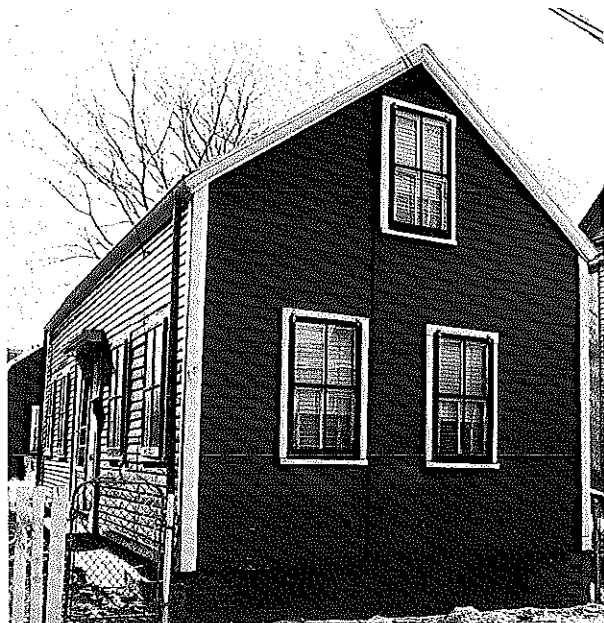
171. 146 Thorndike Street, 1829-30. Photograph 1964 J-23

The gabled worker's cottage is probably the most prevalent wooden house type in East Cambridge (Fig. 171). Built as single or double houses, these cottages range from one to two and a half stories. All, however, share a standard two-room center hall plan and a uniform three-run stair, which could be squeezed into a

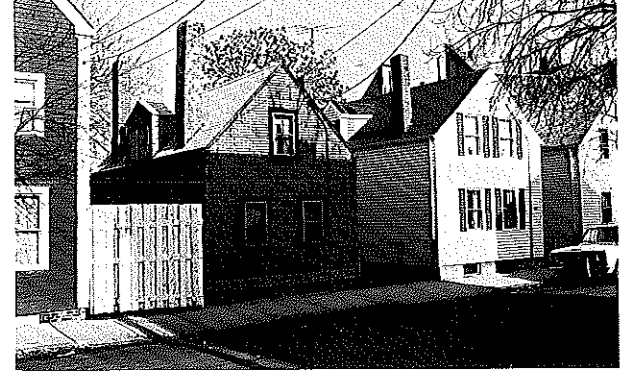
181. Worker's cottages, 67–71 Winter Street, 1843–44

rented and then sold the cottages to artisans (Fig. 181). A comparison with 146 Thorndike Street, built fourteen to fifteen years earlier, shows how little this type changed over time.

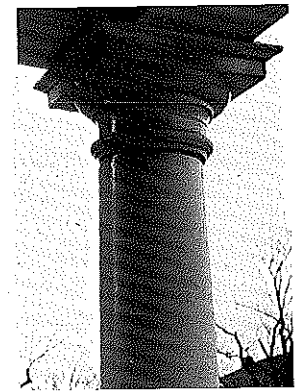
192. Detail of Doric capital and plain column, 98 Otis Street, c. 1845
18521

Most surviving examples of columned Greek Revival houses in East Cambridge use Ionic capitals and fluted columns (Fig. 191); a few domestic examples of the simpler Doric capitals exist (Fig. 192), but none of the more elaborate Corinthian capitals, such as those used in the 1848 remodeling of the old Superior Courthouse. Few East Cambridge columns had plain shafts; most were fluted. A few examples of reeded columns also exist (69 Thorndike Street, 1844, and 80 Thorndike Street) but this treatment was unusual in East Cambridge (see Fig. 197).

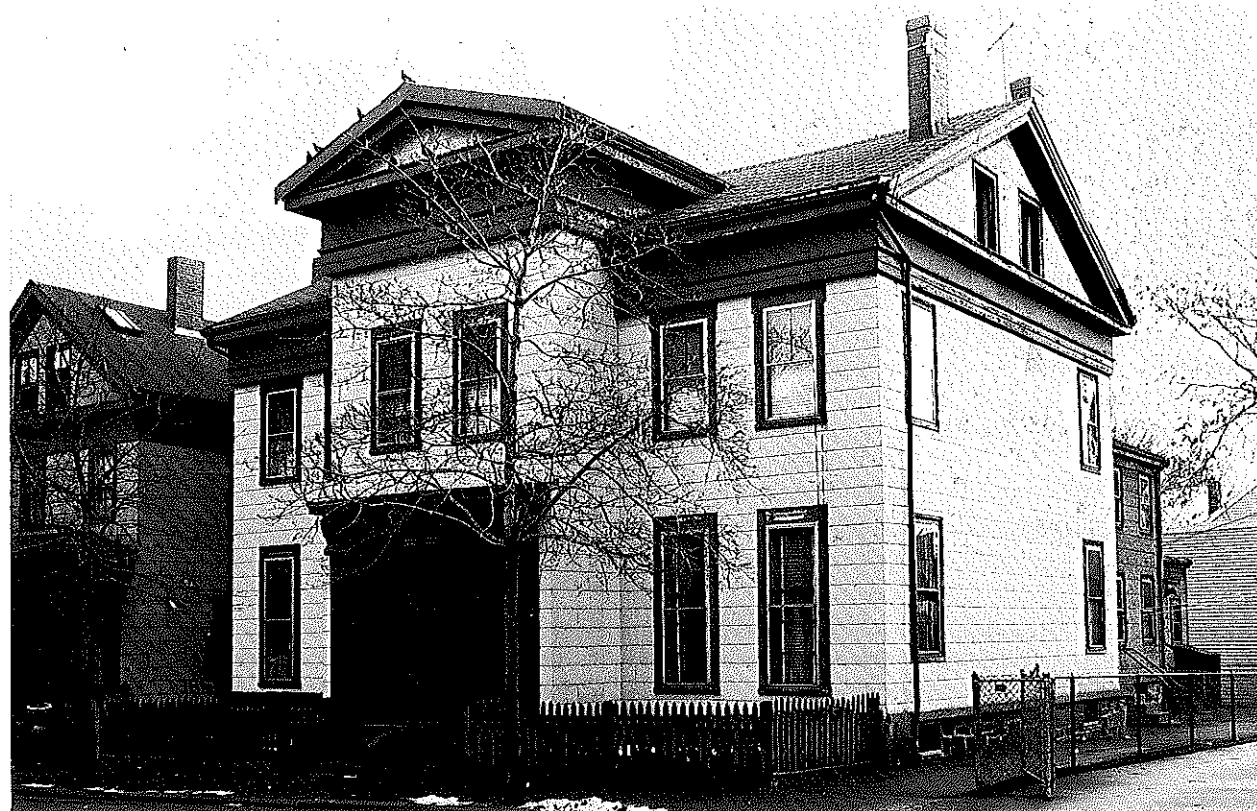
195. 66-68 Otis Street, after siding. Photograph 1964

stock Greek Revival elements (Figs. 194-195). Ornamentation was concentrated on the projecting entrance bay, which has monumental two-story corner pilasters with Ionic capitals and is surmounted by a Classical entablature and pediment; the ends of the house display the same treatment with corner pilasters and pediments. The second-story windows on the entrance bay had the most elaborate detail, with pedimented caps supported by consoles and decorated rectangular panels above, while the second-floor windows on the main part of the house had simpler pediments. The long first-floor windows had projecting mouldings supported by similar decorative consoles. The facade of the house was unfortunately stripped of much of its original decoration in the 1940s and covered with sid-

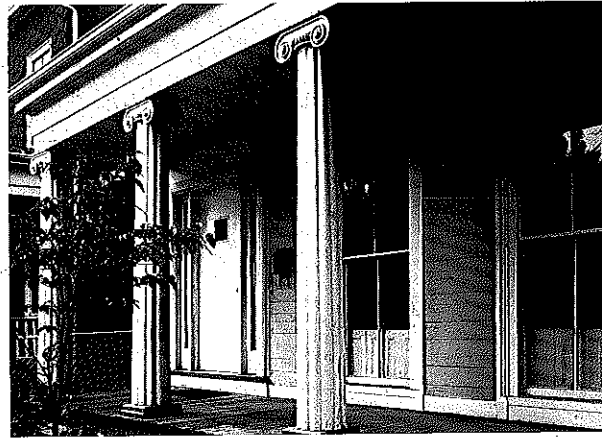
197. Porch detail, 69 Thorndike Street. Photograph 1964

although with curious reeded columns; the reeded pilasters framing the main entrance are a 1940's replacement (Fig. 197). All in all, this was a textbook example of a single-family Greek Revival house of the 1840s. Many simpler two-story examples had no projecting porches, but such features as paneled corner pilasters, handsome pilastered entrances, and proper pediments gave these houses a dignified appearance (Fig. 198).

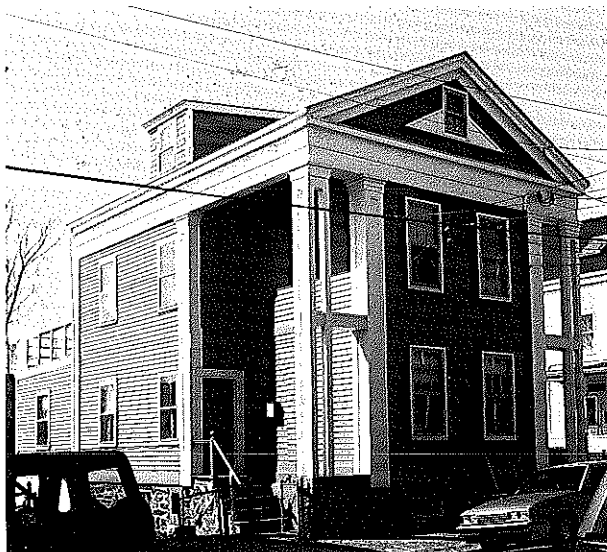
200. 74 Thorndike Street, 1843-44 5851-28

More unusual in form is the T-shaped house at 74 Thorndike Street, with its open two-story corner porches and pedimented gable echoed in the shape of the gable window (Fig. 200). Built in 1843–44 for Peter Wellington of Lexington, the house's two-story pilasters and square porch posts, as well as its unusual form, set it apart from its more conventional neighbors (Fig. 201).

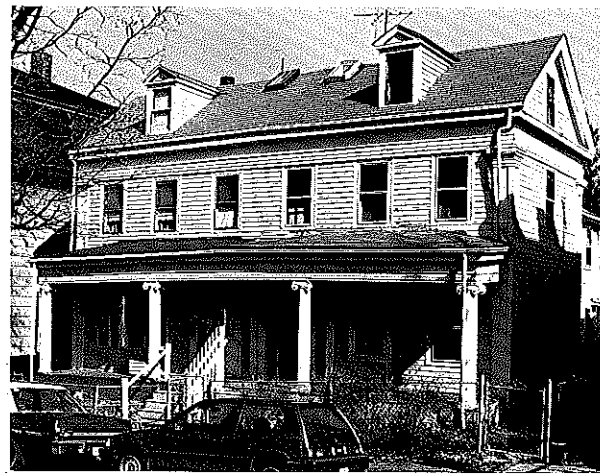
204. 103–105 Otis Street, 1843–44 9951/90-10

faced the side yard, the house could have either paired entrances facing the street, such as 67-69 Otis Street (1839) and 103-105 Otis Street (1843-44) (Fig. 204), or an entrance in each gable end, such as 126-128 Otis Street (1844). An unusual variation was the use of an entrance pavilion and cross gables, as at 66-68 Otis Street (1846-47), a house already noted for its elaborate ornamentation (see Fig. 194).

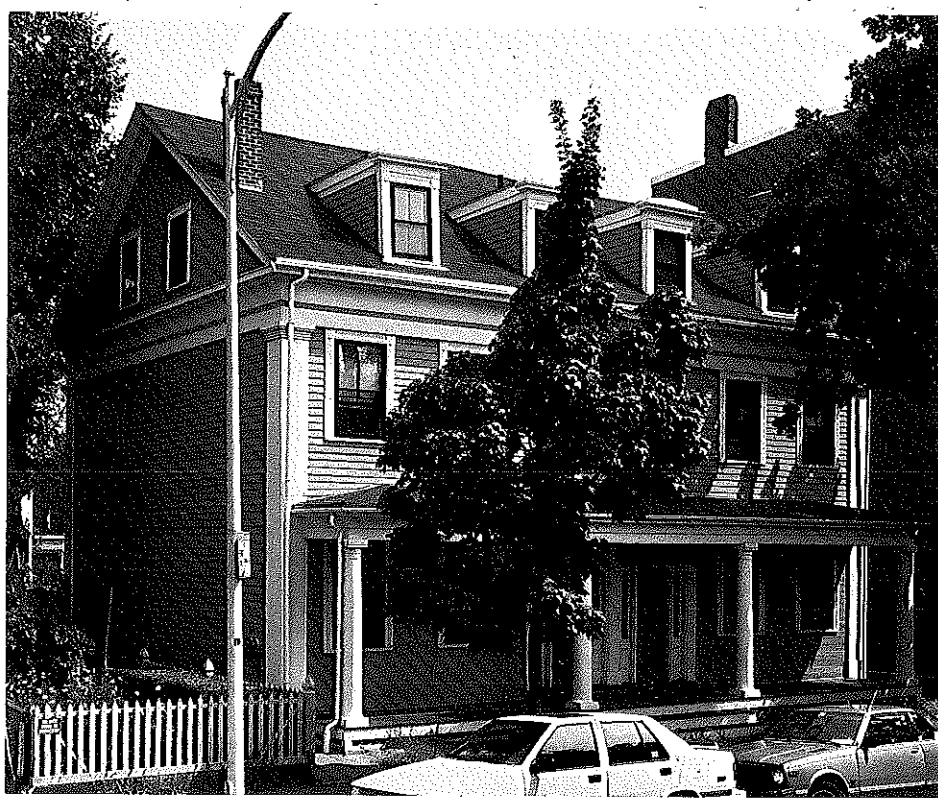
206. 67–69 Otis Street in 1987 (after restoration) ☉

The two-and-a-half-story frame house at 67-69 Otis Street (1839) is a good example of a Greek Revival double house, with paired doors and gables flanking the street (Figs. 205-206). The original owner, Abiel Goss, was a carpenter who built the house with corner pilasters, a full entablature, and a one-story porch facing the street. For years the house stood in ruinous condition, but it was completely restored in 1985-86 (except for the porch columns, which should have been fluted with Ionic capitals) and is once again a good example of this type.

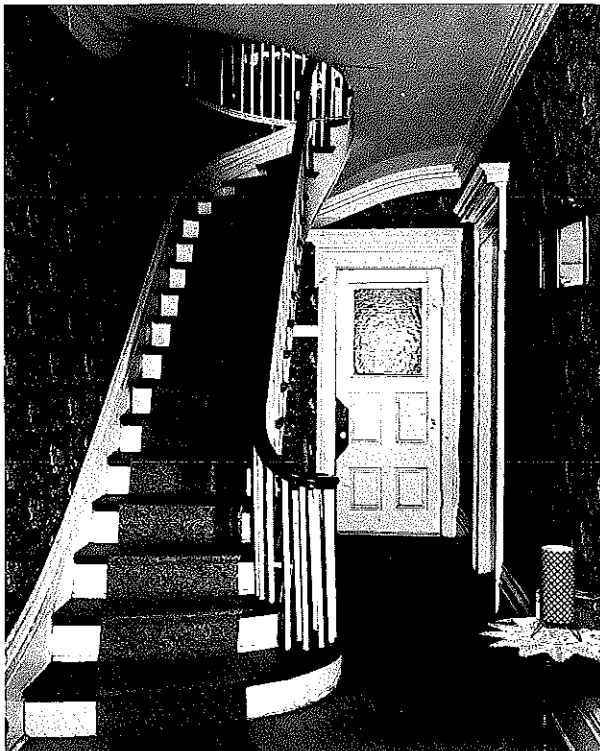
214. Stair, 61 Otis Street, 1851. Photograph 1964

handrail and bottom (curtail) step into a scroll about the newel post (Fig. 214). The rounding of the curtail step and handrail is reflected in the bowed contours of the three or four steps above, and together they create a graceful, cascading effect at the bottom of the flight. Sometimes, as at 36-46 Second Street, the risers form an oblique angle with the wall rather than the usual 90-degree angle, which gives something of the effect of a spiral stair. Toward the top, the stairs again bend easily in a quarter circle, and the rounding movement is repeated in the wall, strings, and handrail. The handrail curves in this manner at each floor and flows from top to bottom without interruption. Balusters are simple, rounded, and sometimes slightly tapered. The elabo-

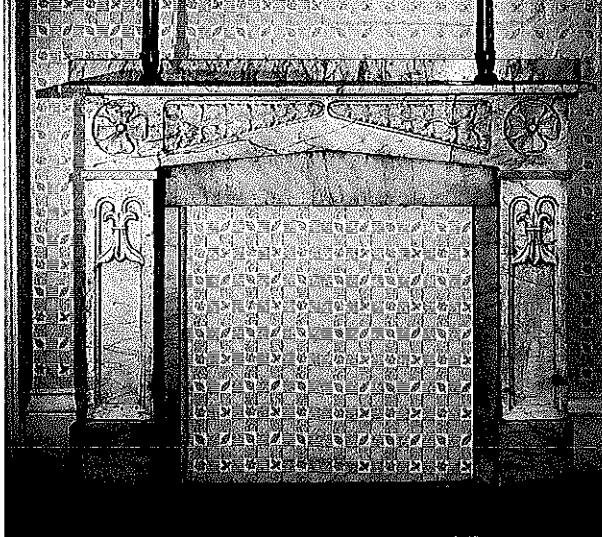
217. Parlor fireplace, 61 Otis Street. Photograph 1964 39

Another central feature of the Greek Revival interior was the parlor fireplace, which incorporated a coal grate, a conventional hearth for burning wood, or a hot air register. The most common mantel of the 1830s and '40s is made of black marble and follows a severe, rectilinear form. Later, more elaborate rooms had gray or white marble mantels; the most elegant example is the gray marble composition decorated with anthemion shapes in low relief in the main parlor at 61 Otis Street (Fig. 217). The chimney breast against which the mantel is placed almost always projects into the room and is emphasized by the plaster cornice brought forward around it. In upper bedrooms and in simpler houses, the mantel casing is of wood, while some unimportant rooms have only a wooden shelf above a tiny fireplace or flue opening.

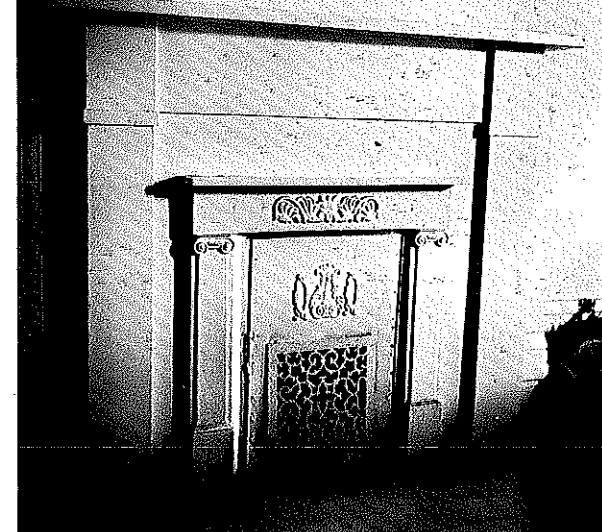
219. Second floor fireplace with hot air register insert, 67-69 Otis Street, 1839 1218/9A

Although expensive, a central hot air furnace could be found in large Boston area dwellings by 1840. At first, hot air ducts were provided to rooms only on the two lower floors, sometimes to only the first one; upper chambers or those in the ell would have individual grates or stoves. Beginning in the 1840s, large houses with furnaces on Dana Hill often omitted fireplaces in the individual rooms. In East Cambridge, the transition to central heating is unclear. While most of the houses inspected that dated from 1820 to 1870 had fireplaces or stove outlets in all the rooms, some had hot air

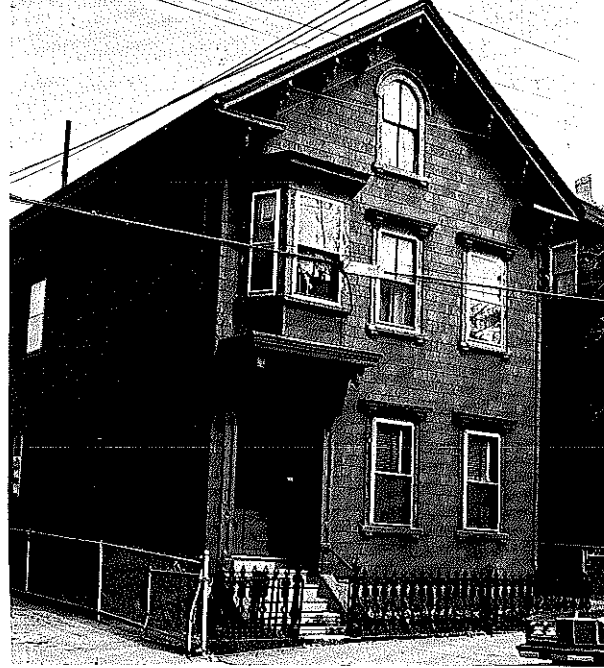
220. 109 Thorndike Street, 1857–58

During this period, numerous Bracketed houses were built in East Cambridge. Most of them followed the side-hall entrance plan with the gable end to the street that had been established in the Greek Revival period, but they added the new style of ornament, including the characteristic decorative brackets (Figs. 220–221). The massing tended to emphasize the vertical more than in Greek Revival times; interior ceiling heights increased, and the roof slope was slightly steeper than before. The house mass became more plastic as well: the overhang of the cornice was emphasized by decorative brackets, and projecting bay windows, almost never found in Greek Revival work, were often used. Windows showed more variety, and windowpanes are usually larger than in the preceding period; two-over-two sash became common. Windows and doors were emphasized by the addition of projecting cornices and sills were supported by yet more brackets. Sometimes these cornices assumed the proportions of hoods. This growth in plasticity was not confined to Bracketed buildings alone, but was part of the gradual change in 19th-century architecture that first became noticeable in Greek Revival work and reached a climax in the Queen Anne style of the 1880s.

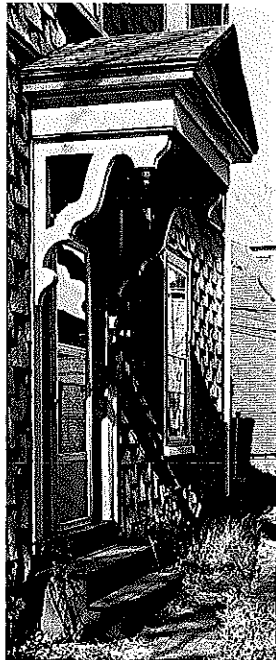
224. Bracketed door hood, 129 Otis Street, c. 1865. Photograph 1964

and a long strut, which usually assumes a curvilinear profile (Fig. 224). Turned work in moderate amounts is found in the form of pendants. In gables, the brackets hang vertically, but the edges are parallel to the angle of the raking cornice.

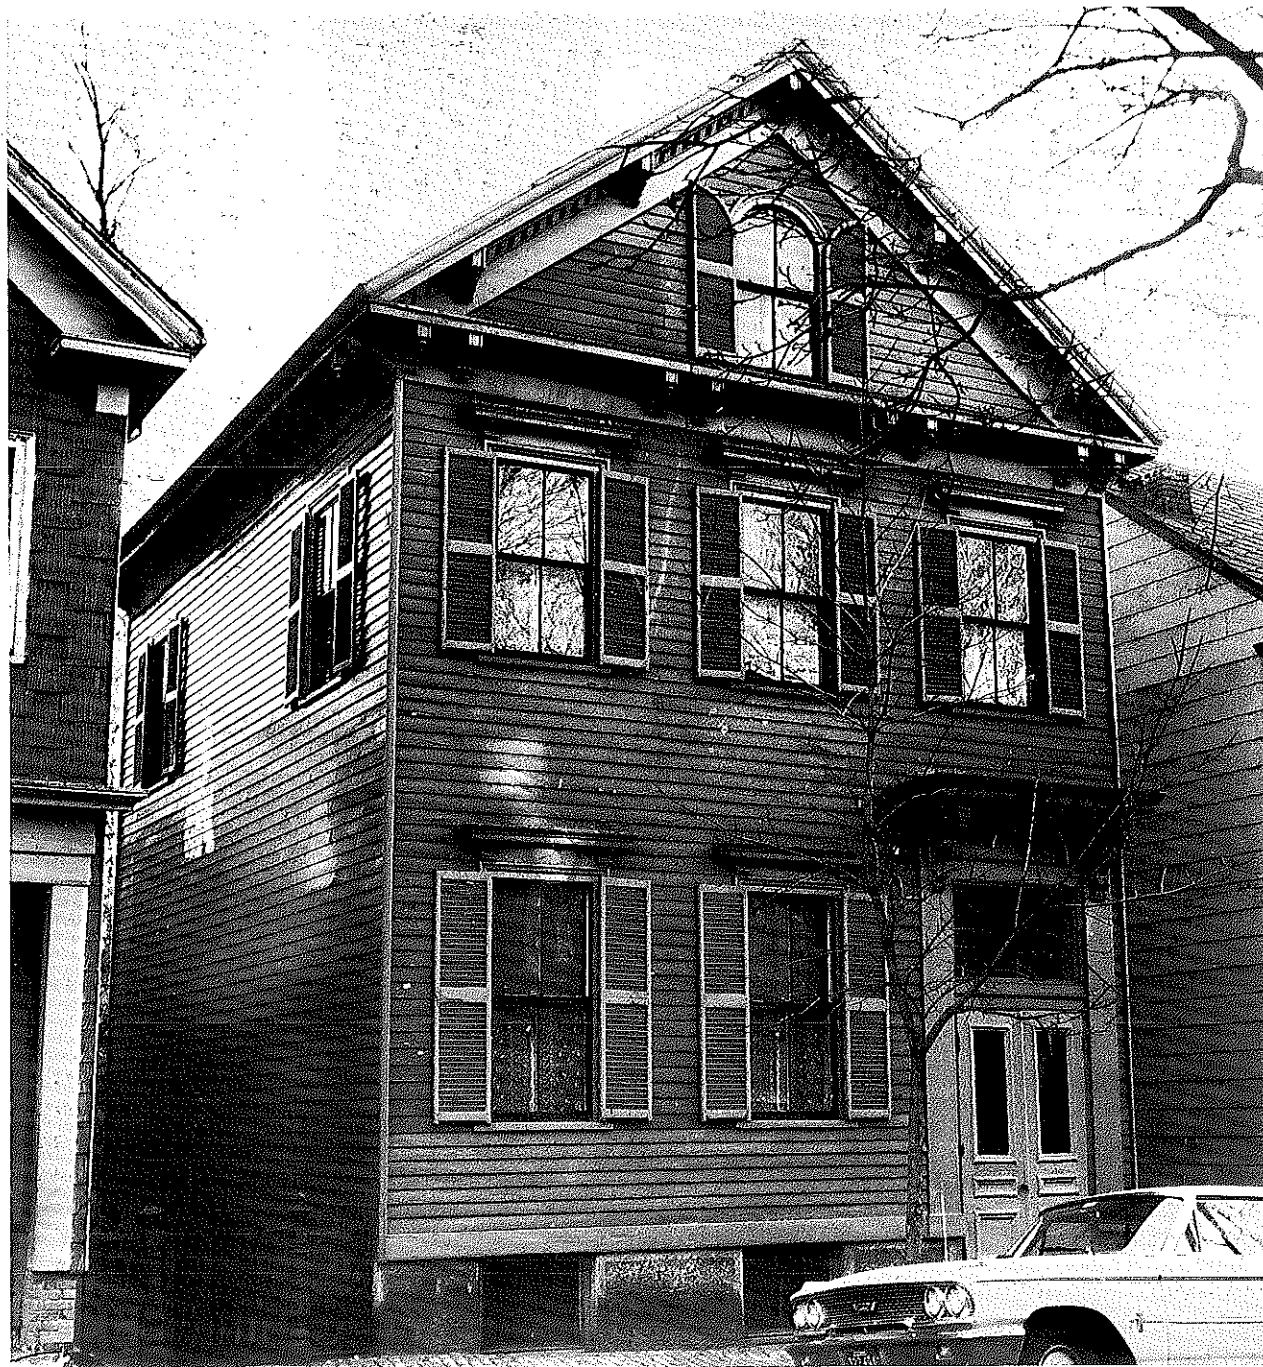
229. 134 Otis Street, 1868–69. Photograph 1965 *J*

One of the finest side-hall Bracketed houses is 134 Otis Street, built in 1868–69 for Benjamin Hoyt, a partner in the very successful granite business of A. C. Sanborn & Company, located on the wharves near Craigie's Bridge (Fig. 229). The main gable of the

house contains the style's characteristic round-headed window and bracketed cornice, while the front entrance provides a textbook example of this style, with double doors, decorative glass, and a projecting hood supported by large decorative brackets. Set directly on the sidewalk on a narrow lot, the house concentrates its main ornamentation on the street facade; the sides have much plainer window trim, although the dentil cornice with paired brackets continues around the sides. The house remains in excellent condition, complete with original shutters and clapboards, and is an important asset to the neighborhood.

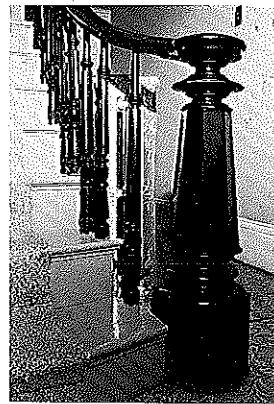
238. Newel post, 109 Thorndike Street, 1857-58. Photograph 1964

Stairway designs show important changes. The scroll newel post of earlier times was abandoned in favor of a stout, turned newel post that is similar to the pot-bellied newels of medium-priced Greek Revival construction (Fig. 238). However, the later newels are larger (8-inch diameter) and the mouldings heavier, and they usually stand on an octagonal base. The handrail is wider, with a more complex profile, and the balusters are thicker and elaborately turned. Although both stairs and rail turn at the head of the flight, the graceful, sweeping quality of earlier designs is gone.

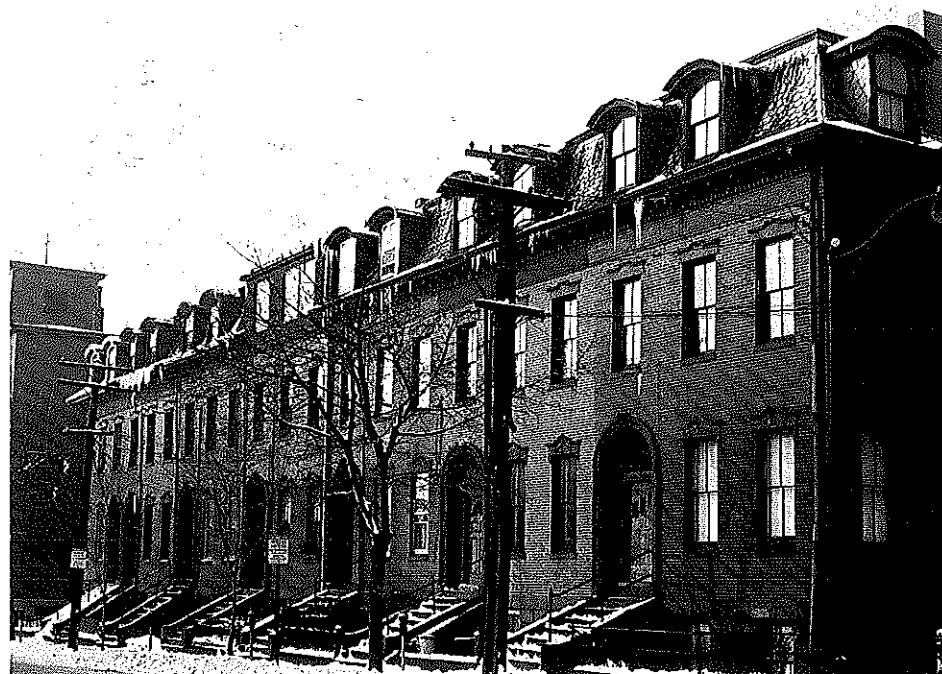
240. 83–95 Third Street, 1860. Photograph 1964 5-10

East Cambridge got its first mansard-roof houses soon after the style was accepted in Boston, in about 1857. In 1860, S. S. Hazard began building what was described in the *Chronicle* as "a valuable brick block of . . . houses with French roof" at 83–95 Third Street, across from the courthouse (Fig. 240). Containing a high brownstone basement, two main floors, and a mansard roof, this row of seven dwellings, which became known as Quality Row, is much closer to contemporary work in the South End of Boston than to that in the Back Bay. The point is important because the South End work belongs to the vernacular, with old-fashioned Italianate overtones, while the Back Bay

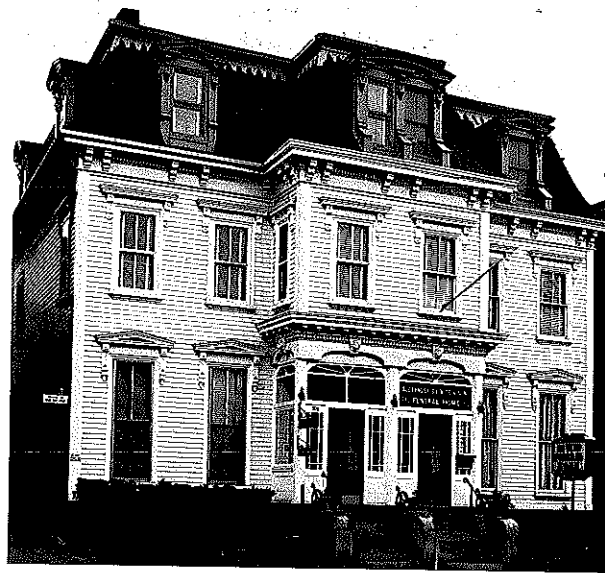
243. 390-392 Cambridge Street, 1869. Photograph 1964

this style are somewhat hard to specify at the level of vernacular architecture by the time they have been combined with features from other styles. These buildings have a pronounced feeling of verticality, which results from the tall roofs as well as the high-ceilinged rooms. A building like 390-392 Cambridge Street (1869) further emphasizes this vertical element by the way the tall, narrow entrance pavilion pushes out in front of the main building and is capped by a mansard roof of its own (Fig. 243).

This house is clearly the most elaborate Mansard in the area and is somewhat closer to the academic norm than most: the pediments over the windows and the fluted brackets that support them, the greatly elongated windows of the main story, the dentil course of the cornice, the elaborate dormers, the segmental arches of the entrance porch, and the exaggerated keystones are all related to the academic tradition (Fig. 244). More fanciful is the lambrequin edging along the top of the mansard roof, which looks more like a curtain than a structural member. The brackets of the cornice, however, would be equally at home on a late Italianate facade. Built for William L. Lockhart, East Cambridge's

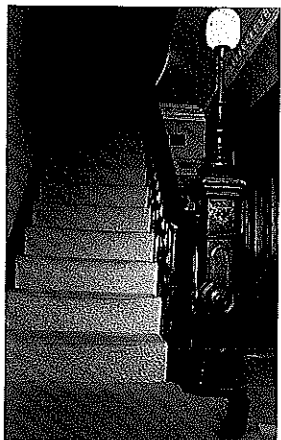
249. Newel post, 392 Cambridge Street, 1869.
Photograph 1964

Concurrently, the bottom newel post took on a larger, more monumental form (Fig. 249). Square or polygonal rather than turned from a single piece of timber, its intricate shape was compiled from a number of parts and mouldings.

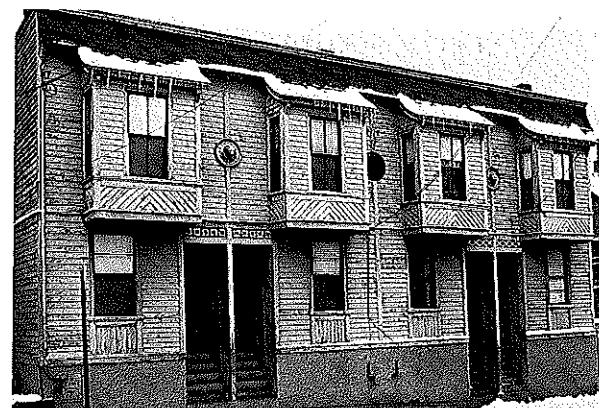
250. 53-59 Sciarappa Street, 1882. Photograph 1964

In East Cambridge, some indications of the Queen Anne influence are a variety of exterior wood surfaces (clapboards, tongue-and-groove paneling, shingles cut in decorative patterns), a wide range of late bracket forms, and wood surfaces decorated by gouging, chiseling, turning, or chamfering. When the possibilities of wood were exceeded, the designer had recourse to molded synthetic materials for such details as the curious medallion busts above the entrances of the mod-

est frame row houses at 53-59 Sciarappa Street (1882), now unfortunately completely re-sided (Figs. 250-251). Because of the emphasis on surface richness and applied ornamentation, Queen Anne buildings, more than others, suffer from the addition of artificial siding.

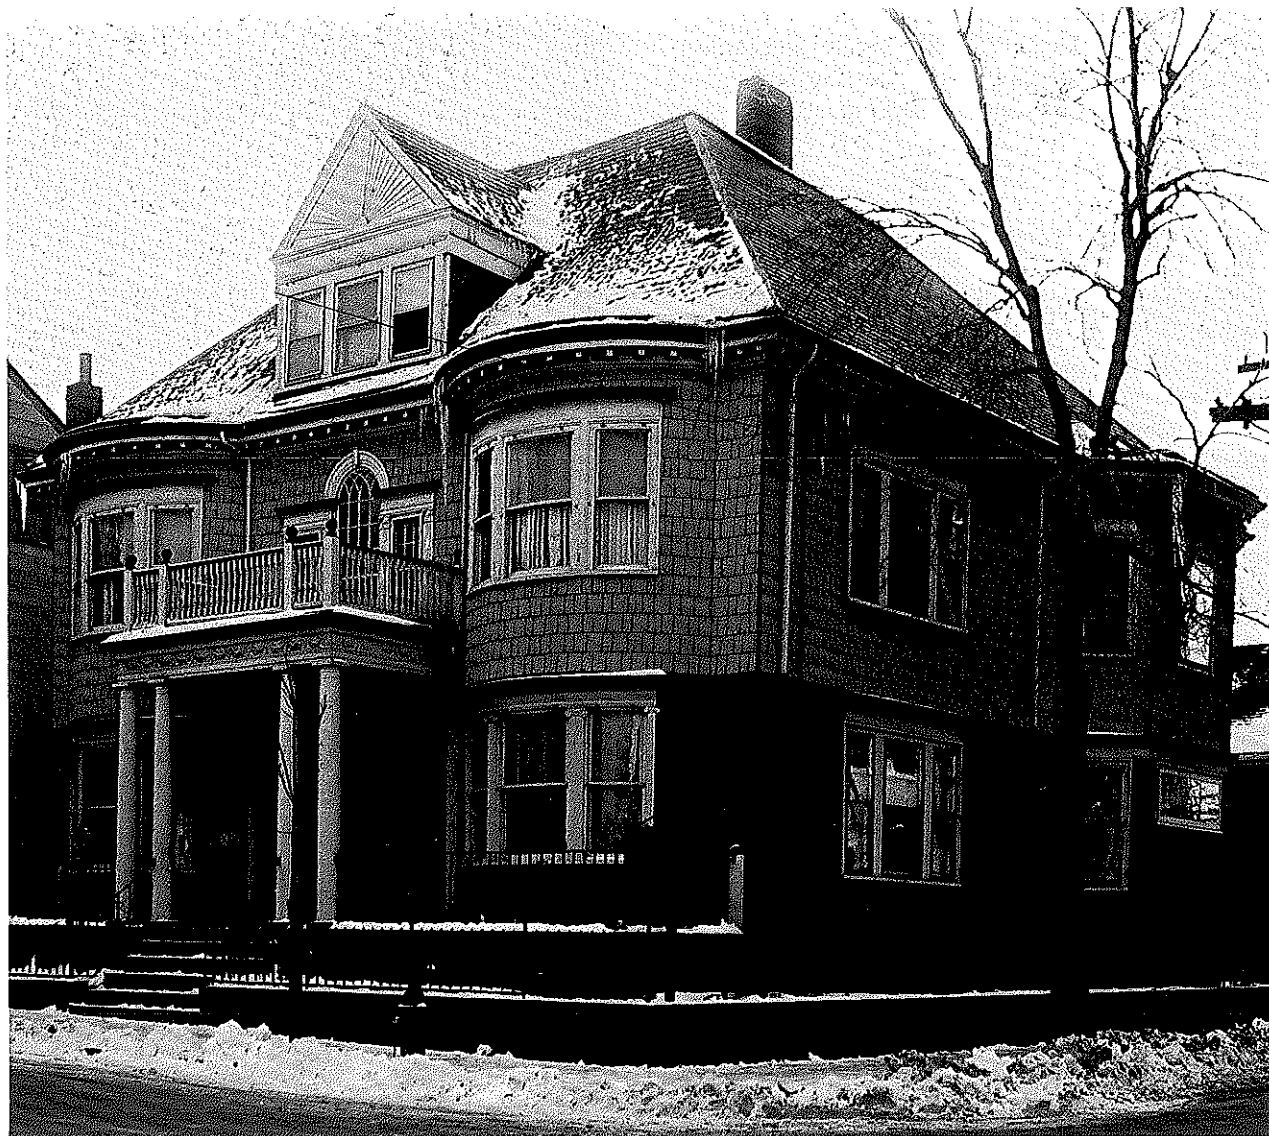
252. 140 Otis Street, 1895, John E. Muldoon. Photograph 1964 J-27

The last private mansion to be built in East Cambridge falls at the end of this period. Erected in 1895 for Catherine Coveney, the wife of John W. Coveney, a prominent East Cambridge undertaker and politician, 140 Otis Street is exactly what one would expect for the period — Queen Anne moving toward Colonial Revival (Fig. 252). Still Queen Anne are the roof, central dormer window, and the paired bay windows; inside, the stair rises in three picturesque runs, and two corner fireplaces exemplify a simple Queen Anne taste. But the detail of the house inside and out is Late Georgian and relatively “correct.” As in all Colonial Revival buildings of the time, much use is made of machine-made molded decorations for window trim, capitals, and mantelpieces. Much of this was removed in 1988, when the house was covered with vinyl siding.

To design the house, the Coveney family hired John Muldoon, the chief designer at the Irving & Casson furni-

ture company, who had begun an architectural practice in 1890 and subsequently produced a number of Colonial Revival houses in Cambridge. Except for two factory buildings for Irving & Casson, Muldoon's only other known works in East Cambridge are a Colonial Revival double house, 41-43 Fifth Street (1890), and the fire stations at Third and Otis (1892, demolished) and Third and Gore streets (1895) (see Figs. 311-312).
