# Memorandum

**Re:** **Illicit Discharge Detection and Elimination Investigation Progress**

This memorandum summarizes the progress made on the IDDE catchment investigations during the Year 3 reporting period of July 1, 2020, through June 30, 2021.

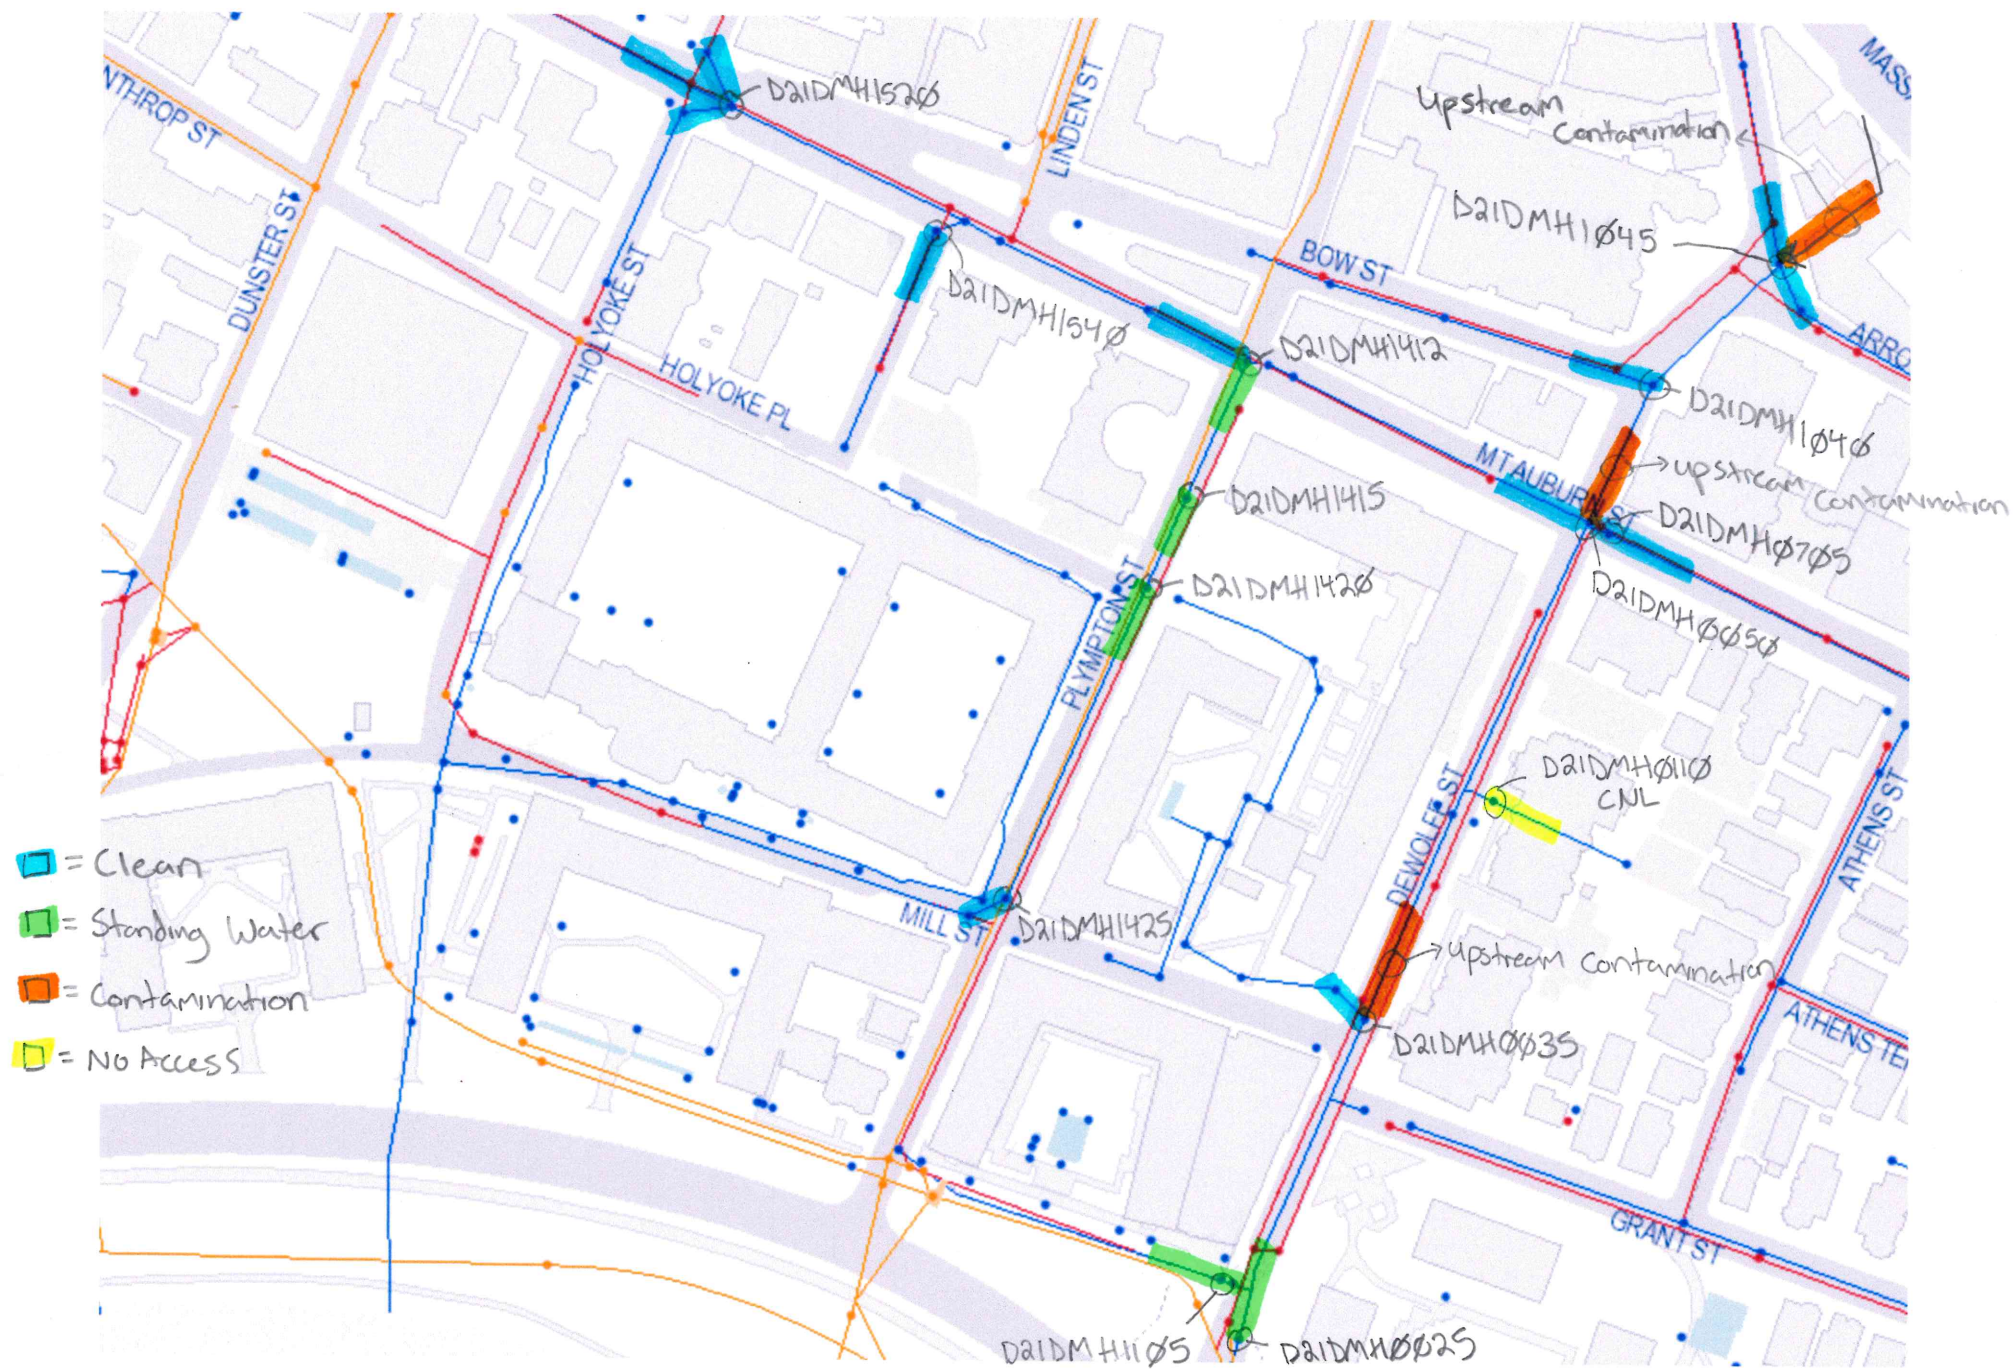
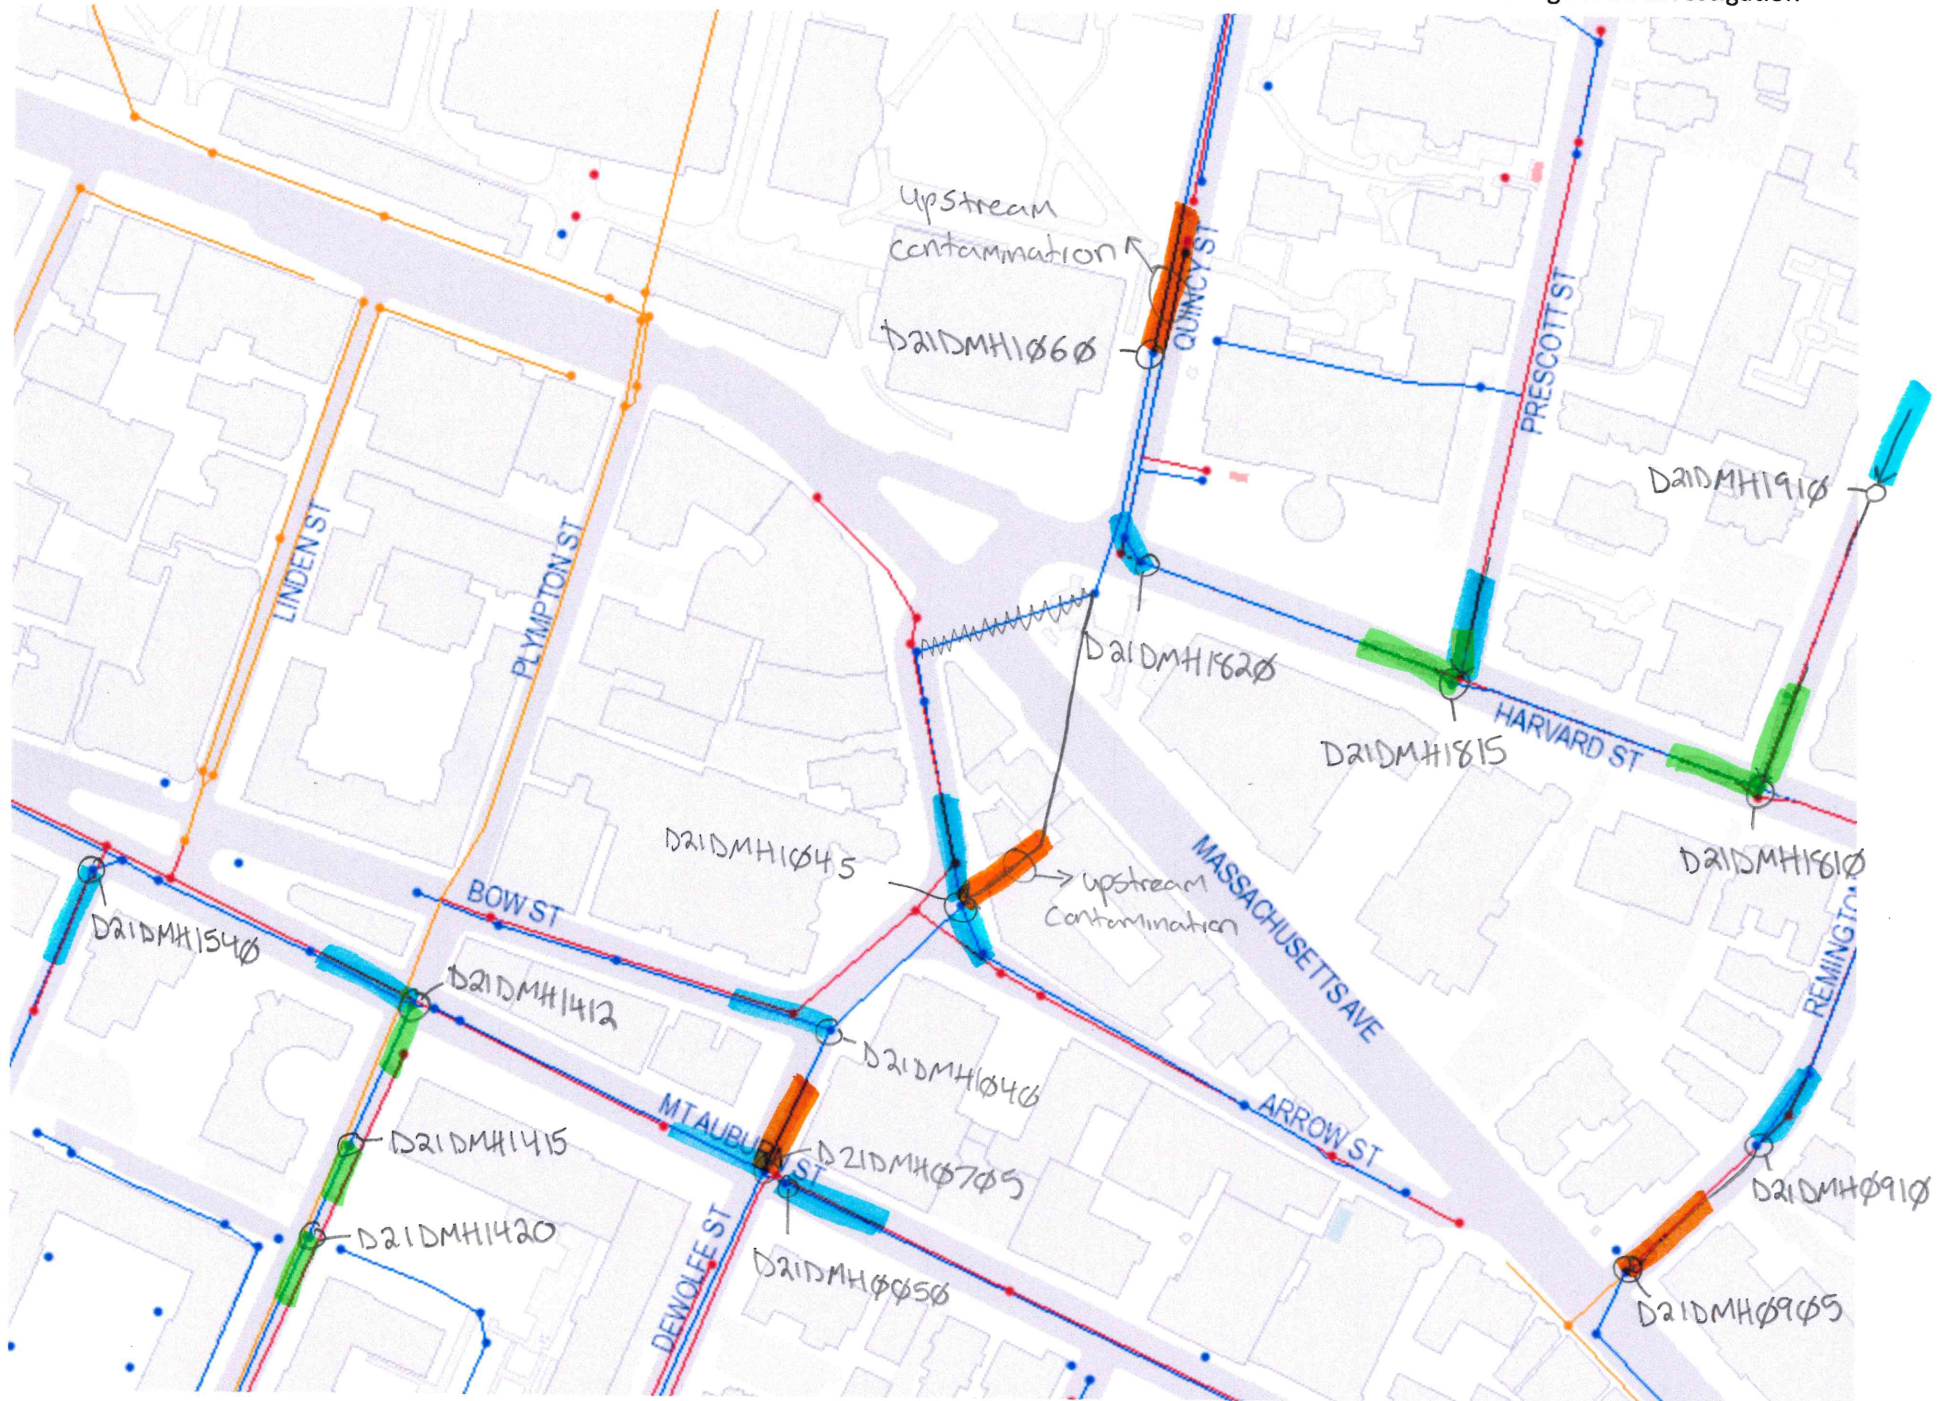
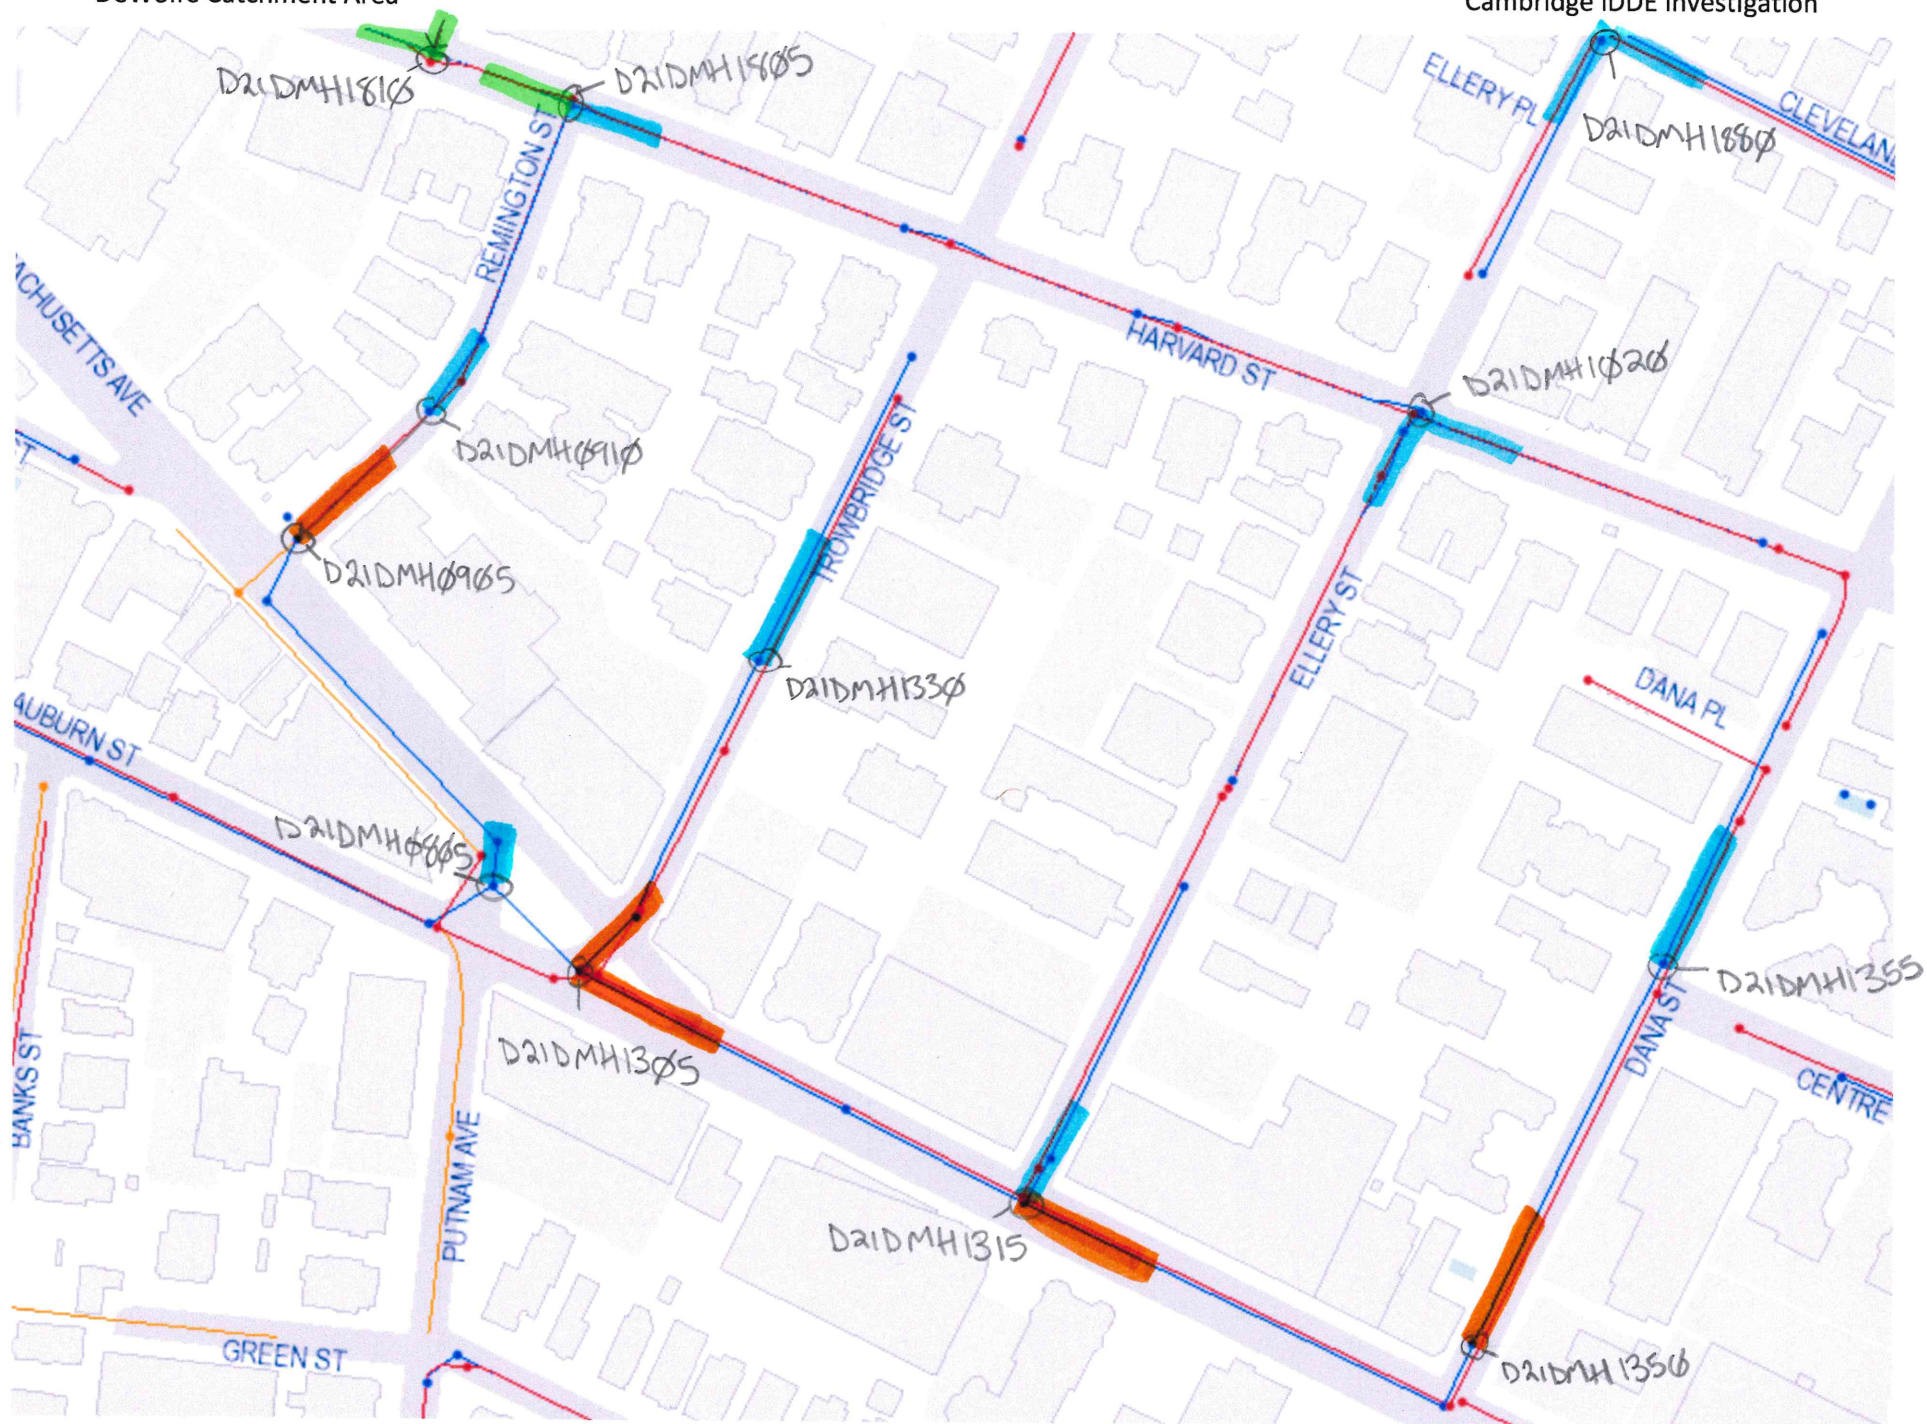
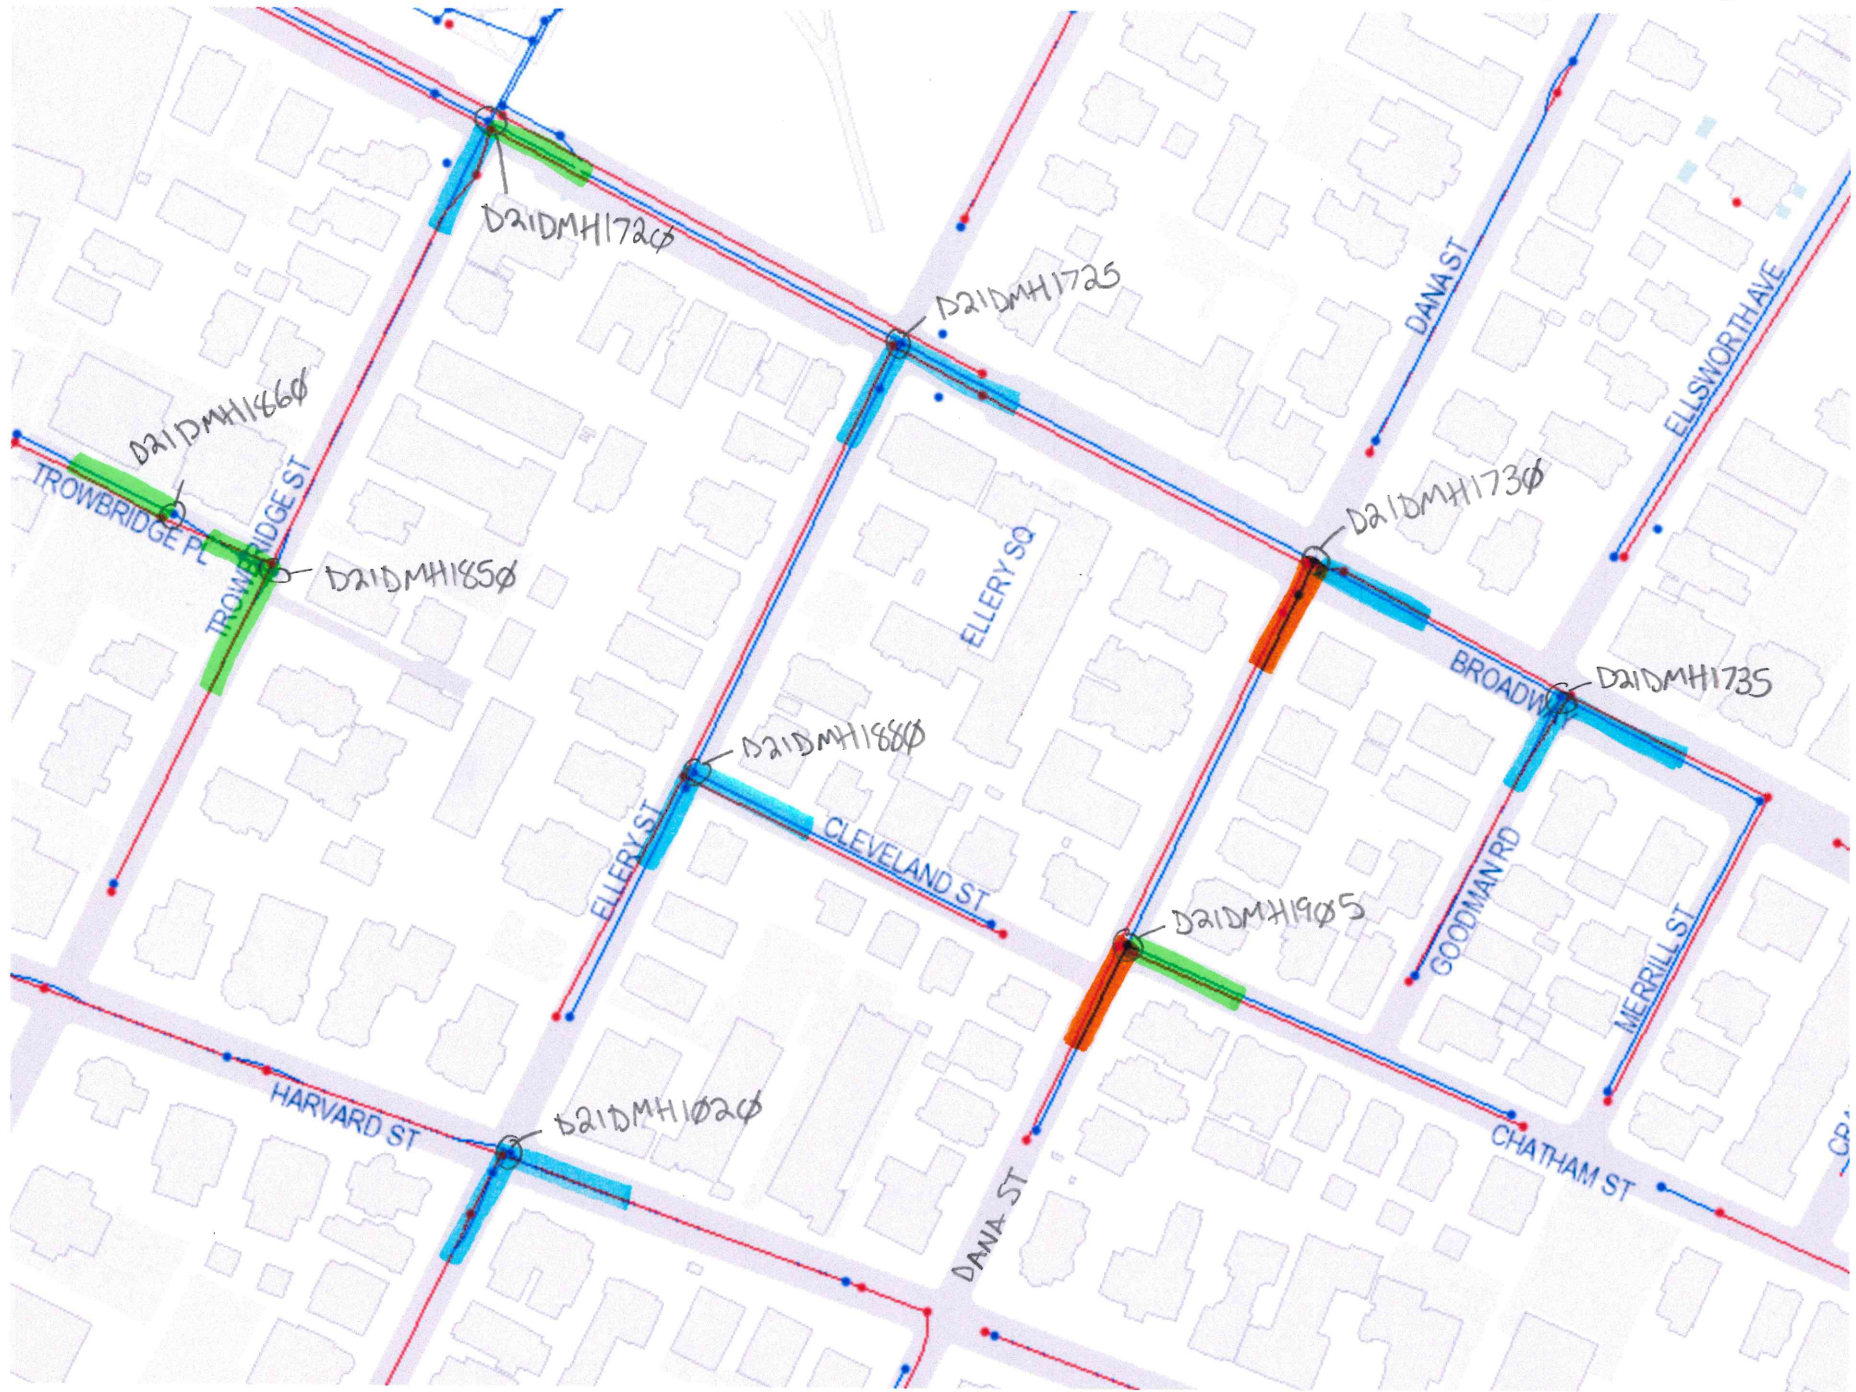
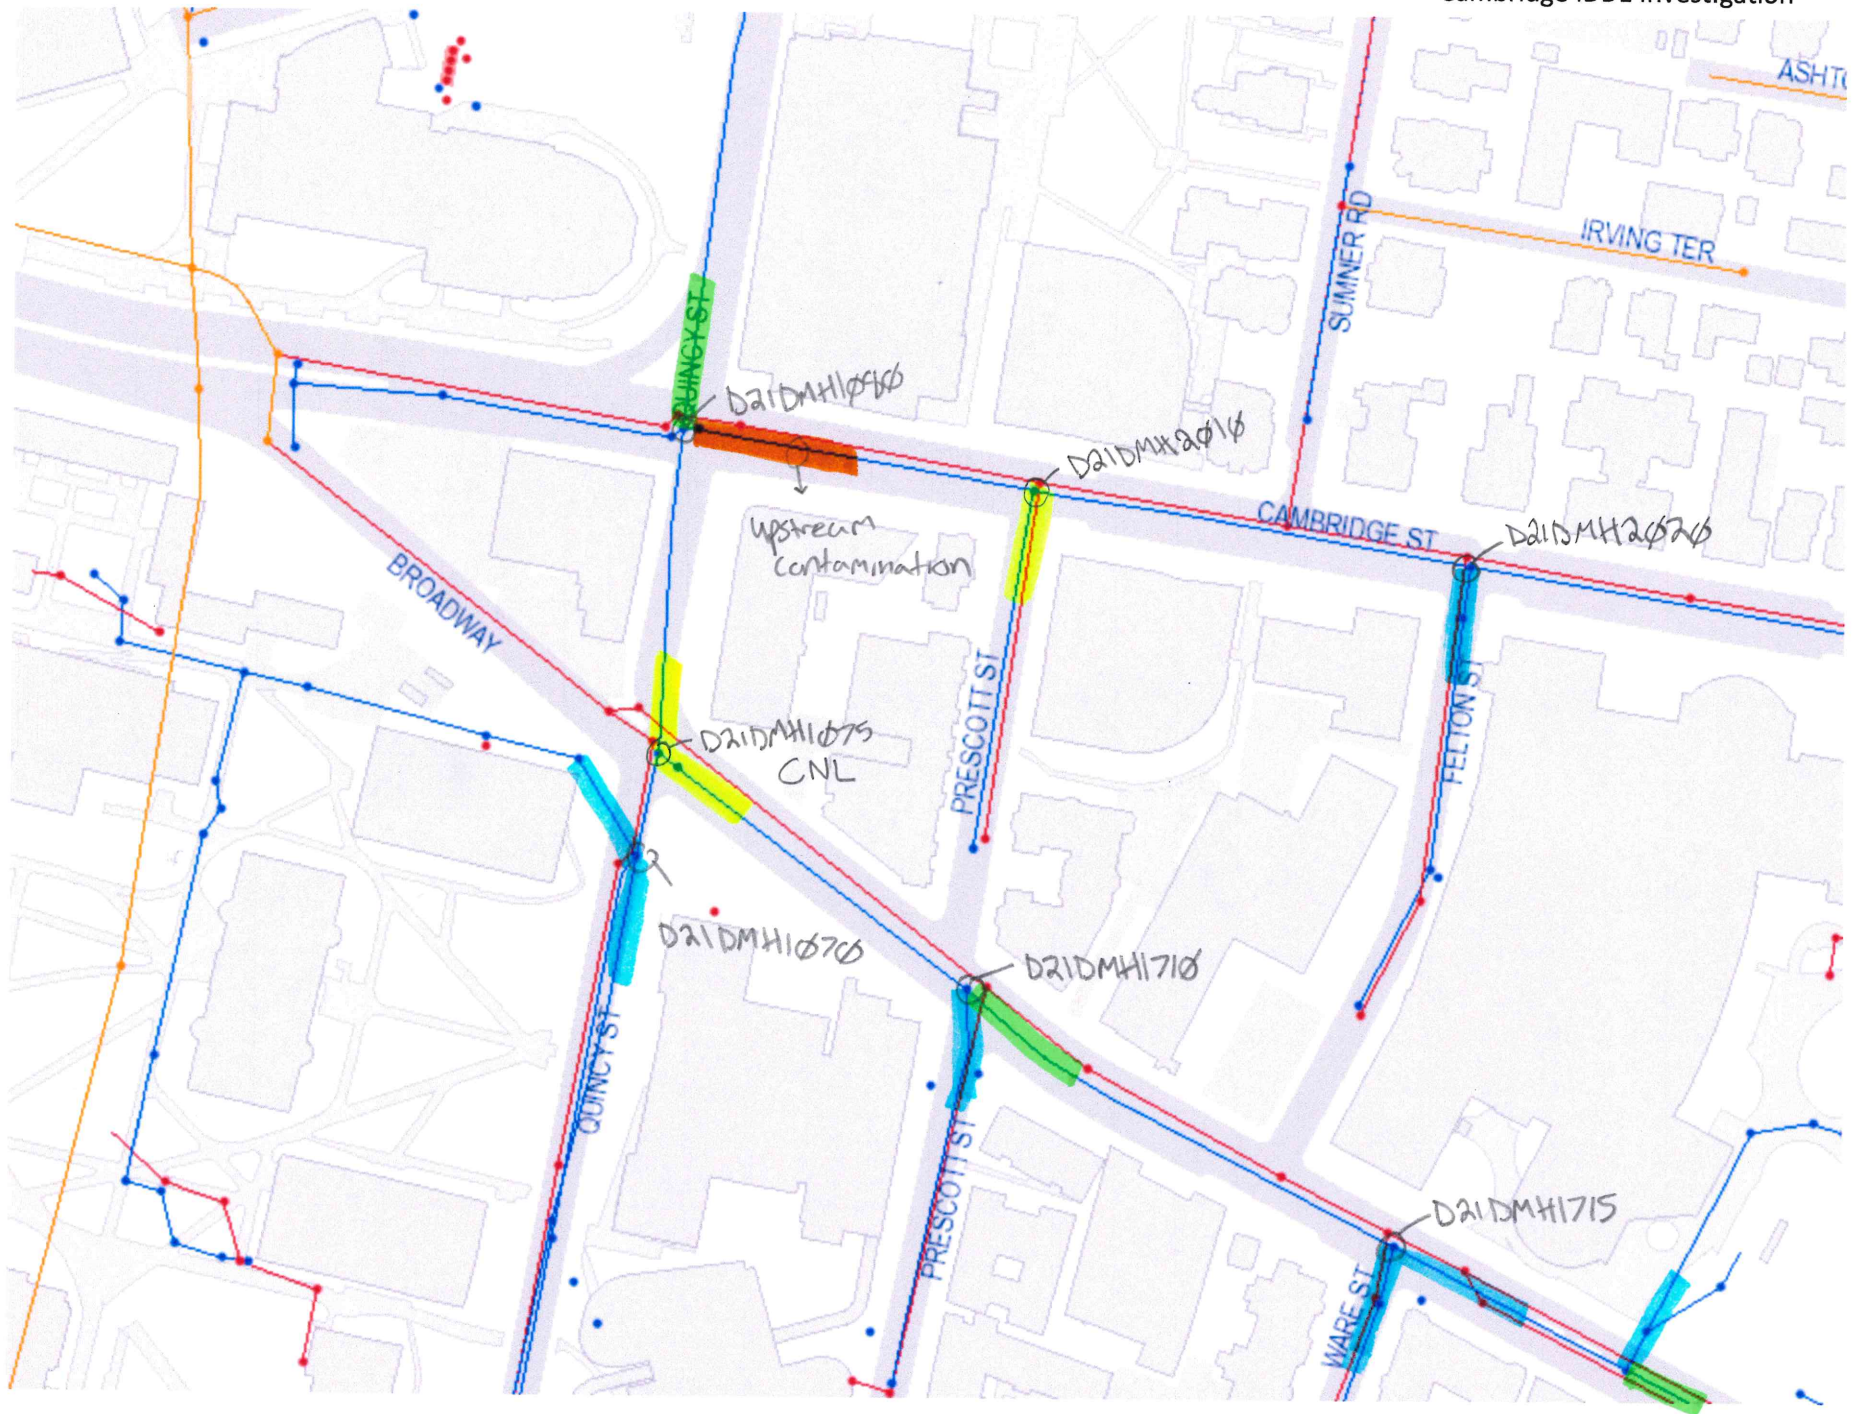
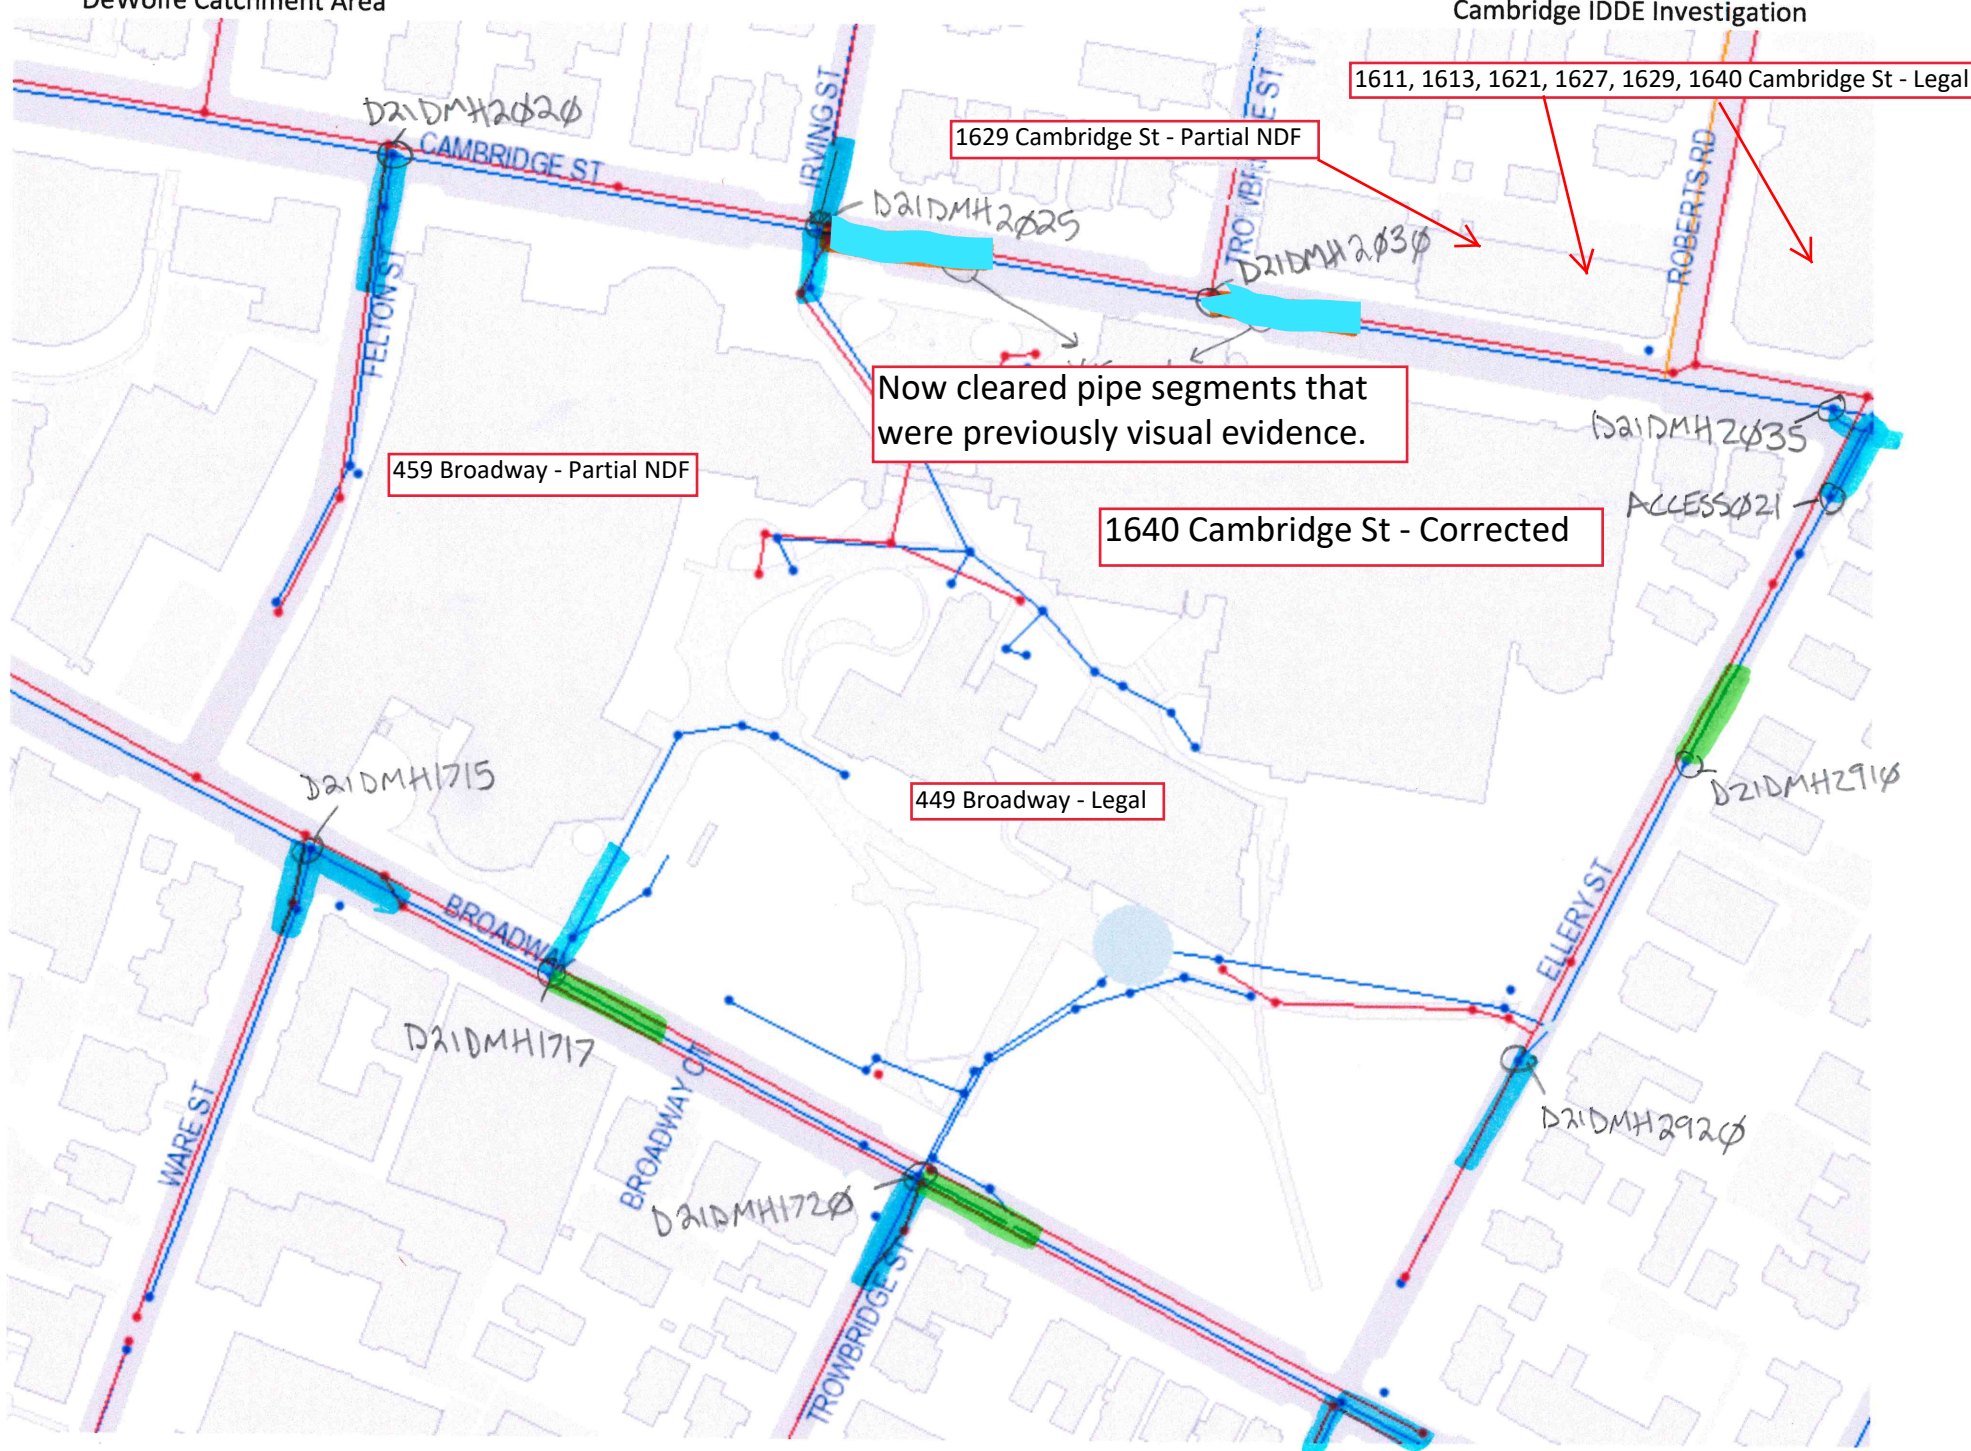
DeWolfe Catchment Area

Dry weather work for this area found multiple locations with high hits for contamination.

- Cleared streets: Mt Auburn St, Bow St, Arrow St, Prescott St, Ware St, Ellery St, upstream portion of Harvard St, Broadway, Quincy St, Felton St, Irving St, Hovey Ave, Leonard Ave and Camelia Ave
- Standing water streets: Plympton St, downstream portion of Harvard St, Trowbridge St, Trowbridge Pl, Ellsworth Ave and Chatham St
- Locations with contamination listed below:

SDE conducted dye tests of the commercial and educational buildings along Cambridge St for the contamination found at drain manhole D21DMH2030. All fixtures in the War Memorial Recreation Center at 1640 Cambridge St were found to be not legal. The dye tests were performed again at later date while a CCTV crew was monitoring the drain and it was determined that all fixtures connected to the same lateral in the drain line. The City corrected the illicit connection. SDE returned to conduct a post correction check dye test and dry weather work to verify the correction. PCC of D21DMH2030 test kit results were A=0.3, S=0.25, C=0.17 and the lab results E. coli=4.09MPN/100ml, A=0.398 mg/l and S=ND.

The following buildings were also dye tested as part of the investigation for D21DMH2030 and found to be legally connected to the sanitary sewer: 1611, 1613, 1621, 1627, 1629, 1640 Cambridge St and 449 Broadway. Additional 1629 Cambridge St and 459 Broadway were partial no dye founds.

SDE plans to conduct dye testing at the buildings adjacent to the remaining contaminated pipes segments when dye testing of residential building types can be resumed.

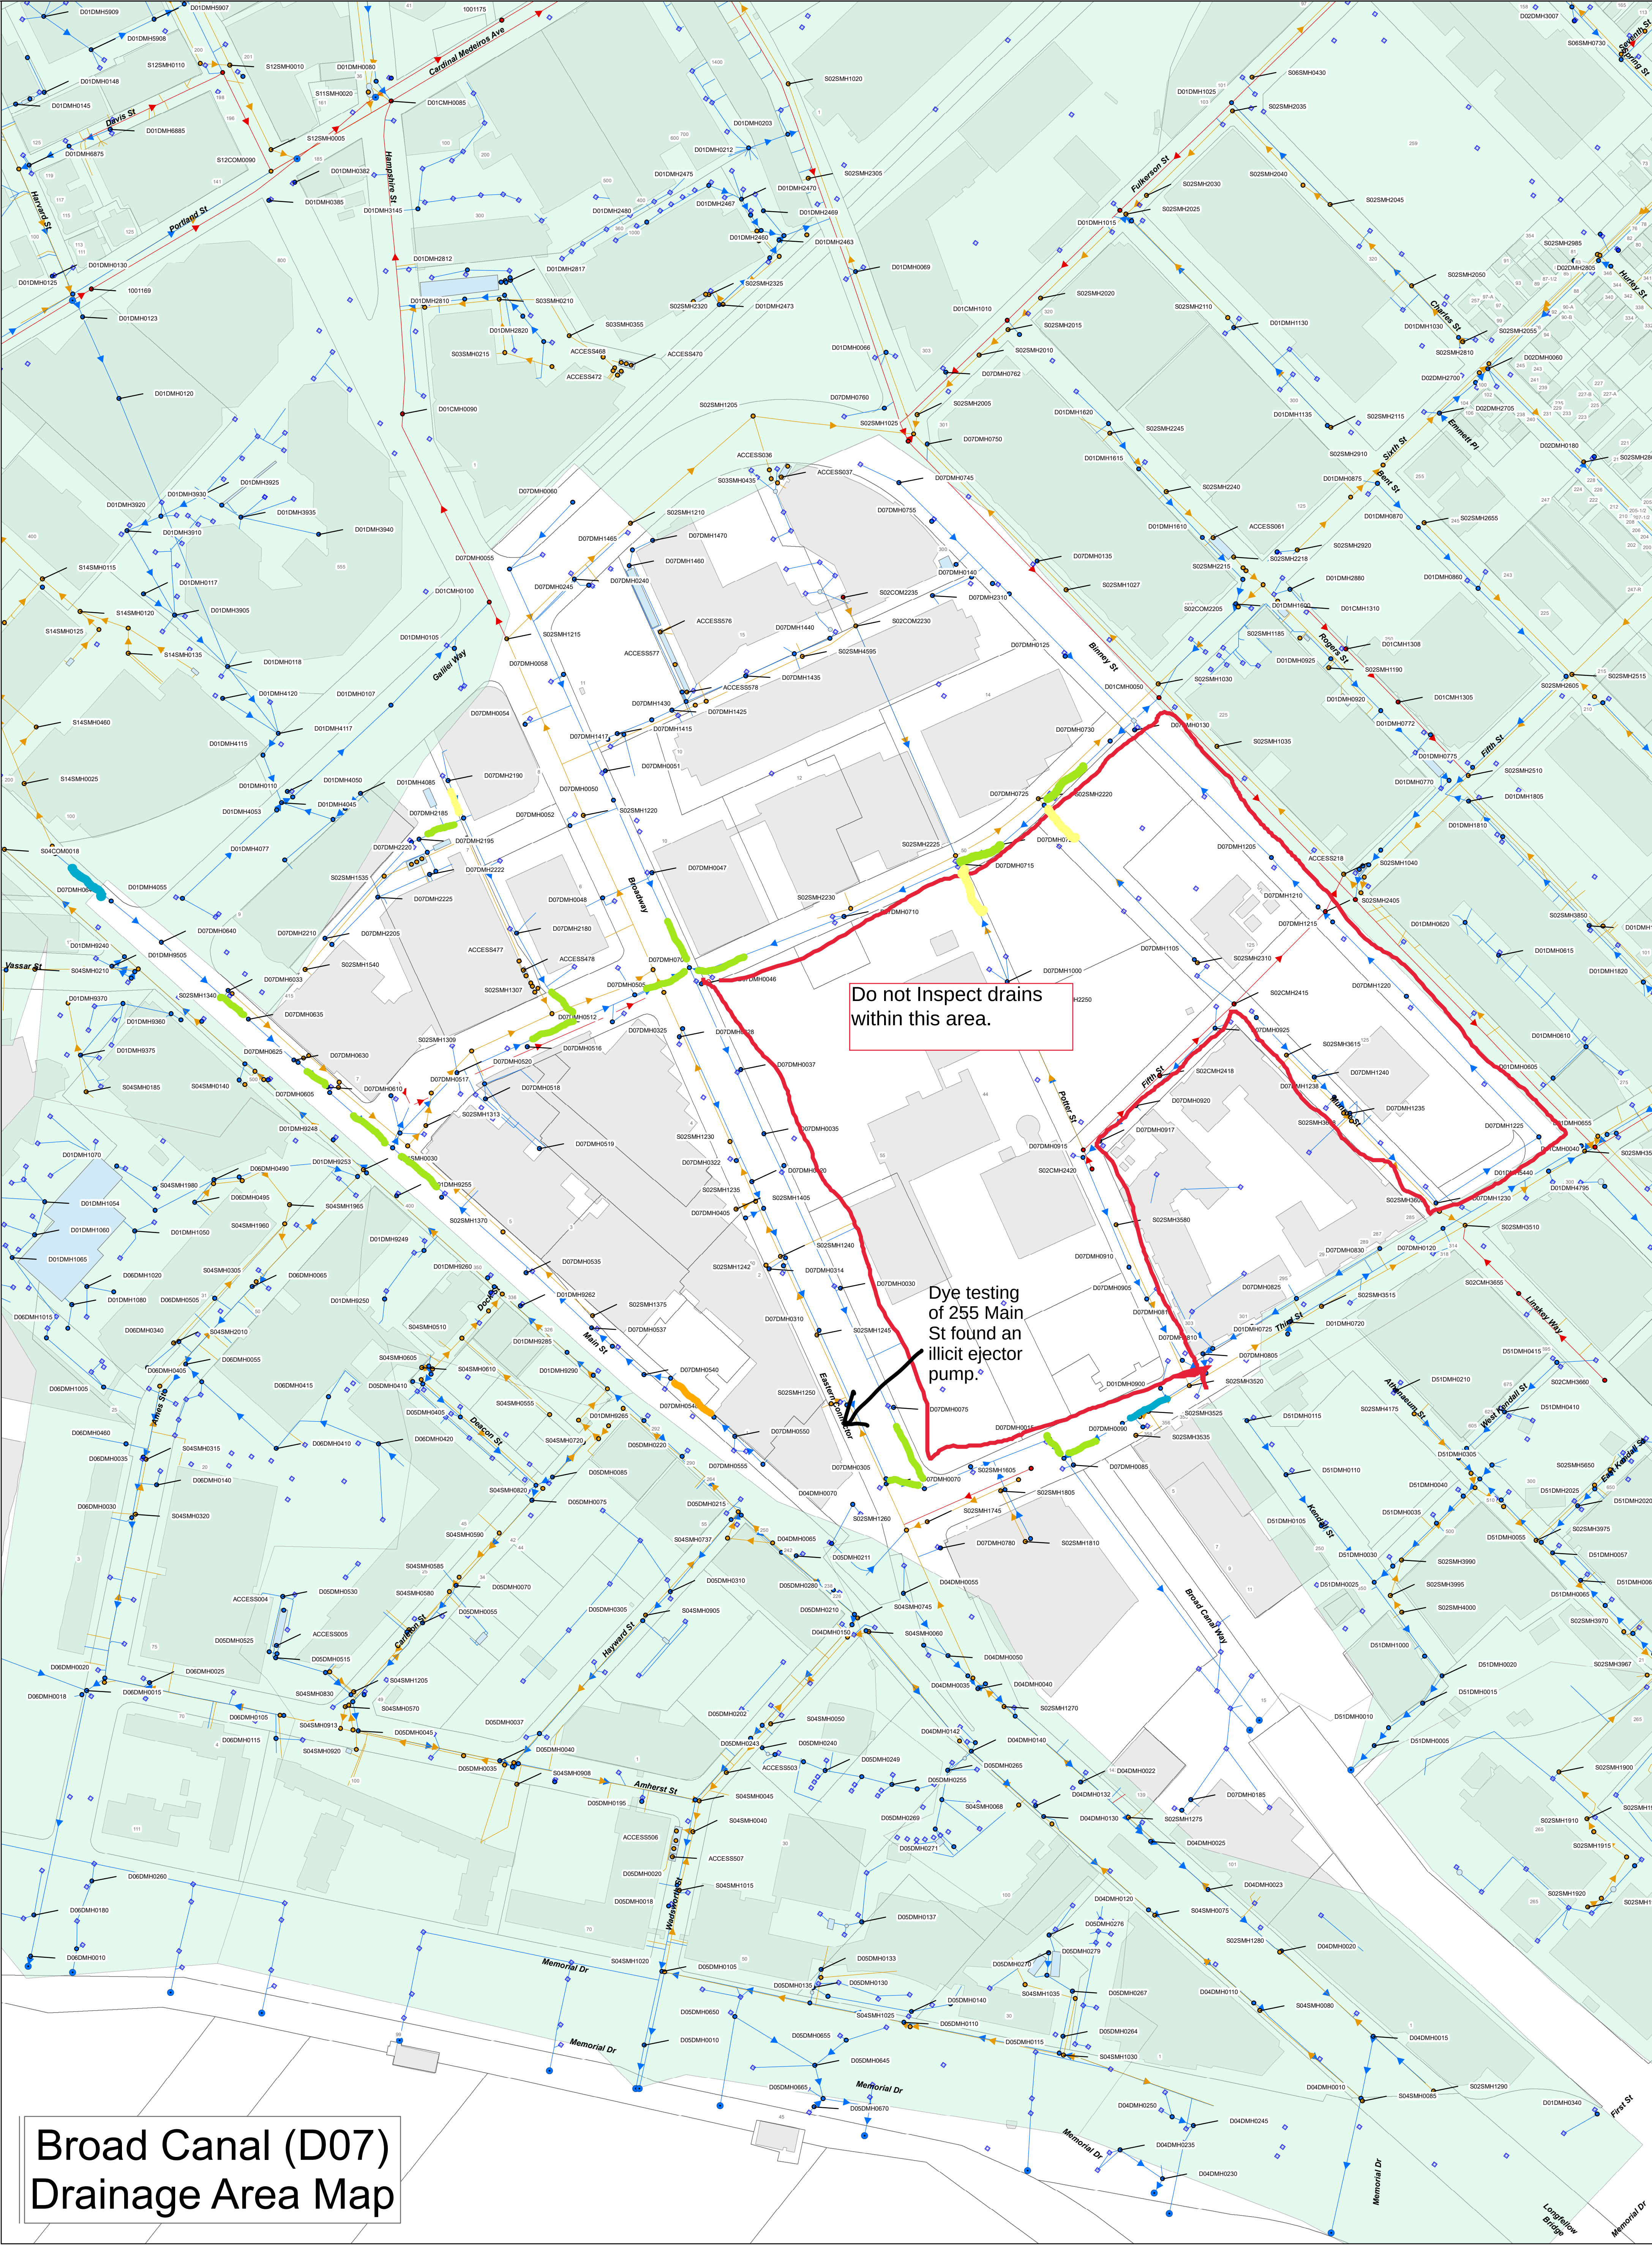
# Broad Canal (D07) Drainage Area Map

Dry weather work for this area found to be mostly standing water, particularly in the downstream portion, with some of the sidelines in the upstream portion being cleared.

- Cleared streets: upstream portion of Main St, upstream portion of Cardinal Medeiros Ave, Marcella St, James Way, Marney St, Michael Way, Cornellius Way, York St and Plymouth St
- Standing water streets: downstream portion of Cardinal Medeiros Ave, downstream portion of Main St, Ames St, Broadway and Third St

- D07DMH0555 (Main St) - visual evidence found in starter manhole
- North inlet of D01DMH3030 (Berkshire St) - A=0.0, S=0.5, C=4.12 and E. coli = 10 MPN/100ml

The commercial buildings on Main St near the contaminated drain line were dye tested. An illicit ejector pump at 255 Main St was found tied into drain manhole D07DMH0555. No dye testing was conducted for D01DMH3030 as all adjacent buildings are residential.
