# Memorandum

**Re:** **Illicit Discharge Detection and Elimination Investigation Progress**

This memorandum summarizes the progress made on the IDDE catchment investigations during the Year 3 reporting period of July 1, 2020, through June 30, 2021.

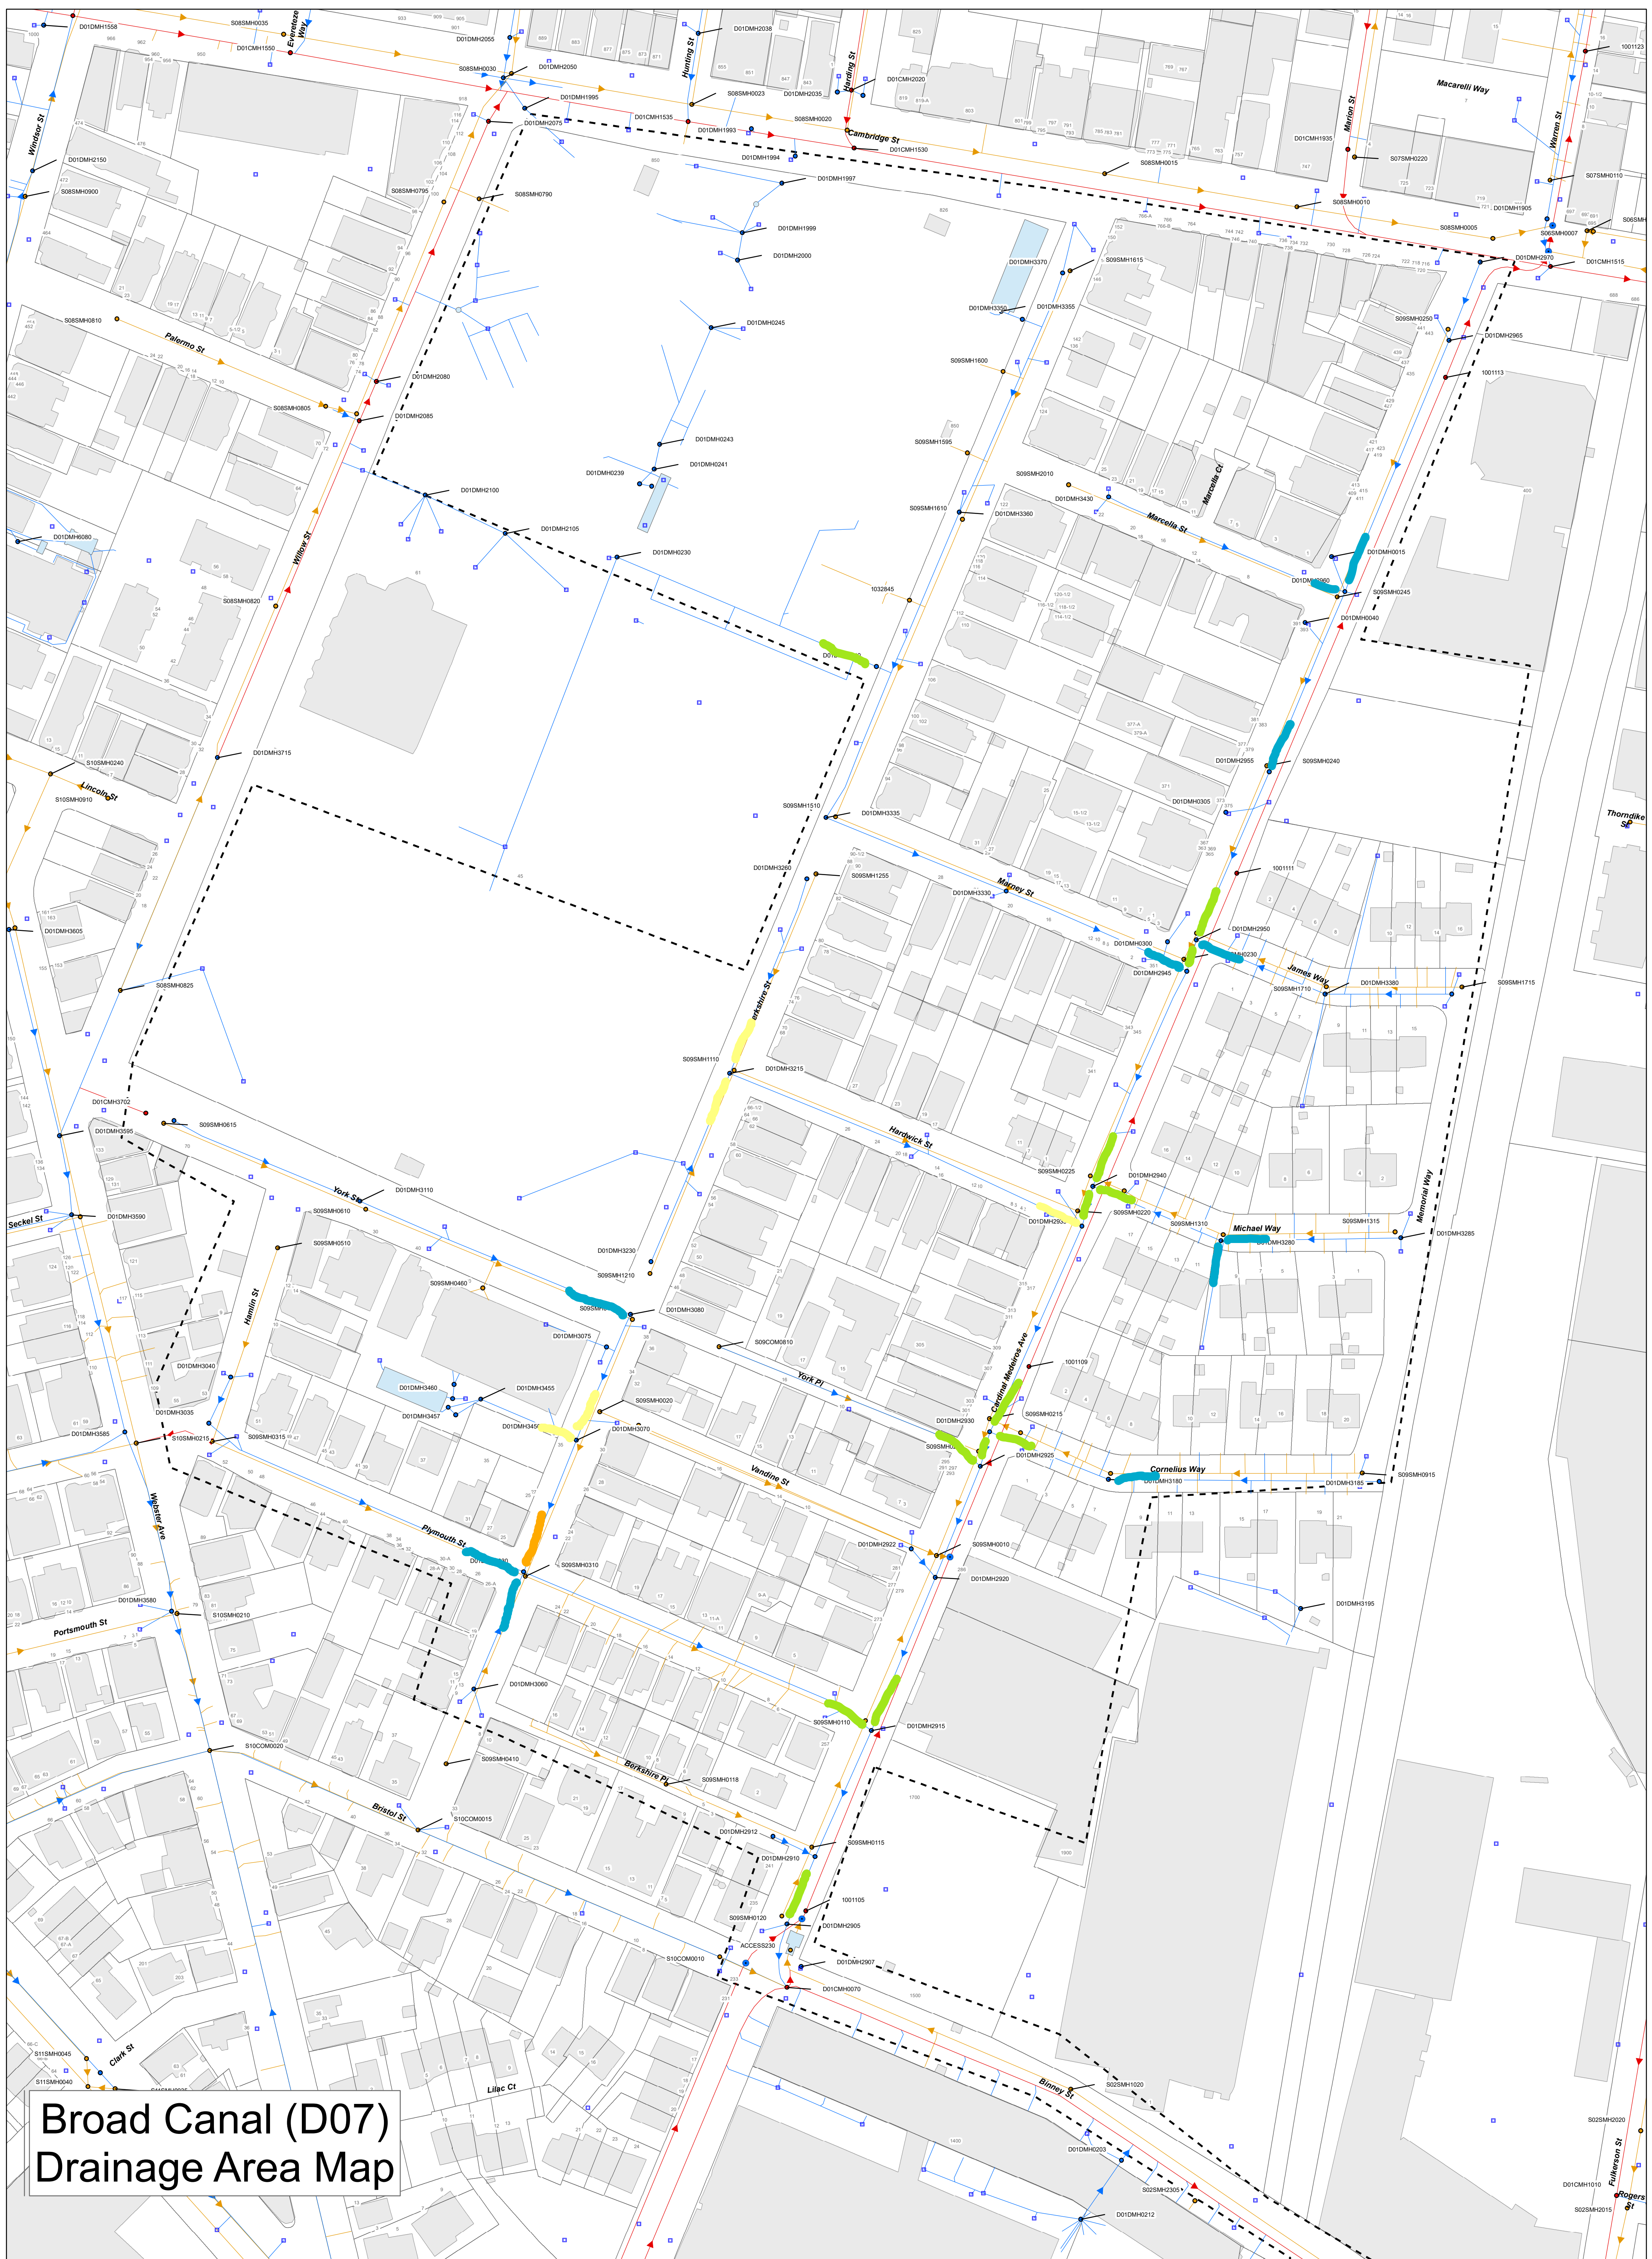
Dry weather work conducted in this area found mostly standing water.

- Cleared streets: Putnam Ave, upstream portion of Green St and downstream portion of Flagg St
- Standing water streets: downstream portion of Green St, Bay St, Franklin St, Kinnard St and upstream portion of Flagg St.
- No pipe segments were identified that have contamination.

Southeast inlet of D19DMH1505 was found to have significant standing water.

- Record drawings from 1974 (SS Contract, Ph 1, Contract 3, Sheet 17) showed the line had previously connected to the combined system but had since been capped.
- SDE used a camera to confirm that the inlet had been capped.

No dye testing has been conducted in this area at this time.

No dye testing for the area has been conducted as the buildings adjacent to the standing water are residential. SDE will attempt to reinspect some of the standing water pipe segments during a future dry weather period. If standing water is still present, the area will have to be cleared through dye testing.

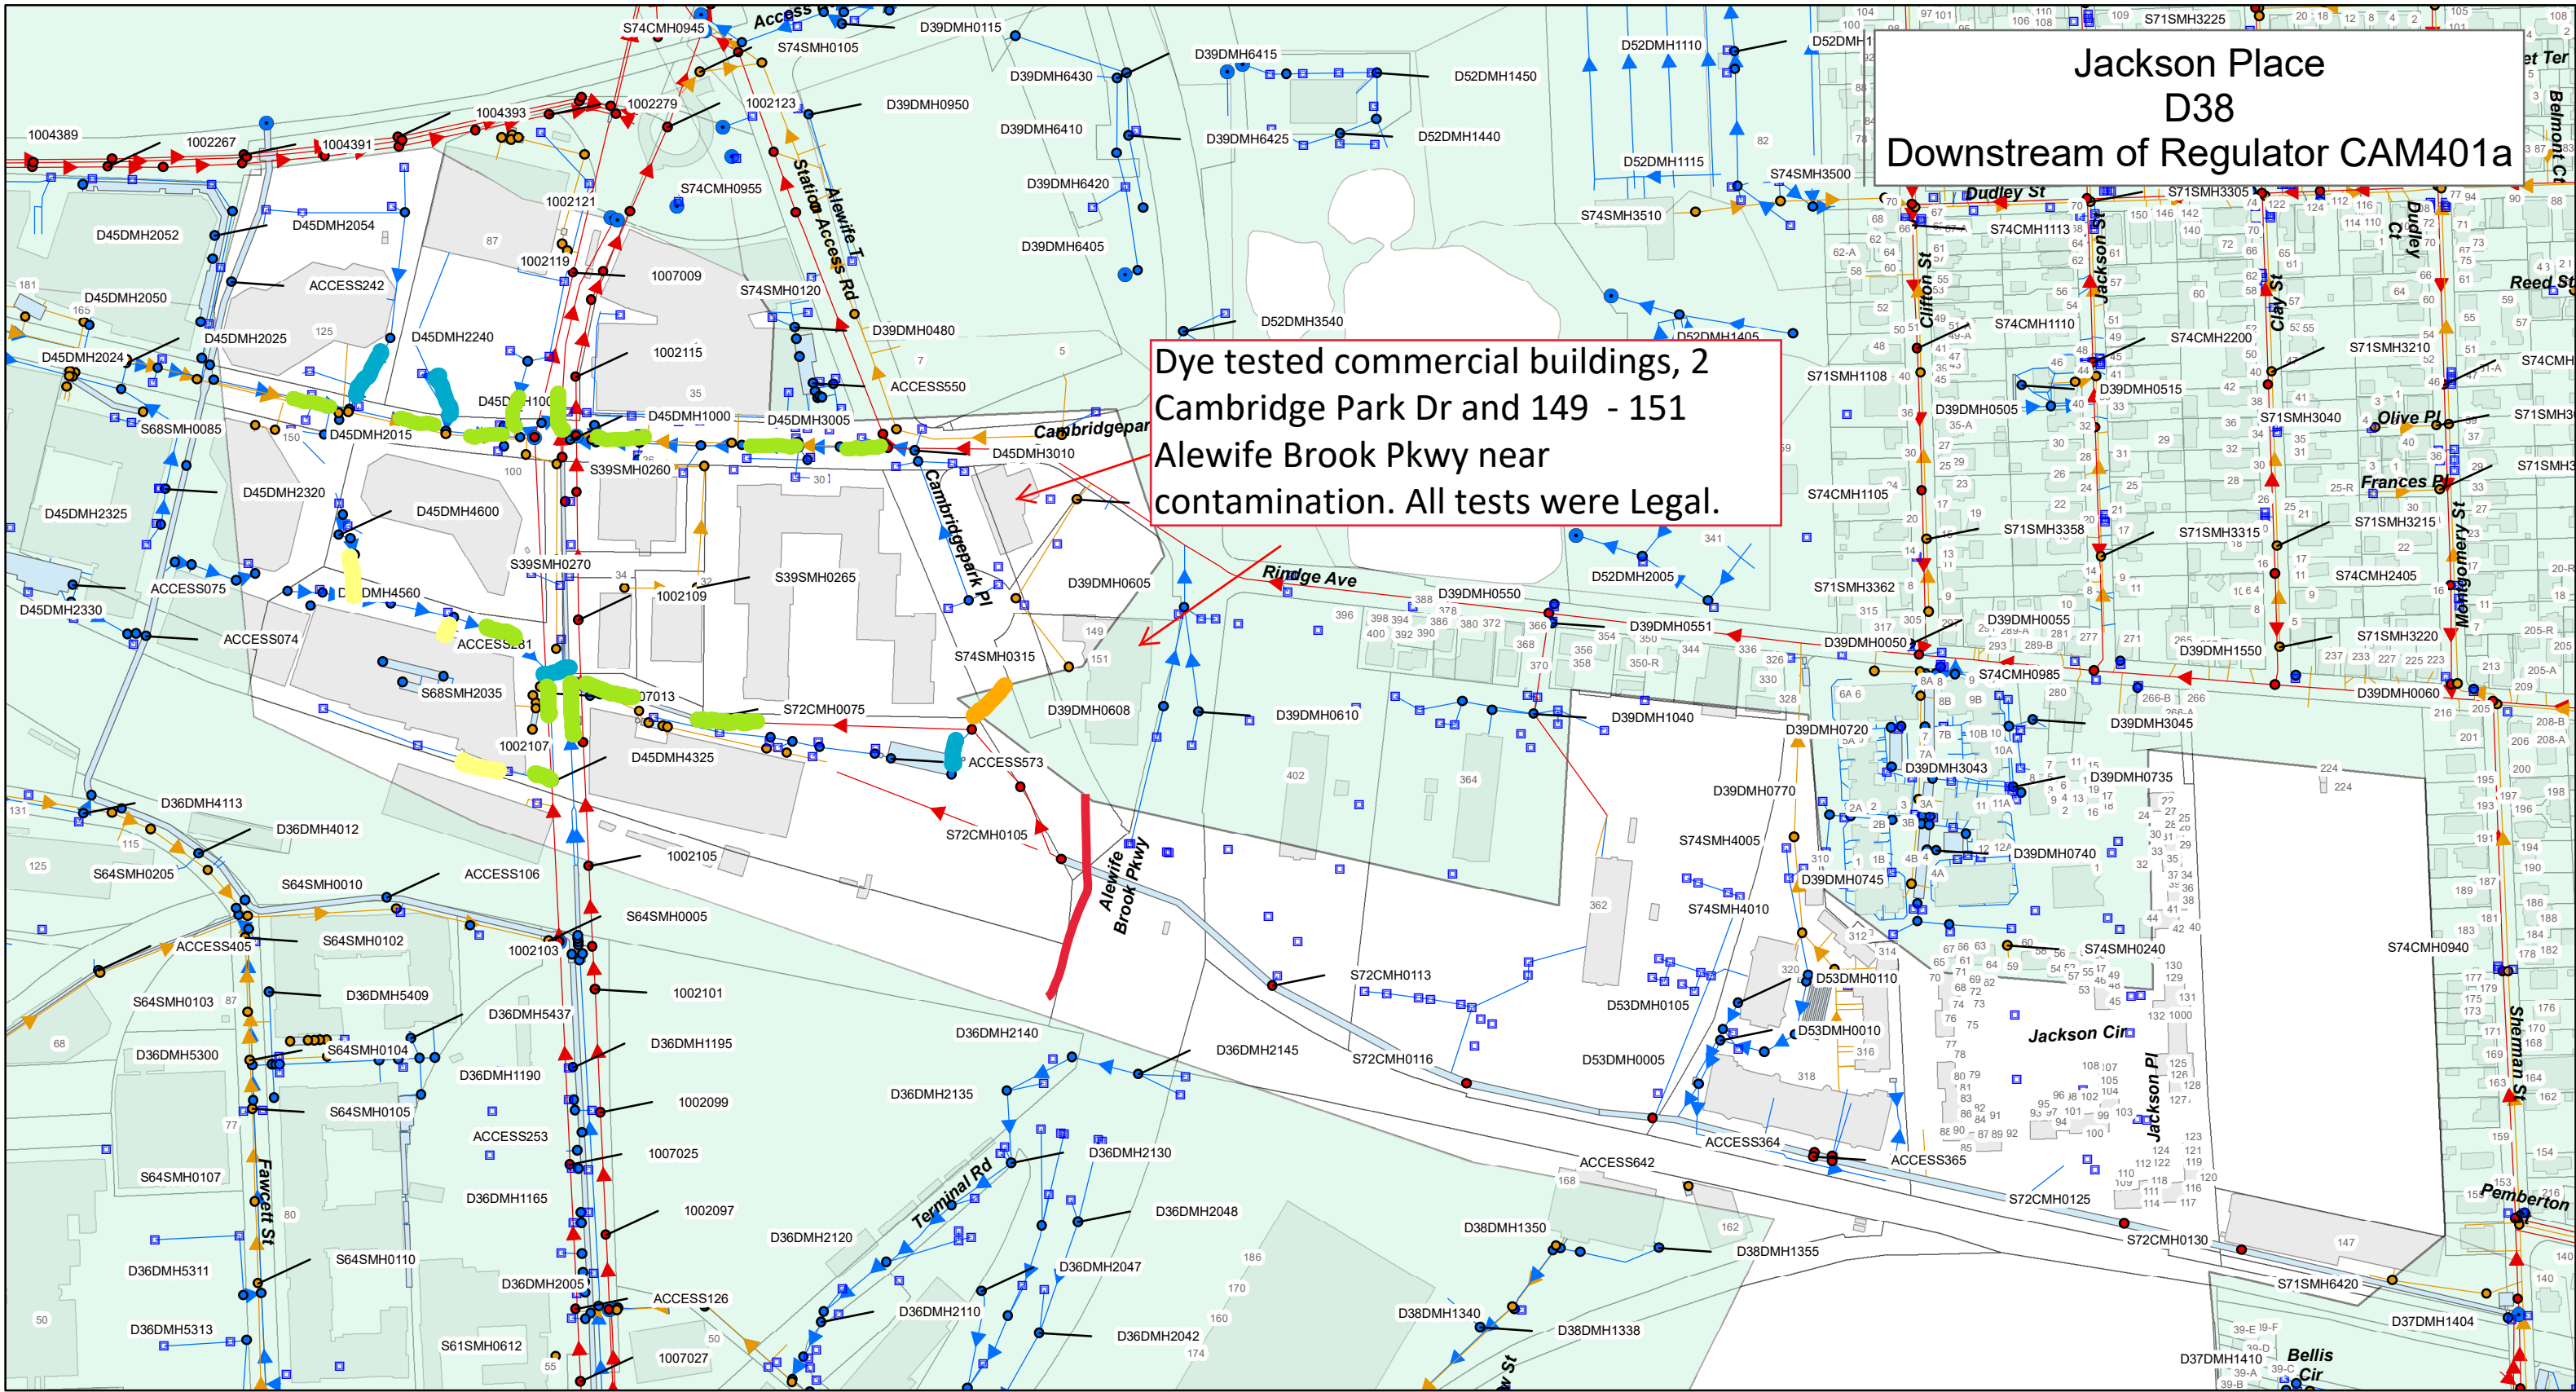
Dry weather work for this area was conducted downstream of regulator CAM401a.

- The main line was found to be mostly standing water including the easement that runs parallel to Rindge Ave located immediately downstream of the regulator.
- Standing water was also found along Cambridge Park Dr with a few sidelines being cleared by sandbags.

Only hit for contamination was found in an unmapped inlet coming from the north in S72CMH0095

- Test kit results: A=6.0, S=0.75, C=0.46 and lab results: E. coli=1 MPN/100ml, A=3.21 mg/l, S=0.09 mg/l
- SDE dye tested commercial buildings (2 Cambridge Park Dr and 149 - 151 Alewife Brook Pkwy) near contamination but all results were Legal.

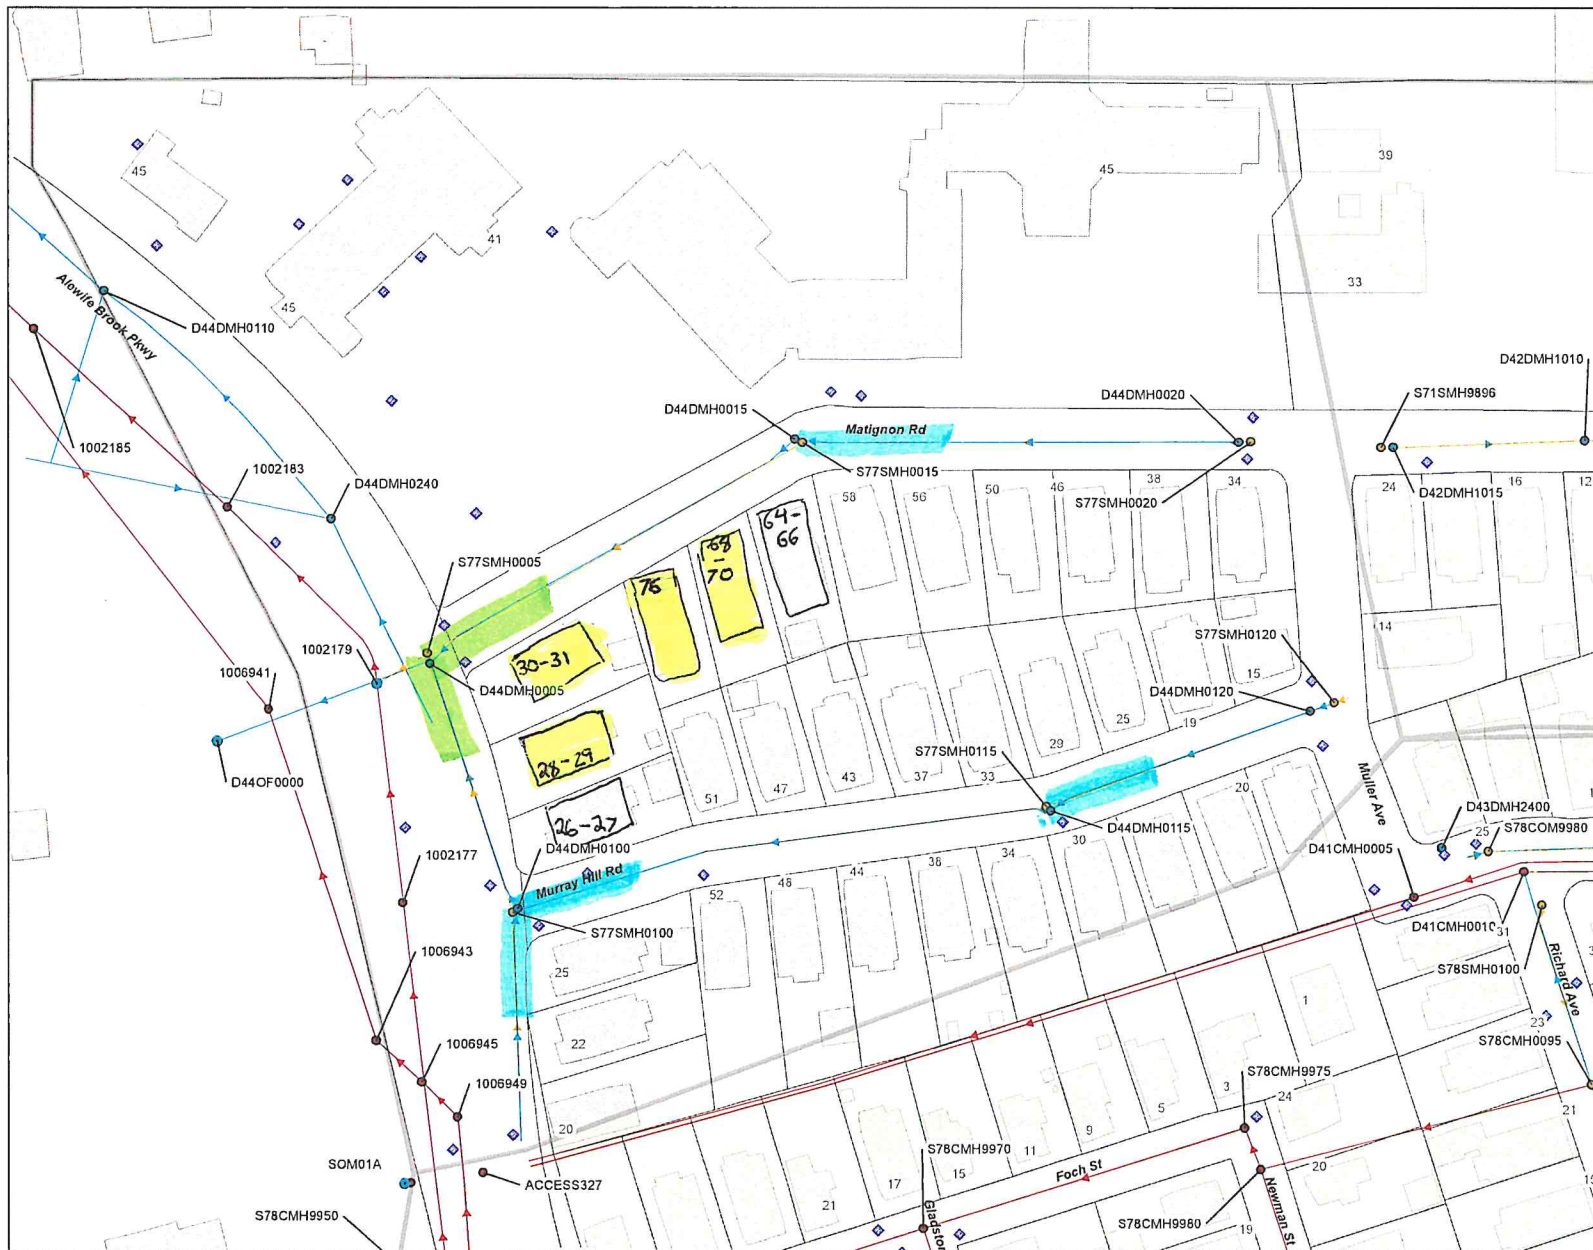
= standing water

= clean

Dye tested 3 building at 80 Sparks St. Two tested legal and one tested partial no dye found.

SDE conducted dye tests at the three buildings apart of Buckingham Browne & Nichols Middle School at 80 Sparks St. Two of buildings tested legal and the third tested partial no dye found. Residential buildings identified for dye testing during the pandemic and those buildings not completed pre-pandemic will resume when dye testing is permitted.

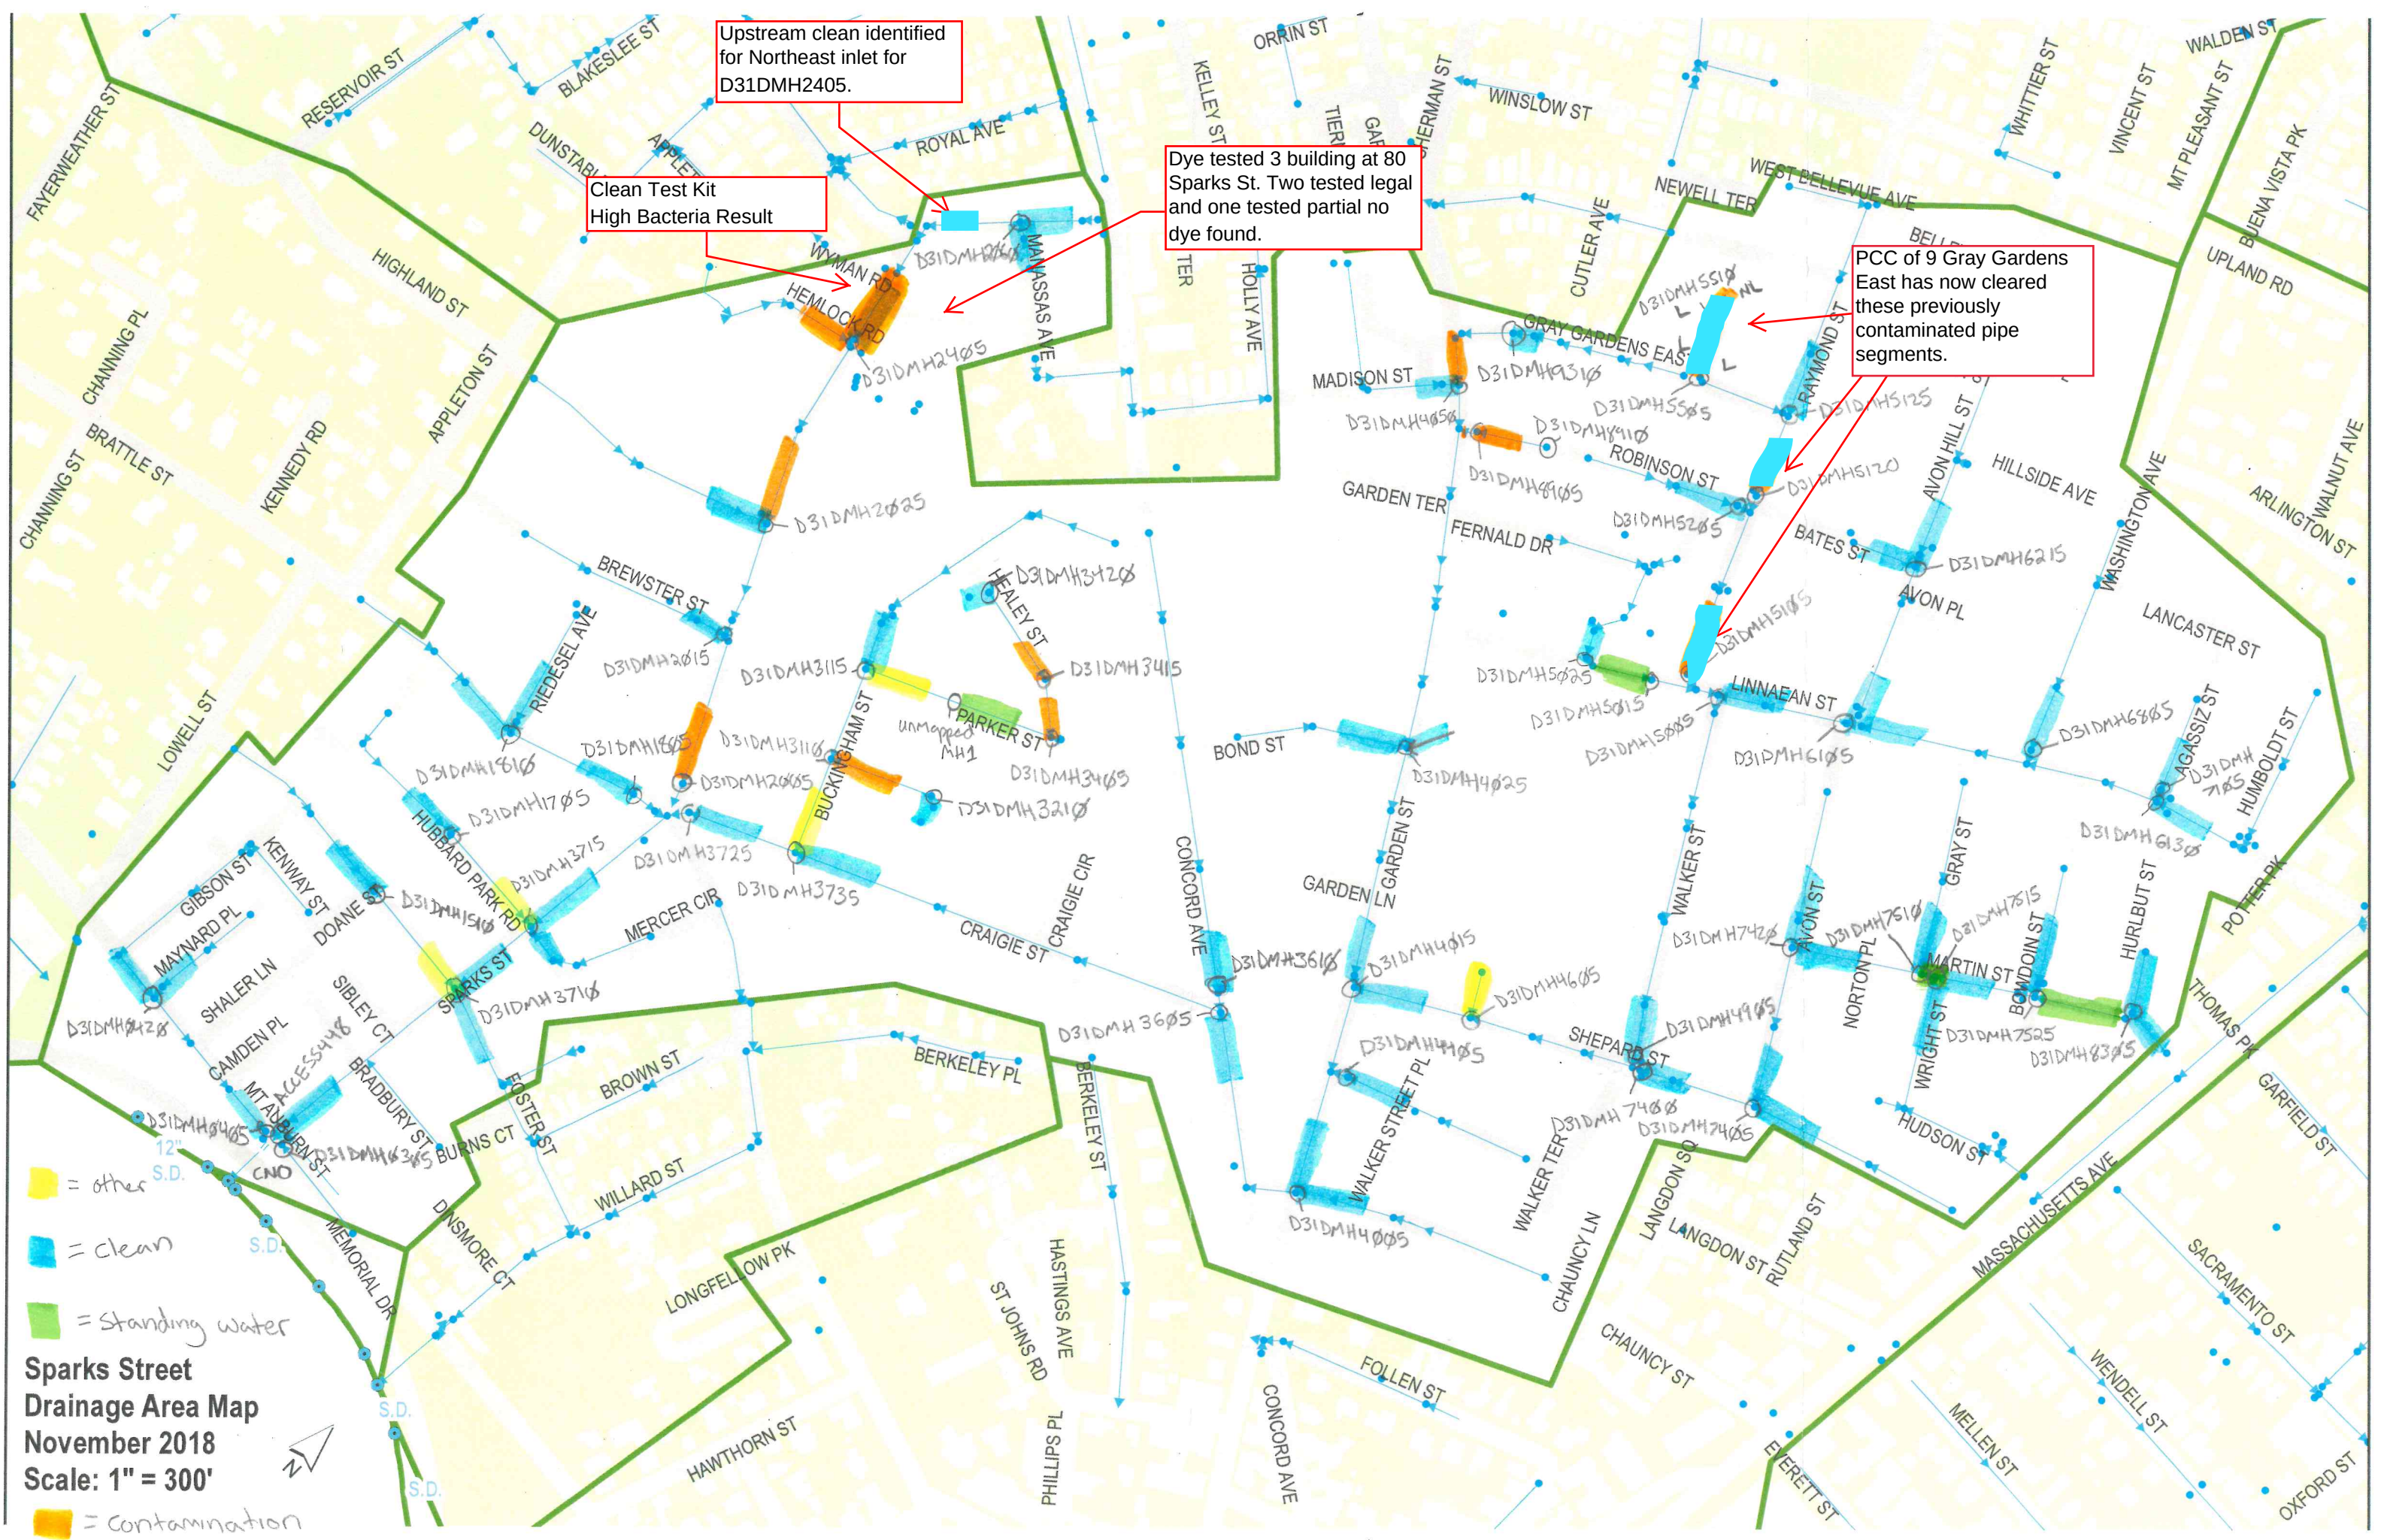
**Sparks Street  
Drainage Area Map  
November 2018  
Scale: 1" = 300'**

Upstream clean identified for Northeast inlet for D31DMH2405.

Clean Test Kit  
High Bacteria Result

PCC of 9 Gray Gardens East has now cleared these previously contaminated pipe segments.
