City of Cambridge Water Department

2019 BENTHIC MACROINVERTEBRATE REPORT

February 2021

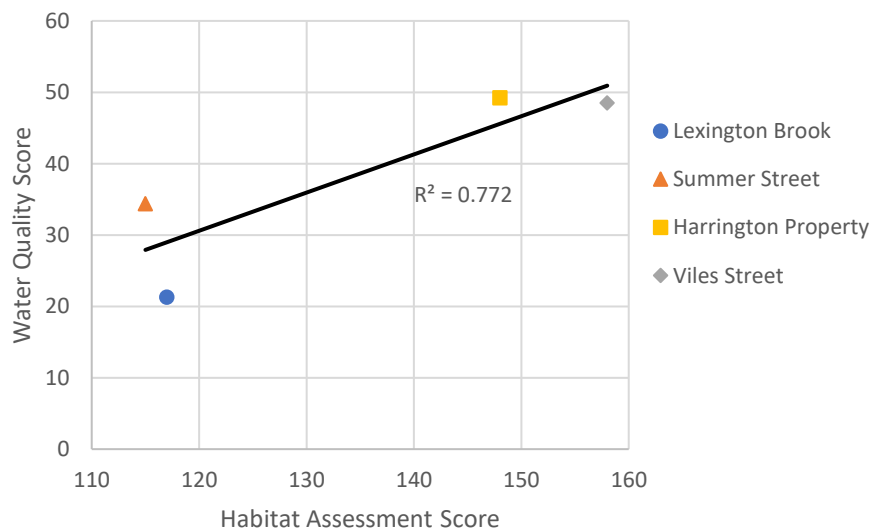
In 2019, higher habitat scores correlated with higher water quality scores (Figure 14). For the four sites monitored by CWD in 2019, albeit a small sample size, the R-squared value for a simple linear

Figure 14: Comparison of 2019 habitat assessment and water quality scores

regression between habitat score and water quality score was 0.772. This shows a moderately strong positive correlation, suggesting that sites with higher habitat scores higher also tend to have better water quality as measured by macroinvertebrate abundance and diversity. Other explanations for differences in water quality scores could include differences in the physical and chemical water quality between sites. This relationship is not explored in this report, but ample information on chemical and physical parameters measured by CWD at Lex Brook, SB @ Viles, and Summer Street through the SWQMP can be found online at the following website:

Out of four categories (poor, marginal, suboptimal, and optimal), habitats at the four sites scored in the suboptimal and optimal ranges. Water quality scores placed the sites in the fair and good categories (out of three categories: poor, fair, and good). None of the sites had water quality scores in the poor range. Higher water quality scores showed a moderately strong positive correlation with higher habitat scores.
