GLACKEN SLOPE RESTORATION PROJECT

LITTLE FRESH POND – POND ACCESS

PINE GROVE ASSESSMENT

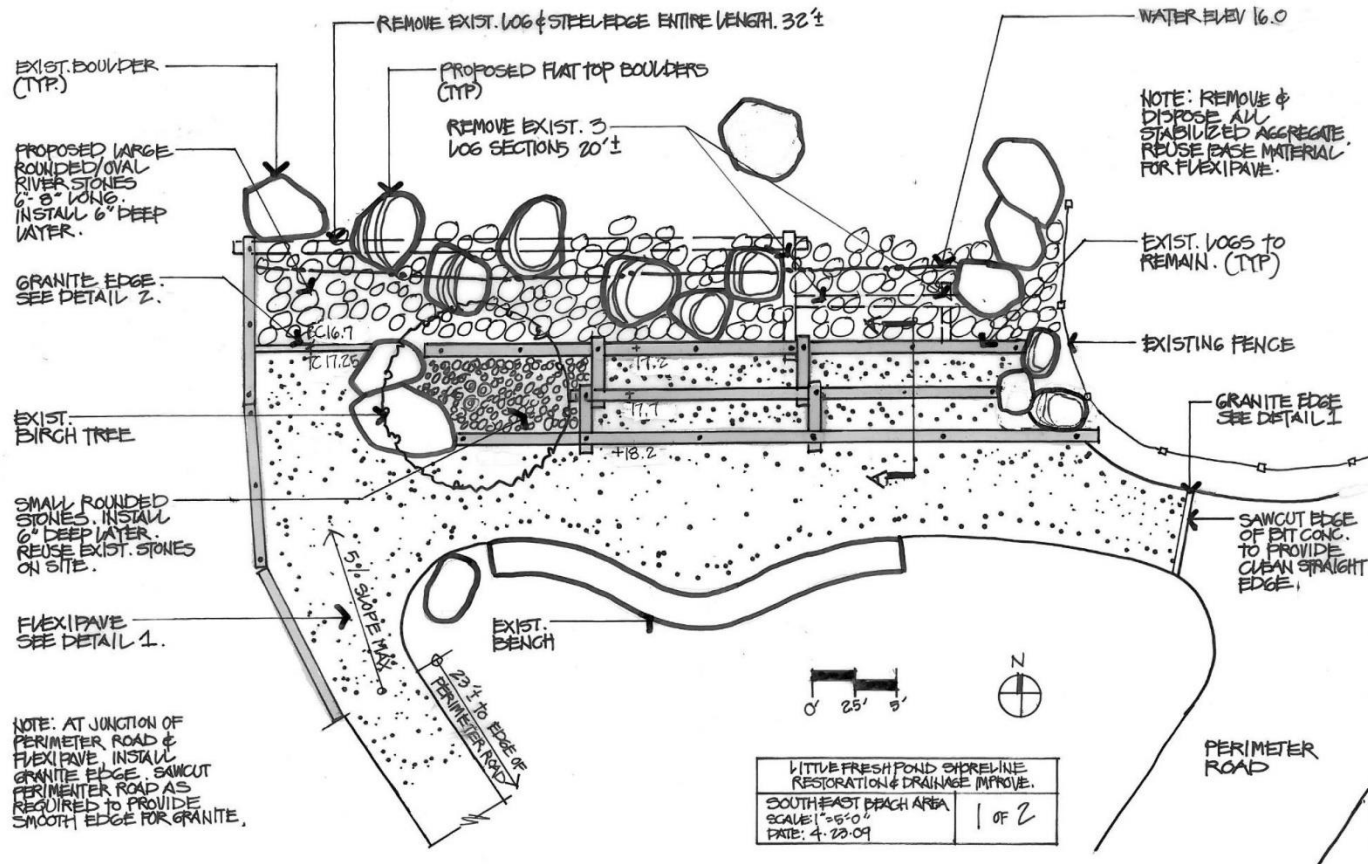
LITTLE FRESH POND – 2009 RETROFIT

1. Constructed in 2007 as part of LFP Restoration project.
2. Small retrofit in 2009.
3. Heavily used access point for dogs.
4. Ipe/boulder bench designed by Mitch Ryerson.

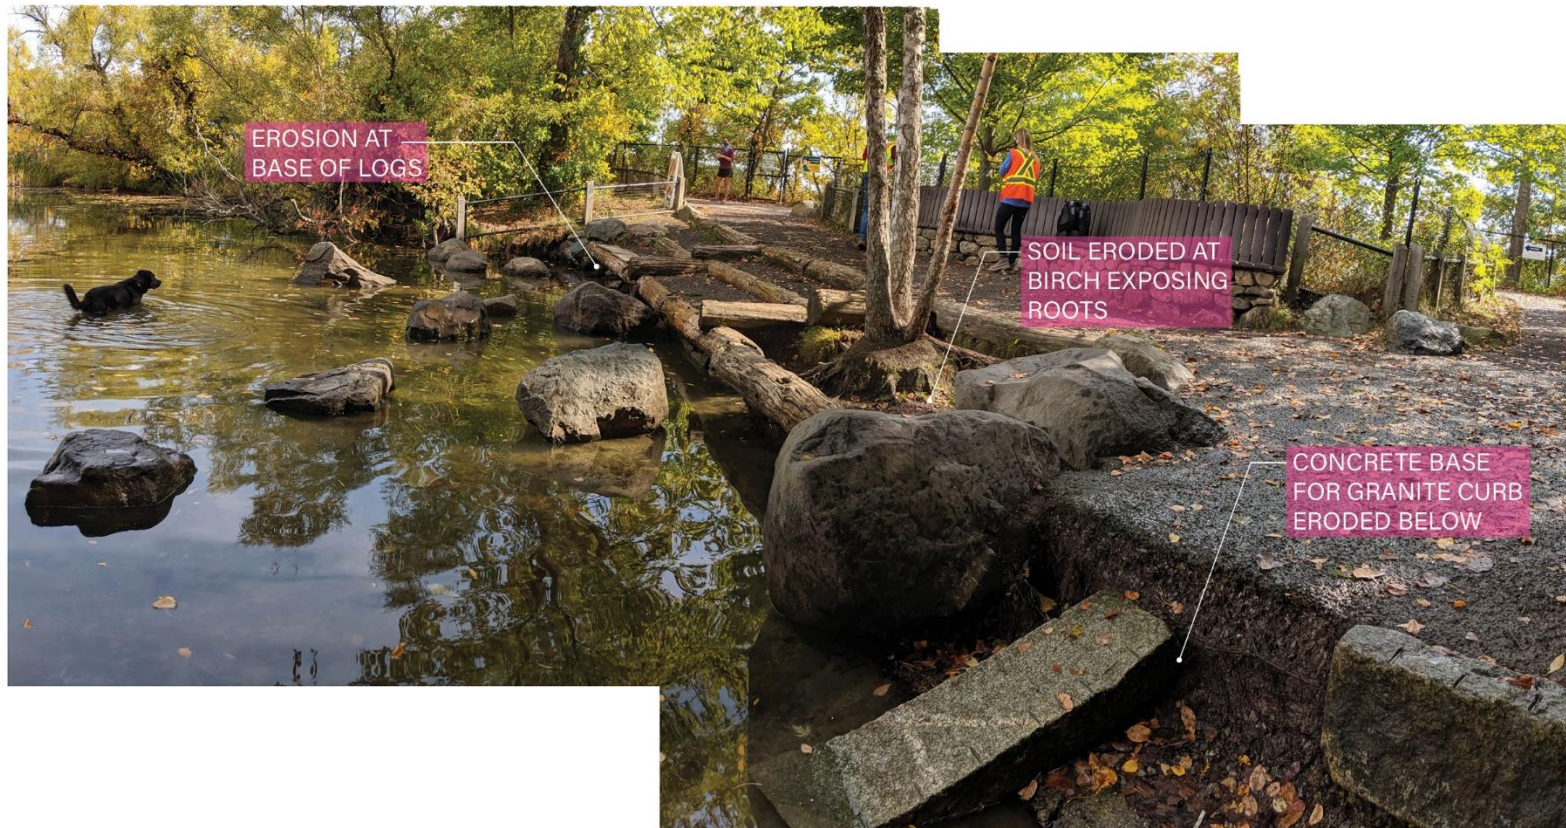
EXISTING CONDITIONS

Little Fresh Pond Dog Beach

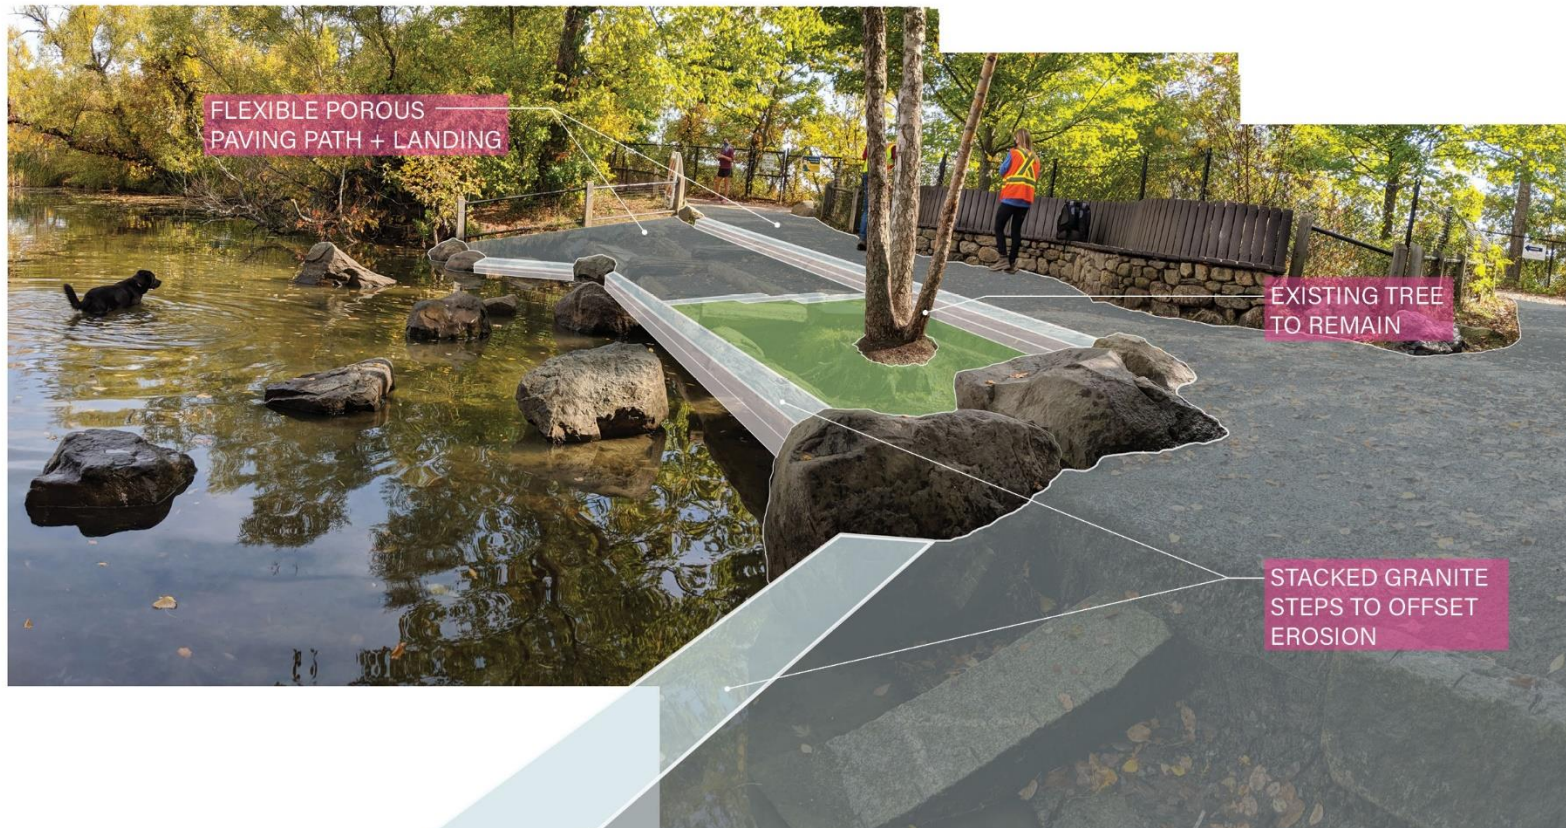
PERSPECTIVE PHOTOMONTAGE

Little Fresh Pond Dog Beach
