Central Square City Lots Study

Appendix A: Technical Assessments

Preliminary Site Assessments

July 2023

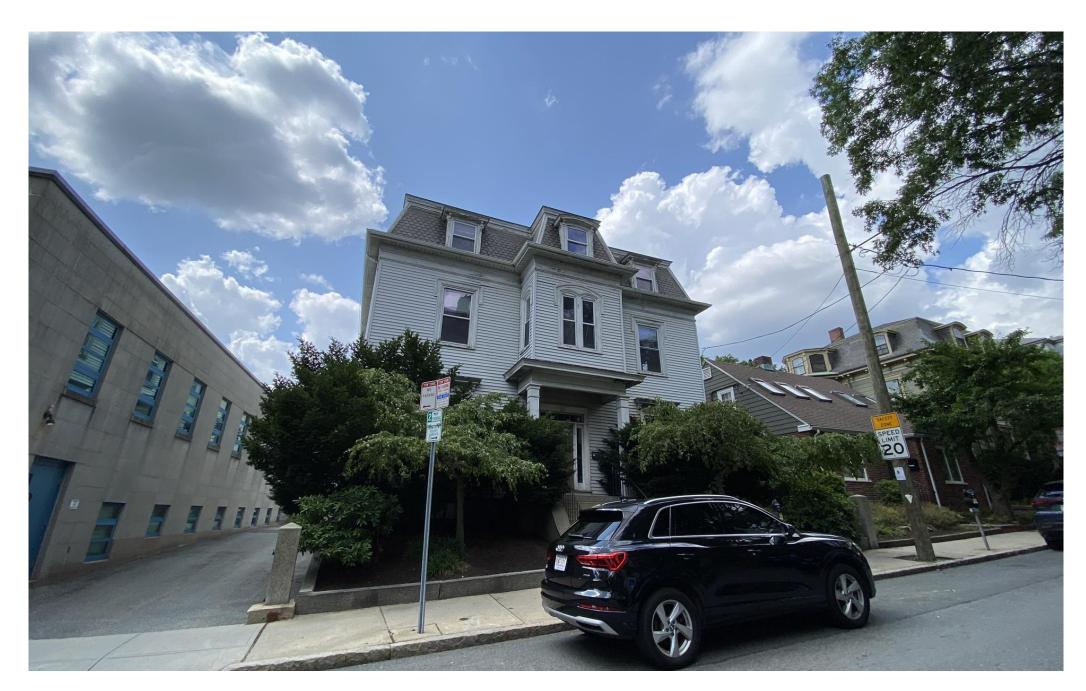
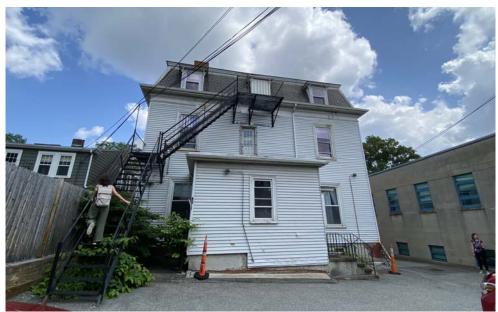
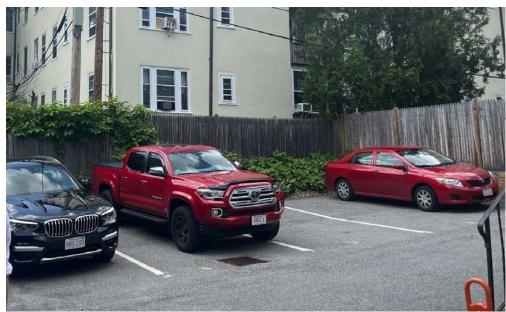
The existing structure is a 3-story wood framed house with a basement, built in the Second Empire Style. Its exterior decorative features include a central projecting pavilion supported by porch columns. The mansard roof has slate shingles in a stylized scallop pattern and metal rope detail edging. Dormer windows have arched 'eyebrow' shapes with decorative brackets.

The condition of the building today is fair to poor. The masonry foundation is visibly deteriorated and the vinyl siding is cracked, exposing the sheathing to the elements in several locations. A 2014 Conditions Assessment Study found evidence of water infiltration at the roof and basement levels and that rot is compromising the structural framing. The life safety systems are not up to code and there is an exterior fire escape from the upper floors. Full building systems (mechanical, electrical and plumbing) require full replacement to meet current standards. The assessment also notes hazardous material abatement and mold remediation may be required.

The building is not wheelchair accessible. There is a granite stoop with 7 risers at the front entrance from the sidewalk; a second entry at the rear parking lot is 5 risers above grade. There is no lift or elevator in the building today.

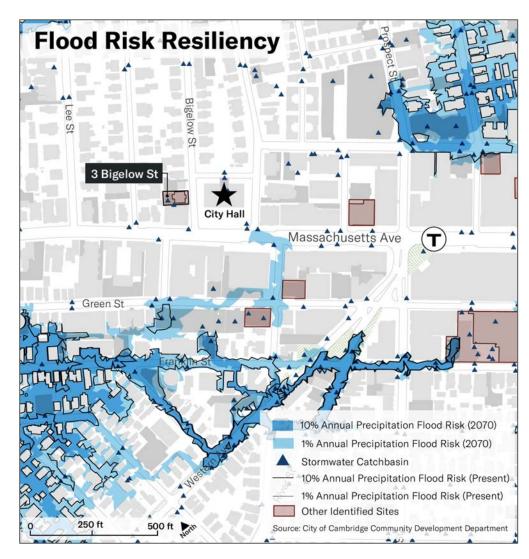
3 Bigelow St is **not at risk of precipitation flooding** today or in the near future (2023 - 2070).

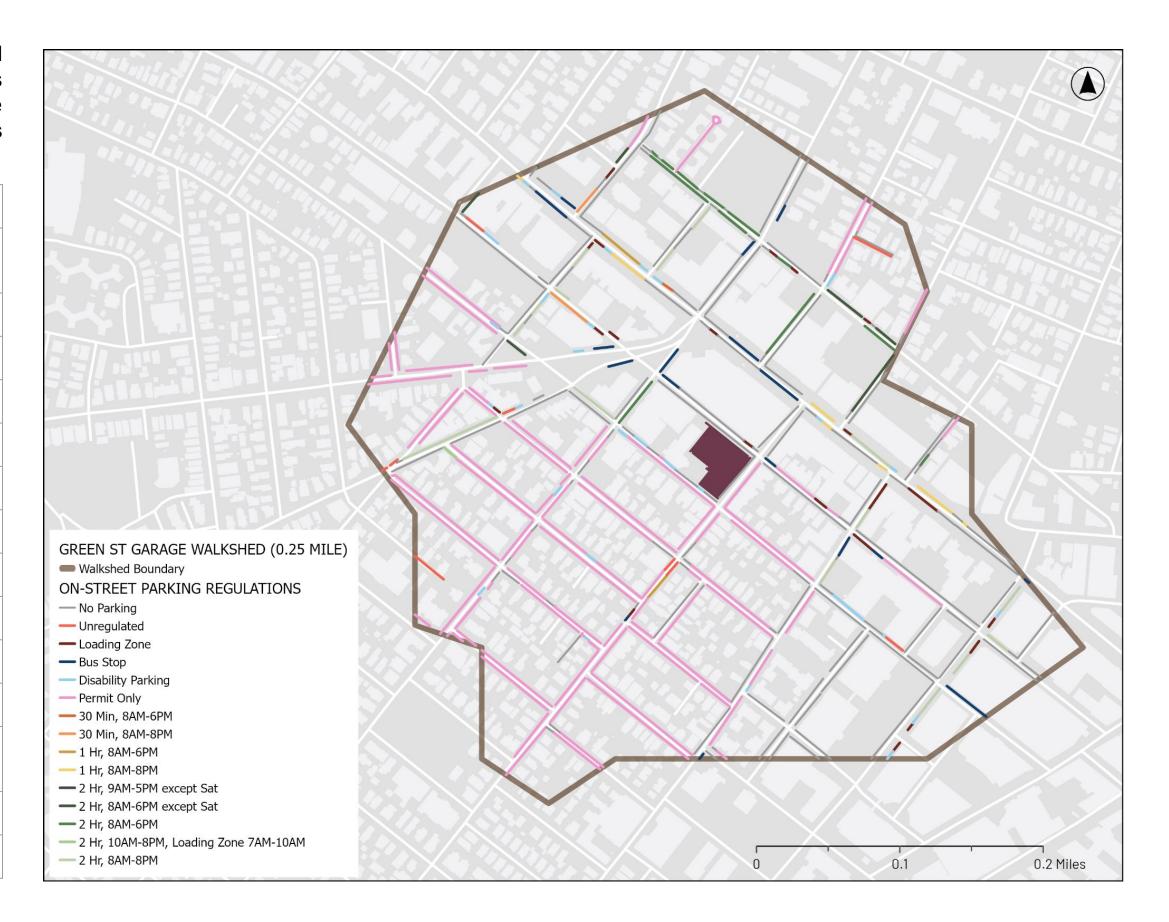
The majority of the 0.25 mile walkshed surrounding the Green Street Garage is dedicated to residential permit parking. The remaining on-street regulated parking is largely made up of 2-hour metered parking.

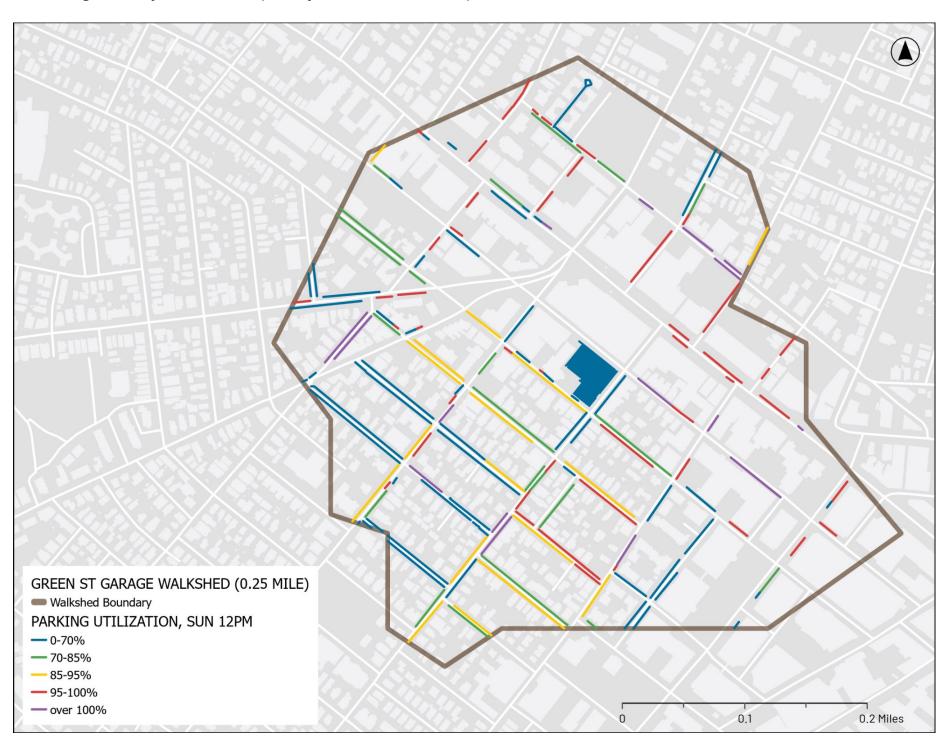
On-Street parking utilization was highest in the study area Sunday at 12:00pm, however, the Green Street Garage had very low occupancy during this time period. Green Street Garage averaged only 41% occupancy across all time periods.

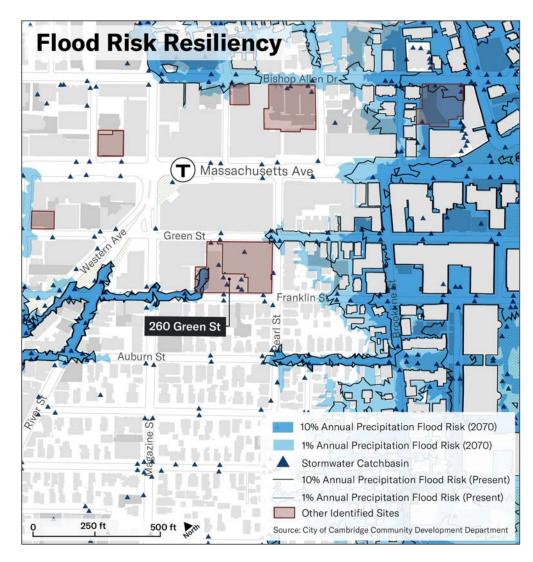
260 Green St is at risk of precipitation flooding, today and in the near future (2023 - 2070). The southwestern corner of the site, alongside Franklin St, has a 10% chance of flooding as of 2023 and into 2070.

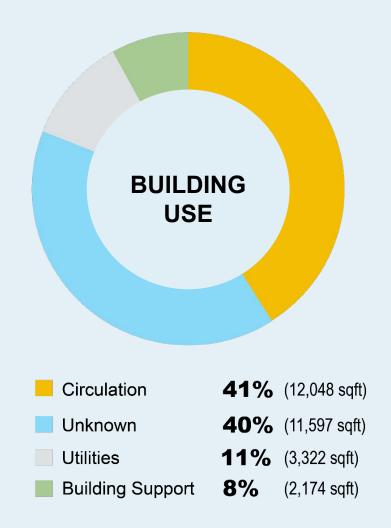
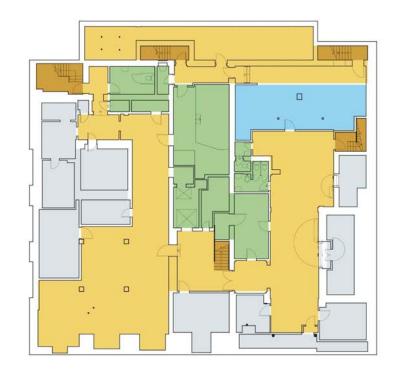
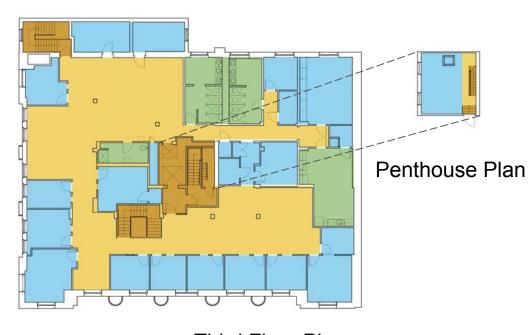
The existing building is 3-stories tall plus a basement. The first floor of the building is five risers above the sidewalk grade. There is a small wheelchair lift in the main vestibule that extends from sidewalk grade to the first floor level. An elevator provided further access to the basement and upper levels of the building.

The condition of the interior building systems and interior finishes in unknown, however, given the range of program updates envisioned for the city, a significant renovation is anticipated.

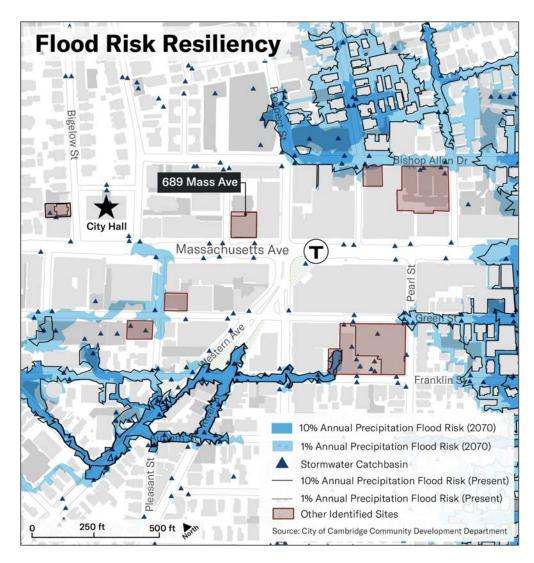
689 Massachusetts Ave is **not at risk of precipitation flooding** today or in the near future (2023 - 2070).

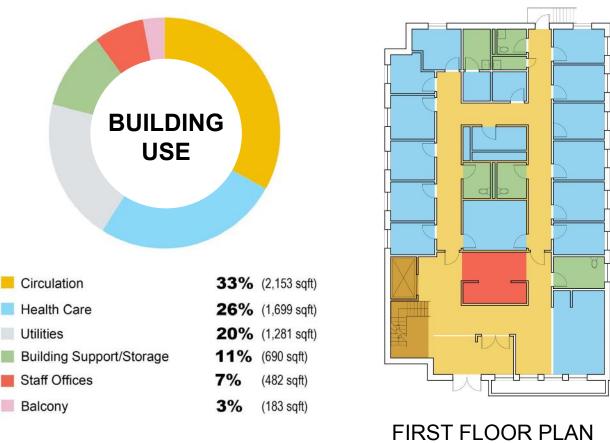
A 2022 Existing Condition Report found the building structure and facades to be in good condition. The single story CMU structure at the rear of the building is complementally covered with ivy on the west and north facades. The electrical, plumbing and fire protection services were reported "adequate" but the ventilation and distribution systems were beyond their useful life. The interiors were reported to be in very poor condition with evidence of water infiltration through the roofs and mechanical systems as a likely culprit. Full replacement of all roof systems down to the concrete deck (plus local deck repairs due to significant water infiltration and stagnant water in the roof insulation) were recommended. High content of hazardous mold was visually observed and tested throughout the space.

A full gut renovation was recommended due to the potential for additional hidden water damage behind finishes. All materials that support mold growth should be removed for the safety of future occupants.

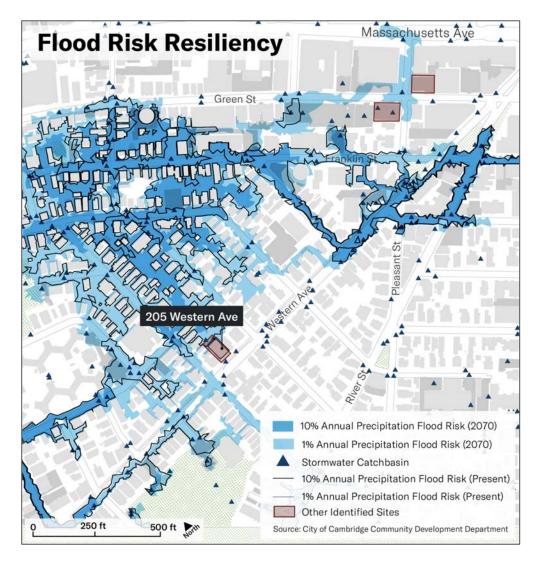
205 Western Ave may be at risk of precipitation flooding today and in the near future (2070). The northern side of the site has a 1% chance of flooding as of 2023. By 2070, the damage from a flood would increase.

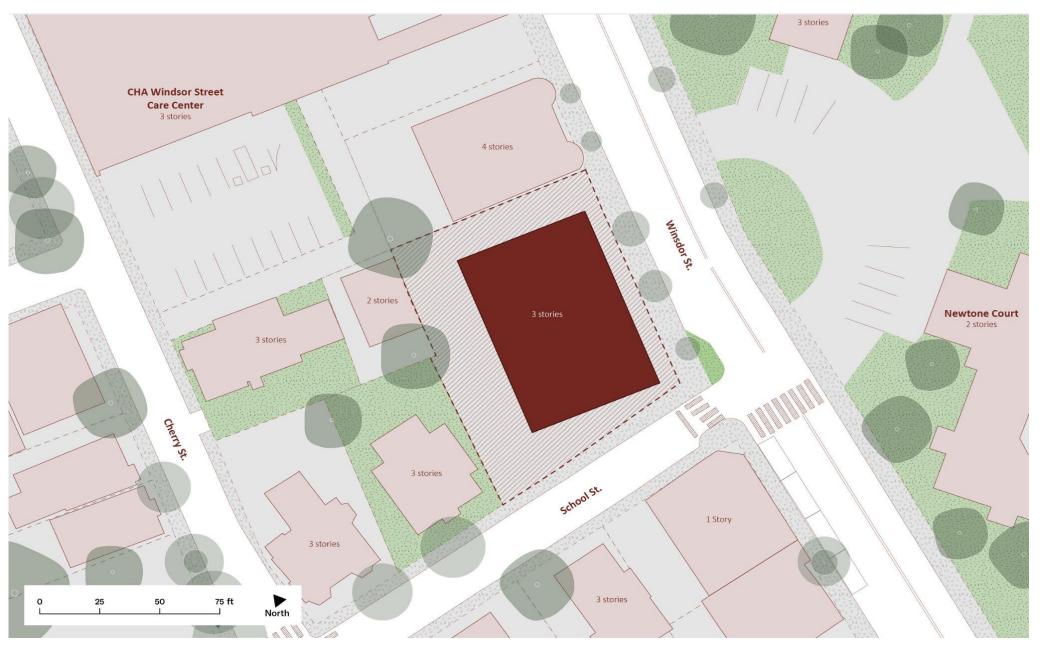
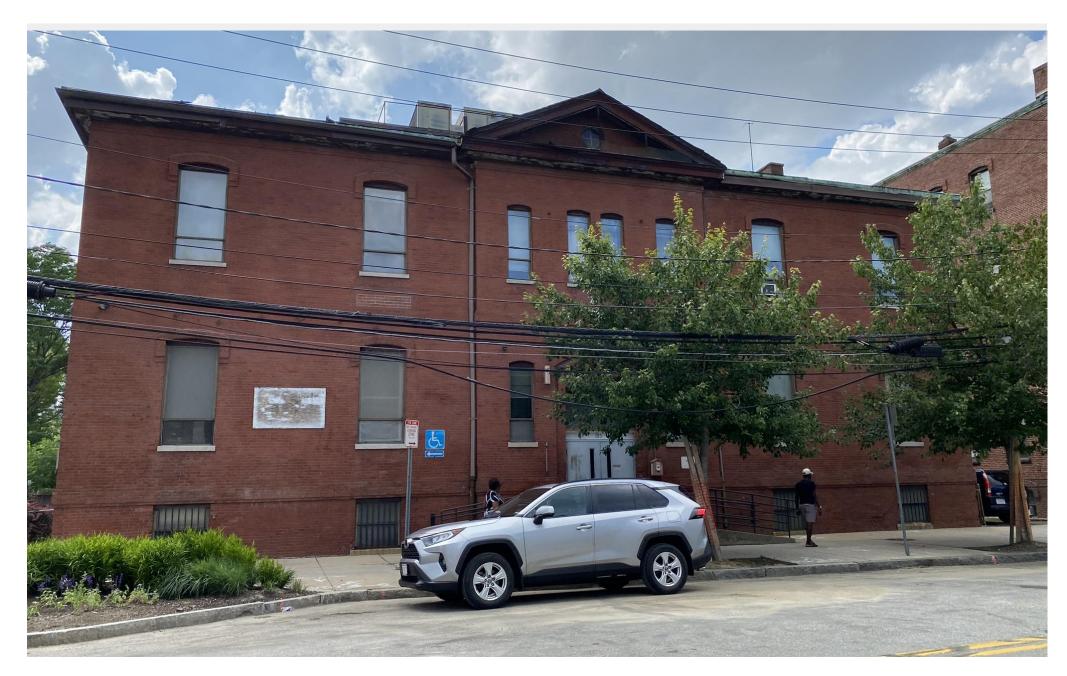
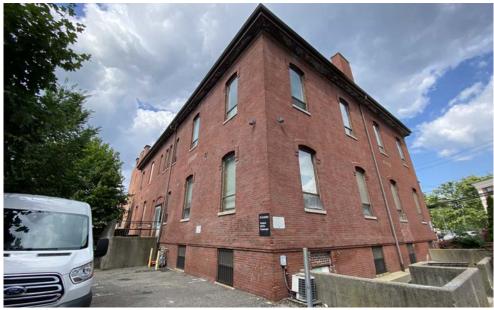
The brick façade is in fair to poor condition. There is significant brick spalling at the main entrance and much of the brick below the first floor windows has stripped or deteriorating mortar. There are diagonal cracks between first and second level windows along the south façade suggesting either freeze thaw issues or uneven settlement in the foundation.

The building has been unoccupied for over a decade (tbc...); it is assumed full building systems upgrades and life safety updates will be required for code compliance and occupancy. There are non-compliant exterior ramps at both the front (east) and rear (west) entrances of the building; the ramp is the rear is in very poor condition and should be replaced. There is no lift or elevator in the building today.

A 2017 Structural Report by (RBF) noted the building does not meet current seismic code requirements; upgrades to the structural system may be required at significant cost depending on the level of alteration planned for the structure.

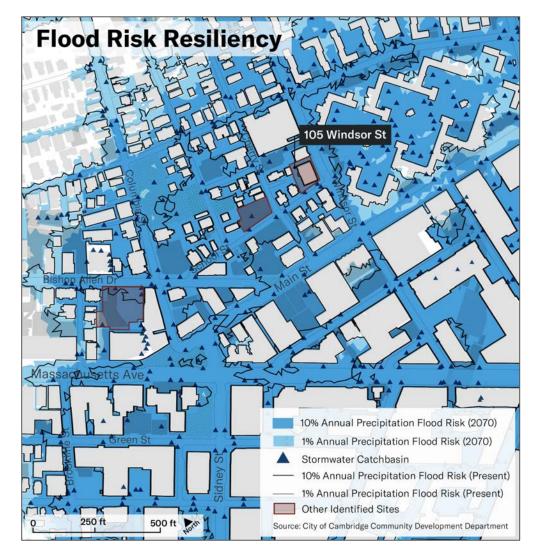
105 Windsor St **is at risk of precipitation flooding** today and in the near future (2023 - 2070). The site has a 10% chance of flooding as of 2023 and into 2070.

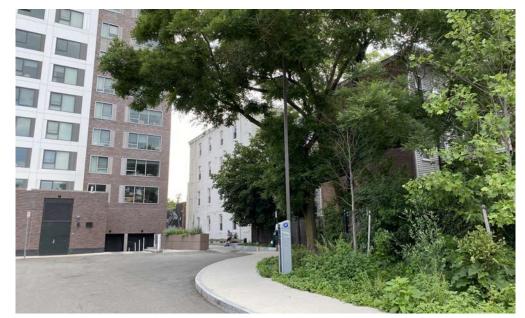
Parking Inventory

The majority of the 0.25 mile walkshed surrounding Lot 6 is dedicated to residential permit parking. The remaining on-street regulated parking is largely made up of 2-hour metered parking.

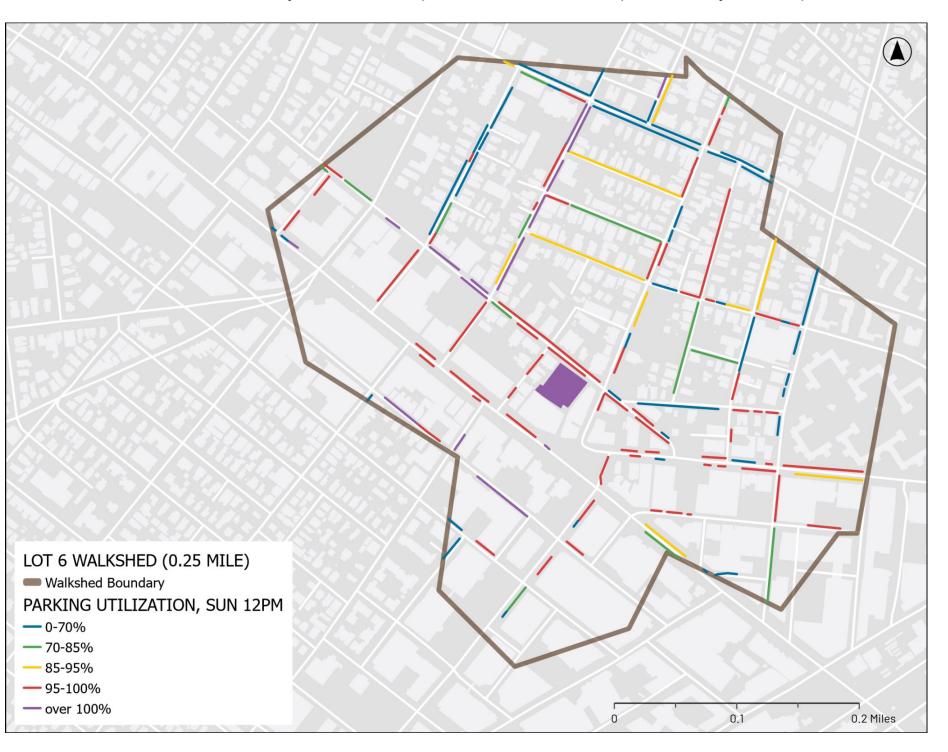
On-Street parking utilization was highest in the study area Sunday at 12:00pm. Lot 6 was over capacity during this time period, having 3 cars parked in the loading area. Lot 6 averaged 100% utilization and was fully or over occupied at all times except Saturday at 6:00pm.

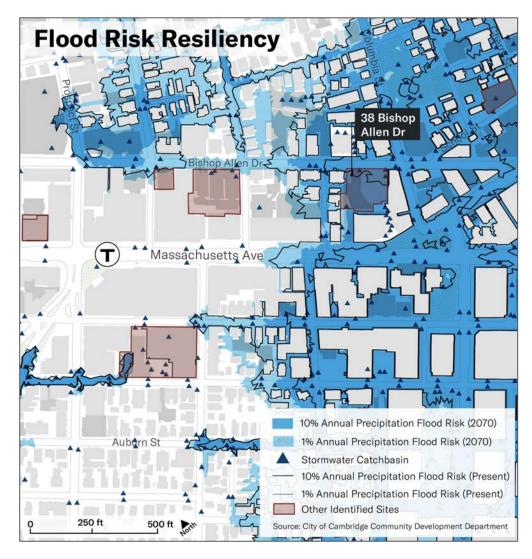
38 Bishop Allen Dr is at risk of precipitation flooding, today and in the near future (2023 - 2070). The site has a 10% chance of flooding.

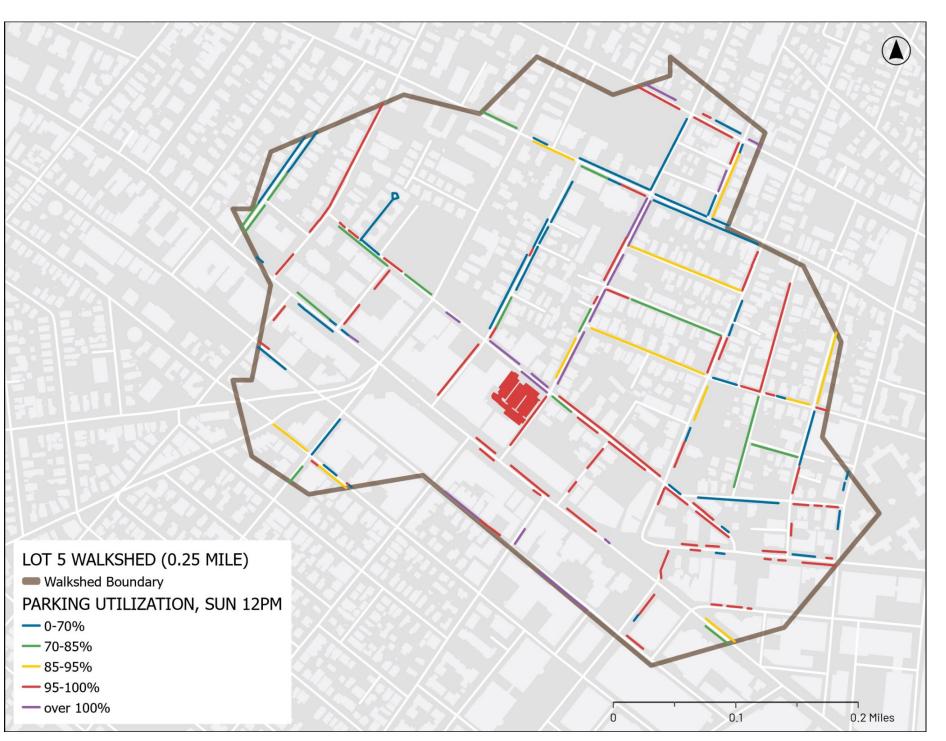
On-Street parking utilization was highest in the study area Sunday at 12:00pm. Lot 5 was nearly full during this time period. The lot was above 90% full at all time periods except for Thursday at 6:00pm.

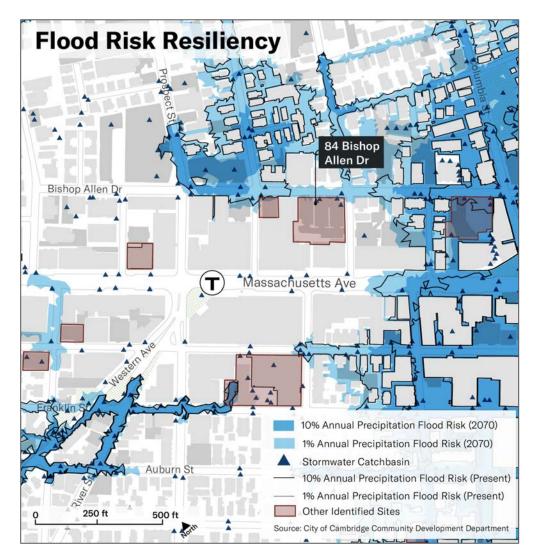
84 Bishop Allen Dr is at risk of precipitation flooding in the near future (2070). The northwestern side of the side, facing Bishop Allen Drive, has a 1% chance of flooding by 2070.

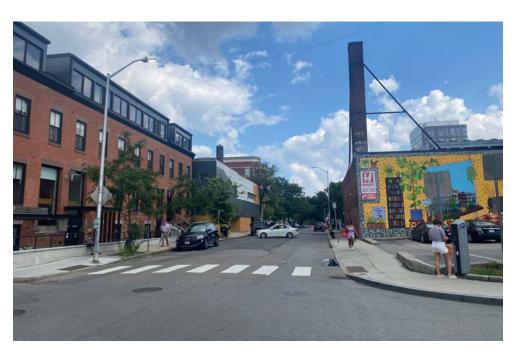
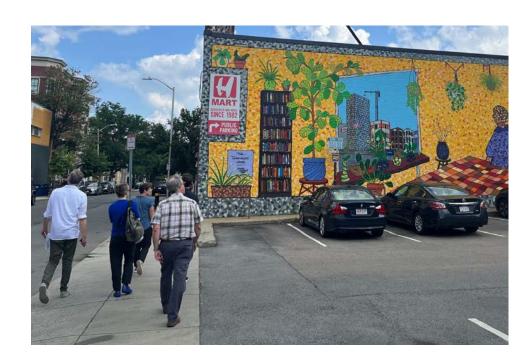
Parking Inventory

The majority of the 0.25 mile walkshed surrounding Lot 4 is dedicated to residential permit parking. The remaining on-street regulated parking is largely made up of 2-hour metered parking.

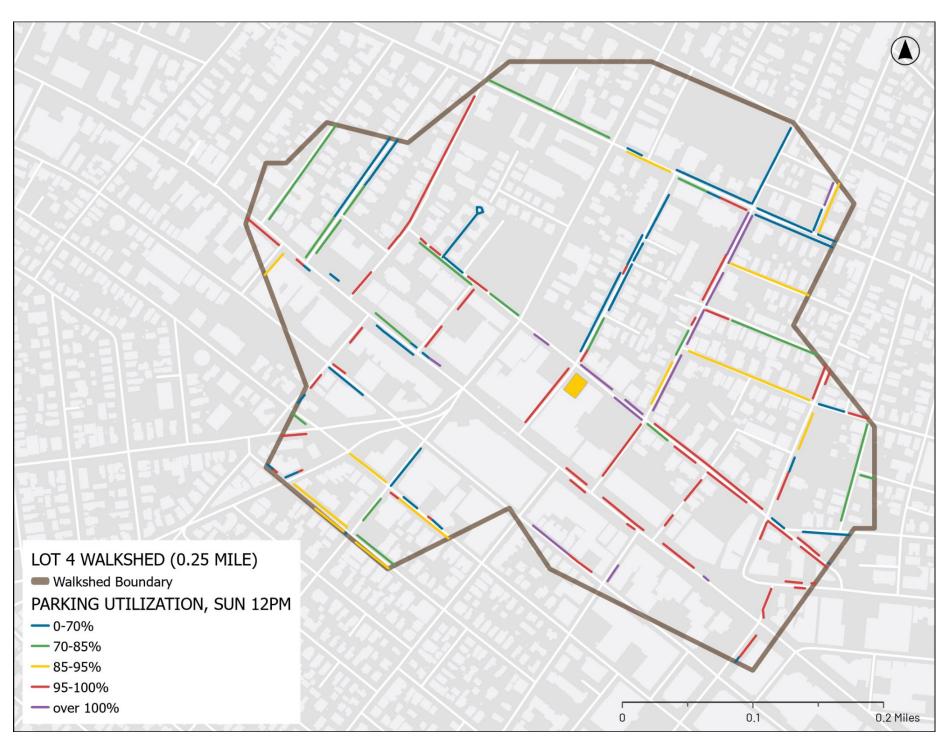
On-Street parking utilization was highest in the study area Sunday at 12:00pm. Occupancy of Lot 4 was slightly higher than the surrounding on-street parking during this time period. This is trend was consistent across other time periods as well.

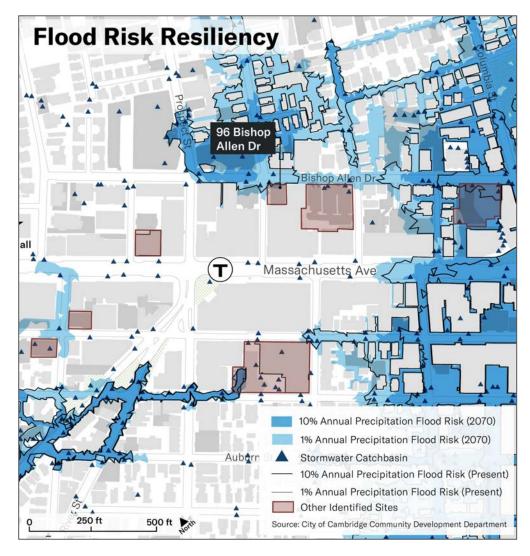
96 Bishop Allen Dr is at risk of precipitation flooding, today and in the near future (2023 - 2070). The northwestern side of the side, facing Bishop Allen Drive, has a 1% chance of flooding.

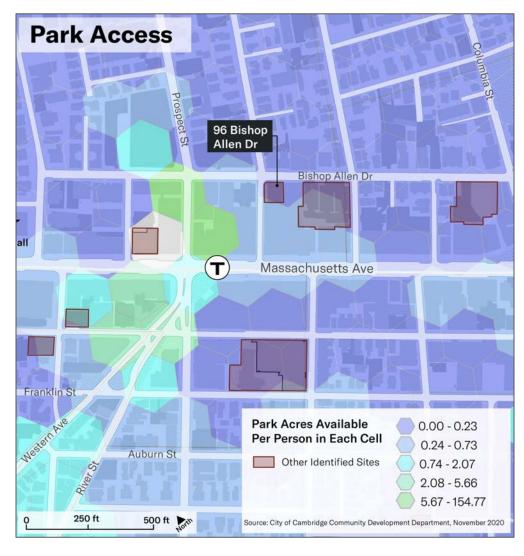
96 Bishop Allen Dr has low park access, ranging from 0 to 0.73 acres of park per person. Park access improves towards the west of the site.

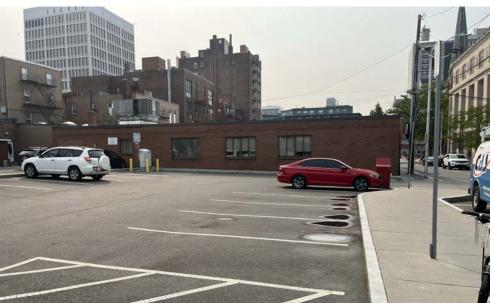
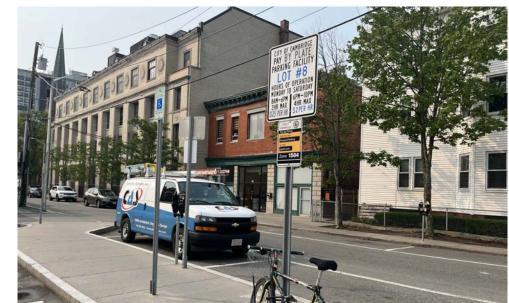
Parking Inventory

The majority of the 0.25 mile walkshed surrounding Lot 8 is dedicated to residential permit parking. The remaining on-street regulated parking is largely made up of 2-hour metered parking. There is also a substantial number of unregulated spaces in this area.

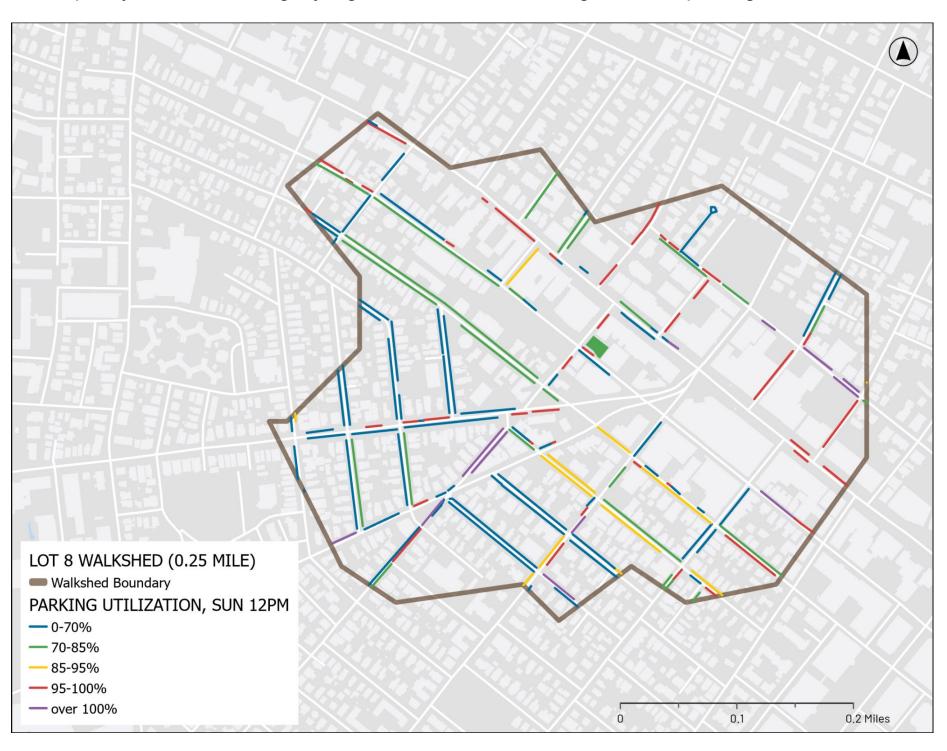
While On-Street parking utilization was highest in the broader study area Sunday at 12:00pm, utilization around Lot 8 was generally higher during weekday periods than weekend periods. Occupancy of Lot 8 was slightly higher than the surrounding on-street parking.

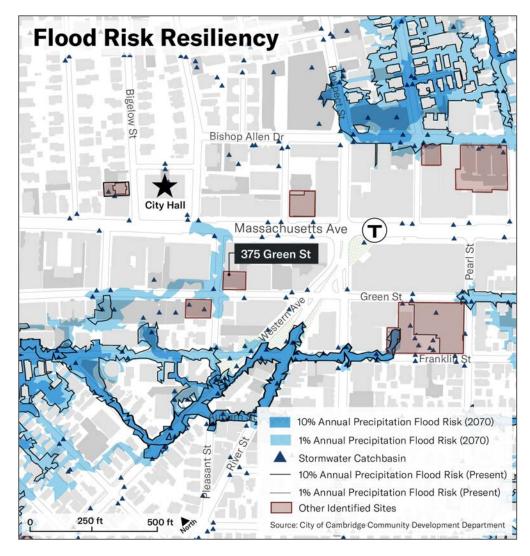
375 Green St may be at risk of precipitation flooding in the near future (2070). The northeastern side of the site, alongside Pleasant St, has a 1% chance of flooding by 2070.

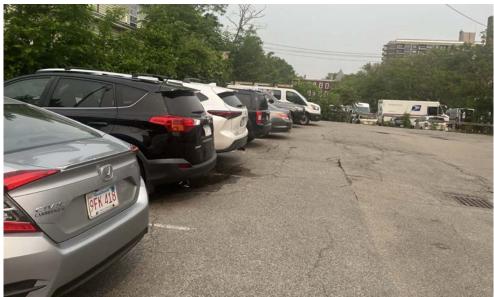
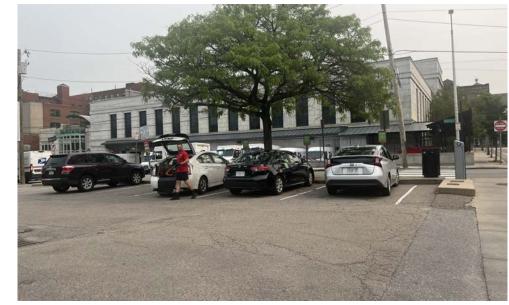
Parking Inventory

The majority of the 0.25 mile walkshed surrounding Lot 9 is dedicated to residential permit parking. The remaining on-street regulated parking is largely made up of 2-hour metered parking. There is also a substantial number of unregulated spaces in this area.

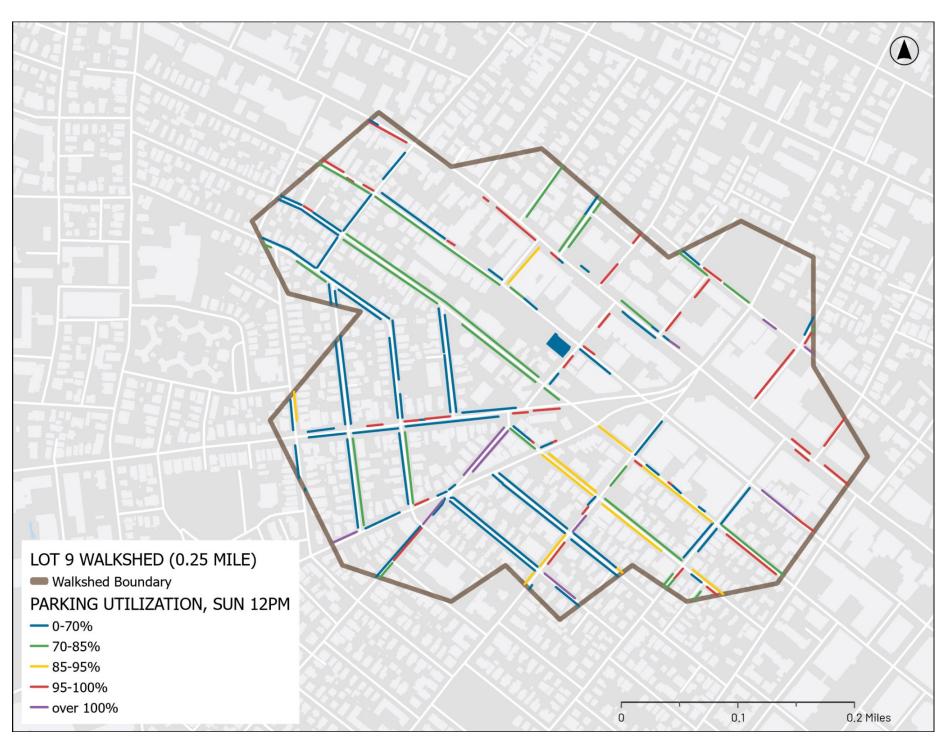
While On-Street parking utilization was highest in the broader study area Sunday at 12:00pm, utilization around Lot 9 was generally higher during weekday periods than weekend periods. Occupancy of Lot 9 was much lower on average than the surrounding on-street parking.

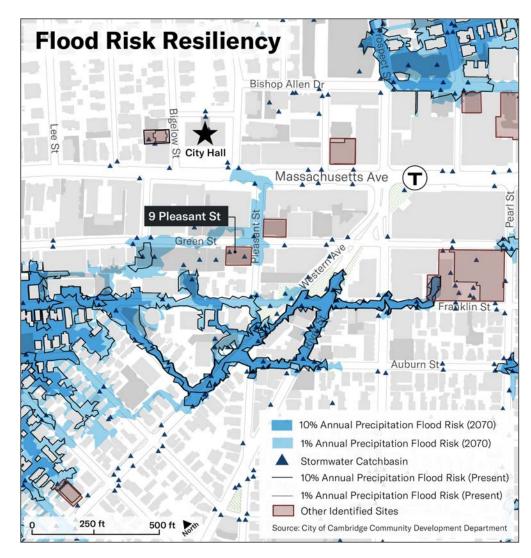
9 Pleasant St may be at risk of precipitation flooding in the near future (2070). The northern side of the site, alongside Pleasant St, has a 1% chance of flooding by 2070.

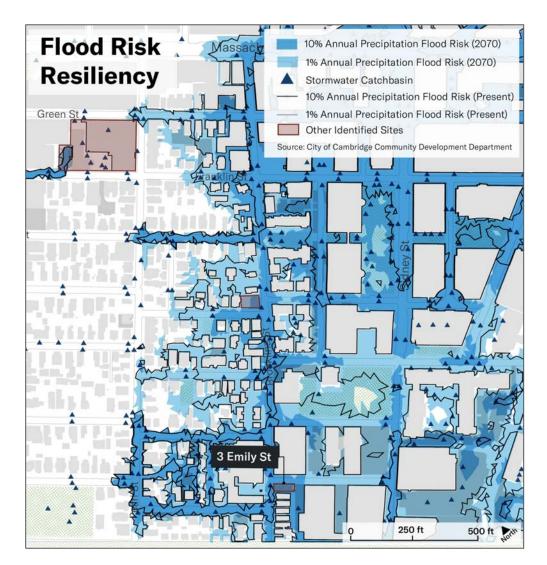
3 Emily St is at risk of precipitation flooding, today and in the near future (2023 - 2070). The northwestern side of the site, alongside Brookline St, has a 10% of flooding as of 2023. By 2070, the entire site has a 10% chance of flooding.

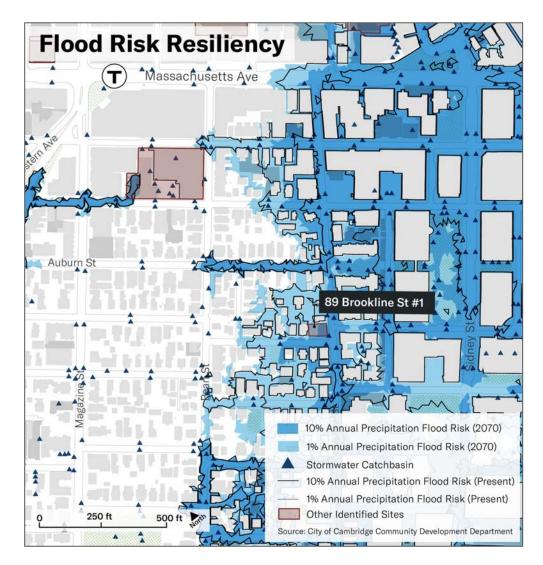
89 Brookline St #1 is at risk of precipitation flooding, today and in the near future (2023 - 2070). The site has a 1% chance of flooding as of 2023, which grows to 10% by 2070.

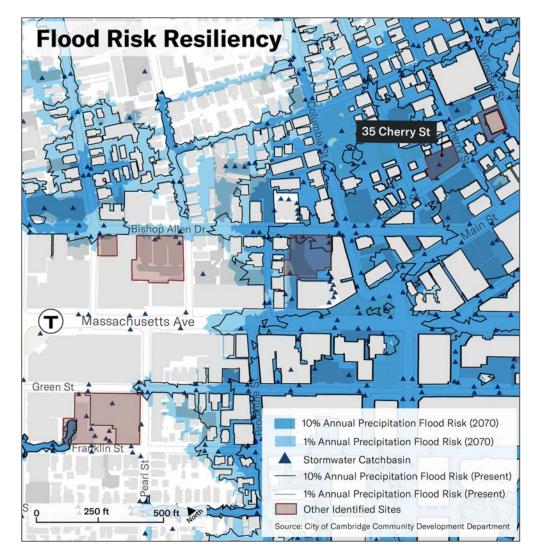
35 Cherry St is at risk of precipitation flooding, today and in the near future (2023 - 2070). The site has a 10% chance of flooding as of 2023 and into 2070.

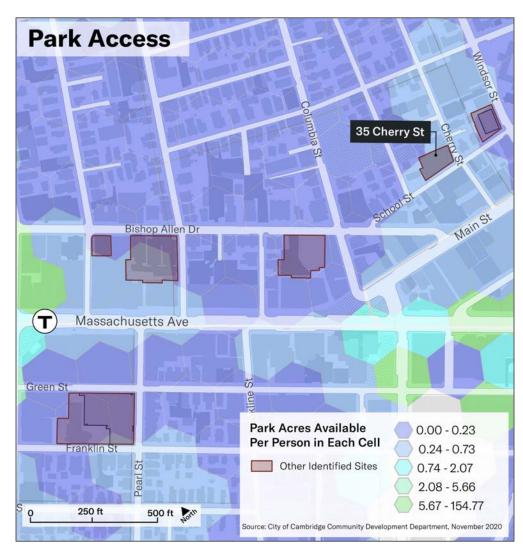
35 Cherry St **has low park access**, ranging from 0.24to 0.73 acres of park per person. Park access improves significantly towards the South of the site.
