Appendix C

Report on Historic Rainfall Events

Climate Change Vulnerability Assessment

City of Cambridge, Massachusetts

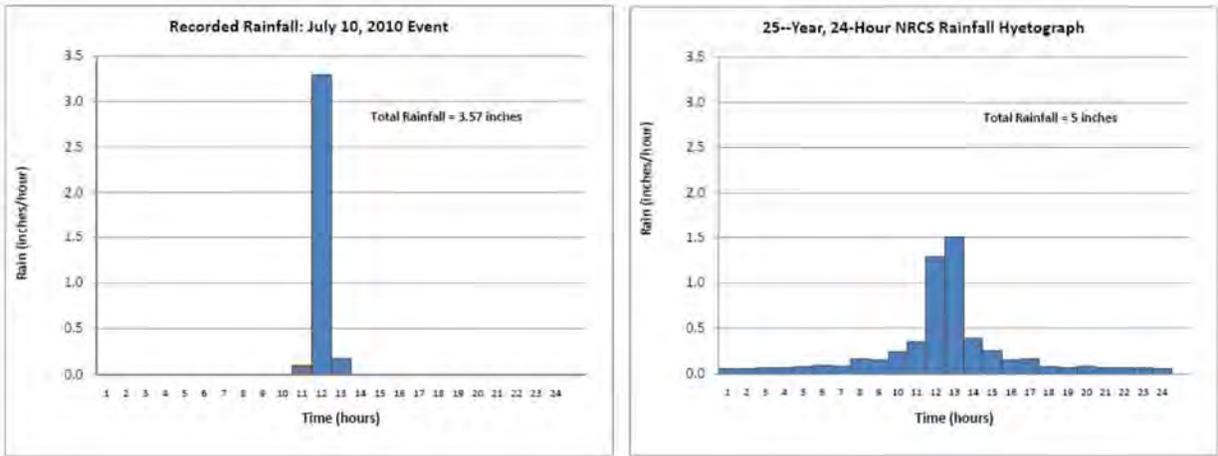
Figure 1: Comparison of the July 10, 2010 storm rainfall and Cambridge's 25-Year, 24-Hour design storm (Source: City of Cambridge²)

The short-duration high-intensity “cloud burst” event of July 10, 2010 caused significant flooding in Cambridge, considered to be one of the most severe floods in recent memory. It is specifically documented here to illustrate how such a storm could impact Cambridge. The flood was caused by an extremely intense storm event that dropped 3.58 inches of rain on Cambridge in only an hour, according to City records.¹ A rainfall event of that intensity has historically only happened on average every 100 to 200 years. That means the historic likelihood of such an event occurring in any given year is between one and one-half of a percent. Figure 1 compares the amount of rainfall distributed over time for this event with that of the City’s 25-year (4% annual chance) 24 hour design storm.

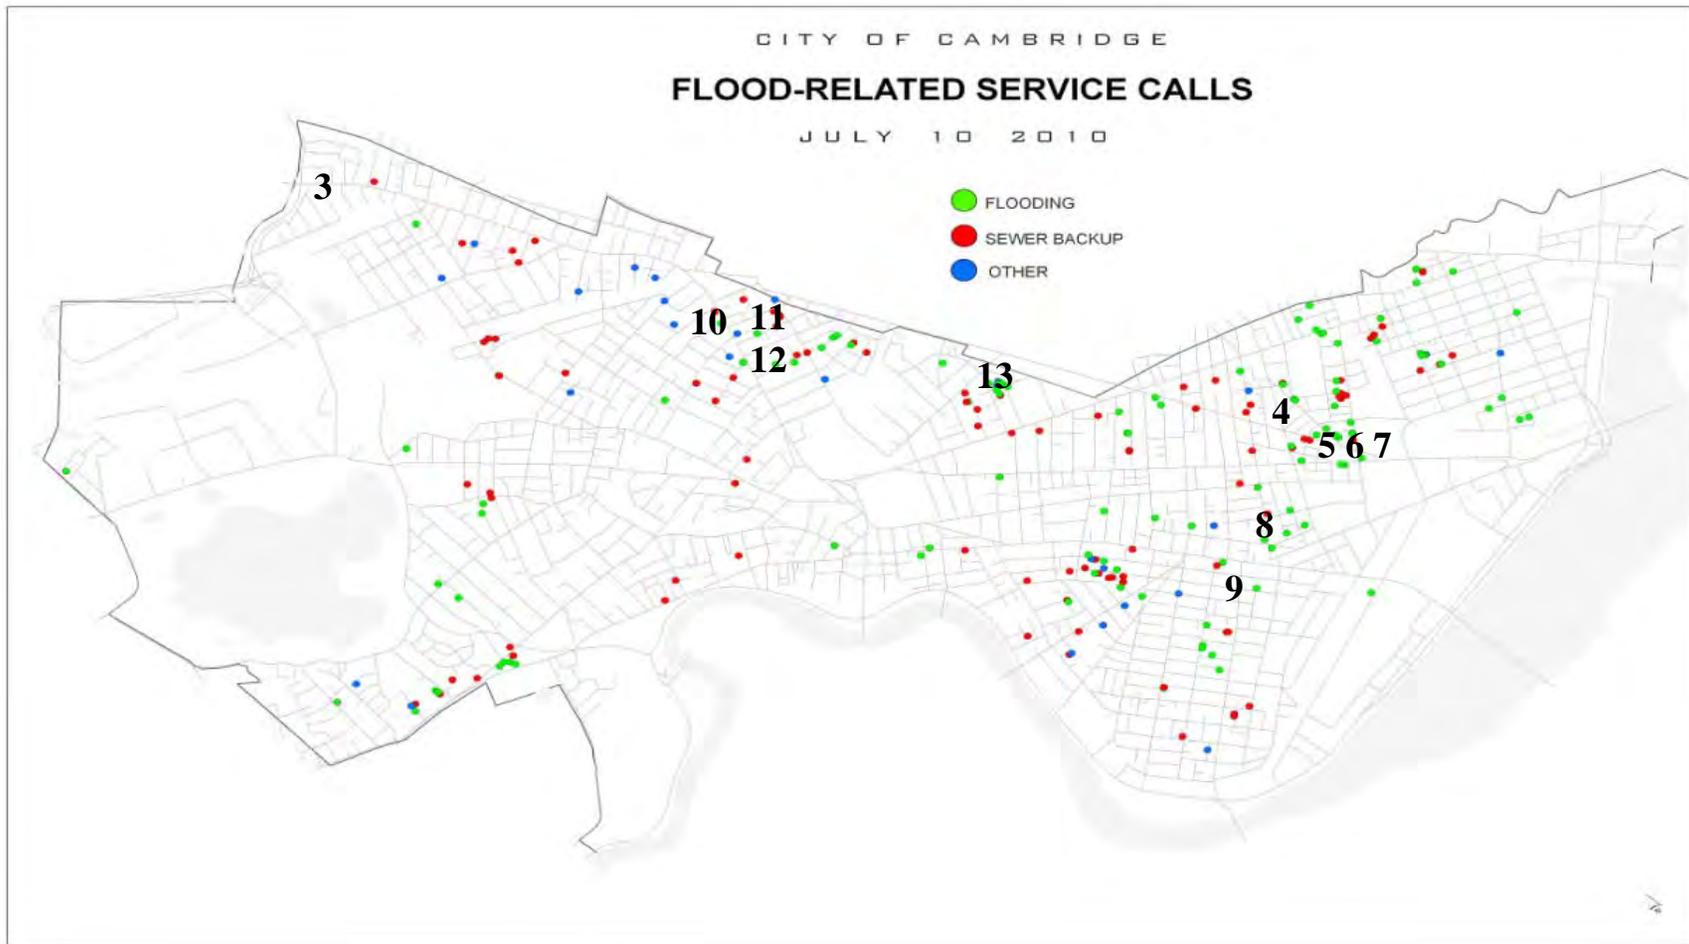
Figure 2: Flood-related service calls July 10, 2010 (Source: City of Cambridge)⁵

⁵ Memo on the July 10, 2010 Flooding from Public Works Commissioner and City Engineer to City Manager dated 09/08/2010. This map serves as a key for the smaller scale maps and images that follow.

Figure 2 shows the locations from which telephone and email reports of surface flooding, back-ups, and other impacts were sent to the City’s Department of Public Works (DPW) in the aftermath

of the July 2010 storm. Reports of flooding came from all 13 Cambridge neighborhoods. However, very few reports (one report of surface flooding each) were made from Area 2/MIT and Cambridge Highlands. Of the 243 calls and emails received by the DPW, approximately 40% reported sewer backups, 38% reported overland flooding, and 22% reported flooding impacts without identifying a specific cause.⁴

In the maps and photographs that follow (Figures 3 - 13), further evidence is provided supporting the geographic distribution of flooding impacts captured in Figure 2. In addition, a cross-comparison revealed that the record of where surface flooding and backups were reported during the July 2010 flood closely matched the locations identified in the City's 2008 Annex to the Metro-Boston Multi-Hazard Mitigation Plan as having been impacted by previous floods.

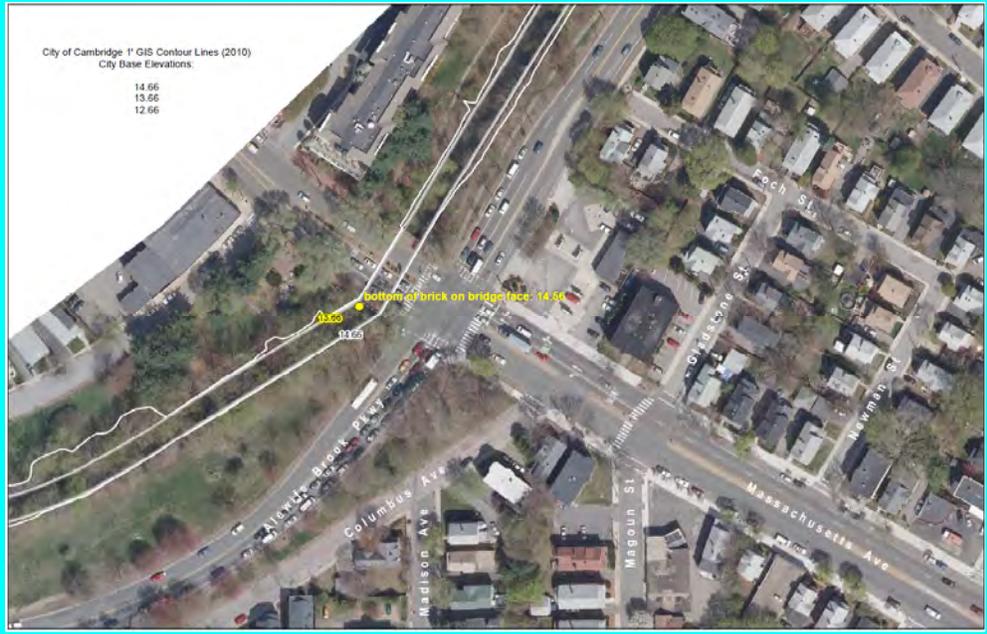
Figure 3: High water elevation from July 10, 2010 flood at Massachusetts Ave and Alewife Brook Pkwy (Source: City of Cambridge)⁶

⁶ Map provided by Owen O'Riordan, City Engineer, on October 24, 2013. Yellow highlights indicate that the area within the highlighted elevation contour would have been flooded, based on elevations of recorded high water marks.

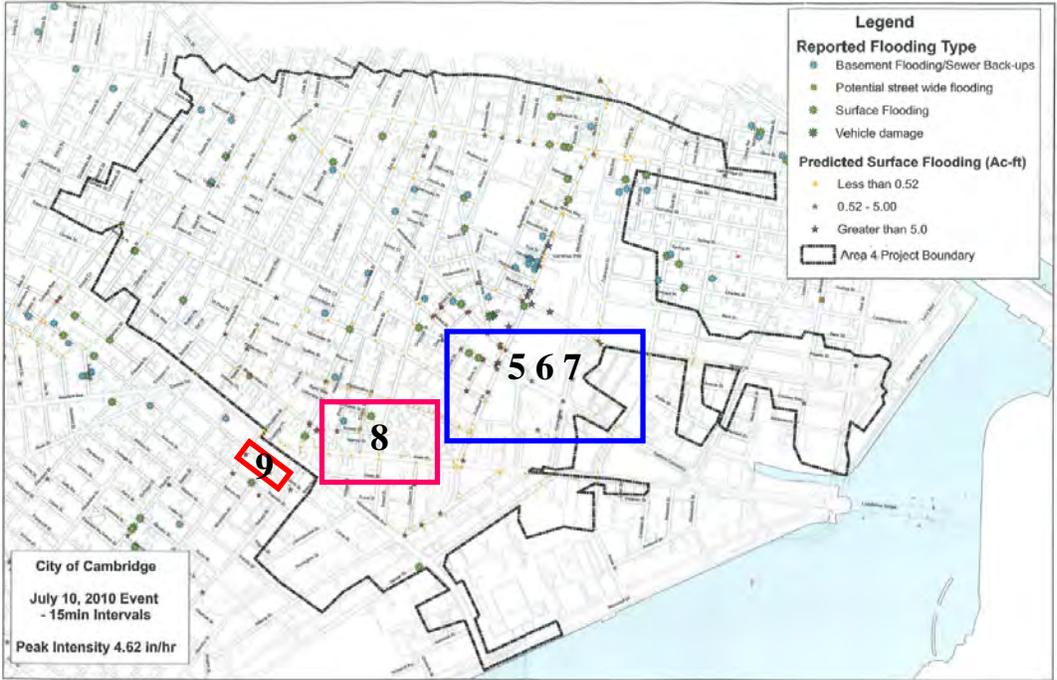
Figure 4: Map of reported flooding locations and predicted surface flooding depths based on modeling in Area 4 (Source: MWH⁷)

⁷ Memo to Cambridge Department of Public Works, from MWH regarding “Review Impact of CSO Regulator Modifications (Charles River)”, dated October 11, 2010

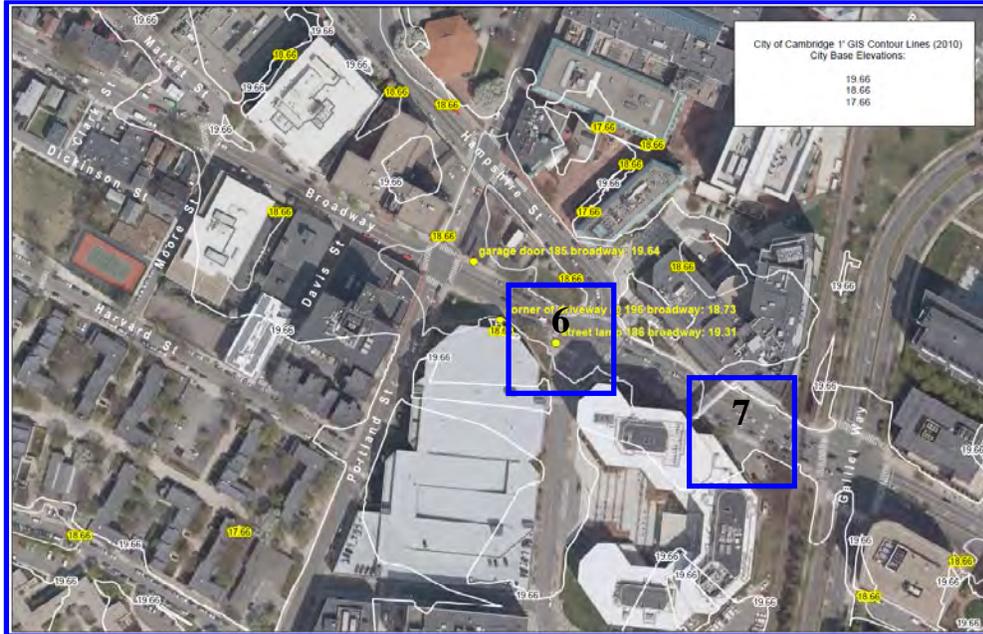
Figure 5: High water elevation from July 10, 2010 flood on Broadway (Source: City of Cambridge)⁸

⁸ Map provided by Owen O’Riordan, City Engineer, on October 24, 2013. Yellow highlights indicate that the area within the highlighted elevation contour would have been flooded, based on elevations of recorded high water marks.

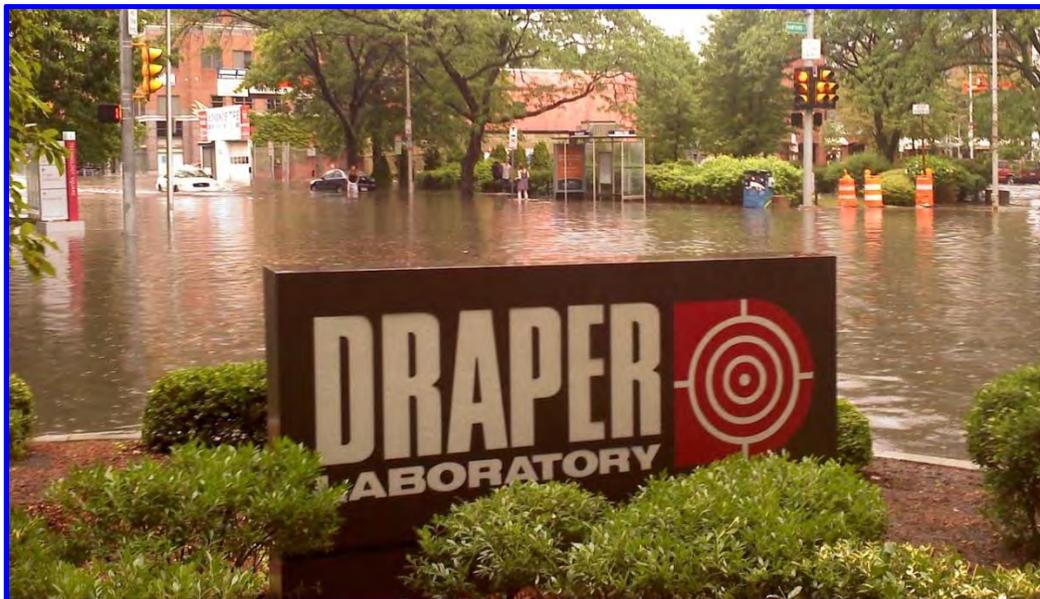
Figure 6: Surface flooding at Broadway and Hampshire St on July 10, 2010 (Source: City of Cambridge)⁹

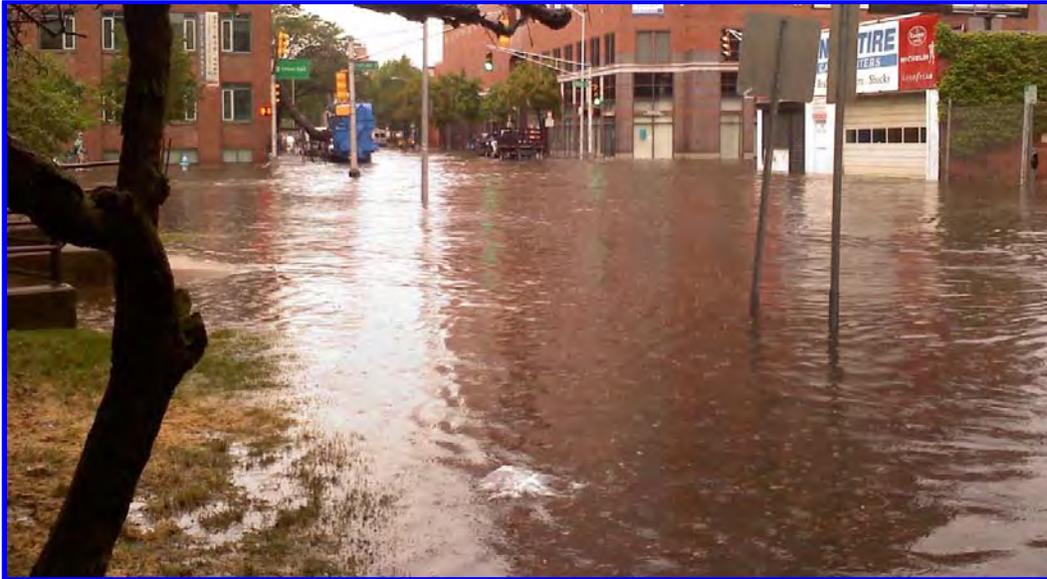
Figure 7: Surface flooding at Broadway and Portland St on July 10, 2010 (source: City of Cambridge)¹⁰

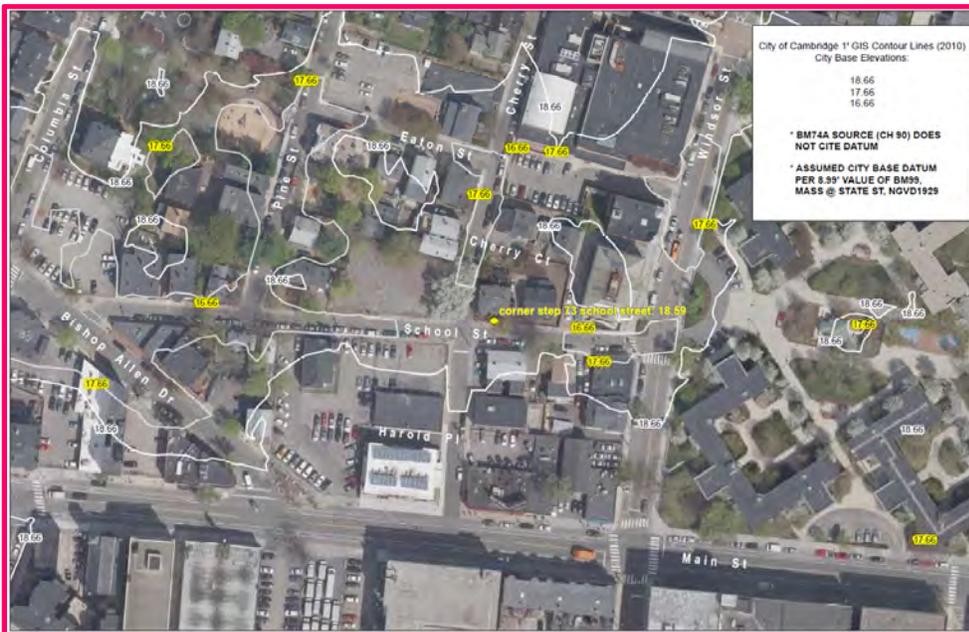
Figure 8: High water elevation from July 10, 2010 flood on School St (Source: City of Cambridge)¹¹

¹¹ Map provided by Owen O'Riordan, City Engineer, on October 24, 2013. Yellow highlights indicate that the area within the highlighted elevation contour would have been flooded, based on elevations of recorded high water marks.

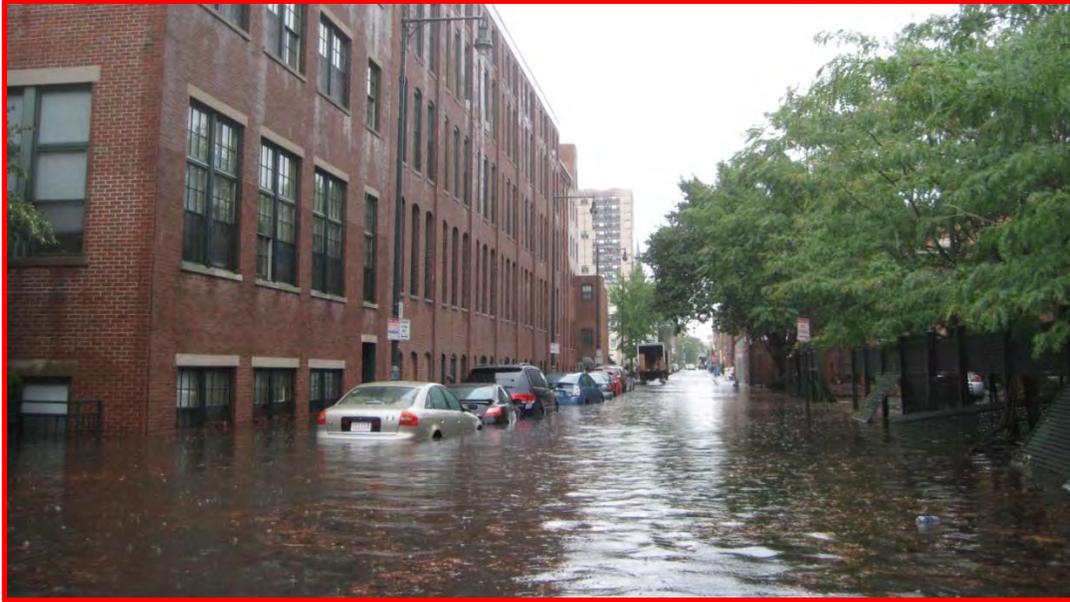
Figure 9: Surface flooding on Green St on July 10, 2010 (Source: Gilad Lotan¹²)

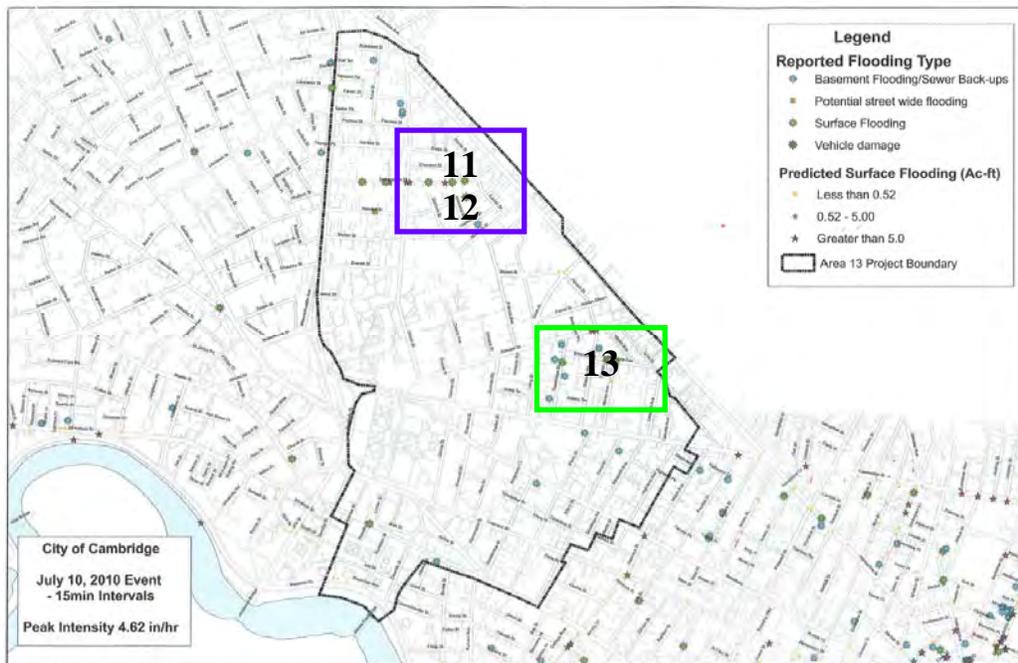
Figure 10: Map of reported flooding locations and predicted surface flooding depths based on modeling in Area 4 (Source: MWH¹³)

¹³ Memo to Cambridge Department of Public Works, from MWH regarding "Review Impact of CSO Regulator Modifications (Charles River)", dated October 11, 2010

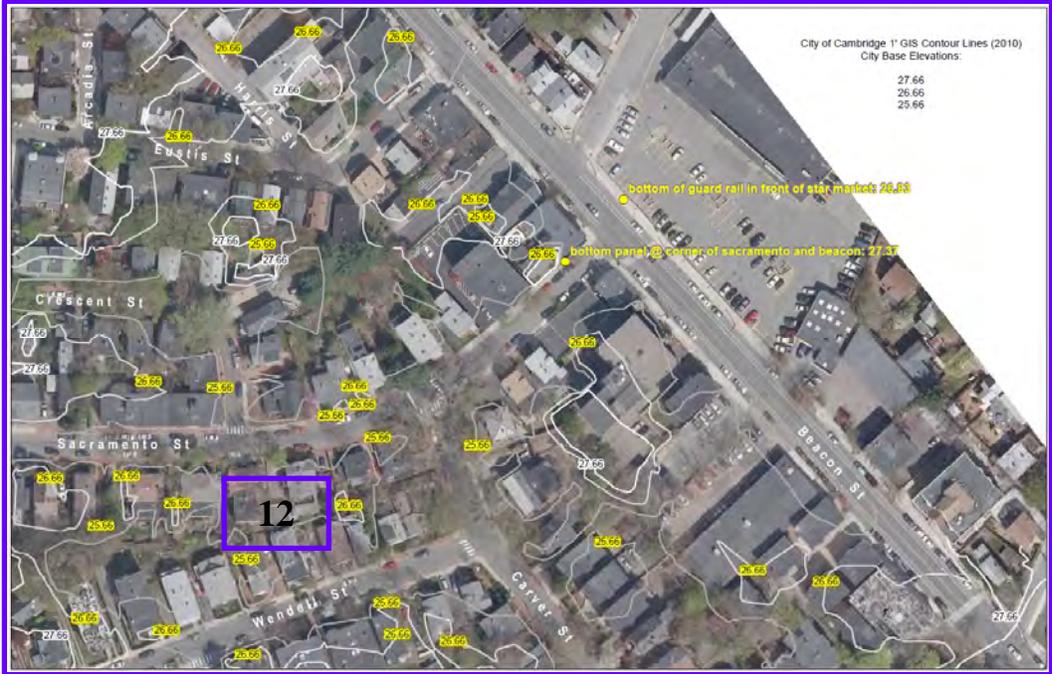
Figure 11: High Water Elevation from July 10, 2010 Flood on Sacramento St and Beacon St
(Source: City of Cambridge)¹⁴

¹⁴ Map provided by Owen O’Riordan, City Engineer, on October 24, 2013. Yellow highlights indicate that the area within the highlighted elevation contour would have been flooded, based on elevations of recorded high water marks.

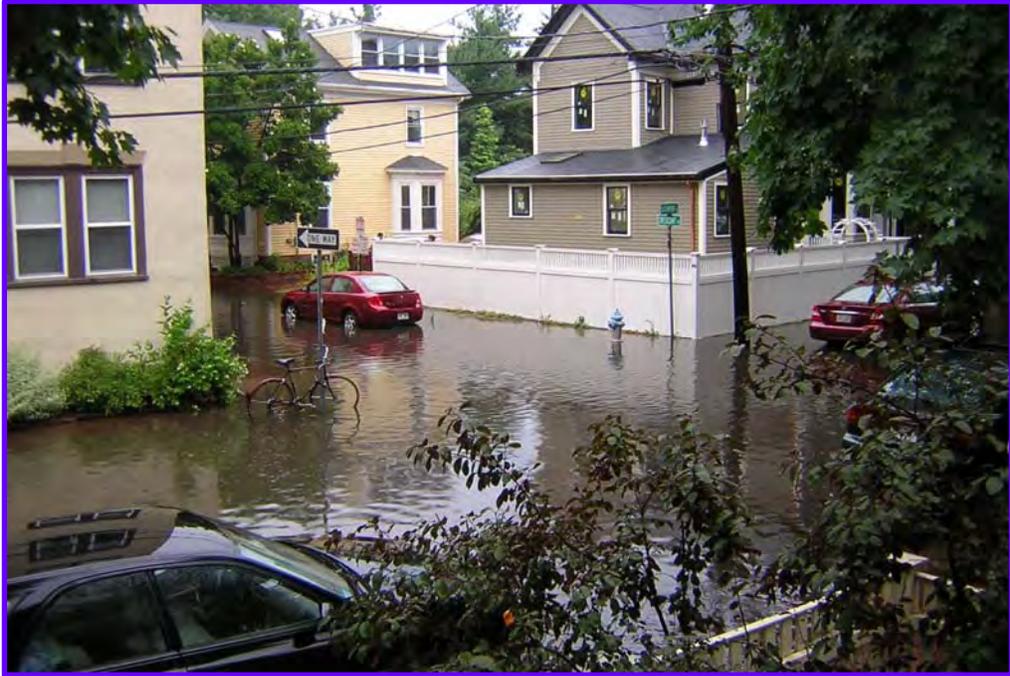
Figure 12: Surface Flooding at the Intersection of Sacramento St and Crescent St on July 10, 2010
(source: City of Cambridge)¹⁵

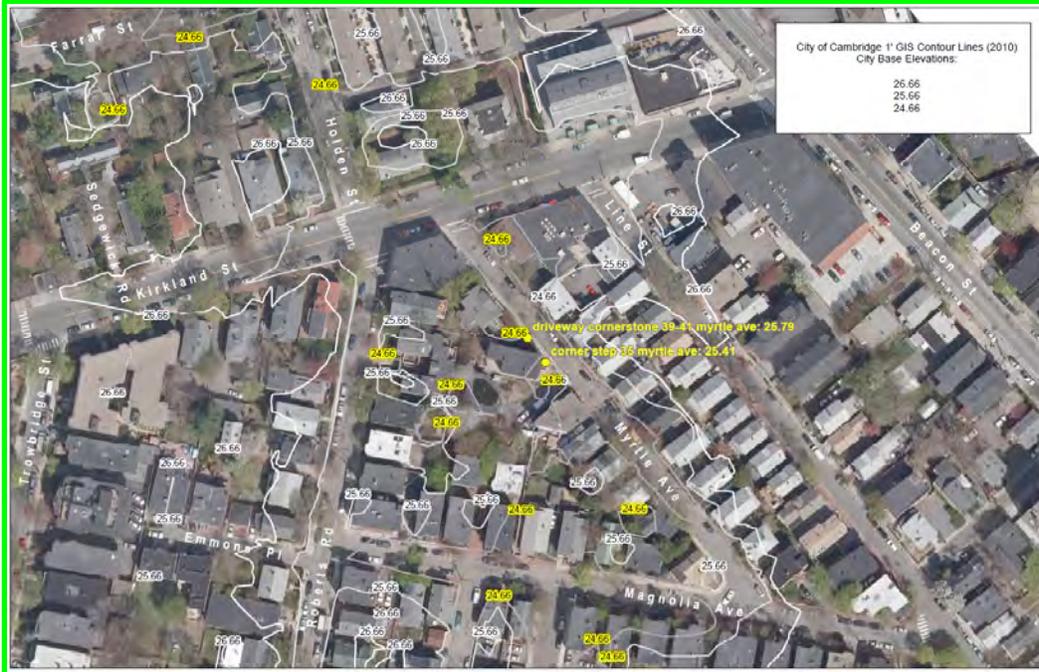
Figure 13: High water elevation from July 10, 2010 flood on Myrtle Ave (Source: City of Cambridge)¹⁶

¹⁶ Map provided by Owen O'Riordan, City Engineer, on October 24, 2013. Yellow highlights indicate that the area within the highlighted elevation contour would have been flooded, based on elevations of recorded high water marks.
