ROAD SAFETY AUDIT

Cambridge Street at Windsor Street
Cambridge Street at Willow Street
Cambridge Street at Hunting Street
Cambridge Street at Harding Street

City of Cambridge

September 2020

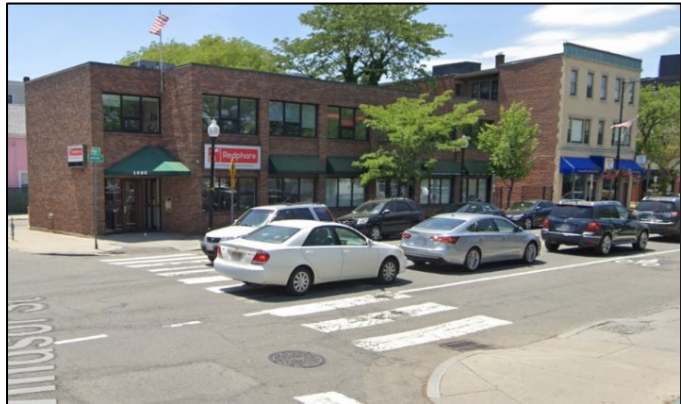
From 2010 to 2019, ten bicycle or pedestrian crashes were reported involving southbound vehicles at the intersection of Cambridge Street at Windsor Street, of which four crashes involved southbound vehicles and eastbound cyclists. In addition, five vehicle-only crashes were reported involving southbound and eastbound-traveling vehicles from 2016-2018. Audit team members noted that these crashes involving southbound vehicles may be partly due to drivers looking for gaps in vehicle traffic, becoming impatient, and attempting to take gaps in traffic when there are no adequate gaps available. Eastbound vehicles may also stop for southbound vehicles to cross the intersection and block the view of eastbound bicyclists who do not stop. Also, until recently, eastbound parking was available right up to the crosswalk, which could have affected drivers' ability to observe bicycles in the bike lane and pedestrians on the sidewalk until they were entering the intersection. Additionally, westbound traffic queues from the intersection of Cambridge Street at Columbia Street (located approximately 250 feet west of this intersection) were observed to be blocking the view of eastbound traffic for drivers exiting Windsor Street.

Image 1: Westbound traffic queue on Cambridge Street blocks view of eastbound traffic for drivers exiting Windsor Street.

- Consider conducting a signal warrant analysis under existing conditions and future conditions with new developments in place and, if warranted, signalizing the intersection.

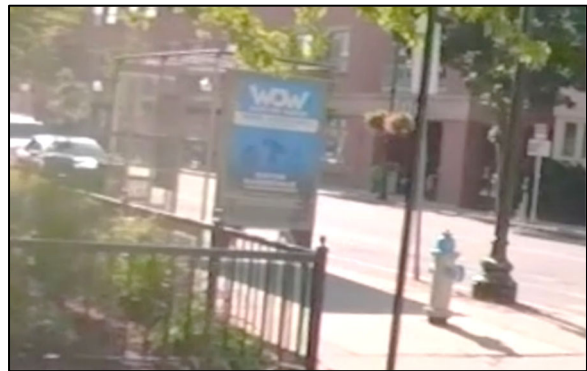
Audit team members noted that the MBTA bus stop on the northeast corner of the intersection may cause a sight distance issue for southbound-traveling vehicles. This may have contributed to the crash that occurred involving a southbound vehicle and a westbound-traveling bicyclist.

Image 2: MBTA bus stop on northeast corner of intersection may be a potential sight distance issue.

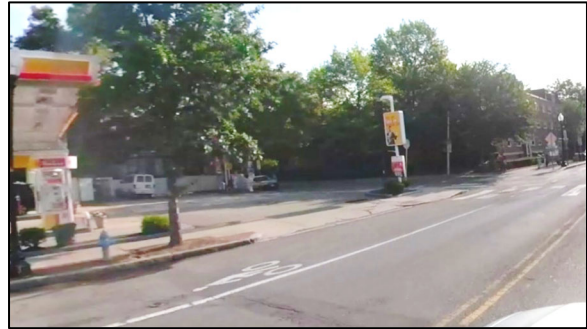
Audit team members noted that pavement markings, including bicycle pavement markings (especially green conflict markings) and crosswalks at the intersection were faded. It was noted that there are no green bicycle conflict markings at the gas station driveways adjacent the intersection of Cambridge Street at Windsor Street, where four crashes were reported between 2010 and 2019. In addition, 10 bicycle crashes and 7 pedestrian crashes were reported at the intersection of Cambridge Street at Windsor Street from 2010-2019, so the area may benefit from refreshed pavement markings to indicate conflict points to motorists.

Image 3: East gas station driveway (also west driveway) does not have bicycle markings at conflict point.

Consider adding green bicycle conflict markings at entrance/exit points for the gas station to increase bicycle visibility.	Medium	Short-Term	Low	City of Cambridge
	Refresh green bicycle conflict markings at Windsor Street intersection.	Medium	Short-Term	Low	City of Cambridge
	Refresh crosswalks with high visibility markings.	Medium	Short-Term	Low	City of Cambridge
Drainage	Evaluate drainage and pavement conditions at the intersection. Ensure catch basins are well-maintained and move drainage infrastructure locations if necessary.	Medium	Short-Term	Medium	City of Cambridge

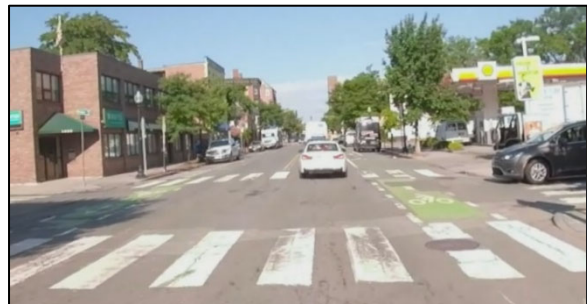
Image 4: Faded pavement markings can be observed, especially green bicycle pavement markings.

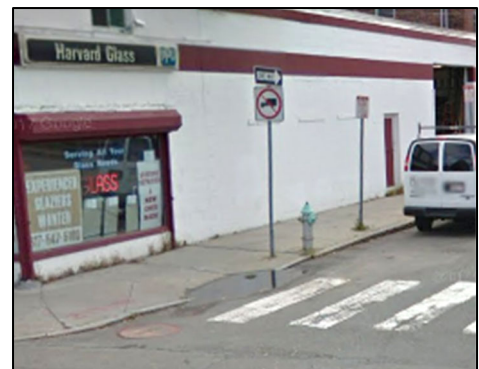
Audit team members noted water pooling at the pedestrian crossings. This may obstruct pedestrian crossings, causing pedestrians to cross out of the crosswalk.

Image 5: Water pools at a pedestrian ramp on the southeast corner of the Windsor Street intersection.

- Evaluate drainage and pavement conditions at the intersection. Ensure catch basins are well-maintained and move drainage infrastructure locations if necessary.

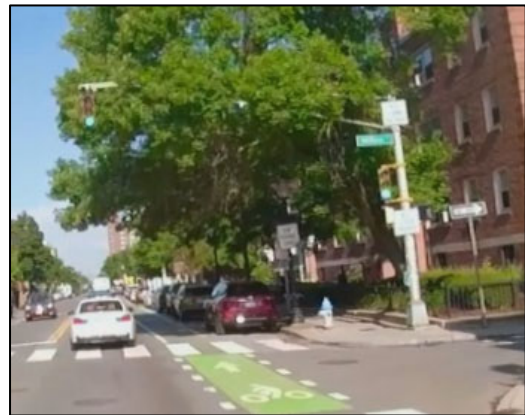
One three-car rear-end occurred in the westbound direction at the intersection of Cambridge Street at Willow Street. In addition, a pedestrian crash was reported at the east leg crosswalk. Audit team members noted that overgrown foliage makes it difficult for motorists to see the westbound signal head, especially when the signal is green. It was also noted that the signal heads are not up to standard and are missing backplates. Audit team members also noted that the post-mounted signal heads on both Cambridge Street approaches are difficult to see.

Image 6: Westbound signal head is difficult to see due to overgrown foliage, lack of backplates, and signal head size.

- Trim vegetation, specifically on the westbound approach, to improve signal head visibility.
- Install 12-inch signal heads and backplates to increase signal head visibility and comply with current standards.
- Consider adding additional mast-arm signal heads to reduce driver confusion and increase signal head visibility.

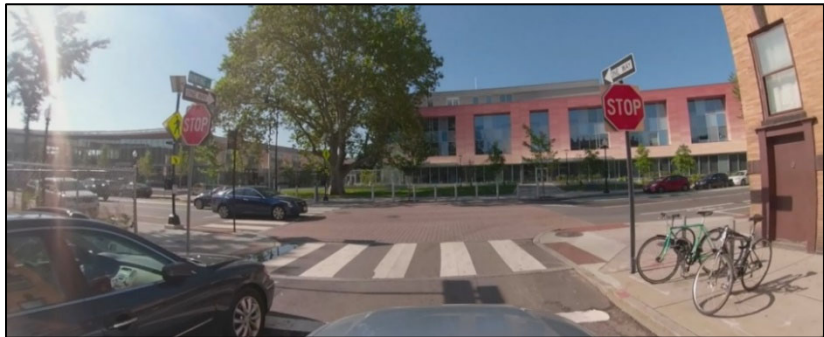
Audit team members noted that the Hunting Street southbound approach has limited sight distance looking right due to a building on the northwest corner of the intersection (871 Cambridge Street). No sight distance obstruction is present looking to the left because a building recently burned down on the northeast corner of the intersection (851 Cambridge Street). Depending on setbacks, sight distance may become obstructed once the site is redeveloped. Obstructed sight lines have the potential to introduce angle crashes at this intersection among vehicles and non-motorists alike. Given that a traffic signal was present at this location for the periods of crash data available, it is unclear whether a lack of adequate sight distance may contribute to crashes in the future.

Image 7: The Hunting Street southbound approach has limited sight distance looking right due to a building on the northwest corner of the intersection.

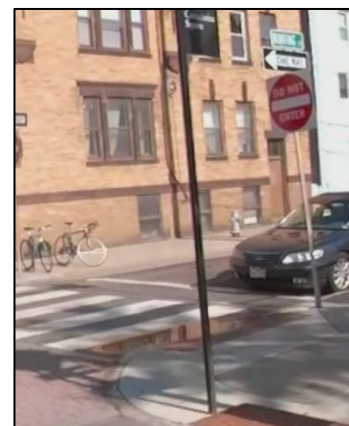
Audit team members observed drainage issues on the crosswalk across Hunting Street. This may interfere with pedestrian crossings, potentially resulting in pedestrians crossing outside of the crosswalk.

Image 8: Water pools on the crosswalk across Hunting Street.

- Evaluate drainage and grading at the intersection. Ensure catch basins are well maintained and move drainage infrastructure locations if necessary.

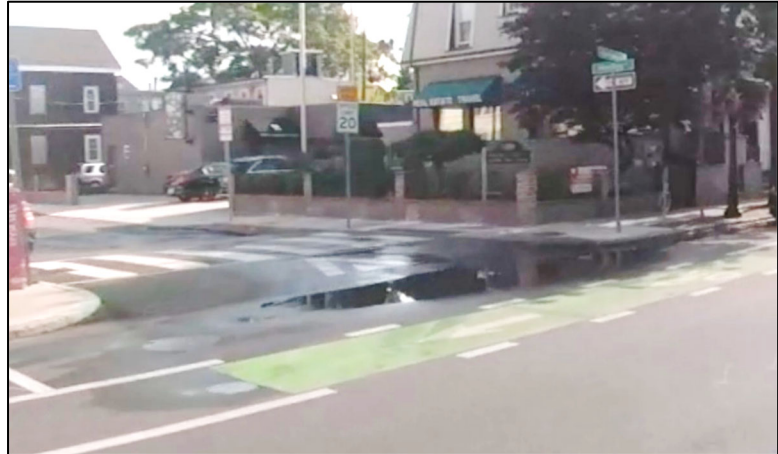
Audit team members observed drainage issues at the raised side street crossing across Harding Street. This may interfere with pedestrian crossings, potentially resulting in pedestrians crossing outside of the crosswalk.

Image 9: Water pools at the raised side street crossing across Harding Street.

- Evaluate drainage and grading at the intersection. Ensure catch basins are well maintained and move drainage infrastructure locations if necessary.

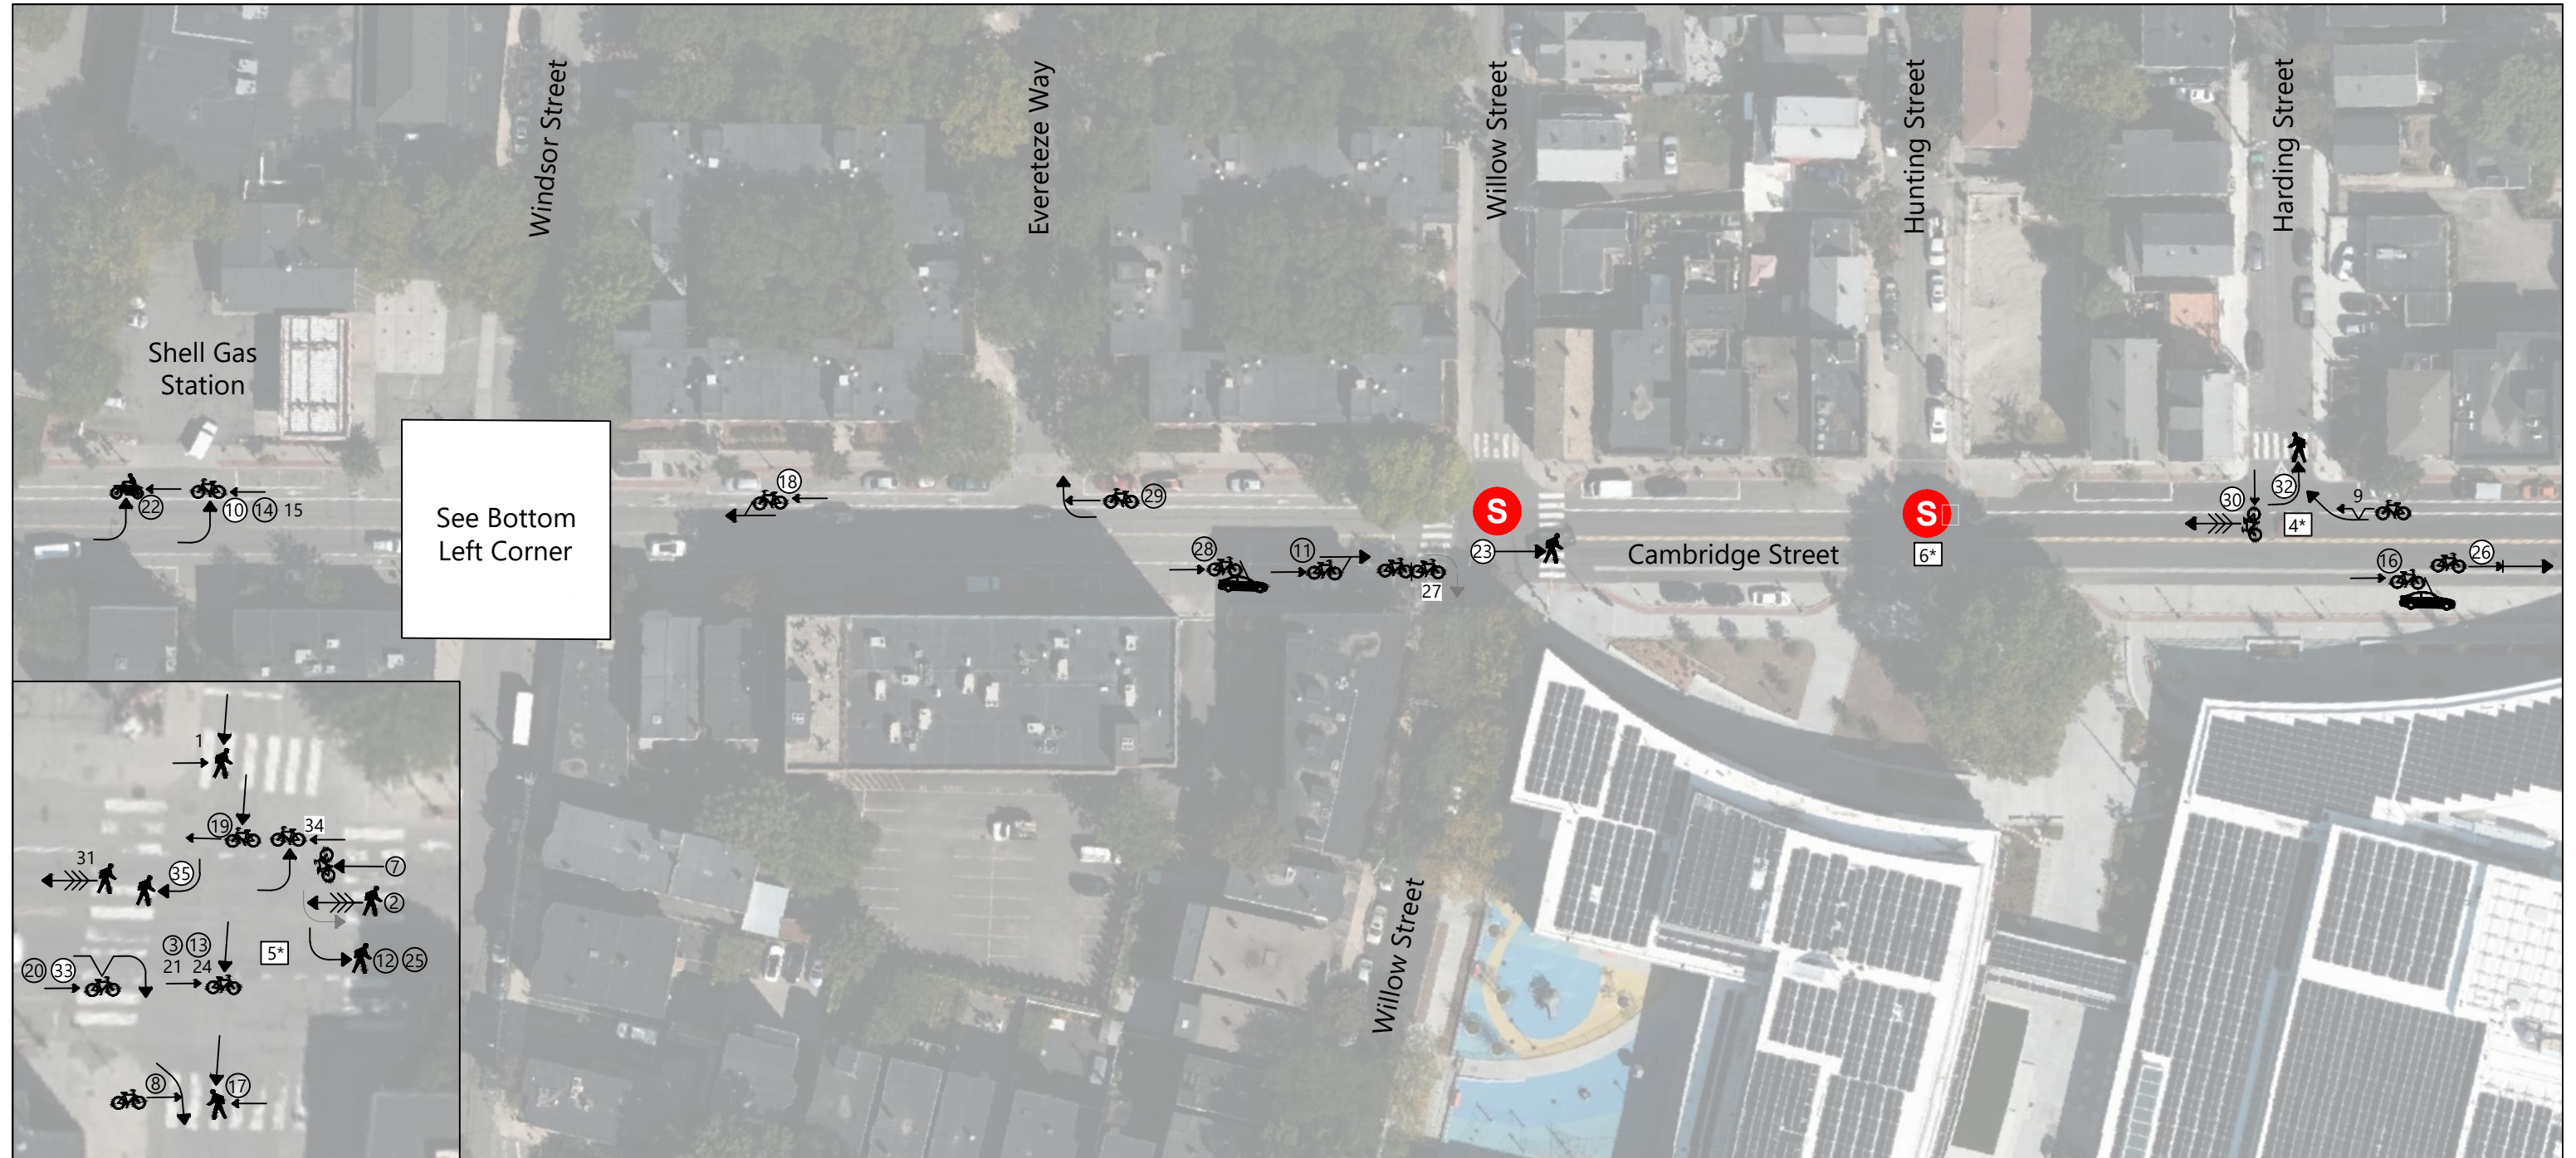
Source of Crash Reports: Massachusetts Department of Transportation and Cambridge Police Department

Note: See Vehicle-Only Crash Diagram for crashes that do not involve pedestrians or bicyclists.

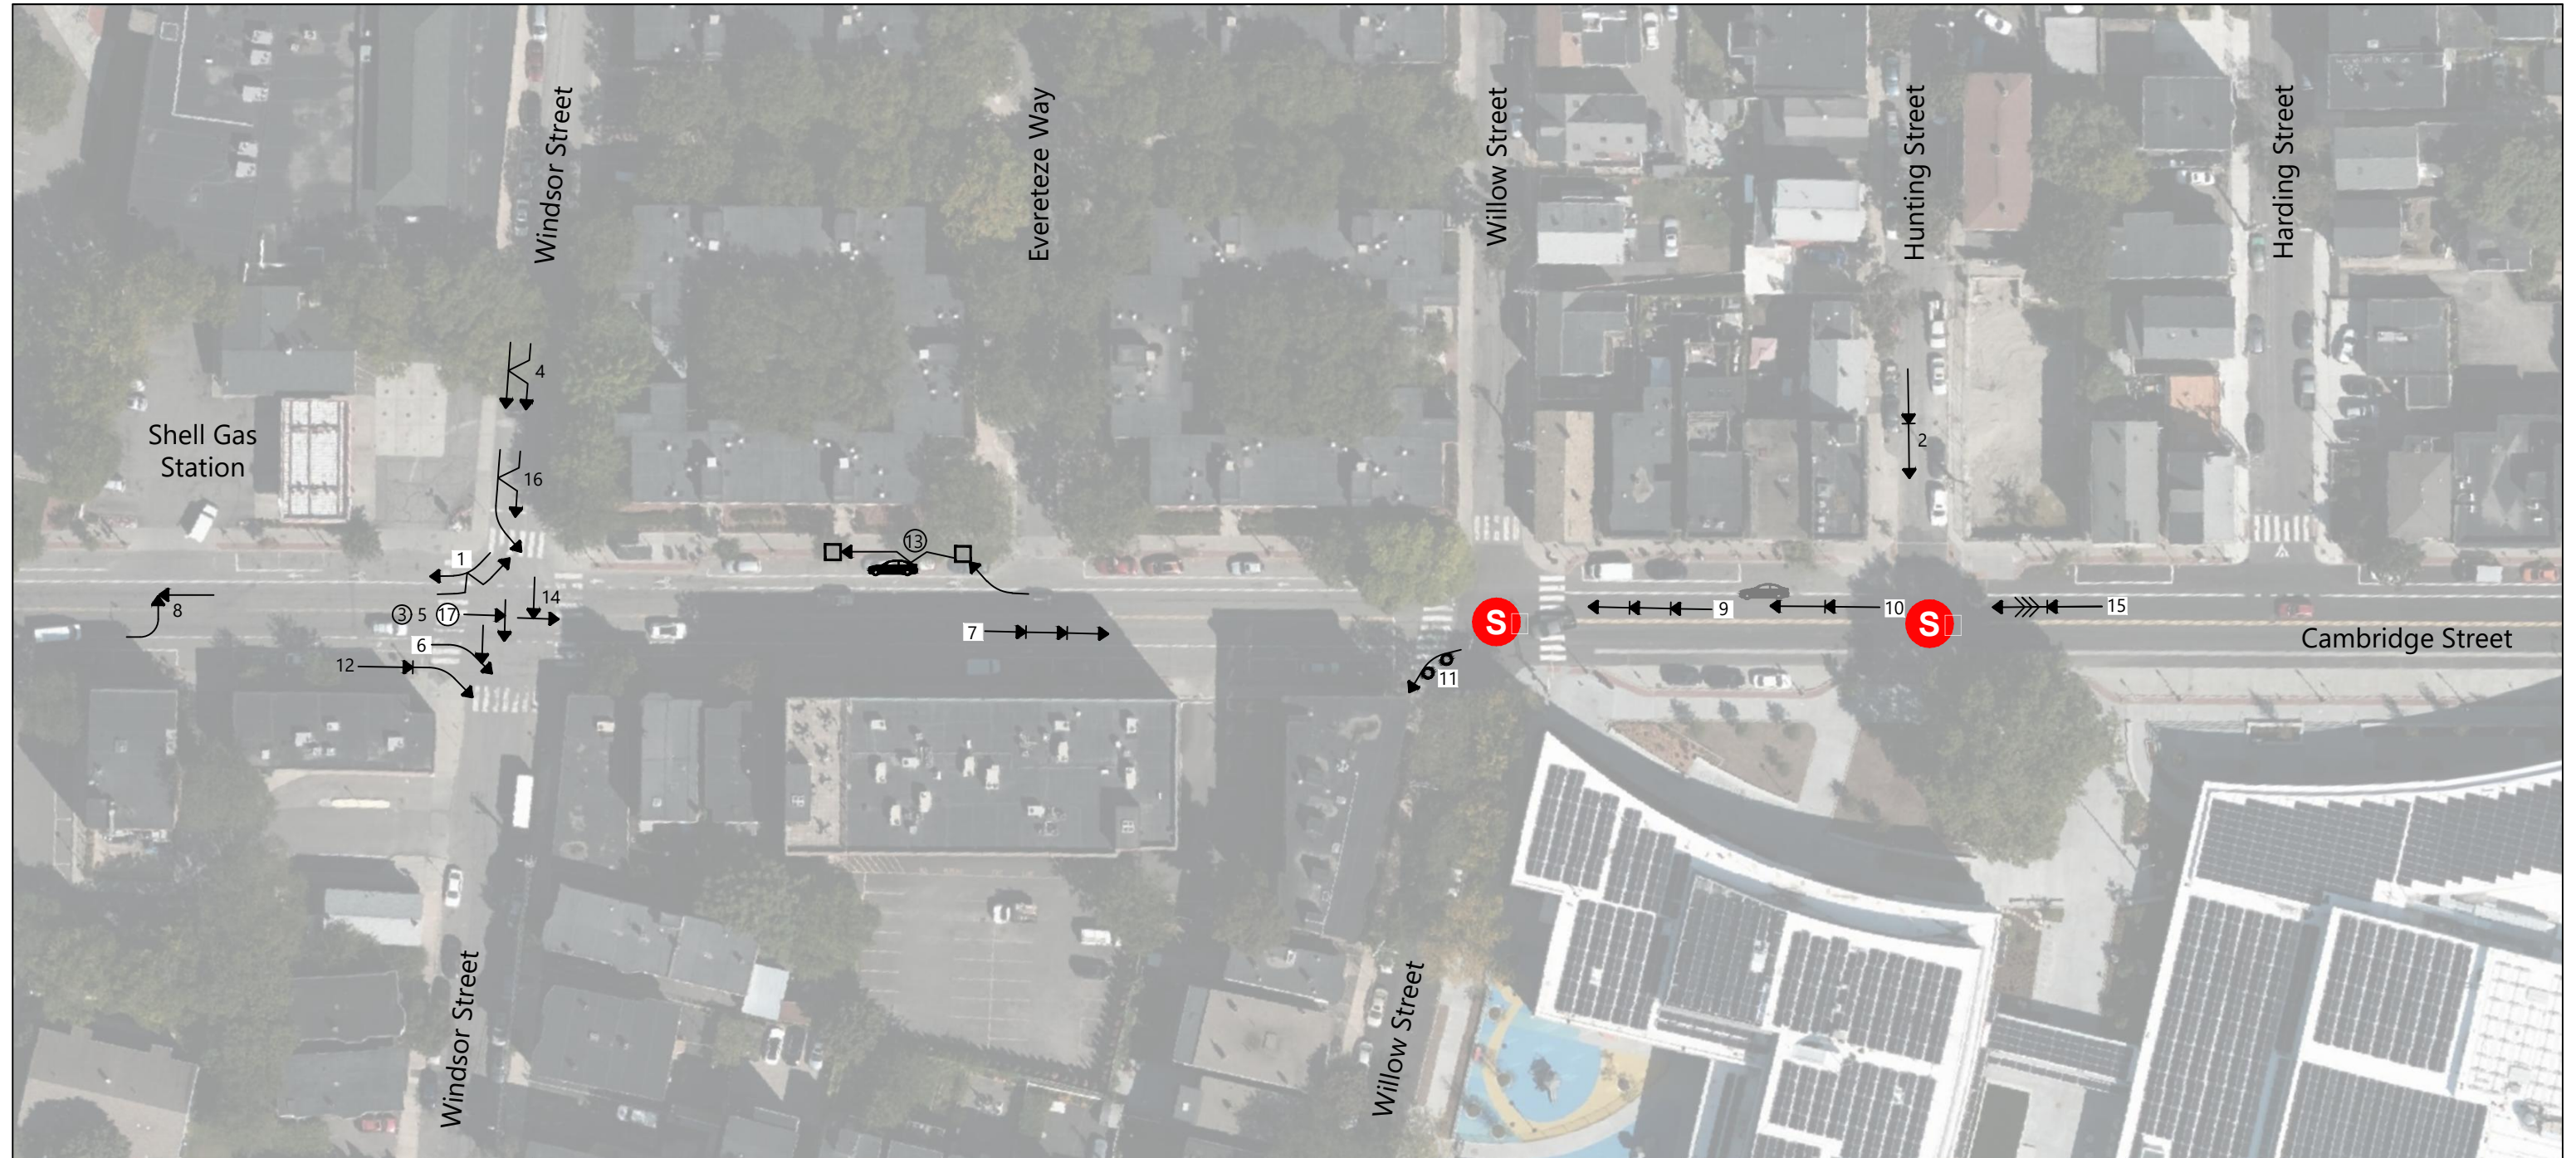
Source of Crash Reports: Massachusetts Department of Transportation and Cambridge Police Department

Note: See Ped & Bike Crash Diagram for crashes involving pedestrians and bicyclists.
