Harvard University Adams House Renewal

Phase II: Randolph Hall

Application for Certificate of Appropriateness

PREPARED BY
Beyer Blinder Belle Architects & Planners LLP

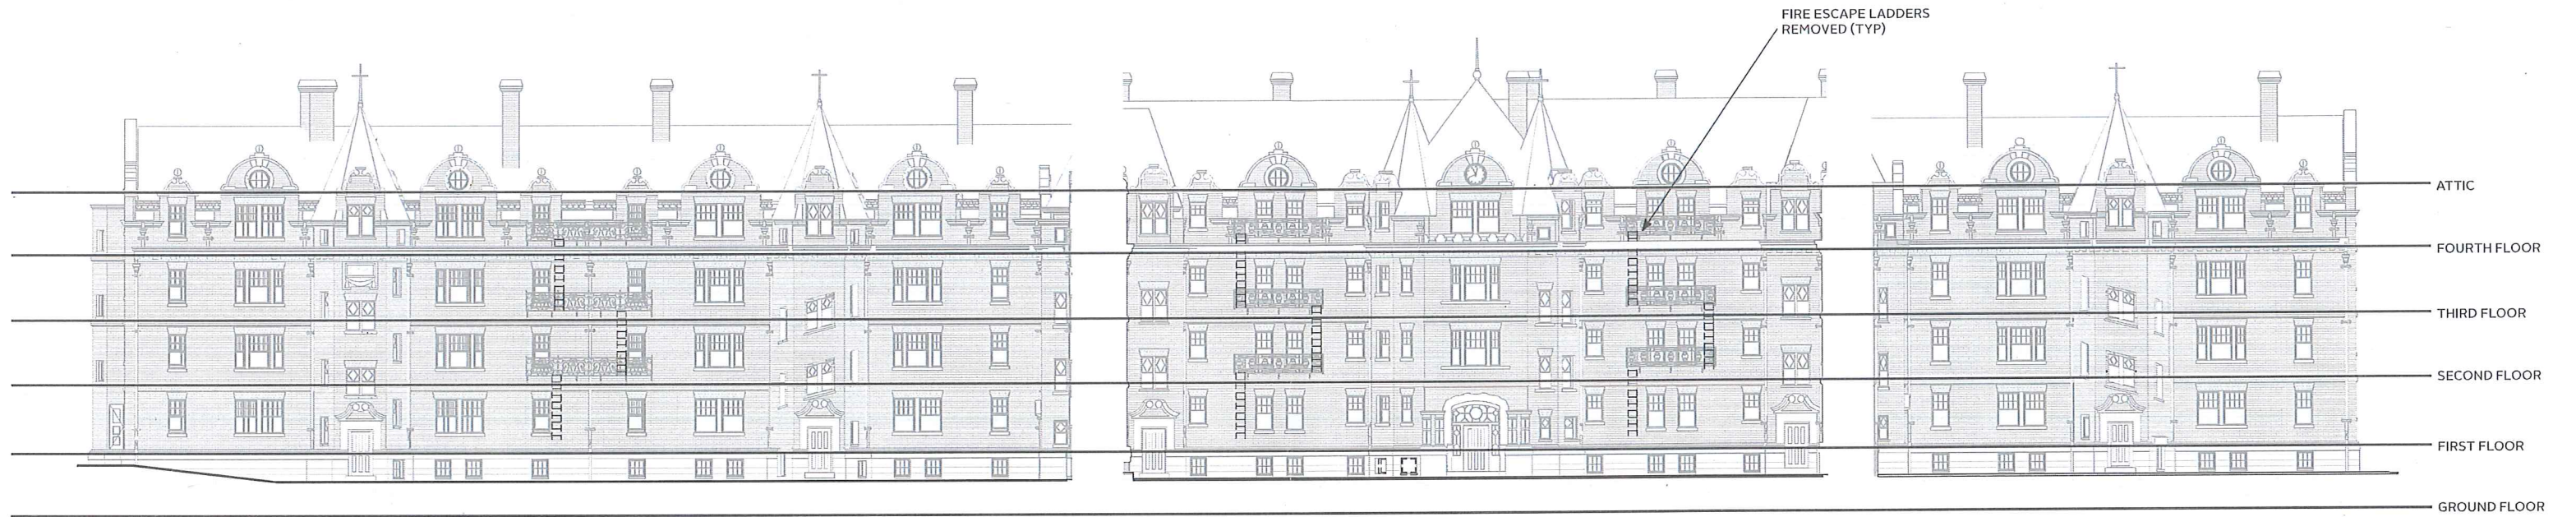
EXISTING/DEMO COURTYARD WEST ELEVATION (EAST WING)

EXISTING/DEMO COURTYARD NORTH ELEVATION (SOUTH WING)

EXISTING/DEMO COURTYARD EAST ELEVATION (WEST WING)

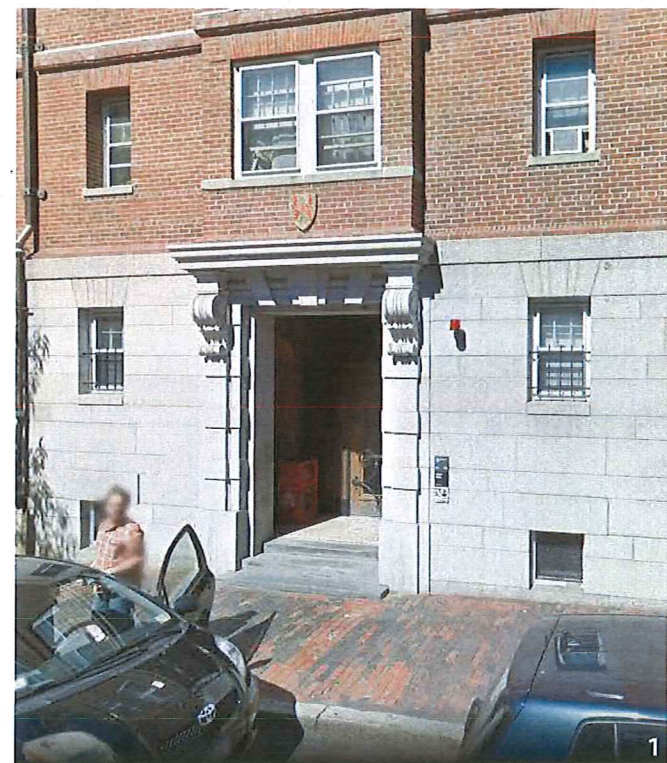
EXISTING ENTRY

At the principal entrance to Randolph on Bow Street, the sidewalk grade is approximately four feet below the level of the main floor. In order to achieve universal accessibility at this entrance, the window bay immediately east will be converted to a grade-level entry door while maintaining the existing window above. This door will give access to an interior lift to make up the level change, as was approved

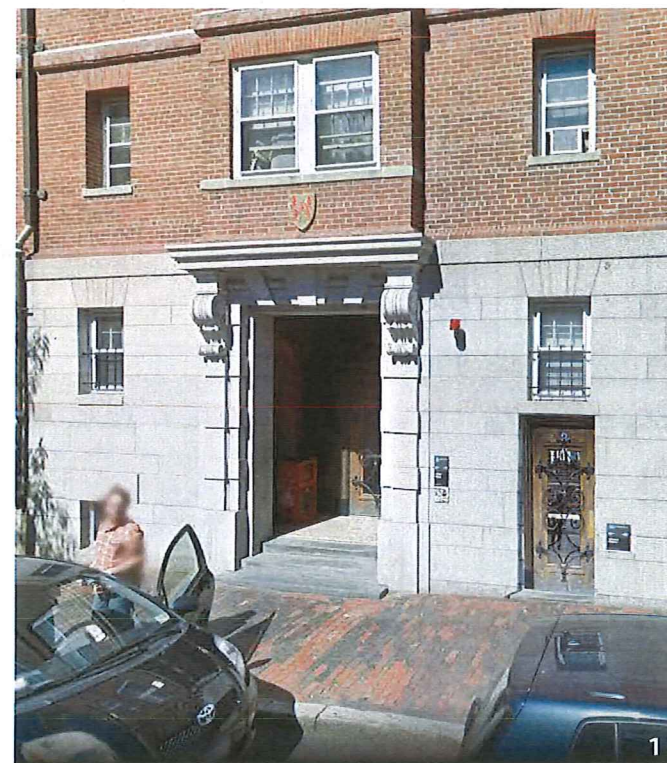
PROPOSED ENTRY WITH NEW LIFT ACCESS

for Claverly Hall. The detailing of the door will be compatible with existing adjacent. Post-mounted painted metal handrails will be added to the existing entrance stoop to meet MAAB accessibility requirements.

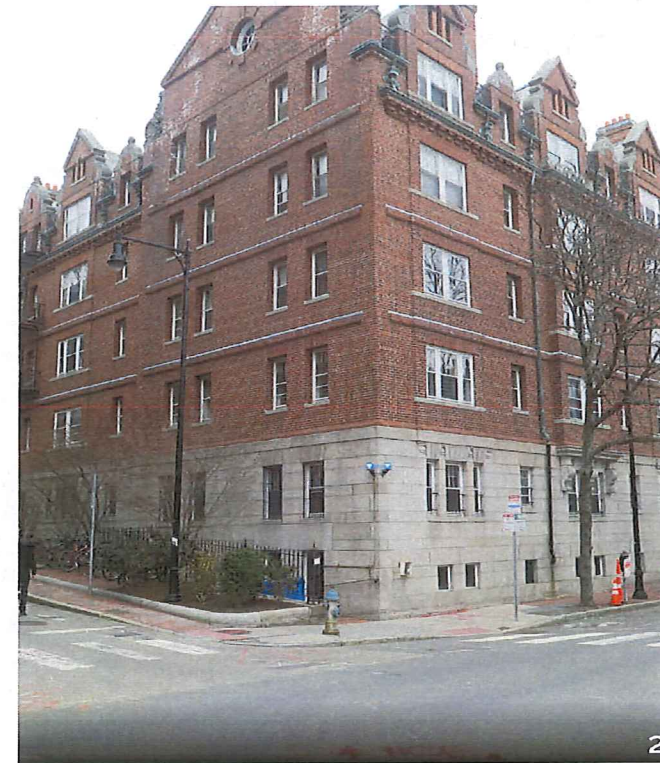
EXISTING SW CORNER - RAMPED ENTRY

At the southwest corner of the building, the existing ramp and basement entrance will receive several upgrades for accessibility. The slope of the ramp will be made less steep for code compliance (1:12 MAX). The entry door threshold will be raised along with the lower landing. This requires a new

door frame/leaf, but the top and sides of the masonry opening can remain as-is. The existing metal handrail on the building wall will be removed, and new, code-compliant painted metal handrails will be installed on both sides. These will be wall-mounted on the east, and post- and wall-mounted on the west.

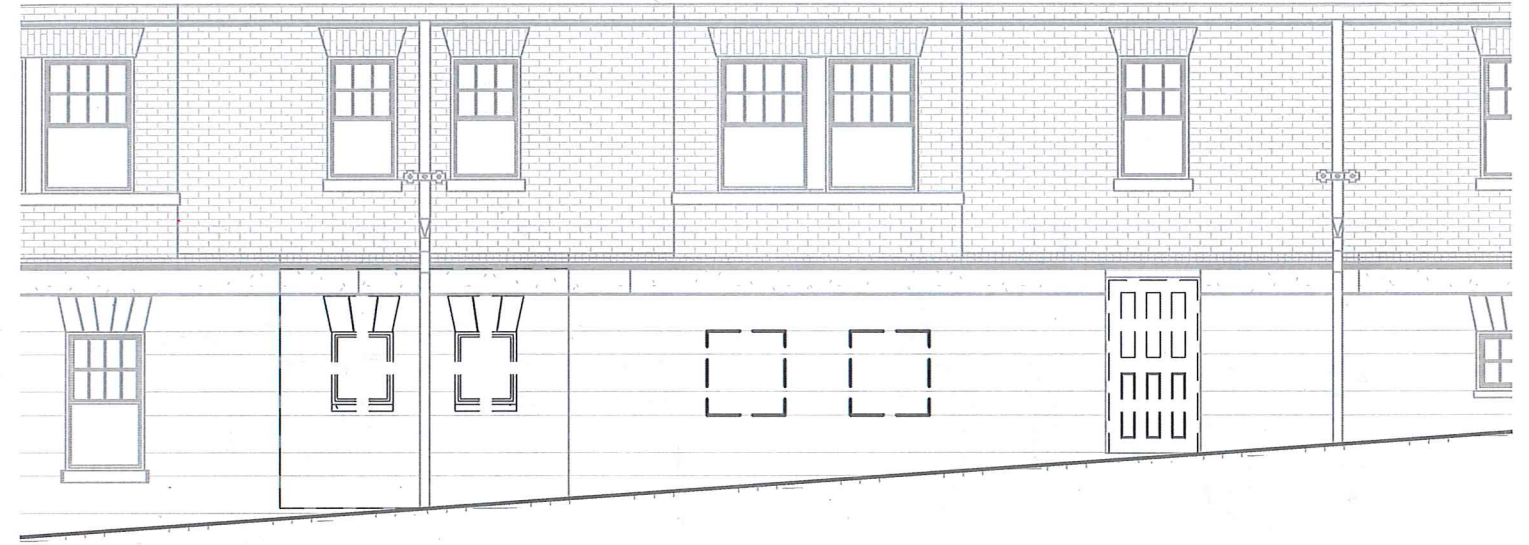
EXISTING ELEVATION - EXISTING ENTRY, BLANK WALL, AND PAIR OF FIXED WINDOWS

The existing Linden mid-block entry into Randolph will remain. The Plympton entry is proposed to be relocated southward.

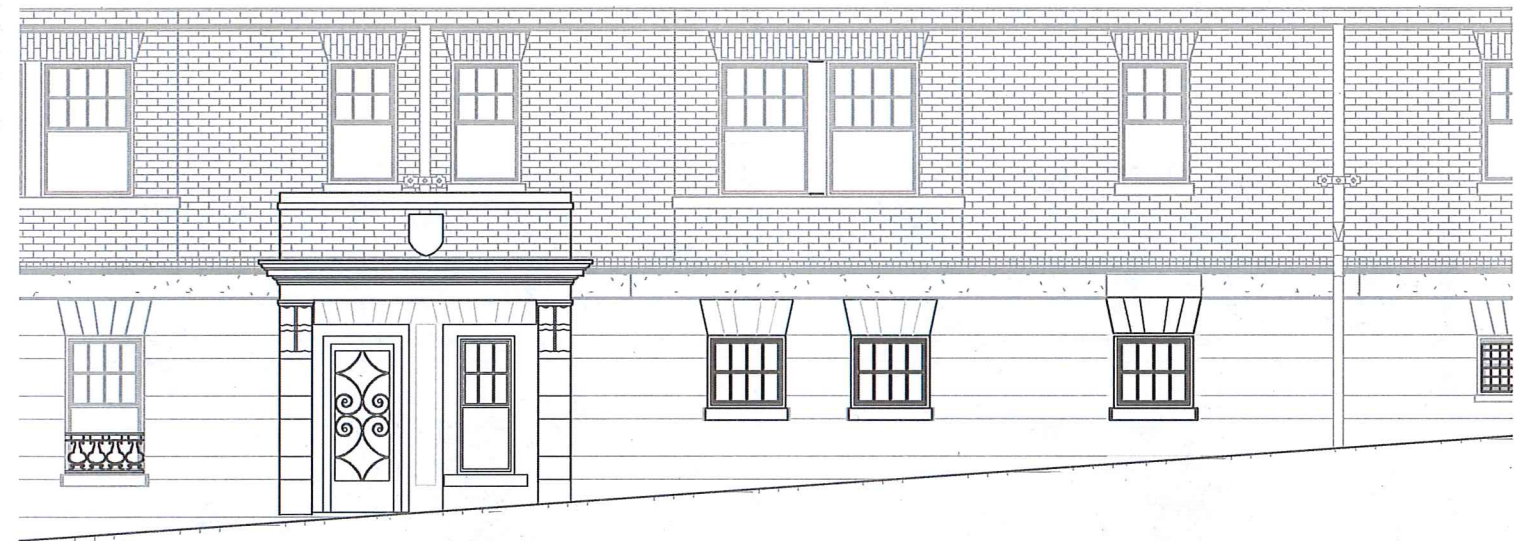
PROPOSED ELEVATION - NEW ENTRY, TWO NEW WINDOWS, AND DOOR CONVERTED TO WINDOW

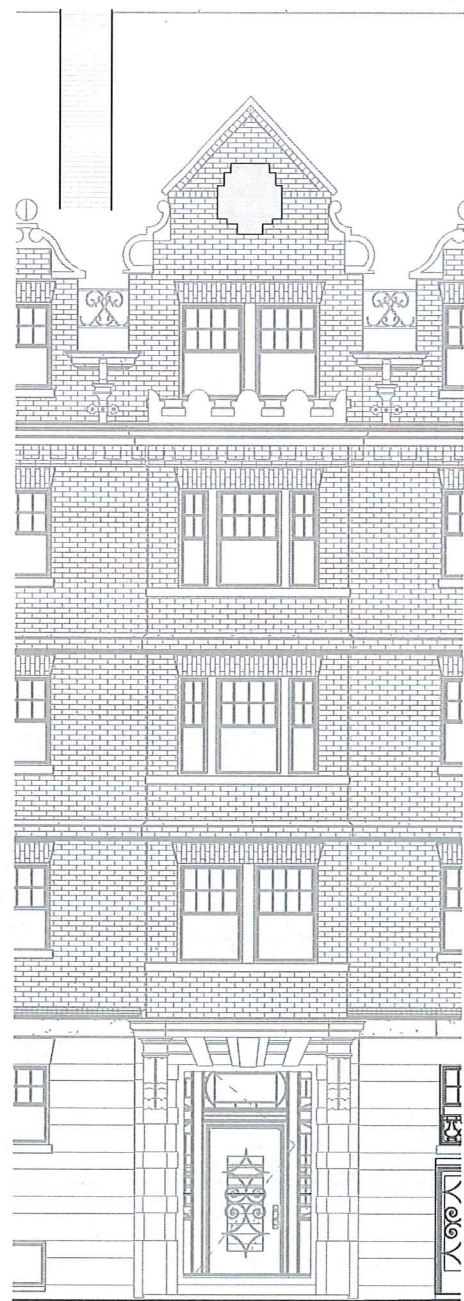
EXISTING BOW ST ENTRY PORTAL CENTERED UNDER PRIMARY GABLE

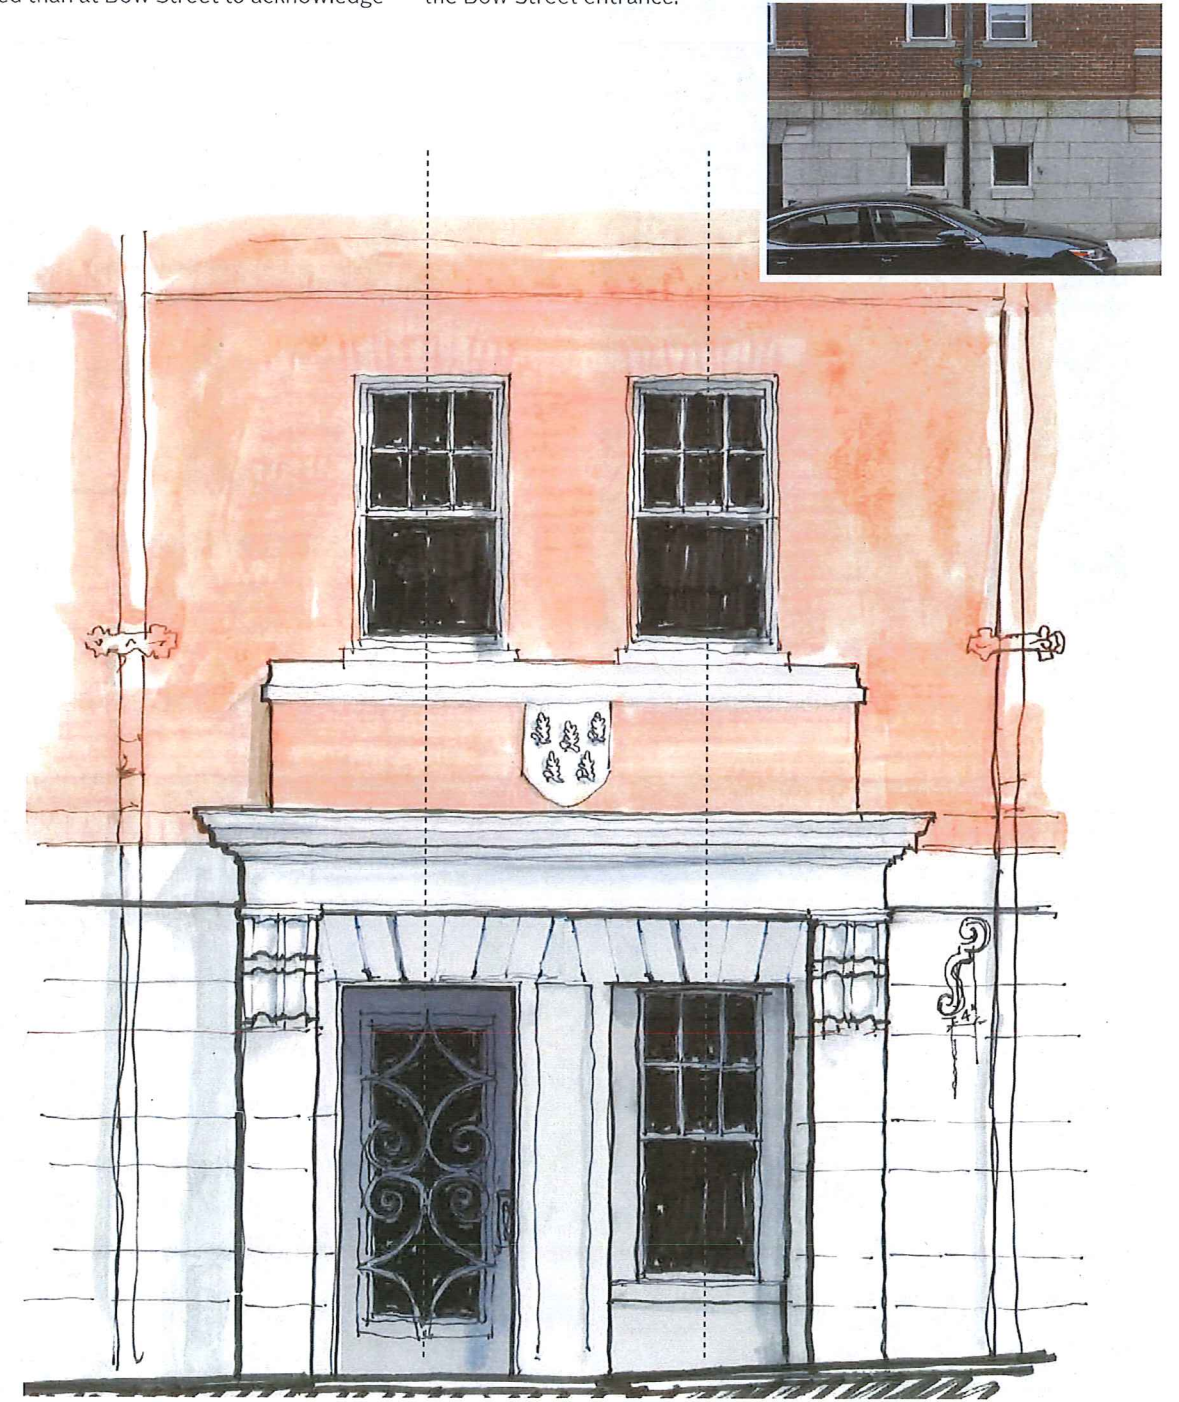
PROPOSED ELEVATION - ACCESSIBLE MID-BLOCK ENTRY ON PLYMPTON

Bow Street entry as a departure point, a similar portal is proposed, framed by granite brackets supporting a cornice. Two existing windows, which are to the immediate north and south sides of a transverse interior masonry bearing wall, become a modified window and new door with the same centerlines. The proposed pilaster between the new door and window is structural. Aspects of the proposed design are more understated or streamlined than at Bow Street to acknowledge

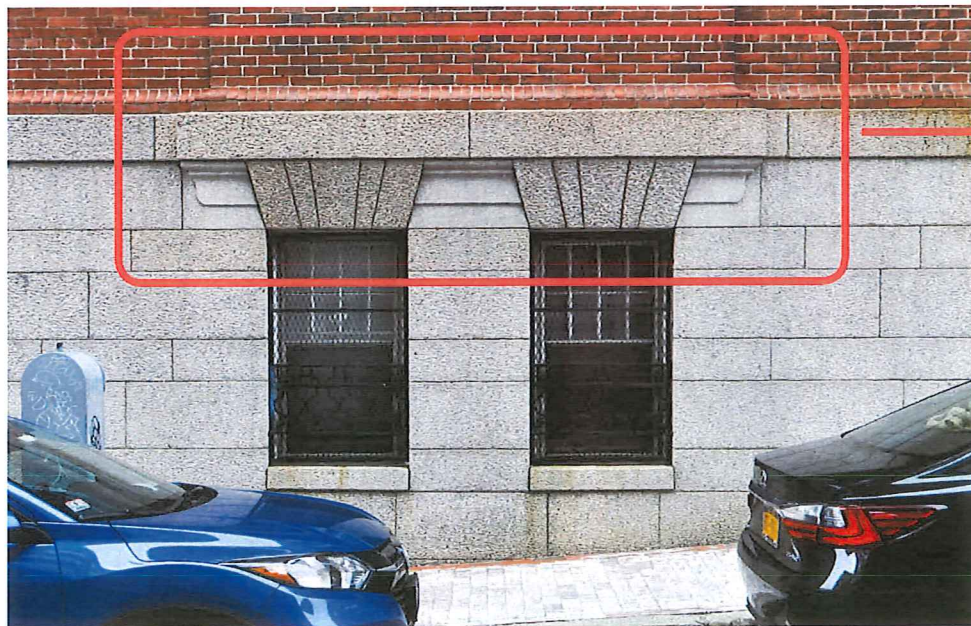
2. PHOTO OF WINDOW HEAD DETAIL - NEXT PROJECTING BAY TO SOUTH

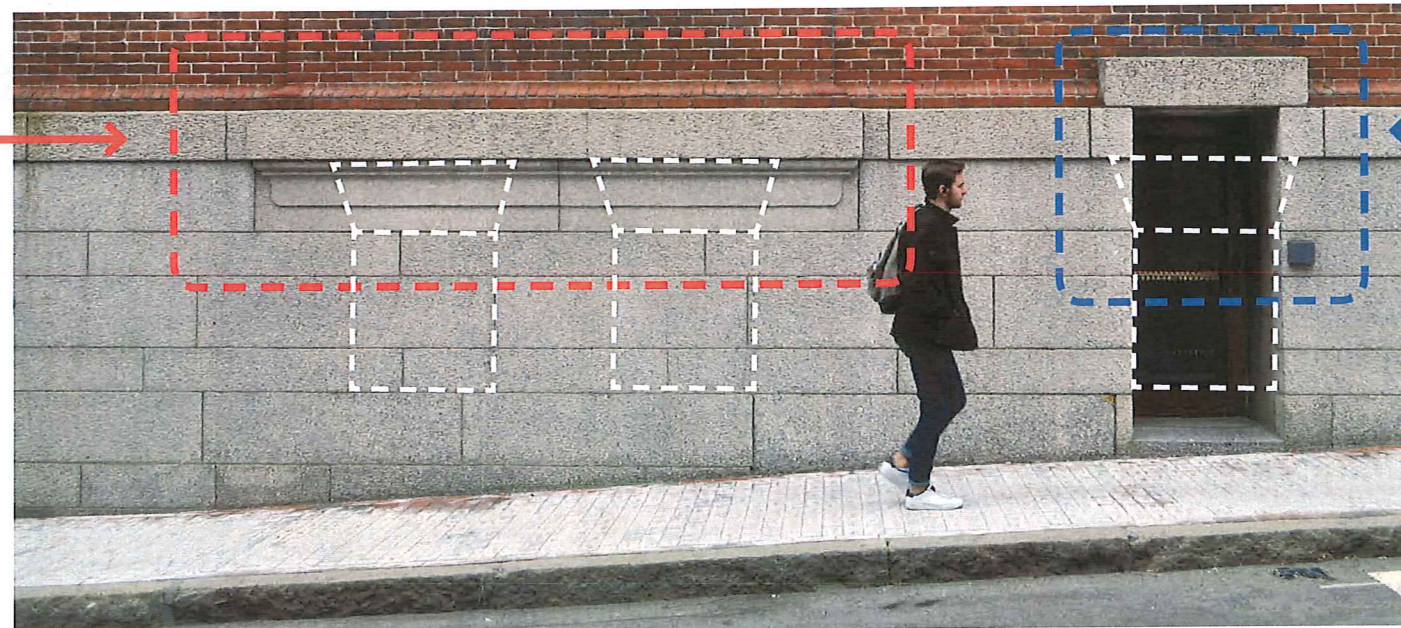
3. PHOTO OF EXISTING CONDITIONS WHERE THREE WINDOWS PROPOSED (SHOWN DASHED)

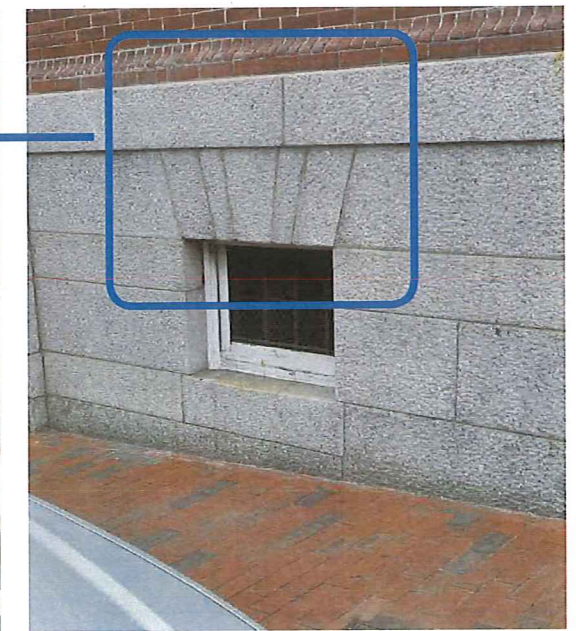
4. PHOTO OF WINDOW HEAD DETAIL - IMMEDIATELY NORTH OF EXG. DOOR

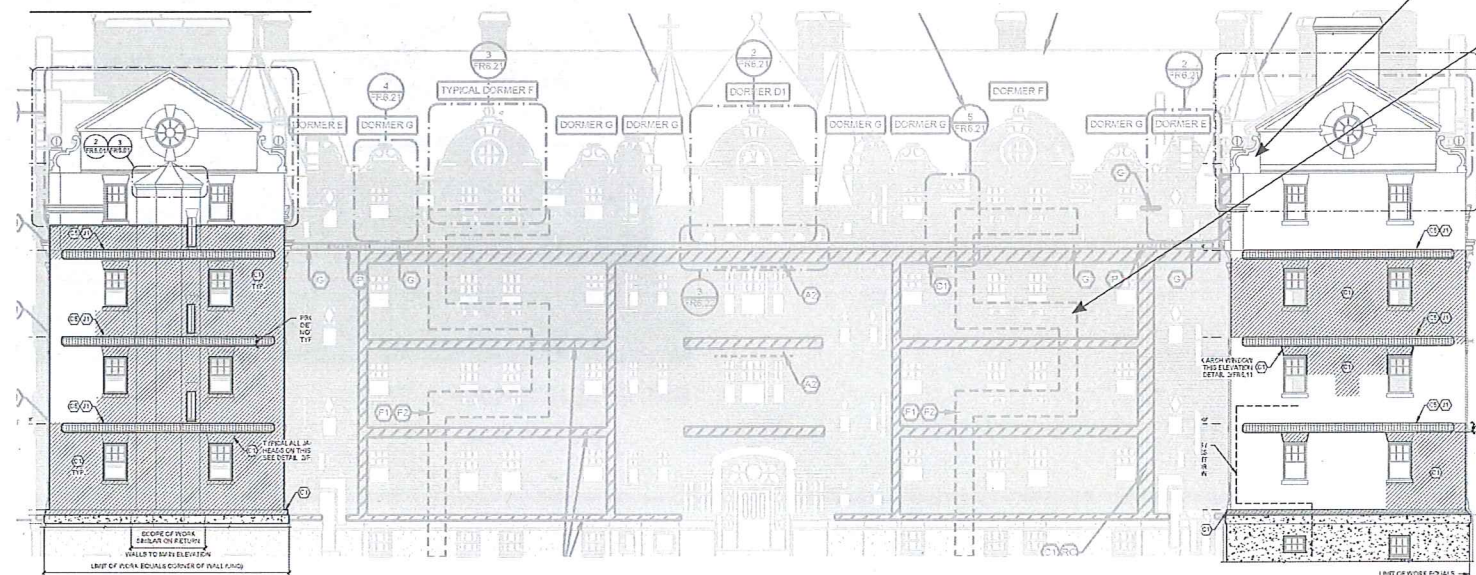
PROPOSED NORTH ELEVATION DRAWING

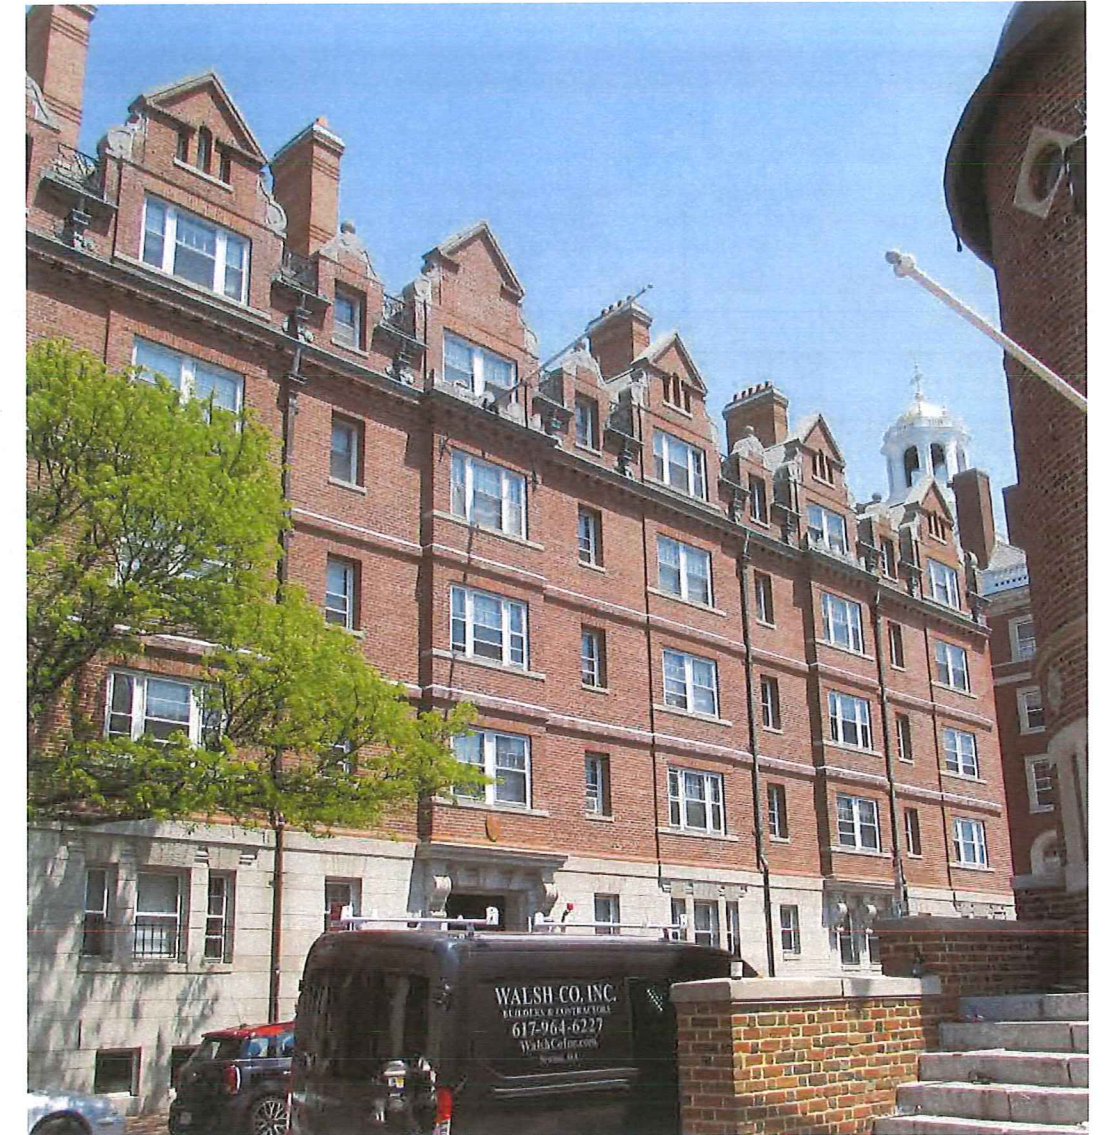
EXISTING SOUTH ELEVATION

The exterior restoration scope at Randolph will be similar in its aims to Claverly Hall, although exploratory survey has indicated that areas of the Randolph envelope, including many of the large window lintels and decorative stone and masonry elements at the dormer/attic level, are more severely deteriorated and will require a greater degree of intervention and preventative repair. In general, the field masonry will also require a greater degree of restoration scope.

The stone trimmings which decorate the dormers, crenelate the main cornice line, and bracket the gable ends were originally carved gray sandstone. These were replaced at some point in the mid-century with cast stone, likely due to deterioration of the original. These replacements themselves are in poor condition and are slated for replacement in-kind. Molds are being taken of the existing elements.

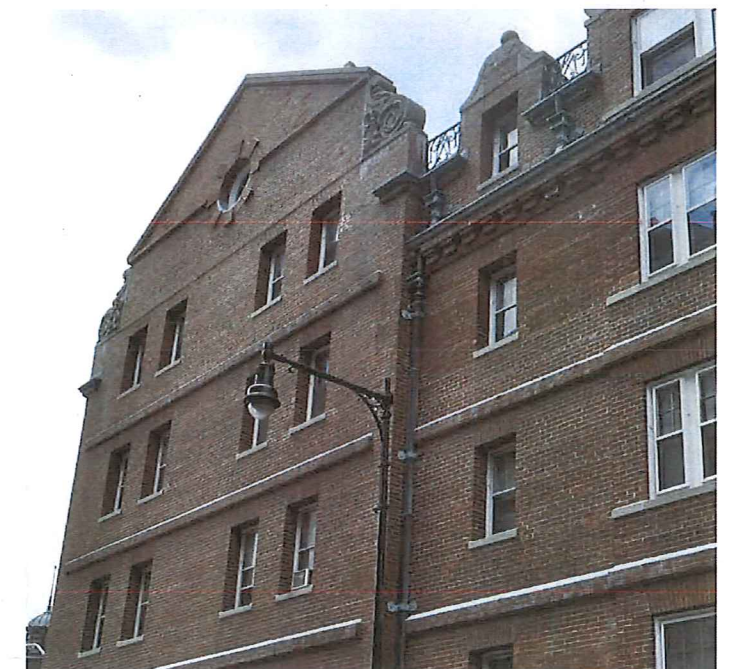
EAST FACADE GABLE-END

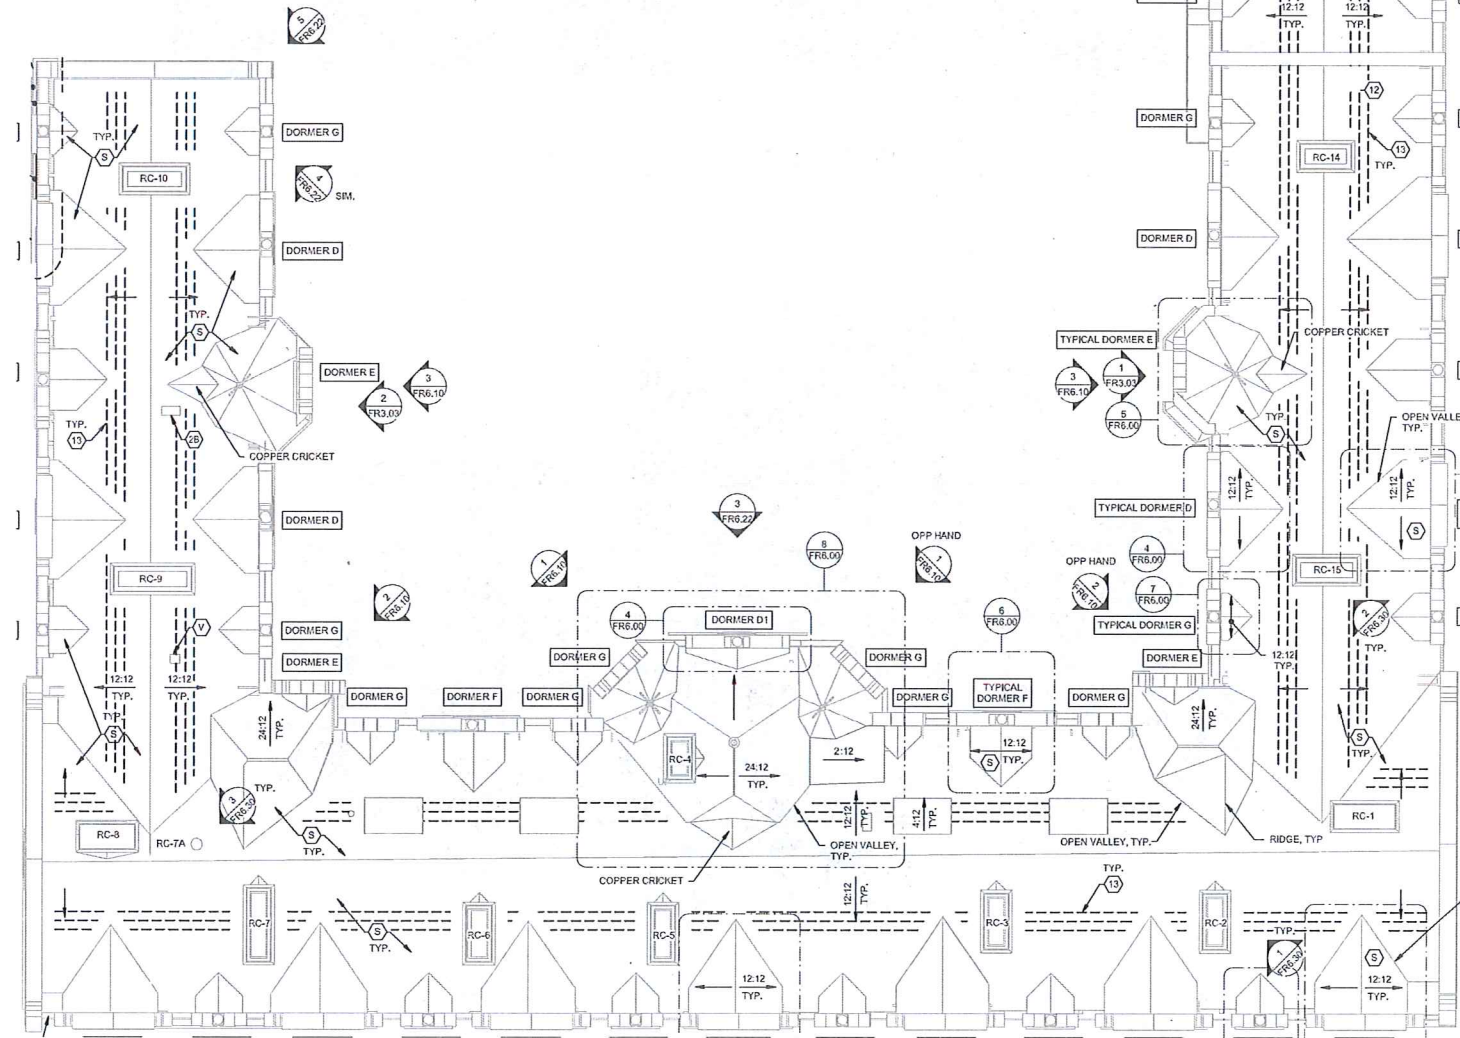
ROOF PLAN

The slate and copper roofing has reached the end of its useful life and will be replaced. The new slate will be culled so as to be consistent with original slate color. All of the existing chimneys are significantly deteriorated and will be rebuilt from the attic floor upwards, matching the original size, configuration, and detailing, similar to what has been done at other House Renewal projects; salvage brick will be used in the reconstructions. The chimneys will remain inactive as Randolph will have no wood-burning fireplaces after Renewal. Concrete and copper flashed chimney caps will be replaced as part of chimney rehabilitation.

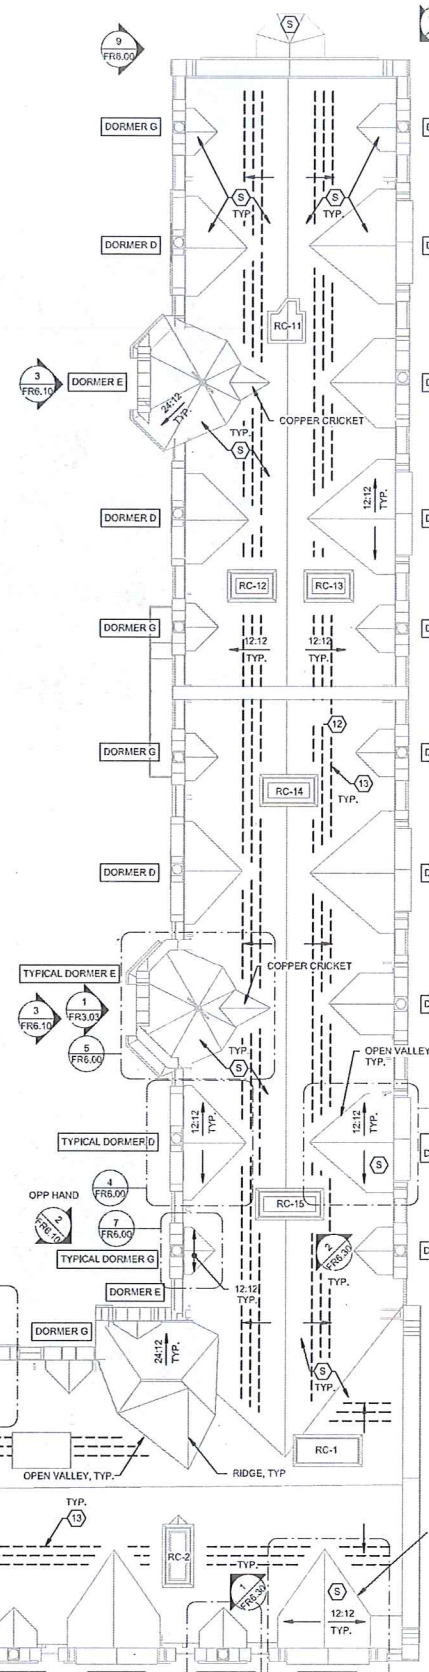
EAST WING ROOF

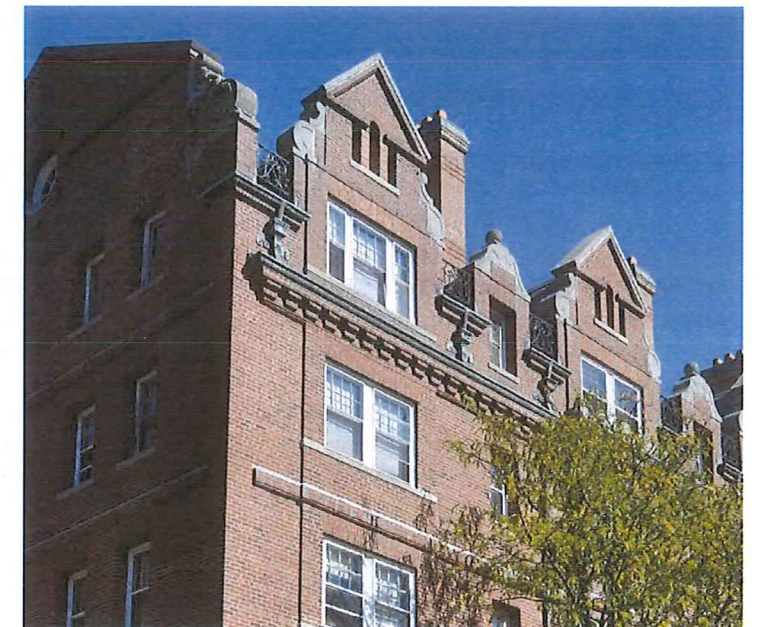
SOUTHWEST CORNER DORMER AND GABLE END

The brick masonry at the many dormers and one of the end-gables is heavily deteriorated and will need to be extensively rebuilt. These dormers can be categorized into several types, with specific cast stone ornament associated with each; because of their unique geometry, each dormer has a complex interrelationship of envelope components. Extensive exploratory survey has been conducted to understand how these elements come together, and will inform a restoration and repair approach that ensures the longevity of the building. Where there are to be reconstructions, salvage brick will be used as much as possible.

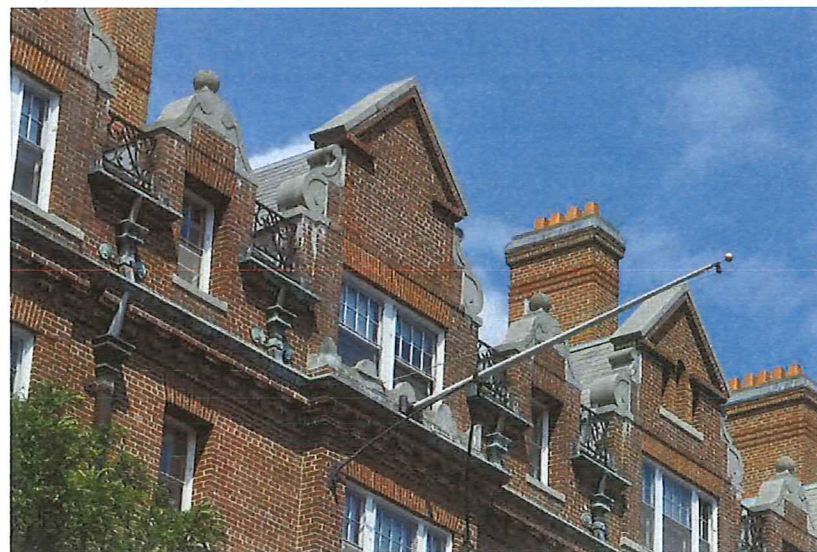
EXISTING CONDITIONS PHOTOGRAPH

A perspective drawing published in 1898 upon the building's completion, as well as a historic photograph from 1903, indicate the presence of a decorative cartouche in the field of the brick masonry on the gable directly above the Bow Street entrance. At some point—perhaps in the mid-century at the same time the sandstone ornament was replaced with cast stone—this cartouche was removed. With seven major gabled dormers on this elevation, the cartouche effectively set the center dormer apart and expressed the axis of symmetry and formal entrance below.

As part of the renovation, it is proposed to install a new cartouche of the same size and shape. Nothing is known of the original content of the cartouche, but the new design will be historically sympathetic and express Adams insignia.

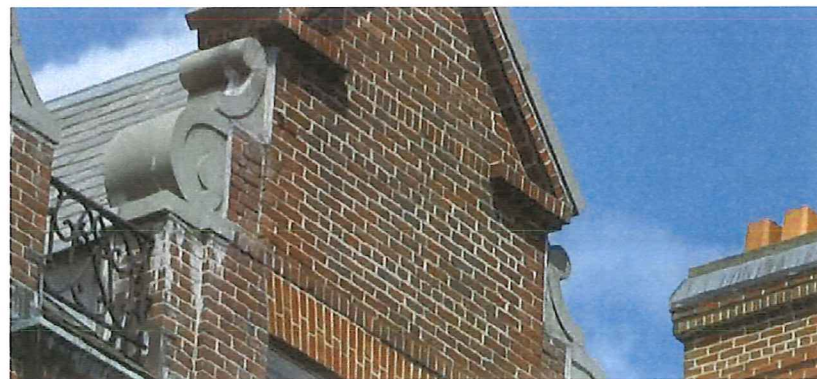
EXISTING CONDITIONS PHOTOGRAPH DETAIL

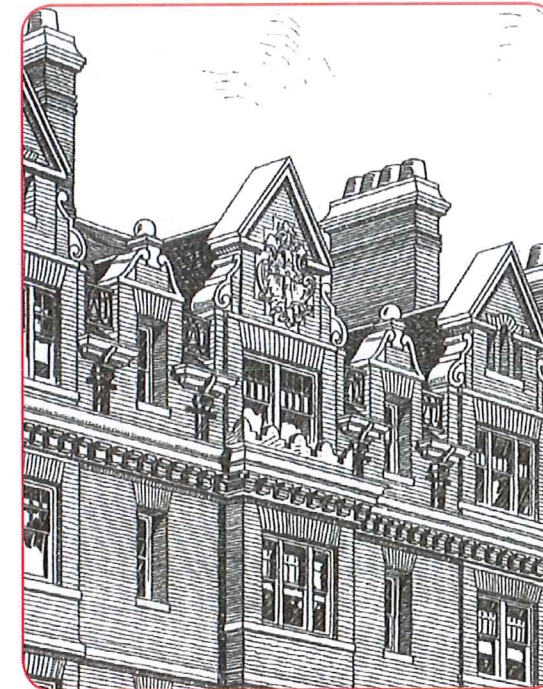
DETAIL OF PERSPECTIVE DRAWING

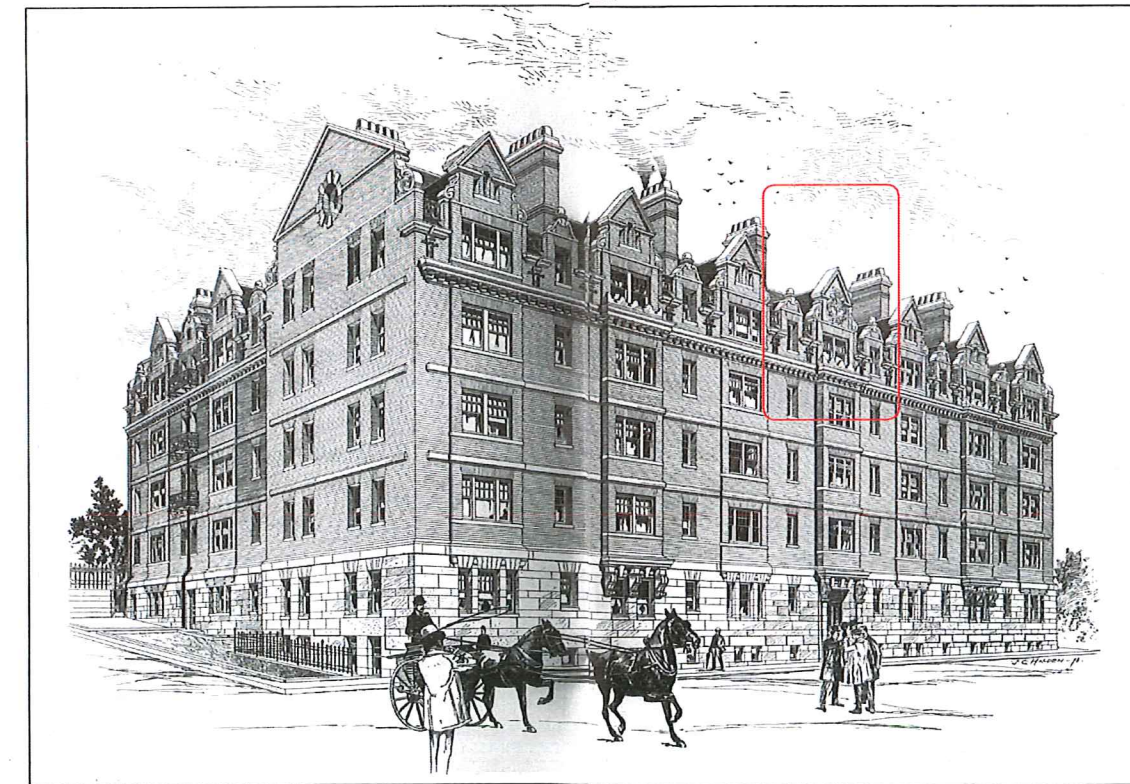
PERSPECTIVE DRAWING IN AMERICAN ARCHITECT AND BUILDING NEWS, APRIL 23, 1898

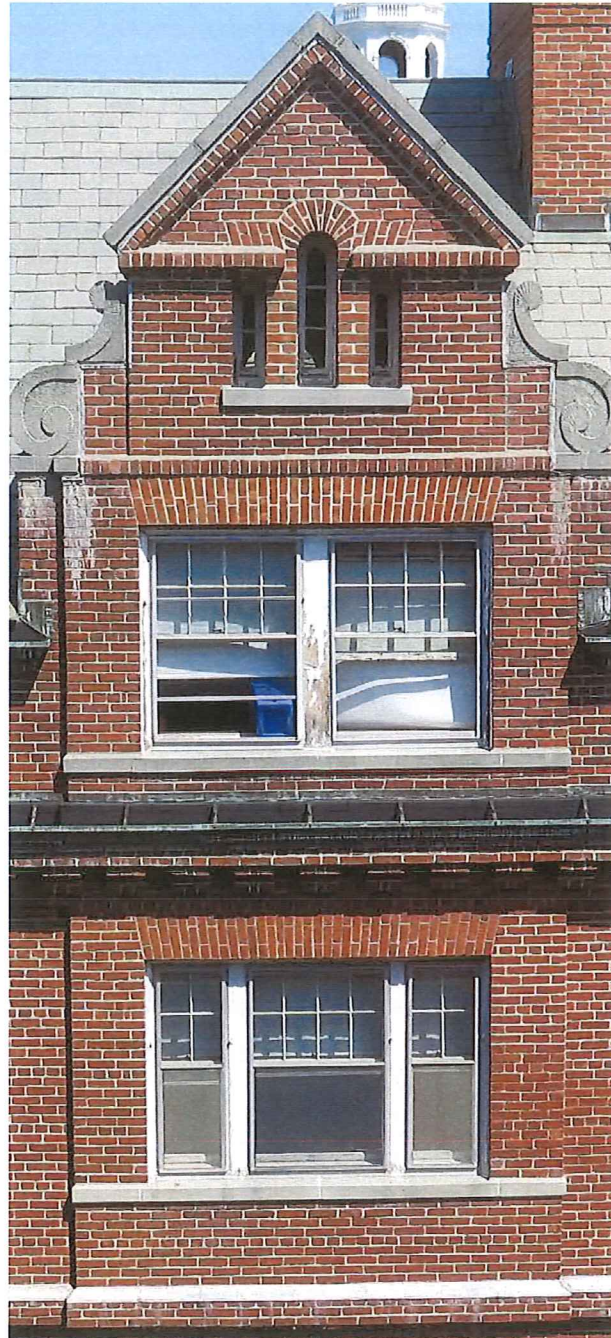
MULTI DIVISION WINDOWS AT WEST WING

The great majority of Randolph's windows are double-hung wood sash windows, the exception being rhomboid wood casements at two of the stair towers within the courtyard, and single-sash wood windows at the basement levels. At the typical double-hung windows, whether single-unit

or ganged, the lower sash contains a single lite with no dividing muntins, while the upper sash has a horizontal muntin and one to three vertical muntins. Windows are headed by flush or projecting granite flat arches at the ground floor and basement, or brick jack arches set flush on the upper floors.

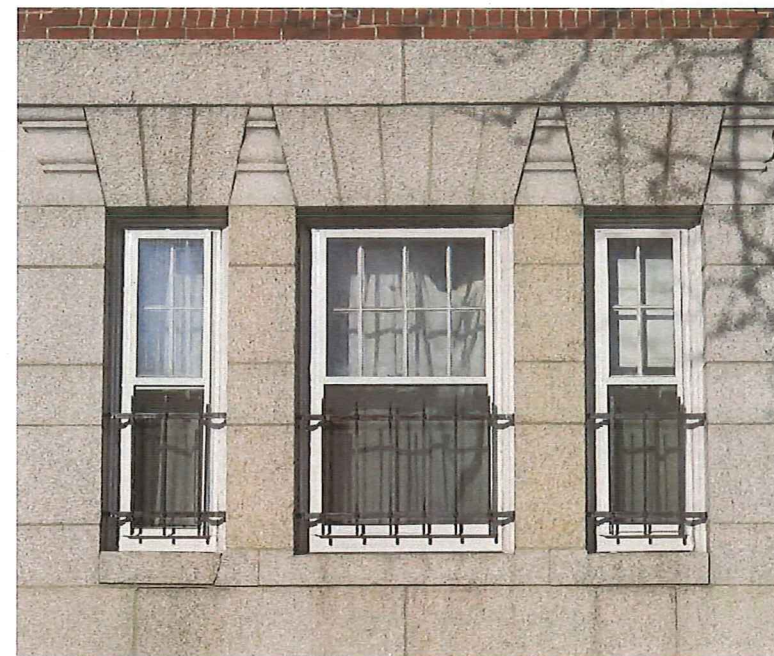
GROUND FLOOR MULTI DIVISION ON BOW ST

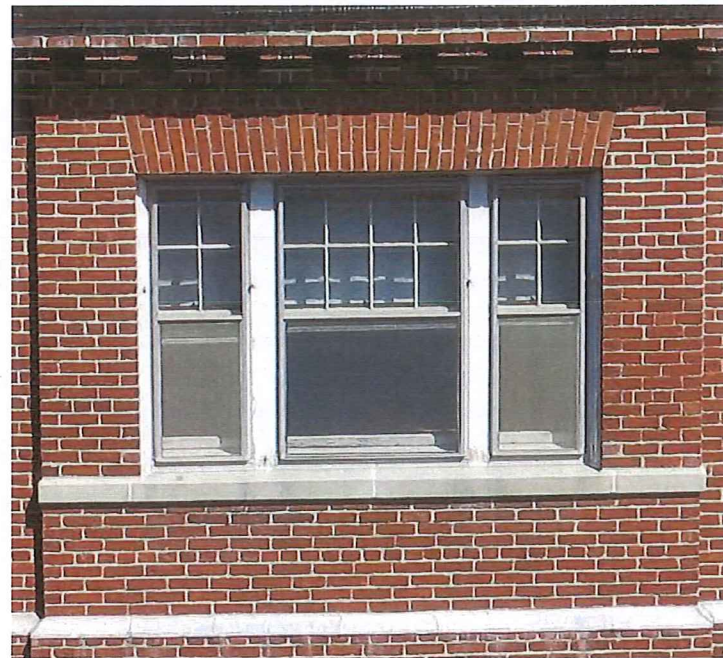
EXISTING WINDOW TYPES - MULTI-DIVISION WINDOWS (COMBINATION OF TWO- AND THREE-PART DIVISIONS; SILL HEIGHTS AND RECESSES VARY)

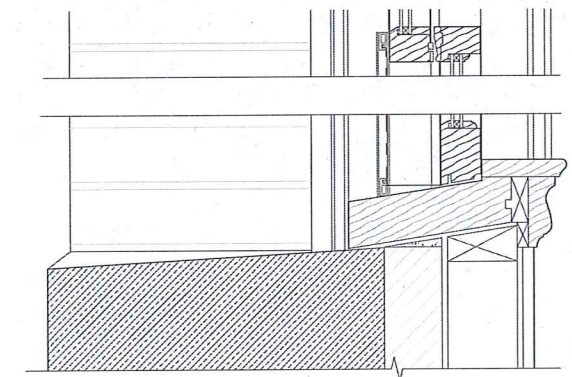
SILL DETAIL - 12" SET BACK

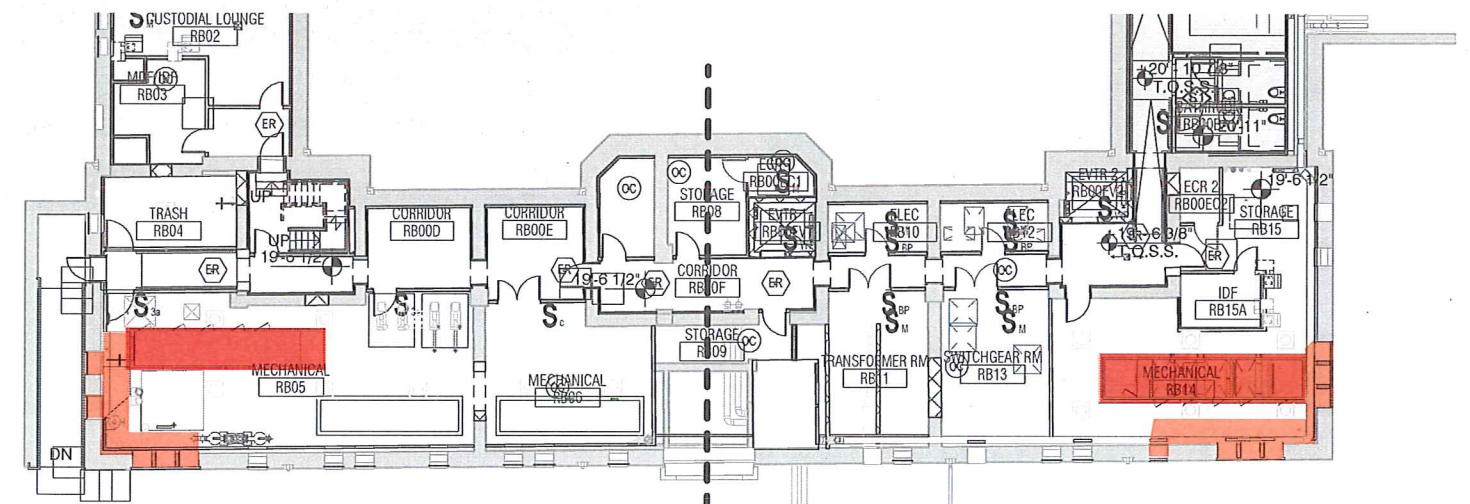
PROPOSED BASEMENT MECHANICAL PLAN
(AIR HANDLING UNITS IN DARK RED TONE, AIR INTAKE PLENUMS IN LIGHT RED)

These matters impact the Randolph exterior due to the requirement for intake air to serve the two air handling units. As illustrated on the next page, the proposed renovation scope involves converting several basement windows to louvered openings (intake only) while maintaining the existing masonry opening. At three locations comprising a total of six small windows, however, it is proposed to widen and combine masonry openings to achieve the required louver area. These locations are generally below waist-height for passers-by on the city sidewalks. However, intermediate granite mullions are proposed to better relate these modified openings to historic proportions, and to lessen their visual impact.

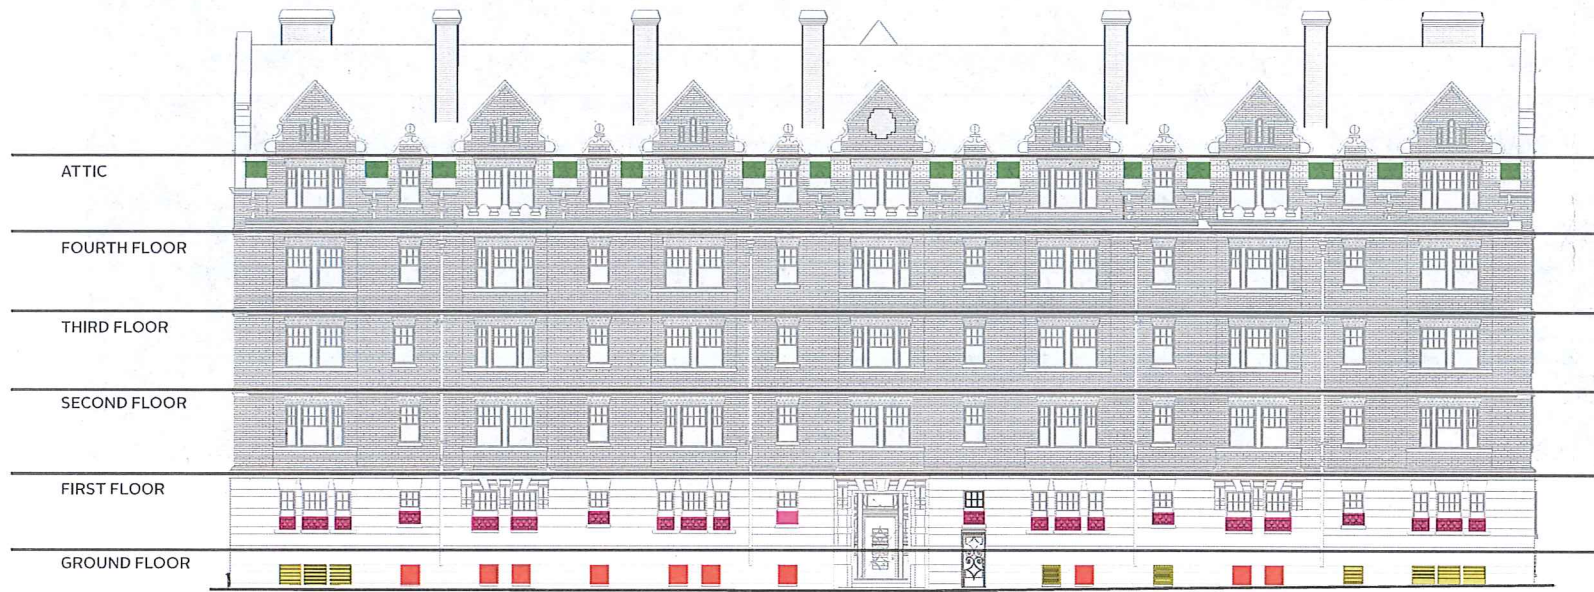
PROPOSED SOUTH ELEVATION

At windows, missing grilles will be replicated, and new security

grilles are to be added outside the Ground Floor lower sashes in a sympathetic style which uses the lyre motif found elsewhere on the ground floor. Lattice grilles are to be installed at the small windows on the basement level. The copper gutter at the cornice and upper cornice between dormers is deteriorated and will be replaced, along with all copper downspouts.

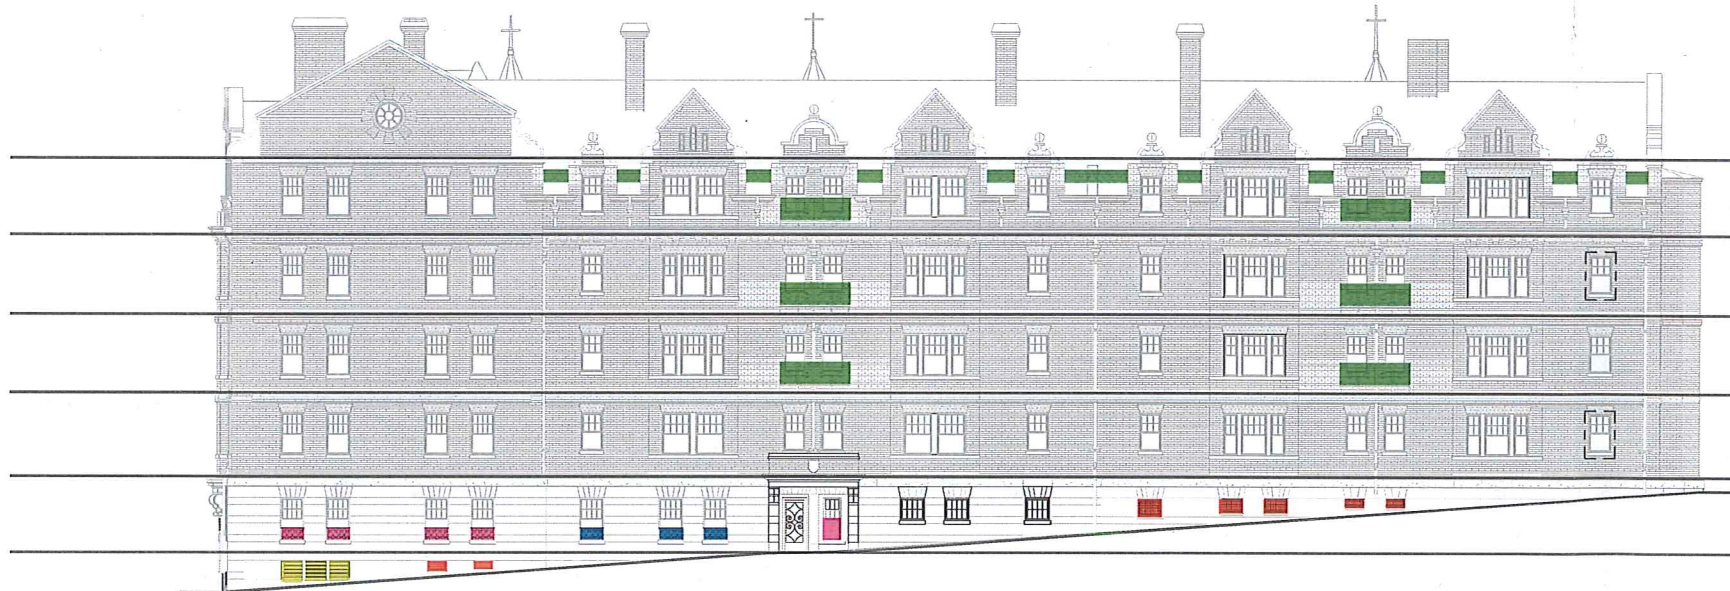
PROPOSED EAST ELEVATION
