Harvard University Adams House Renewal

Phase II: Randolph Hall

Application for Certificate of Appropriateness

PREPARED BY
Beyer Blinder Belle Architects & Planners LLP

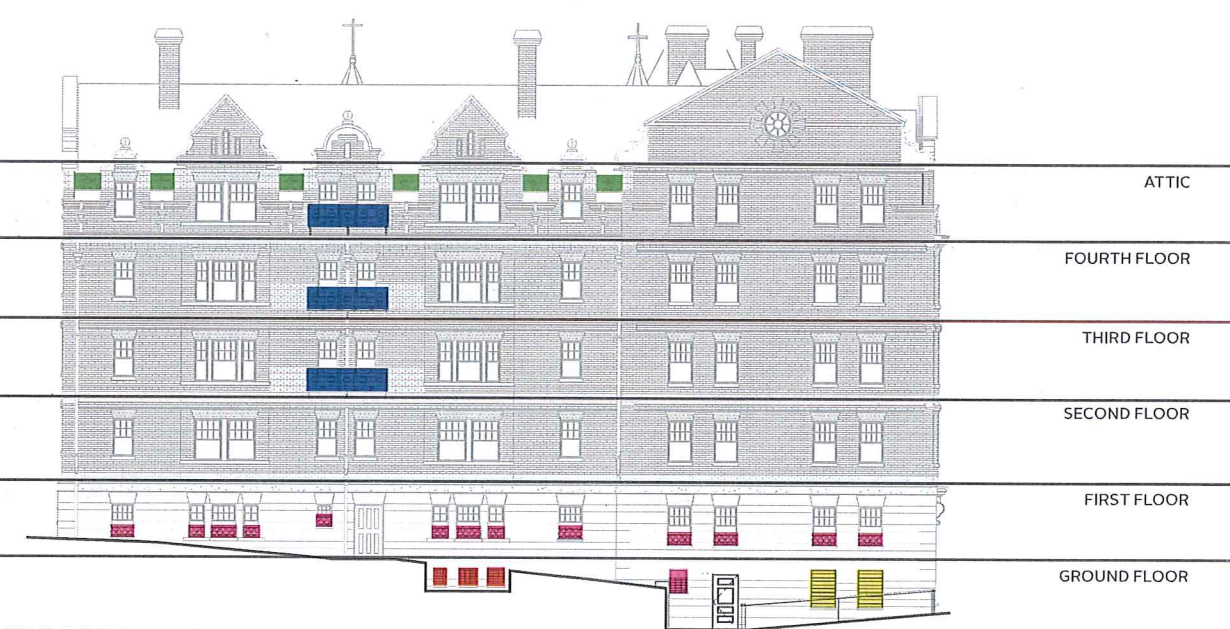
PROPOSED WEST ELEVATION

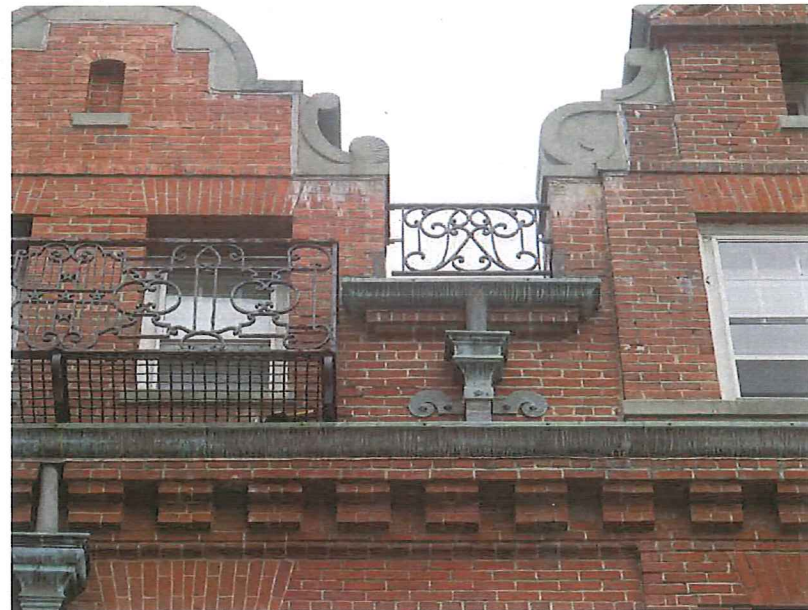
BALCONY AND BALUSTRADE TYPICAL OF EAST & WEST WINGS

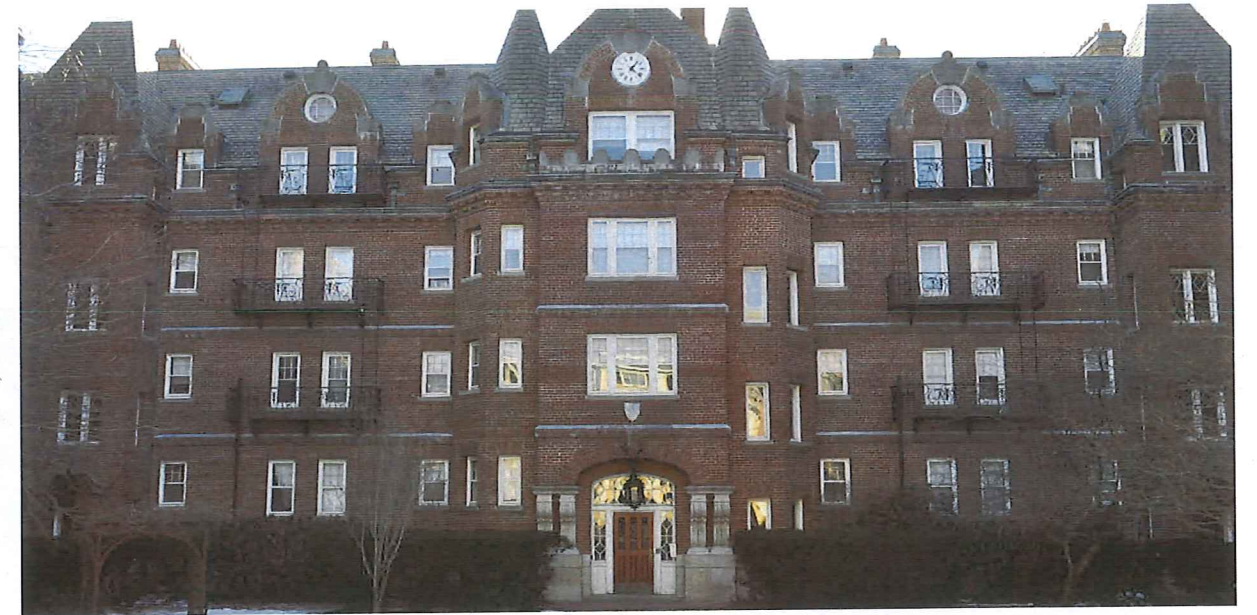
SOUTH COURTYARD BALCONIES WITH UNORIGINAL LADDERS AND WIDTH EXTENSIONS

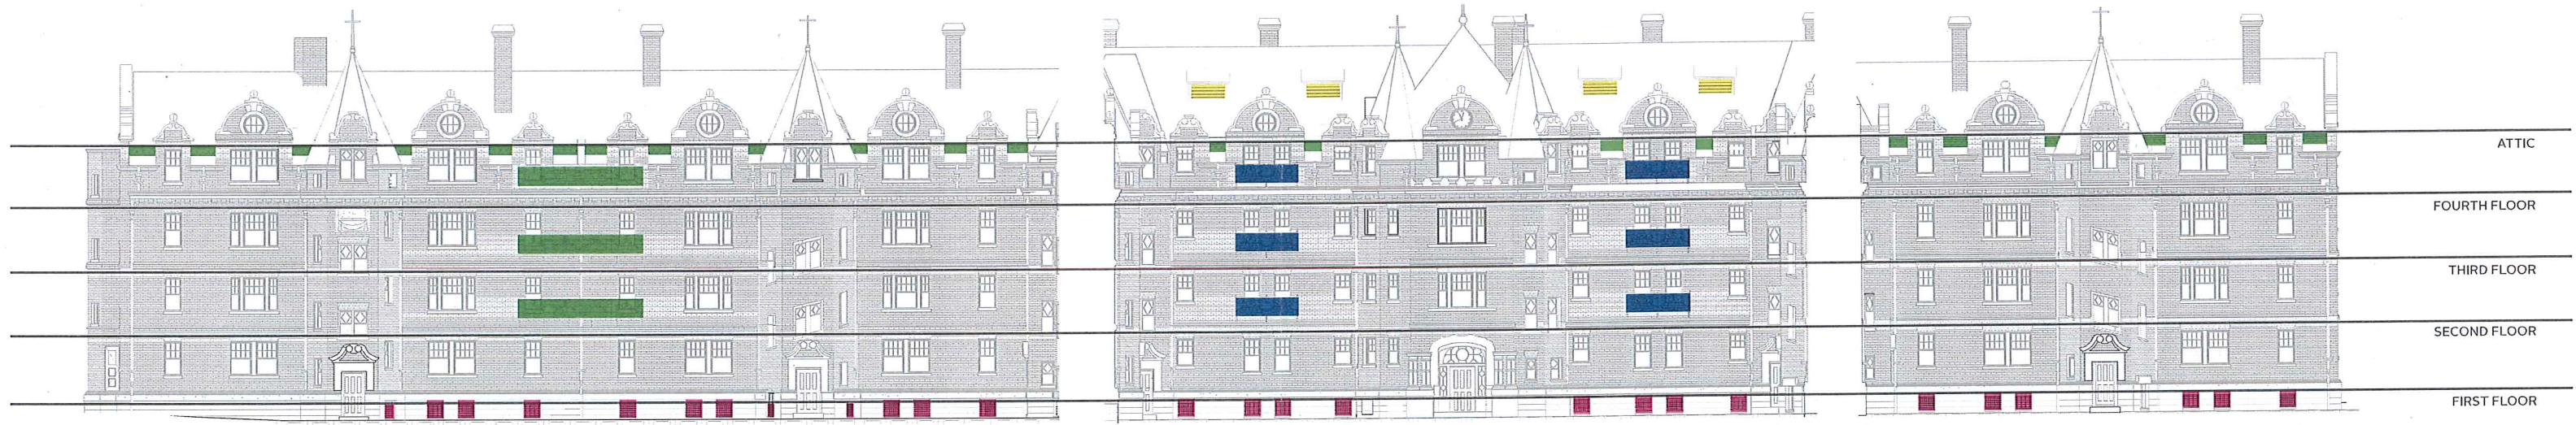
PROPOSED COURTYARD WEST ELEVATION (EAST WING)

PROPOSED COURTYARD NORTH ELEVATION (SOUTH WING)

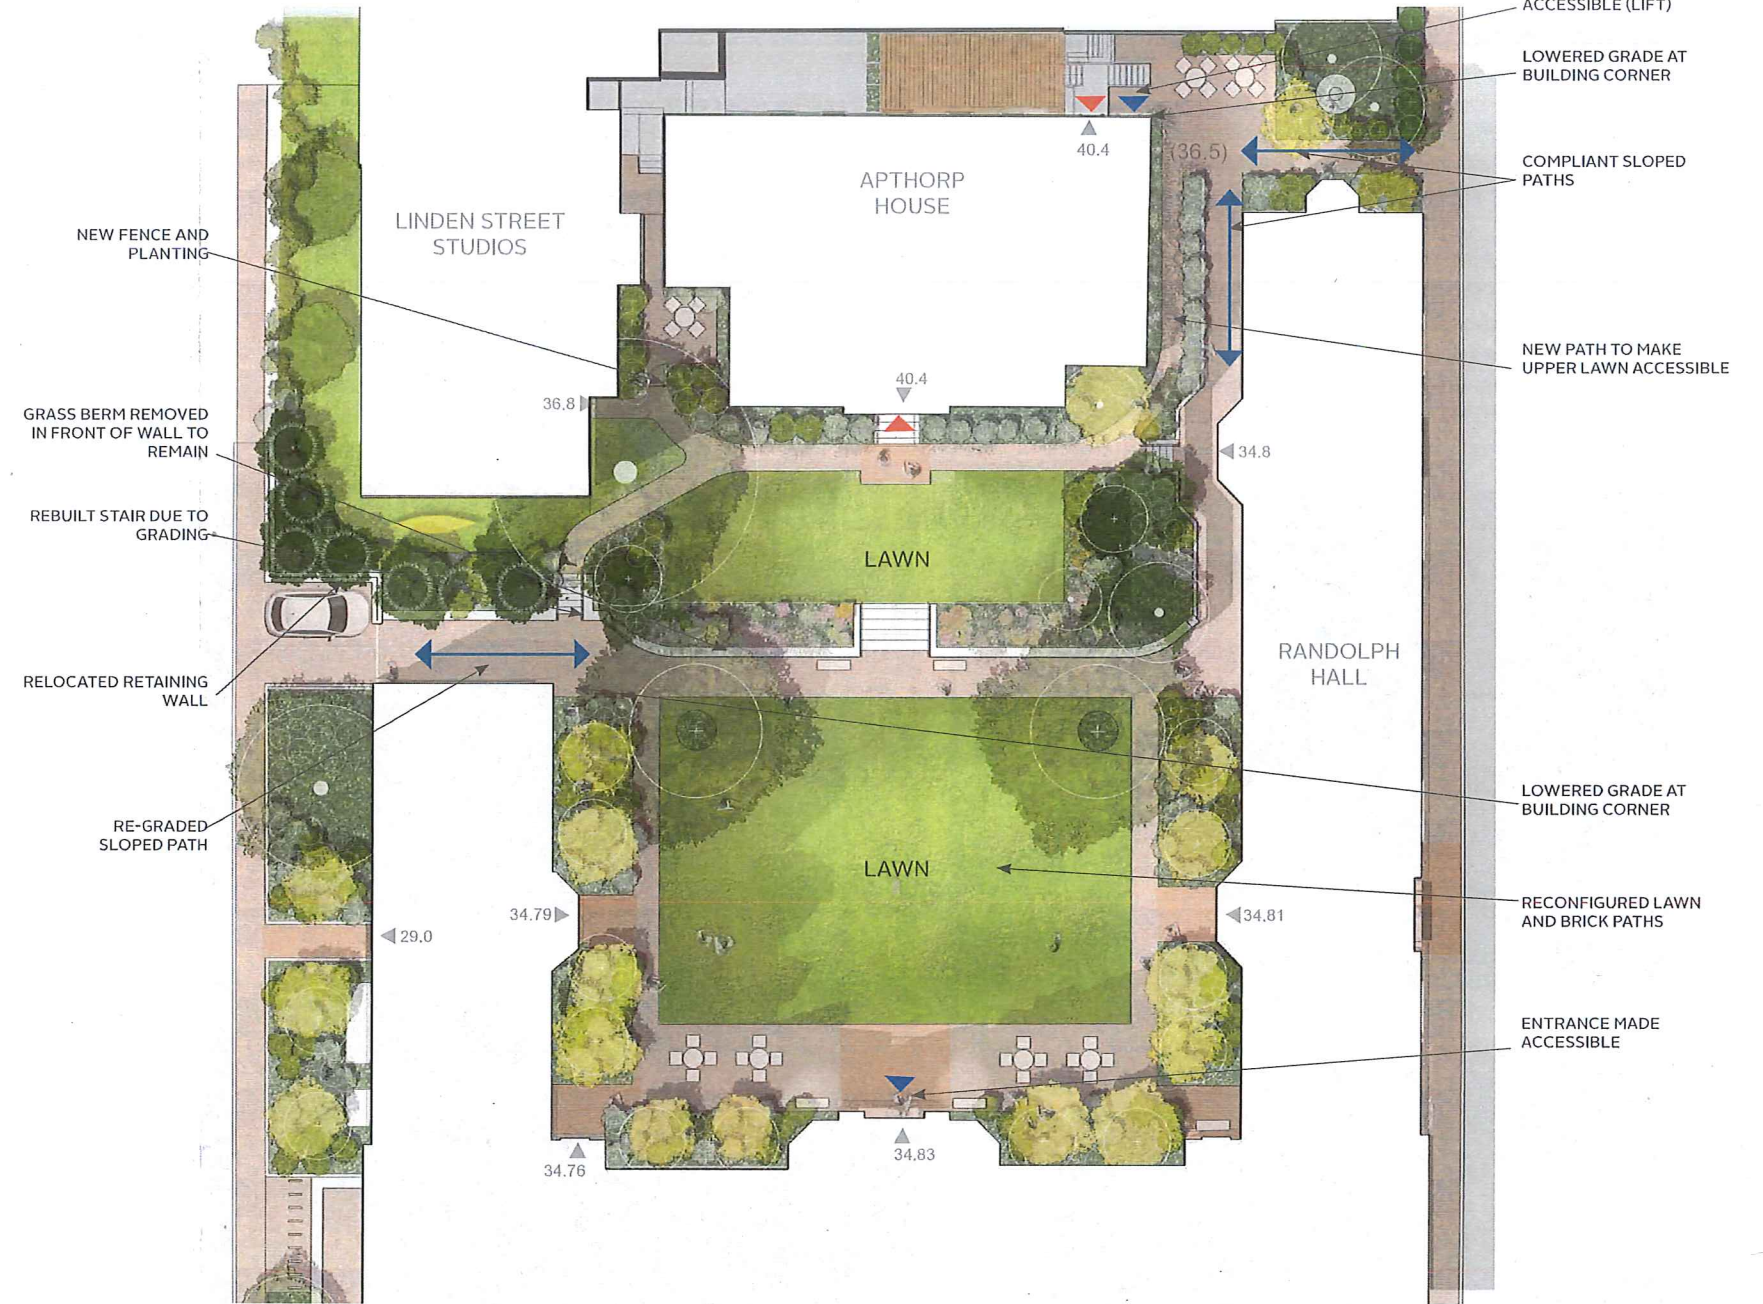
PROPOSED LANDSCAPE DESIGN

The proposed changes to the landscape comprise an overall rationalization and improvement to the hardscape, walking paths, and plantings as well as key upgrades to accessibility—since none of the upper or lower courtyard spaces are currently accessible—while maintaining the unique sense of historic character. The brick walks along the perimeter of the central lawn have been pulled away from the building to allow for planting beds and to soften the meeting of the building and the ground. To increase usable space for recreation, the lawn will be cleared of all plantings apart from a pair of larger trees. A more generous zone of hardscape will be located along Randolph's

south wing, which is shaded most of the year and has less optimal growing conditions. The non-historic grass berm against the historic retaining wall will be removed. The existing granite center stair, installed ca. 1999, plays a key role in the House's diploma ceremony each May. It will be reconfigured and re-formalized, embedded into the existing retaining wall and given a more generous width. Improvements at the Linden and Plympton gates will make both courtyard entries accessible, while a compliant route along the east wing of Randolph provides access to the accessible Apthorp entry and upper lawn. Discrete handrails will be added to all stairs.

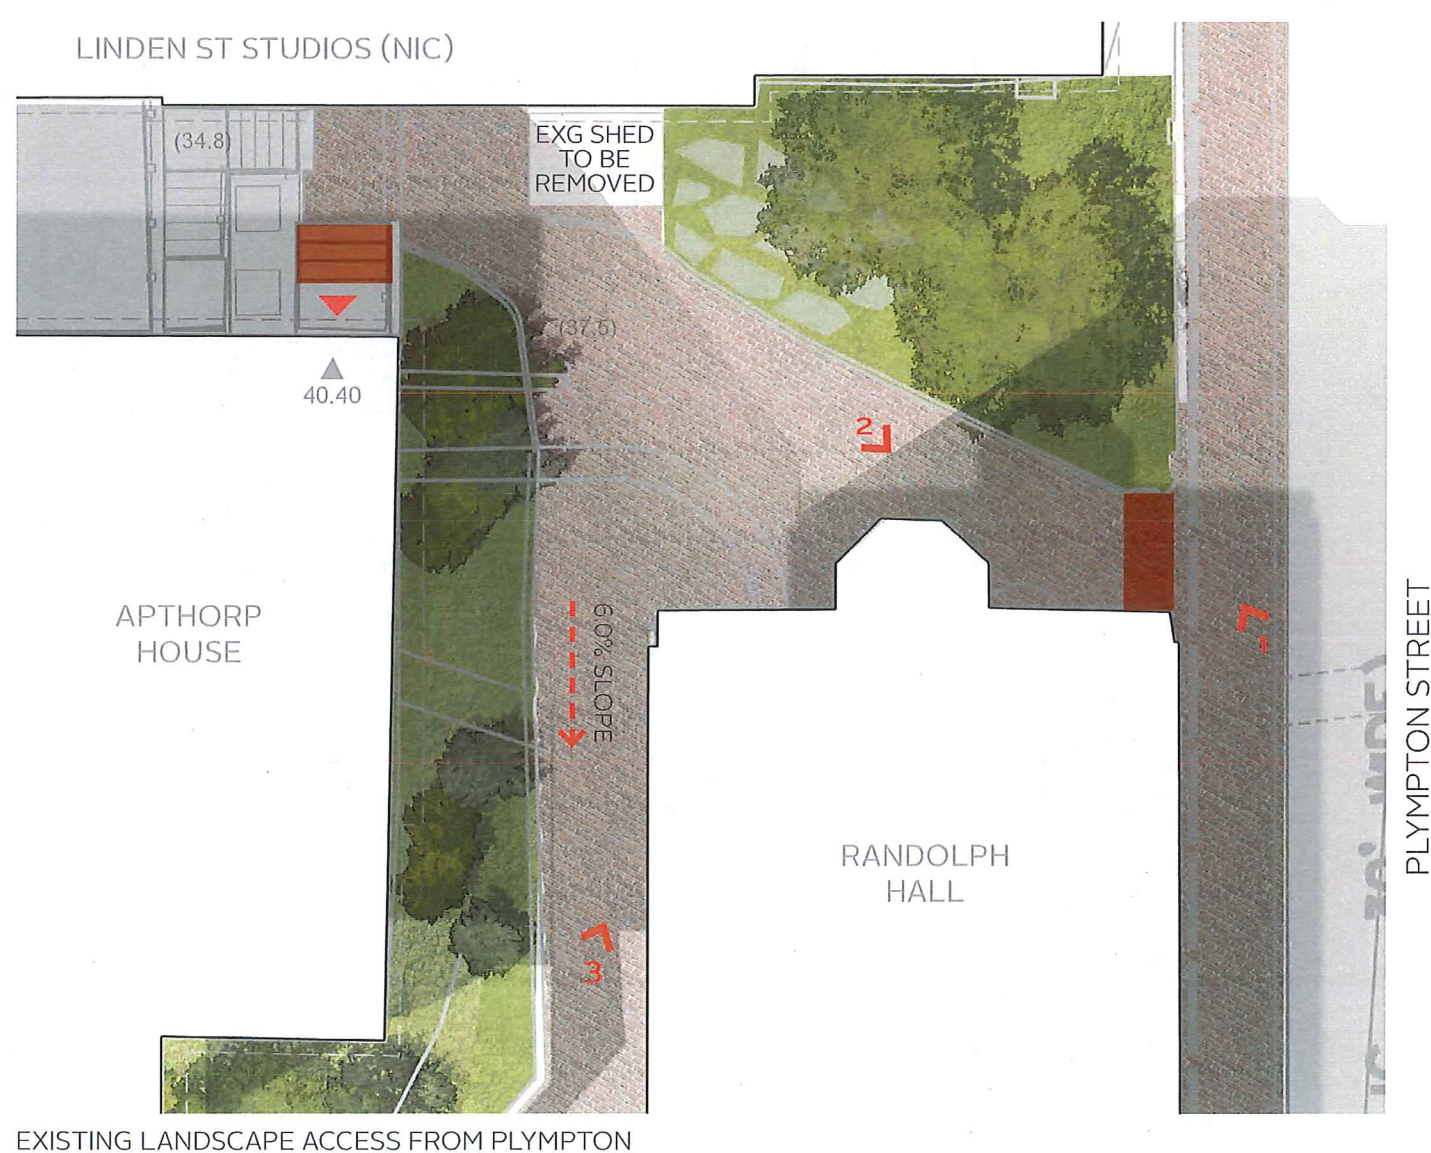
EXISTING LANDSCAPE ACCESS FROM PLYMPTON

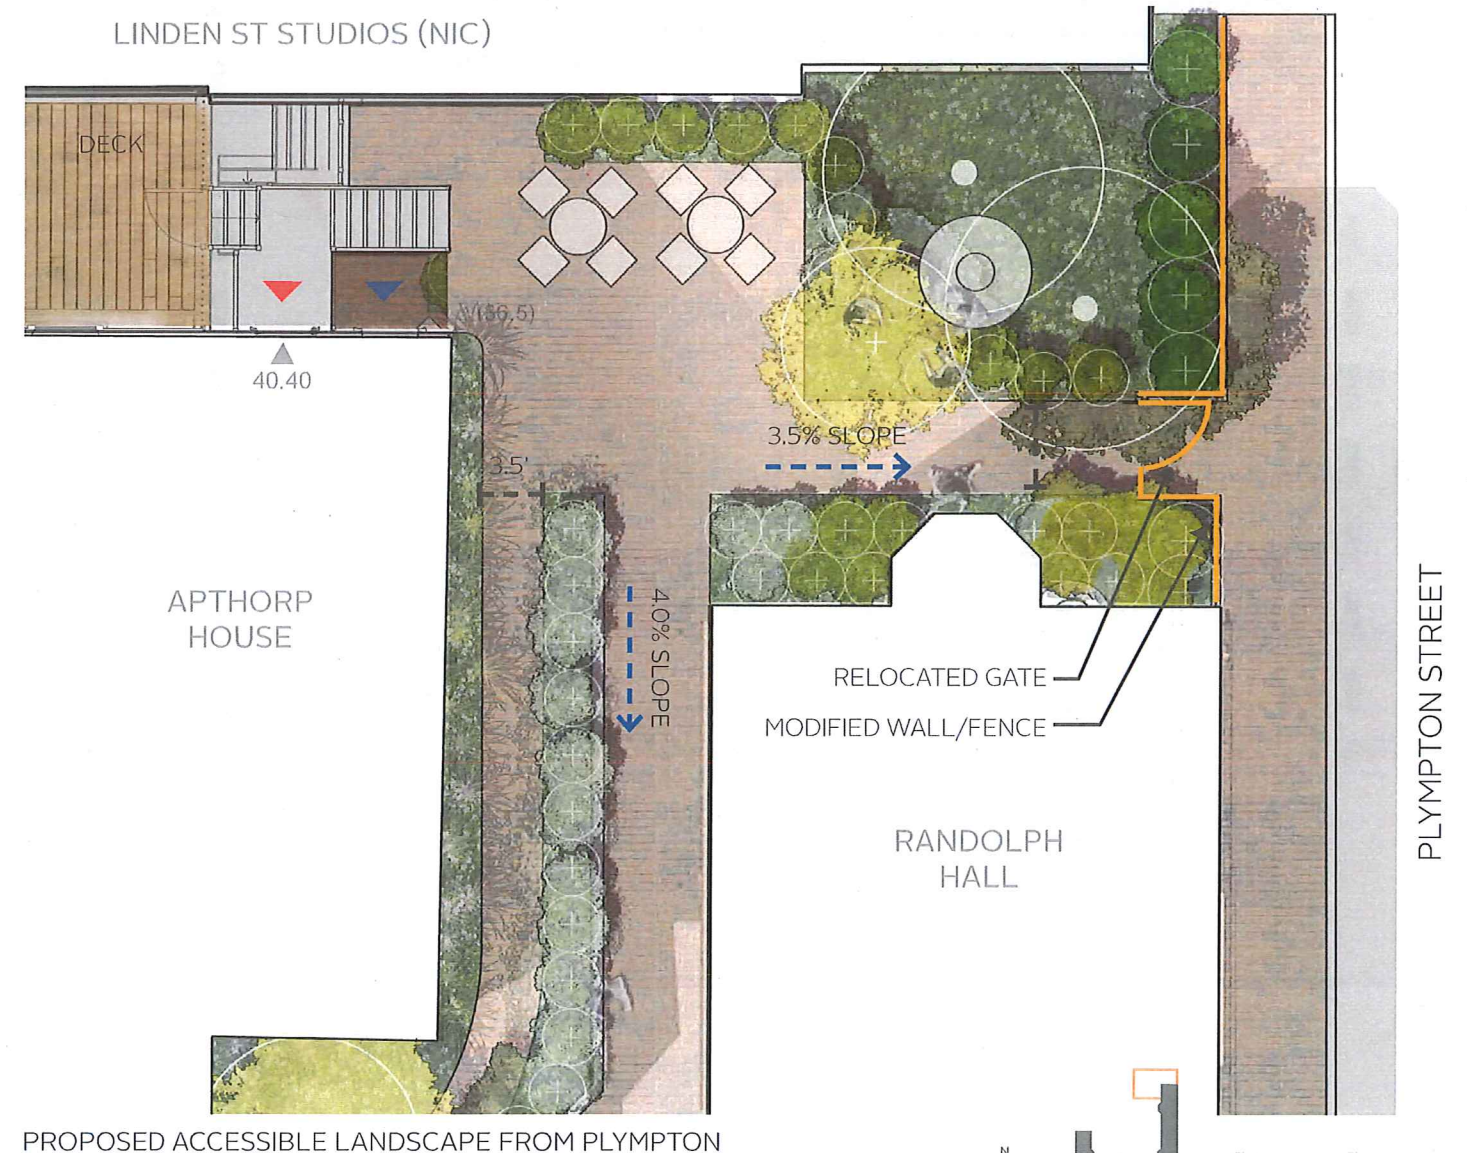
PROPOSED ACCESSIBLE LANDSCAPE FROM PLYMPTON

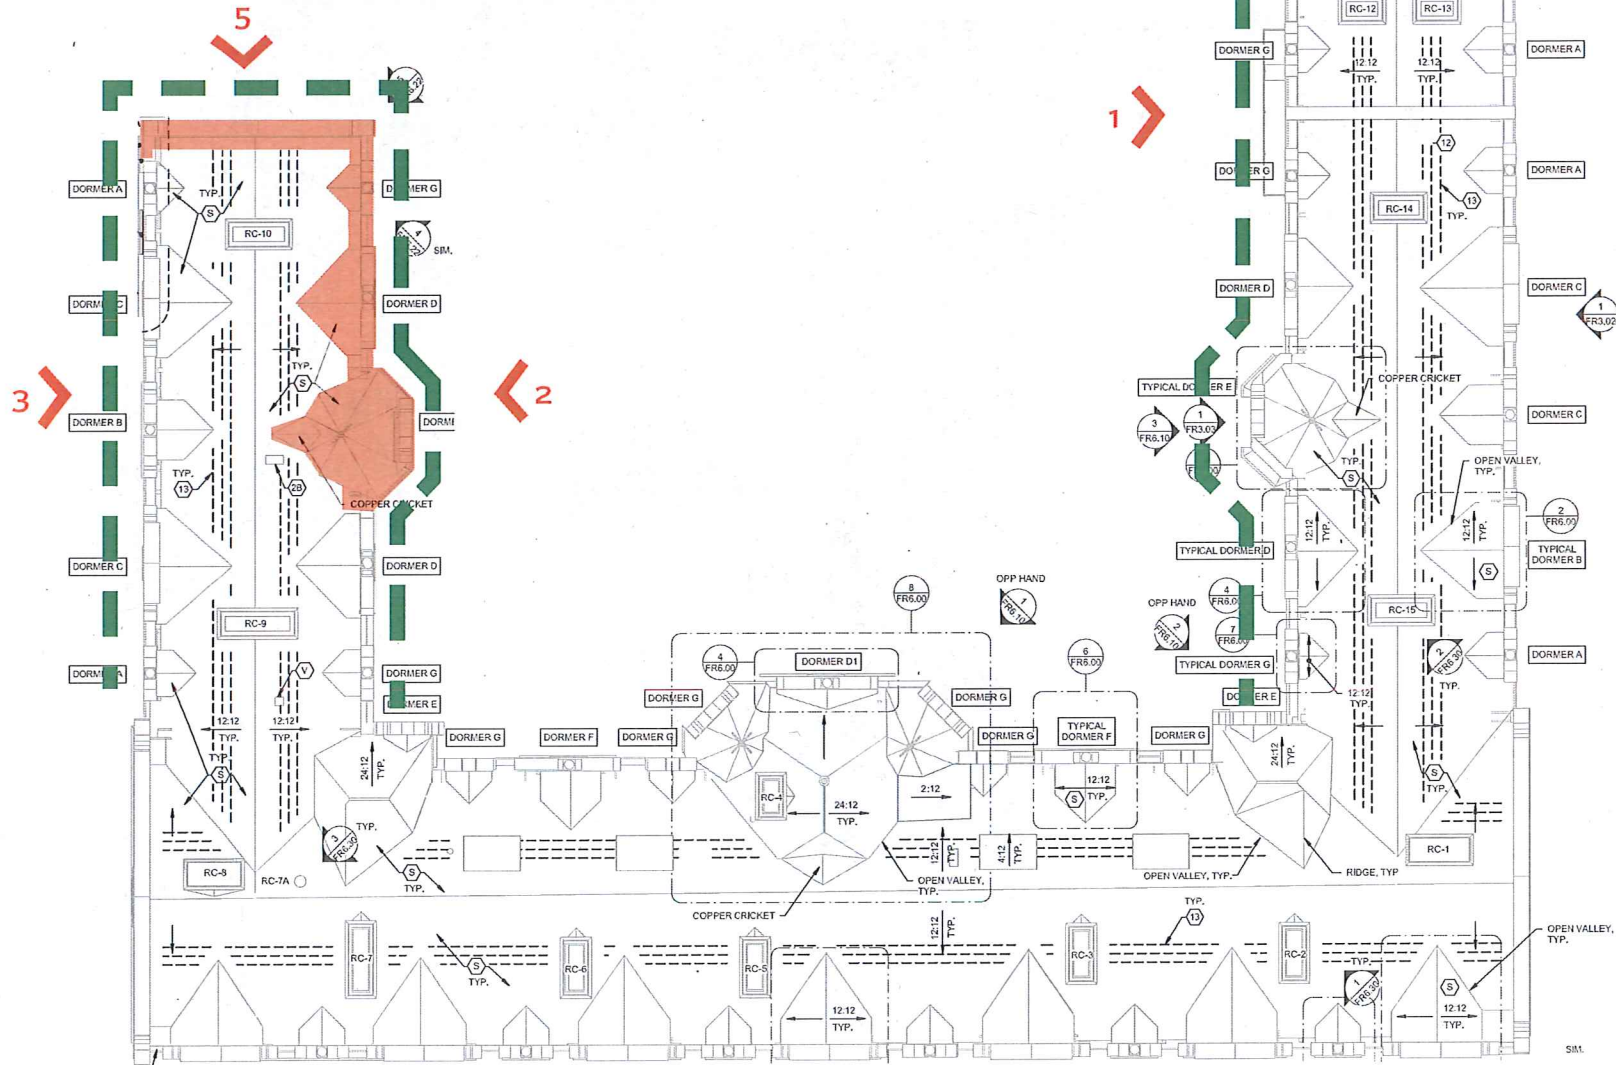
ROOF PLAN

scope includes: masonry repair and restoration along the north, east, and west facades of the west wing; the north and west facades of the east wing; restoration and reconstruction of the roof and brick masonry of three different types of dormers on each wing, and selective window restoration (sash replacement and frame restoration). The proposed exterior window trim color has been reviewed with CHC staff and approved.
