Synthetics in Cambridge Historic Districts

Charles Sullivan

Cambridge Historical Commission

September 22, 2017 (updated September 7, 2018)

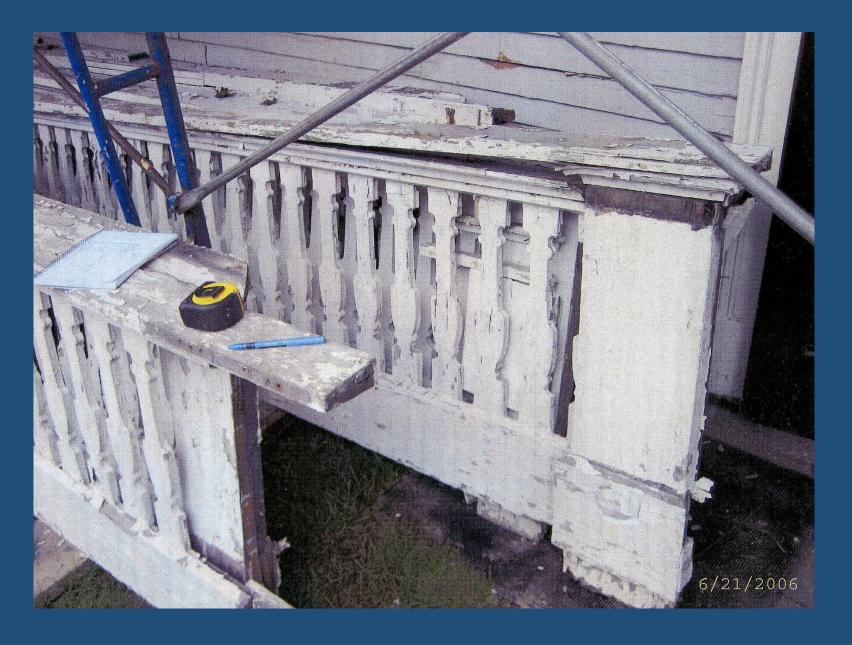
Dana Palmer balustrade in 2006.

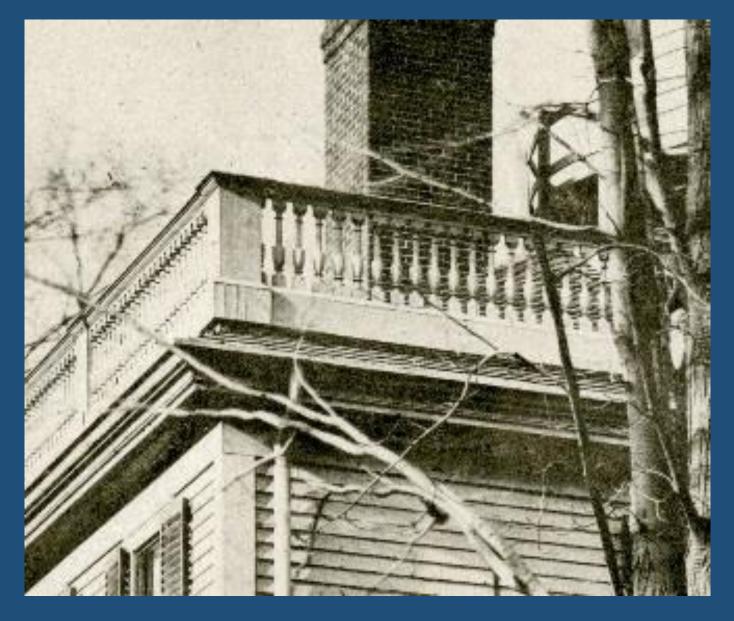
Dana Palmer House balustrade in 1874.

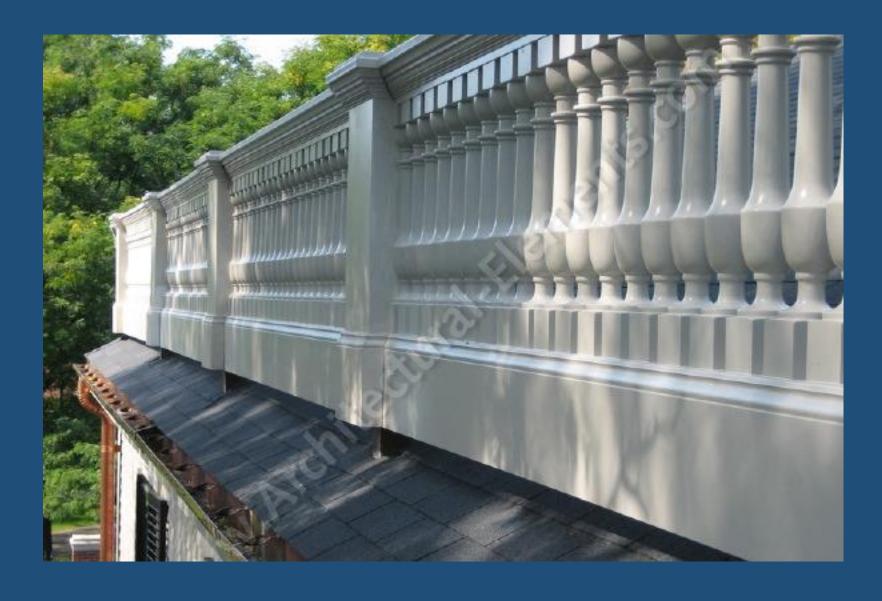
Reproduction high-density polyurethane balustrade, 2006 http://www.architectural-elements.com/reproduction-balustrade.html

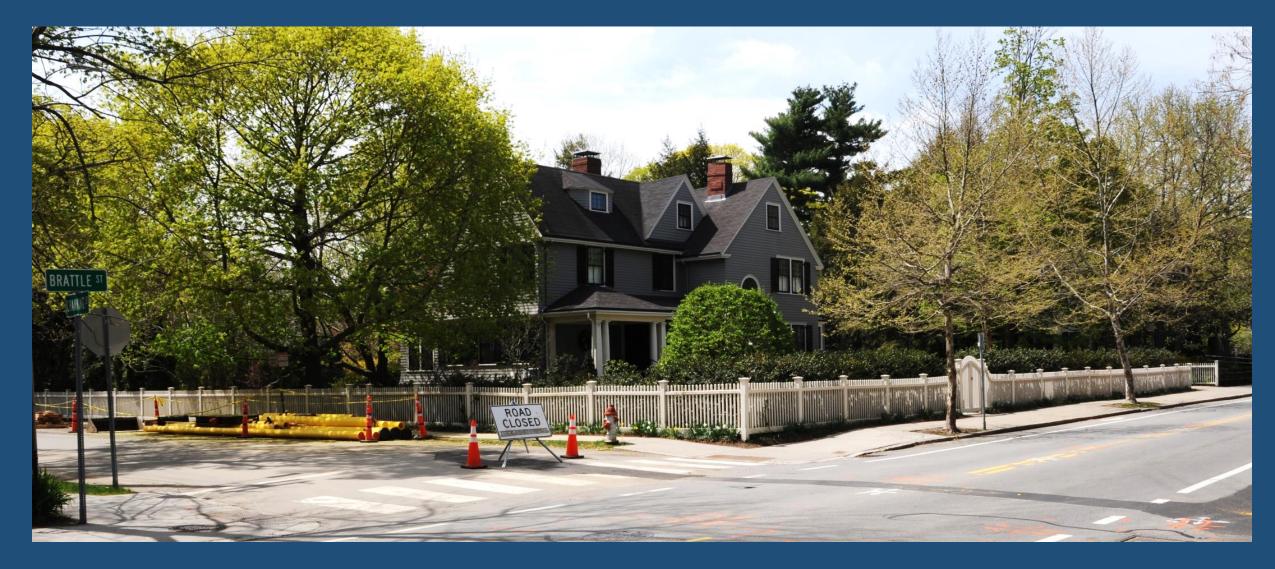
394' of wood fence installed with a Certificate of Appropriateness in 2003. Photo 2015.

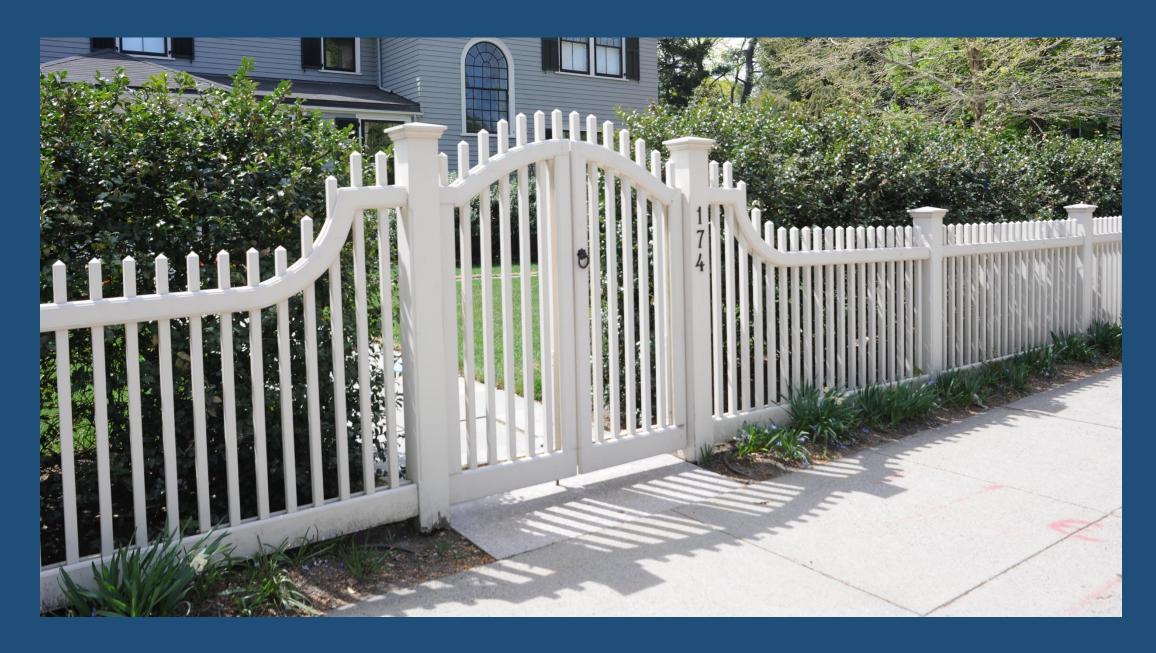
174 Brattle Street. Wood fence and gate installed 2003. Photo 2015.

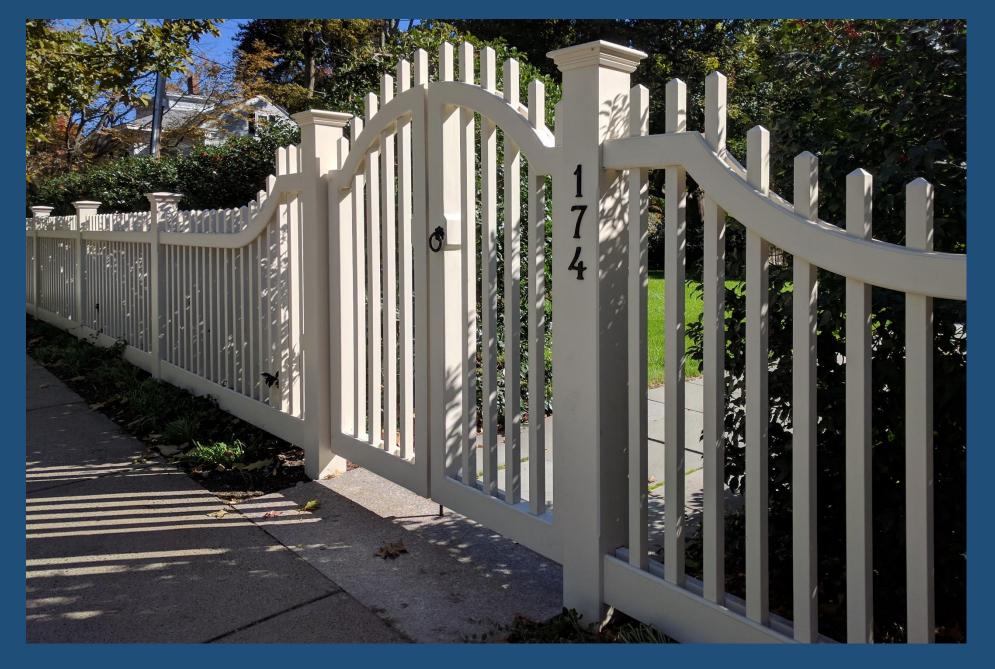
174 Brattle Street. PVC fence and gate installed 2015. Photo 2017.

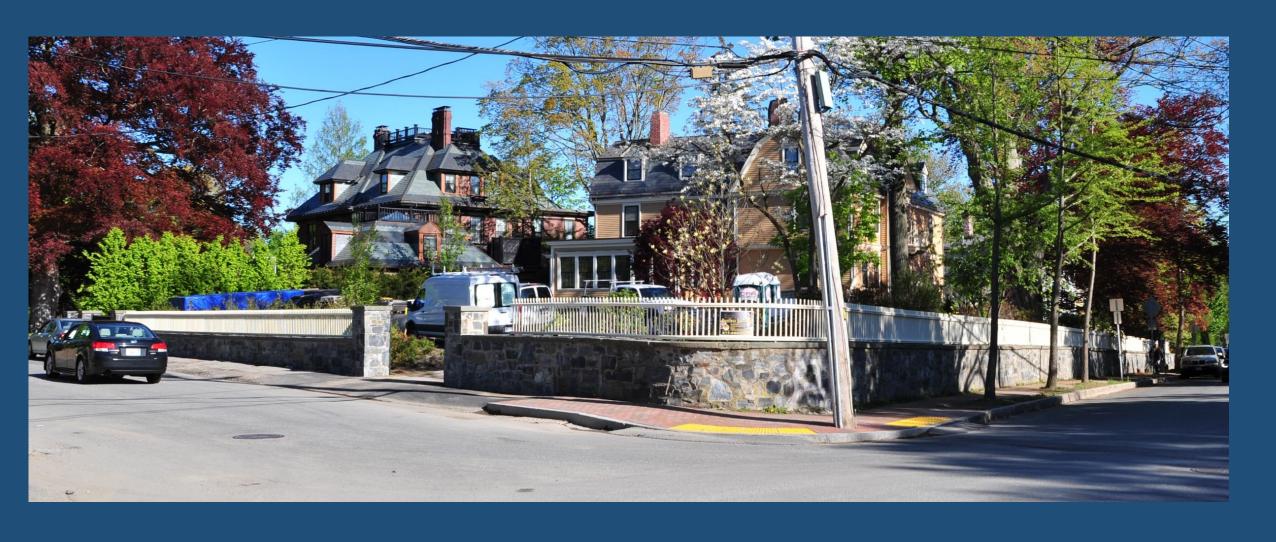
28 Fayerweather Street (1882, Sturgis & Brigham, architects). Cambridge Landmark. 350' fence reproduced from historic photographs.

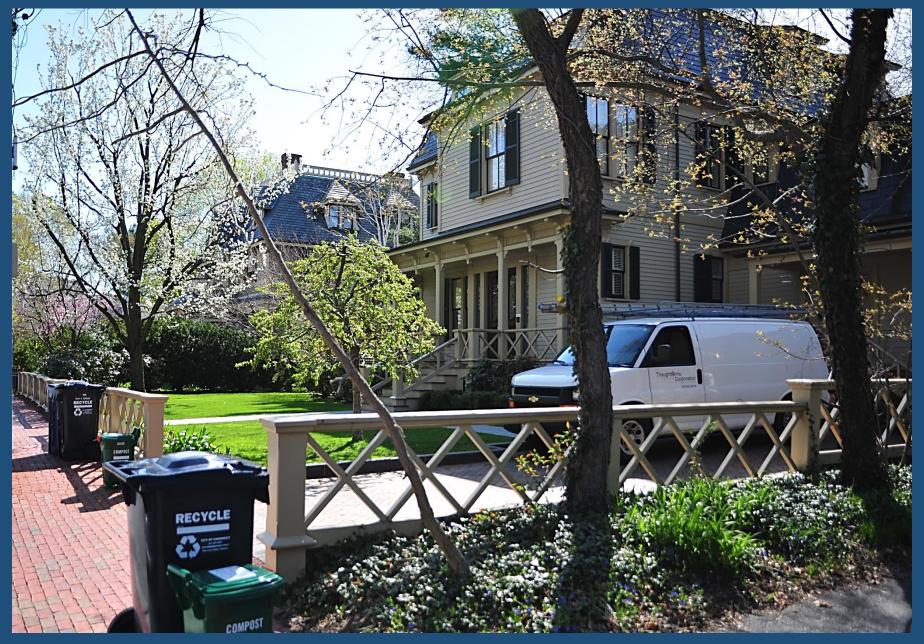
8 Follen Street (1872) with replica wood fence (ca. 1991), May 2018

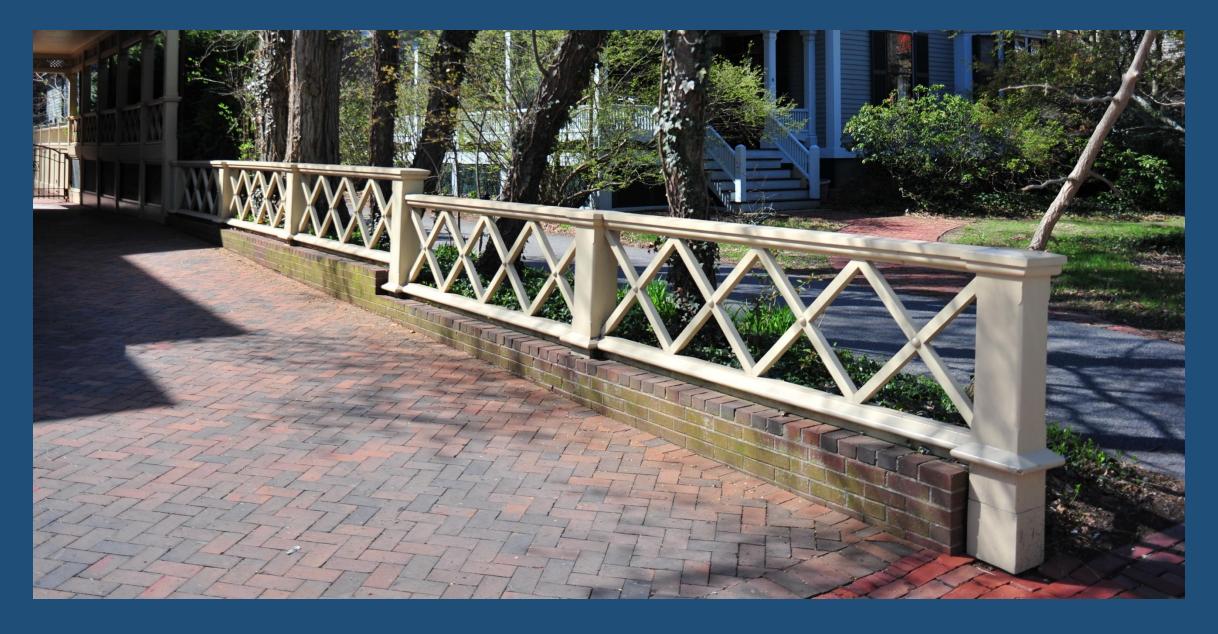
8 Follen Street (1872) with replica wood fence (ca. 1991), May 2018

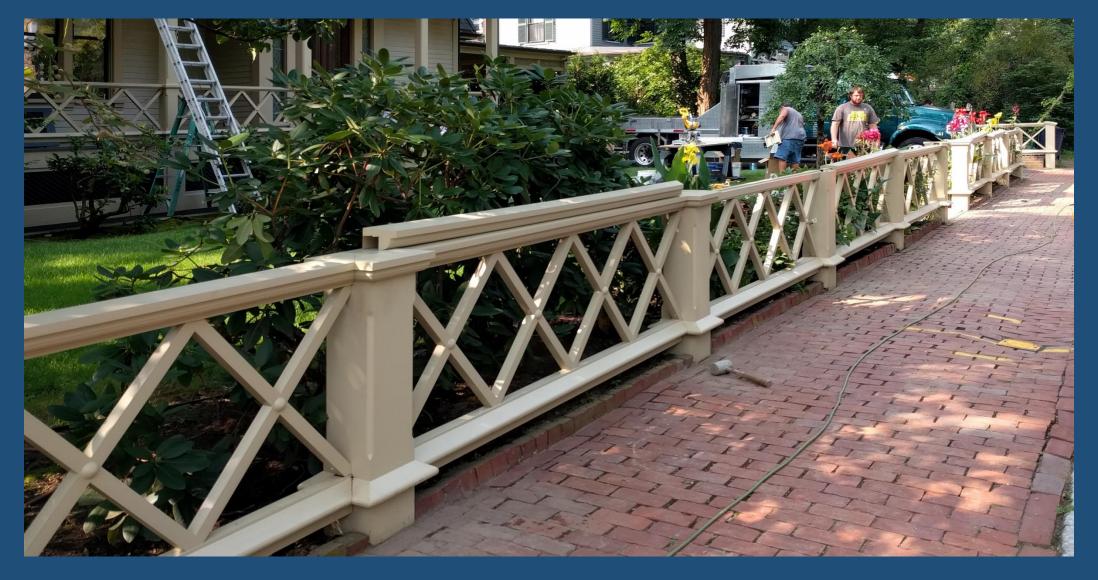
8 Follen Street, Old Cambridge Historic District Replica PVC fence under construction, August 2018

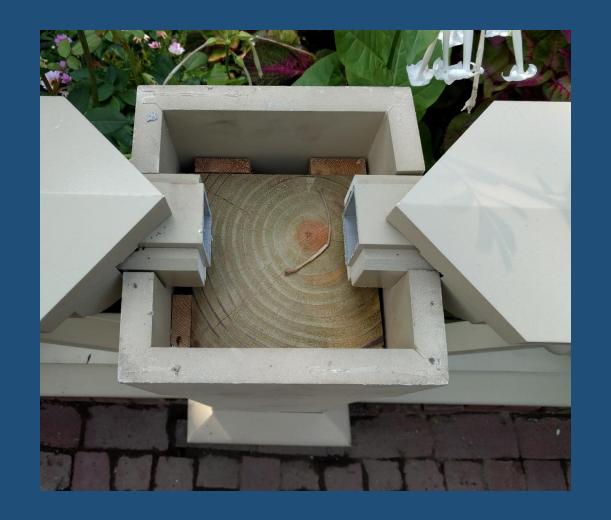
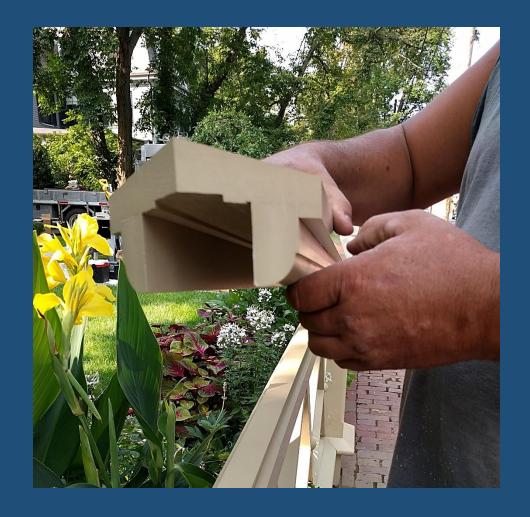
8 Follen Street, details of post and top rail PVC construction Contractor: Perfection Fence, Marshfield, Mass.

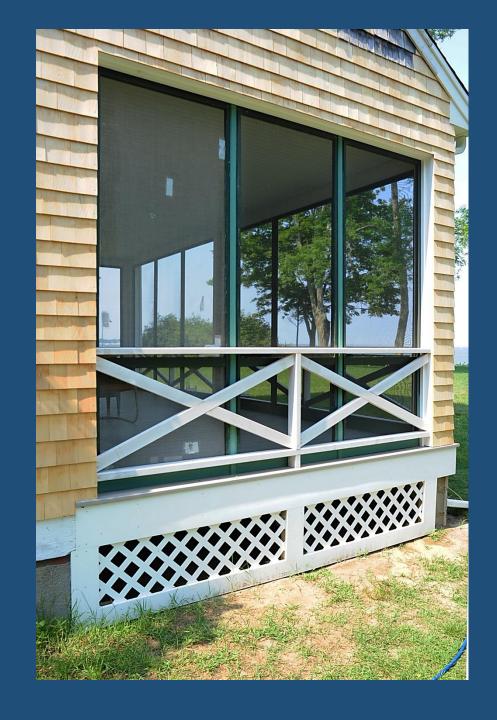
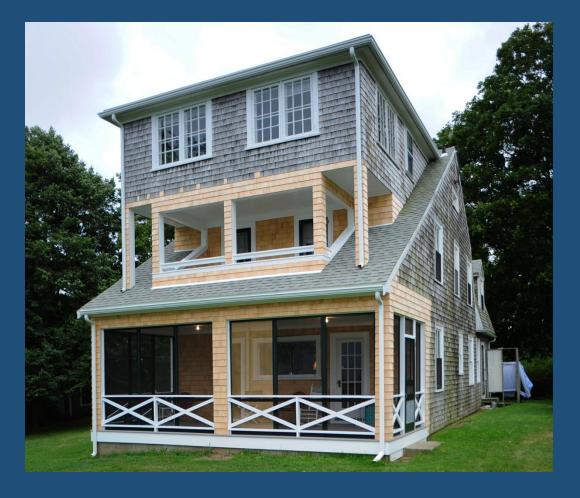
Duxbury, Mass.
Porch reconstruction with PVC railings and trim, 2012.

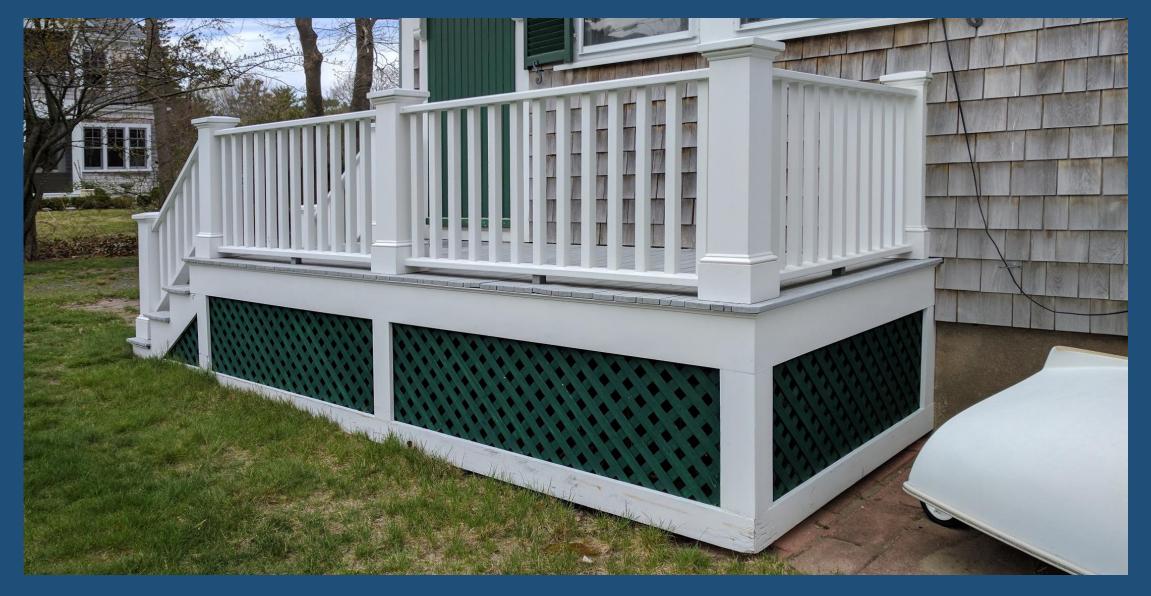
Duxbury, Mass. Deck and railing built with wood in 2010, partially replaced with PVC 2015. Photo 2016.

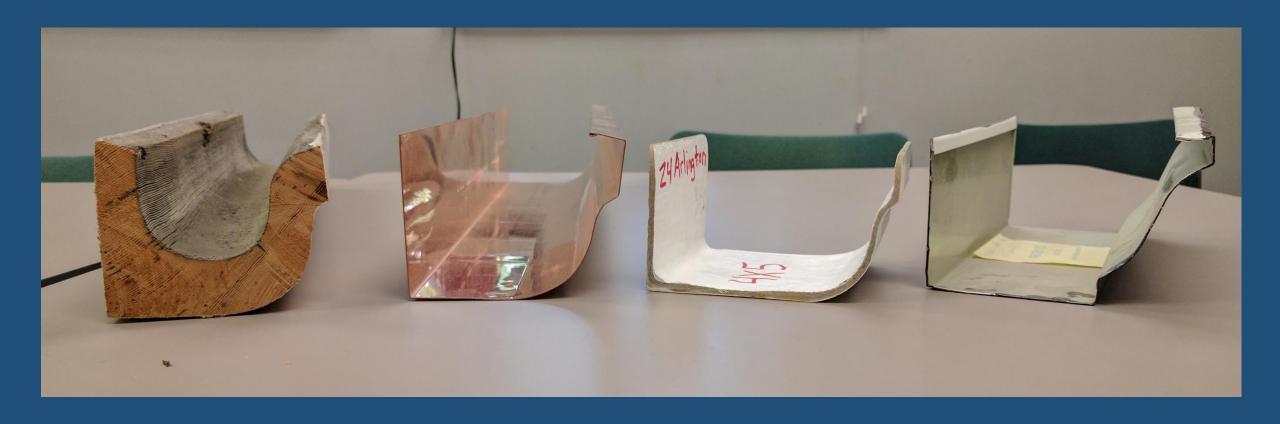
Wood, copper, fiberglass, and aluminum gutter sections

The Commission also allows wood gutters to be replaced with copper or fiberglass as long as the profile matches the original or existing profile.

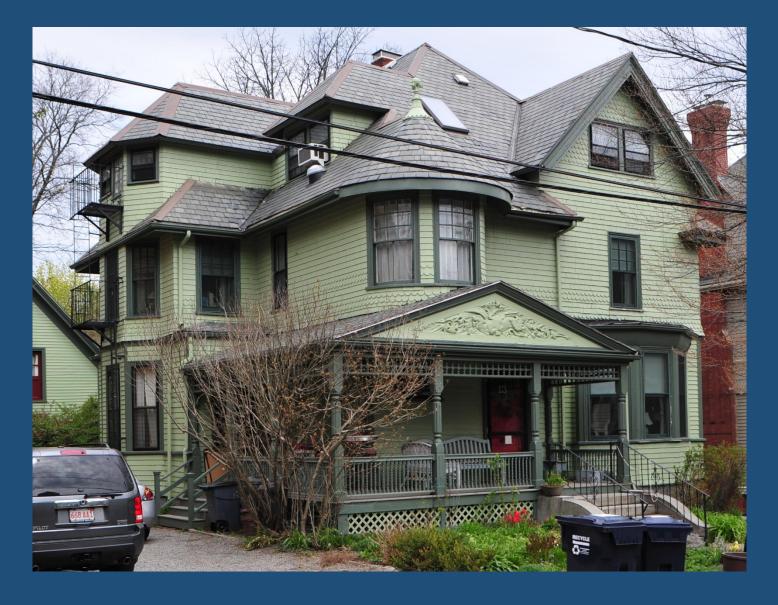
13 Lancaster Street (1885). Avon Hill Neighborhood Conservation District. Slate roof, K-Style gutters and bare fascia. Photo 2016.

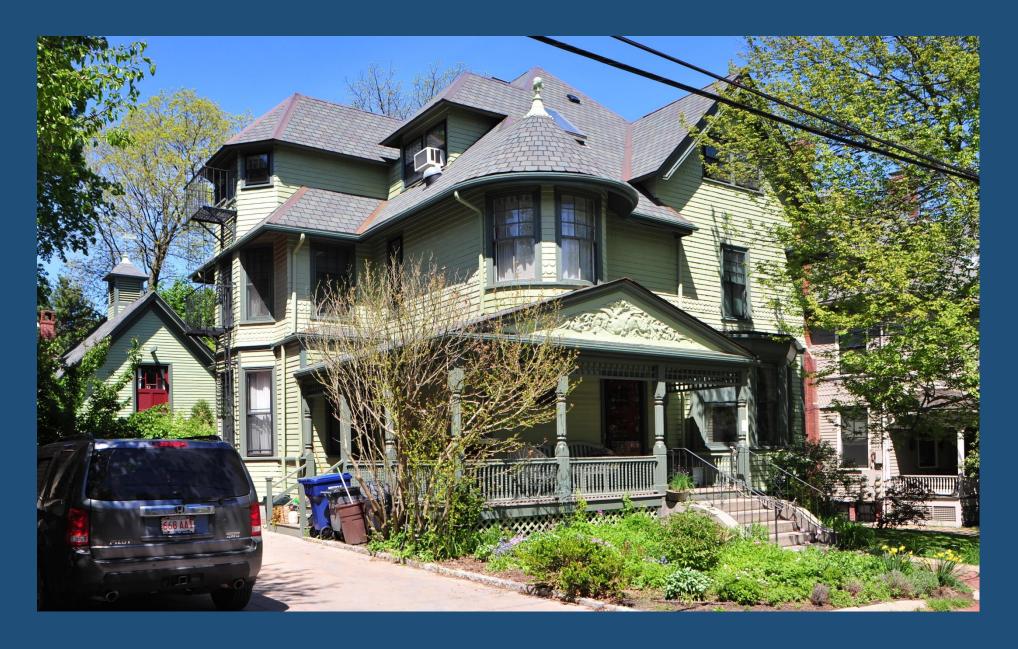
Asphalt shingles with custom-made curved fiberglass gutter, 2016. Photo 2017.

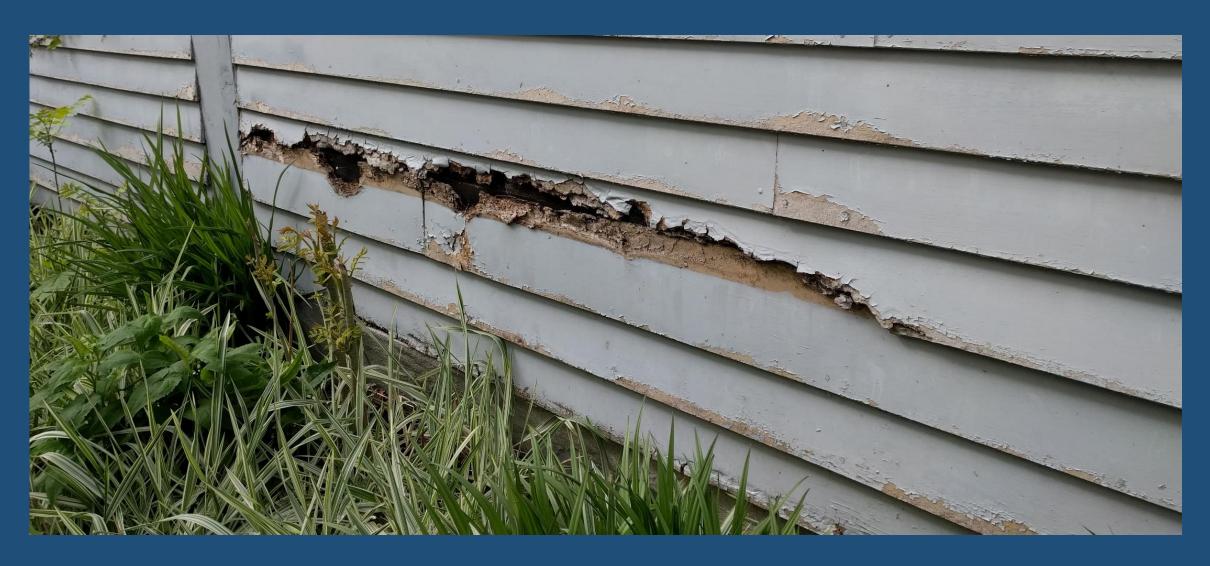
Masonite clapboards, 10 Salem Street (ca. 1971)

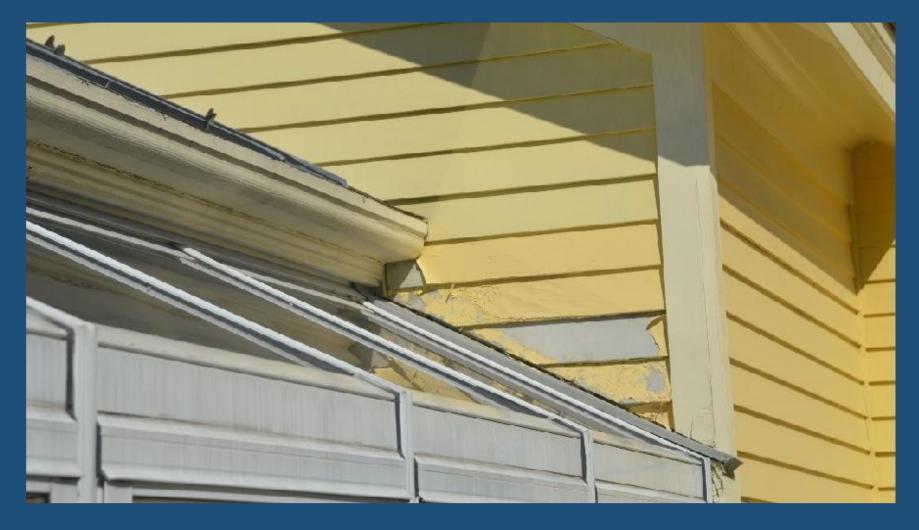
Old Cambridge Historic District
New construction 2005: Hardiplank clapboards with wood trim and gutters.
Photo 2016.

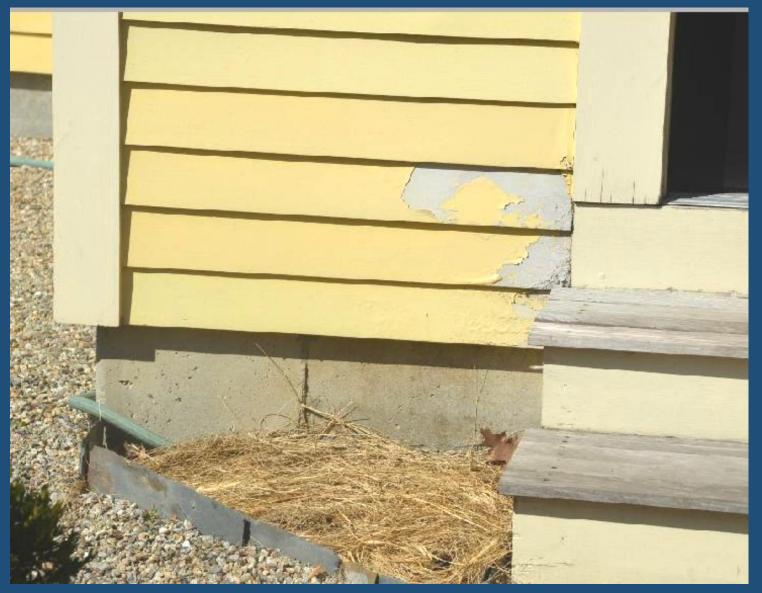
2005: new construction

2009: repair soffits

2012: replace wood gutters

2013: replace trim, gutters

2016: replace Hardiplank in kind,

wood trim with Azek, line gutters

with copper

Photo 2016

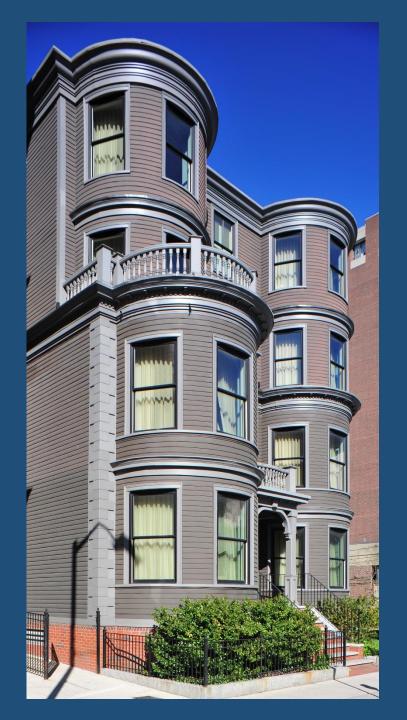
Will it last?

Veritas Hotel, 1131 Massachusetts Avenue (2008, Boyes-Watson Architects)

New construction; all-PVC exterior
