**WHY DO WE NEED TO  
MAINTAIN THE WATER  
DISTRIBUTION SYSTEM?**

## The Cambridge Water Distribution System

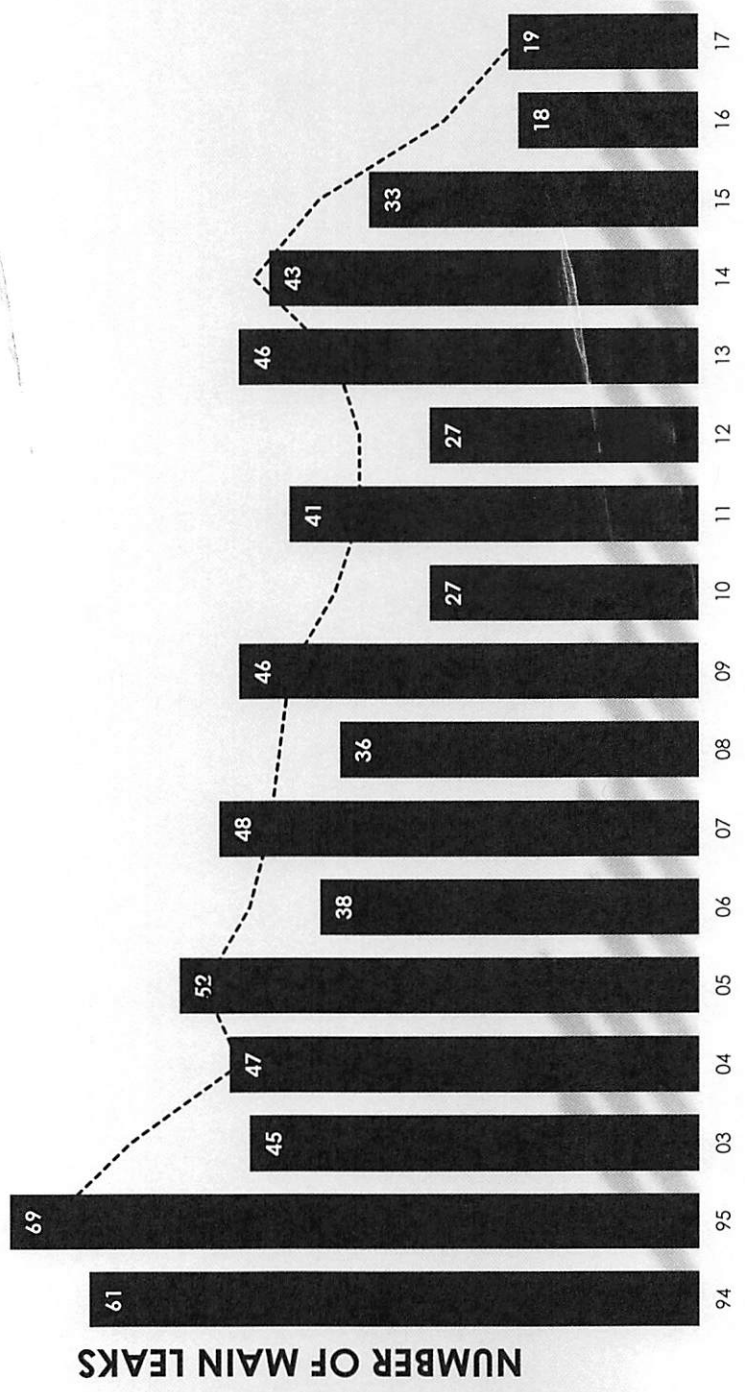
# MAIN LEAKS COMPARISON BY YEAR

MILES OF NEW WATER MAIN INSTALLED 1992 - 2017

SIZE	FT OF MAIN	MILES
4	1370.34	0.26
6	14107.9	2.67
8	106987.85	20.26
10	15705.55	2.97
12	68045.34	12.89
16	8336.73	1.58
20	483.18	0.09
24	897.69	0.17
30	2534.31	0.48
36	2241.88	0.42
40	2904.31	0.55
42	4259.78	0.81
48	533.25	0.10
TOTALS	228408.11	43.26

CWD has been able to reduce the amount of annual leaks by approximately 50% since the early 90's

In the past couple of years CWD has been well below the Average of .25 leaks per foot of pipe established by The Water Resources Association
