Agenda – Glacken Slope Phase 6

Glacken Slope Restoration - Overview of Phases 1-5

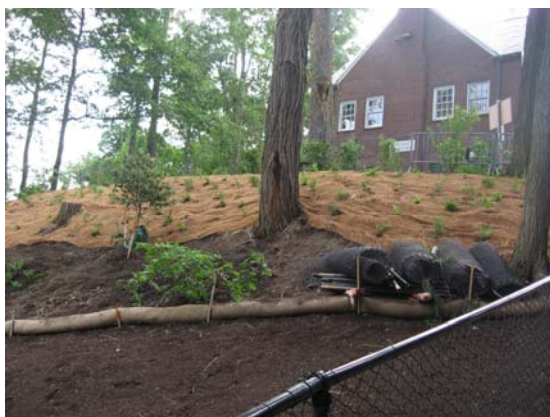
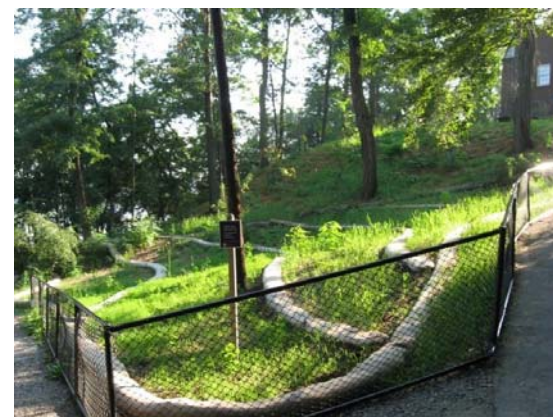
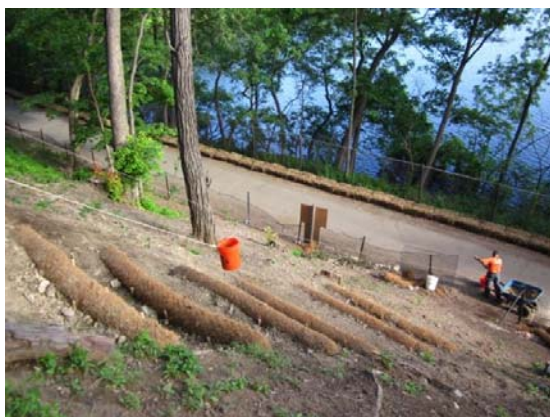
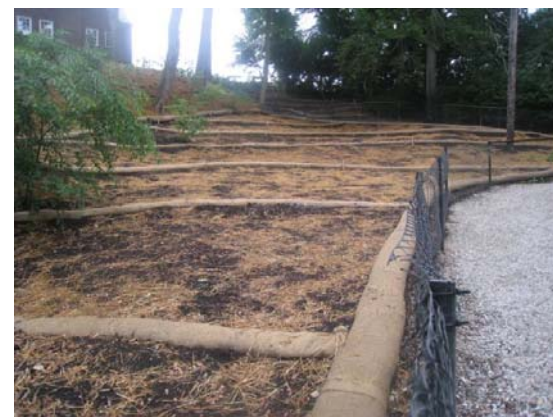
Slope Restoration (Phases 2 thru 4)

Slope Stabilization

Gully Repair

Woodland Soil
Amendments

Trail Closures

Invasive Species
Removal

Restoration Plantings

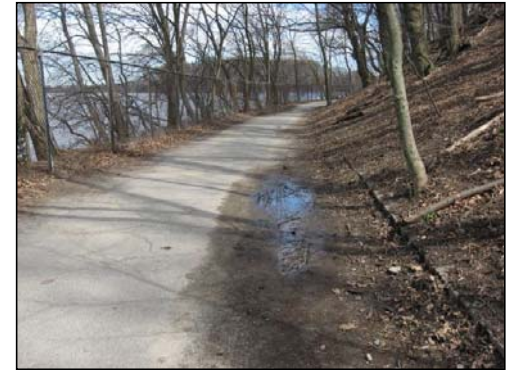
Slope Restoration (Phase 5)

Drainage Improvements to Perimeter Road

1. Cobble Swale
2. Porous Bituminous Concrete Perimeter Road

Improve Views of Fresh Pond / New Fence

Restoration Plantings

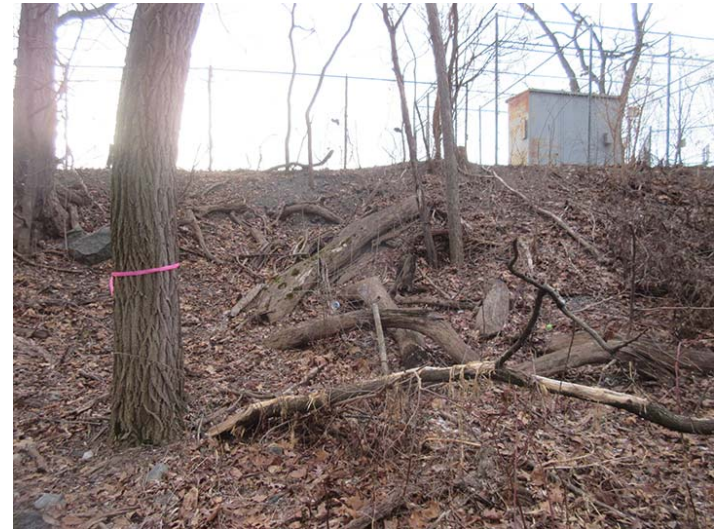
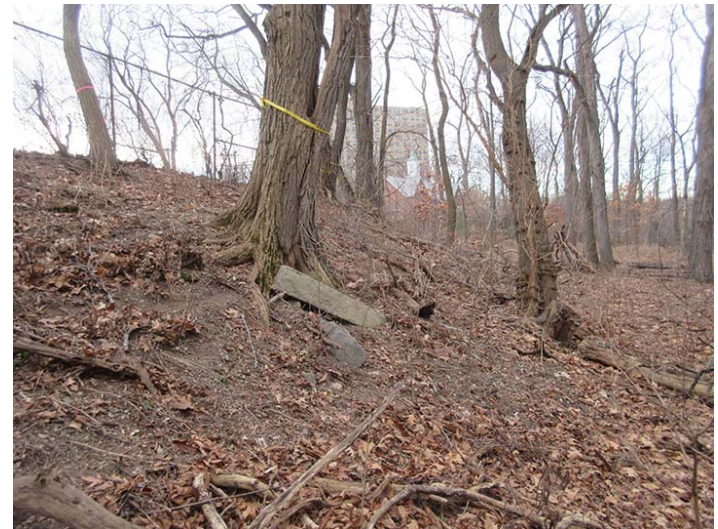
Site Inventory - Slopes

1. Three Categories:
 - 0 to 5%
 - 5 - 33%
 - 33% and steeper
2. Historic erosion / gullies
3. Less stable / loose material
4. Urban Fill soils

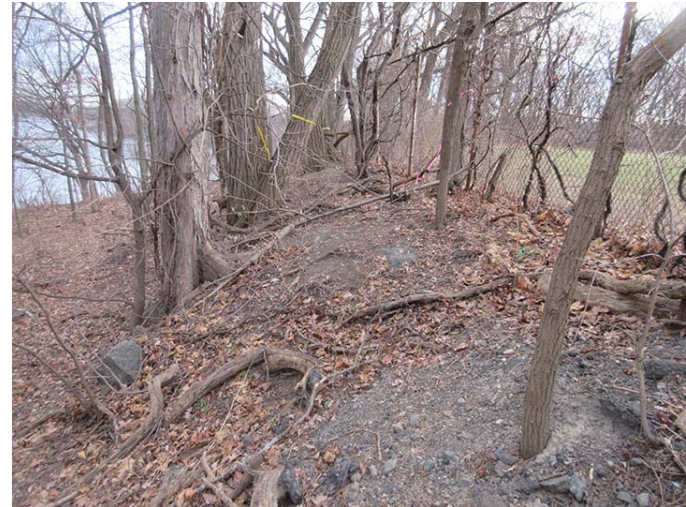
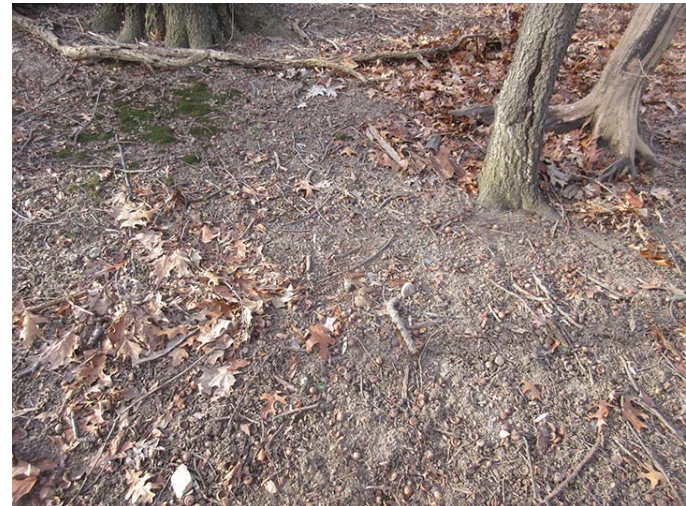
Soil Sampling Locations

- A. Physical & Chemical, Compaction
- B. Physical & Chemical
- C. Physical & Chemical, Biological
- D. Compaction
- E. Biological
- F. Compaction

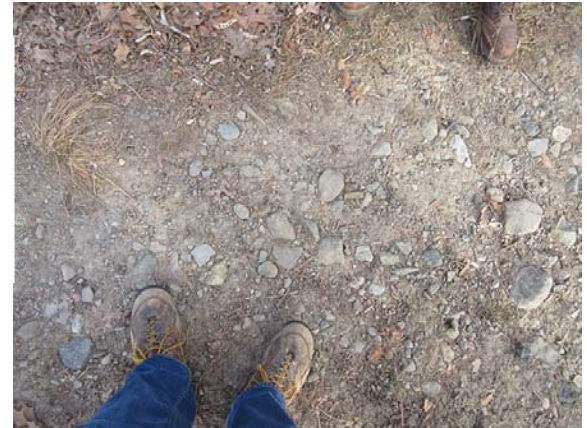
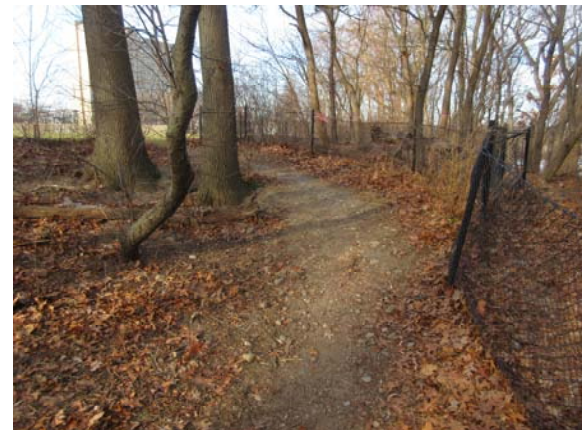
Soils Inventory – Compaction

Pocket Soil Penetrometer:

1. Measures Compressive Strength (Tons/Sq. Ft)
2. Locations (3):
 - Athletic Field (turf) 0.09 (very soft)
 - Forest Floor (flat) 0.10 (very soft)
 - Woodland Trail 0.20 (firm)

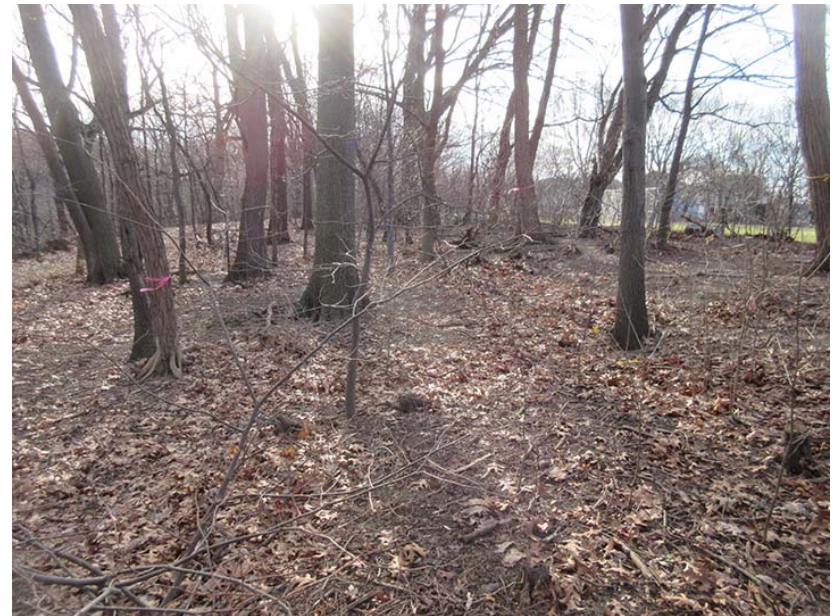
1. Natural Community Type – Oak Hickory Forest
2. Forest Composition – closed canopy & mid successional
3. Well-drained sites
4. Open Understory – only invasives
5. Invasive Community – trees, shrubs and groundcovers
6. Tree Permit required for tree removals 8" cal. and greater

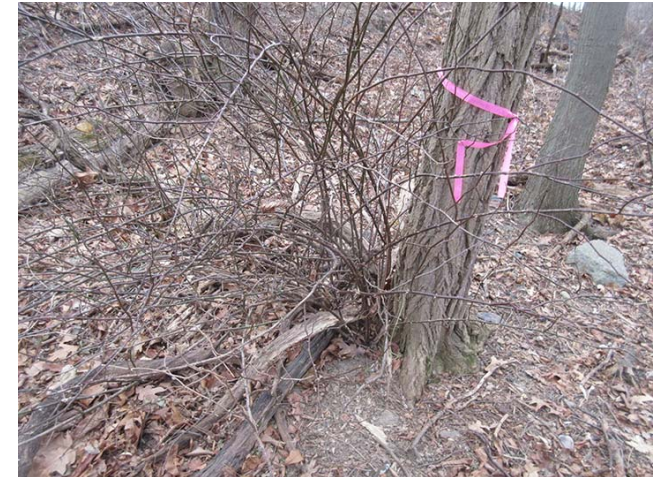
- *Invasive removals*
- *Debris removal (>1" dia.)*
- *Leaf compost amendment*
- *Gully repair & slope breaks*
- *Tree and understory planting*

- *Decompaction (select areas)*
- *Invasive removals*
- *Leaf compost amendment*
- *Woodland Edge planting*

- *Decompaction (select areas)*
- *Invasive removals*
- *Debris removal (>1" dia.)*
- *Leaf compost amendment*
- *Tree and understory planting*

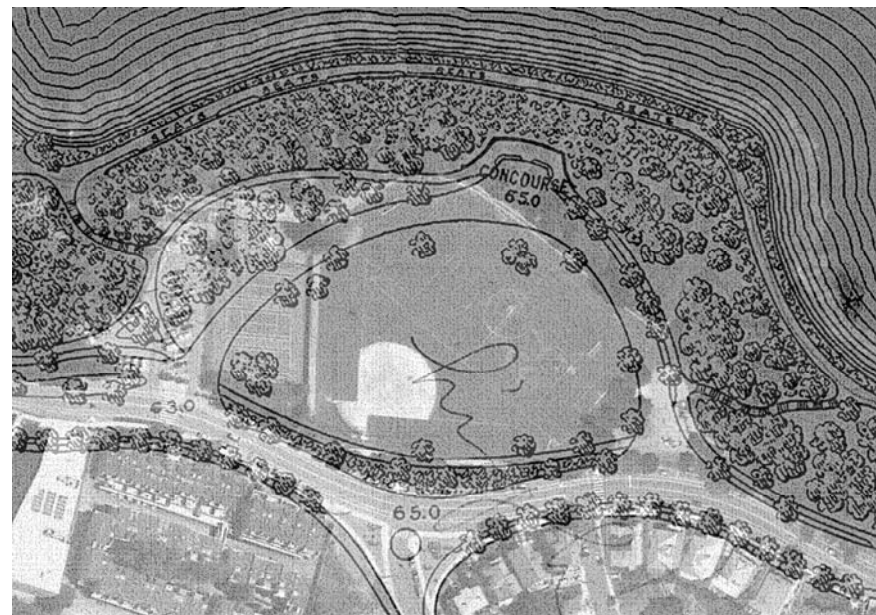
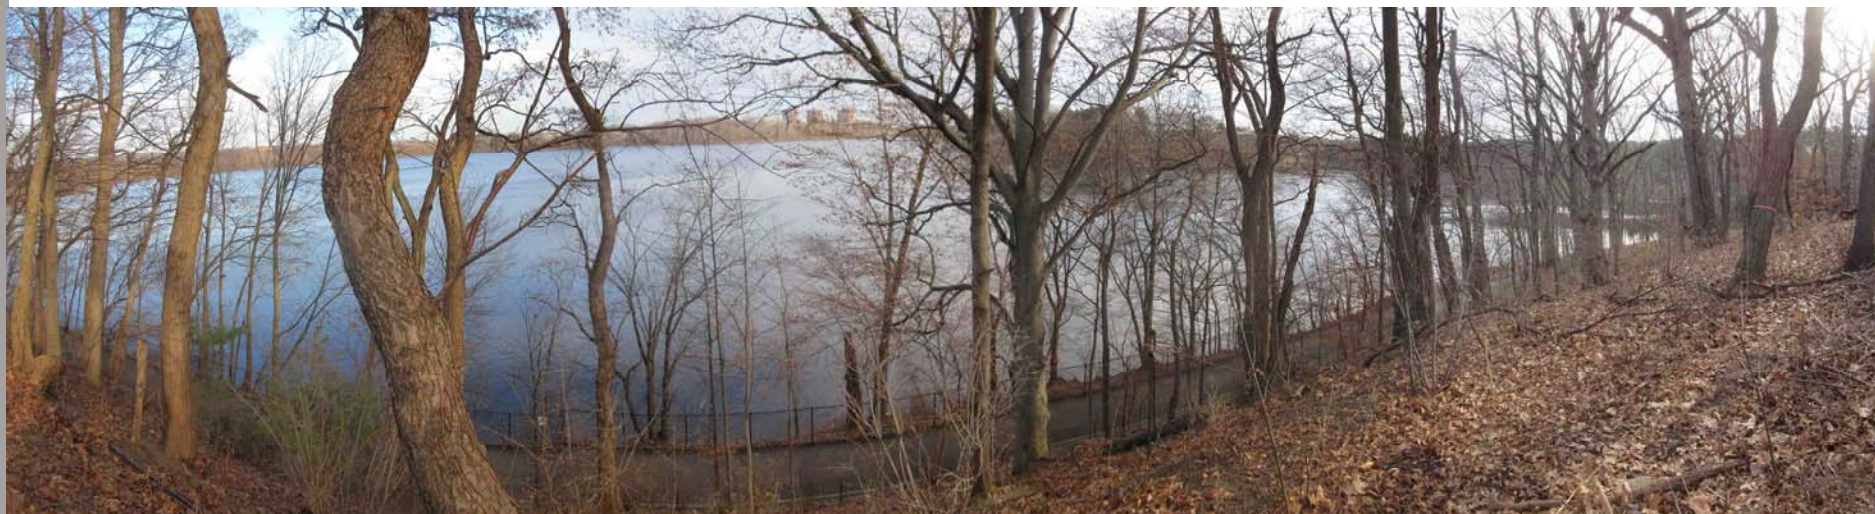
Proposed Path Alignment

All Alternatives

1. Ten foot (10') width
2. ADA-compliant
3. Porous bituminous concrete paving
4. Drains away from Fresh Pond
