50 YORK STREET – PHOTOGRAPHS OF EXISTING CONDITION

Impact of December 3, 2016 Fire on 50 York

**RE: 50 YORK STREET
CAMBRIDGE, MASSACHUSETTS**

SUBJECT: FIRE DAMAGE INVESTIGATION

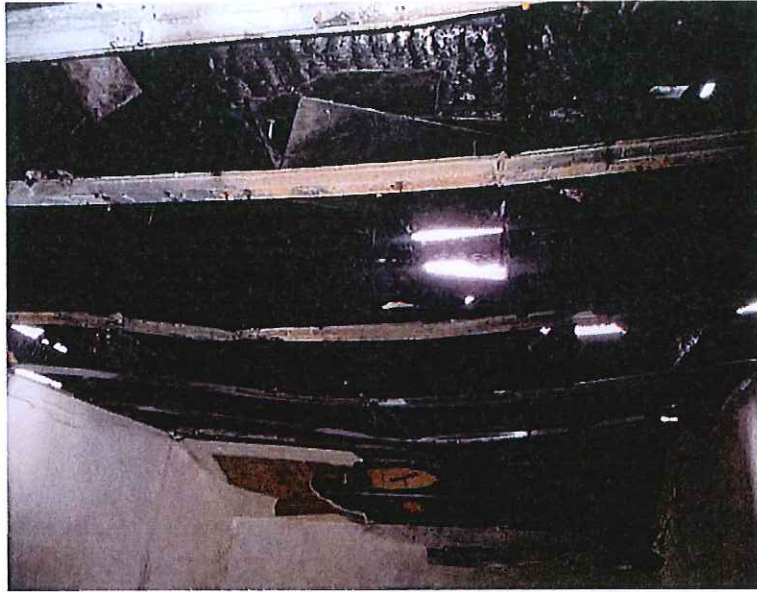
Photo 3

- We then visited the First Floor. Two units at the southeast corner were blocked off due to the partial collapse of the floor above and we observed them from the corridor. We entered the other units. The first floor appeared to be okay with some water damage and debris from the above. We went to the second floor of each unit and we noticed that the existing roof over the southern units was extensively burnt and damaged. Please see Photos 3 and 4. In addition, it appeared that the interior beam supporting the existing shed roof and the clerestory wall above was also compromised due to the fire. The units on the north side of the corridor didn't have fire damage but had extensive water damage due to the roof damage. Please see Photo 5.
